Tree Inventory Report

REXFORD L.A.X. INDUSTRIAL
9000 Airport Boulevard
Los Angeles, California

February 21, 2024

**Subject: Arborist tree survey and Report for Rexford LAX Industrial Project 9000 Airport Boulevard
Los Angeles, California**

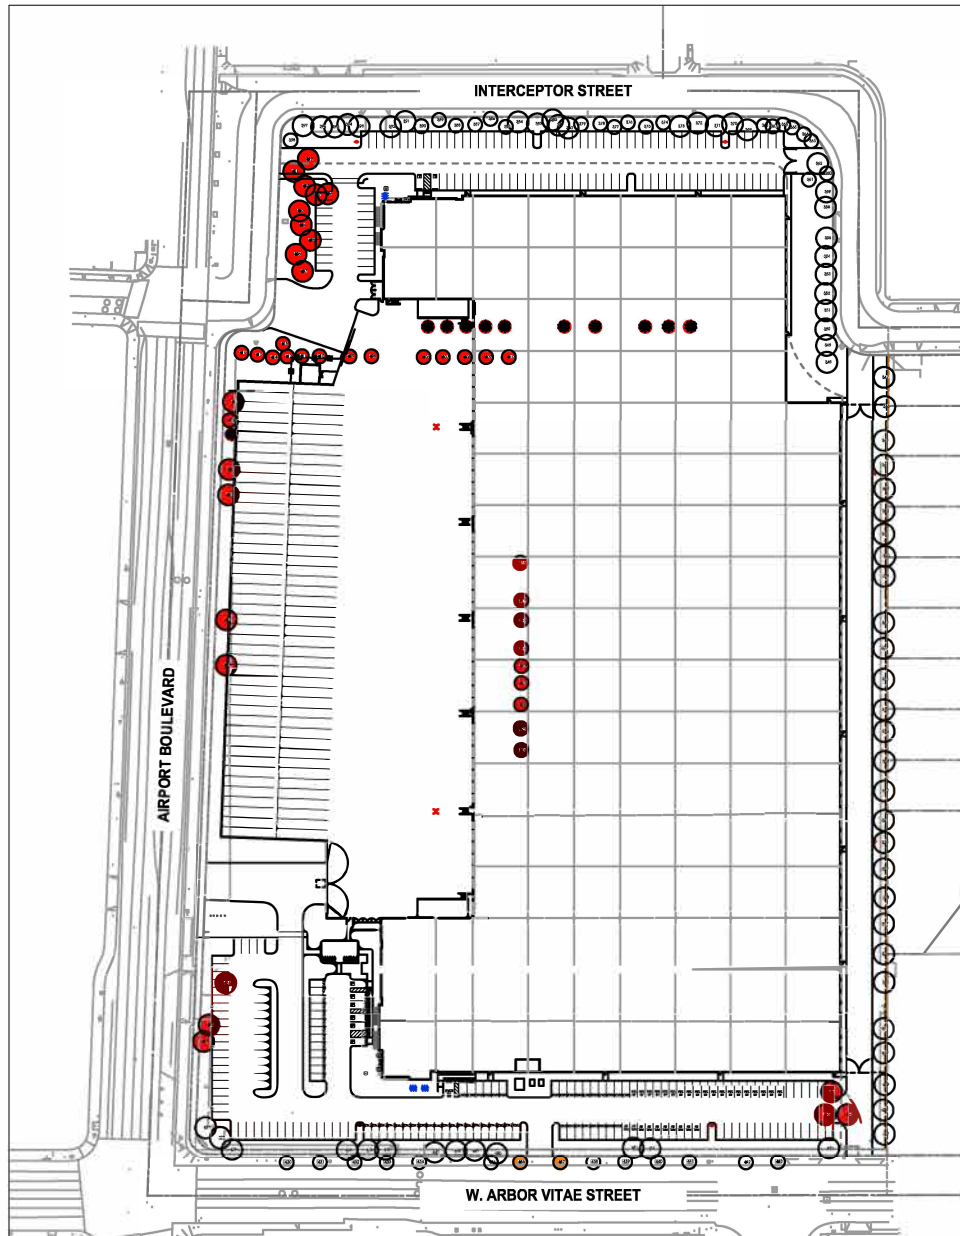
OPTION 1 PLAN

- (45) ONSITE TREES TO BE REMOVED
 - NO TREE REMOVAL RATIO
- (11) ONSITE PALMS TO BE REMOVED
 - NO TREE REMOVAL RATIO
 - REFER TO TREE TABLE FOR SPECIES TYPE

- (2) STREET TREES TO BE REMOVED (#436, 437)
 - TREE REMOVAL RATIO 2:1
 - REFER TO TREE TABLE FOR SPECIES TYPE

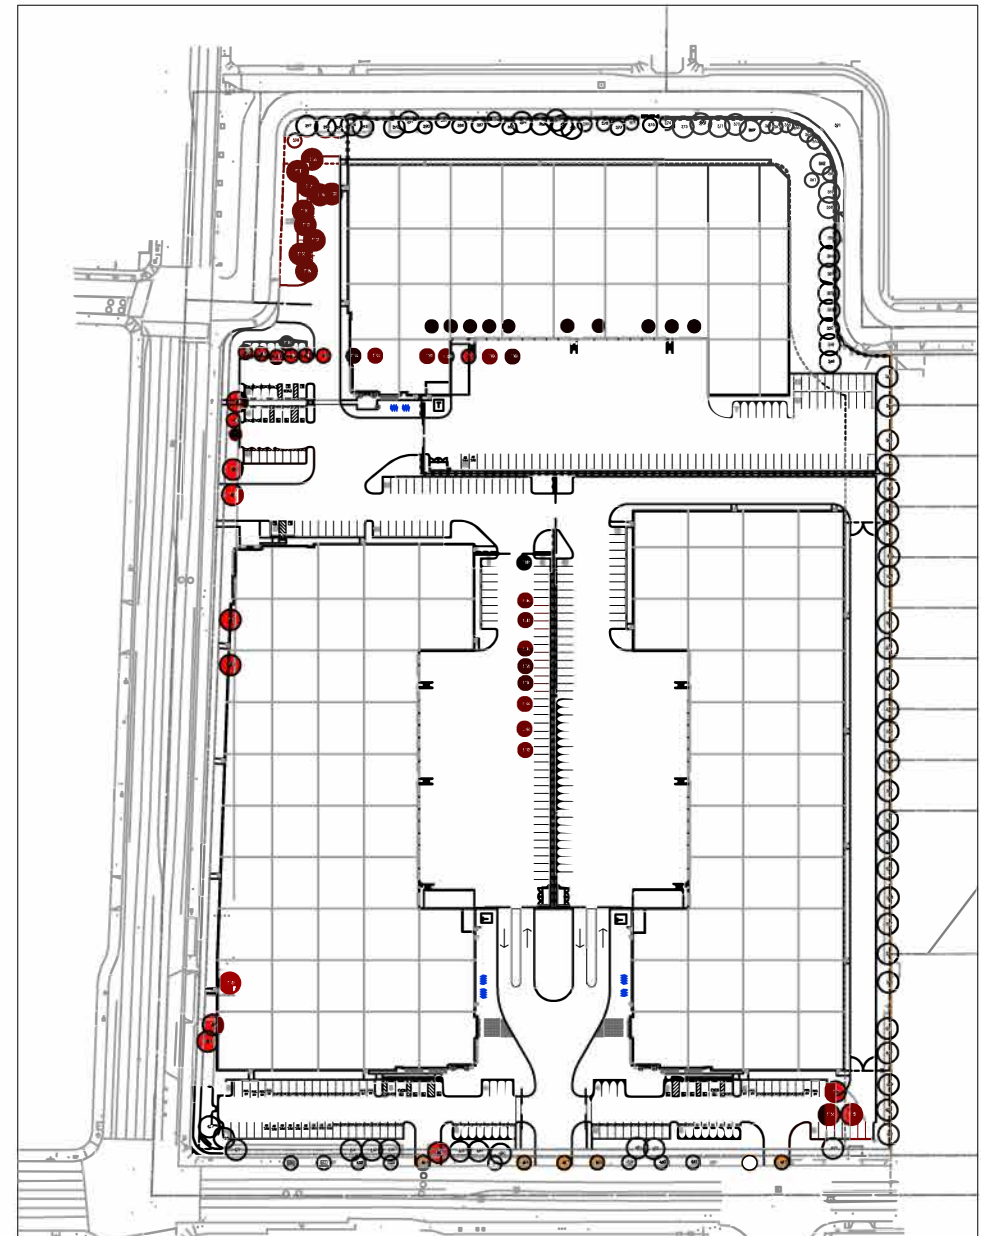
OPTION 2 PLAN

- (46) ONSITE TREES TO BE REMOVED
 - NO TREE REMOVAL RATIO
- (11) ONSITE PALMS TO BE REMOVED
 - NO TREE REMOVAL RATIO
 - REFER TO TREE TABLE FOR SPECIES TYPE

- (5) STREET TREES TO BE REMOVED (#434, 436, 437, 438, 443)
 - TREE REMOVAL RATIO 2:1
 - REFER TO TREE TABLE FOR SPECIES TYPE
