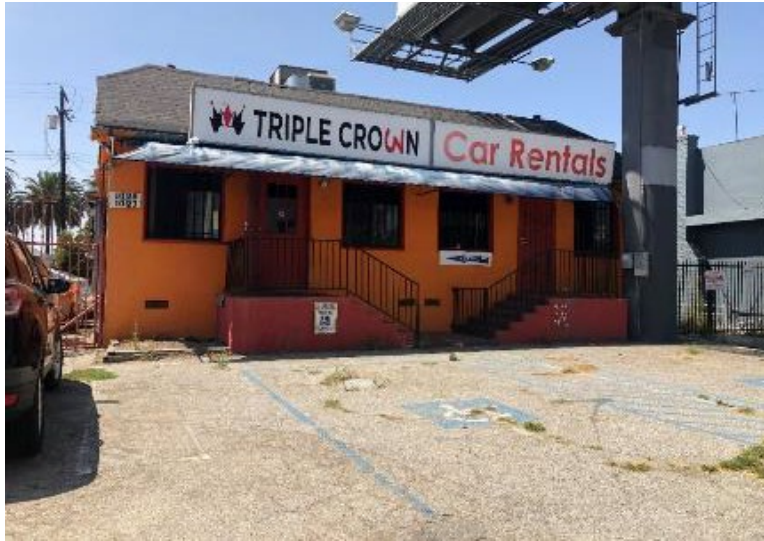
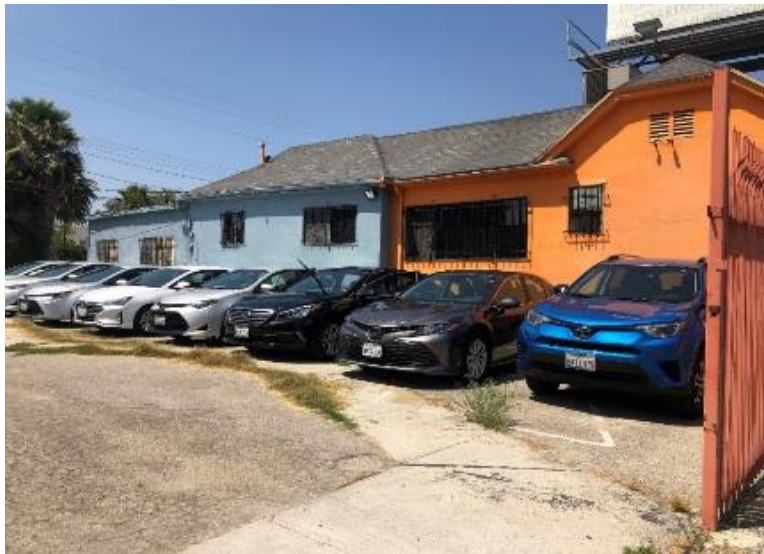
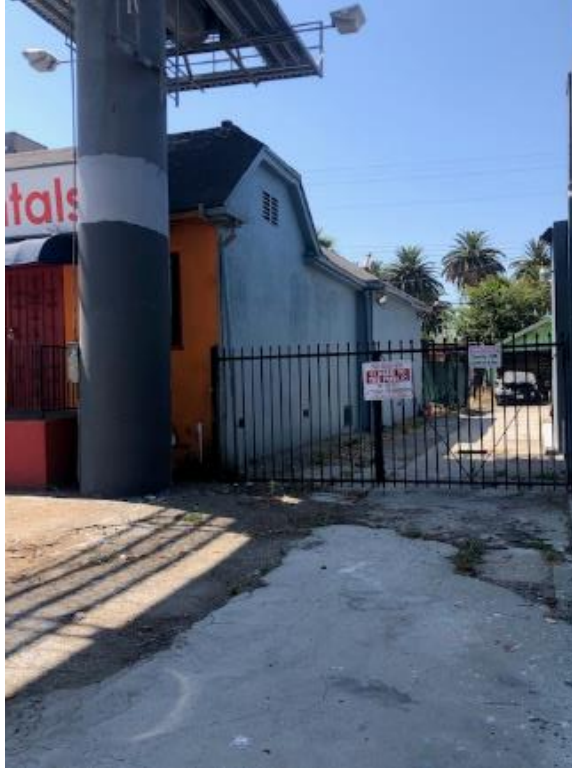
**Figure 1A. 1025–1027 Crenshaw Boulevard**  
 SOURCE: Sapphos Environmental, Inc., 2020

**Figure 1B. 1025–1027 Crenshaw Boulevard**  
 SOURCE: Sapphos Environmental, Inc., 2020

**Figure 1C. 1025–1027 Crenshaw Boulevard**  
SOURCE: *Sapphos Environmental, Inc.*, 2020

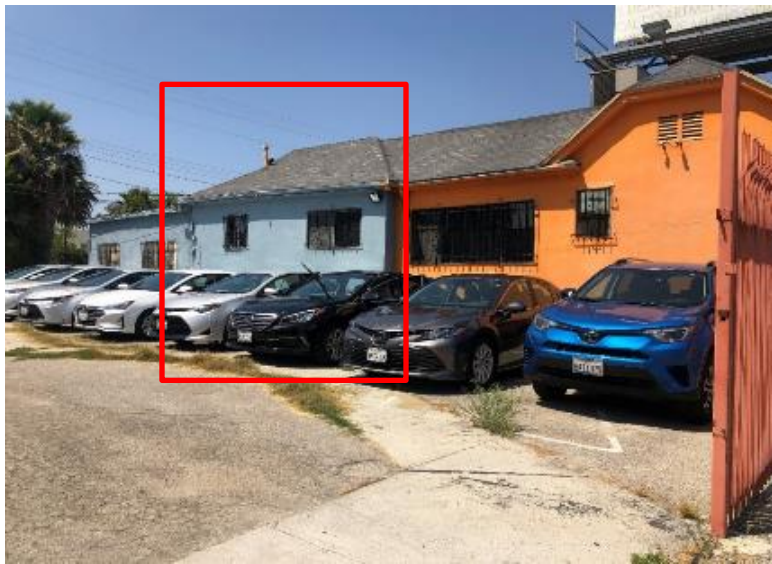
**Figure 3. Southwest Façade Showing Rear Addition**  
 SOURCE: Sapphos Environmental, Inc., 2020

2. Addition of security bars over windows (Figure 2)
3. Rear addition with hipped roofs and vinyl windows near center of the building<sup>17</sup> (Figure 3, *Southwest Façade Showing Rear Addition*; Figure 4, *Historic Drawing of Crenshaw Women’s Center without Rear Addition, 1970–1972*; Figure 5. *Historic Aerial 1964*; Figure 6. *Historic Aerial 1972*)

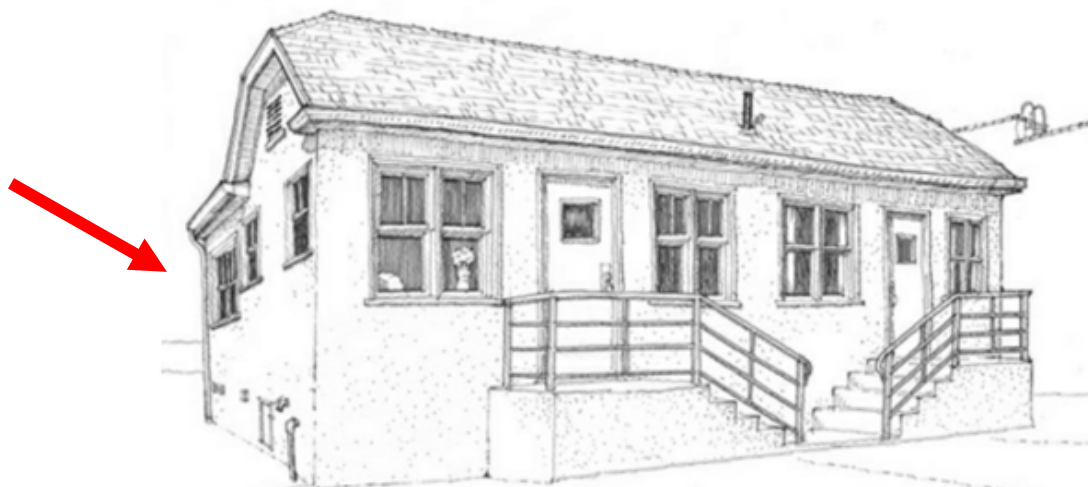
**Figure 4. Historic Drawing of Crenshaw Women's Center without Rear Addition, 1970–1972**  
 SOURCE: *Constructive Feminism: Women's Spaces and Women's Rights in the American City*  
 by Daphne Spain

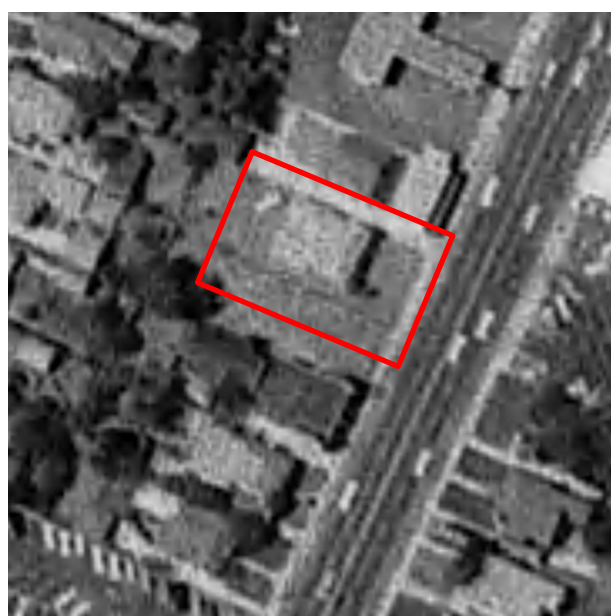
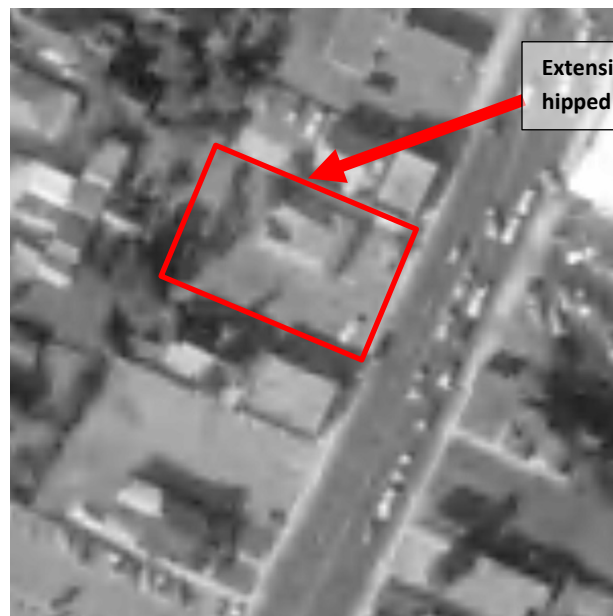
**Figure 5. (Left) Historic Aerial, 1964; Figure 6. (Right) Historic Aerial 1972**  
 SOURCE: *Historicaerials.com*

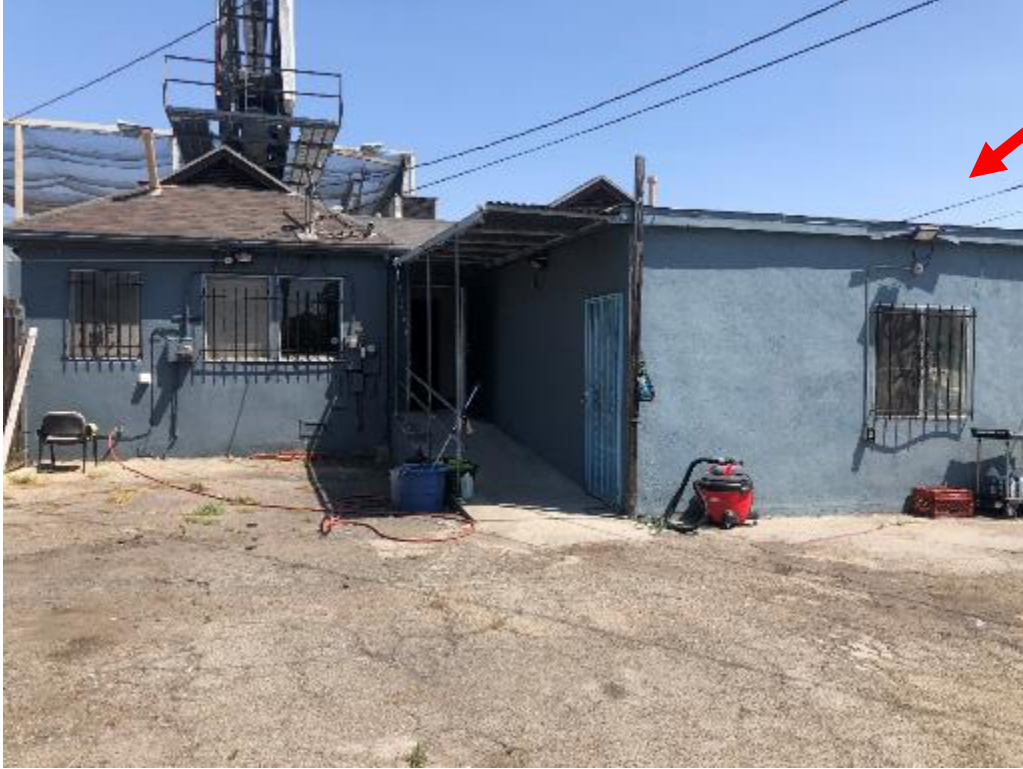
**Figure 7. Rear Addition with Differing Material and Roofline**  
 SOURCE: Sapphos Environmental, Inc., 2020

4. Rear addition added to the northwest façade with an entrance door and ramp after 1980 (Figure 7, *Rear Addition with Differing Material and Roofline*; Figure 8, *Historic Aerial, 1980*; Figure 9. *Historic Aerial 2003*)

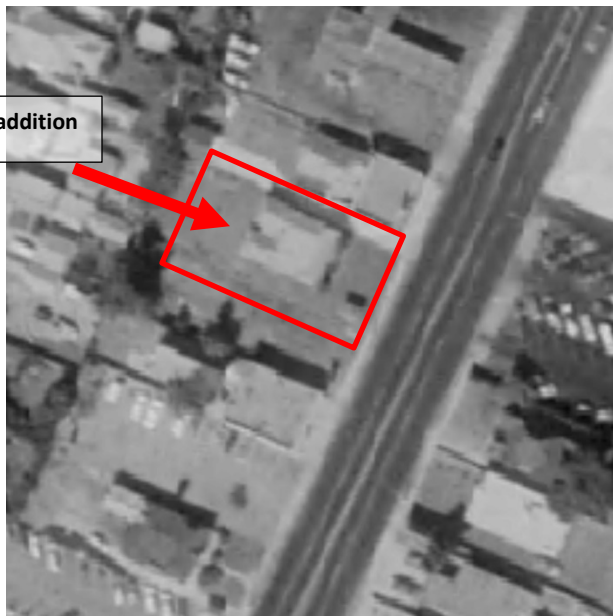
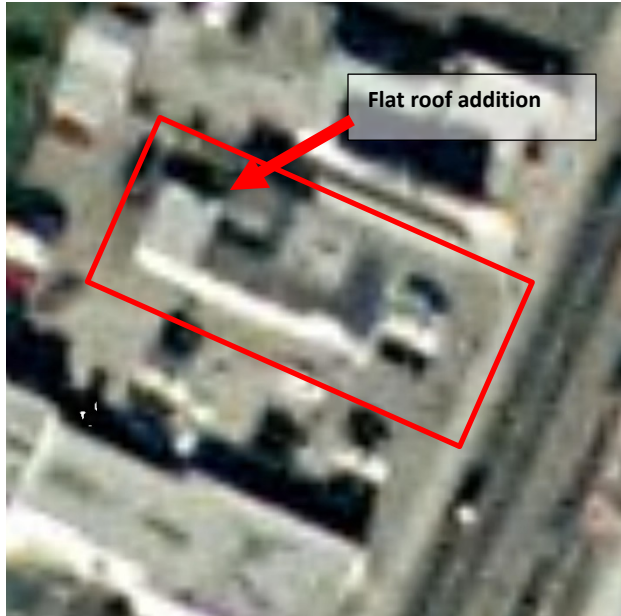
**Figure 8. (Left) Historic Aerial, 1980; Figure 9. (Right) Historic Aerial, 2003**  
 SOURCE: *Historicaerials.com*

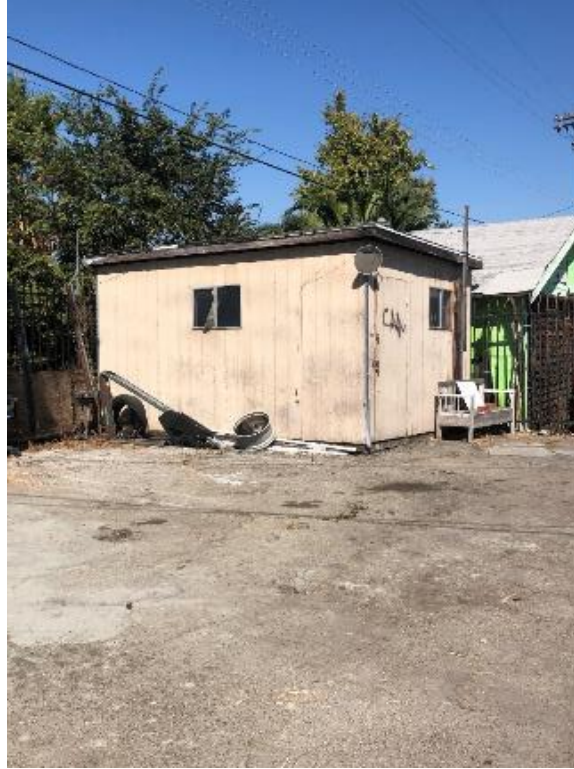
**Figure 10. Detached Garage (view north)**  
 SOURCE: *Sapphos Environmental, Inc.*, 2020

5. Addition of rear detached garage and removal of playground equipment (Figure 10, *Detached Garage*)
6. Extensive remodel of the interior of the building (Figures 11A–B; *Historic Interior 1971*; Figure 12A–G, *Current Interior*)

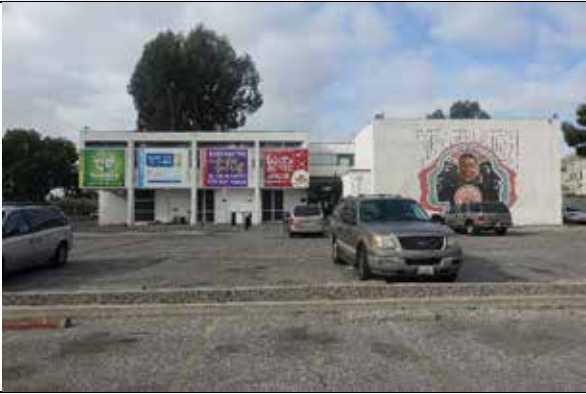
| Feature Number | Photograph | Estimated Date | Feature type | Historically Significant | Description | Condition class | Condition description | Recommendations for Treatment |
|---|---|---|---|---|---|---|---|---|
| 8-1 | | c. 1970 - 1971 | Asphalt parking lot | No | Asphalt parking lot | Poor | Cracked; stained with oil and gasoline; slight dome in center to enable drainage to external edges of the parking lot; under the weight of vehicles the asphalt has compressed and sunk in certain locations creating opportunities for water pooling and poor drainage | Rehabilitation <ol style="list-style-type: none"><li>1. In consideration of the recent passing of Measure W, consider replacing asphalt with more permeable concrete or pavers.</li><li>2. Regrade to prevent pooling water and insure appropriate runoff.</li><li>3. Consider directing water runoff in neighboring planting beds (see rehabilitation and reuse suggestions for Front Planting Beds in Softscape Treatment Table)</li></ol> |

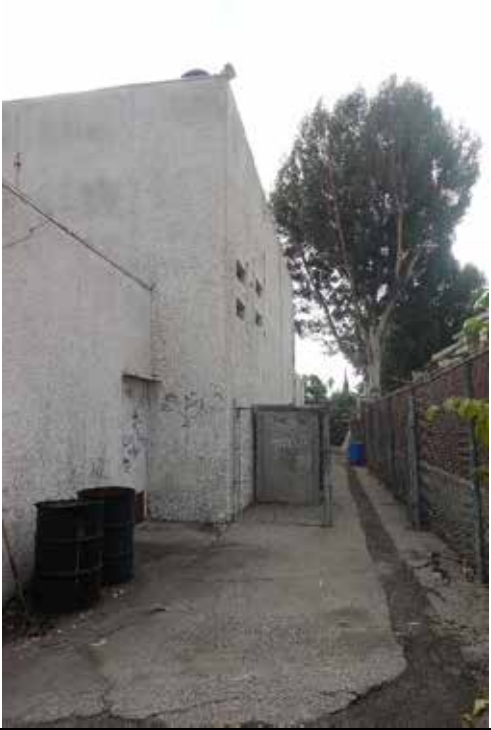
| 8-2 | | unknown | Asphalt alley | No | Asphalt alley | Poor | Cracked and stained asphalt with a separate section recently removed and replaced due to recent plumbing work; oil cans stand next to a back entry door; an electrical box is caged off by chain link fence that cuts off half of the alley to create a narrow pathway only accessible by pedestrians; chain link fence topped with barb wire is stretched along the back of the alley attached to a brown-red plexiglass fence blocking the view of the next-door neighbors | Rehabilitation <ol style="list-style-type: none"> <li>1. Remove and replace portions of the asphalt with more permeable paving in the locations requiring vehicular access.</li> <li>2. Consider replacing asphalt with more permeable materials.</li> <li>3. Grade to prevent pooling and insure appropriate runoff</li> <li>4. Extend garden or planting area out into the alley as is represented in some of the building's original renderings by Kennard and Silver Architects.<sup>1</sup></li> <li>5. Plant trees to develop a protective and cooling canopy.</li> </ol> |

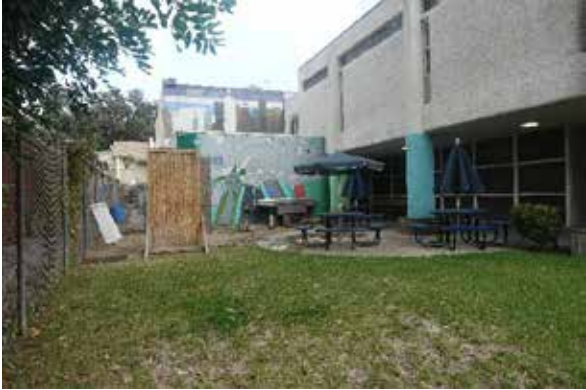
| 8-3 | | Unknown, possibly c. 1971 | Patio extension with central dip | Yes | A rounded patio extension currently with a central cutout and central dip containing large rocks | Fair | The concrete is of a different composition than the rest of the patio space with a larger concentration of smooth river rocks; the central break and circle contains large rocks; at present it is being used for water collection; plastic picnic tables with umbrellas are placed on the patio extension; there are colorful designs on the patio and it is unclear if they are painted permanently on them or removable chalk | I am unaware of the historical use of this patio and central dip and this requires more research before I can make recommendations. It may have been designed by landscape architect Garrett Eckbo who worked with Kennard and Silver Architects frequently, but I have been unable to locate any original design and planting plans for the landscape. |

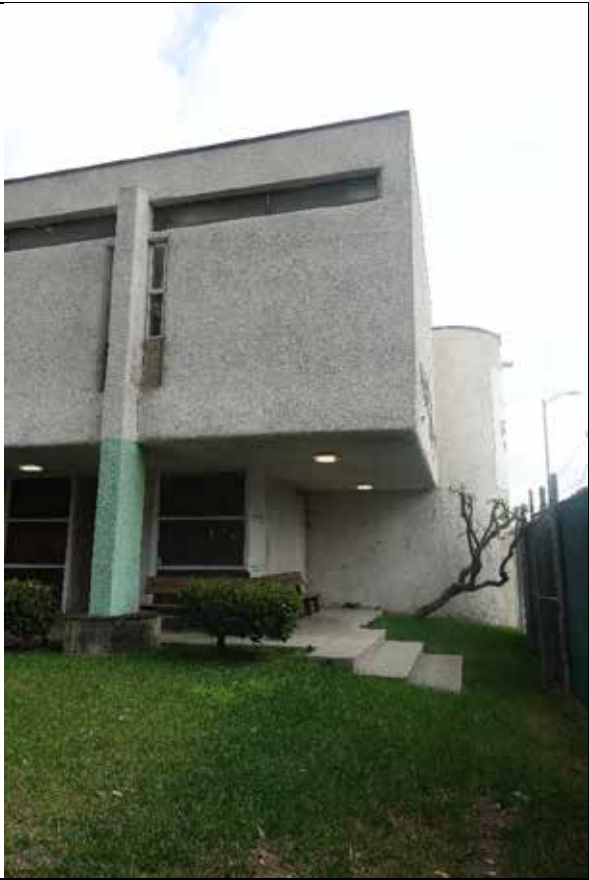
| 8-4 | | c. 1969 | stairs | Yes | Historical concrete stairs | Fair <ul style="list-style-type: none"><li>A large bottom slab connecting the upper patio area and the sidewalk is missing</li></ul> | The last three concrete stairs that used to be connected to a lower concrete slab that connected to the outer sidewalk. Concrete still seems in good condition. | Rehabilitation, but Redesign Necessary <ul style="list-style-type: none"><li>These stairs were a part of the original circulation design of the outer landscape and accessibility to the building.<sup>2</sup></li><li>1. A walk way is needed to connect the upper patio area to the sidewalk as originally intended by the designers, but the stairs do not meet current ADA requirements. Therefore, they should be replaced with an ADA compliant ramp.</li></ul> |

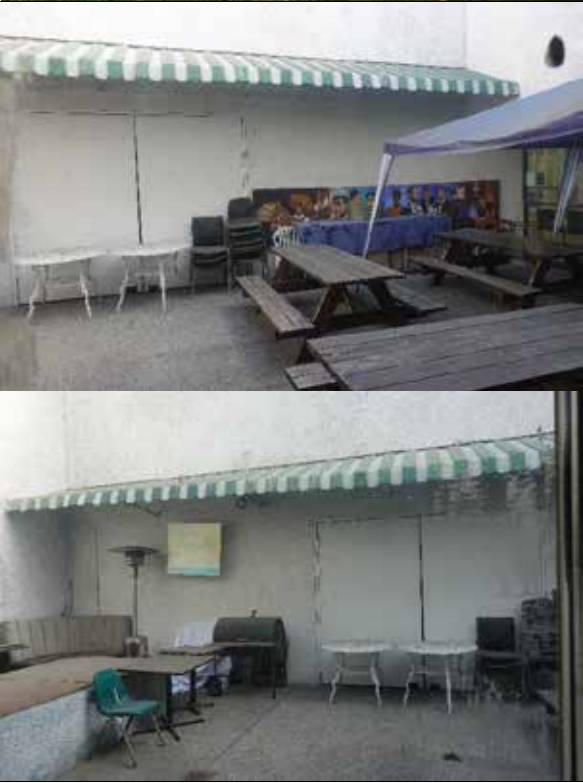
| 8-6 | | Unknown;<br>post 1969 | Watts Coffee House Patio | Yes | Watts Coffee House Patio | Fair | <ul style="list-style-type: none"> <li>Patio is enclosed in the center of the building with only one way to enter and exit.</li> <li>Two doors on one side are permanently closed.</li> <li>Concrete pavement with large aggregates</li> <li>A small drain in the center</li> <li>Fountain designed by a local artist remains unfinished and is used to store other materials.<sup>5</sup></li> <li>Awnings established on two sides to provide shade.</li> <li>Filled with patio furniture, outdoor heaters, and a grill.</li> </ul> | Improvements Needed <ul style="list-style-type: none"> <li>Awnings should be removed as it is believed by Rita Cofield that the original designers would not want them.</li> <li>Shade should be provided in other ways such as bringing in large, potted trees to provide a natural canopy.</li> <li>The fountain should be finished and allowed to run which would also improve local microclimate.</li> <li>A second entrance/exit is required to meet current codes.</li> </ul> |

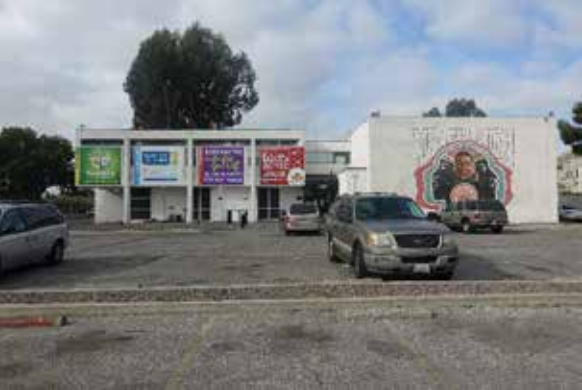
| Feature Number | Photograph | Common Name | Botanical Name | Quantity | Site Description | Condition Class | Date of Introduction | Historically Significant | Treatment Recommendations | Priority |
|---|---|---|---|---|---|---|---|---|---|---|
| 8-7 | | Not Applicable | Not Applicable | 0 | Parking Lot Planting Islands | Poor <ul style="list-style-type: none"><li>No vegetation at present</li><li>Soil surface is covered with river stones</li><li>Not known if there is an irrigation system installed</li></ul> | unknown | No | Reuse <ul style="list-style-type: none"><li>Should consider widening or in other ways redesigning planting islands if possible.</li><li>Test soil for compaction, petrochemicals, heavy metals, salinity, and nutrient availability and make appropriate changes. If toxicity levels are high, soil may need to be removed and replaced.</li><li>Install or fix present irrigation system<ul style="list-style-type: none"><li>A drip irrigation system may be better for smaller beds, but would likely require more maintenance.</li></ul></li><li>Implement a new planting plan that should provide shade, be heat and sun tolerant, preferably has low water requirements, and provides other desired purposes such as attracting wildlife and pollinators or could capture and filter stormwater and run off from the parking lot.</li></ul> | 2 |

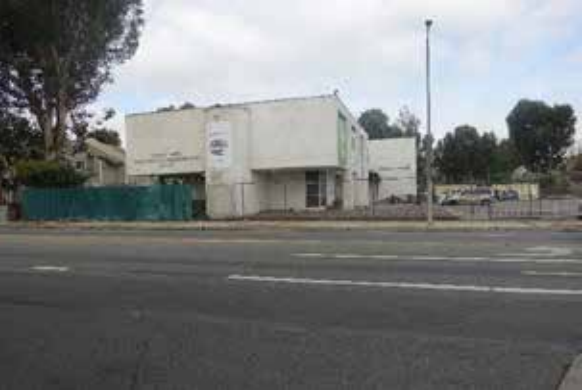
| Feature Number | Photograph | Common Name | Botanical Name | Quantity | Site Description | Condition Class | Date of Introduction | Historically Significant | Treatment Recommendations | Priority |
|---|---|---|---|---|---|---|---|---|---|---|
| 8-8 | | Not Applicable | Not Applicable | 0 | Front Planting Beds | Poor <ul style="list-style-type: none"><li>No vegetation at present; open vegetation beds have a layer of river stone</li><li>According to an interview with Rita Cofield by Peyton Hall, it is believed an irrigation system is installed.</li><li>A few volcanic rocks are in the front.</li><li>In the same interview, Rita Cofield recalled a drought tolerant landscape had been installed</li></ul> | 1969 | Yes | Rehabilitation and Reuse <ul style="list-style-type: none"><li>Historical plantings included a tropical and non-native plant palette that provided lush foliage texture and shade for the building and pathways. Historical photos show a diverse planting palette including an understory of ivy, possibly some bromeliads, finely pruned shrubbery, tall and leggy <i>Yucca sp.</i>, <i>Nandina domestica</i>, palms, and a large tree which could be either a European plane tree (<i>Plantanus sp.</i>) or a native sycamore (<i>Platanus racemosa</i>).<sup>7</sup></li><li>Maintain historic layout of front beds</li><li>Test soil for compaction, petrochemicals, heavy metals, salinity, and nutrient availability and make appropriate changes. If toxicity levels are high, soil may need to be removed and replaced.</li><li>Test irrigation system and make appropriate repairs.</li><li>Replant a canopy of trees</li><li>Implement new planting plan and design that:<ul style="list-style-type: none"><li>follows a similar aesthetic and provides</li></ul></li></ul> | 1 |

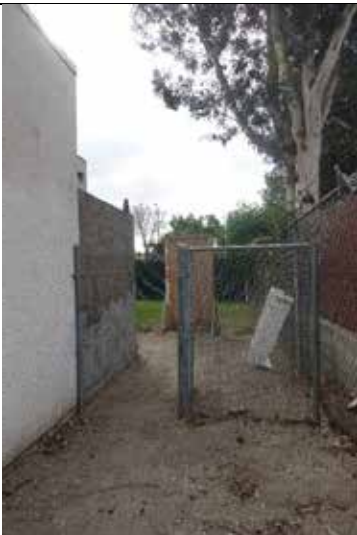
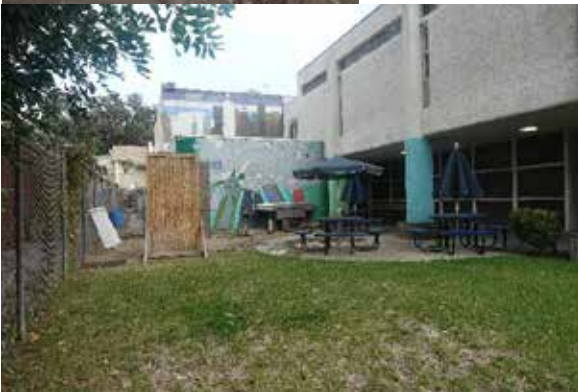
| 8-9 | <div></div> <div></div> | | Not Applicable | Not Applicable | See Vegetation Table Below | Back Yard | Poor <div><ul style="list-style-type: none"><li>· Site is surrounded by chain link fence topped with barbed wire.</li><li>· Two entrances, one from back chain link fence and gate, and the other from the building.</li><li>· Grass is patchy</li><li>· Soil is heavily compacted</li><li>· Exposed soil in about one third to one half of the site</li><li>· Shrubs are minimal and badly pruned</li></ul></div> | c. 1970 or later | Yes | Rehabilitation and Reuse <div><ul style="list-style-type: none"><li>· According to Esther Hovey’s dissertation “The Mafundi Preschool,” the back yard was originally assembled in around 1970 as an outdoor lawn and play space for the Mafundi Preschool.<sup>8</sup></li><li>· In addition, according to an interview with Rita Cofield by Peyton Hall, it is believed there used to be a small stage that was later removed.<sup>9</sup></li><li>· Historical photos show a very different planting design as recently as the early 1980s consisting of lawn in the back landscape, some sharply pruned evergreen shrubs, a small tree, and a thick understory of ivy around the borders of the stairs. Most of these plantings are gone with the exception of the grassy lawn.<sup>10</sup></li></ul></div> <div><ol style="list-style-type: none"><li>1. Test soil for compaction and toxicity levels, and make appropriate changes. If toxicity levels are high, soil may need to be removed and replaced.</li><li>2. Test irrigation system and make appropriate repairs.</li><li>3. Rebuild stage if desired by current staff and instructors.</li><li>4. Redesign planting beds to include plants of contemporary use for educational and other purposes:<div><ul style="list-style-type: none"><li>- Alternative plantings could be drought tolerant, native pollinator gardens, vegetable and herb beds, or bioswales for stormwater capture and filtration.</li></ul></div></li><li>5. Replant trees for shade</li><li>6. Push back the gate further into the back alley, and extend back yard space and plantings.</li></ol></div> | 1 |

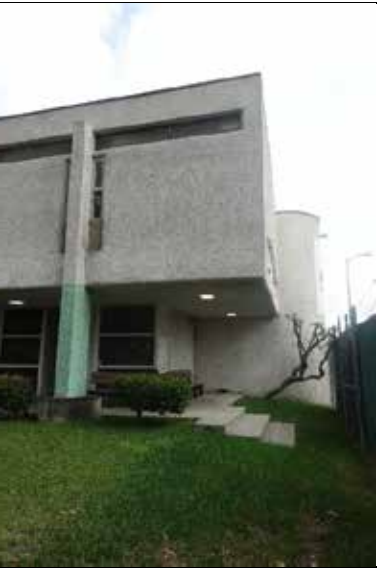
| 8-12 | | | Heavily pruned, small tree | Cannot identify from photographs | 1 | Back Yard | Fair <ul style="list-style-type: none"> <li>Seems to be producing healthy foliage</li> <li>But badly pruned each year</li> </ul> | Post 1970 | No | Rehabilitate or Replant <ol style="list-style-type: none"> <li>Tree should undergo a different maintenance regime allowing for better pruning approaches, regular fertilizing, and proper soil care.</li> <li>The tree should also undergo analysis for any diseases or pests.</li> <li>Or, the tree should be removed and area replanted with a new tree that will provide shade and follow similar planting designs of the past as shown in photographs.<sup>11</sup></li> </ol> | 28 | |

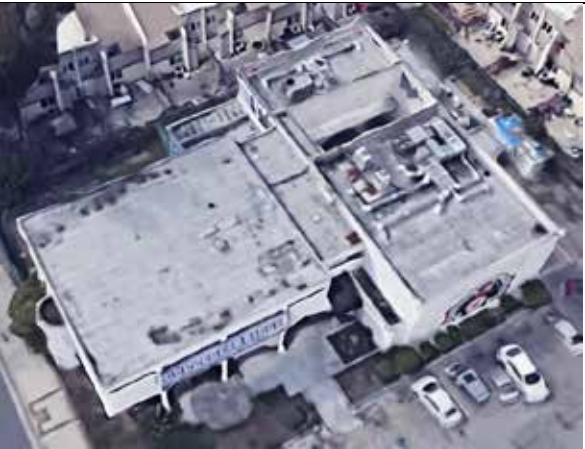
| Feature Number | Photograph | Estimated Date | Feature type | Significant | Description | Condition class | Condition description | Recommendations for Treatment |
|---|---|---|---|---|---|---|---|---|
| 13-1 | <br><br> | 1969 | Roofing | No | <p>The building roof is not visible from the ground and therefore does not impact the historic character of the building. Based on Google Maps imaging and the age of building construction, the existing roofing is likely a 2-ply modified bitumen, original to the building.</p> <p>There are scuppers, some of which have downspouts, around the building. For scuppers that do not have downspouts, there is not staining on the building wall below. This indicates they are likely secondary drains in case the primary drains become clogged.</p> <p>The thermal performance of the roofing is unknown.</p> | Fair | <p>There have been leaks from the roofing above into the interior space below, including into the Watts Coffee House. There are water stains at the corner of the Watts Coffee House (red arrow). Isolated repairs have been performed at the roofing to address past water infiltration. Based on past water infiltration, the roofing appears to be near the end of its service life.</p> | <p>A visual survey of the roofing should be performed to evaluate the condition of the existing roofing. Drains can be flood tested to evaluate water tightness. The visual survey and water testing will help determine the exact roofing condition and approximate remaining service life. Once the roofing has reached the end of its service life, the following are recommendations for reroofing:</p> <p>The roofing should be replaced with a new single-ply PVC roofing membrane. The roofing should be installed over 1/2 in. thick primed cover board and polyisocyanurate insulation. Tapered insulation should provide positive slope to drain of 2%, or minimum 1% if existing conditions do not allow for 2% slope.</p> <p>While the California Historical Building Code exempts the building from minimum insulation requirements for reroofing, additional insulation will improve the energy performance of the building without changing the historic character. A higher roof insulation R-value will also make mechanical HVAC equipment more efficient. At a minimum, it is recommended to meet the California Energy Code insulation requirements for reroofing, consisting of R-8 minimum continuous exterior insulation and a U-value of 0.082 for the roof assembly. Additional insulation build up can be provided as existing conditions allow.</p> <p>At mechanical penetrations, curbs, and other vertical elements turn up roofing 8 in. and providing stainless steel reglet and counterflashing to protect the leading edge of roofing. Mechanical equipment should be raised as required to allow 8 in. upturn.</p> <p>While downspouts are recommended at overflow scuppers from a waterproofing perspective, they will be highly visible. If primary roof drains become clogged, water will drain out of scuppers and stain the building exterior. In lieu of downspouts at highly visible overflow scuppers, maintenance staff should periodically review roof drains and ensure drains are functioning and clear of debris.</p> |

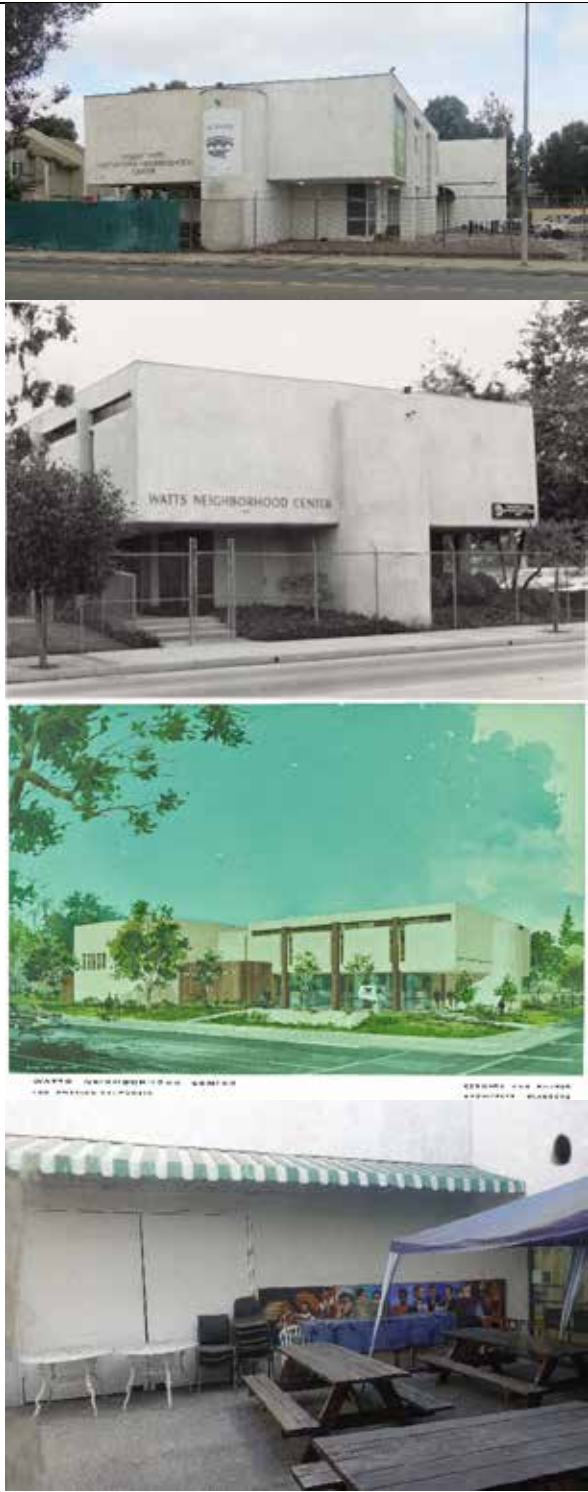
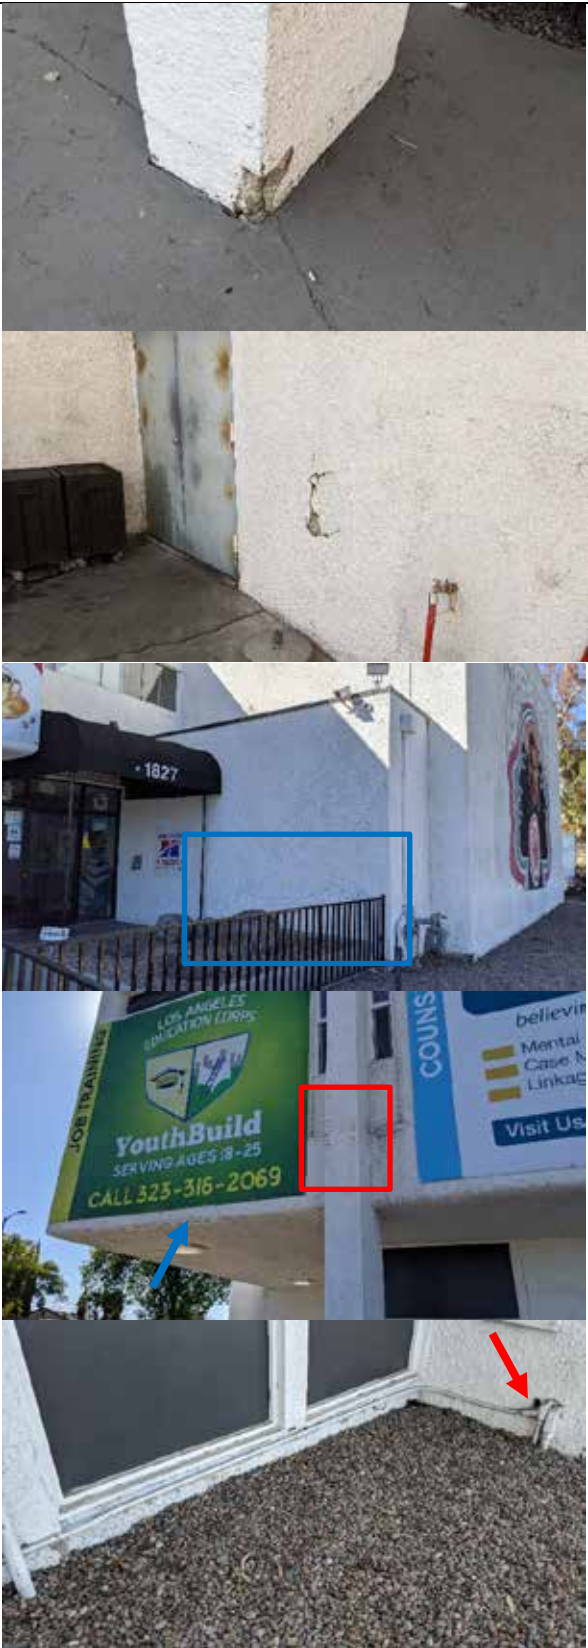
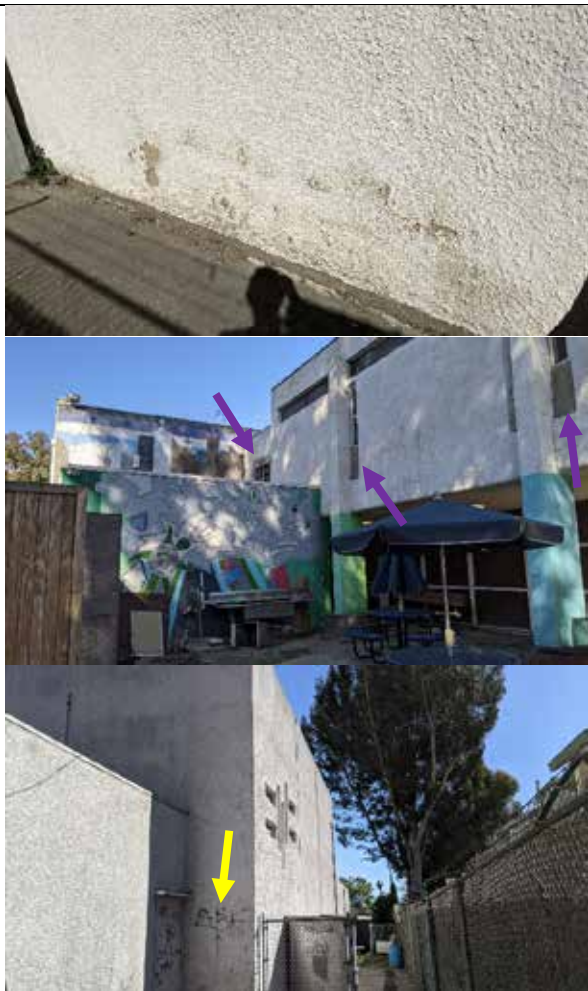
| 13-2 | | 1969 | Walls | Yes | <p>The building walls and columns are a prominent feature of the modernist building given the building geometry and sparse use of windows.</p> <p>The exterior walls and columns consist of a stucco parge coat over concrete structure substrate. The stucco is approximately 1/8 to 1/4 inches thick, and appears to consist of a scratch coat and finish coat. The stucco finish coat is white. Historical photographs confirm this was the original building finish. A historic rendering confirms the original color of the stucco finish.</p> <p>A metal awning was added to the patio seating area. The awning was not original to the building and does not match the modernist building design.</p> <p>The thermal performance of the walls is unknown.</p> | Fair | See next page for photos and condition description. | <p>All delaminated, spalled, or damaged stucco should be removed and the concrete substrate examined. Spalled concrete substrate will need to be removed, corroded reinforcement cleaned and coated with a corrosion inhibiting coating, and patched with polymer modified repair mortar. Sawcut the edges of the concrete patch perpendicular to the surface to avoid feather edges. Replace stucco with Portland Cement based scratch coat and finish coat to match the existing stucco thickness; a bonding agent can be applied at the new-to-existing stucco joint. The finish coat of the stucco should match the existing stucco finish.</p> <p>Hairline cracks can be sealed with a thin slurry coat consisting of finish coat. Wider non-moving cracks can be floated, consisting of applying fiberglass tape down the length of crack and applying joint compound over crack extending 6 in. on either side of crack.</p> <p>Remove any unused fasteners. Fastener holes should be sealed or patched. The metal awning in the patio seating area should be removed and fastener holes sealed.</p> <p>Remove previous stucco infill / patches at west windows and install windows or new stucco patches to match original construction per historic photos. If installing new stucco, finish coat should match existing stucco.</p> <p>The stucco surface should be cleaned using a low-pressure water wash. Non-ionic detergents and scrubbing with natural bristle brushes can be performed as required at areas of heavy staining. An additional finish coat or paint matching the existing stucco finish will likely need to be used at graffiti.</p> <p>Mockups should be performed for all of the recommended repairs at less visible areas in the back of the building to evaluate quality of repairs and matching of the existing stucco finish.</p> <p>As an option to improve the waterproofing performance of the walls, a breathable, clear silicone based elastomeric coating can be applied to the stucco surface. Silicone coatings have high vapor permeability and can generally bridge cracks up to 1/16 in. wide. However, while clear, these coatings can slightly darken or modify the sheen of the stucco. As an alternative, a polyurethane based elastomeric coating can be used instead which is still breathable, bridges cracks up to</p> |

| | | | | | | <p>There are isolated spalls of the concrete substrate. The stucco is cracked (blue arrow in photo below) and spalled at isolated locations.</p> <p>There are irregularities in the stucco finish adjacent to the entrance (blue box). The adjacent gravel was originally landscaping based on historic photographs, and these irregularities may be water damage from irrigation.</p> <p>There are several unsealed penetrations through the stucco for fasteners (red box) and mechanical equipment (red arrow) at the front of the building; there is corrosion staining on the building from the fasteners. Some of the fasteners are either no longer used, or the fasteners removed and holes left exposed. There is soiling on the stucco.</p> | <p>1/32 in. wide, and is available in multiple sheens and custom colors. Mockups of coating products should be performed to a small hidden portion at the back of the building to evaluate the aesthetic changes to the stucco.</p> |

| | | | | | | <p>The finish coat of the stucco is delaminated at the base of wall on the north portion of the west elevation.</p> <p>Windows on the back of the building have been infilled and/or patched with a cementitious material (purple arrows). The patches are darker than the adjacent stucco finish.</p> <p>There is graffiti on the backside of the building adjacent to a door (yellow arrow).</p> | | |

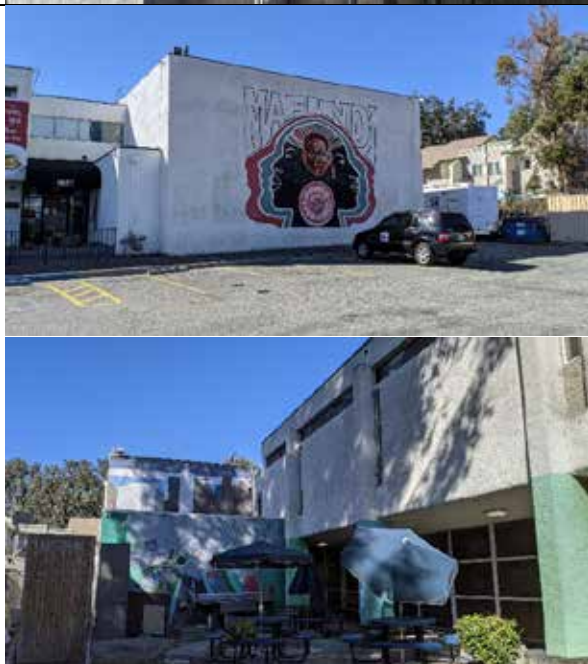
| 13-3 | | 1972 and unknown | Murals | Yes | <p>The exterior walls have several murals, including the Mafundi mural at the front of the building, which was painted in 1972. The mural consists of a black man's silhouette with the words "Power, Unity, Love, Peace" underneath. The Mafundi Institute, which provided black artists a space to display their work, occupied the building from 1969 to 1975. Since the Mafundi mural relates to the building's original use, it is historic.</p> <p>The backside of the building includes a couple murals near a landscaped area, although it is unclear when</p> | N/A | <p>A conservationist specializing in murals should review the condition.</p> | <p>An art conservation analysis should be performed of the murals. If a breathable elastomeric coating at the stucco is considered per recommendation above, the mural conservationist should evaluate appropriate treatment at murals.</p> |

| | | | | | these murals were added and their significance. The mural on the first level consists of a road with various arrows above. The mural on the second floor consists of a city skyline. | | | |

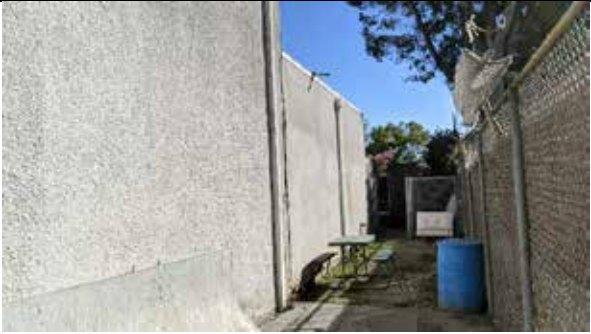
| 13-4 | | 1969 | Site Drainage | No | <p>The site drainage is unknown. We do not know if there is sub-drainage around the perimeter of the building.</p> <p>There are scuppers with downspouts at the building perimeter, but it is unclear if these are primary or overflow scuppers.</p> | Unknown | <p>Splash blocks are partially buried at the base of the downspout. However, the condition of the site drainage is generally unknown.</p> | <p>A civil engineer should be retained to assess site drainage and make recommendations. The building should have area drains and a subgrade drainage system installed if one does not currently exist.</p> <p>Splash blocks at base of down spouts should be replaced.</p> |

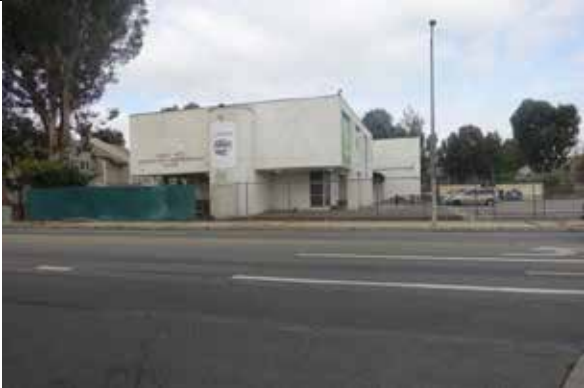
| Feature Number | Photograph | Estimated Date | Feature type | Significant | Description | Condition class | Condition description | Recommendations for Treatment |
|---|---|---|---|---|---|---|---|---|
| 6-1 | | 1969 | Foundation | Yes | The foundation of the building is constructed by continuous reinforced concrete spread footing on grade. | Good | The foundation of this building is original. There are no obvious failures or damage on the surface of reinforced concrete, from the perspective of structure, the foundation appears to be in good condition. | <ol style="list-style-type: none"> <li>1. According to the observation, there is no obvious problem on the foundation surface of the building, so it would probably be retained.</li> <li>2. Engage a structural engineer to assess the building.</li> </ol> |

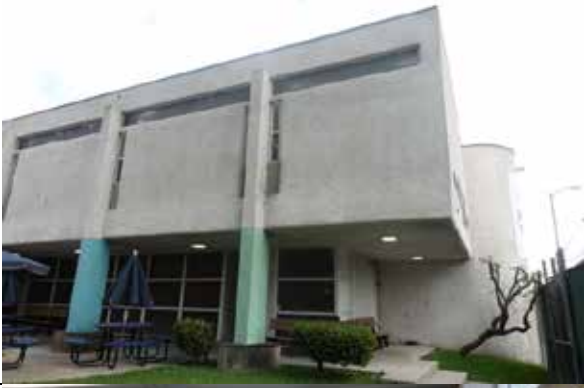
| Feature Number | Photograph | Estimated Date | Feature type | Significant | Description | Condition class | Condition description | Recommendations for Treatment |
|---|---|---|---|---|---|---|---|---|
| 6-2 | | 1969 | Column | Yes | The rectangular columns of the building, two stories high, appear to be made of reinforced concrete. | Good | The columns of the building seem to be original. The stucco on the surface of the columns is intact and has no cracks. From the structural point of view, it seems that the column is in good condition. | <ol style="list-style-type: none"> <li>1. Although from the surface, the column structure appears to be in good condition, in view of the older age of the building, engage a structural engineer to assess the building.</li> </ol> |

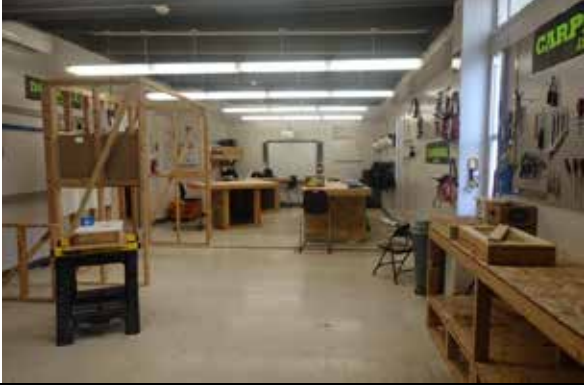
| Feature Number | Photograph | Estimated Date | Feature type | Significant | Description | Condition class | Condition description | Recommendations for Treatment |
|---|---|---|---|---|---|---|---|---|
| 6-3 | | 1969 | Second-floor framing | Yes | The second-floor framing appears to be wood. The wood beams above at the roof framing are level. | Good | The two-story wood structural frame is original and hidden above the ceiling. The wooden beams above do not appear to be damaged or cracked and look in good condition. | <ol style="list-style-type: none"> <li>1. It is recommended to retain it.</li> <li>2. The second-floor frame can be connected with the wall and ceiling to make the whole building stronger, which is helpful for its resistance to earthquakes.</li> <li>3. Engage a structural engineer to assess the beams and second-floor framing.</li> </ol> |

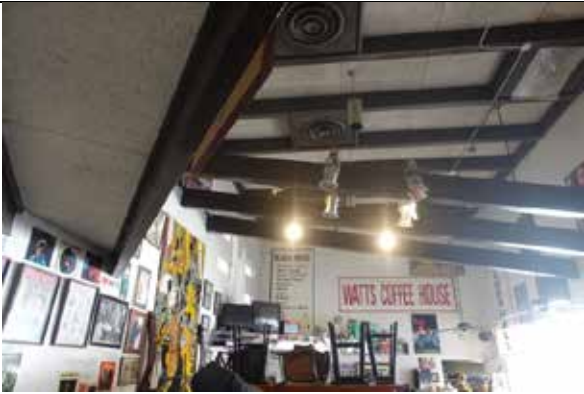
| 6-4 | | 1969 | Roof framing | Yes | The roof's structural framing appears to be wood and hidden above the ceiling. The wood beams above at the ceiling finish are level. Some wood beams below are placed obliquely over the walls and seem to brace them. But it's also possible that the wood beams are just decorative. | Good | The wood structural framing is original and hidden above the ceiling. The wood beams at the ceiling level also appear to be original. Slight abrasion can be seen at the edges of the beam surface, exposing the wood material inside. But the overall condition seems to be good. | <ol style="list-style-type: none"><li>1. It is recommended to retain it.</li><li>2. The roof frame can be connected with the wall and ceiling, so as to make the whole building stronger.</li><li>3. Engage a structural engineer to assess the beams and floor framing.</li></ol> |

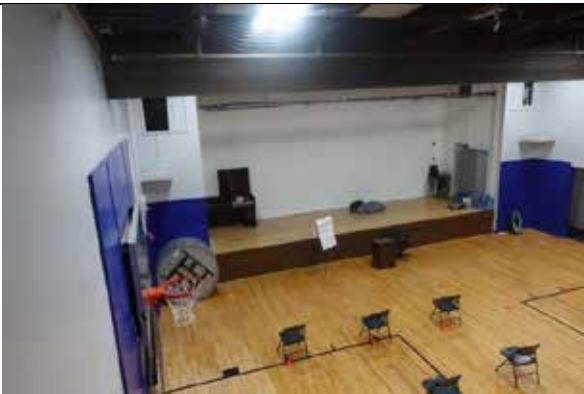
| 6-5 | | 1969 | Concrete slab on grade | Yes | This structure appears to be a reinforced concrete slab on grade. | Good | The reinforced concrete slab is original and hidden under the wood floor. There is no obvious failure on the wood floor above. From a structural point of view, it seems that the reinforced concrete slab is in good condition. | <ol style="list-style-type: none"><li>1. It is recommended to retain it.</li><li>2. Professional historical architectural engineers should pay more attention to the large space because it has large spans and two-story walls, which will exert greater pressure on the frame structure, concrete slab, and wooden beams. It is also suggested that engineers provide an assessment.</li></ol> |

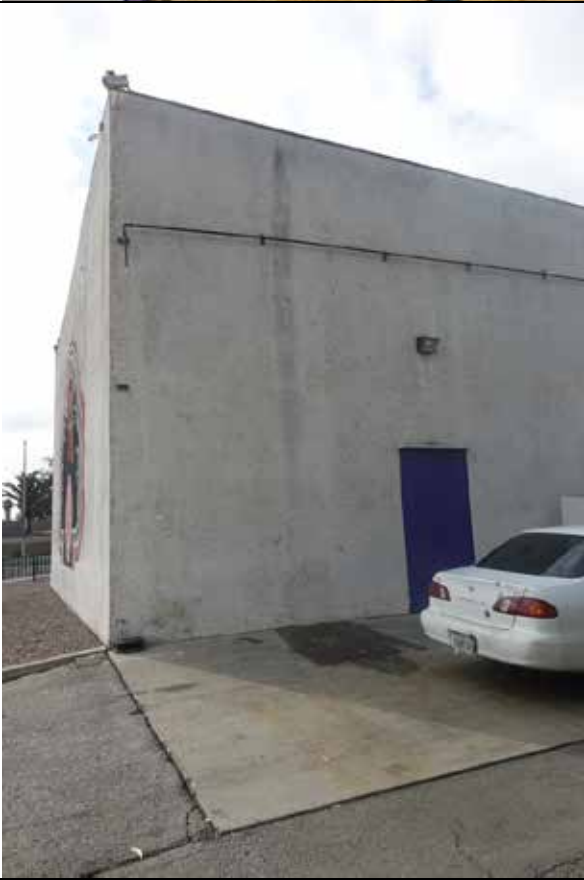
| 6-6 | | 1969 | Exterior wall | Yes | The external wall of the building appears to be constructed by reinforced concrete. | Good | Exterior wall painting is well preserved, with no obvious cracks. From a structural point of view, it seems to imply that the reinforced concrete inside is in good condition. | <ol style="list-style-type: none"><li>1. There are few openings in the building, which will not weaken the shear value of the exterior walls and help the lateral strength of the whole building. Therefore, it is recommended to avoid adding large openings.</li><li>2. Engage a structural engineer to assess the building.</li></ol> |

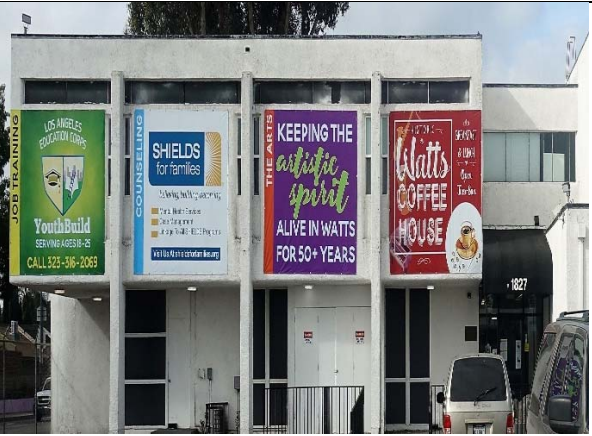
| Feature Number | Photograph | Estimated Date | Feature type | Significant | Description | Condition class | Condition description | Recommendations for Treatment |
|---|---|---|---|---|---|---|---|---|
| 7-1 | | c. 1969/1970 | Window | Yes | Front of building, East elevation, view is West. Examples of clerestory windows, vertical and horizontal windows, all fixed operability with the exception of the vertical single hung windows with a single movable sash, raised from the bottom for ventilation. All provide architectural mid-century modern design interest and originally provided natural light. Mix of metal and wood framing. Interior lobby view to exterior unavailable. | Poor | The first floor windows are no longer performing their intended purpose. The windows have been blacked out with painted plywood and have been replaced with acrylic sheets on the first floor, for security reasons. The historical character is greatly hindered. | Removal of black painted plywood blocking the window. Replace in acrylic sheets with energy conserving glass. Such as low emissions glass which reduces heat gain, low iron glass which provides glass that is more clear/unobstructed; insulated glass with internal thermal glazing. Wood framing with termite damage replace in kind with treated wood. Further field study needed. |

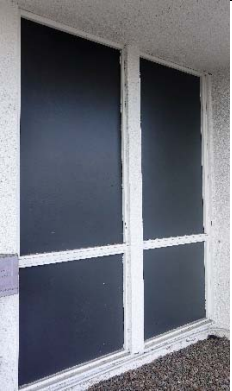
| Feature Number | Photograph | Estimated Date | Feature type | Significant | Description | Condition class | Condition description | Recommendations for Treatment |
|---|---|---|---|---|---|---|---|---|
| 7-2 | | c. 1969/1970 | Window | Yes | First floor windows. Wood framing. Altered from original glass with acrylic sheet which was scratched and etched with graffiti, now windows are blacked out. Painted plywood on the inside secures window openings. Fixed -inoperable. | Poor | The windows are no longer performing their intended purpose. These first floor windows have been blacked out with painted plywood and acrylic sheet on the first floor, for security reasons. | Removal of black painted plywood blocking the window. Replace in acrylic sheets with energy conserving glass. Such as low emissions glass which reduces heat gain, low iron glass which provides glass that is more clear/unobstructed; insulated glass with internal thermal glazing. Wood framing with termite damage replace in kind with treated wood. Further field study needed. |

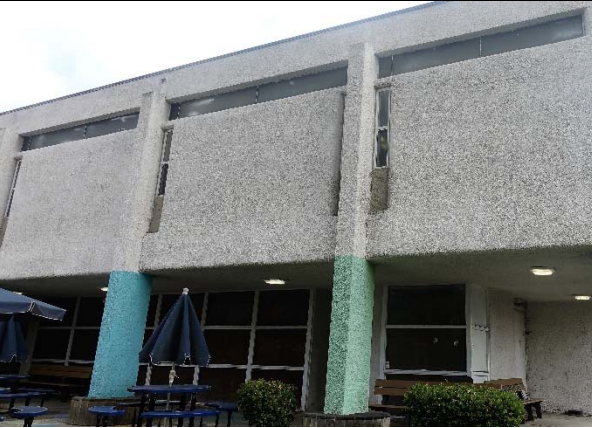
| Feature Number | Photograph | Estimated Date | Feature type | Significant | Description | Condition class | Condition description | Recommendations for Treatment |
|---|---|---|---|---|---|---|---|---|
| 7-3 | | c. 1969/1970 | Window | Yes | Windows facing the patio area at the rear of the building, West elevation, view is East/Northeast. 2 <sup>nd</sup> story – Fixed-inoperable clerestory windows with vertical windows flanking the stucco columns. Vertical single hung windows with a single movable sash, raised from the bottom for ventilation. 1 <sup>st</sup> floor horizontal windows with painted plywood on the inside block window | Poor | Both the first floor windows and the vertical windows flanking the stucco columns are no longer performing their intended purpose. These first floor windows have been blacked out with painted plywood and acrylic sheet on the first floor, for security reasons. Vertical windows that flank the stucco column have been altered by the lower 1/3 of the window removed and replaced with stucco. Unknown if the clerestory figured | First floor-Removal of black painted plywood blocking the window. Replace acrylic sheets with energy conserving glass. Such as low emissions glass which reduces heat gain, low iron glass which provides glass that is more clear; insulated glass with internal thermal glazing. Wood framing with termite damage replace in kind with treated wood. Remove lower 1/3 stucco from vertical windows and restore opening to original size. Replace vertical windows in kind to original size. Further field study needed. |

| | | | | | openings. Wood framing with possible termite damage. | | glass is original. | |
