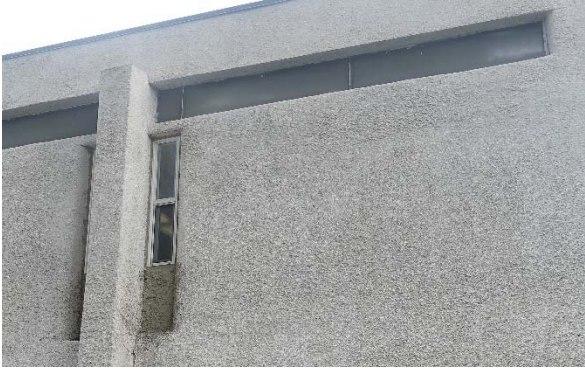
| 7-4 | | c. 1969/1970 | Window | Yes | 2 <sup>nd</sup> story fixed-inoperable clerestory windows with metal framing, with figured glass. Vertical windows that flank the stucco column have been altered by the lower 1/3 of the window removed and replaced with stucco. Vertical single hung windows with a single movable sash, raised from the bottom for ventilation. | Poor | Vertical windows that flank the stucco column have been altered by the lower 1/3 of the window removed and replaced with stucco. Windows are no longer performing their intended purpose.<br><br>Unknown if the clerestory figured glass is original. | Remove lower 1/3 stucco from vertical windows and restore opening to original size.<br>Replace vertical windows in kind to original size.<br>Further field study needed. |

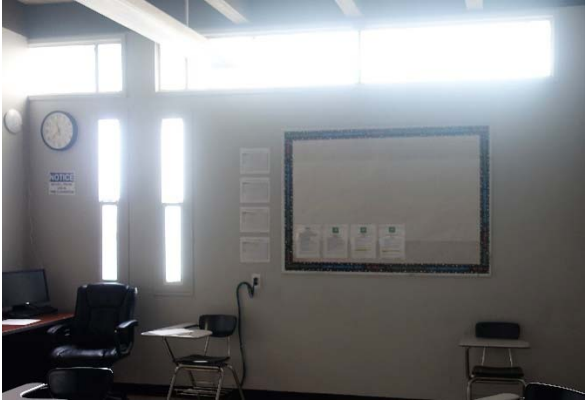
| 7-5 | | c. 1969/1970 | Window | Yes | Interior view of the amount of light 2 <sup>nd</sup> story clerestory & vertical windows allow in. Shows the lower 1/3 of the vertical windows that flank the column blocked for desk space. Vertical single hung windows with a single movable sash, raised from the bottom for ventilation. | Poor | Windows are no longer performing their intended purpose. Vertical windows that flank the stucco column have been altered by the lower 1/3 of the window removed and replaced with stucco. Interior space has desks, chairs, equipment blocking original window space.<br>Unknown if the clerestory figured glass is original. | Remove lower 1/3 stucco from vertical windows and restore opening to original size.<br>Replace vertical windows in kind to original size.<br>Further field study needed. |

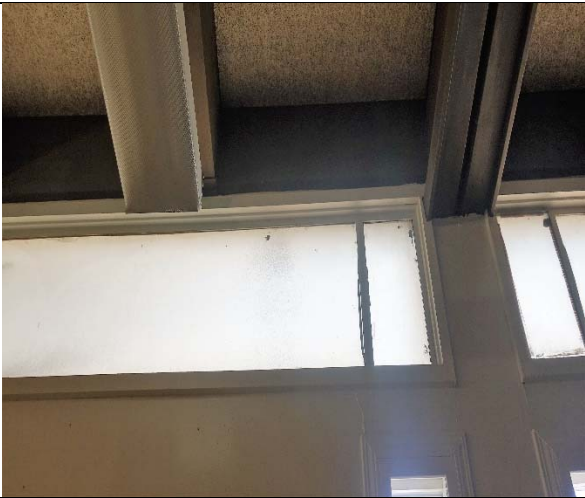
| 7-7 | | c. 1969/<br>1970 | Window | Yes | Directional view unknown. 2nd floor fixed-inoperable clerestory windows with figured glass. | Poor | Unknown if clerestory figured glass is original. If not, the windows are no longer performing their intended purpose. | Determine if original glass was figured or clear. If original glass was clear; replace with energy conserving glass. Such as low emissions glass which reduces heat gain, low iron glass which provides glass that is more clear; insulated glass with internal thermal glazing.<br><br>If original glass was this figured glass, install new thermal glazing for increased energy efficiency. Further field study needed. |

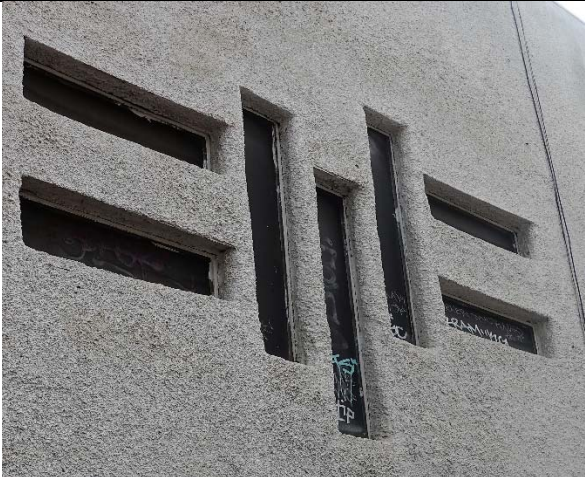
| 7-8 | | c. 1969/<br>1970 | Window | Yes | Exterior view of Watts Coffee Café windows. North elevation, view South. Intentionally assymetrical decorative pattern adds visual interest to the interior daylighting. Metal framing with figured glass. Design is original. Fixed-inoperable. | Fair | Though the windows are generally structurally sound and performing their intended purpose, the exterior of figured glass has graffiti. Metal framing appears to have excess paint. Design is original. Unknown if figured glass is original. | Determine if original glass was figured or clear. If original glass was clear; replace with energy conserving glass. Such as low emissions glass which reduces heat gain, low iron glass which provides glass that is more clear; insulated glass with internal thermal glazing.<br><br>If original glass was this figured glass, remove graffiti and excess paint. Install new thermal glazing for increased energy efficiency. Further field study needed. |

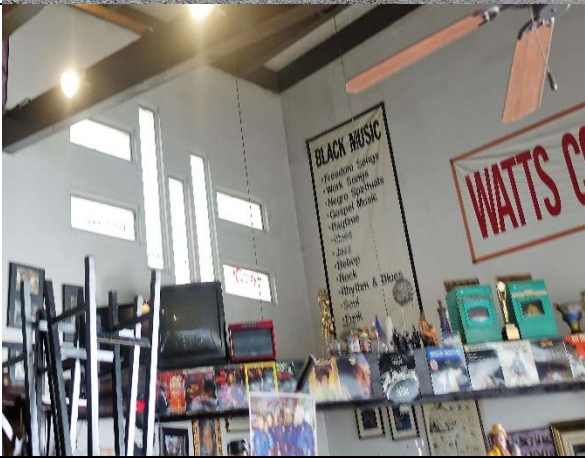
| 7-9 | | c. 1969/<br>1970 | Window | Yes | Interior view of the Watts Coffee Café windows. North elevation and view. Demonstrates amount of light and architectural design. Fixed-inoperable. | Fair | Though the windows are generally structurally sound and performing their intended purpose, the exterior of figured glass has graffiti and can be seen from the interior. Metal framing appears to have excess paint. Design is original. Unknown if figured glass is original. | Determine if original glass was figured or clear. If original glass was clear; replace with energy conserving glass. Such as low emissions glass which reduces heat gain, low iron glass which provides glass that is more clear; insulated glass with internal thermal glazing.<br><br>If original glass was this figured glass, remove graffiti and excess paint. Install new thermal glazing for increased energy efficiency. Further field study needed. |

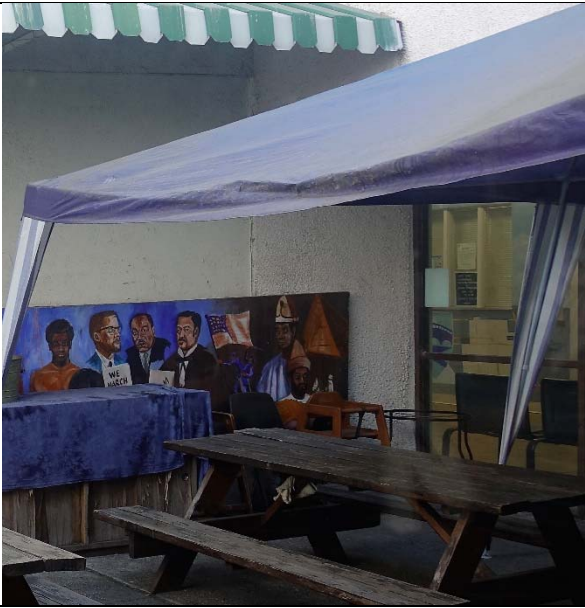
| 7-10 | | c. 1969/<br>1970 | Window | Yes | View from the interior of the Watts Coffee Café, West elevation, to the inner courtyard patio, located in the center open area of the building, towards fixed metal frame windows and interior Northeast hallway. | Good | The windows are structurally sound and performing their intended purpose. | For increased energy efficiency – may want to consider installing new internal secondary glazing where appropriate.<br>Further field study needed. |

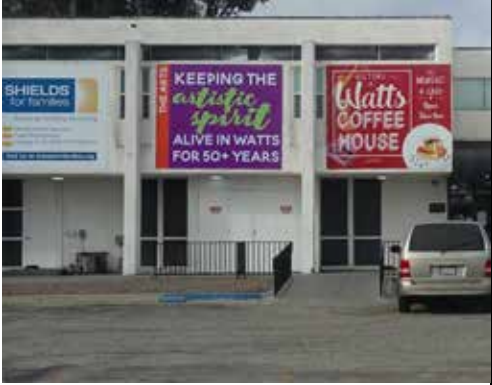
| Feature Number | Photograph | Estimated Date | Feature type | Significant | Description | Condition class | Condition description | Recommendations for Treatment |
|---|---|---|---|---|---|---|---|---|
| 11-1;<br>1799 | | c. 1969-2021 | Exterior doors | Yes (Watts Coffee House entry door) | Flush, bi-fold, and full glass door types. Three exterior doors located on the east facing side of the coffee shop entrance. | Fair/Good | All appear to be in decent condition; unclear if all are original. Exterior doors 1 and 2 have been painted white. Exterior door 1 is flush; doesn't have any noticeable exterior framing. It has three painted hinges, a small kick plate, and a door knob. Unclear about the metal finish on the door knob. Exterior door 2 appears to be a bi-fold double flush door with no visible door knobs; it has six painted hinges; has signage that reads "Danger do not enter". Possible electric or maintenance closet. Exterior door 1: Full glass door type with aluminum glazing; serves as an entry into the Watts Coffee House. | Further study and testing needed to determine if front exterior doors/hardware are part of the original design of Robert Kennard and Arthur Silvers.<br><br>Glass panels within exterior door 1 may require re-glazing as part of maintenance.<br><br>Painting and sealing exterior doors to protect from deterioration/damage/use (weathering and people).<br><br>All facets of the door should be checked for wear and tear (hinges and other hardware, threshold, casing, and locks) each time the door is re-painted. |

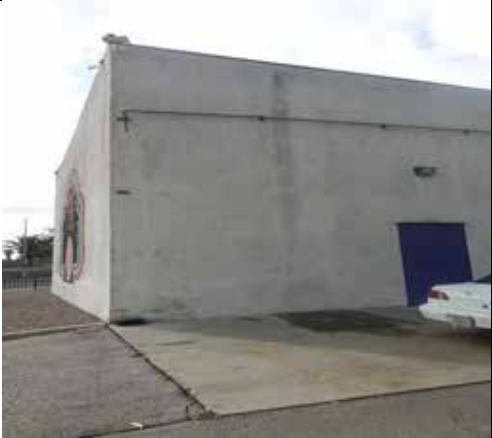
| Feature Number | Photograph | Estimated Date | Feature type | Significant | Description | Condition class | Condition description | Recommendations for Treatment |
|---|---|---|---|---|---|---|---|---|
| 11-2;<br>1800 | | c. 1969-2021 | Exterior door | No | Flush door, painted blue. No door knob. | Fair | Appear to be in fair condition; unclear if original. Minimal framing; no hinges; very small hood over the door. Security light located above the door frames. | Painting and sealing exterior doors to protect from deterioration/damage/use.<br><br>Anti-graffiti coating may be necessary.<br><br>All facets of the door should be checked for wear and tear (hinges and other hardware, threshold, casing, and locks) each time the door is re-painted. |

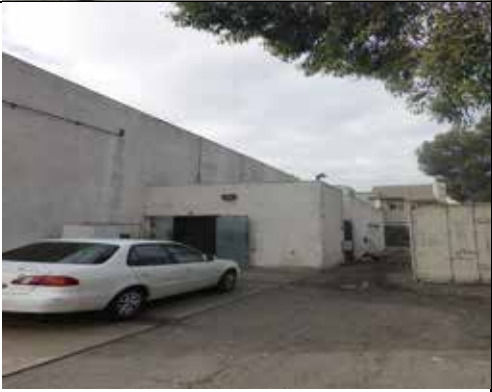
| Feature Number | Photograph | Estimated Date | Feature type | Significant | Description | Condition class | Condition description | Recommendations for Treatment |
|---|---|---|---|---|---|---|---|---|
| 11-3;<br>1801 | | c. 1969-2021 | Exterior doors | No | Flush door types. Two exterior doors located on the north east and north facing side of the Watt Neighborhood Center. | Poor/Fair | The north east exterior door appears to be gray metal in color. Has a minimal styled black security grille interior door. Some weathering/rusting; hand prints. Minimal framing. No door knob; has a lock. Small hood and security light over the door. The north facing exterior door is black steel framed security grille with a silver colored metal knob. | Painting and sealing exterior doors to protect from deterioration/damage/use.<br><br>Doors should be treated for weathering and any rust. |

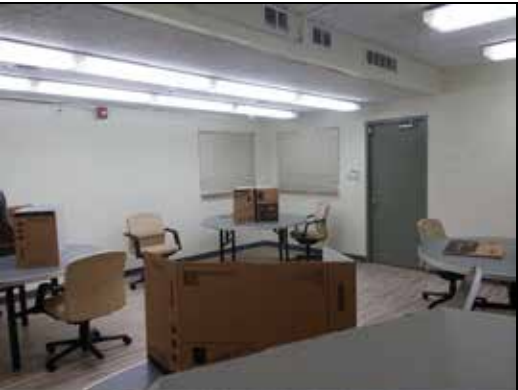
| 11-4;<br>1816 | | c. 1969-2021 | Interior door | No | Interior flush door | Good | Classroom door painted gray. Includes a door closer at the top. Lock and door knob. Possible door alarm box near frame. | Door appear to be in good condition. Annual maintenance plan may include repainting/cleaning and checking locks/door knobs for wear and tear. |

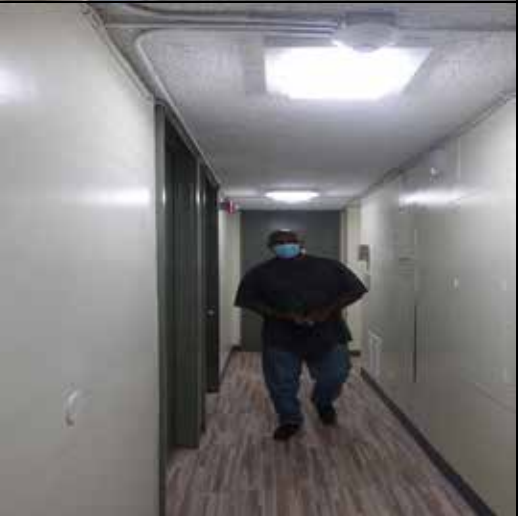
| 11-5;<br>1817 | | c. 1969-2021 | Interior doors; Hallway | Unclear | Interior flush doors located in the hallway. | Good | Hallway doors. All appear to be in good condition. Minimal framing. Painted gray. | Door appear to be in good condition. Annual maintenance plan may include repainting/cleaning and checking locks/door knobs for wear and tear. |

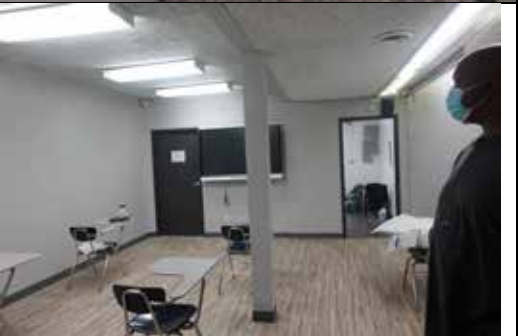
| 11-6;<br>1824 | | c. 1969-2021 | Interior doors; Classroom | No | Interior flush door | Good | Two door frames. Painted black. Only one visible door, with lever door knob. | Door appear to be in good condition. Annual maintenance plan may include repainting/cleaning and checking locks/door knobs for wear and tear. |

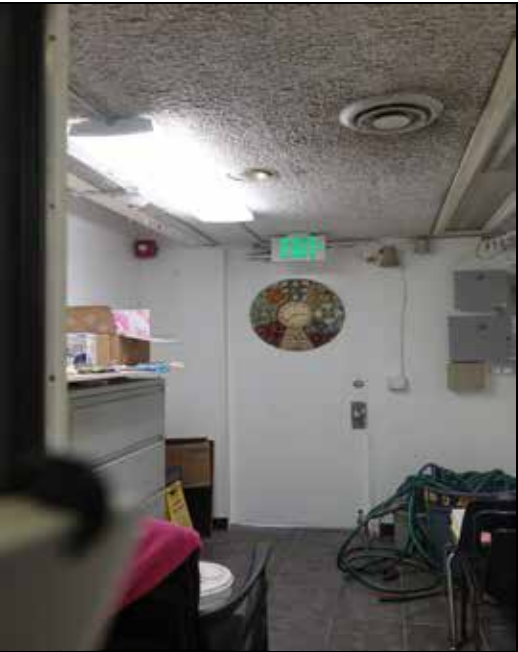
| 11-7;<br>1827 | | c. 1969-2021 | Interior door | Unclear | Interior flush door | Good | Emergency exit door in possible storage space. Painted white with minimal door framing. Metal lock and door knob. Includes door closer and alarm? Alarm in the shape of a bell. Possibly not contemporary. | Door appear to be in good condition. Annual maintenance plan may include repainting/cleaning and checking locks/door knobs for wear and tear. |

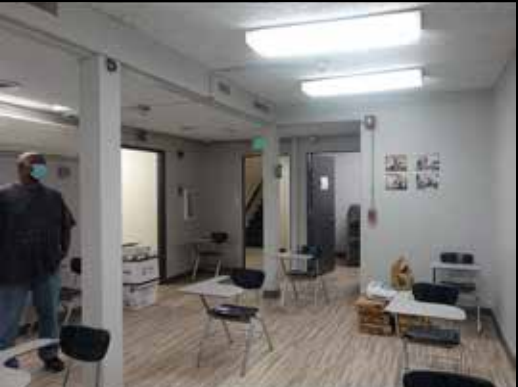
| 11-8;<br>1829 | | c. 1969-2021 | Interior doors | No | Interior flush door | Good | Classroom space includes three visible door frames. All are minimal (not decorative). One visible door in good condition. Gray hinge and metal door knob. | Door appear to be in good condition. Annual maintenance plan may include repainting/cleaning and checking locks/door knobs for wear and tear. |

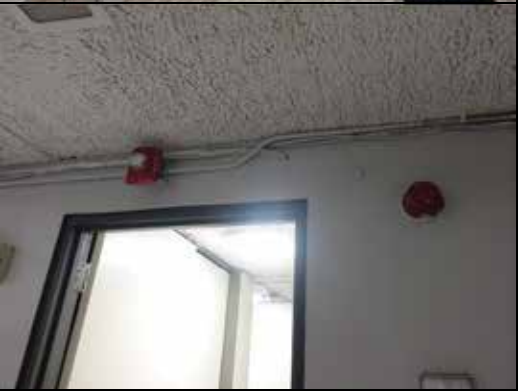
| 11-9;<br>1832 | | c. 1969-2021 | Interior door frame | No | Interior flush door | Good | Interior door frame with minimal framing. Fire alarm located above door. Door appears to have been removed. One visible hinge has been painted white. | Door appear to be in good condition. Annual maintenance plan may include repainting/cleaning and checking locks/door knobs for wear and tear. |

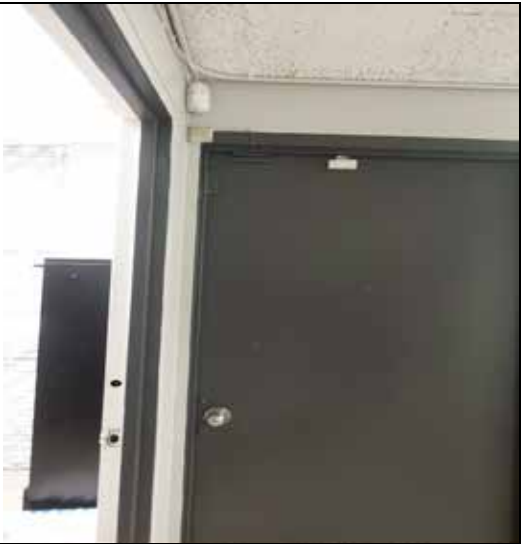
| 11-10;<br>1834 | | c. 1969-2021 | Interior doors | No | Interior flush door | Good | Interior door that has been painted gray. Minimal framing. Metal door knob, no visible lock. No visible wear and tear. | Door appear to be in good condition. Annual maintenance plan may include repainting/cleaning and checking door knobs for wear and tear. |

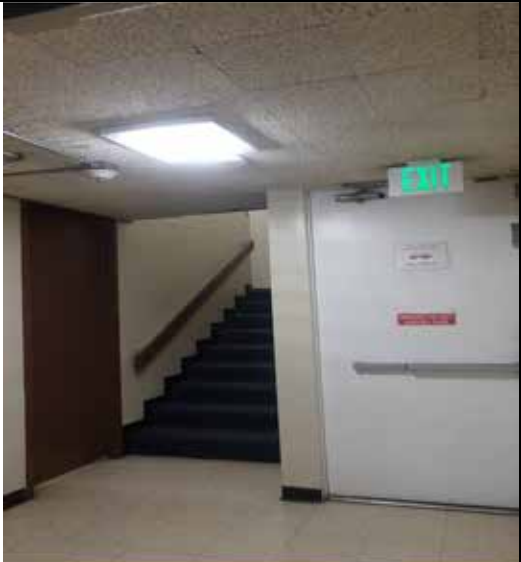
| 11-11;<br>1835 | | c. 1969-2021 | Interior door | No | Interior flush door with security lock | Good | Emergency exit door. Includes door closer and security lock. Some wear/possible rust on door closer. | Door appear to be in good condition. Annual maintenance plan may include repainting/cleaning and checking door knobs for wear and tear. Treat for rust, check door closer, and security lock. |

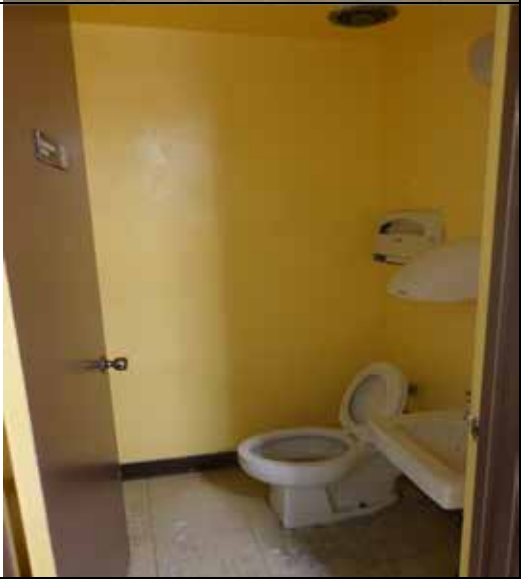
| 11-12;<br>1836 | | c. 1969-2021 | Interior door | Unclear | Flush door type; restroom door | Good | Restroom door. Exterior has been painted brown, the interior is painted yellow. No visible wear and tear. Minimal framing. Possibly original to the space. | Further study and testing needed to determine if interior door is part of the original design of Robert Kennard and Arthur Silvers.<br><br>Door appear to be in good condition. Annual maintenance plan may include repainting/cleaning and checking door knobs for wear and tear. |

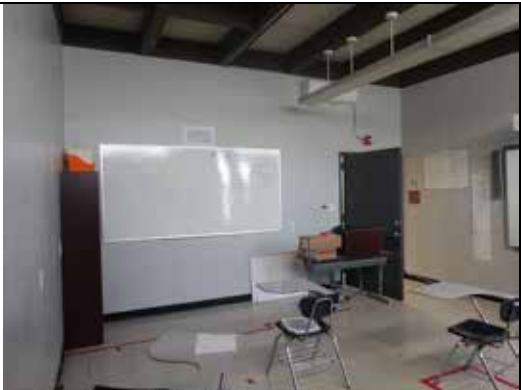
| 11-13;<br>1842 | | c. 1969-2021 | Interior door | Unclear | Interior flush door | Good | Gray classroom door. Minimal framing. Appears to be in good condition; no visible wear and tear. It has three unpainted hinges. Fire alarm located above door. | Door appear to be in good condition. Annual maintenance plan may include repainting/cleaning and checking door knobs for wear and tear. Also checking the fire alarm to make sure that it's functioning. |

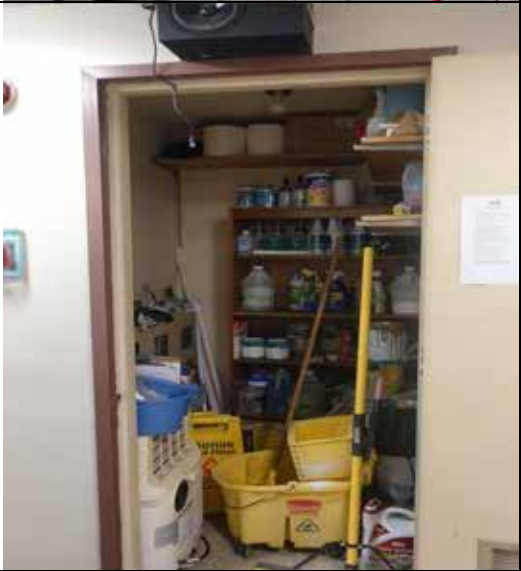
| 11-14;<br>1844 | | c. 1969-2021 | Interior door | Unclear | Interior flush door | Good | Custodian closet door. Door's exterior is painted brown; the interior is beige. Door has minimal framing. Includes door vent grille. Appears to be in good condition. | Door appear to be in good condition. Annual maintenance plan may include repainting/cleaning and checking door knobs for wear and tear. |

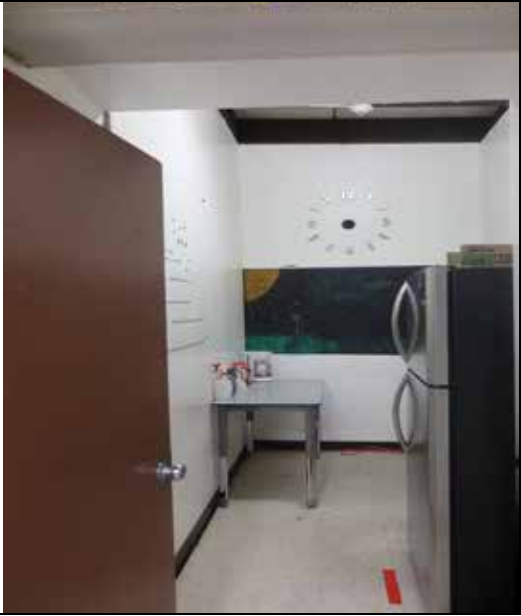
| 11-15;<br>1846 | | c. 1969-2021 | Interior door | Unclear | Interior flush door | Good | Interior flush doors painted brown. Leads to a breakroom for staff? No visible wear and tear. | Door appear to be in good condition. Annual maintenance plan may include repainting and cleaning. |

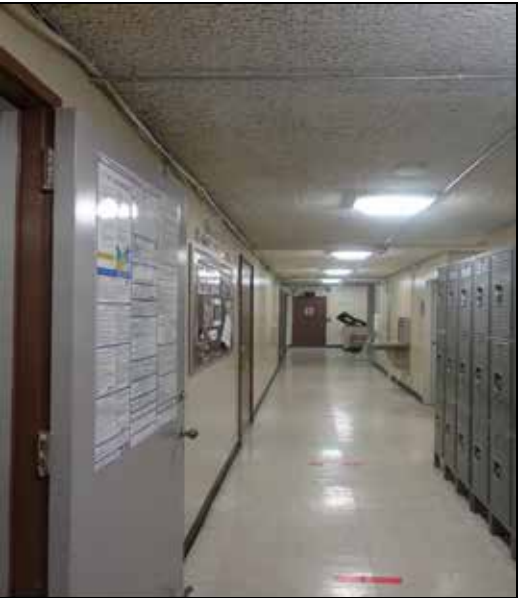
| 11-16;<br>1848 | | c. 1969-2021 | Interior door | Unclear | Interior flush door | Good | Hallway doors. All appear to be in good condition. Minimal framing. Painted hinges. Locks and door knobs appear on all doors. | Door appear to be in good condition. Annual maintenance plan may include repainting/cleaning and checking door knobs for wear and tear. |

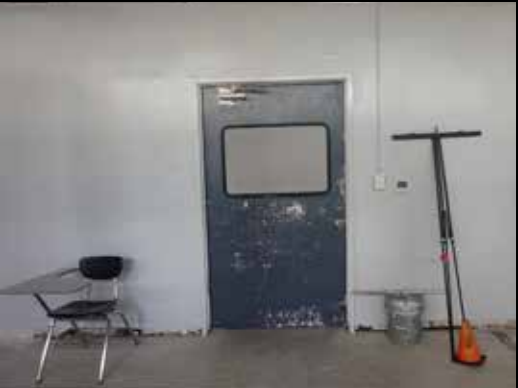
| 11-17;<br>1866 | | c. 1969-2021 | Interior door | Unclear | Interior flush door | Good | Some wear or possible in transition? Paint flecks are on the door. Overall good condition. Minimal door framing. Lock and door knob in good condition. Includes industrial door closer. | Door appear to be in good condition. Annual maintenance plan may include repainting/cleaning and checking door knobs for wear and tear. Treat for rust, check door closer, and security lock. |

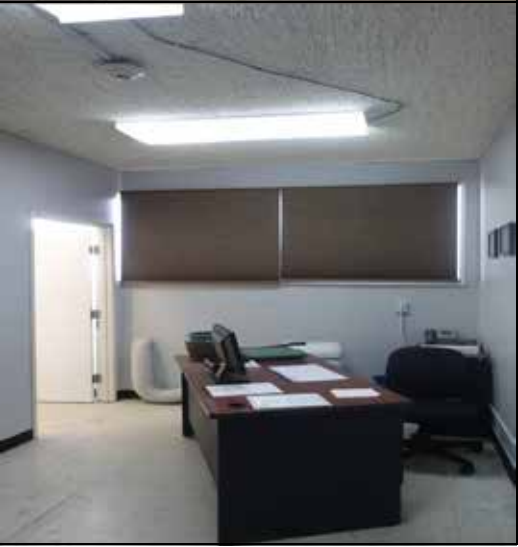
| 11-18;<br>1867 | | c. 1969-2021 | Interior door | Unclear | Interior flush door | Good | Office door. Appears to be in good condition. Painted white. The hinges, unpainted. Good condition overall. | Door appear to be in good condition. Annual maintenance plan may include repainting/cleaning and checking door knobs for wear and tear. |

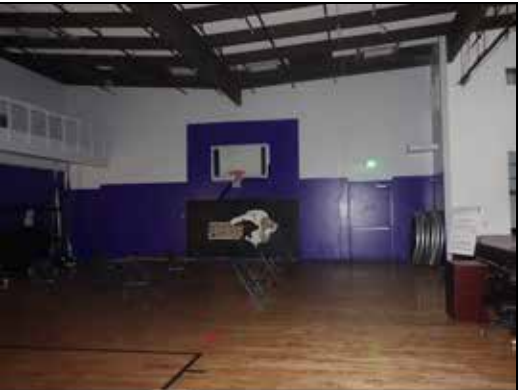
| 11-19;<br>1882 | | | Interior door | Maybe | Interior flush door | Fair/Good | Security door that has been painted (purple or navy blue in color). Some denting on the door. Includes push bar/panic exit and door closer. Fairly/good condition. | Door appear to be in good condition. Annual maintenance plan may include repainting/cleaning and checking door knobs for wear and tear. Treat for rust, check door closer, and security lock. |

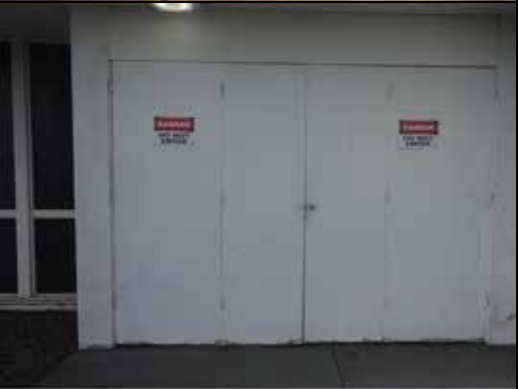
| 11-20;<br>1885 | | c. 1969-2021 | Interior door | Maybe | Exterior doors 1 and 2 have been painted white. | Fair | All appear to be in decent condition; unclear if all are original. Exterior doors that have been painted white. Appears to be a bi-fold double flush door with no visible door knobs; it has nine painted hinges; has signage that reads "Danger do not enter". Same doors from first row assessment. | Painting and sealing exterior doors to protect from deterioration/damage/use (weathering and people).<br><br>All facets of the door should be checked for wear and tear (hinges and other hardware, threshold, casing, and locks) each time the door is re-painted. |

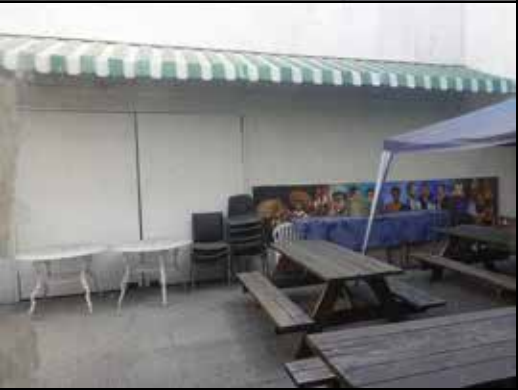
| 11-21;<br>1887 | | c. 1969-2021 | Exterior door | Maybe | Exterior flush/double doors that have been painted white. | Fair | White exterior flush/double doors that have been painted white. Industrial, almost door length hinges that have been painted white. Door condition is fair. Minimal framing; lacks door knobs. | Painting and sealing exterior doors to protect from deterioration/damage/use (weathering and people).<br><br>All facets of the door should be checked for wear and tear (hinges and other hardware, threshold, casing, and locks) each time the door is re-painted. If the art work isn't attached to the wall, it should be stored or installed inside. |

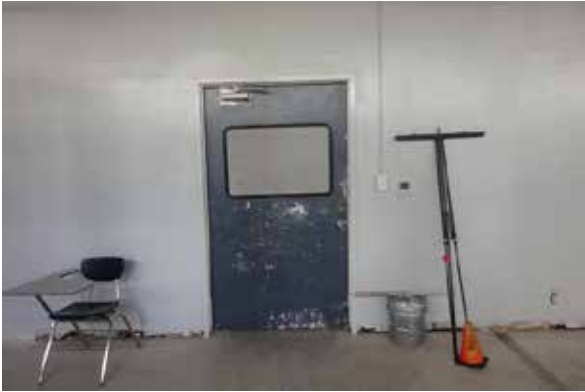
| Feature Number | Photograph | Estimated Date | Feature type | Significant | Description | Condition class | Condition description | Recommendations for Treatment |
|---|---|---|---|---|---|---|---|---|
| 14-1 | | 1969 | Door closer | Yes | The door closer is made of white metal and it is used to ensure that the door keeps close when some emergencies happens. | Good | <p>The door closer has its substantial features.</p> <p>The door closer works.</p> <p>The whole door closer is soiled and part of the door closer is rusty.</p> | <p>RECOMMEND: 1. Replace it with a new white metal door closer such as a white metal heavy duty automatic door closer.</p> <p>2.Retain and keep the original condition. Check its condition regularly. Adjust the speedy of the door closer to ensure the safety if necessary.</p> <p>3.Retain. Clear the rust on the surface of it. Identity the material of the door closer and take a test before cleaning to choose the gentlest method. Then clean it. After cleaning, Adjust the speedy of the door closer to ensure the safety if necessary.</p> |

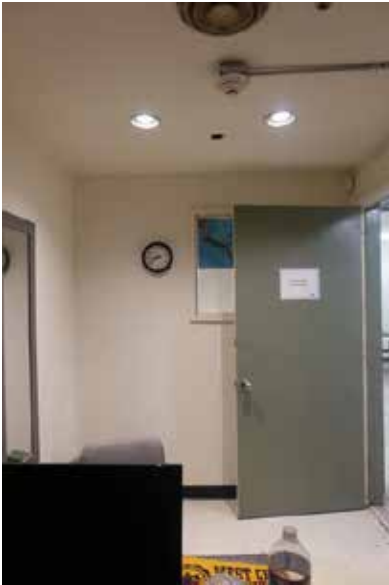
| Feature Number | Photograph | Estimated Date | Feature type | Significant | Description | Condition class | Condition description | Recommendations for Treatment |
|---|---|---|---|---|---|---|---|---|
| 14-2 | | Unknown | Lock | No | <p>It is a deadbolt lock, which is made of metal.</p> <p>Usually, it provides security to the room.</p> | Good | <p>The lock does not lose its substantial features and works well.</p> <p>The lock is just a little soiled and tarnished.</p> | <p>1.RECOMMEND: Replace it with a cylindrical lock which has chrome reversible privacy door handle or a tubular lock which has satin chrome satin chrome reversible privacy door handle.</p> |

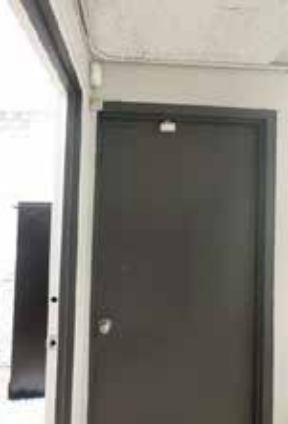
| 14-3 | | Unknown | Door knob | No | It is a white metal passage door knob, which does not have lock and is used to open the door. | Good | <p>The door knob has its substantial features and works.</p> <p>The condition of the door knob is pretty good.</p> | 1.RECOMMEND: Replace the door knob with a door lever such as a Broadway lever or a latitude lever, which is made of white metal such as aluminum. |

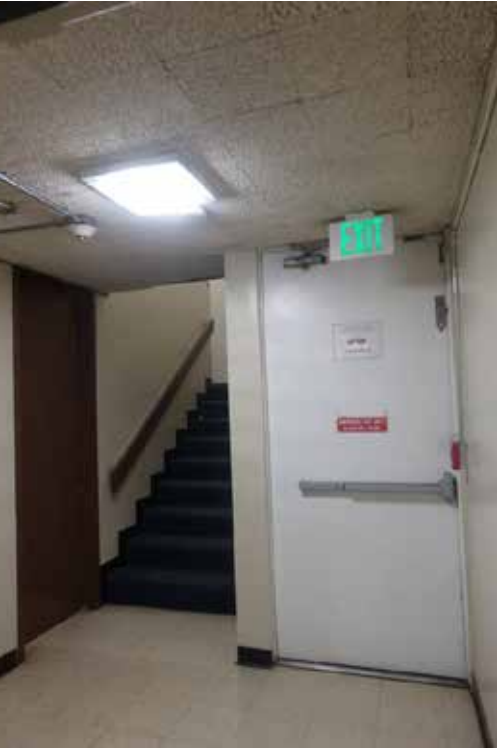
| 14-4 | | Unknown | Panic bar | Unknown | <p>The silver panic bar is made of metal.</p> <p>It is a type door opening mechanism, which allows people to open a door by pushing it.</p> | Good | <p>The panic bar has its substantial features.</p> <p>The panic bar works.</p> <p>The coating on the surface has little scratches.</p> <p>The part that connects the door is soiled.</p> | 1. RECOMMEND: Retain it and check its condition regularly and repair it immediately if any questions are found because the door is a emergency exit, which has the relation with the safety of people. |

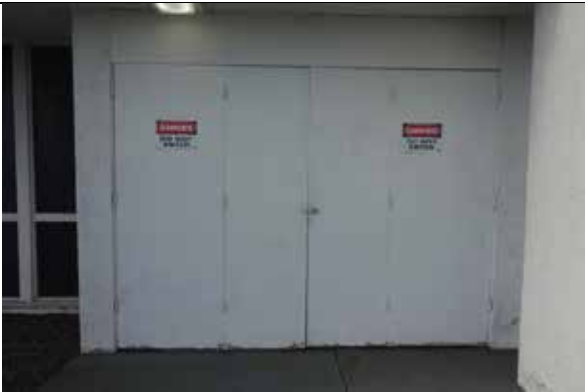
| 14-5 | | 1969 | Butt Hinge | Yes | <p>Butt hinges are made of metal and are painted in white.</p> <p>Butt hinges have two leaves, one is attached to and another one is attached to door.</p> <p>They are used to operate</p> | Fair | <p>These butt hinges still have their substantial features.</p> <p>These butt hinges works but there are soiled..</p> <p>Parts of the white coating on the</p> | <p>1. RECOMMEND: Replace these butt hinges with new white metal butt hinge.</p> <p>2.Retain. Clear the rust on the surface of these hinges. Identity the accurate material and take a test before cleaning to choose the gentlest method. Then clean it. After cleaning, Adjust and tighten these to ensure the safety if necessary.</p> |

| | | | | | doors. | | surface of butt hinges fall off and the interior metals are exposed. | |

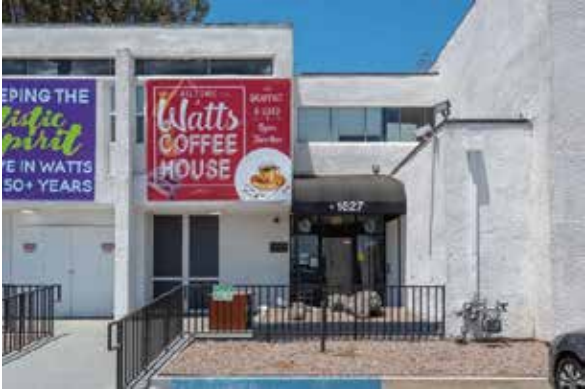
| 14-6 | | unknown | pull handle | No | <p>The pull handle is black.</p> <p>The pull handle is a type of handle. People can grip the pull handle by one or both hands and pull it to open the door.</p> | Good | The black pull handle works and it is not soiled or rusty. | 1.RECOMMEND: Replace it with a white metal offset pull handle. |

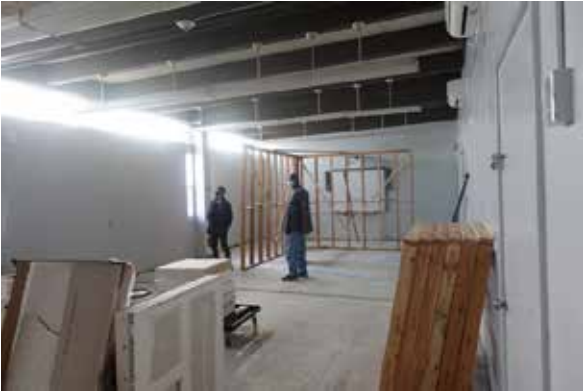
| Feature Number | Photograph | Estimated Date | Feature type | Significant | Description | Condition class | Condition description | Recommendations for Treatment |
|---|---|---|---|---|---|---|---|---|
| 1-1 | | c. 1969 | Wood deck | Yes | Original to the structure, the traditional plywood sheathing on wood floor framing is both durable and utilitarian. This allows for interstitial space between the floor and ceiling below for distribution of utilities. Resilience can provide problems for heavy, brittle floor finishes that can be mitigated with cement board. | Good | This flooring appears in fair condition with remnants of adhesive from previously applied flooring and remaining stains from earlier work. | Because this floor is a sub floor that is part of structural system, it is not intended to be finish floor. Given the durability of this floor, an applied finish suitable to the future needs of the space would be the most appropriate treatment. Since much of the flooring throughout the building is resilient vinyl tile or square composition tile, either of these would provide consistency with the rest of the interior. |

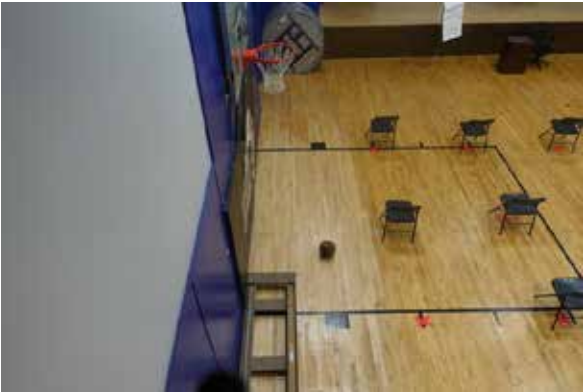
| Feature Number | Photograph | Estimated Date | Feature type | Significant | Description | Condition class | Condition description | Recommendations for Treatment |
|---|---|---|---|---|---|---|---|---|
| 1-2 | | c. 1969 | Hardwood strip flooring | Yes | The warm hardwood strip flooring in the multipurpose room is original to the structure and possibly made from maple for its strength and durability. There are small areas that have been repaired through replacement in kind. The consistency and glossy finish of the strips adds a fine finish to the space while the resilience of the material allow for plenty of bounce for basketball and dance. | Good | The wood appears in good condition with minimal damage and staining. | First remove any surface debris by sweeping, dusting or using a vacuum with a hard floor attachment to avoid damaging the finish. Next, clean using a pH-neutral, wax-free, and petroleum-free hardwood surface cleaner using a mop or sponge. After, rinse the mop or sponge with water, ring it out, and use the damp mop or sponge to soak up any remaining cleaner before using a towel to dry the floor. In areas where replacement boards are needed, replace in kind. |

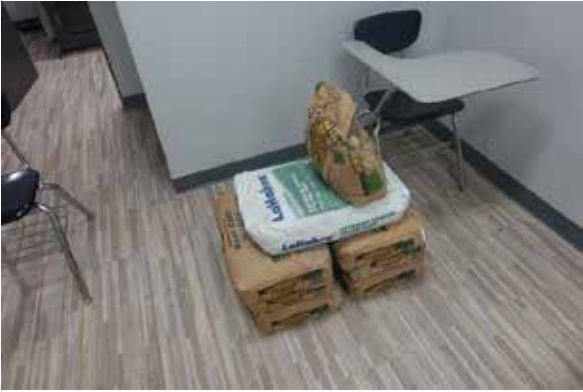
| Feature Number | Photograph | Estimated Date | Feature type | Significant | Description | Condition class | Condition description | Recommendations for Treatment |
|---|---|---|---|---|---|---|---|---|
| 1-3 | | est. 2011 | Resilient vinyl tile | No | The various shades of sand and stone accentuate the long strips of resilient vinyl tile used throughout many of the classrooms. Used for its durability, the material is durable, low maintenance and easily installed. | Good | This flooring appears in good condition as it displays clean and smooth surfaces with little to no visible damage or adhesive deterioration. | After removing all soils with sweeping and/or dust mopping (vacuuming is not recommended), the floor should be cleaned with water and a non-abrasive cleaner. In areas of significant dirt build up or staining, a natural bristle or nylon brush can be used to gently scrub away the remnants. Finally, the floor should be rinsed with clean water and left to dry, but it is recommended to not put furniture back for at least 24 hours. |

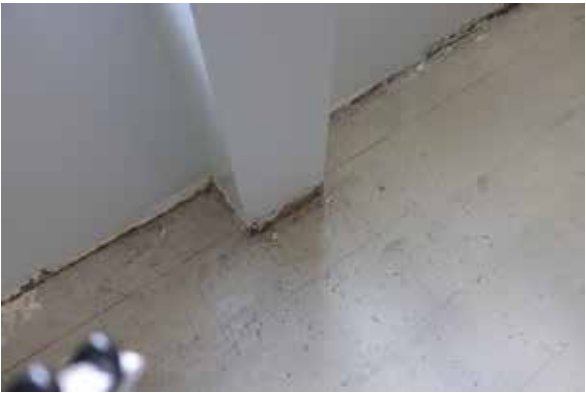
| 1-4 | | c. 1969 | Square composition tile | Yes | The 1' x 1' square resilient composition tile a marbleized pattern in a light neutral tone, and is common in the hallways, some of the classrooms, the bathrooms and the coffee shop. This appears to be the typical original floor finish in many use areas. | Fair | Everyday use is apparent in the scuffing and staining, and the mastic adhesive appears to be deteriorating in areas where there seems to be greater space between the tiles. | Floors should be thoroughly vacuumed or swept before being gently cleaned with a non-soap based cleaner. After cleaning, the floor should be rinsed with clean water and allowed to dry. To repair the coating, the tiles must be stripped of their old layers of wax and dirt using a gentle stripping agent applied with a mop and bucket. After the stripping solution has been applied, a wet vac or auto scrubber can be used for its removal. Next the floor should be rinsed with water and dried before applying the finish. |

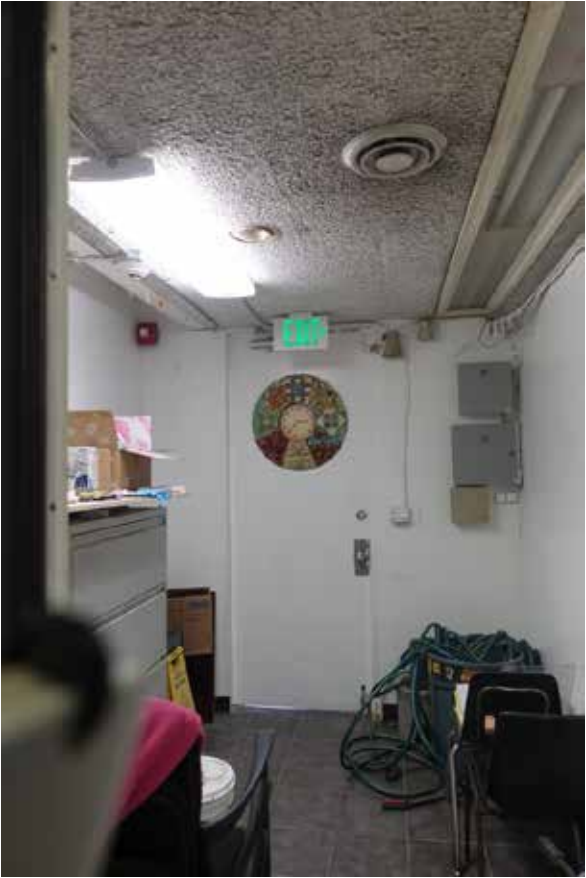
| 1-5 | | est. 2011 | Square glazed ceramic tile | No | The graphite grey 1' x 1' square glazed ceramic tile has a variegated finish and appears infrequently in the structure where it is used for storage spaces. A similar square glazed ceramic tile in a lighter warm color is used in the lobby and parts of the coffee house. | Good | This flooring presents in good condition as it maintains its glaze and exhibits few areas of damage or adhesive deterioration. | Treatment for this flooring should begin with cleaning. Vacuuming or sweeping the dirt will prepare the tiles for cleaning with the gentlest means. Pre-wetting the floor will ensure the porous material does not absorb chemicals or cleaning agents. A non-soap-based floor cleaner should be used with a natural bristle or nylon brush to remove stubborn stains or dirt. Afterwards the floor should be rinsed thoroughly with clean water, and it is suggested doing this twice to ensure the removal of any cleaning product, then dried with terry cloth towels. In areas with persistent staining, ammonia or a household spray product intended for tiles can be used, but should be tested on a spot first and should not remain on the surface too long as it may cause discoloration. Alternatively, because this flooring is not original, the floor could be replaced to be compatible with the character of rest of the building, such as sheet linoleum like marmoleum. |

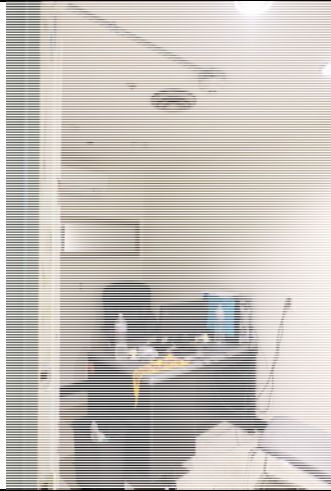
| Feature Number | Photograph | Estimated Date | Feature type | Significant | Description | Condition class | Condition description | Recommendations for Treatment |
|---|---|---|---|---|---|---|---|---|
| 2-2 | | Unknown | Gypsum board | No | This is a gypsum board in white color located in an office. | Good | The ceiling is generally in a good condition, except a small hole close to the air conditioner. | Consult professionals in structures about the surrounding gypsum board's conditions. If the structure is stable, firstly apply a layer of base coat plaster in place and scraped back below the existing plaster; when the base plaster is set but not dried, apply more plaster to create a smooth surface. If it is not in a good condition, consult structural engineers. |

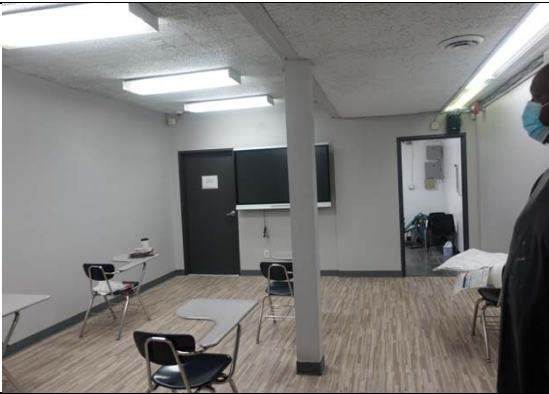
| 2-3 | | c.1969 | Acoustical tile ceiling | Yes | It is a tile ceiling general equally divided into two parts by a fascia to accommodate a change in ceiling height. The left side is a little bit higher than the right part. | Good | The tile joints are tight; cracks are difficult to see. The connection area between right part and the fascia is slightly loose. | Annual inspection by a qualified conservationist, especially the cracks. No treatment needed at this time. |

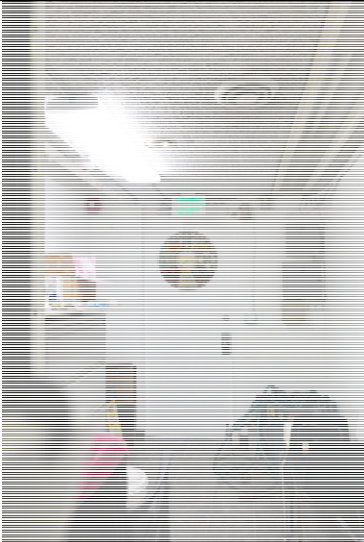
| 2-4 | | c.1969 | Acoustical tile ceiling | Yes | The ceiling finish is rough textured tiles. The left edge is covered connected to a gypsum board. | Fair | Some parts of the ceiling are soiled. The tile joints are tight; cracks are able to see. The crack between the left edge and gypsum board is obvious. | <ol style="list-style-type: none"> <li>1. Clean the ceiling gently, minimize the potential damages to the ceiling.</li> <li>2. Consult professionals about the conditions of cracks surroundings. If they are in good conditions, use patching materials to fill them. For larger cracks, may need to use tape and fiberglass mesh tape during the treatment. If they are not in good conditions, consult structural engineers.</li> <li>3. Annual inspection by a qualified conservationist, especially the cracks.</li> </ol> |

The ceilings of Watts Center primarily remain the same as the building was constructed in 1969. Some ceilings were modified in the following decades, and the reconstruction dates are unknown. Watts Center has four types of ceilings: acoustical tile ceiling, gypsum board, acoustical panel with boxed beams ceiling, and conventional ceiling. 1x1 textured acoustical tile and Tectum are the most ideal type of ceilings in most spaces since they are cost-effective and aesthetic. Meanwhile, most ceilings are in good condition. Besides annual inspection by professional conservationists or architects, it is unnecessary to have extra treatment on them. Some ceilings may need detailed and gentle cleaning. Only a few spots need to be repaired after consulting professionals of related fields. For spots that need to be repaired in 2-2, 2-4, and 2-6, it is suggested to consult structural engineers about the structure around cracks, then make decisions. If they are in good

condition, cracks could be repaired by patching materials. If they are in dangerous conditions, further treatments should be made after talking to structural engineers. For the square cut of 2-6, besides structural engineers, it might be necessary to consult the treatment with circuit engineers.

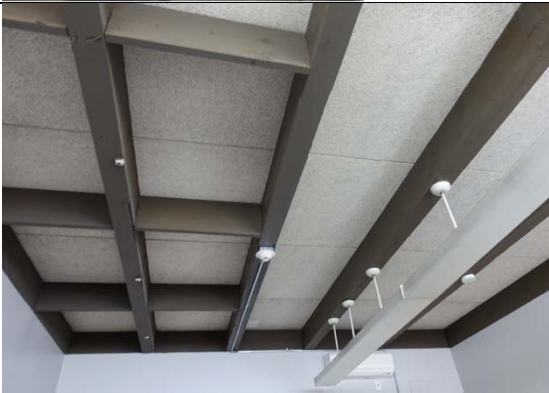
| 2-5 | | c.1969 | Acoustical panel and boxed beam ceiling | Yes | The ceiling uses Tectum as its finished surface above dark-painted wood box beams. The beams are probably for decoration and not structure. Six beams equally divide the ceiling into five columns. The left two columns are divided into small rectangles by vertical beams. | Good | The finished surface and wood beams are in good conditions. Joints are tight. | Annual inspection by a qualified conservationist. No treatment needed at this time. |

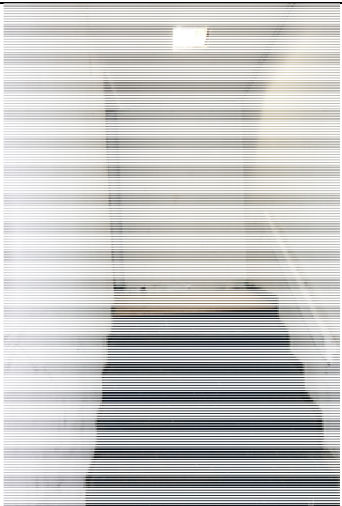
| 2-6 | | Unknown | Painted gypsum board ceiling | No | This is a flat ceiling covered in white paint. A rough square was cut in the center of the ceiling, and a light is placed in the square. | Fair | The area around the square is rough; other parts are generally in good conditions, except small dusty scratches. | <ol style="list-style-type: none"> <li>1. Consult professional structural engineers about the structure around the square. Based on professional suggestions, decide to repair the square cut or not.</li> <li>2. Consult professionals to clean the ceiling, minimize the potential damages.</li> </ol> |

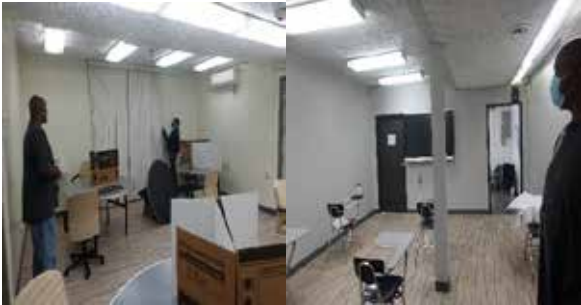
| Feature Number | Photograph | Estimated Date | Feature type | Significant | Description | Condition class | Condition description | Recommendations for Treatment |
|---|---|---|---|---|---|---|---|---|
| 5-1 | | N/A | Surface Mounted Ceiling Light Fixture LED | No | Surfaces mounted lighting that are newly installed and energy efficient, but not very compatible with the design and disrupt the continuity of the ceiling | GOOD | New and energy efficient | According to U.S. GENERAL SERVICES ADMINISTRATION's suggestion for restoring lighting fixtures in historical buildings, the success would be determined by factors below:<br>"-- Preservation of historic materials and character,<br>n Occupant comfort,<br>n Energy conservation,<br>n Initial costs,<br>n Operational costs,<br>n Maintenance requirements,<br>n Disposal costs and environmental impact, and<br>n Aesthetics."<br>I believe the lighting fixtures in the Watts satisfied most of the factors except might needs some improvement on the aesthetics. |

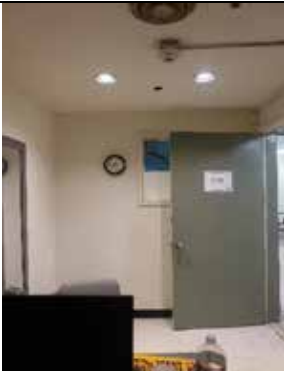
| Feature Number | Photograph | Estimated Date | Feature type | Significant | Description | Condition class | Condition description | Recommendations for Treatment |
|---|---|---|---|---|---|---|---|---|
| 5-2 | | N/A | Recessed down lights for the office | No | Recessed Ceiling light that is compatible with the original ceiling and doesn't catch unnecessary attention to the ceiling | GOOD | New and energy efficient | In Watts, many places installed energy-saving light sources, like LED lamps. "LEDs represent an evolving technology "that could save energies, which can reduce operational costs. |

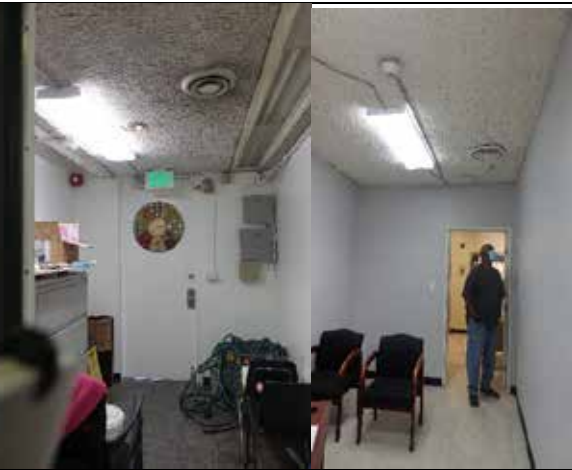
| 5-4 | | N/A | Surface mounted lighting fixture with electrical conduit attached to the surface of the ceiling | No | Surfaces mounted lighting that are newly installed and energy efficient, but not very compatible with the design and disrupt the continuity of the ceiling | GOOD | New and energy efficient | Using recessed lighting system to replace the incompatible lighting system.<br><br>Might come up with a better way to hide the electrical conduit. |

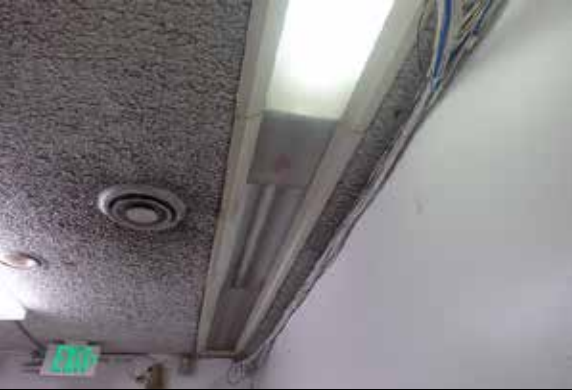
| 5-5 | | 1970 | a recessed lighting system that appears integrated with the older ceiling system. | Yes | Fluorescents lighting that integrated with ceiling systems, and it has continuous diffusing light. this would have been a cleaner approach to lighting, than suspended lighting from the ceiling. | GOOD | Older installed but still in good condition, might replace with LED and hide the wire and cods nearby | Make this work with new led strips that are much more energy efficient and go back to the original integrated lighting system that speaks to the 1960s |

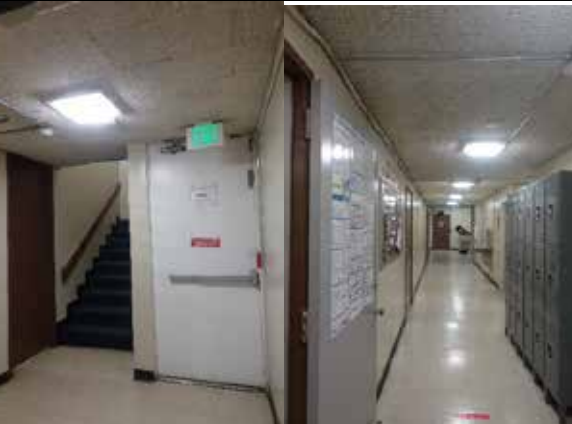
| 5-6 | | N/A | Surface mounted hallway lighting fixture | No | The new replaced LED lightings are compatible with the original design and the character of the building. And the LED is very energy efficient as well. | GOOD | New and energy efficient | |

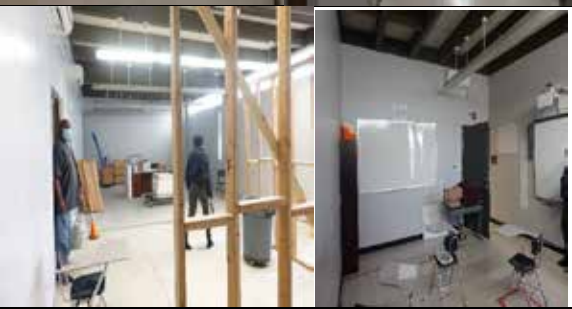
| 5-7 | | N/A | Pendant LED Lighting | No | Newly installed LED lighting that is bright and energy efficient enough for the work shop, however the hanging lighting might seem a extra as an addition to the existing ceiling system. | GOOD | New and energy efficient | |

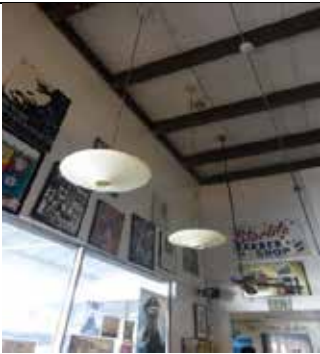
| 5-8 | | N/A | Pendant Lighting | No | Very interesting and distinctive lighting. Sets the tone and vibe for the very artistic space | GOOD | Good Condition | <p>According to the PBS P100 Federal Standards for the Public Buildings Service ,Chapter 6. Electrical Engineering, Lighting – Historic Structures: “Historic fixtures may be upgraded with energy efficient lamps, ballasts, reflectors, or other means to achieve required light levels, if changes can be made without affecting the appearance of the fixture. Energy efficient light sources should match the warm to white color range of incandescent light or daylight as closely as possible.”</p> <p>Thus, if the light bulb can be changed into an energy efficient one and keep the appearance of the lighting fixture would be fine.</p> |

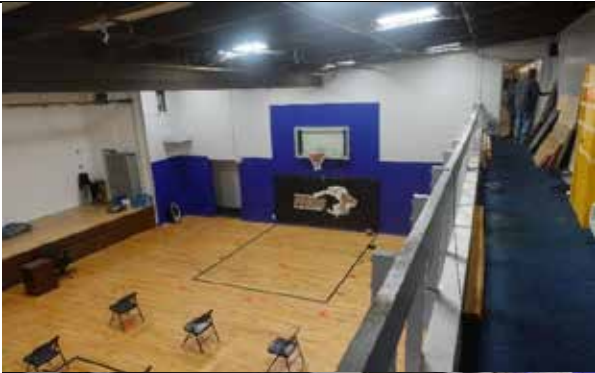
| 5-9 | | N/A | Surface mounted ceiling fixtures<br><br>Lighting boom<br><br>Pendent Lighting<br><br>Spotlight | No | There are four different types of light in this stadium. The surface mounted ceiling lights are bright enough to illuminate the whole room; the spotlights and lighting boom and some extra pendent lighting working together to highlight the stage presentation | GOOD | New and energy efficient | |

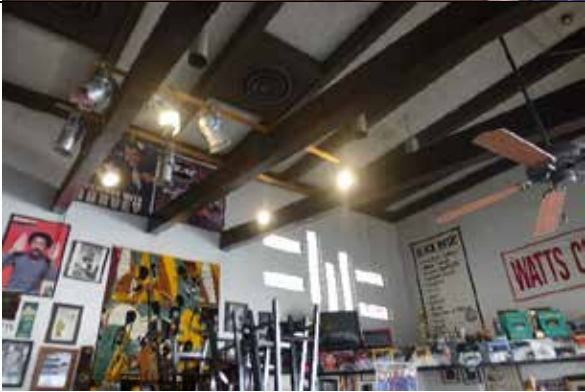
| 5-10 | | N/A<br><br>1970 | Theatrical spotlight<br><br>Pendant cylinder lighting (original) | No<br><br>Yes | Those added theatrical spotlight and in addition to the original pendant cylinder lighting are used to illuminate the art performance happening below in the shop | GOOD | Good Condition | <p>Also according to the PBS P100 Federal Standards for the Public Buildings Service, Chapter 6, in restoration zones, “opportunities should be sought to replace unsympathetic contemporary lighting with replicas of original historic fixtures. Replica fixtures in which light sources are not exposed should incorporate high output, energy efficient lamps as necessary to achieve required light levels and meet energy conservation standards.</p> <p>Supplemental lighting, if required, should be designed and installed to avoid competing visually with historic lighting. Freestanding torchieres, task lighting and discrete accent lighting are recommended for increasing light levels in ceremonial spaces containing ornamental ceilings and historic chandeliers”</p> |
