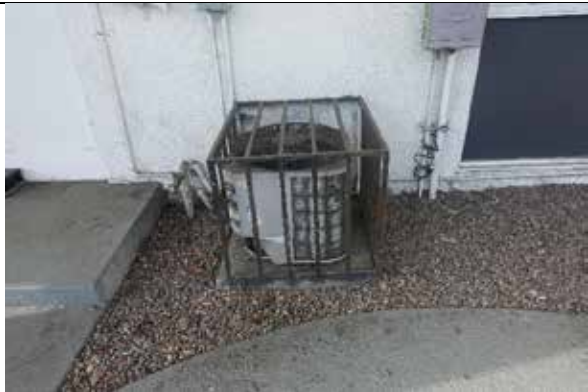
| Feature Number | Photograph | Estimated Date | Feature type | Significant | Description | Condition class | Condition description | Recommendations for Treatment |
|---|---|---|---|---|---|---|---|---|
| 9-1 | | c. 1995 | Packaged air condenser | No | Ground-based single-fan packaged air condenser, small commercial. Elevated on a thin concrete foundation, located on the East side of the building facing the parking lot. Protected from tampering by a locked metal cage. | Poor | Minor vandalism; unknown if currently operating. | Condensers should not be spatially and visually conspicuous, especially at ground level.<br><br>If a packaged air condenser is required, place it elsewhere – on roof or in side yard – away from public view. |

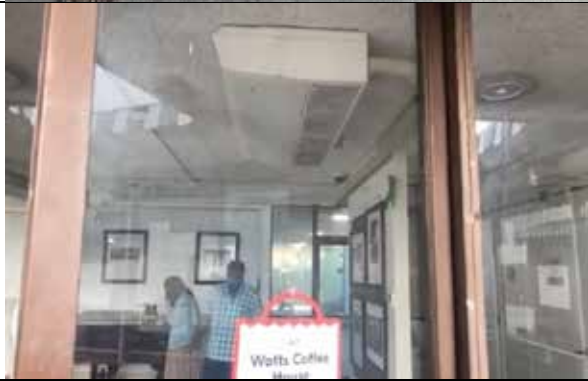
| Feature Number | Photograph | Estimated Date | Feature type | Significant | Description | Condition class | Condition description | Recommendations for Treatment |
|---|---|---|---|---|---|---|---|---|
| 9-2 | | c. 1995 | Mini-split evaporator | No | Ceiling-mounted multi-zone hybrid system utilizing supplementary soft ducting (Daikin or similar brand). Multiple throughout building. Pictured is the unit blocking the courtyard door.<br><br>(See: recording timestamp 01:47:00) | Fair | Working condition. However, its location is disrupting user circulation via the courtyard in a manner that could be unsafe, and it is significantly altering the experience of the interior. | Evaporators should not be spatially and visually conspicuous, nor should it block circulation.<br><br>Replace with active chilled beams integrated into ceiling assembly, or another less invasive system.<br><br>If required, integrate into ceiling or floor assembly. If this is not possible, place adjacent to wall away from egress and common circulation paths. |

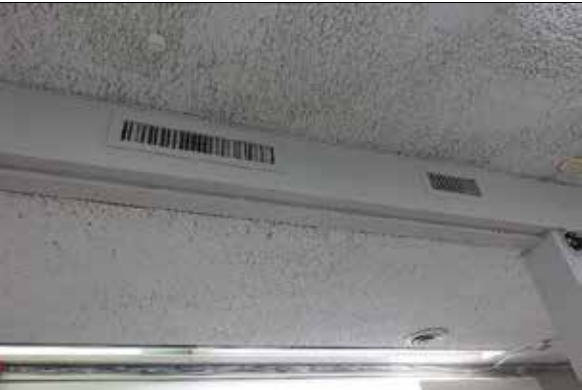
| 9-3 | | c. 1969 | Air supply grilles at soffit ducts | Yes | In lobby and throughout the second floor, soffits of about 8-10" in between columns and room divisions acts as plenum for original ducting of the air-only central air conditioning system. Vents are rectangular, approx. 4-6" tall, varying widths. | Fair | Integrity appears to be intact; unknown if currently operating. | Integrated ceiling design involving soffits should be retained and utilized to the greatest extent possible.<br><br>Reconnect air supply ducts to central system, if disconnected. |

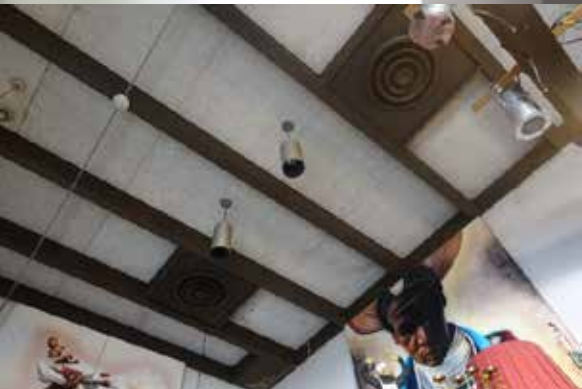
| 9-4 | | c. 1969 | Structure-integrated anemostats, round grilles | Yes | Architectural vents with round grilles, integrated into a system of nonstructural beams and painted in the same color. Connected to original ducting of the air-only central air conditioning system. | Fair | Integrity appears to be intact; unknown if currently operating. | Integrated ceiling design involving box beams should be retained and utilized to greatest extent possible.<br><br>Reconnect air supply ducts to central system, if disconnected. |

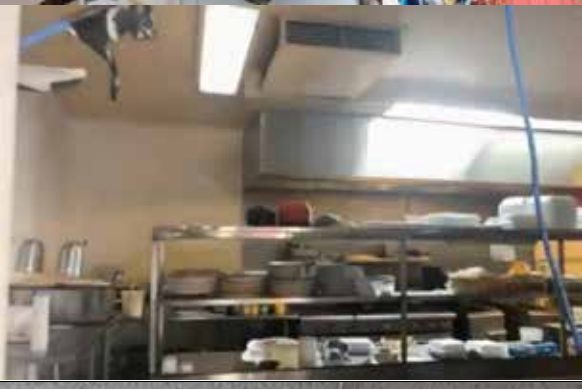
| 9-5 | | c. 2000s | Commercial kitchen ventilation system | No | Later installation of heat exhaust and ventilation system, including range hoods and associated grease ducting and fire suppression according to the CA Building Code and CA Mechanical Code; reference most recent inspection. | Good | Recently installed and working according to code. | Determine if an upgrade or maintenance is needed for long-term operability. |

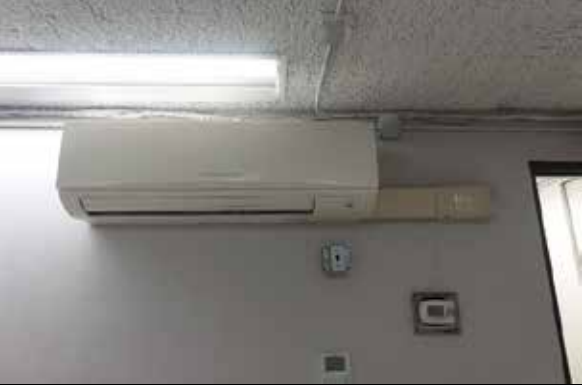
| 9-6 | | c. 2010s | Mini-split evaporator | No | Newer wall-mounted terminals of an additional multi-zone hybrid system, likely added during the renovation of the second floor. Mitsubishi brand, multiple throughout the second floor. | Fair | Working condition. Penetrates existing wall in a manner that may compromise historic integrity. | Evaporators should not be spatially and visually conspicuous.<br><br>Replace with active chilled beams integrated into ceiling assembly, or another less invasive system.<br><br>If required, integrate into ceiling or floor assembly. If this is not possible, place adjacent to wall away from egress and common circulation paths. |

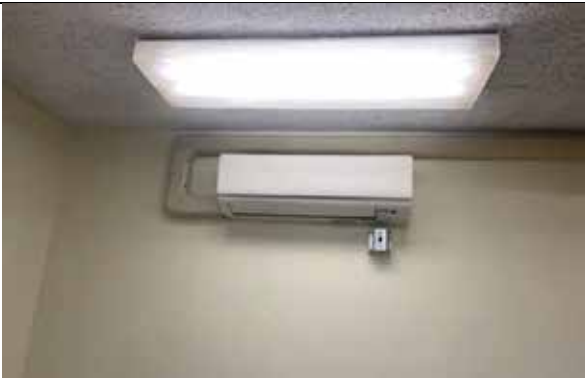
| 9-7 | | c. 2010s | Mini-split evaporator | No | The terminals on the first floor are different from those on the second floor, in brand and design. Still a wall-mounted terminal of a multi-zone hybrid system, augmenting the ventilation from soffit ducts. | Fair | Working condition. Augments historic ventilation system, but nevertheless may compromise interior spaces, especially when all units are considered. | Evaporators should not be spatially and visually conspicuous, nor should it block circulation.<br><br>Replace with active chilled beams integrated into ceiling assembly, or another less invasive system.<br><br>If required, integrate into ceiling or floor assembly. If this is not possible, place adjacent to wall away from egress and common circulation paths. |

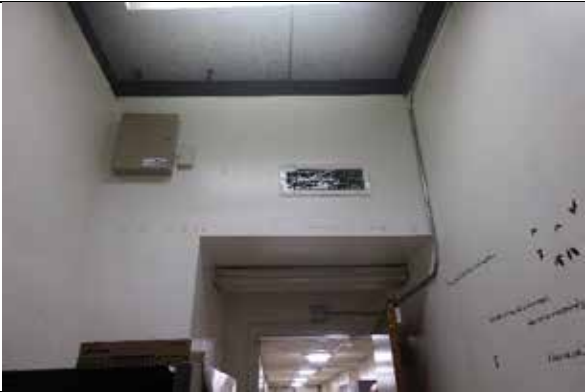
| 9-8 | | c. 2010s | Air supply grille at duct. | No | Newer or expanded duct in room formed by partition walls, likely connected to the same original air-only central conditioning system which is supplemented by the multi-zone mini-splits. Curiously, it is taped over. | Poor | Assuming poor condition based on its non-utility at the time of inspection. It being taped over implies the air flow to this room is not desirable or may even burden the central system's efficacy if it is not stoppered. | Determine if layout of room and its ventilation is appropriate.<br><br>Reconnect air supply ducts to central system, if disconnected. |

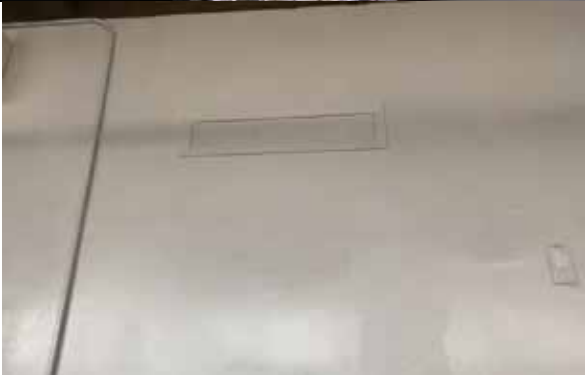
| 9-9 | | c. 1969 | Air supply grilles at duct | Yes | On interior wall in partition group space (new culinary arts space), original vents serving ducts connected to the air-only central conditioning system, no longer in use.<br><br>(See: recording timestamp 02:34:30) | Poor | Remains connected to central system but is completely painted over and no longer in use. | Remove paint and replace vent grille as necessary.<br><br>Reconnect air supply ducts to central system, if disconnected. |

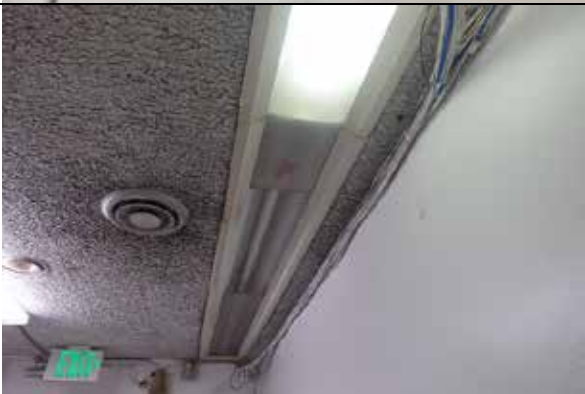
| 9-10 | | c. 1969 | Round ceiling anemostat and grille | Yes | Small vents with round grilles, installed in the textured ceilings of the first floor, connected to original ducting of the air-only central air conditioning system. | Fair | Appears to still be in working condition and connected to central air system. Grilles may be deteriorated. | Integrated ceiling design involving box beams should be retained and utilized to greatest extent possible.<br><br>Reconnect air supply ducts to central system, if disconnected. |

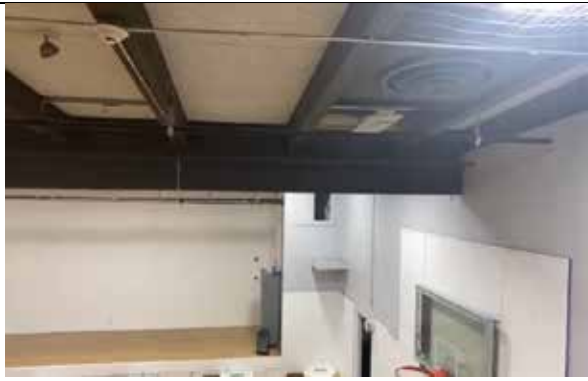
| 9-11 | | c. 1969 | Structure-integrated anemostat and round grille | Yes | In gymnasium (original dance hall), a collection of architectural vents with round grilles, parallel to the Coffee Shop, integrated into a system of nonstructural beams and painted in the same color. Connected to original ducting of the air-only central air conditioning system. | Fair | Appears to still be in working condition and connected to central air system. Grilles may be deteriorated. | Integrated ceiling design involving box beams should be retained and utilized to greatest extent possible.<br><br>Reconnect air supply ducts to central system, if disconnected. |

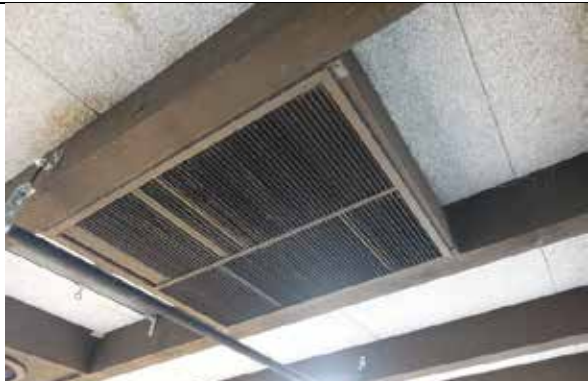
| 9-12 | | c. 1969 | Structure-integrated square ceiling vent and grille | Yes | Clearly a part of the same system as the round veiling vents and grilles. Possibly an exhaust vent, though at unusual proximity to anemostat.. Grille date uncertain. | Fair | Appears to still be in working condition and connected to central air system. Grilles is deteriorated and in need of replacement. | Integrated ceiling design involving box beams should be retained and utilized to greatest extent possible.<br><br>Replace exhaust grille as necessary.<br><br>Reconnect air supply ducts to central system, if disconnected. |

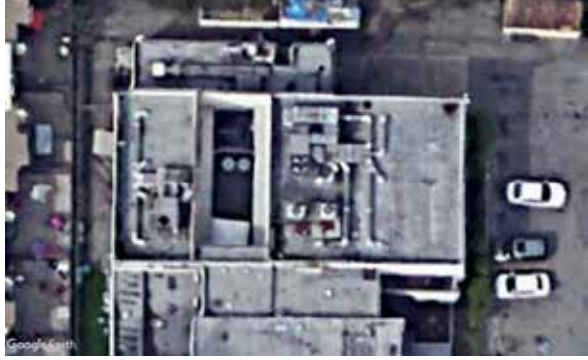
| 9-13 | | 1969-present | Rooftop packaged condensers, ducts, and motorized air handler | No | Meant to be unseen by the public, any of the mechanical systems on the roof may not be considered significant. Many added over time, including condensers serving the network of mini-split evaporators, as well as what may be an updated motorized central air handler on the Coffee House roof, of unknown make. | Fair to Poor | An unconfirmed assembly making up the central forced air system, many of these packages would appear to be maintained while others are not. Judging by the state of the original forced air ventilation and its needing to be supplemented by a system of mini-split interior evaporators, the original system may be significantly degraded or otherwise unsuitable for the contemporary building use. | Replace conventional forced air system with centralized direct outside air supply (DOAS) system; utilize existing duct system and retain ceiling character features to greatest extent possible; expand duct system modestly; include network of active chilled beams directly adjacent to duct system.<br><br>All system equipment should be supported on the roof or, if necessary, on the ground in a location away from the public eye. |

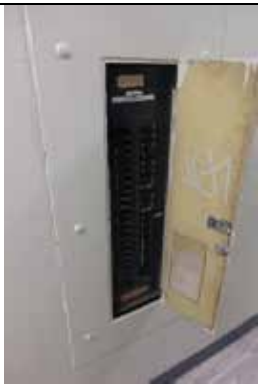
| Feature Number | Photograph | Estimated Date | Feature type | Significant | Description | Condition class | Condition description | Recommendations for Treatment |
|---|---|---|---|---|---|---|---|---|
| 12-1 | | 1969 | Electrical sub panel | Yes | The electrical sub panel is updated recently. | Good | It's new, modern and safe. | People need to check the electric sub panel regularly, even if they don't need any electrical repairs. In particular, people should inspect for signs of rust or scorching. These two situations indicate potential damage to the system. Based on experience, electrical sub panels need to be replaced every 25-40 years. |

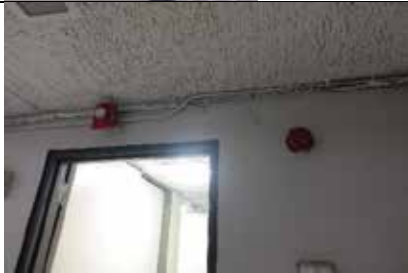
| Feature Number | Photograph | Estimated Date | Feature type | Significant | Description | Condition class | Condition description | Recommendations for Treatment |
|---|---|---|---|---|---|---|---|---|
| 12-2 | | 2020 | Alarm | No | There is strobe light on the alarm. Therefore, it's audible and visible. When the fire breaks out, the alarm would sound, the lights would flash as well. For deaf, they could see the strobe light, even if they can't hear the sound. | Good | The alarms are updated recently. They are new and in good condition. | The alarms should be inspected and tested annually and replaced every 10 years to ensure their reliability.<br><br>Everyone should know what this sound and flashing lights mean and how to react by holding fire drills. When the alarm sounds and the light flashes, people are supposed to get out of the building until the alarm stops. |

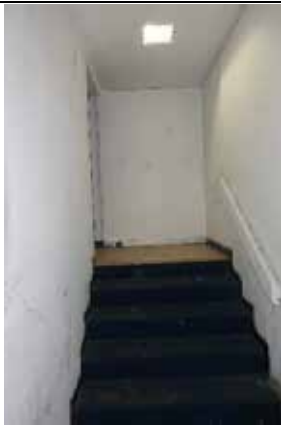
| Feature Number | Photograph | Estimated Date | Feature type | Significant | Description | Condition class | Condition description | Recommendations for Treatment |
|---|---|---|---|---|---|---|---|---|
| 12-3 | | 1969 | Stairway | Yes | This is the first stairway with semicircular shape on the outside of the building. It is covered by blue carpet. | Good | There is no decoration on the walls of the stairs. The stairs only have handrail on one side. No sundries were placed on the stairway. It's free and clear. | The stairway is one of an important fire escapes in this building. People are not supposed to decorate them in any way or store any belongings, even small things, in the stairwells that would prevent people from using them to escape safely when the fire happens. |

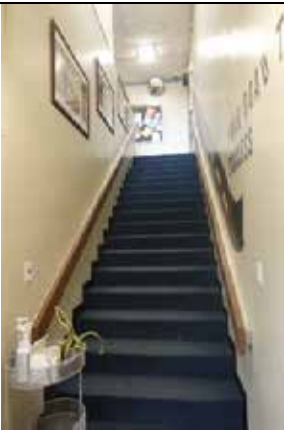
| 12-4 | | 1969 | Stairway | Yes | This is the second stairway which has the same circular shape on the outside of the building. It is covered by blue carpet. | Good | Some pictures are hung on the walls of the stairs as decoration. There are handrails on both sides of the stairs. Sundries were placed at the end of the stairway, obstructing the access. | The stairway is one of an important fire escapes in this building. People are not supposed to decorate them in any way or store any belongings, even small things, in the stairwells that would prevent people from using them to escape safely when the fire happens. |

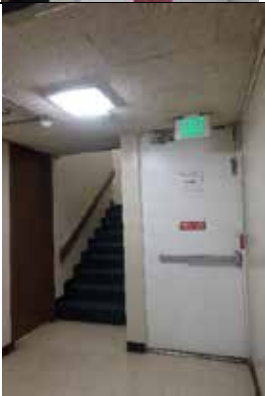
| 12-6 | | 1969 | Emergency exit | Yes | The outside emergency exit door is near to the stairway. The label "EMERGENCY EXIT ONLY, ALARM WILL SOUND" is attached to the door. The exit sign hangs in front of the door. | Good | No structural or material damage visible on the exit door. It is in good condition. | People should inspect the exit doors at least quarterly by operating it to ensure they are working properly. Everyone there should be informed that it's forbidden to use this exit except for emergencies and inspection. |

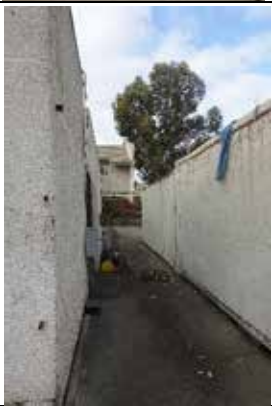
| 12-7 | | 1969 | Access and egress | Yes | This is the access from the emergency exit to the outside | Good | Some cleaning tools and garbage are piled up on the access and egress. | People should not be allowed to store anything or pile up garbage on the access and egress. The exit should always have clear access in case of an emergency. |

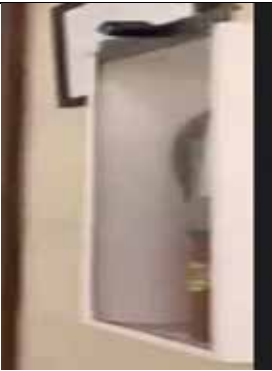
| 12-8 | | 2020 | Fire extinguisher | No | The fire extinguisher is installed in a recessed cabinet. | Good | The fire extinguisher is in good condition. | <p>People need to ensure that the fire extinguisher is working at all times whenever they need. Therefore, fire extinguishers should be inspected when they are initially installed and once a month after that.</p> <p>The fire extinguishers are not supposed to be installed in humid environment which would make them easy to rust. The recessed cabinet is also necessary which could prevent it from being impacted especially be children.</p> <p>In addition, fire extinguishers are divided into two types: charging and non-charging. For charging extinguishers, they need to be recharged every 5 to 6 years. For non-charging extinguishers, they need to be replaced every 12 years.</p> |

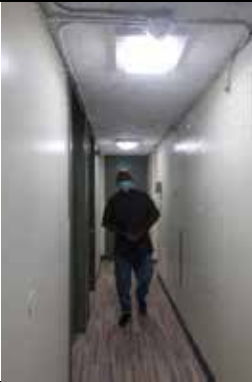
| 12-9 | | 2020 | Test smoke detector | No | The test smoke detector is installed on the ceiling in the corridor. It would sound when too much smoke enters. | Good | It's new and in good condition. | Smoke detectors should be tested regularly. People should know what they sound like as well, so there's no confusion if the alert comes on. In general, the batteries of hardwired detectors should be replaced every six months. If the detectors are run by lithium batteries, they should be replaced every 10 years. |

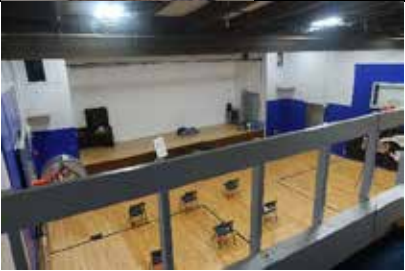
| 12-10 | | 1969 | Handrail | Yes | The handrail is installed in the mid-level of the multipurpose room. The wood is finished with white paint. | Good | No visible structural or wood damages. White paint finish is peeling in parts. | Regular inspections and maintenance of handrails are necessary. Only in this way, people can identify and correct problems before they become accidents that could have prevented. For peeling paint, people could remove lifted layers of paint and recoat with a fresh layer of white paint. |

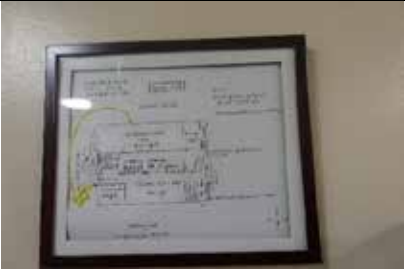
| 12-11 | | 1969 | The second-floor plan | No | The drawing of second-floor plan is hung on the wall at the end of the stairway. It shows the layout of the building and egress route as well. | Good | The drawing shows the egress routes clearly and the location of the viewers. | <p>The floor plan of the building should be hung at each egress instead of just one of them. The location of the fire extinguisher should be marked on the drawing as well.</p> <p>People working here should be familiar with the floor plan and teach their students to read it. They are supposed to hold fire drills with their students twice a year. Have one both in the day and the night with clear instructions on how to exit the building in case of a fire. Inform students and staffs well in advance which exit they should go, so stairways won't become jammed with people and they could escape as fast as possible.</p> |

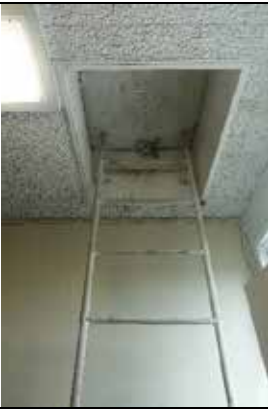
| 12-12 | | | 1969 | ladder | Yes | It is a ladder that goes up to the roof. The metal is finished with white paint. | Fair | No visible structural damage. White paint finish is peeling, and metal is rusting in parts. | Regular inspections and maintenance of ladders are necessary as well. People are supposed to inspect the ladder prior to each use, especially the loose, split, cracked, or missing rungs. People are supposed to clean metal ladder rungs regularly to prevent accumulation of materials that might destroy nonslip properties. For peeling paint, people could remove lifted layers of paint and recoat with a fresh layer of paint. |

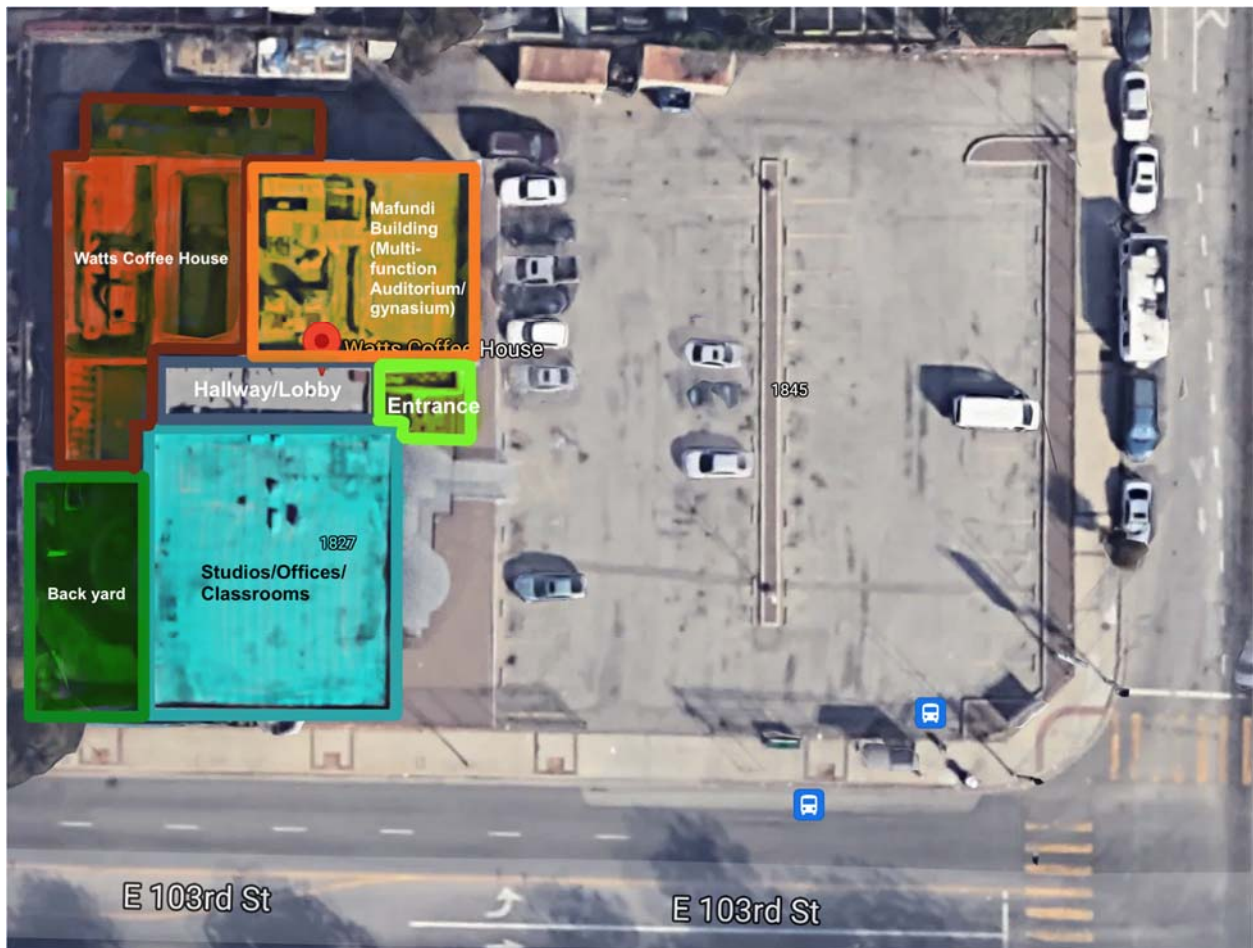
Figure 2. The functional division of Watts Happening Cultural Center<sup>3</sup>

Except for the Watts Coffee House and the Mafundi Center, most spaces of the building are used for educational purposes to serve local community. The back yard, which used to be open performance space, was converted as a educational space with reversible alterations. The studio/office/classroom spaces(shaded as blue rectangle in Figure.2) were also moderately altered both interiorly and exteriorly. For the building interior, the changed components include: the layout on the second floor(classrooms), lighting, ceilings, flooring in some rooms, ventilation system, etc. For the exterior, symbolic vertical windows and ground glass window were changed in varying degrees.

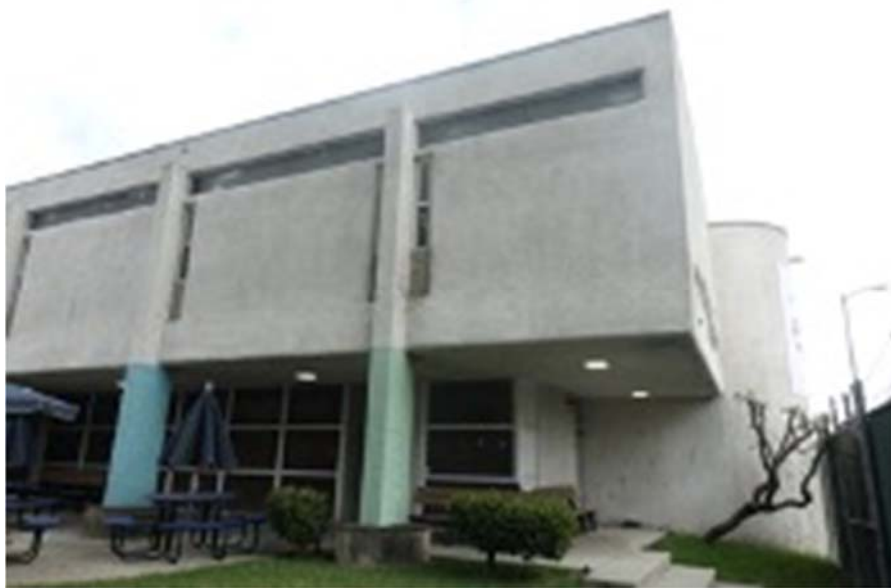
Figure 3. The symbolic vertical windows. The vertical sash was removed, and the bottom portion filled, which is an indication of adaptation over time.

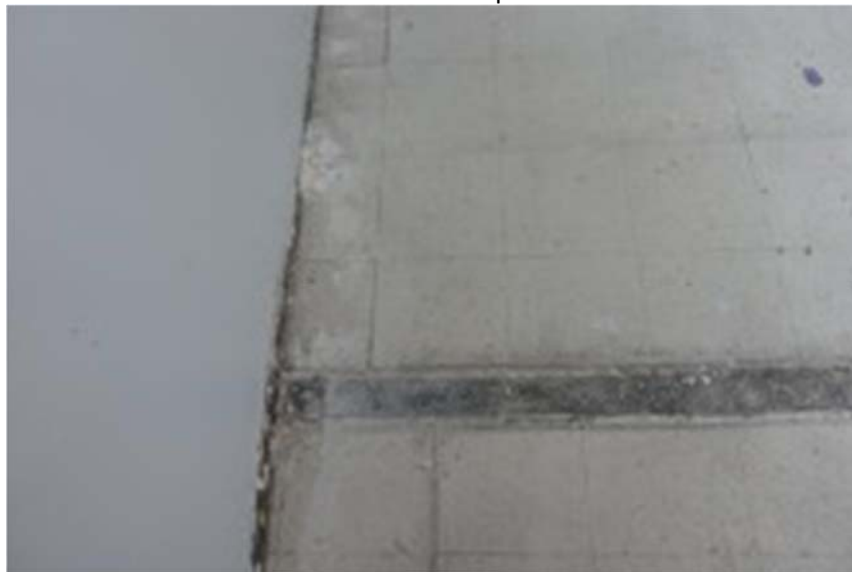
Figure 4. The exposed dark trace in the floor indicates that a partition was removed and the floor plan was changed. It is a non-reversible alteration and an indication of adaptation over time.

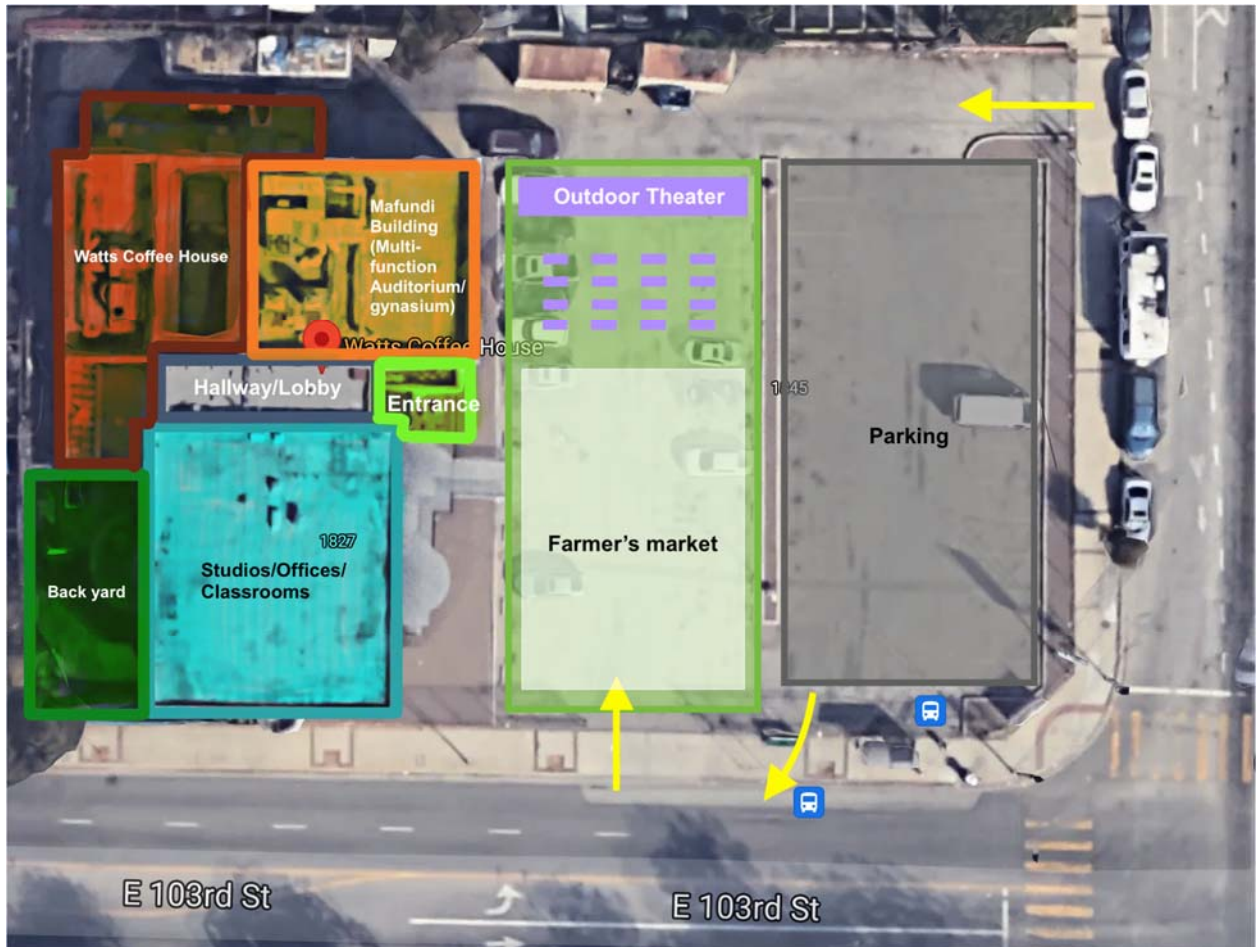
Figure 7. Site plan-1 for potential compatible uses

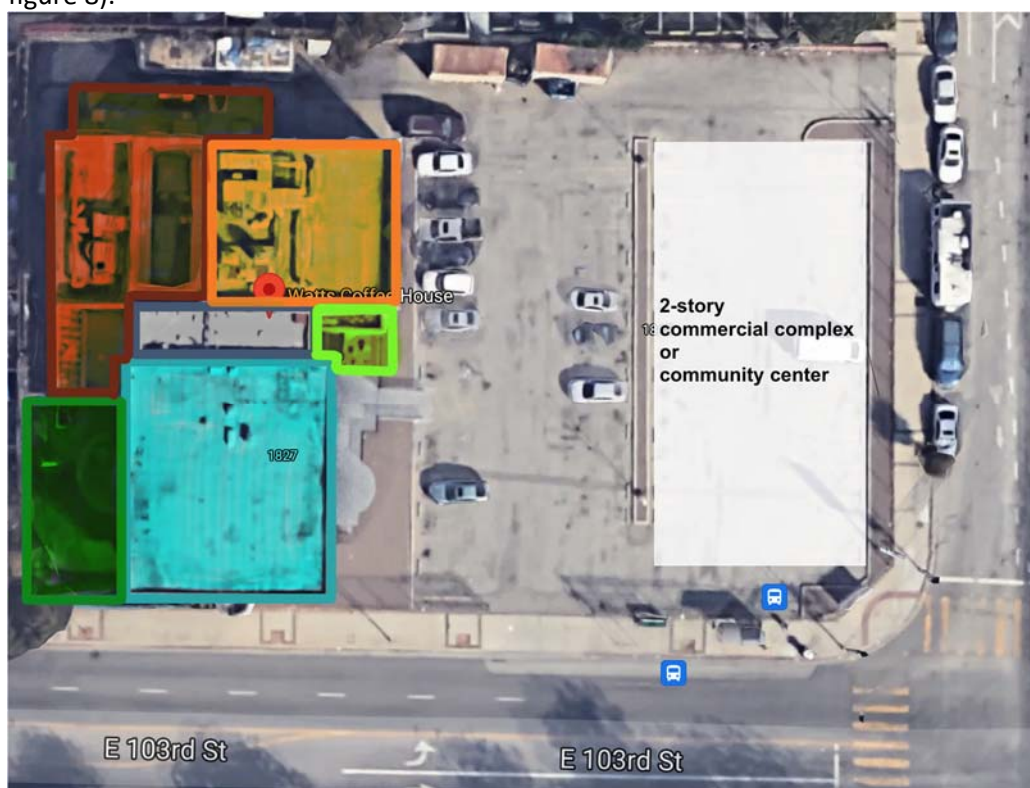
Another option for programing the parking space is to build an additional 2-story commercial or community center at the eastern part of the parking lot. The building should remain the same architectural style as the original Watts Community Center(See figure 8).

Figure 8. Site plan-2 for potential compatible uses of Watts Community Center

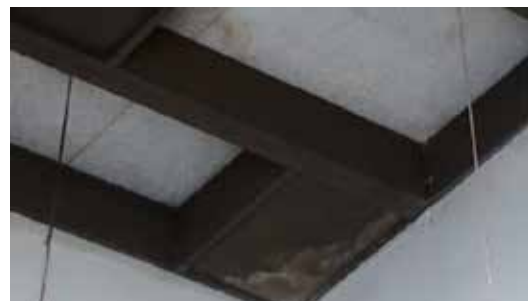
Figure 3 Water Damage. Photo: Peyton Hall

**Water Damage to Wood:** Though a bit tricky to treat if the wood is unpainted, the damage can be mitigated by using a conservator.

- First try to find where the leak is coming and stop the leak
- If the wood is painted and is in sound condition, repaint with matching paint or use a new color to hide discoloration.
- If it is unpainted wood, seek help of a professional conservator.

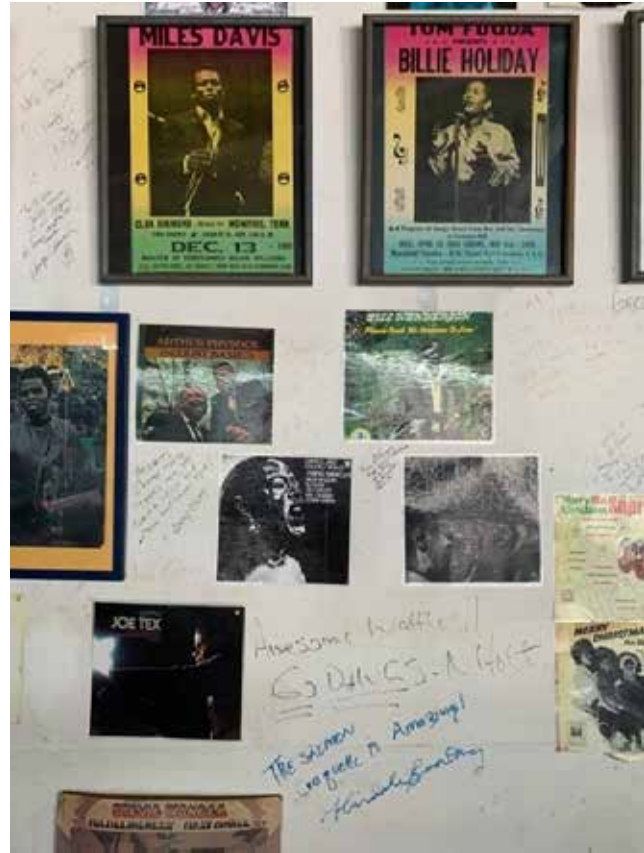
Figure 4 Autographs on the wall and photocopies. Photo: Author

**Recommendation:** Inventory, label and catalog the collection. The autographs on the walls will need special treatment and protection. You will want to work with a conservation professional.

- o Determine the substrate of the wall.
    - o Once the substrate is determined perform a localized cleaning around the notes
    - o As the notes are easily accessible to many people who can touch or damage the wall, Rosa suggested that a protective barrier be put in place to help preserve the notes from further deterioration or fading.

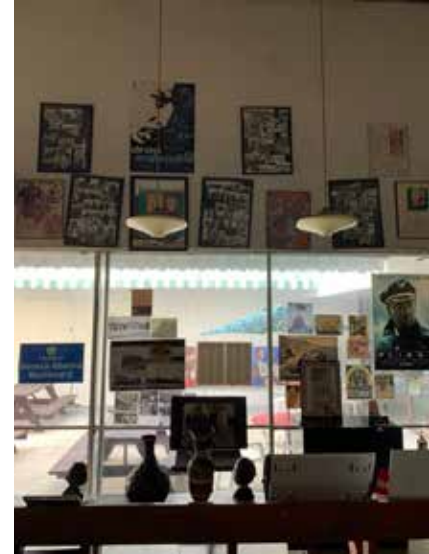
Figure 5 Light fixtures & windows. Photo: Author
