HISTORICAL RESOURCES ASSESSMENT AND ENVIRONMENTAL IMPACTS ANALYSIS

6220 WEST YUCCA PROJECT LOS ANGELES, CALIFORNIA

Environmental Science Associates
233 Wilshire Boulevard, Suite 150
Santa Monica, California 90401

JANUARY 2018

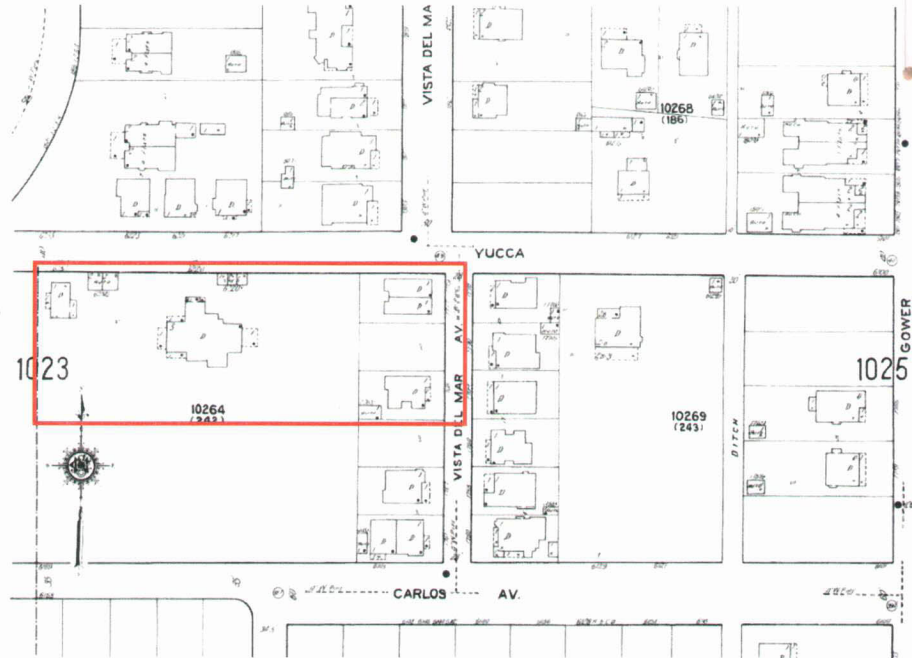
Figure 4. 1919 Sanborn Map, Vista del Mar Ave was beginning to fill in with residences, The Project Site is outlined in red. (Los Angeles Public Library, Sanborn Insurance Map Collection)

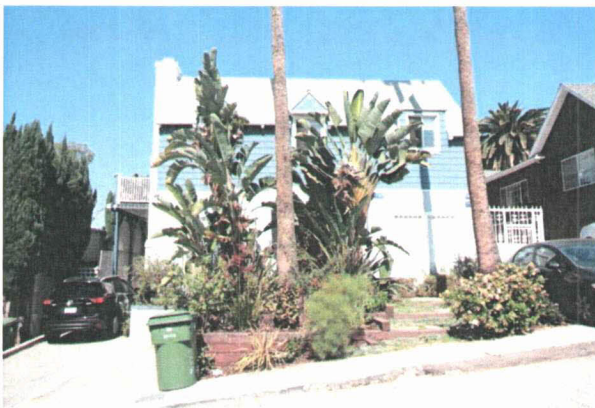
Figure 6. (Left) Street façade, 1765 Vista del Mar Street, Facing west. (ESA 2015)

1765 Vista del Mar Street is located in the neighborhood of Hollywood, City of Los Angeles, California, on an approximately 4,043 square foot parcel and occupies the majority of the lot (Figures 6 and 7). The two-story residence was originally designed as a one-story stucco home with a flat roof, most likely in the Spanish Colonial Revival style like its neighbor at 1763 N. Vista del Mar. However, the second floor addition in 1935 has altered the residence, giving it a Minimal Traditional appearance (alteration). The residence is composed

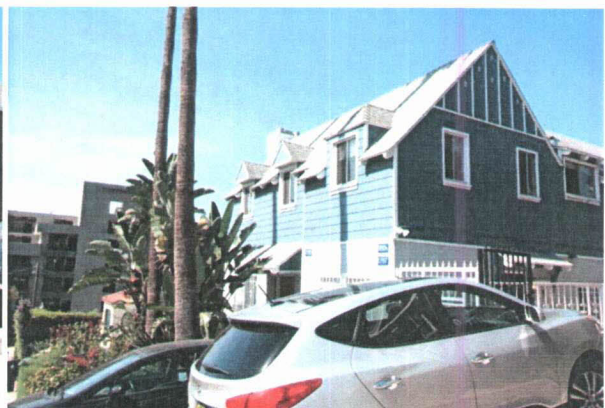
Figure 7. (Right) Street façade, 1765 Vista del Mar Street, Facing southwest. (ESA 2015)

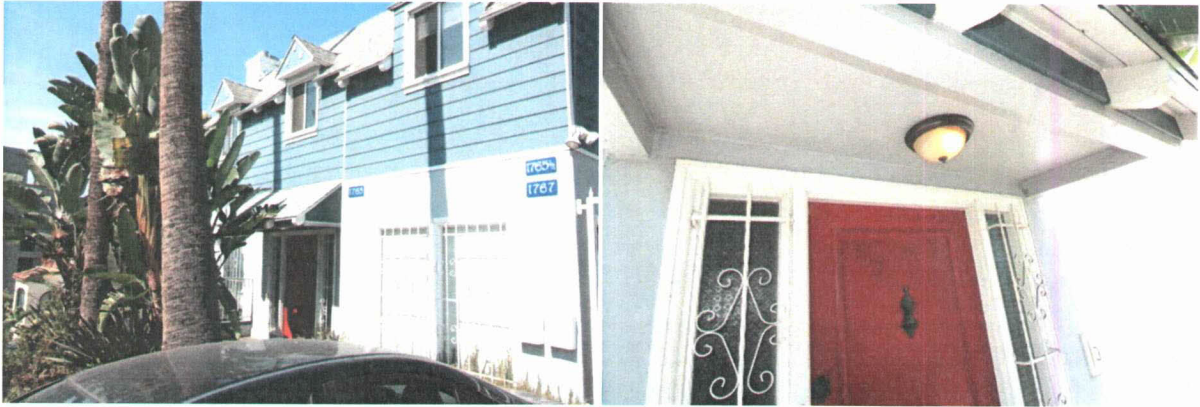
Figure 8. (Left) Closer view of front elevation, view facing southwest (ESA 2015)

Figure 9. (Right) Front entry with sidelights, view facing west (ESA 2015)

The primary elevation (east) consists of the main entry situated on a small brick stoop, beneath a modest shed roof (Figure 8). Previous evaluations stated the shed roof was supported by posts, however no posts currently exist (alteration). The residence's primary entrance contains a single wood paneled door flanked by sidelights with decorative grates (Figure 9 and 10). The brick stoop depicted in Figure 10 is covered with clay tile (alteration) and enclosed on the south end by a metal railing (alteration). Fenestration on the primary elevation's ground floor consists of paired fixed aluminum windows on flanking the main entrance (Figure 11) (alteration). There are three windows on the second floor of the residence situated in dormers, two of which are gabled while the third (northern most) is hipped (alteration).

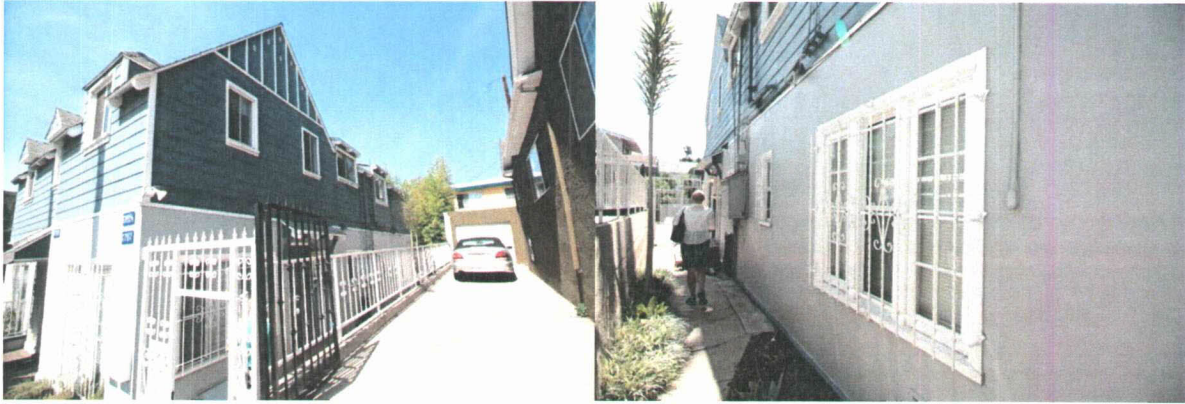
Figure 12. (Left) View of north elevation and side-facing gable, facing southwest (ESA 2015)

The north façade consists of a secondary entrance providing access to the second floor apartment. Above the secondary entrance is the side-facing gable, containing detailing characteristic of the Minimal Traditional style (Figure 12) (alteration). Fenestration along the north elevation consists of paired and single wood frame double hung windows with metal security bars. A tripartite grouping of windows with divided light is located at the west end of the south elevation and includes two wood casement windows flanking a fixed wood frame window (Figure 13).

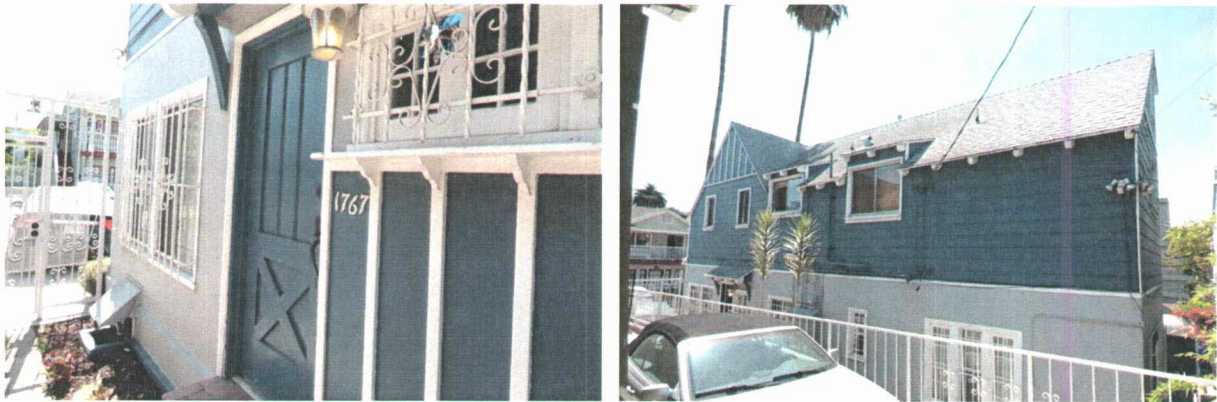
Figure 14. (Left) Secondary entrance providing access to upstairs apartment, facing southeast (ESA 2015)

Figure 15. (Right) Second floor with wood clapboard siding and aluminum windows, facing south (ESA 2015)

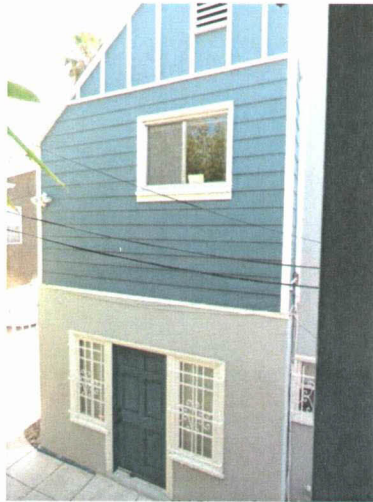
Figure 16. (Left) North side of rear elevation, facing east (ESA 2015)

The west elevation (rear) consists of another secondary entrance on the ground floor, providing rear access to the ground floor apartment. The entrance includes a single wood paneled door flanked by two wood framed casement windows with divided light (Figure 16). The doorway and windows are encompassed by a beveled wood frame. Metal security bars are found on these and other first floor windows. The wood clapboard siding found on the second floor of the east and north elevations continues onto the west elevation, however it ends just passed the mid-point of the rear facing gable (alteration). The rest of the rear elevation is clad in stucco (Figure 17). Like the side-facing gable on the north façade, the rear-facing gable exhibits decorative features characteristic of the Minimal Traditional style (alteration). Additional fenestration along the west façade includes a tripartite grouping of wood framed divided light windows near the south end as well as single wood framed double hung windows. Fenestration on the second floor includes aluminum sliding windows of various sizes (alteration).

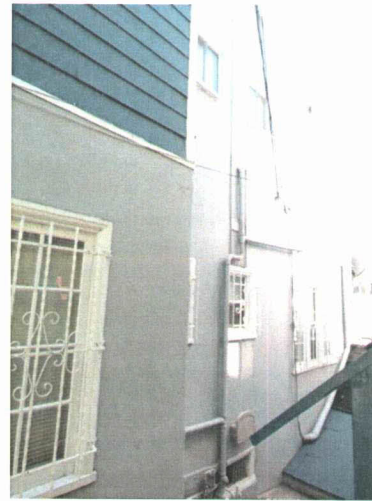
Figure 17. (Right) South side of rear elevation with all stucco siding, facing southeast (ESA 2015)

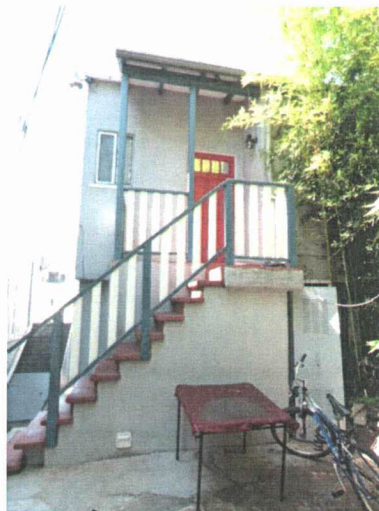
Figure 18. (Left) Detached garage and studio apartment, facing south (ESA 2015)

Also located at the rear of the residence is a detached garage with what was once a servant's quarters but is currently used as a studio apartment (alteration). Permits on file at the Los Angeles Department of Building and Safety show the apartment was added in 1931 (see page 22 of this report). Wood steps lead to the studio apartment's second floor entrance and are accompanied by a wood railing. A small landing and porch are enclosed by a wood balustrade, while posts support a shed roof style canopy above the main entry (Figure 18). Fenestration on this building is made up of aluminum sliding windows (alterations). The ground floor of the detached garage contains a single wood door to a utility room and a pair of partially glazed wood doors leading to the garage/storage space (Figure 19).

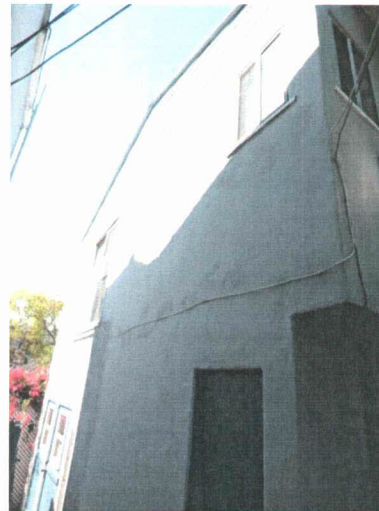
Figure 19. (Right) View of garage/studio apartment's east elevation, facing southwest (ESA 2015)

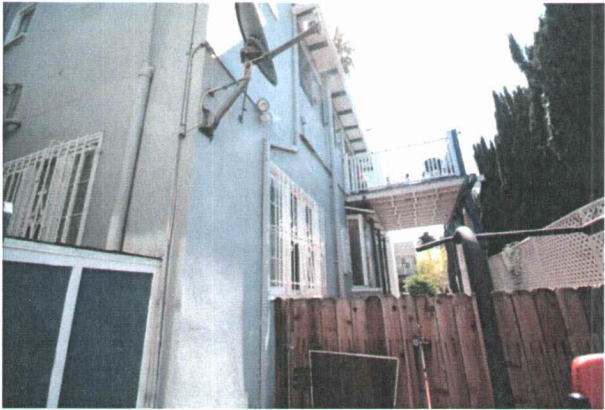
Figure 20. (Left) Southwest corner of Residence with view of second floor patio, facing northeast (ESA 2015)

Like the other elevations, the south façade consists of a combination of stucco siding and stucco siding wood clapboard siding. However, the wood clapboard siding on the second floor ends where a second floor balcony extends from the residence (alteration). The second story patio is supported by wood posts and doubles as a carport over the concrete driveway (Figure 20) (alteration). Also below the second floor patio is a small, angled protruding porch with a shed style roof (Figure 21). The porch is enclosed with wood framing and floor-to-ceiling plate glass windows (alteration). Near the front of the residence, there is an external brick chimney extending above the roofline (alteration). Fenestration along the east elevation includes single wood frame, double hung windows as well as a wood frame tripartite group of windows near the rear. Second floor fenestration is composed of aluminum sliding windows of various sizes (alteration). A sliding glass door provides access to the second floor apartment from the outdoor patio (alteration).

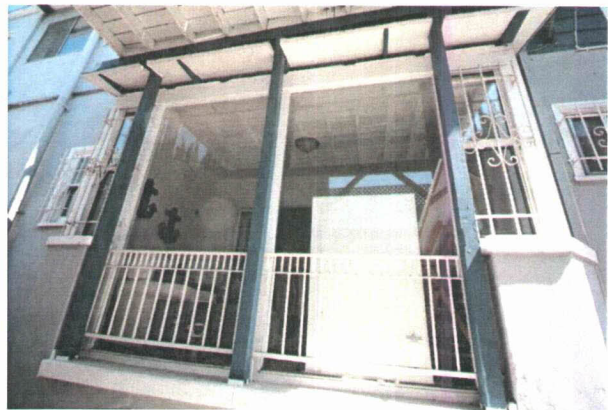
Figure 21. (Right) Close up view of enclosed porch on south elevation, facing north (ESA 2015)

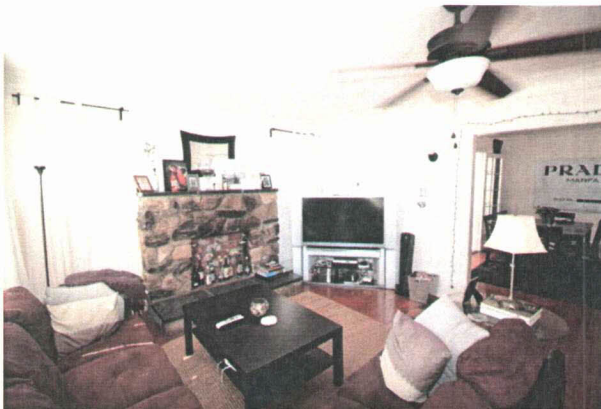
Figure 22. (Left) Interior view of first floor living room with fireplace (ESA 2015)

Visitors to the residence's first floor apartment are greeted by an open living room with a large stone fireplace (alteration) and wood flooring throughout (Figure 22). To the right of the entry is a pair of wooden doors leading to a small bedroom. A large dining room is located west of the living room. Original decorative crown molding, baseboards, and door jams are present throughout. On the south side of the dining room are fully glazed, divided light, wood French doors accessing a small enclosed space that was once an open porch (alteration) (Figure 23). North of the dining room is the unit's kitchen, which has been updated with new tile, cabinets, countertops and appliances (alterations). The rear of the unit consists of two additional bedrooms, flanking a single bathroom.

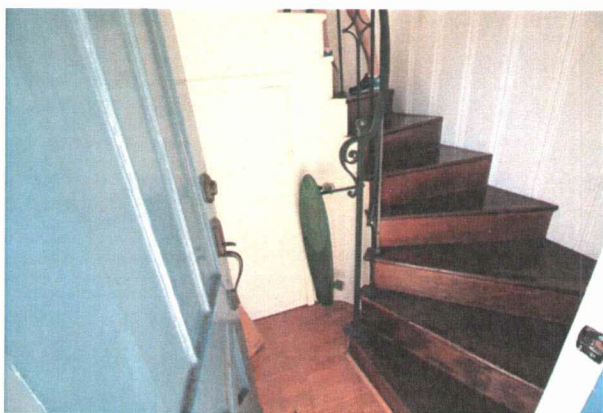
Figure 24. (Left) Ground floor view of staircase leading to second floor unit (ESA 2015)

The second floor apartment is accessed from a side entrance on the residence's north elevation (alteration). Upon entering the side entrance, the visitor is greeted by a large winding stair case with wooden steps a decorative wrought-iron railing (Figures 24 and 25) (alteration). The staircase leads to a large open landing on the second floor with built in storage space and wood flooring. From the landing, a doorway to the west leads to a renovated kitchen with new countertops, cabinets, and tile (alteration). To the south, a large opening leads to an open living room dominated by a decorative metal and brick fireplace (Figure 26) (alteration). Next to the living, to the west is the dining room, which includes elaborate wood built-ins and decorative wood tongue-and-groove siding (Figure 27) (alteration). A sliding glass door leads to an outdoor patio south of the dining room. The rear of the upstairs unit contains bedrooms and a bathroom (alteration).

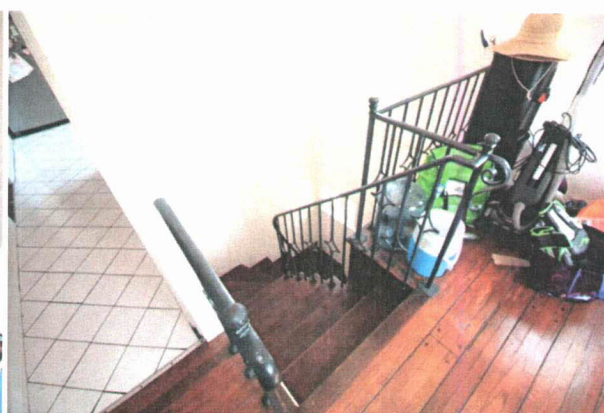
Figure 25. (Right) View of staircase from second floor (ESA 2015)

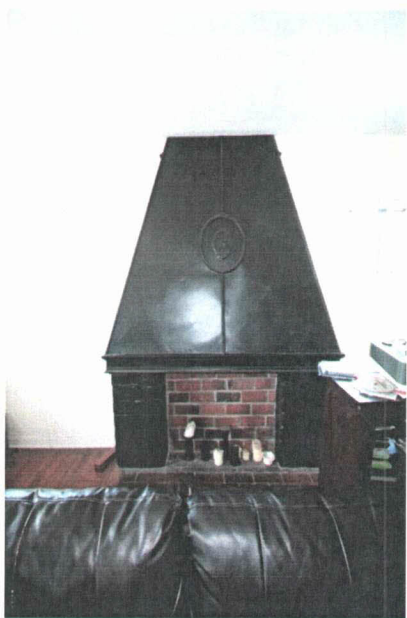
Figure 26. (Left) View of decorative fireplace in second floor unit (ESA 2015)

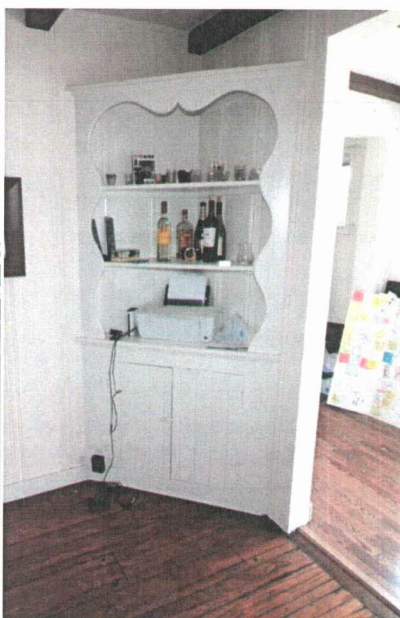
Figure 27. (Right) Built-ins in second floor unit's dining room (ESA 2015)

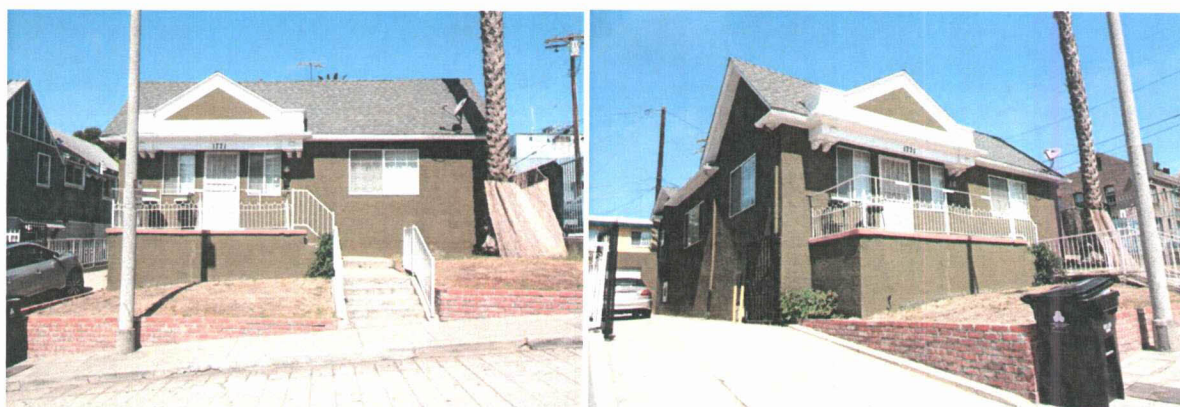
Figure 28. (Left) Primary (East) Elevation, View West (ESA 2015)

Figure 29. (Right) Primary (East) and Side (South) Elevations, View Northwest (ESA 2015)

Constructed in 1920, the bungalow at 1771 Vista del Mar is located on an approximately 4,042 square foot parcel oriented facing west towards Vista del Mar (Figure 28). Sited on the approximate center of the gently sloping lot 3, the bungalow is set back behind a grass lawn. There is a concrete driveway that runs parallel to the south property line to the rear one-car garage (Figure 29 and 30). Behind the bungalow is landscaped backyard enclosed by a chain-link fence (Figure 31). The bungalow has an overall rectangular plan, concrete foundation, wood-frame construction covered in stucco (alteration, originally the bungalow was sheathed with wood clapboard siding), and a hipped roof with two side gables. The roof is sheathed in composition shingles (alteration).

Because of the graded lot, concrete stairs with painted metal railings lead to the primary entrance located on the southern end of the primary elevation (Figure 28). Flanking the single-entrance door consisting of a wood panel door (alteration, replacement) and a metal-security door (alteration) are vinyl slider windows with false sashes and muntins (alteration, replacements). Over the door and two windows is a decorative wood cornice and oversized pediment (alteration, it appears the middle of the pediment has been stuccoed). A vinyl vertical slider false sashes and muntins (alteration, replacement) on the northern end of the balances the primary entrance ensemble.

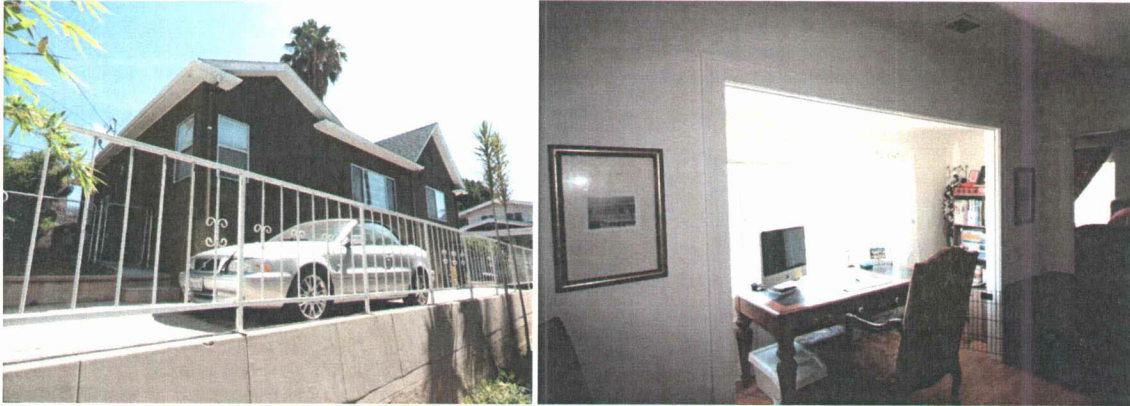
Figure 32. Side (South) Elevation, View North (ESA 2015)

Located in the middle of the side (south) elevation (Figure 33) once was an open porch that has subsequently been infilled. The boxed wood eave over this middle portion of the side (south) elevation appears to be a remnant from the former porch. Now the side (south) elevation consists of flat stucco plane with three vinyl slider windows with false sashes and muntins (alteration, replacements).

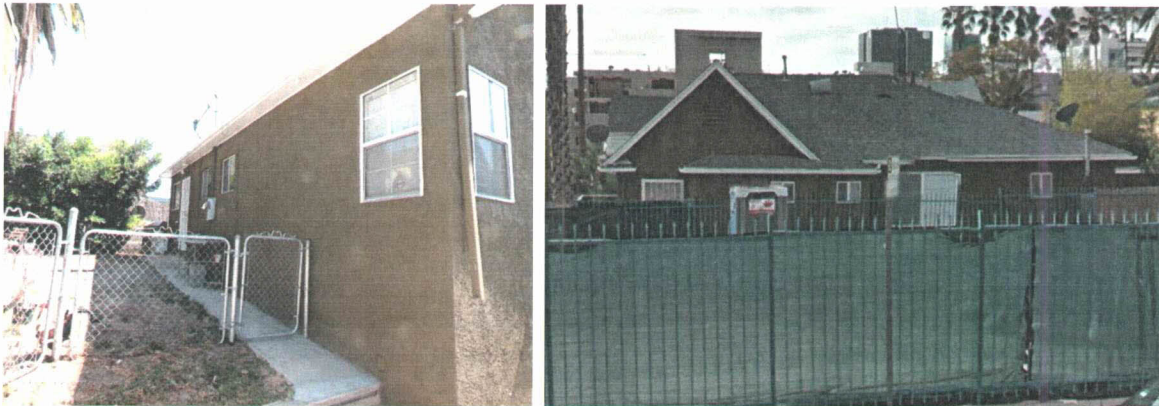
Figure 34. (Left) Rear (West) Elevation, View Northeast (ESA 2015)

The rear elevation also has a wide boxed eave at the roofline, four vinyl slider windows with false muntins and sashes (alteration, replacements) and a wood panel door covered with a metal-security door (alteration, replacement). The side (north) elevation has a bay window and five vinyl slider windows with false muntins and sashes (alteration, replacement) in varying sizes.

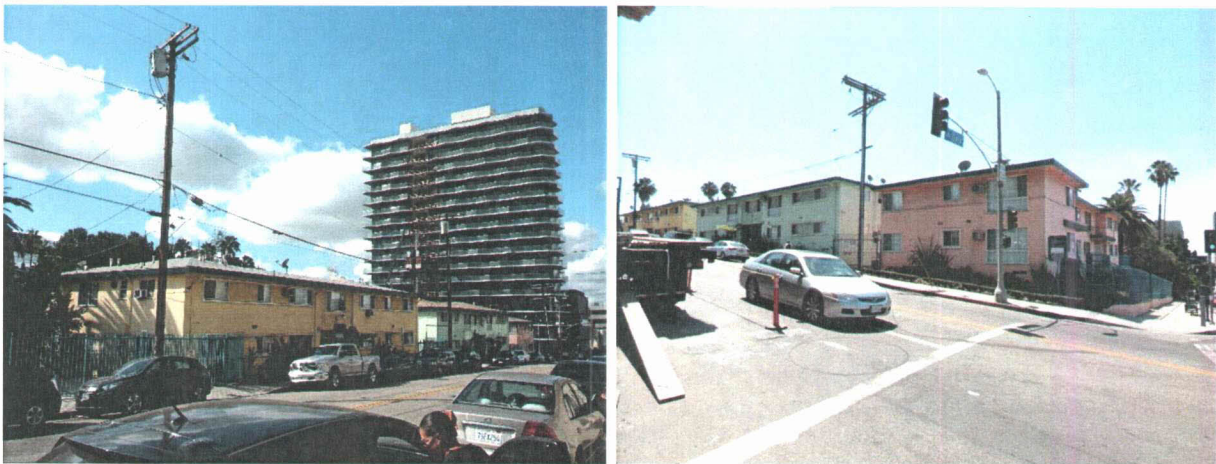
Figure 39 (Left) North elevation of Yucca Argyle Apartment Buildings, view to southwest (ESA 2015)

The multi-family complex is designed in a Minimal Traditional style utilizing wood frame construction, painted stucco, low sloping cross-hipped roofs, deep overhanging eaves with occasional rectangular screened vents, and a combination of fixed and sliding multi-light vinyl windows (alteration, all of the windows have been replaced) (Figure 41). The front facades are organized symmetrically.

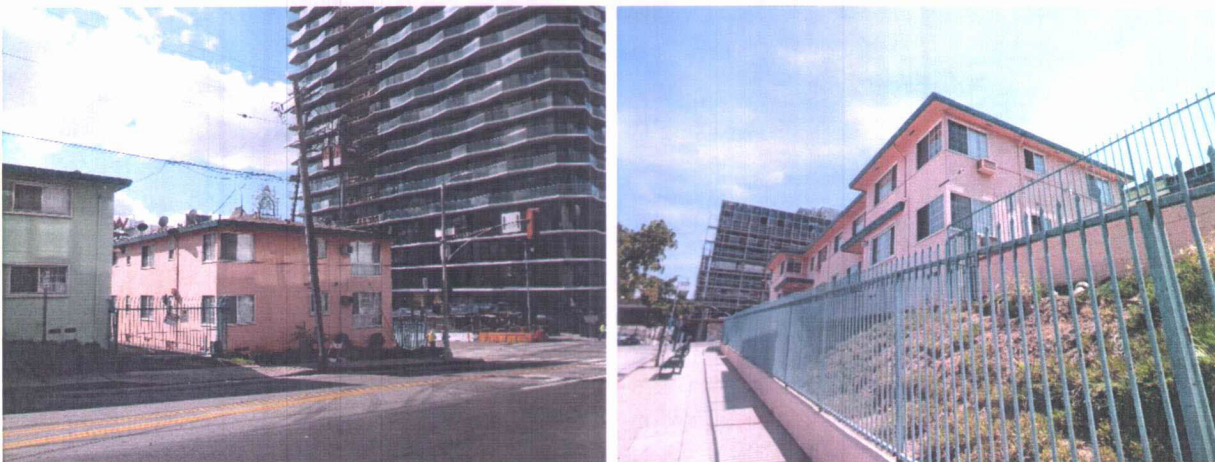
Figure 43. (Left) North elevation of rectangular Building, view to south (ESA 2015)

The two-story front (north) façade is organized as two rectangular masses on either side of a slightly recessed center plane with a large gated entry portal below and a modest multi-light combination fixed/sliding window above (alteration, replacements). Six multi-light combination fixed/sliding windows (alteration, replacements) on each floor are arrayed in sets of three on either side of the center opening; these sets of three are framed within a heavy applied molding.

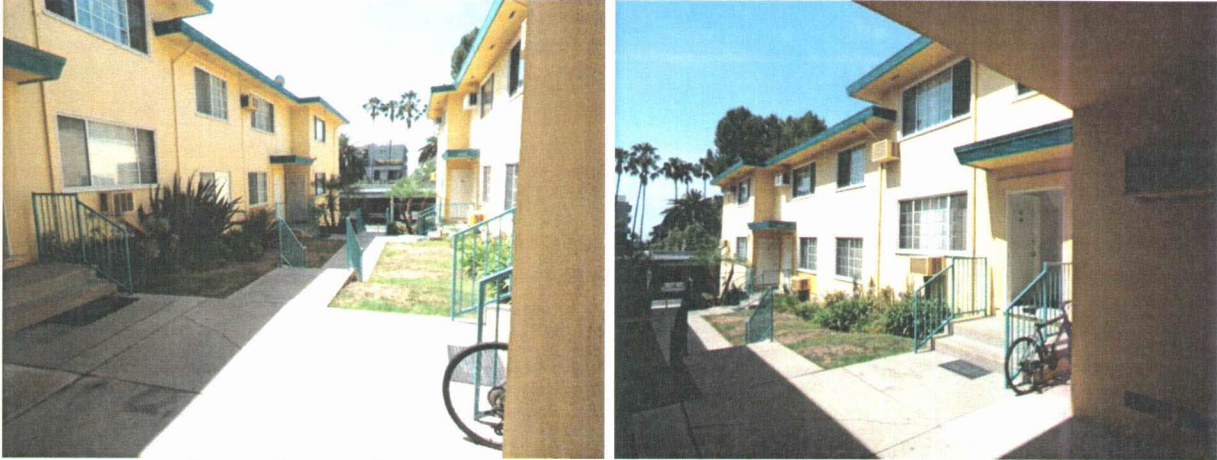
Figure 45. (Left) Central courtyard of yellow Building, view to south (ESA 2015)

Figure 46. (Right) Replacement windows found throughout the yellow Building, view to south (ESA 2015)

The deep center portal is entered through a secured and grated, square vertical post steel gate painted blue-green (alteration) and contains a bank of individual mailboxes on either side as well as wall air conditioning units (alteration). The pavement is concrete and runs through from the sidewalk, into the entryway, and beyond into the courtyard (Figure 45). At the courtyard it forms a central spine dropping down several sets of shallow stairs out to the parking area. It also links narrow walkways to the four recessed first- and second-floor apartment entries. Each entry porch is accessed by two stairs framed with steel square post railings painted blue-green that rise above the concrete ground plain (alteration) and give way to two front doors for downstairs units or to an internal staircase rising to doors for the second-floor units (Figure 46).

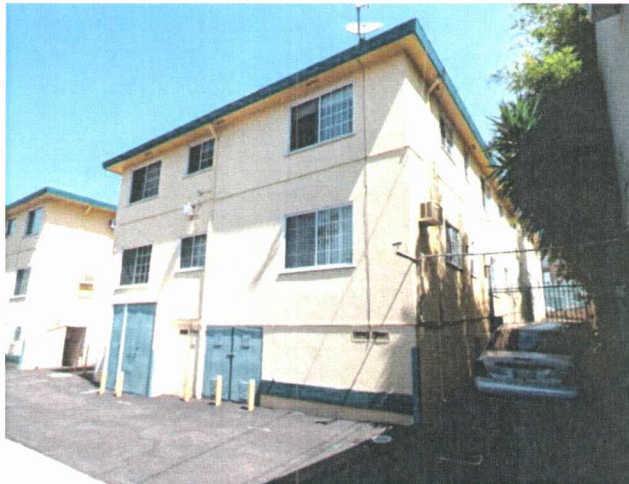
Figure 47. South elevation of yellow Building's east wing, view to north (ESA 2015)

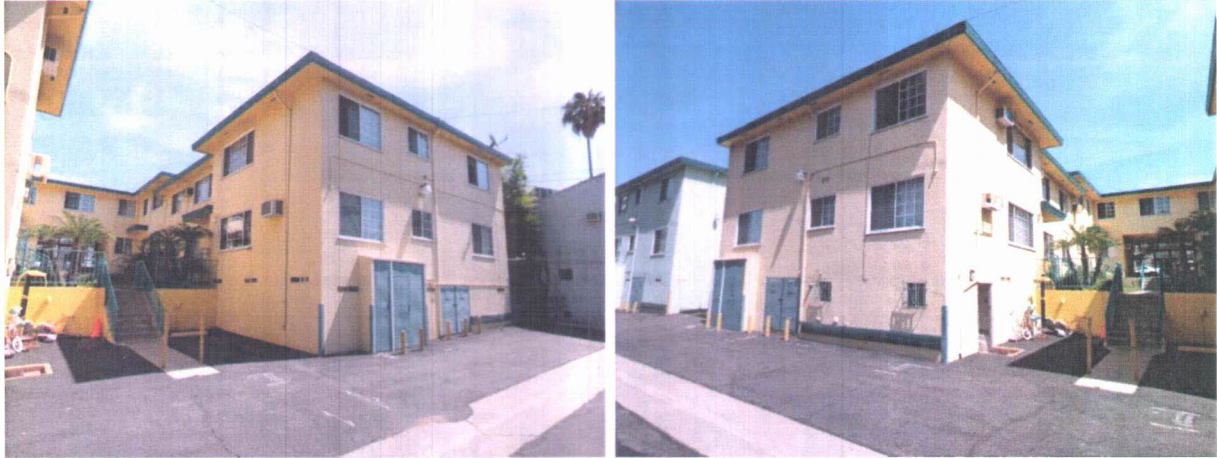
Figure 48. (Left) Rear elevation of yellow Building with view of central courtyard, view to northeast (ESA 2015)

Figure 49. (Right) Rear elevation of yellow Building's west wing, view to northwest (ESA 2015)

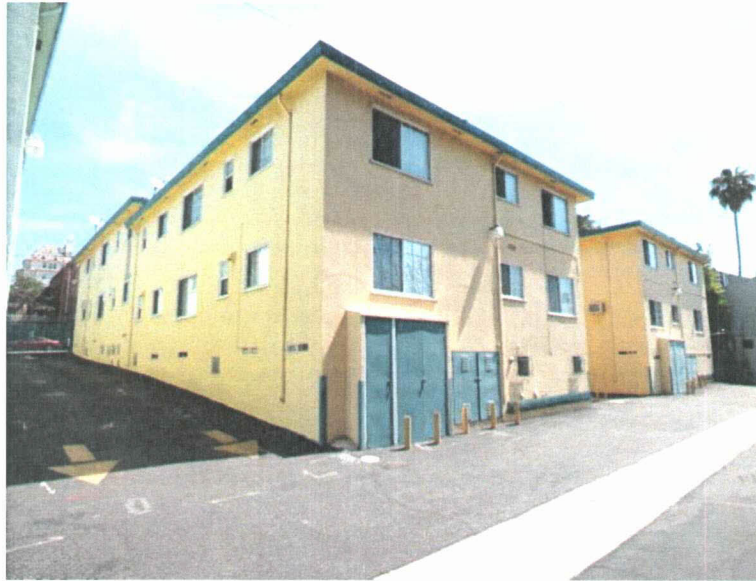
Figure 50. West elevation of yellow Building's west wing, view to northeast (ESA 2015)

The west elevation faces onto the active entrance driveway and onto the complex's center building. Like the east elevation, it features differently sized sliding and sash multi-light windows (alteration, replacements) in white frames, vertical downspouts, raceways for electrical cabling, and, at the lower level, screened rectangular vents (Figure 50). From this vantage point it is easy to see the break in the roofline as the building steps down to meet the change in slope.

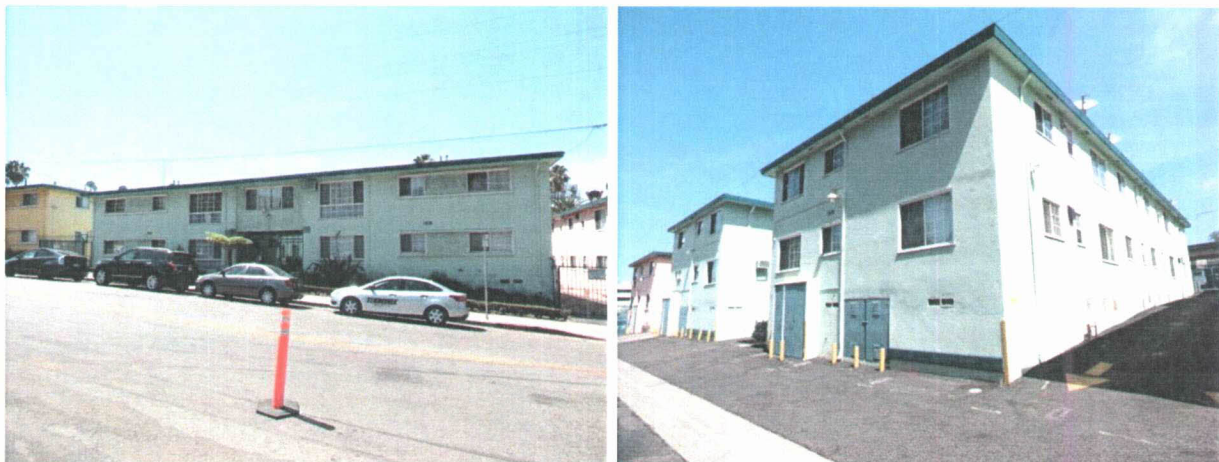
Figure 51. (Left) Primary (north) elevation of green Building, view to south (ESA 2015)

Figure 52. (Right) View of east and south elevations of green Building, view to northwest (ESA 2015)

The second largest building is located in the middle of the site (Figure 51). Currently painted a light blue-green, it also features the darker blue-green color along the roof eave and porch canopies. Unlike the largest building, this building does not break the roofline as negotiates the change in slope from front to back (Figure 52).

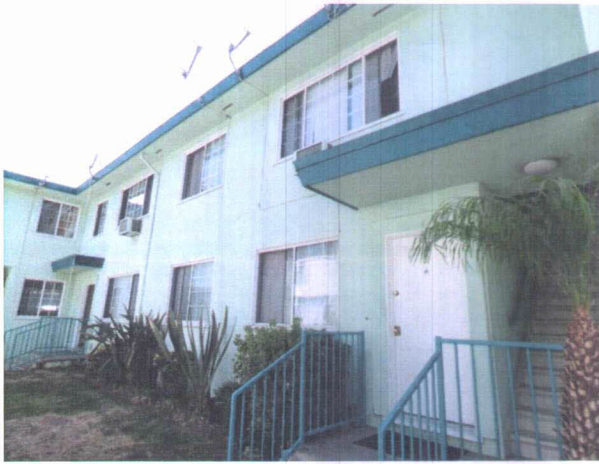
Figure 53. (Left) entrances to apartments and staircases, and replaced windows in the green Building's courtyard area, view to east (ESA 2015)

This middle building contains 16 units in 12,634 square feet. Its two-story front (north) façade is also organized as two rectangular masses on either side of a slightly recessed center plane with a large gated entry portal below and a modest multi-light combination fixed/sliding window above (Figure 54). The windows are also arranged as three above and three below on either side of the front entry but differ from the building to the east by being framed with heavy molding as pairs at the outer edge of the building with the third inboard window closest to the entry standing alone both top and bottom. This wall beneath this third window has been enlarged and another multi-light window (alteration) added at the base, each window in this position identically treated (Figure 53).

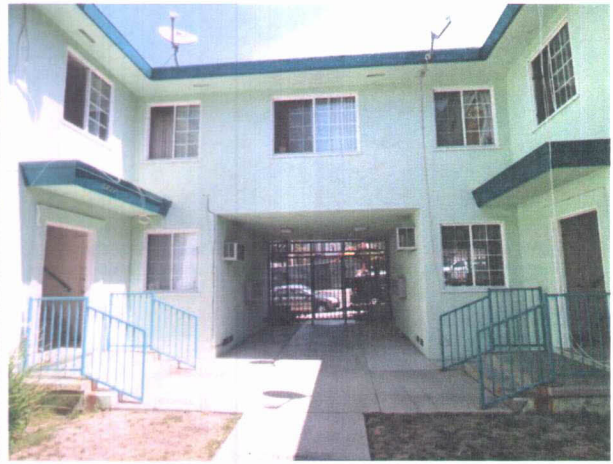
Figure 54. (Right) View of main entry into green Building's courtyard area, view to north (ESA 2015)

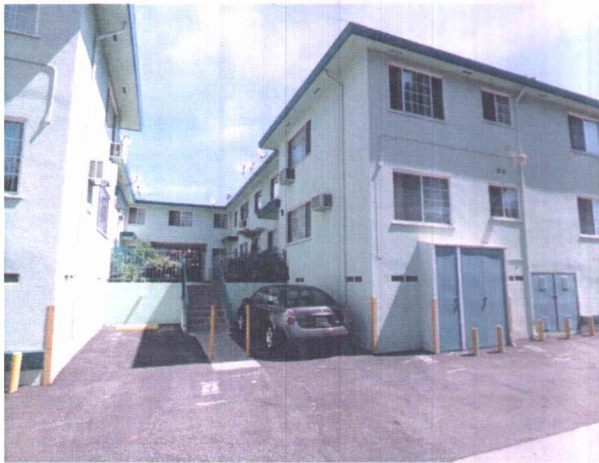
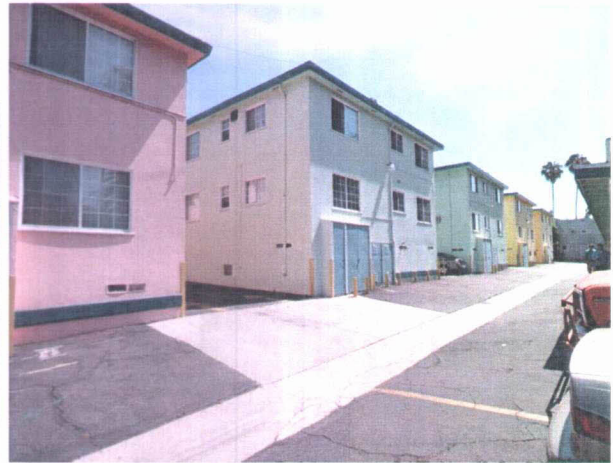
Figure 55. (Left) View of rear elevation and central courtyard of green Building, view to north (ESA 2015)

Figure 56. (Right) Rear and west elevations of green Building, view to northeast (ESA 2015)

The details of the entry, courtyard, east, south, and west elevations are similar to those of the largest building with one exception: there are no residential back doors on the perimeter of this building. Its west elevation faces onto the active exit driveway and onto the complex's west building (Figures 55 and 56).

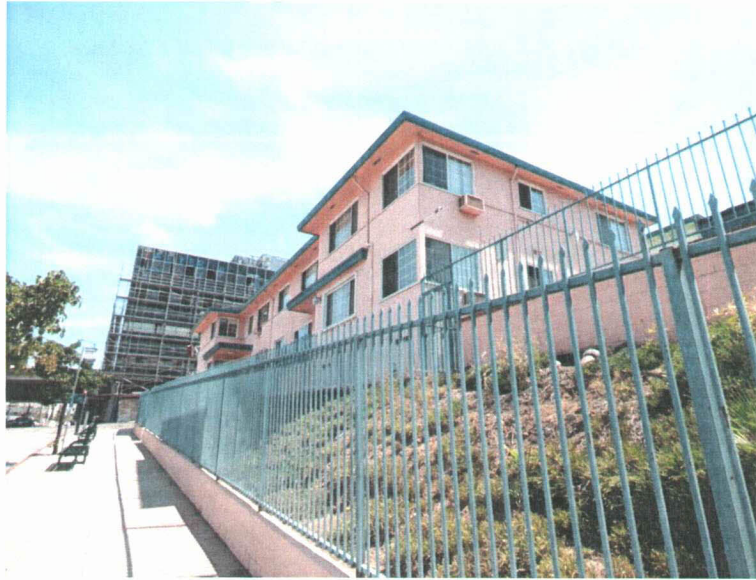
Figure 57. South and west elevations of pink Building, view to northeast (ESA 2015)

The front (west) façade is arrayed symmetrically as a long rectangular mass with two end units projecting forward to accommodate porches and stairs for entry to first and second floor units (Figure 57). The façade sits above the street on an elevated and fenced earthen berm and faces onto a concrete walkway. A gated and locked stair rises from the sidewalk and navigates the berm at the center of the front façade. A combination of individual fixed and sliding multi-light windows (alteration) are framed with substantial white molding at the first and second floors. Two vertical downspouts and incidentally located electrical cable raceways, wall air conditioning units and safety lights further populate the surface. As on the other buildings, the thick profile of the roof eave gives weight and horizontal definition to the building; dissimilar to the other buildings, this façade introduces a narrow band of molding beneath the second floor window frames that defines a boundary between first and second floors and brings unity to the façade composition.

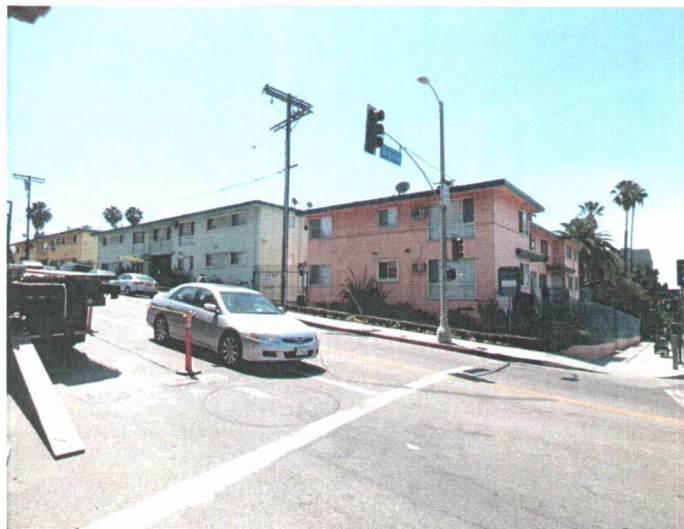
Figure 58. North elevation of pink Building, view to south (ESA 2015)

This linear element continues to the **secondary (north) elevation** where it creates a baseline for that side's second floor windows (Figure 58). This elevation is configured with three windows above and three below, again in a combination of fixed and sliding multi-light units (alteration, replacements). Similar to the front façade of the adjacent middle building, the wall at two of the window units on this elevation has been enlarged and an additional multi-light window added at the base. A number of rectangular screened vents are located at the base of the wall and between first and second floors; wall air conditioning units are located inboard of the westernmost windows at the first and second floors.

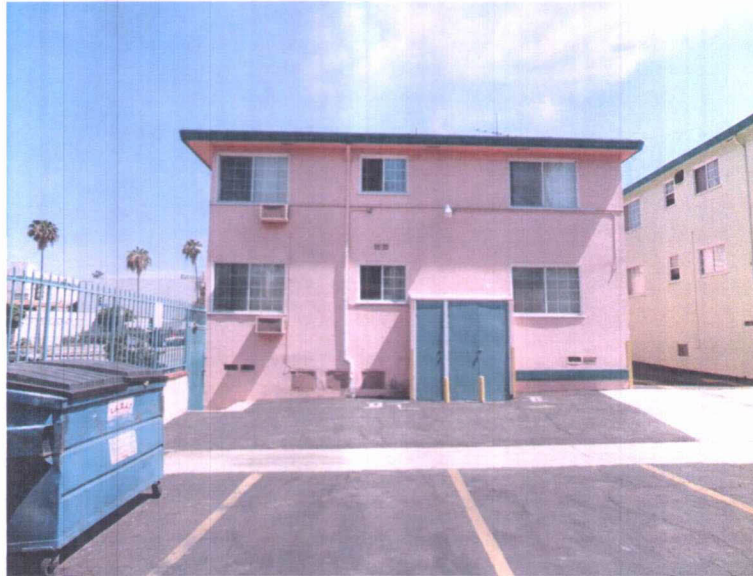
Figure 59. Rear (south) elevation of pink Building, view to north (ESA 2015)

The treatment of the east and south (rear) elevations is similar to that of the other buildings with the exception being that the rear elevation includes the features only one bar meaning three windows top and bottom and only one set of service doors (Figure 59).

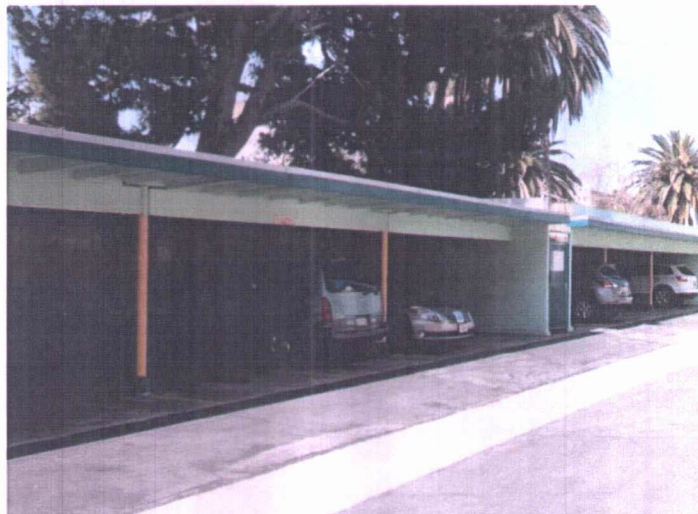
Figure 60. Rear parking area, view to southeast (ESA 2015)

A covered parking shed is sited along the south (rear) property line of the complex (Figure 60). It is open on one side with a flat roof and exposed rafters. The shed is wood frame stucco construction supported with
