GEOLOGIC AND GEOTECHNICAL ENGINEERING REPORT PROPOSED ADDITION, FOUR NEW BUILDINGS, RETAINING WALLS, AND SWIMMING POOL LOT 1, TRACT 23823 3900 STANSBURY AVENUE SHERMAN OAKS, CALIFORNIA FOR THE BUCKLEY SCHOOL THE J. BYER GROUP, INC. PROJECT NUMBER JB 19376-B JUNE 6, 2006

Per your written authorization, The J. Byer Group has prepared this report to summarize findings of our geologic and geotechnical engineering exploration performed at the site. The purpose of this study is to evaluate the nature, distribution, engineering properties, relative stability, and geologic structure of the earth materials underlying the site with respect to constructing additions, four new buildings, retaining walls, and a swimming pool.

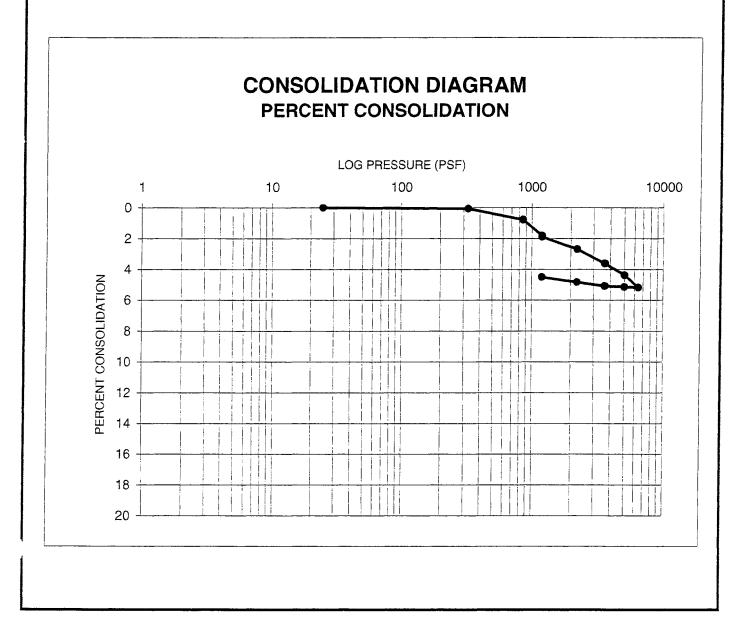
Earth Material:	Alluvium		
Sample Location:	B6 - 25'	Specific Gravity:	2.65
Dry Weight (pcf):	92.4	Initial Void Ratio:	0.79
Initial Moisture:	26.8%	Water Added At (psf):	1206.0
Initial Saturation:	90.0%	Consolidation Coef. (Cc):	0.1021

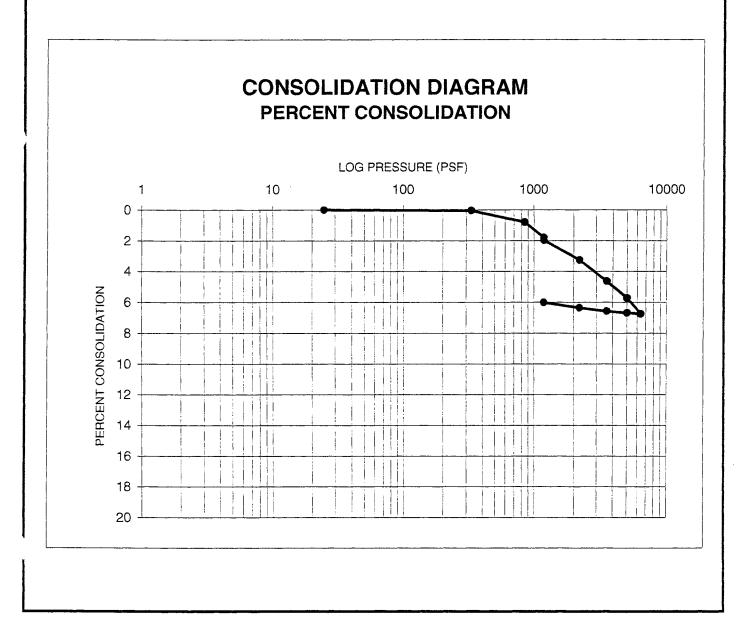
Earth Material:	FILL		
Sample Location:	B11 - 15'	Specific Gravity:	2.65
Dry Weight (pcf):	113.3	Initial Void Ratio:	0.46
Initial Moisture:	12.2%	Water Added At (psf):	1203.0
Initial Saturation:	70.4%	Consolidation Coef. (Cc):	0.1158

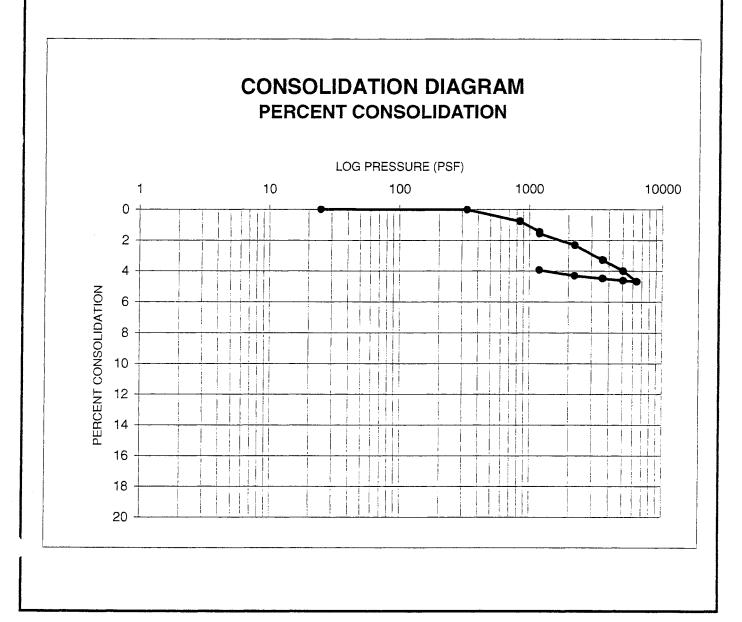
Earth Material:	Fill		
Sample Location:	B14 - 20'	Specific Gravity:	2.65
Dry Weight (pcf):	93.7	Initial Void Ratio:	0.77
Initial Moisture:	16.3%	Water Added At (psf):	1203.0
Initial Saturation:	56.4%	Consolidation Coef. (Cc):	0.0938

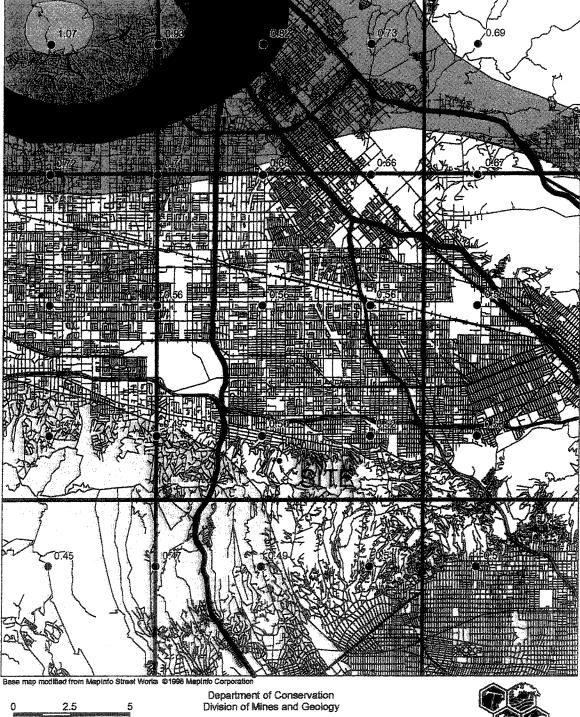
Figure 3.3

10% EXCEEDANCE IN 50 YEARS PEAK GROUND ACCELERATION (g)

1998 **ALLUVIUM CONDITIONS**
