Cultural Resources
TECHNICAL REPORT

Wilshire Boulevard Temple Master Plan
Los Angeles, California

HISTORIC RESOURCES GROUP, LLC
1728 Whitley Avenue
Hollywood, CA 90028

December 2010

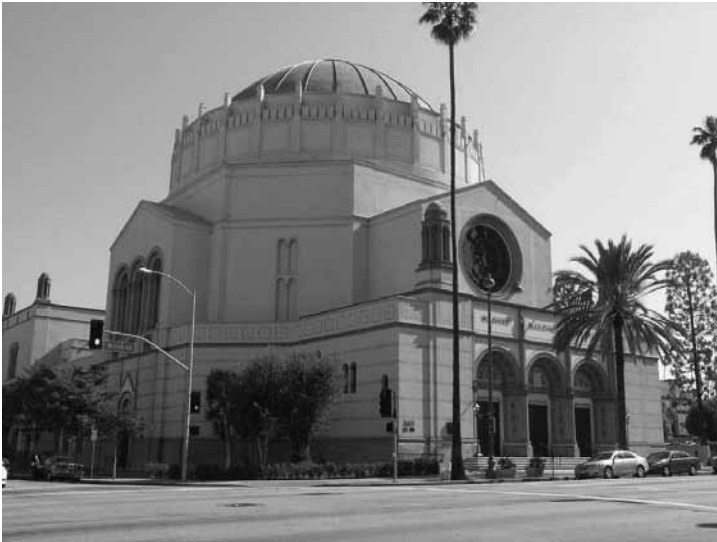
Figure 4.2: Temple Building; Sanctuary

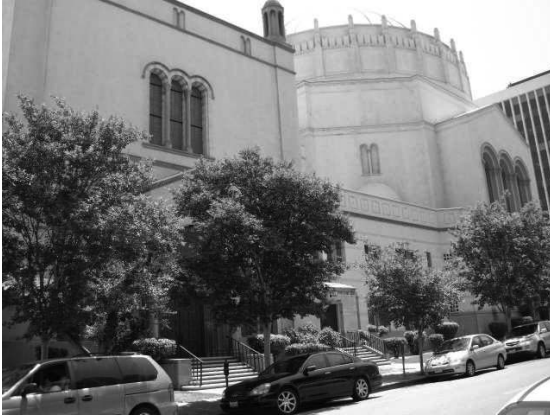
Figure 4.3: Temple Building; Assembly Halls

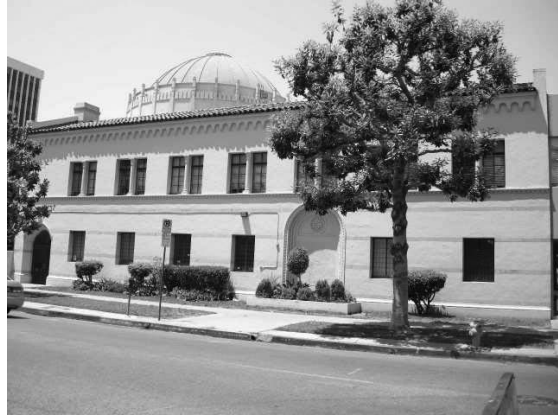
Figure 4.4: Temple Building; School Building

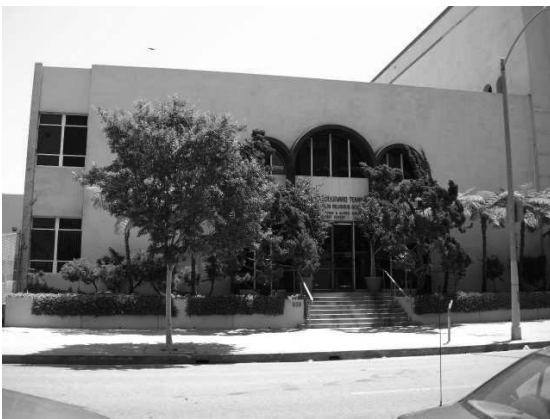
Figure 4.5: Temple Addition, Administrative Building on Hobart Boulevard.

A two-story stucco-clad addition was built to the north of the historic complex in 1962-63, expanding the administrative offices and providing a new school building. The administrative offices face Hobart Boulevard, and the school wing on the eastside faces Harvard Boulevard. The addition was designed by architect Maurice Fleishman, AIA. The addition is attached to the historic Temple building. It is mostly utilitarian in style with little decorative detailing. A grouping of three arched glazed openings, mimicking those on the Temple facades, marks the administrative entrance on Hobart Boulevard. The primary façade of the school wing has symmetrical multi-light window fenestration with the entrance marked at the south end by smooth unadorned cast stone pilasters and spandrels with glazed double doors.

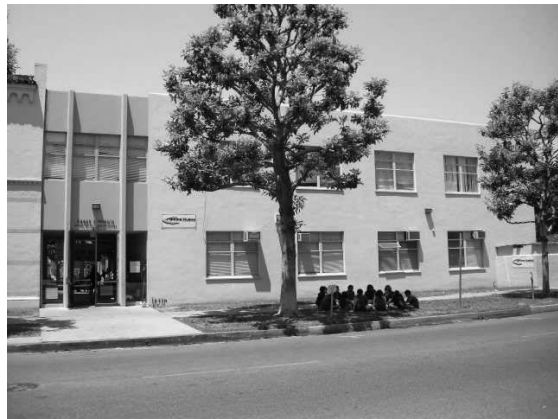
Figure 4.6: Temple Addition, School Building on Harvard Boulevard.

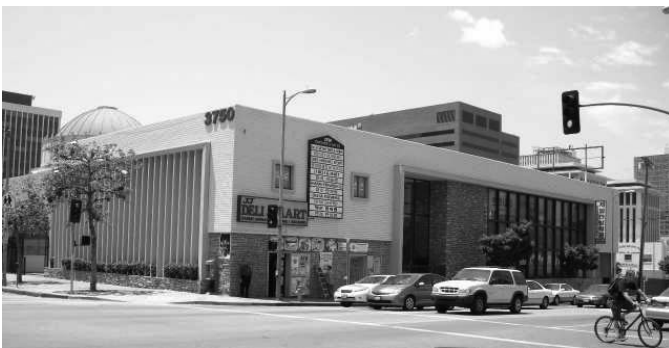
The commercial office building was built in 1952-53 and designed by architect Cejay Parsons, AIA. The rectangular-shaped steel-framed building is clad with a mix of painted brick, field stone and fixed glazing set in a metal framing system. The window system is slightly recessed and framed with a cast stone surround. The main entrance, slightly off-center and recessed on the main façade, is marked by terrazzo steps and a frameless glazed door with a cylindrical Lucite door pull. The field stone creates a shallow planter along the lower portion of the north and east façades. The east façade has three-quarter-height cast stone vertical louvers. The roof is flat. There is surface parking at the rear (south) of the building. In 1989, two ground floor windows at the east end were converted to doorways to create a retail space at street level.

Figure 4.8: 3750 6th Street Commercial Office Building

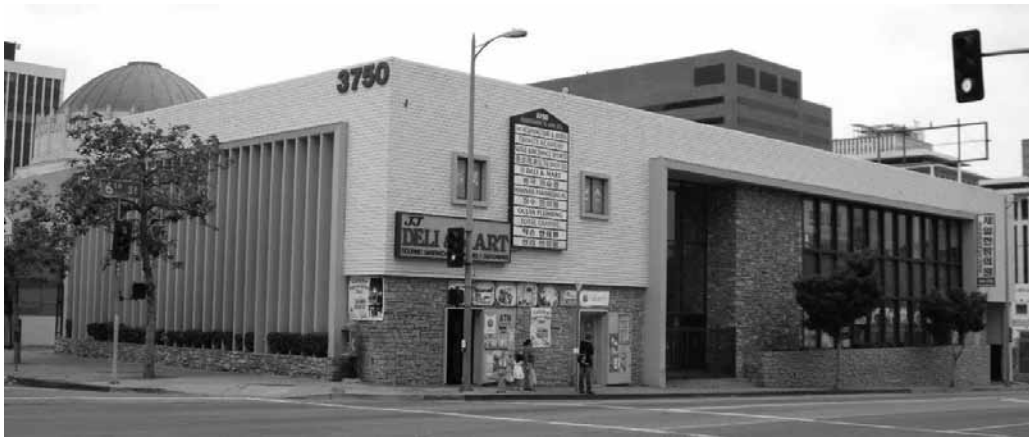
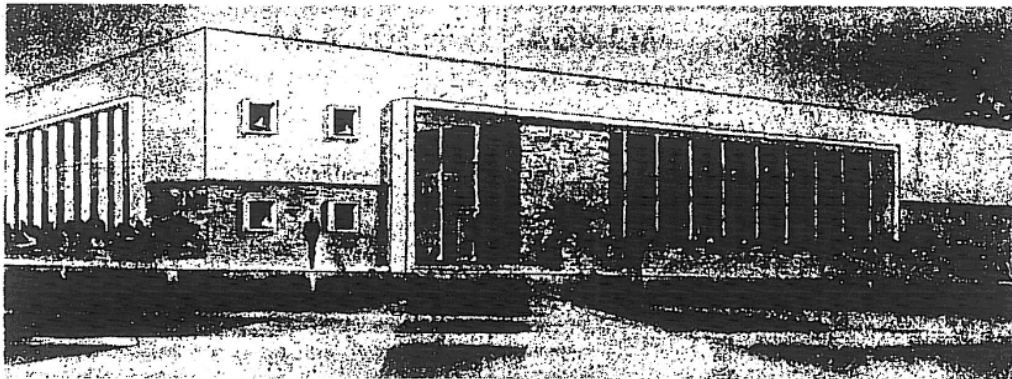
Figure 5.1: Comparison of current condition with original conception

This building was constructed in 1952-53 and designed by architect Cejay Parsons, AIA. It is a relatively intact two-story mid-century Modern commercial office building from the 1950s with good integrity. The building's appearance has changed little from its original conception. (See Table 5.2 for permit history and Figure 5.1 for comparison of original drawing with current condition.)

The architectural design of 3750 6th Street remains substantially unaltered since its construction. The building's main character-defining features remain unchanged and the mid-century Modern hallmarks are apparent including the brick, fieldstone and glass cladding, rectangular volume and strong vertical and horizontal lines. The only major alteration appears to be the replacement of two windows at the east end on the ground level with two doors. The additions of signage and security gates are reversible.
