Appendices

Appendix IS-1

STREET TREE REPORT

8th St and Figueroa St
Los Angeles, CA 90017

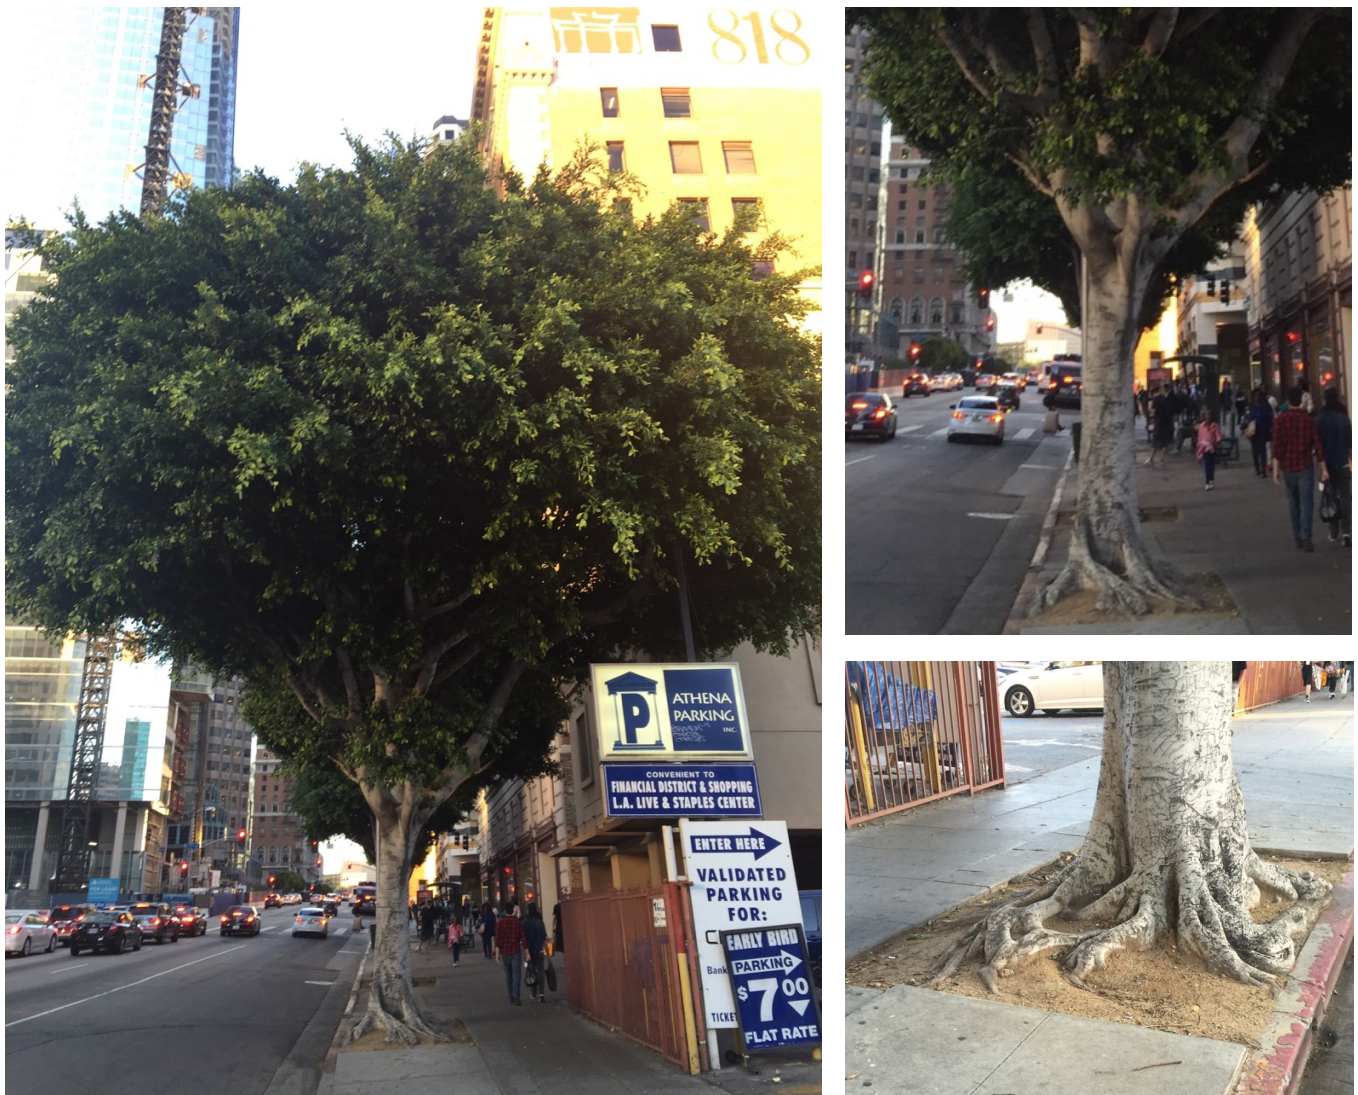
PHOTO 1. Shows Street Tree #1, *Ficus microcarpa* 'Nitida'. This tree will be impacted by site improvements and is recommended for removal and mitigation to the satisfaction of the City of Los Angeles Department of Urban Forestry.

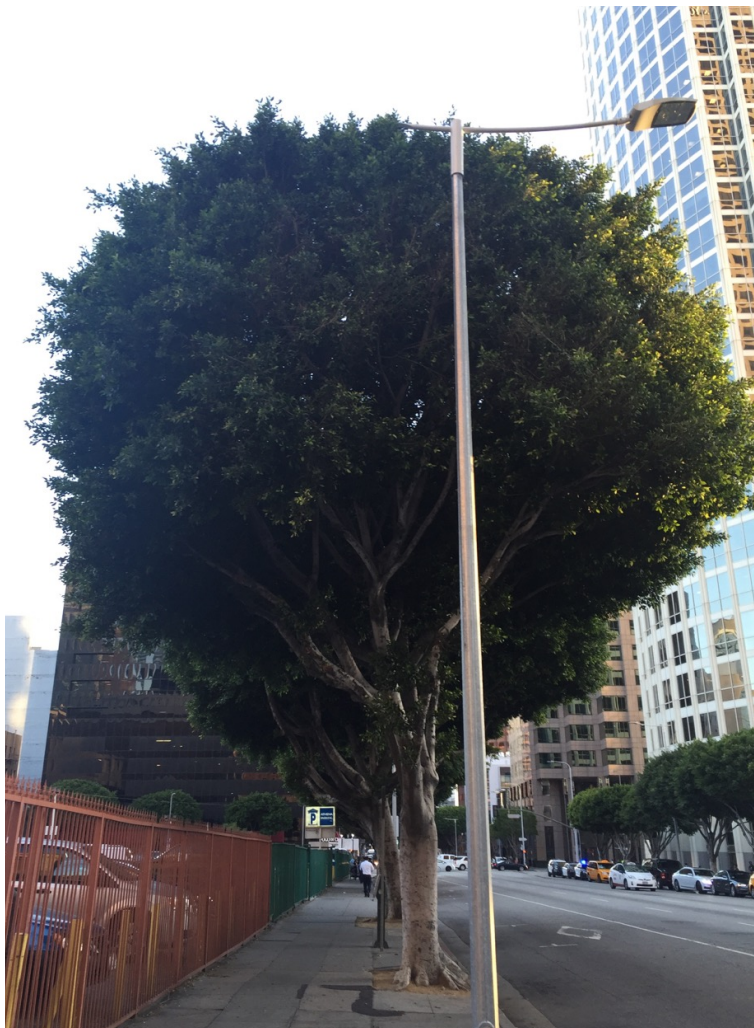
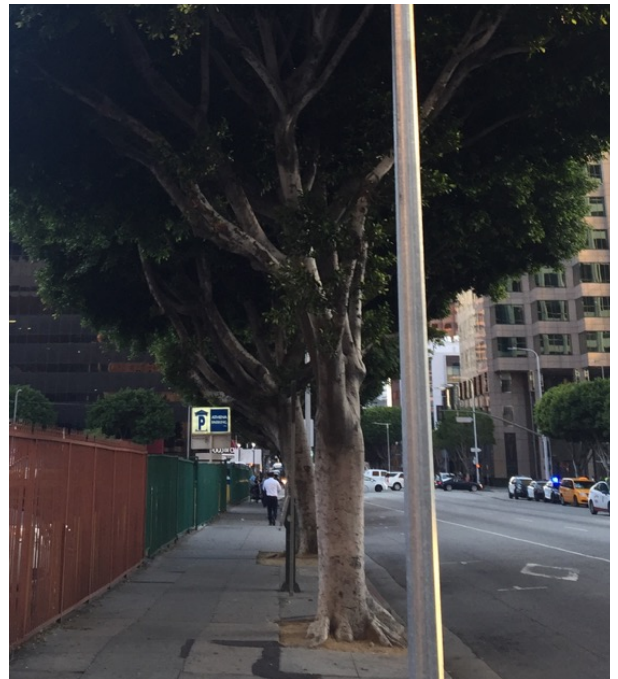
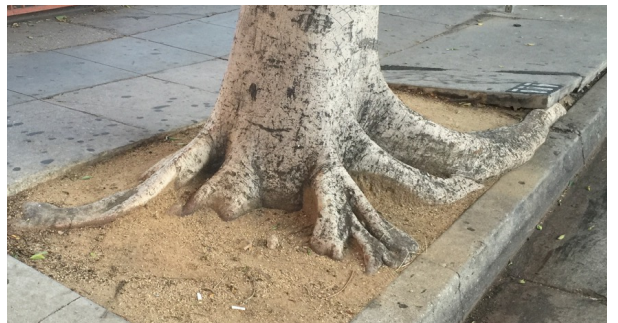
PHOTO 2. Shows Street Tree #2, *Ficus microcarpa* 'Nitida'. This tree will be impacted by site improvements and is recommended for removal and mitigation to the satisfaction of the City of Los Angeles Department of Urban Forestry.

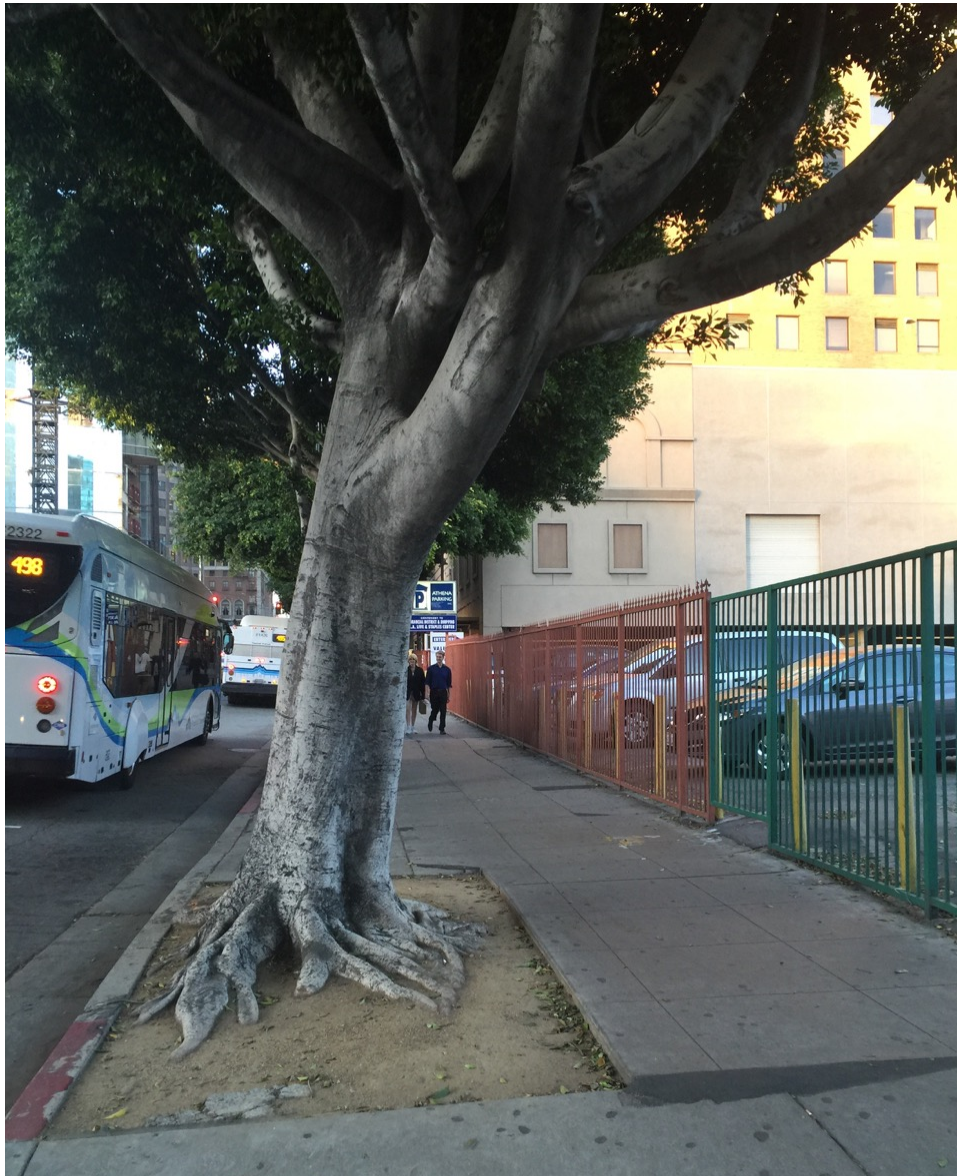
PHOTO 3. Shows Street Tree #3 *Ficus microcarpa* ‘Nitida’. This tree will be impacted by site improvements and is recommended for removal and mitigation to the satisfaction of the City of Los Angeles Department of Urban Forestry.

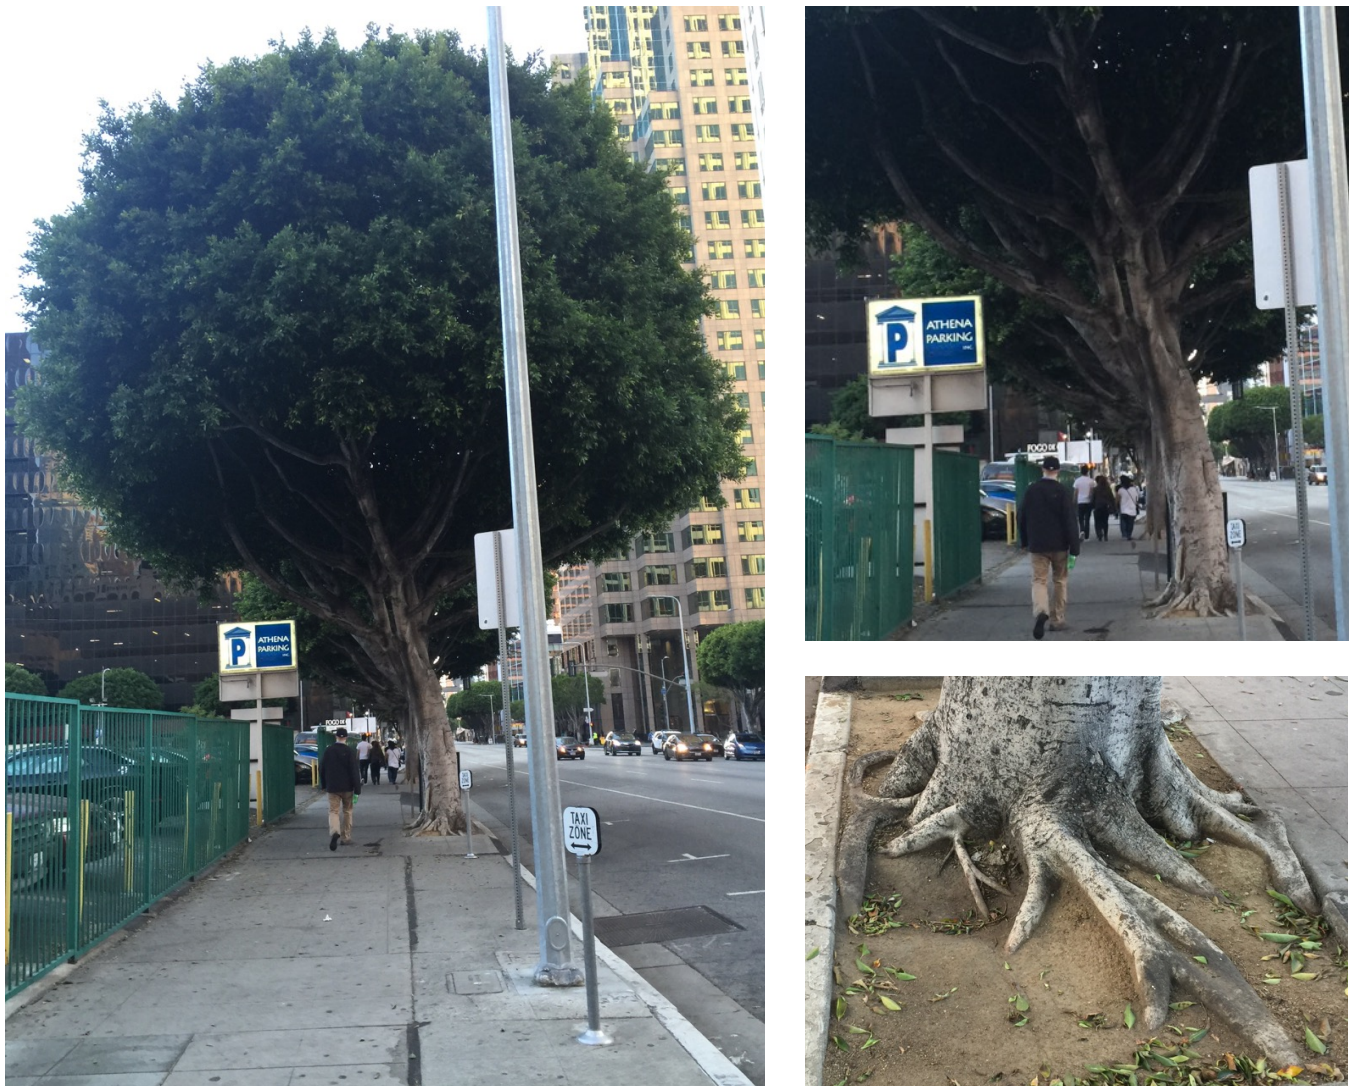
PHOTO 4. Shows Street Tree #4 *Ficus microcarpa* 'Nitida'. This tree will be impacted by site improvements and is recommended for removal and mitigation to the satisfaction of the City of Los Angeles Department of Urban Forestry.

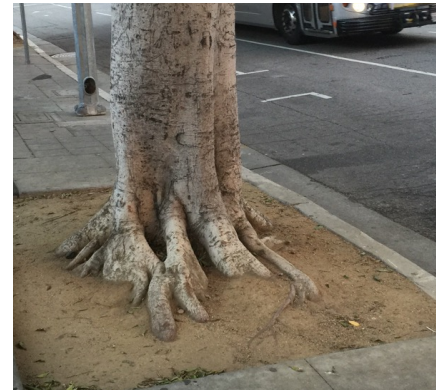
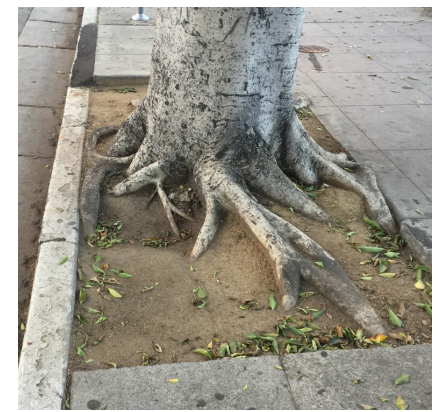
PHOTO 5. Shows Street Trees #5 and #6, both *Ficus microcarpa* 'Nitida'. The root detail pictures are both of Street Tree #5. Both trees will be impacted by site improvements and are recommended for removal and mitigation to the satisfaction of the City of Los Angeles Department of Urban Forestry.

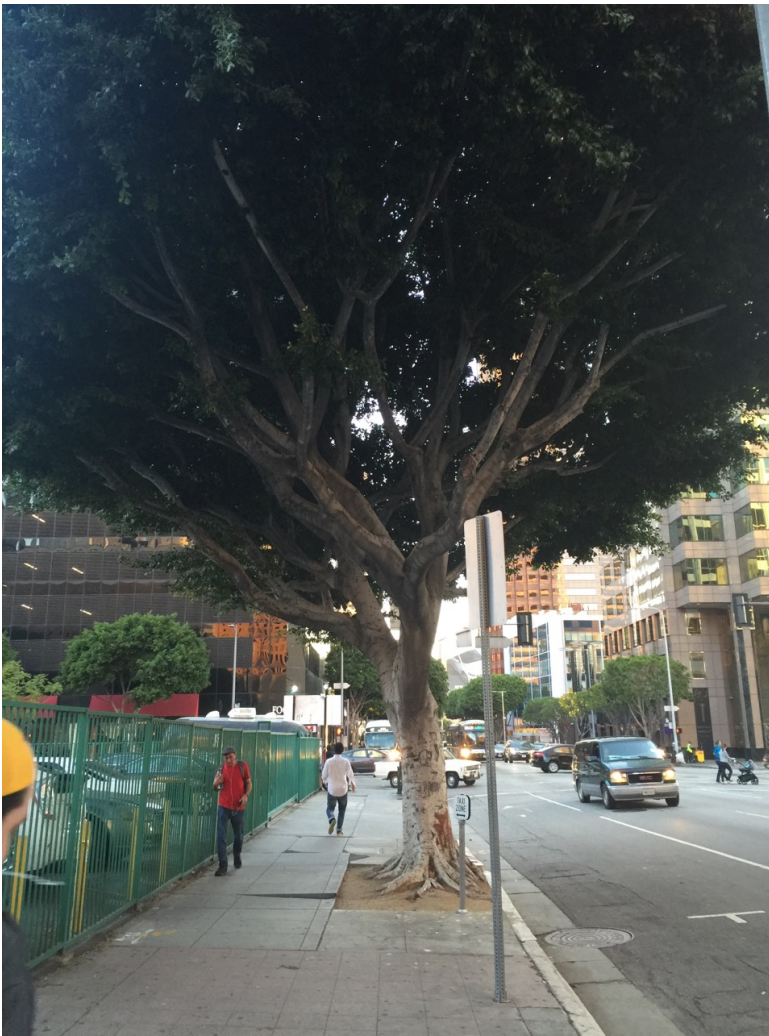
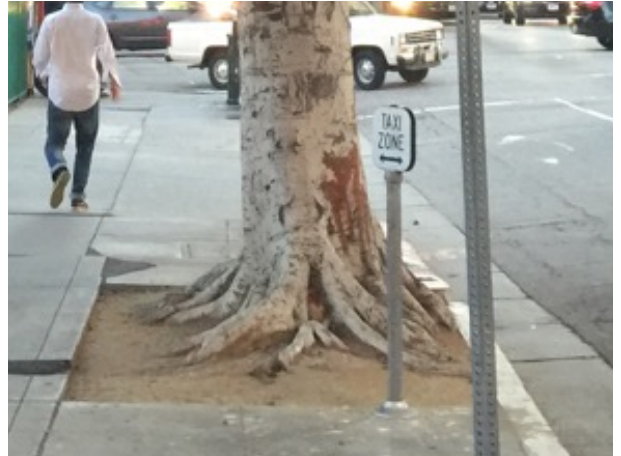
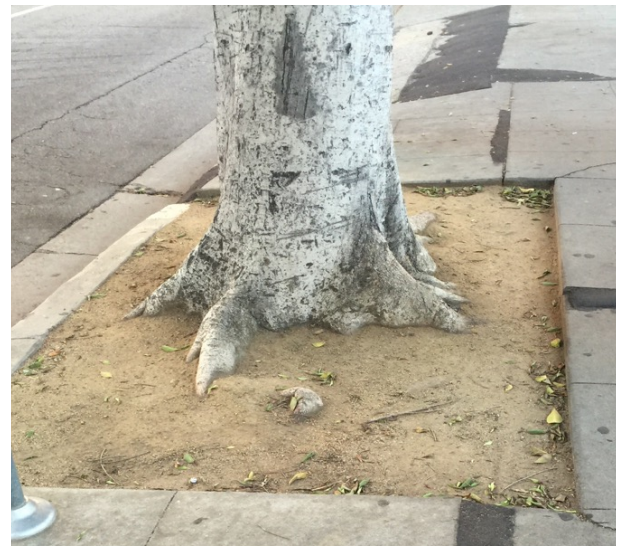
PHOTO 6. Shows Street Tree #6, *Ficus microcarpa* 'Nitida'. This tree will be impacted by site improvements and are recommended for removal and mitigation to the satisfaction of the City of Los Angeles Department of Urban Forestry.

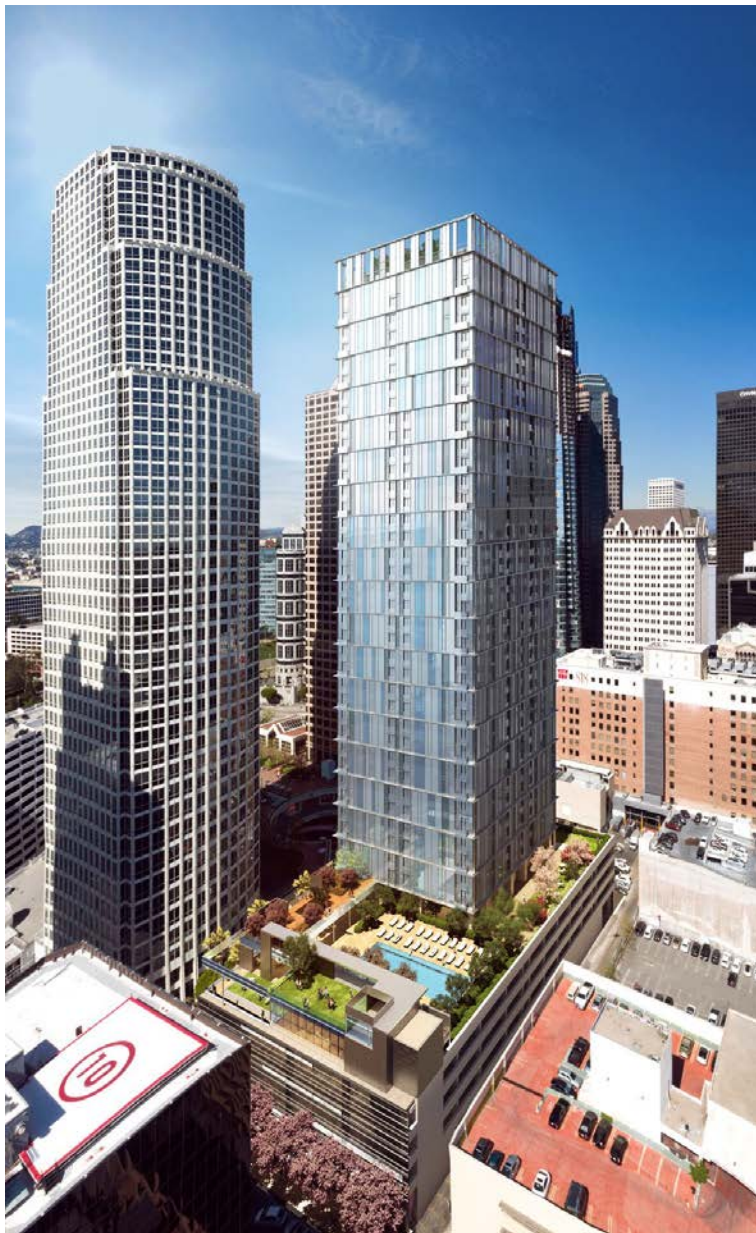
Figure 7: Rendering of proposed project.

The project involves the construction of a 43-story residential tower with ground floor retail, three levels of above ground parking, and four levels of subterranean parking. The residential tower would be situated over the northwestern portion of a five-level podium. Amenities for the building tenants would be located south and east of the tower on top of the podium and include a pool, landscaped patio, and fitness room. The tower is roughly square in shape and clad in vision, patterned, and spandrel glass, while the podium is rectangular and clad in stone and aluminum. Vehicular ingress and egress would occur at the north end of the building with

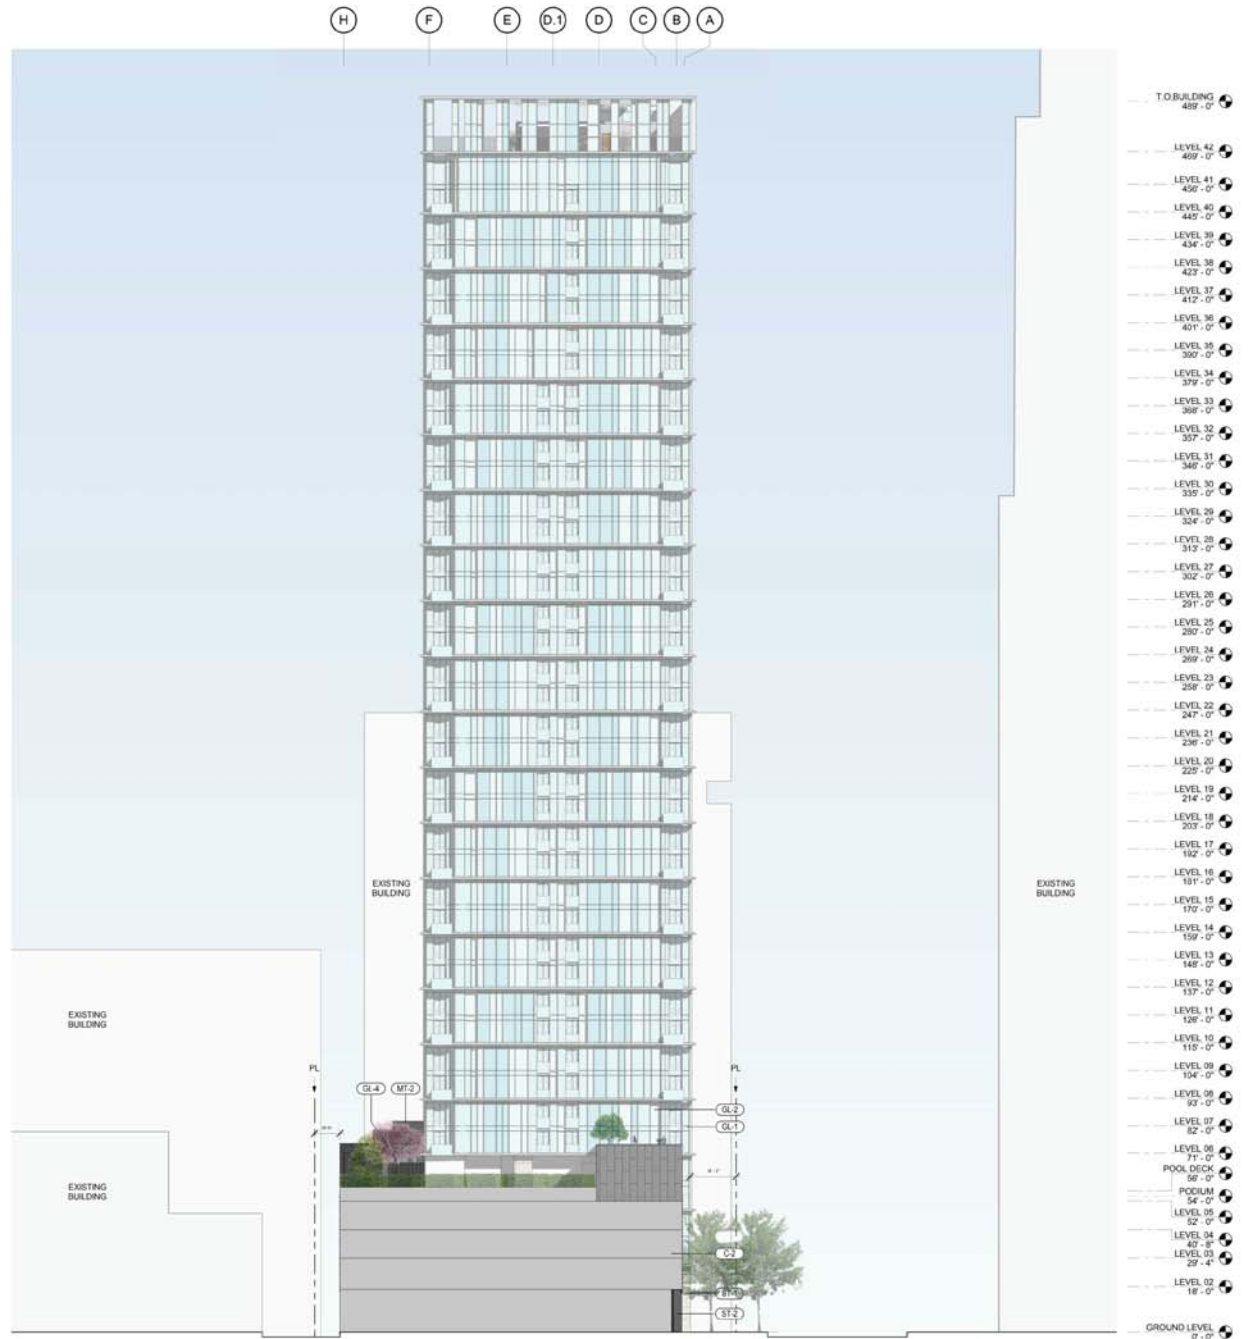
1 NORTH ELEVATION
SCALE: 1" = 20'-0"

MATERIALS	
T	T
G -	VISION GLASS
G 2	ALUMINUM GLASS
G 3	STAINLESS STEEL GLASS
G 4	SILVER TINTED GLASS
C-	ARCHITECTURAL CONCRETE PANELS
	CONCRETE
	REINFORCED ALUMINUM

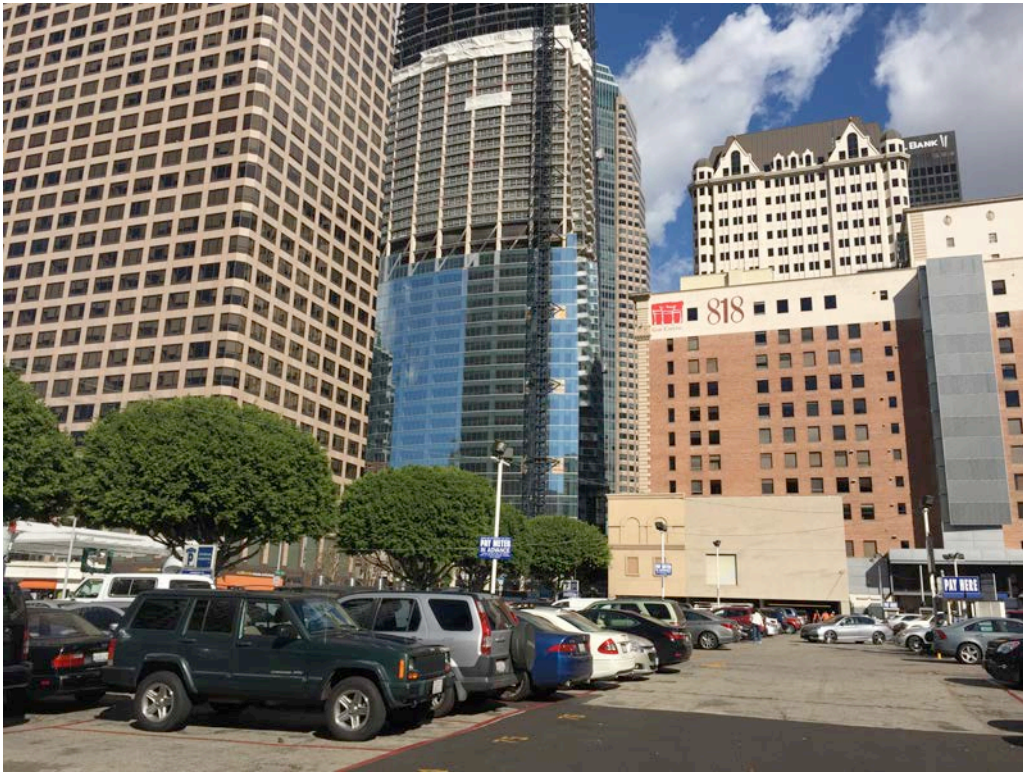
Southwest portion of the subject property; view to the north
Figueroa Street & W 8th Street, Los Angeles, CA 94105

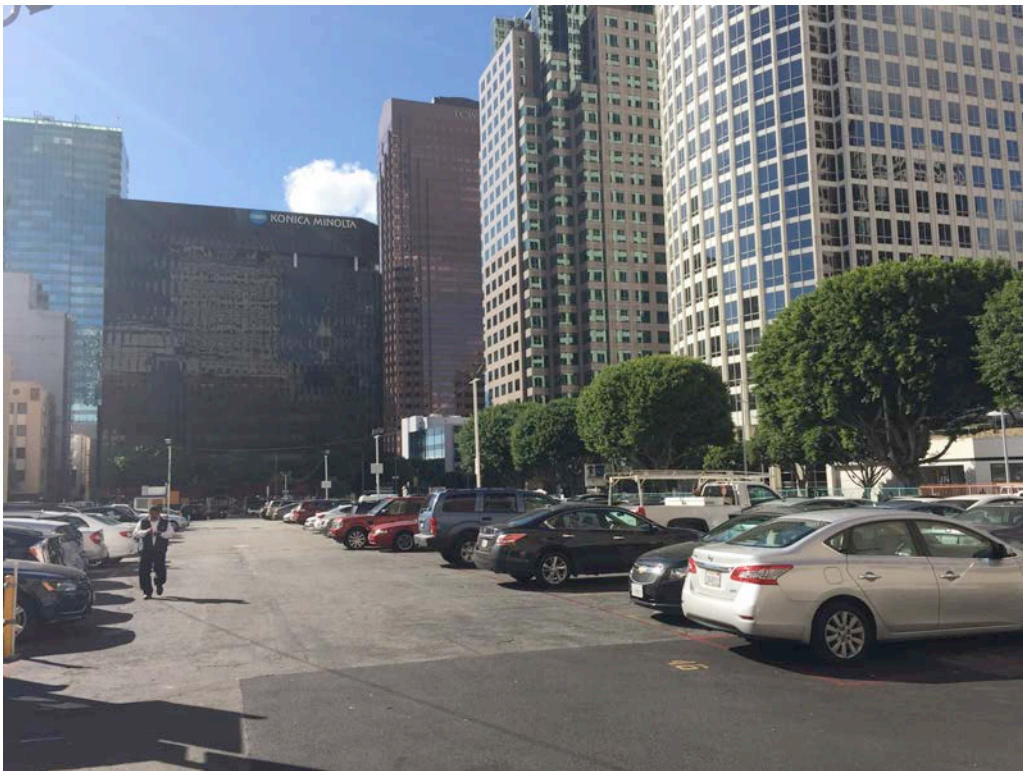
Northeast portion of the subject property; view to the southwest
Figueroa Street & W 8th Street, Los Angeles, CA 94105

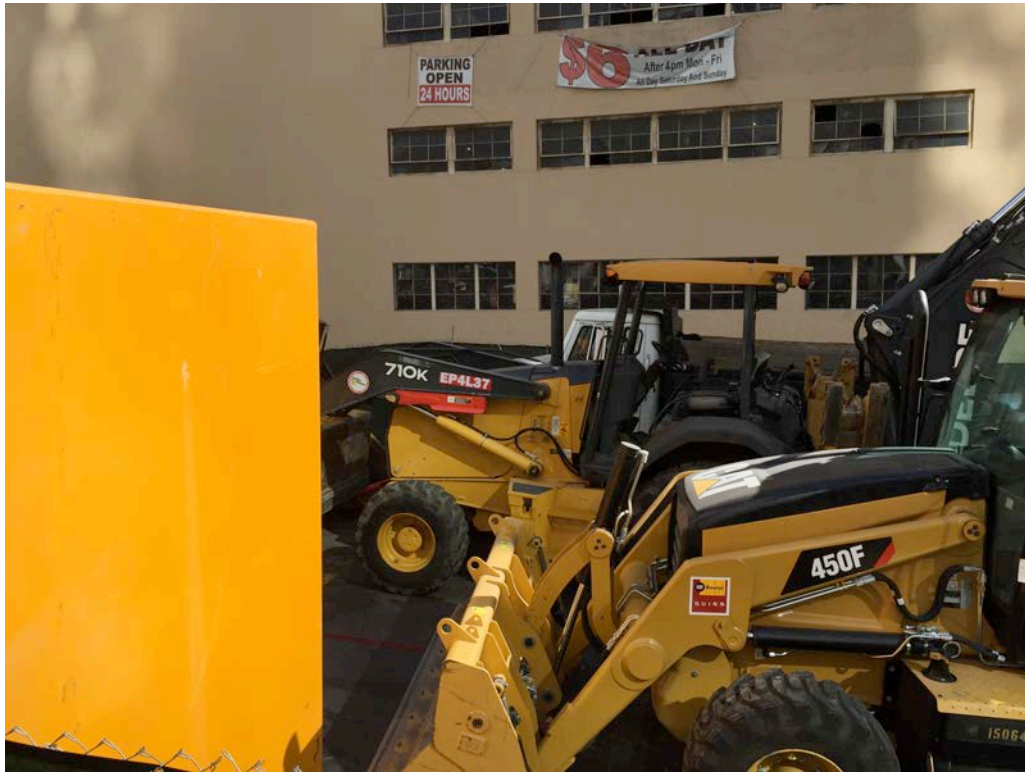
Front loader storage on the southern corner of the property
Figueroa Street & W 8th Street, Los Angeles, CA 94105

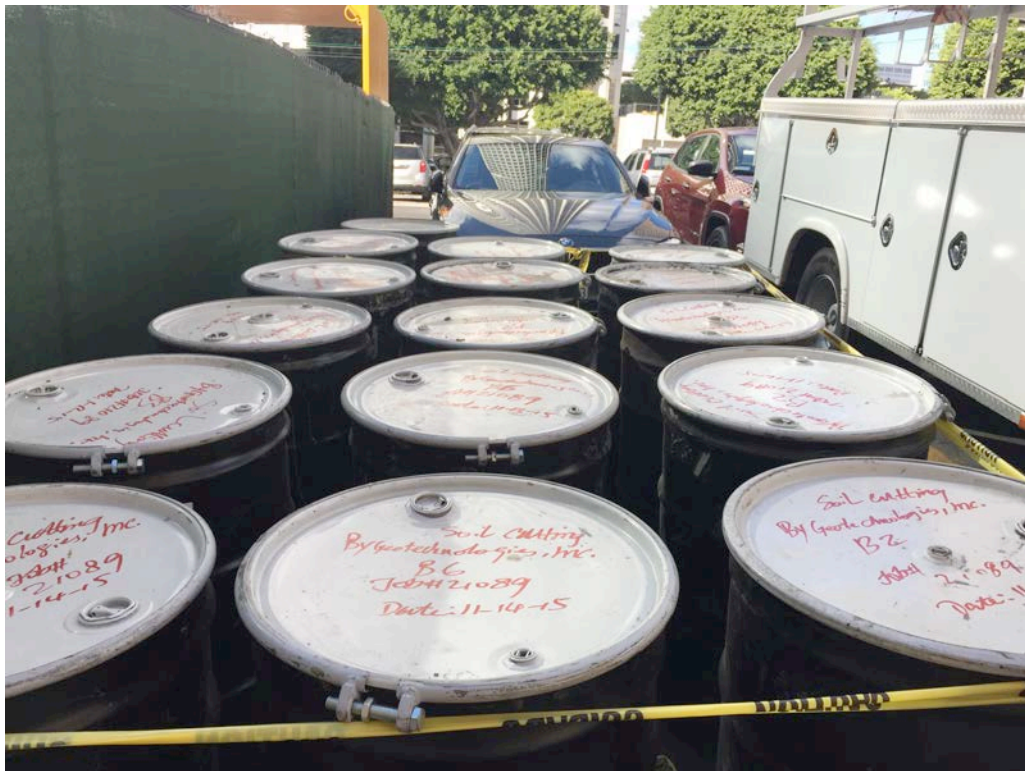
Soil cuttings storage on the southern edge of the property
Figueroa Street & W 8th Street, Los Angeles, CA 94105
