Santa Monica and Barrington Mixed Use Project

APPENDIX A

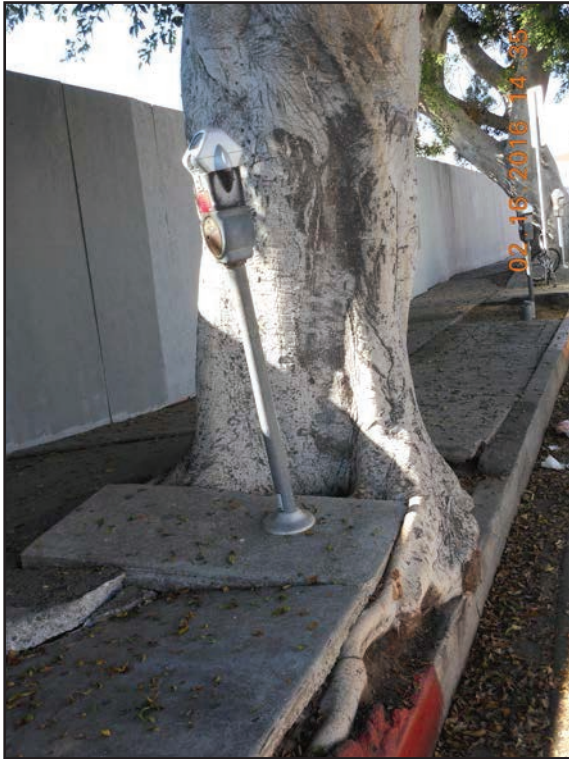
Photo E

Sidewalk Conditions

As shown on the attached Tree Evaluation Matrix sheets, the trees are generally in poor to good health and aesthetic condition. It should be noted that in most cases the trees have caused severe damage to the surrounding sidewalk and curbs due to root incursion (refer to **Figure 4a** through **Figure 4d**).

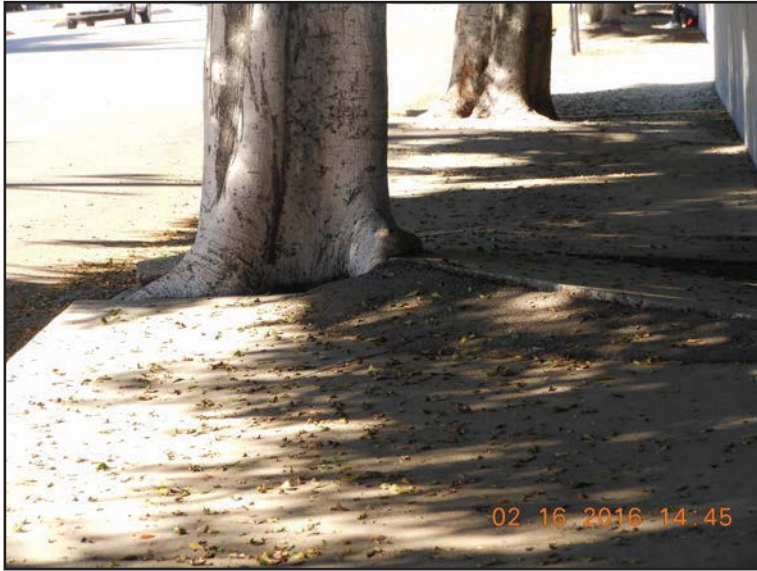
Photo I

Sidewalk Conditions

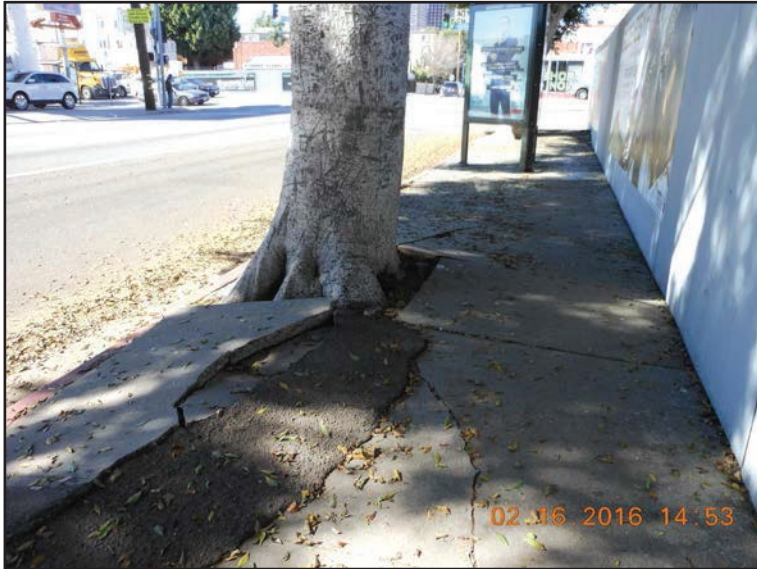
Photo M

Sidewalk Conditions

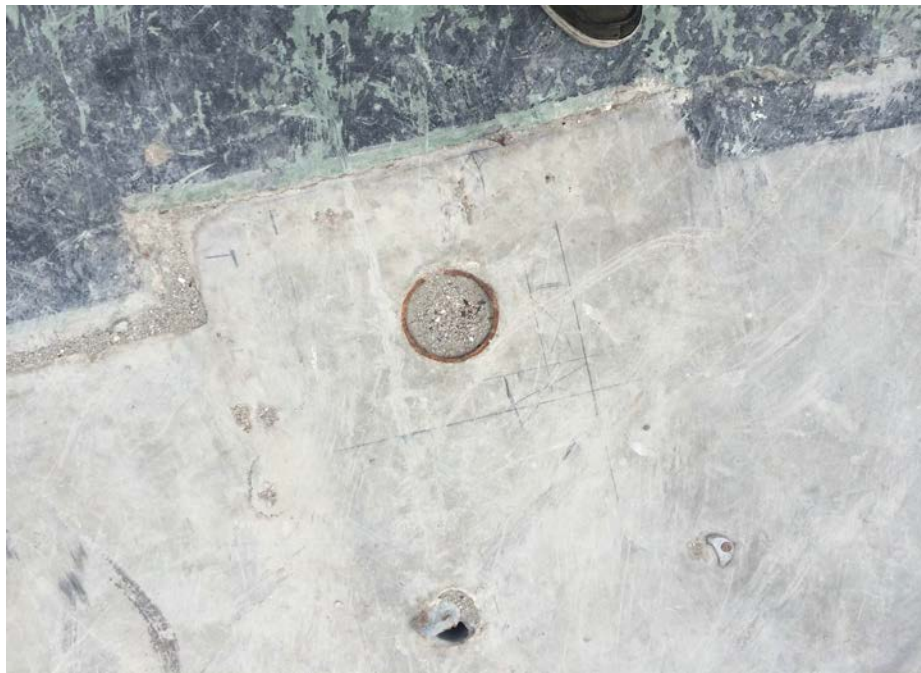
Photo 11 – View of remnant pipe stubs observed on the subject property.

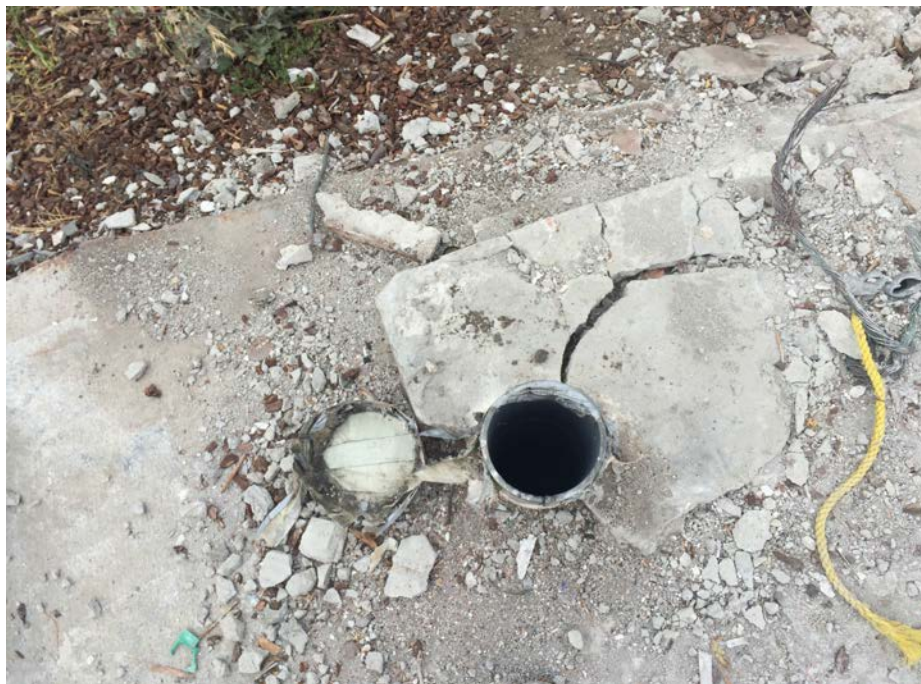
Photo 12 – View of additional pipe stub observed on the subject property associated with remnant foundations.

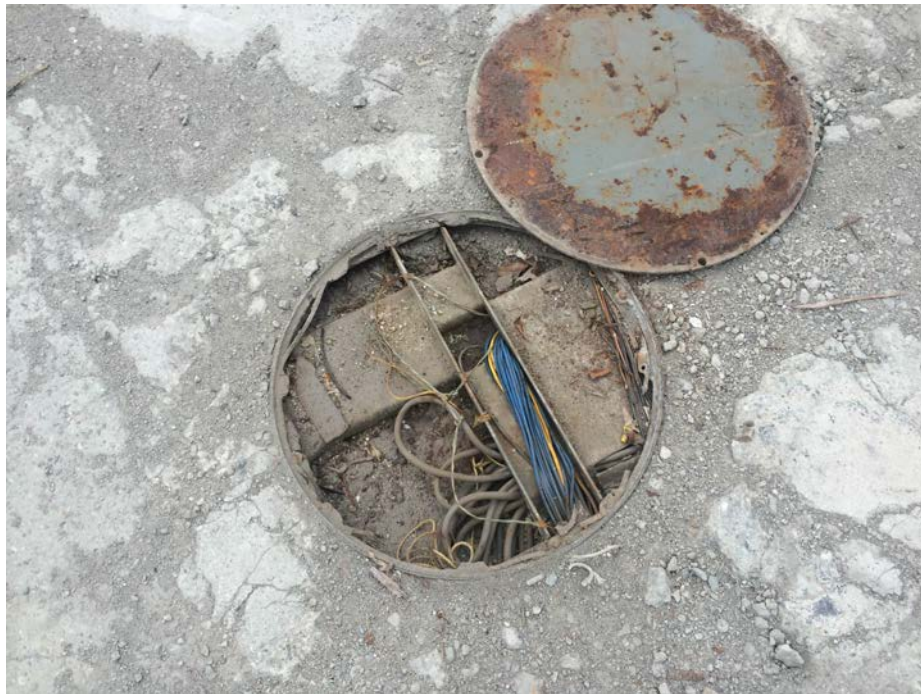
Photo 20 – View of additional electrical connections observed near center of the subject property.
