**Sunshine Canyon Landfill
Independent Monitor
Quarterly Site Monitoring Status Report
October 1, 2020 – December 31, 2020**

City of Los Angeles Department of City Planning

County of Los Angeles Department of Regional Planning

June 14, 2021

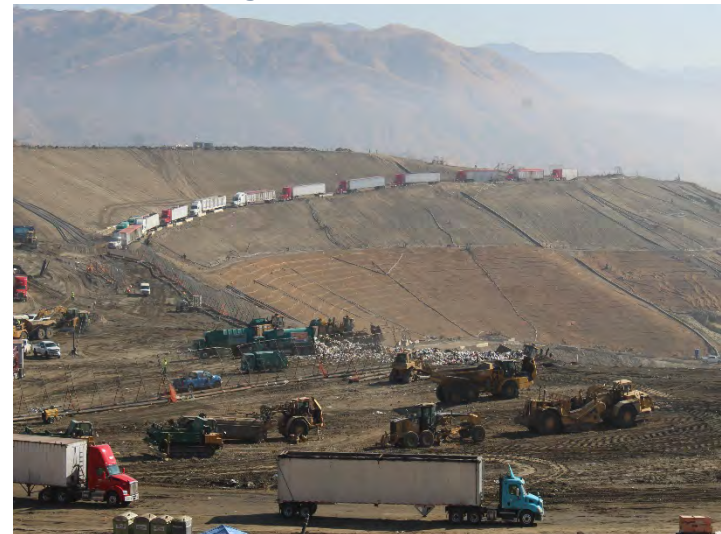
Photo 15: Working Area, CC-4 Part 3: October 20, 2020

Current Status/Comment – There was no grading outside of the approved landfill development limits during the 4th Quarter. Cell CC-4 Part 3 was the only area accepting waste during the 4th Quarter. Cell CC-4 Part 1/2 was at the finished elevation for this phase. CC-4 Part 4A construction was completed in September, with the liner approved by RWQCB in December, and waste being placed in this cell on December 16, 2020. This cell provides a good lower elevation, wind-protected area for winter and spring weather conditions. This construction included the relocation of the truck scales, administration buildings and employee locker room to the City North top deck. This top deck was graded for the facilities and parking. The shop and LEA building will be moved in 2021.

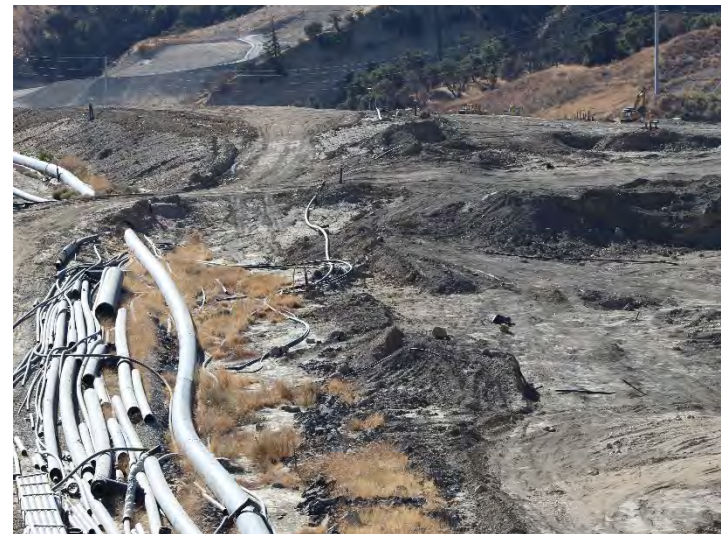
Photo 227: County Top Deck: December 16, 2020

Current Status/Comments – In the 4th Quarter, localized dust clouds occurred on the County top deck when waste hauling transfer and soil importation trucks used the dirt roads. Packer trucks using the top decks' roads from the scales to the active area generated localized dust clouds. Climatic conditions were an important factor on dust generation. The use of more water trucks employed on a demand-basis should be considered. The dust was not observed leaving the site.

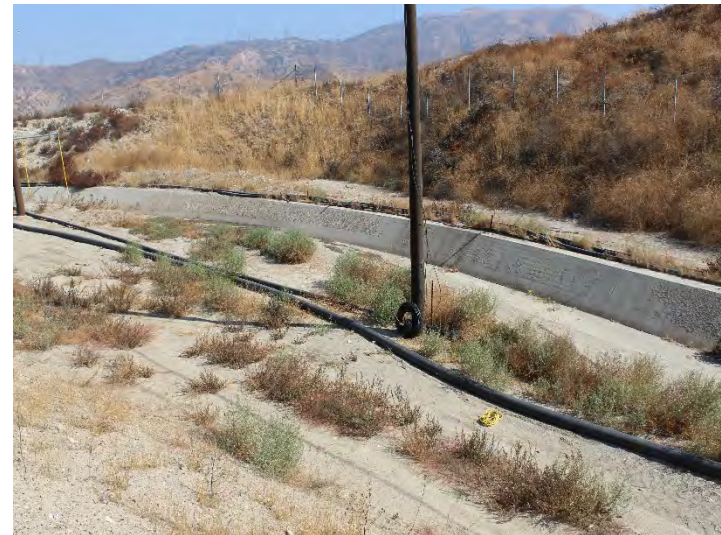
Photo 247: Eastside Drainage Channel: November 30, 2020

In the 4th Quarter, it was observed that vegetation was growing out of numerous cracks in the water retention basins and drainage conveyance channels' concrete. The terminal basin had vegetation growing out of cracks in the interior and exterior concrete side walls and top access walkway. Basins B and D concrete high flow outlets had vegetation growing in cracks. The eastside drainage channel had vegetation growing in and adjacent to the concrete channel. There were areas of the channels and basins that needed the growing vegetation to be removed, and repair of the concrete and sealing of cracks.

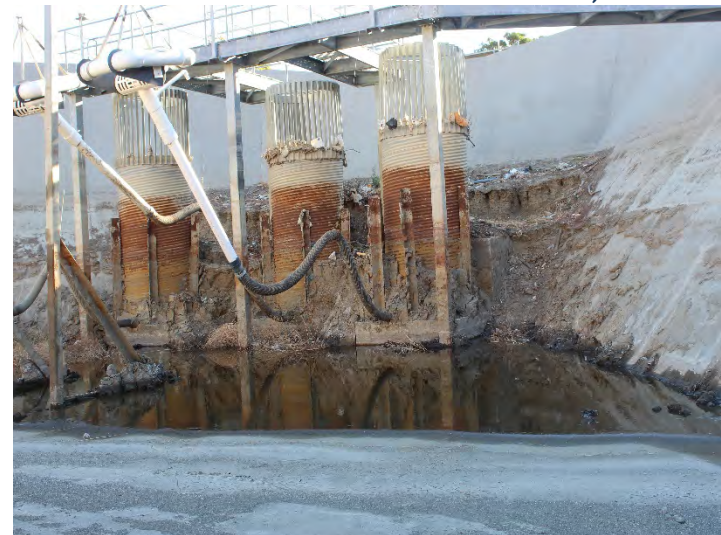
Photo 283: Terminal Basin Outlet Risers: December 16, 2020

Current Status/Comments – By mid-December, all basins were almost dry and free of sediment and litter. The terminal basin had ponding water and the outlet risers' area had sediment and litter around them. Basin A was dry and free of sediment. Windblown litter was in the back native vegetation slopes. Basin D was dry and free of sediment and litter. Basin B was dry and free of sediment. Litter was observed on the back slope's native vegetation. The channels were free of sediment on all but the eastside drainage system. These channels had growing vegetation, windblown brush, and some spots with an accumulation of sediment and windblown litter. The current erosion control plans should be available for agency and monitor review.
