**Sunshine Canyon Landfill
Independent Monitor
Quarterly Site Monitoring Status Report
October 1, 2012 – December 31, 2012**

City of Los Angeles Department of City Planning

County of Los Angeles Department of Regional Planning

February 22, 2013

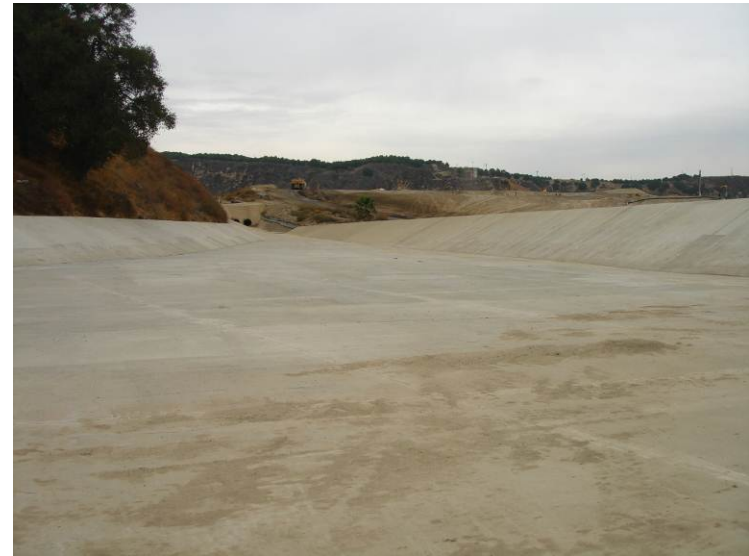
Photo 5: Basin A (November 15, 2012)

Areas of concern included: no safety bars on Basin A outflow pipes; no safety covers on Basin D outlet risers; cracks and spalling in a portion of the westside drainage ditch concrete bottom and walls; concrete wall undermined and collapsing at Basin D North drainage ditch and HDPE liner material loose and blocking flow; concrete wall undermined by surface flow at the new eastside drainage ditch; horizontal crack in the exterior wall of the Terminal Basin.

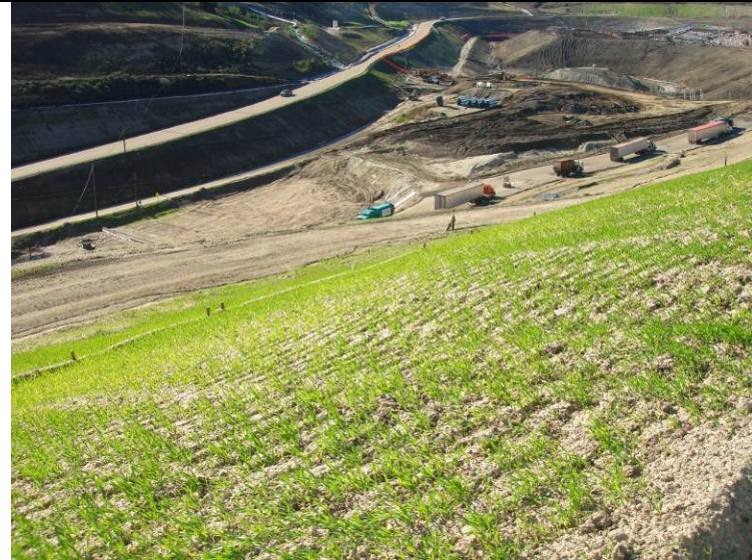
**Photo 233: City North New Seed Mix Hydroseeding
(December 7, 2012)**

Current Status/Comments – In October, the establishment of temporary re-vegetation on inactive and closed landfill surfaces had not been successful. Republic's consulting biologists were proposing a new seed mix and soil treatment procedures that were scheduled for November. During the November 15, 2012 site visit, it was observed that the City North area was hydroseeded with the new seed mix. As of then, very little hydroseed had germinated within the interim cover areas. On the November 28, 2012 site visit, it was noted that the City North slopes that were hydroseeded with the new seed mix had vegetation growing. In December, the City North slopes that had been hydroseeded with the new mix had germinated and were starting to show vegetation growth. Other previously seeded areas had also started to grow vegetation. The recent rainstorms in December may have contributed to the germination and recent growth. A follow-up to track the growth and coverage of this new seed mix and

a review of Republic's consulting biologists' report concerning the success and any recommendations will be important to implementing a successful interim vegetation program.

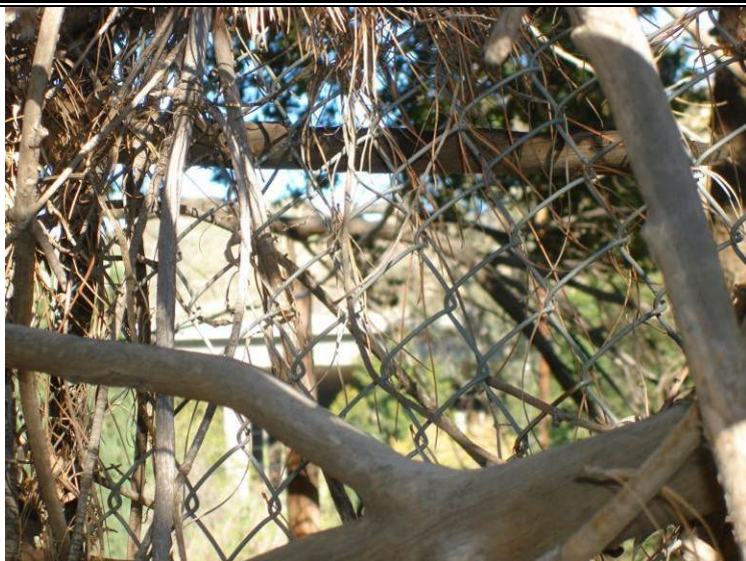
Photo 256: Leachate Treatment Electrical Lines (December 19, 2012)

Current Status/Comments – During the December 19, 2012 site visit, the power lines from condensate handling facility to the leachate treatment facility had tree branches hanging over them creating a fire hazard. The tree branches need to be trimmed.

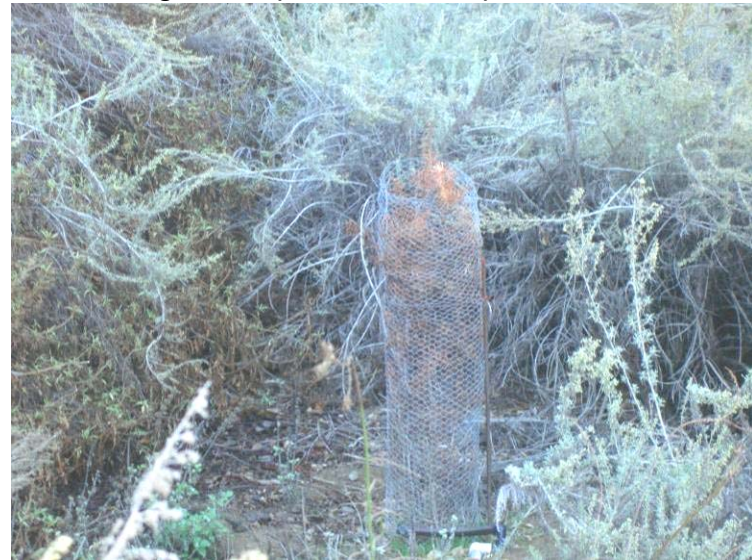
Photo 263: Big Cone Fir (December 7, 2012)

In December, it was observed that the Big Cone Fir mitigation area had some of the fir trees growing into the mesh support cages. Additionally, some of the plants were growing taller than the cages and basal growth was being stunted by the cages. Republic's consulting biologist should evaluate the condition of the fir mitigation trees and make any modifications to the cages as required.
