**Sunshine Canyon Landfill
Independent Monitor
Quarterly Site Monitoring Status Report
April 1, 2016 – June 30, 2016**

City of Los Angeles Department of City Planning

County of Los Angeles Department of Regional Planning

August 19, 2016

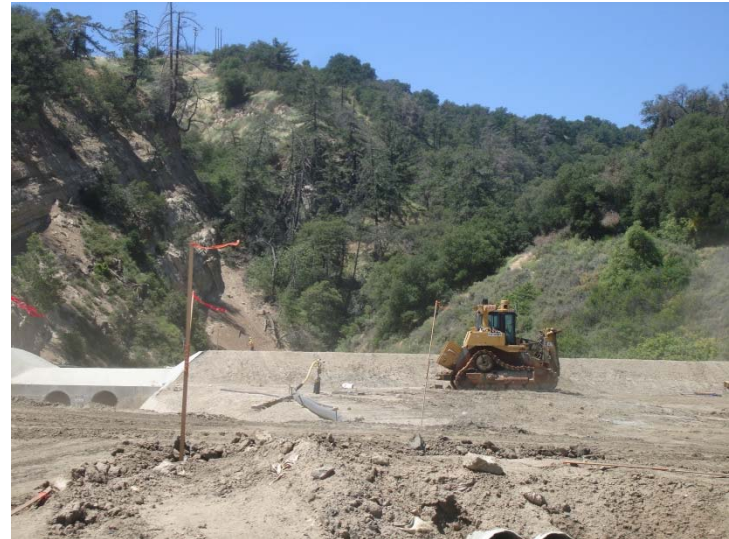
Photo 53: Oil Well Casings to be Abandoned: May 25, 2016

Current Status/Comments – During the May 10th and May 25th site monitoring, it was observed that the two old oil well steel casings in the area north of the new office site have been gradually lowered. The soil around them still has to be lowered by approximately 100 feet. Final lowering of the well casings and permanent abandonment will be done after final grades are reached. The wells did not have any gas or oil emissions when tested.

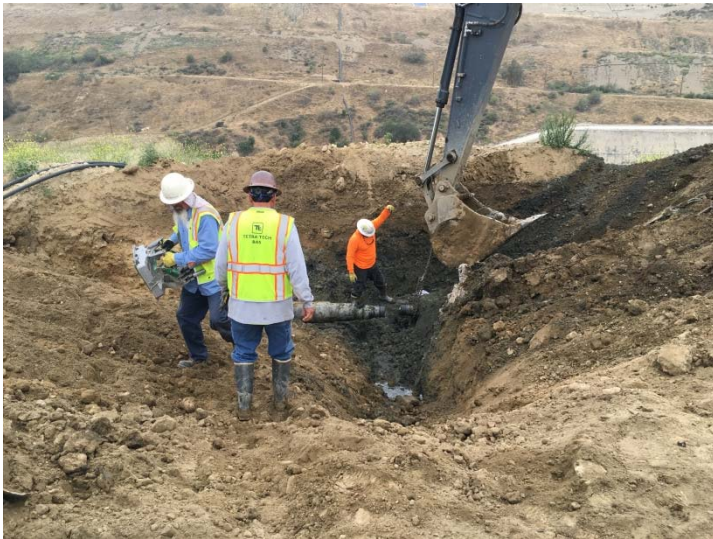
Photo 162: Main Access Road Box Drainage: May 10, 2016

The access road box drainage discharge had the HDPE temporary drainage channel removed for Cell CC-3B construction, and the last rain event caused side slope erosion and deep ruts.

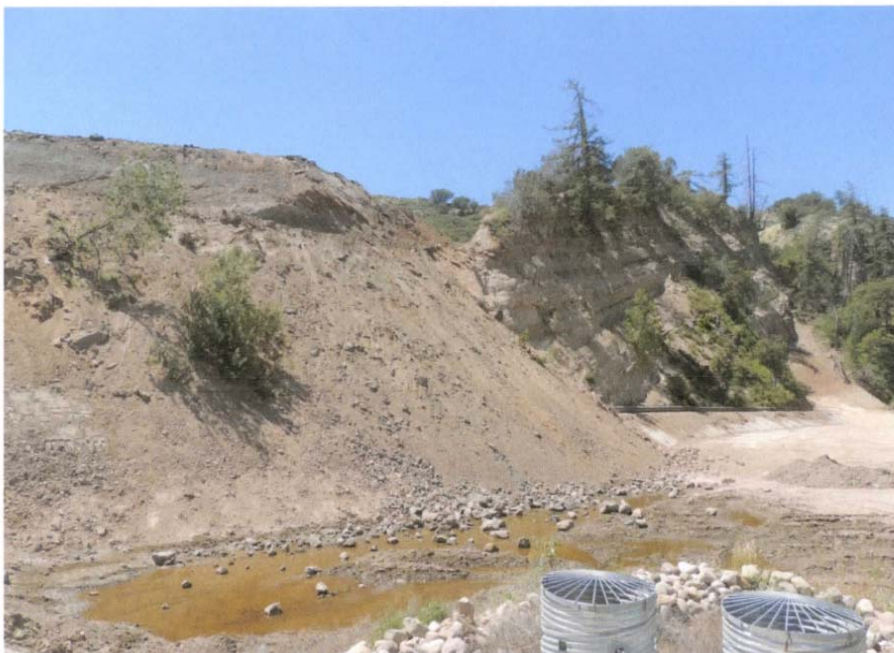
Photo 2: Soil in Basin A

Current Status/Comments – During the 2nd Quarter monitoring, it was observed that there was a significant amount of sediment, construction rock and dirt in Basin A, and sediment in the terminal basin. Republic staff stated that the sediment was drying and the basins are scheduled to be cleaned and ready for fall rains by September.
