**Sunshine Canyon Landfill  
Independent Monitor  
Quarterly Site Monitoring Status Report  
July 1, 2012 – September 30, 2012**

**City of Los Angeles Department of City Planning**

**County of Los Angeles Department of Regional Planning**

October 17, 2012

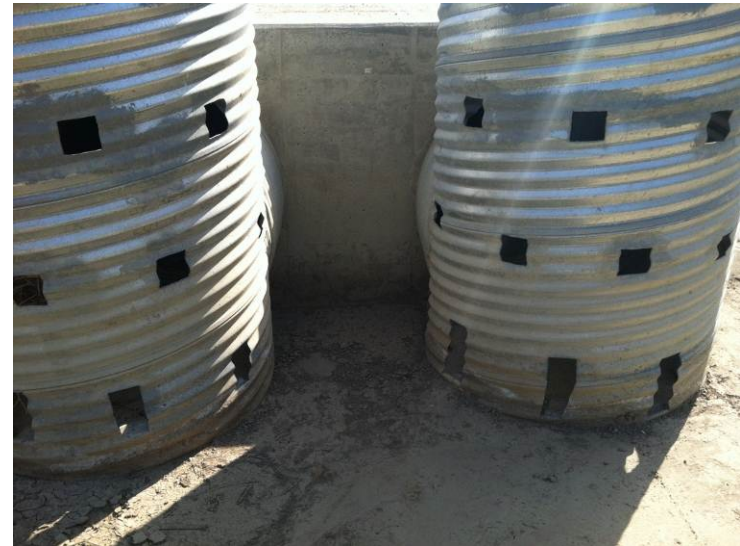
**Photo 12: Basin A Outlet Risers (September 12, 2012)**

In September, all but the terminal basin outlet risers were repaired and rock placed around them. The terminal basin risers were scheduled for the first week of October.

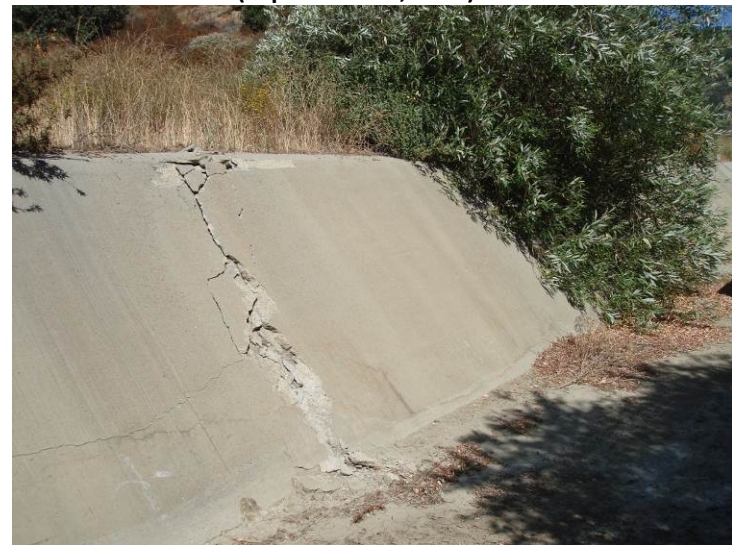
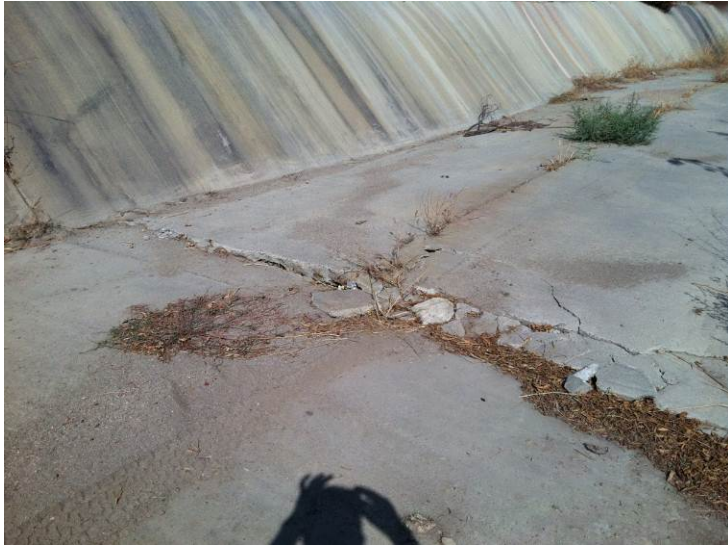
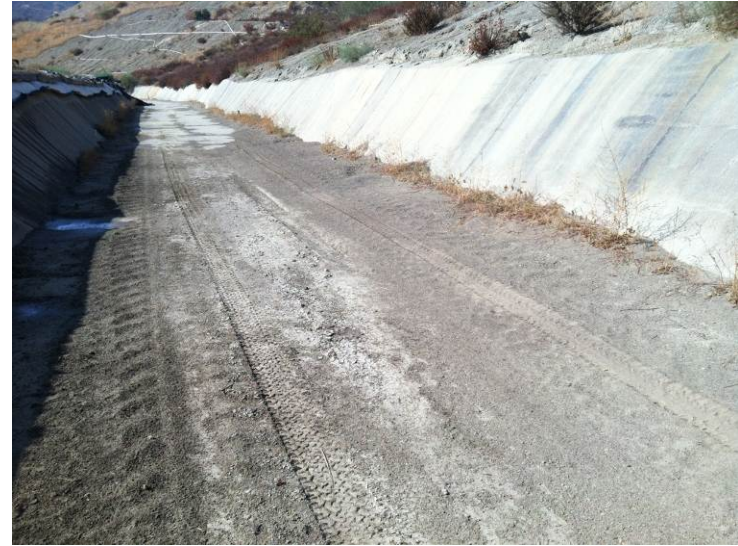
In July, damage to the concrete gunite lining in the bottom of the Westside drainage ditch and the side walls of a portion of the Basin D North drainage ditch between Basin D and flare 9 was observed. The Basin D North drainage ditch also had sediment and vegetation blocking portions of the drainage ditch. The Eastside concrete drainage system was under construction extending it south of the temporary flare to the concrete inlet to the terminal basin.

**Photo 16: Westside Drainage (July 25, 2012)**

**Photo 17: Westside Drainage (September 12, 2012)**

**Photo 18: Westside Drainage (September 12, 2012)**

In September, the Basin D North drainage ditch between Basin D and Flare 9 was cleaned and repaired. The Eastside concrete and asphalt drainage ditch construction was completed. This drainage system appeared to be ready for handling runoff. Damage to the concrete gunite bottom of a small area in the Westside drainage ditch was still observed.

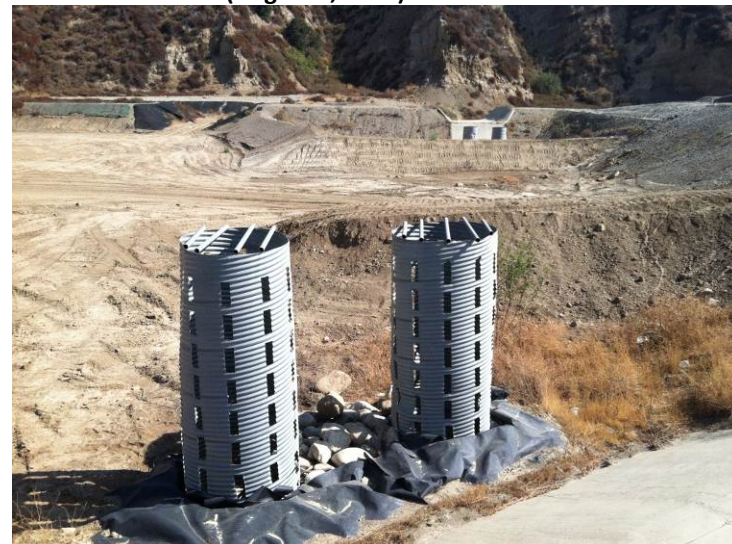
**Photo 24: Basin D Outlet Risers (September 12, 2012)**

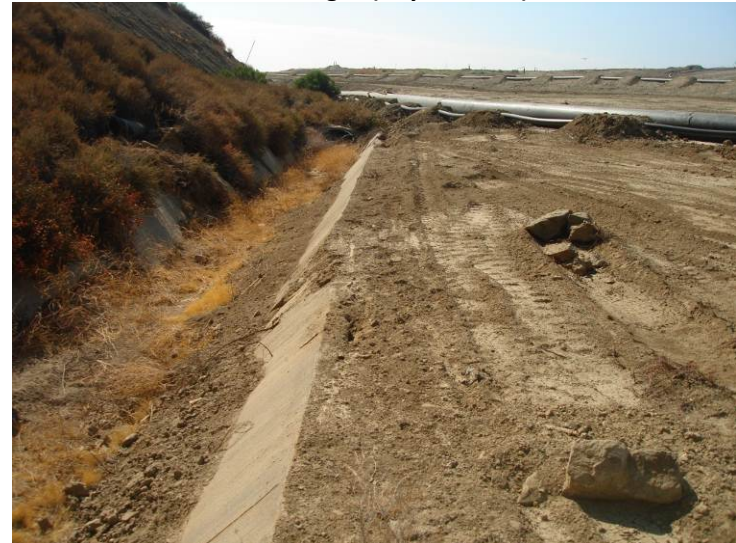
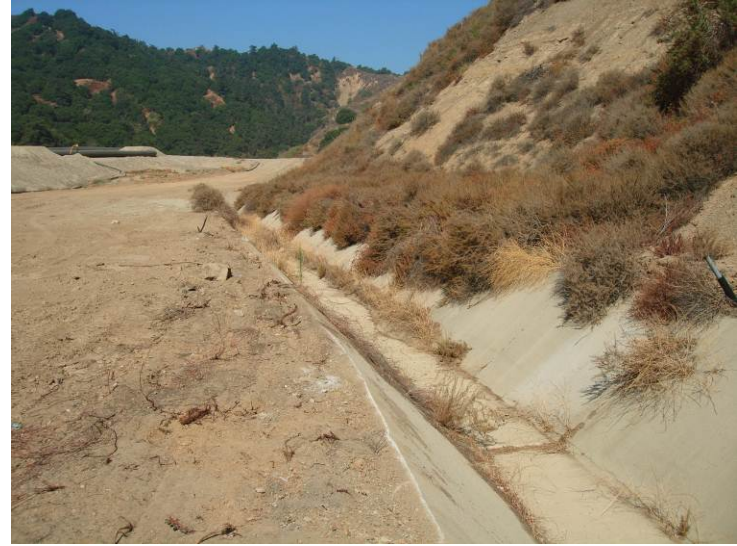
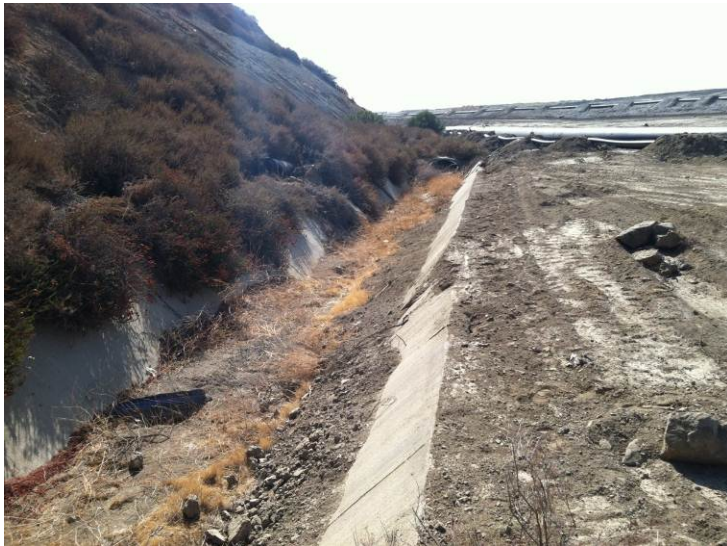
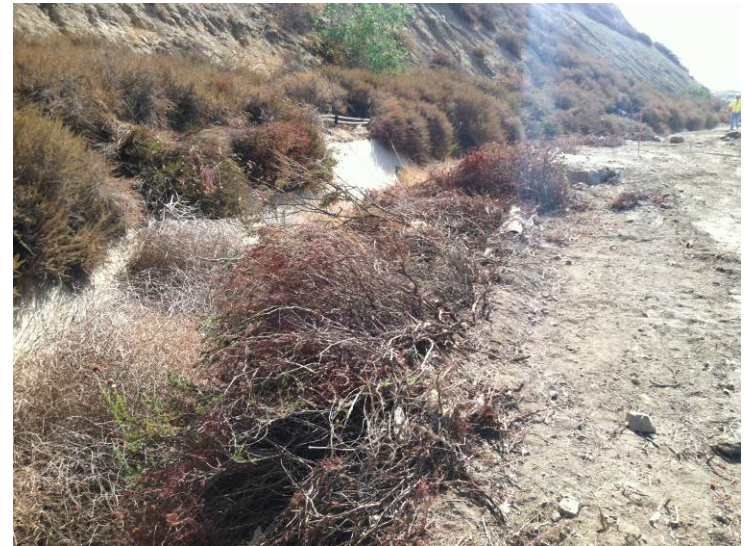
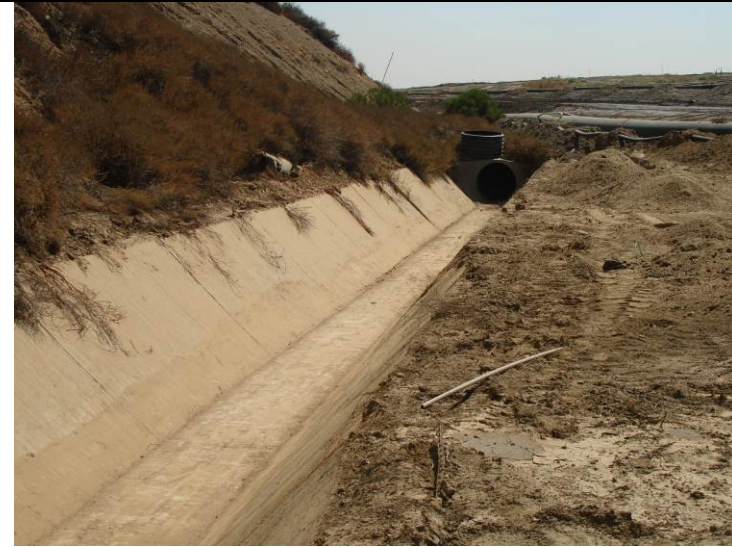
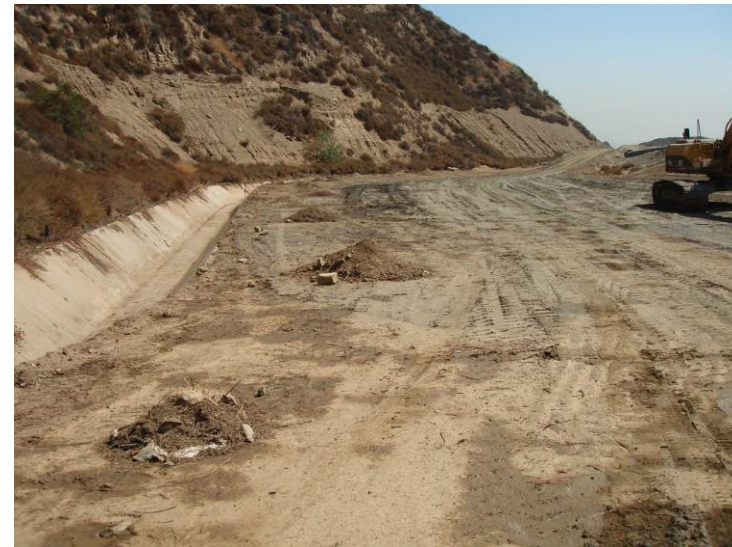
**Photo 36: Basin D North Drainage (August 22, 2012)**

**Photo 38: Basin D North Drainage (August 22, 2012)**

**Photo 39: Basin D North Drainage (September 12, 2012)**

**Photo 40: Basin D North Drainage (September 12, 2012)**

**Photo 42: Basin D North Drainage (September 25, 2012)**

**Photo 44: Basin D North Drainage (September 25, 2012)**

In August, the Eastside concrete drainage system was still under construction extending it south of the temporary flare to the terminal basin inlet system. The cleaning and repair of the Basin D North drainage system was scheduled to be done in September.

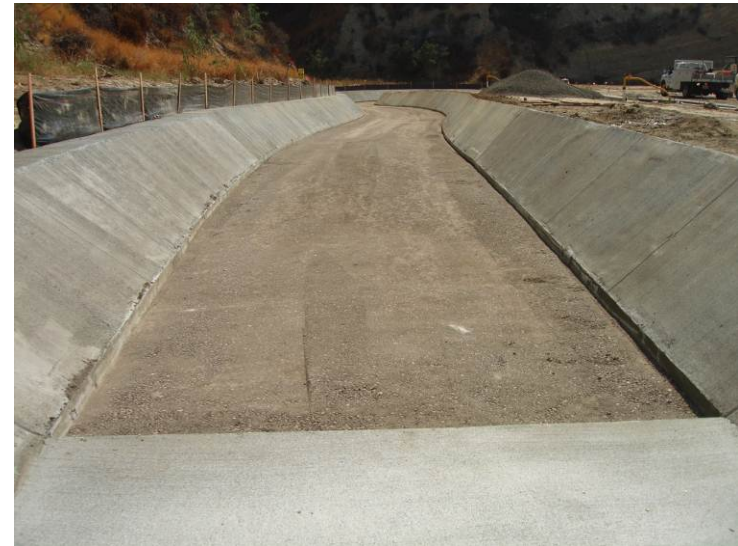
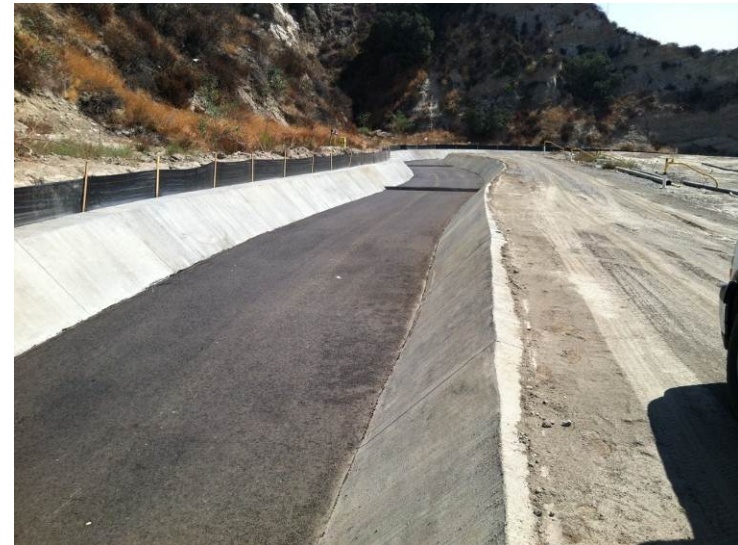
**Photo 62: Eastside Perimeter Drainage (August 22, 2012)**

**Photo 64: Eastside Perimeter Drainage to Terminal Basin (September 12, 2012)**

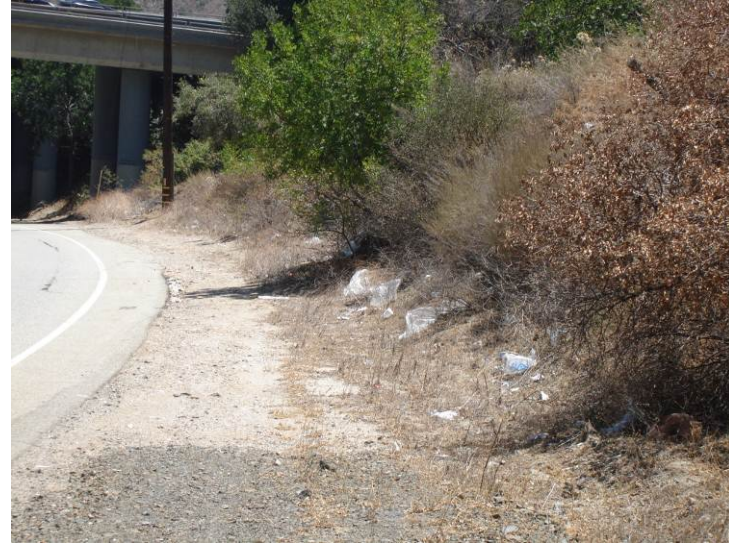
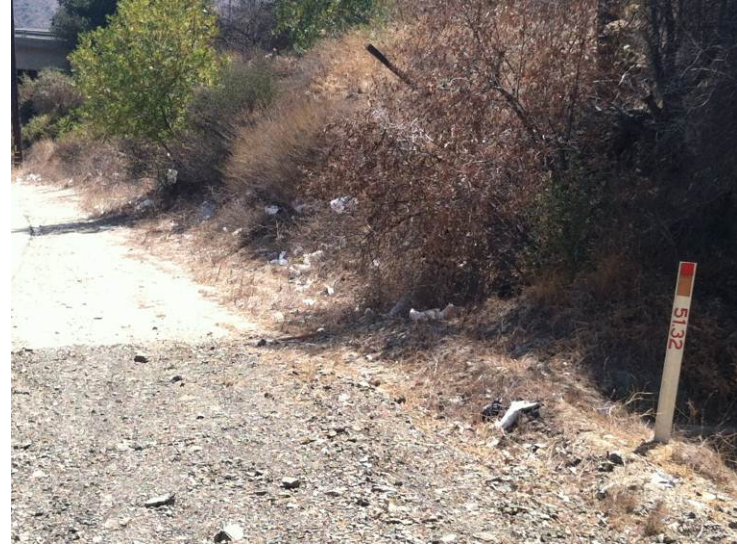
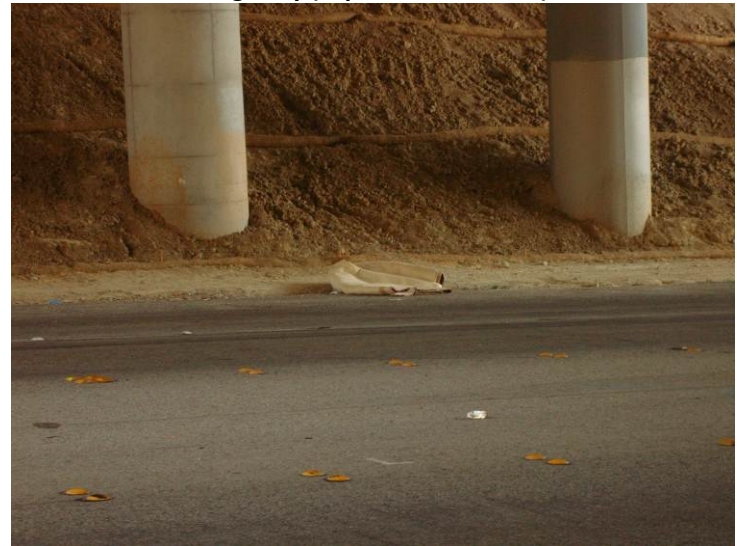
**Current Status/Comments** - Litter was observed along the roadway on Sierra Highway between San Fernando Road and the Highway 14 overpass. Some illegal dumping was also observed.

**Photo 142: Sierra Highway Near I-14 (July 25, 2012)**

**Photo 146: Sierra Highway (September 12, 2012)**

**Photo 148: Sierra Highway (September 25, 2012)**

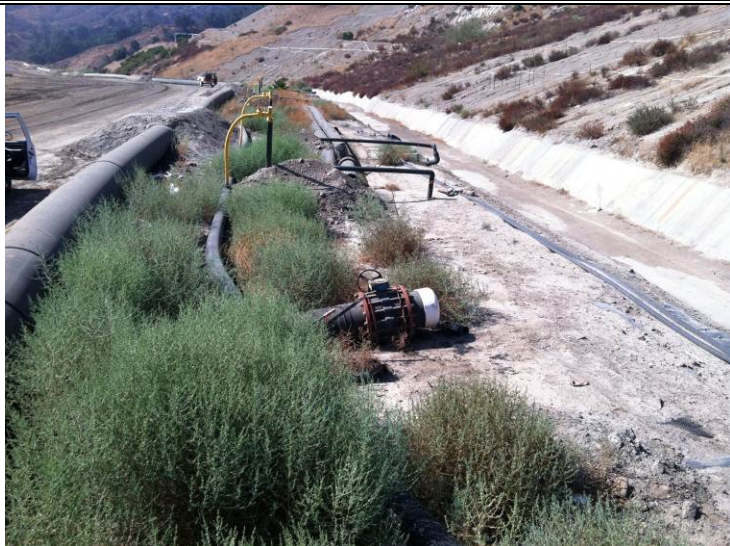
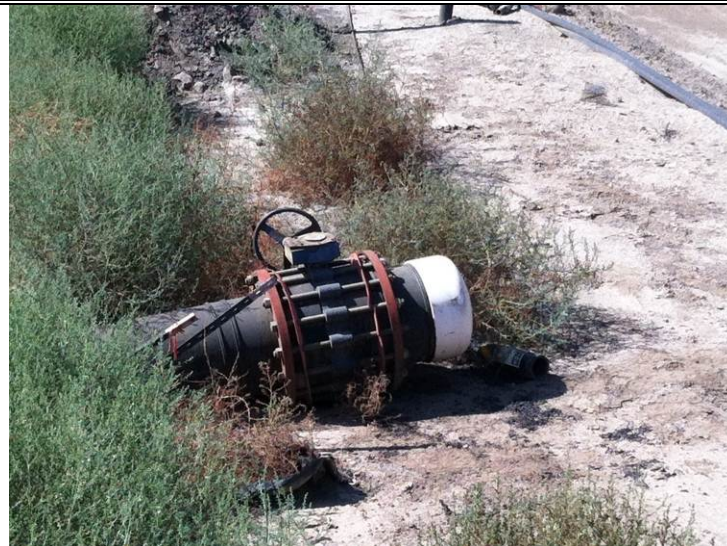
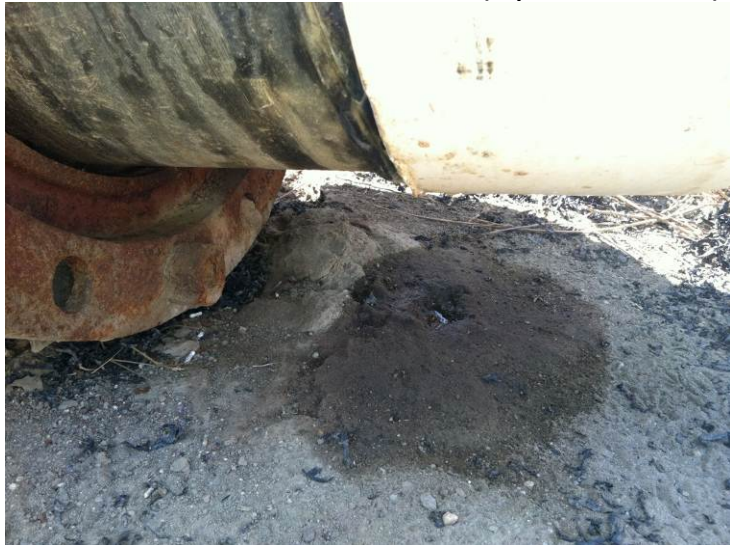
On September 12, an abandoned capped gas collection pipe was noted to be leaking gas condensate. This condition was reported to Republic's gas systems manager. Repair parts were placed on order to make the repair.

**Photo 150: Abandoned Gas Collection Line (September 12, 2012)**

**Photo 151: Abandoned Gas Collection Line (September 12, 2012)**

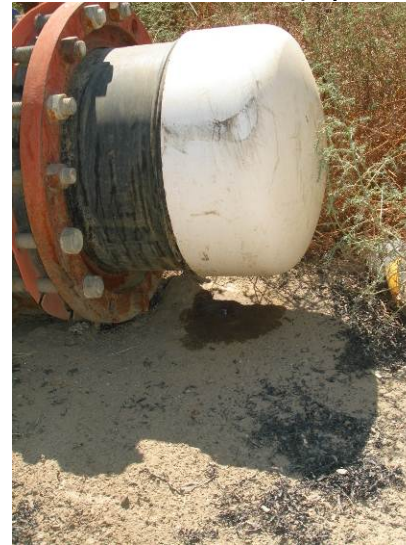
**Photo 152: Abandoned Gas Collection Line Liquid Leak (September 25, 2012)**

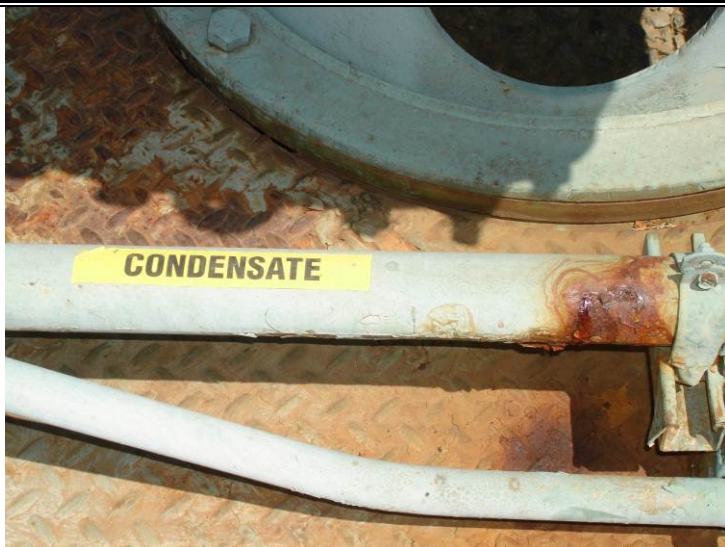
**Current Status/Comments** – On August 22, 2012, a condensate line on the compressor discharge knock-out drain at Flare 1 was noted to be corroded and seeping condensate. A flange on the discharge of Blower A was noted to be leaking gas. These conditions were reported to the landfill gas systems manager. They were aware of the flange leak and had ordered repair parts. This leak was fixed by the next monitoring visit, on September 12th. The corroded pipe on the Flare 1 knockout drainpipe was investigated and repair parts were received on September 25th. Repairs were underway on September 25th.

Photo 153: Flare 1 (August 22, 2012)

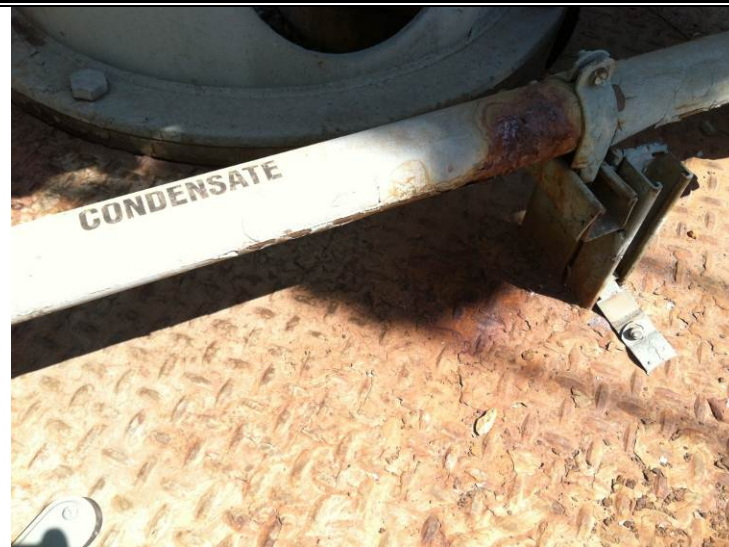
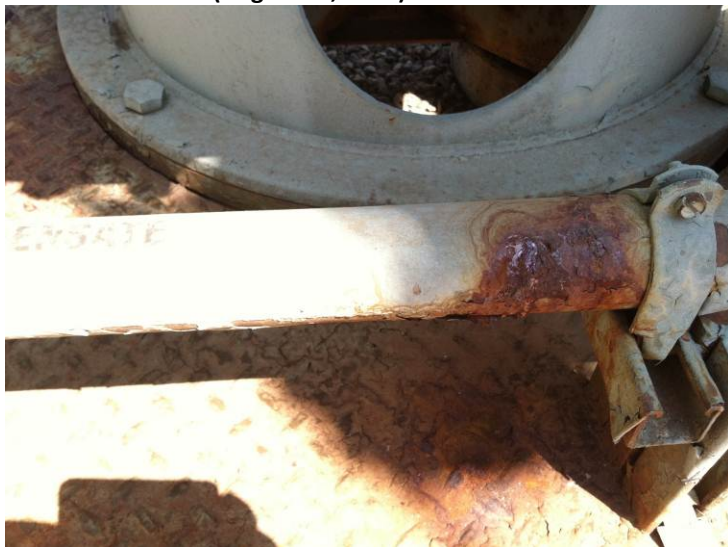
Photo 154: Flare 1 Knockout Condensate Drain (September 12, 2012)

Photo 155: Flare 1 Knockout Condensate Drain (September 12, 2012)

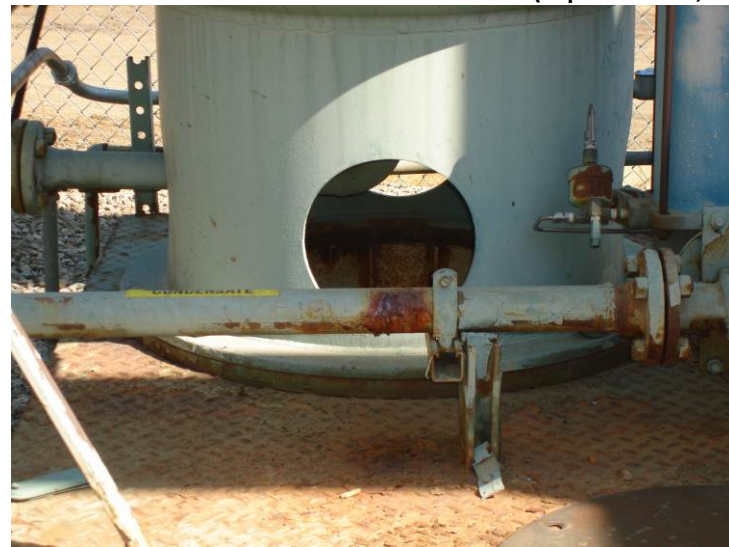
Photo 156: Flare 1 Knockout Condensate Drain (September 25, 2012)

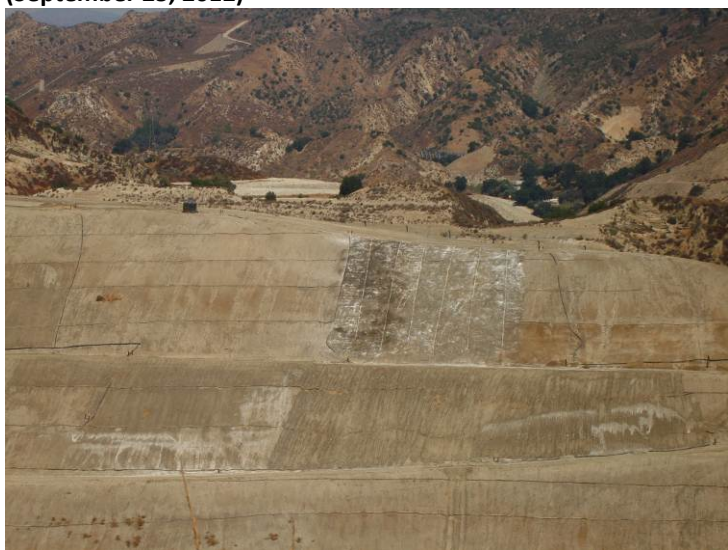
**Current Status/Comments** - To date, very little hydroseed has germinated within the interim cover areas and the coastal sage mitigation areas have had minimal success. In the second quarter of 2012, Republic's biologist consultant was directed to evaluate the performance of the revegetation plan that was implemented. The results of the evaluation and any recommendations for corrective action was to be provided to them by the consultant. In July, Republic directed their biologist consultant to develop new plans and procedures to obtain the desired results. In August, different ways of adjusting the soil pH by applying lime was tested within the City jurisdiction. In September, a coastal sage plan was presented to the County Task Force. A test plot for interim cover revegetation planting is scheduled to be planted in October 2012. The first evaluation of this test plot will occur during the first quarter of 2012. Soil treatment with lime is now being tested on slopes in City North, above the scalehouse.

**Photo 183: Soil Liming Plots (August 22, 2012)**

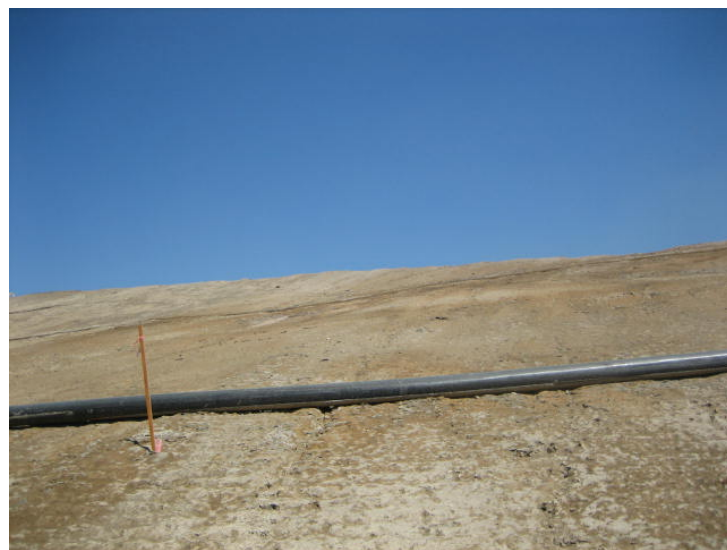
**Photo 184: Interim Cover Areas Lime Treatment Area #1 (September 25, 2012)**
