**Sunshine Canyon Landfill  
Independent Monitor  
Quarterly Site Monitoring Status Report  
April 1, 2025 – June 30, 2025**

**City of Los Angeles Department of City Planning**

**County of Los Angeles Department of Regional Planning**

**UltraSystems**  
environmental | management | planning

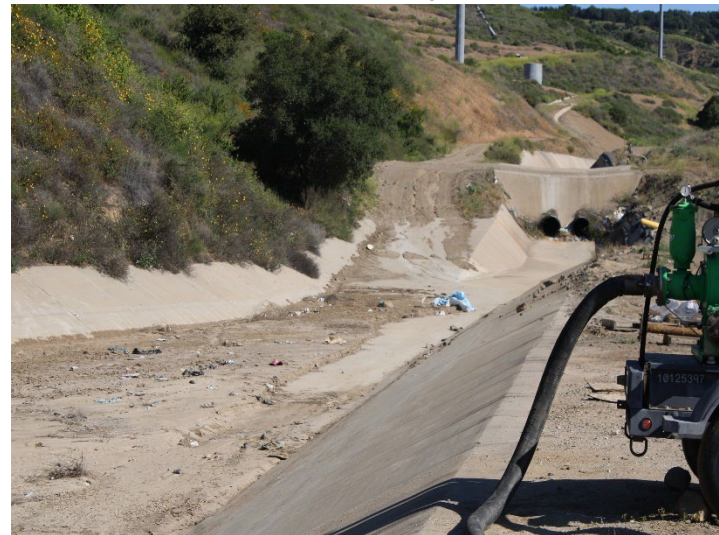
**Photo 7: Basin A: May 20, 2025**

**Current Status/Comments** – In the 2nd Quarter, all the basins were full of sediment. Standing water and windblown litter was observed in the Terminal Basin. The water was dark in color and was not being discharged. Basin A was full of dry sediment and in the process of removal. Basin B was dry and covered with sediment. Basin E had standing water and sediment. Major modifications were made to the Terminal Basin and its inlet channels. No hydrology reports were available to the monitor or the County that would show the current rainwater handling capacities and what future rainwater control improvements would be needed and their capacities.

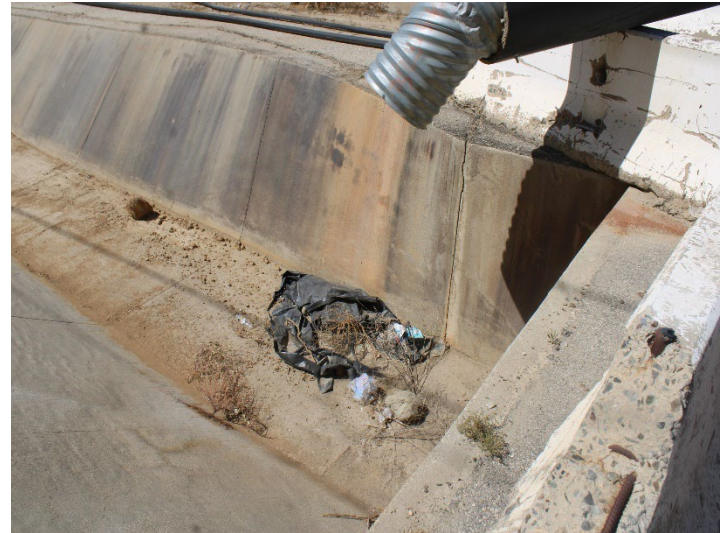
**Photo 117: Eastside Drainage Channel: June 18, 2025**

In the 2nd Quarter, it was observed that vegetation was growing out of numerous cracks in the water retention basins and drainage conveyance channels' concrete. There were areas of the channels and basins that needed the growing vegetation to be removed, and repair of concrete and sealing of cracks. These clean-up and maintenance tasks are put on the Republic's monthly preventative maintenance program work list. The concrete drainage channel wall south of Basin B had the soil supporting the back of the wall being washed away by rain. The concrete wall was being compromised by not stopping water from flowing into the back of the wall. Areas of the wall were cracked and are moving. There were numerous items on the preventative maintenance program list to accomplish at this location. All the maintenance was completed in June of the 2nd Quarter.

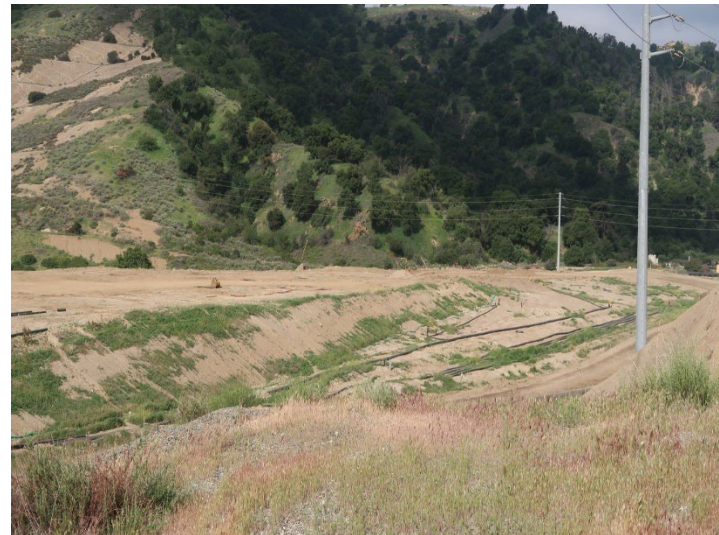
**Photo 151: County Top Deck: April 24, 2025**

**Current Status/Comments** – In the 2nd Quarter, localized dust clouds occurred on dirt roads to and on the County top deck when soil importation trucks were delivering soil. These temporary roads did not have rock nor recycled concrete surfacing or soil stabilizer to control dust generation. Dust was not observed leaving the site from this location. On windy and dry days, dust clouds were observed coming from the cut slopes near the future toe berm location. These dust clouds could have left the site.

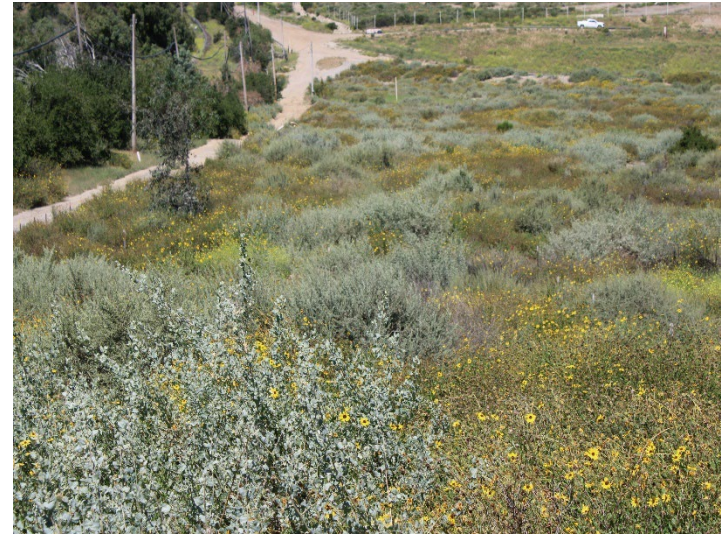
**Photo 245: Sage Mitigation, Deck C: May 20, 2025**

**Current Status/Comments** – During the 2nd Quarter, City sage mitigation area decks B and C were being maintained by the removal of non-native vegetation. Native vegetation was doing well. Bare spots are being filled in from seeds and spreading of prior planted native plants. The condition of the PM-10 oak trees was still being evaluated by Republic's consulting biologists. Their yearly oak tree mitigation status report was being prepared. There was a substantial amount of dead PM-10 trees observed by the monitor. No schedule for tree replacement has been issued. There was no activity in the County sage mitigation area. Native plants were doing well in the County sage area, repopulating in the areas where they naturally came back. No grading of the hillside slopes to have benches and mitigation revegetation planting activity was done for this area in the 2nd Quarter. Areas of City decks B and C were graded for the new temporary waste hauling access roads. There appears to be minimal impacts to the sage mitigation areas.
