**Sunshine Canyon Landfill
Independent Monitor
Quarterly Site Monitoring Status Report
October 1, 2014 – December 31, 2014**

City of Los Angeles Department of City Planning

County of Los Angeles Department of Regional Planning

February 16, 2015

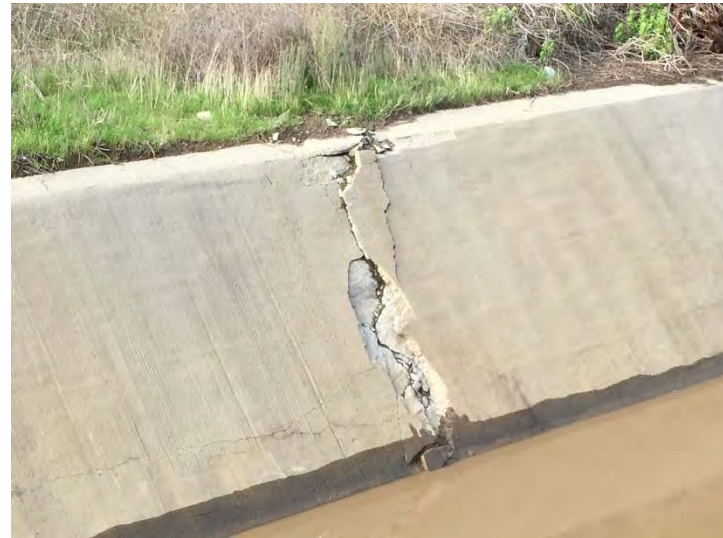
Photo 15: Westside Drainage Channel: November 10, 2014

Current Status/Comments – On November 10, 2014 it was observed that conditions of a portion on the westside drainage channel between Basin A and Basin D, noted in previous site visits as needing repair, has been cleaned with all soil and debris removed and the concrete ground on the upstream side to minimize the risk of hydraulic jump or underflow. Republic staff stated that the westside drainage channel has been configured so that only flow from the watershed (i.e. the hills on the westside) adjacent to the channel would discharge to this channel and that no runoff flow would be coming from Basin D. Republic staff stated that maintenance will be done when other westside channel work is scheduled.

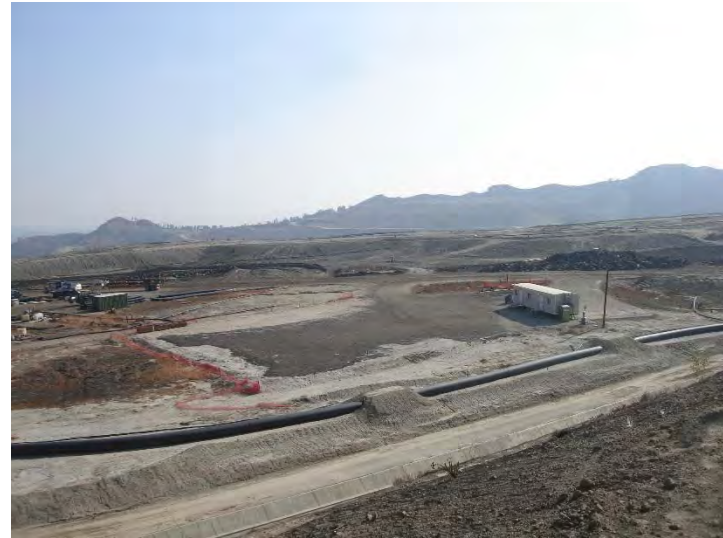
Photo 41: County Top Deck: November 10, 2014

Current Status/Comments – It was observed during the November 10, 2014 site monitoring that there is no clear drainage pattern on the decks and there are numerous low spots where water may pond and infiltrate. This condition was previously noted on the prior August 27, 2014 site monitoring.

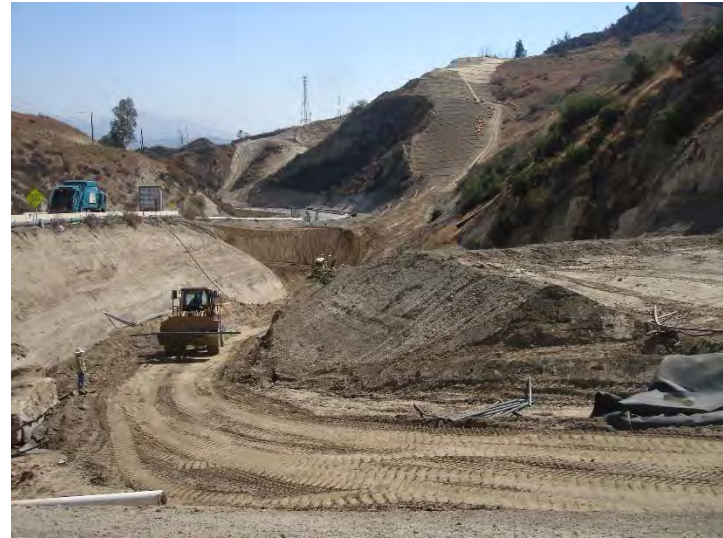
Photo 61: Access Road Realignment Area: October 8, 2014

Current Status/Comments – During the October 8, 2014 site monitoring, it was observed that the access road realignment had grading being done to previously graded slopes in order to winterize

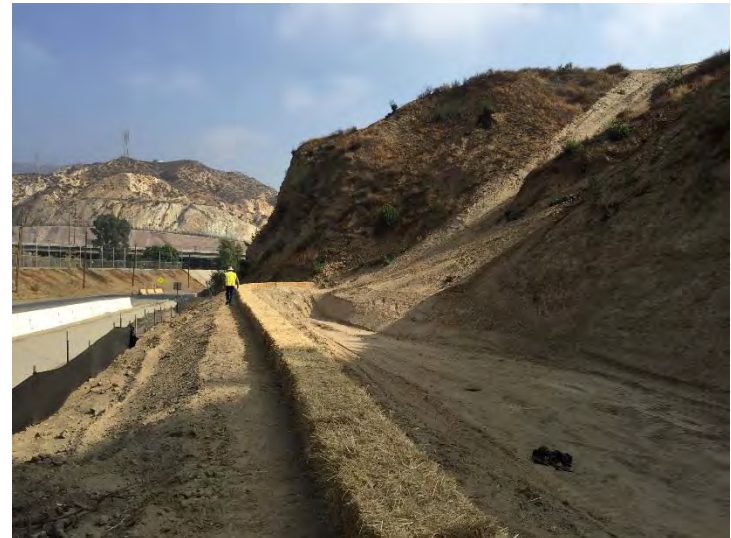
Photo 67: Access Road Realignment Area: November 10, 2014

the slopes. On November 10, 2014, the monitor observed that the access road realignment area had best management practices (BMPs) put on all of the disturbed slopes. BMPs observed within disturbed slopes included jute netting, straw wattles, and straw bales. Three water runoff control basins were also constructed between the condensate treatment plant and the terminal basin. One additional basin was constructed just west of the oil field access road. Prior to resuming grading activity that includes habitat removal, surveys should be conducted to assess the presence of migratory birds, California gnatcatcher, raptors and other birds, and the San Diego Horned Lizard. Any areas not previously surveyed for archeological and paleontological resources should also be surveyed.

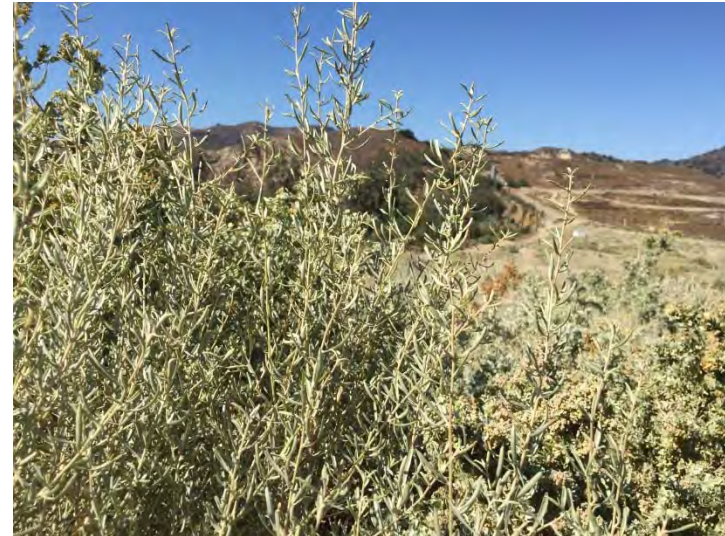
Photo 82: City Sage Mitigation Deck C: October 8, 2014

| Discipline | City Condition Reference # / Mitigation # | County Condition Reference # / Mitigation # | Responsible Agency | Further Review Needed-Comments |
|---|---|---|---|---|
| | M - 4.4.1 / 60 | | City Planning | I-q: The City Deck C sage mitigation plants have greened up and grown from the recent rains and cool weather. The California sage and other non-Atriplex (salt tolerant) plants were observed doing well. |

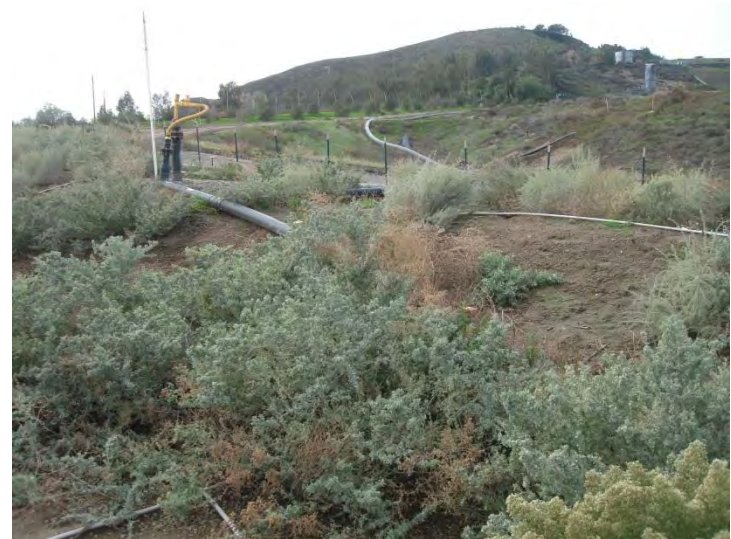
Photo 89: City Sage Mitigation Deck C: December 18, 2014

Current Status/Comments – On December 18, 2014 it was observed that City Deck C sage mitigation plants have greened up and grown from the recent rains and cool weather. The California sage and other non-Atriplex (salt tolerant) plants were observed doing well. The County sage area was much greener and appeared more filled in with vegetative growth due to the recent rains.

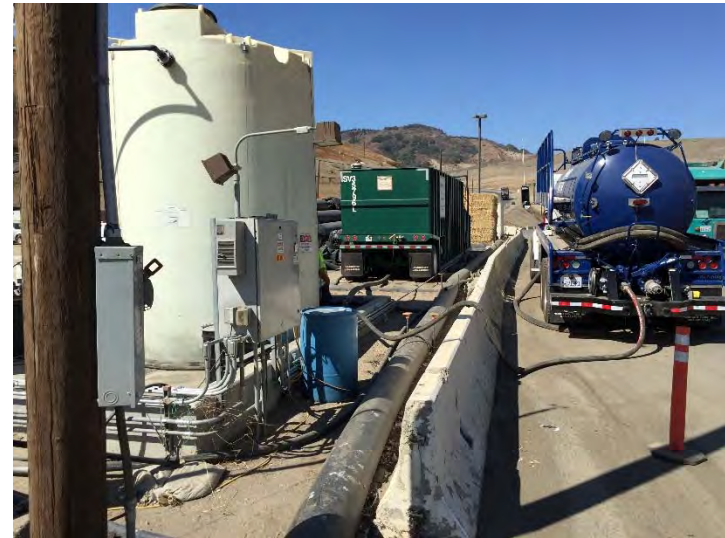
Photo 109: Condensate Treatment Facility: October 8 2014

During the October 22, 2014 site monitoring, the condensate treatment facility had strong localized odors coming from the Baker tank and the transfer pump truck vent when it was loading condensate to haul to the leachate treatment facility. The transfer pipelines have not yet been replaced. The 55-gallon carbon drum vent scrubbers at the leachate treatment facility were not eliminating tank vent odors. Replacements should be investigated.

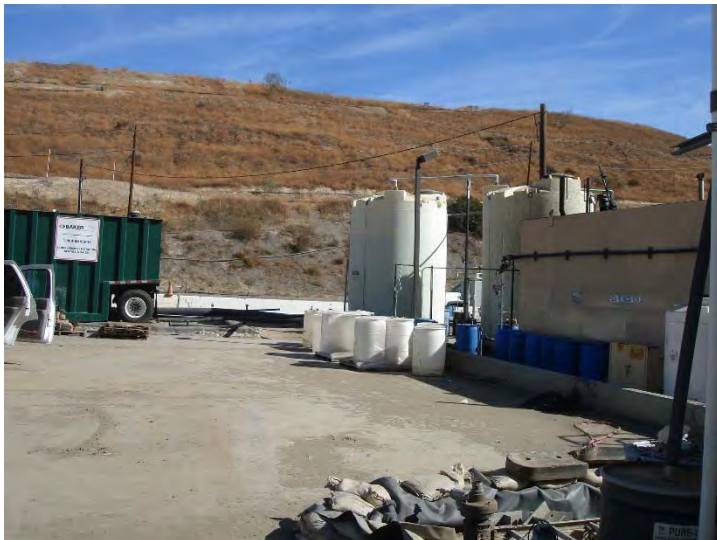
Photo 110: Condensate Treatment Facility: October 8, 2014

| <p>15. Condensate Treatment Plant (by existing truck scales) had strong odors around facility. A pump truck was removing stored condensate from storage tank, and taking it to lower facility by land fill entrance. This is done 3-4 times per week now, since pipeline is disturbed due to construction work.</p> <p>16. Terminal Sediment Basin is clear of sediment piles, with a line of K-rails extending from vertical drains.</p> <p>17. Westside Drainage has been cleaned out, with soil and weeds removed. Concrete walls and floor are cracking and buckling more near center area.</p> <p>18. BAS pipe storage yard is in good order, with an increase in stockpiled materials. Three 40-yard containers have been delivered for scrap removal.</p> <p>19. Sediment Basin D is in good order. A temp. tarp/cover machine with tarp rolls are being stored here.</p> <p>20. The Gas-to-Energy plant is fully operational. Flares 9 and 10 are off-line. A scheduled shutdown for maintenance and inspection is planned for Oct. 23/24. Met Steve, the third member of the operations team (along with Rich and Travis).</p> <p>21. Met with Larry Bressman (Republic):</p> <p>a. Jim Ardukas delivered a 2001 PM-10 Berm Planting Plan drawing to Larry for their use and records.</p> <p>b. Wet weather pads are being built near City working face; approx. 200 feet by 400 feet wide.</p> | |
