Subject: Report to the Joint Sunshine Canyon Landfill Technical Advisory
Committee SCL TAC Meeting Date – February 13th, 2024

Subject: Report to the Joint Sunshine Canyon Landfill Technical Advisory Committee
SCL TAC Meeting Date - February 13th, 2024

1.0 Cell Development

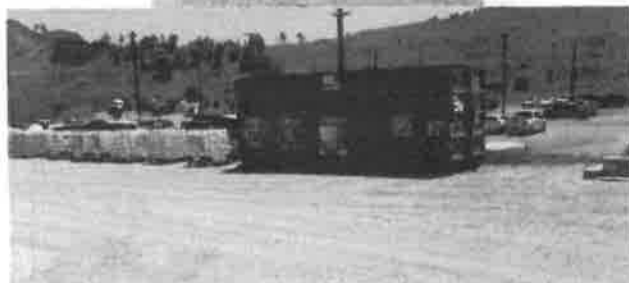
- The tank is used to store bulk H_2O_2 while the tote is used for temporary storage of the oxidant

- Totes need to be stored in shaded area to prevent degradation of chemicals that could make it less effective in treating DS

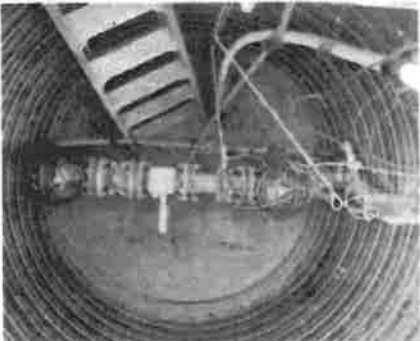
<ul style="list-style-type: none">• Lift Station Sewer Line that includes different instrumentation for monitoring

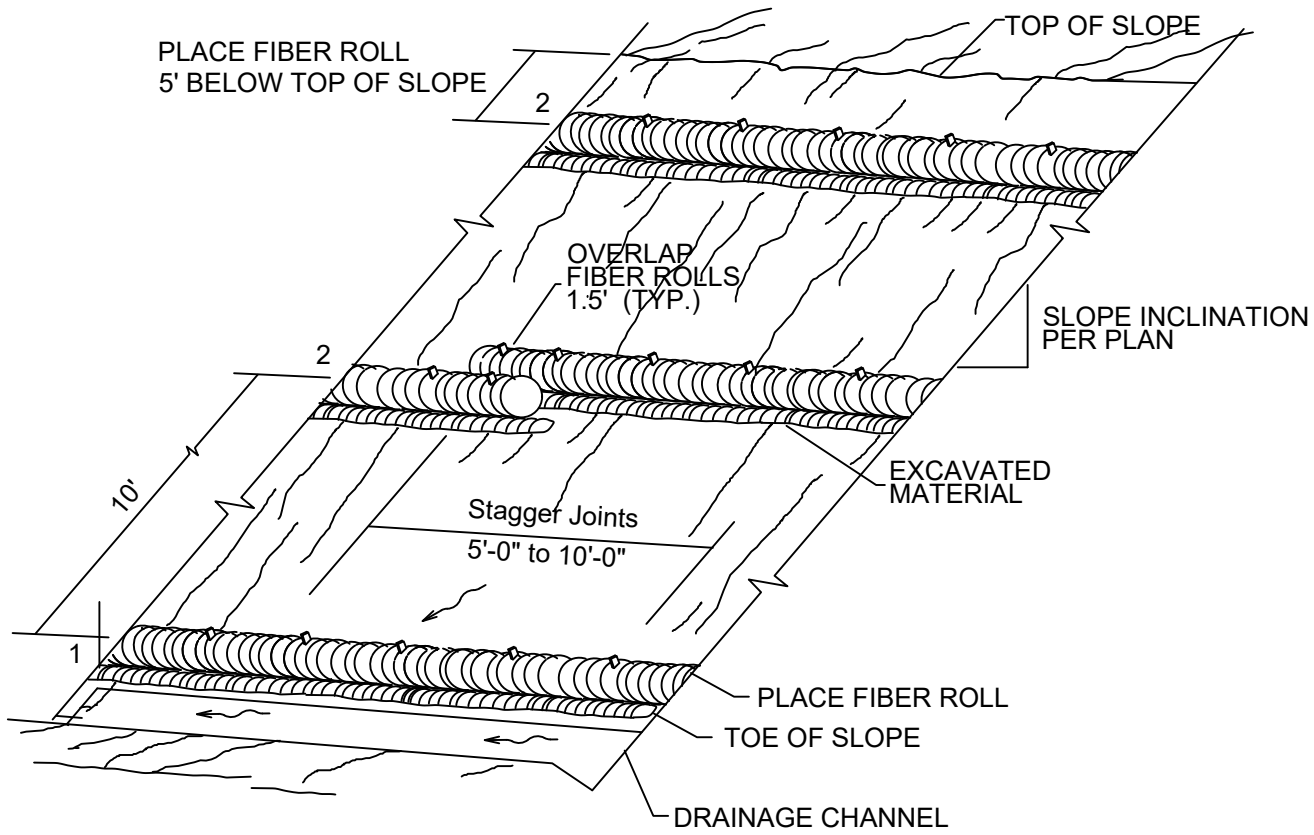
FIBER ROLL INSTALLATION
TYPICAL FOR ALL CUT AND FILL SLOPES
DETAIL 1
1" = 2' C8.0

NOTE:
1 FIBER ROLLS SHALL BE INSTALLED ON ALL CUT AND FILL SLOPES.

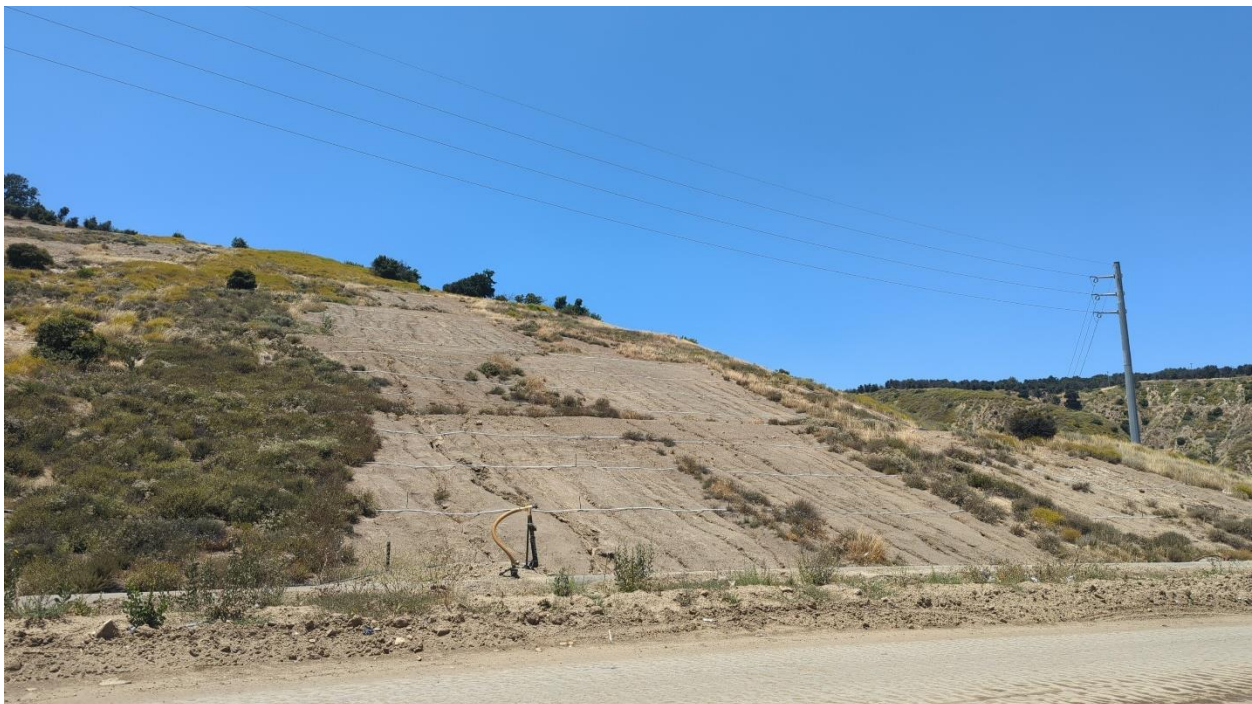
Photograph 2. Facing northwest at the northern portion of the County-Side Sage Mitigation Area where plant growth has been problematic due to poor soil conditions (June 22, 2023).

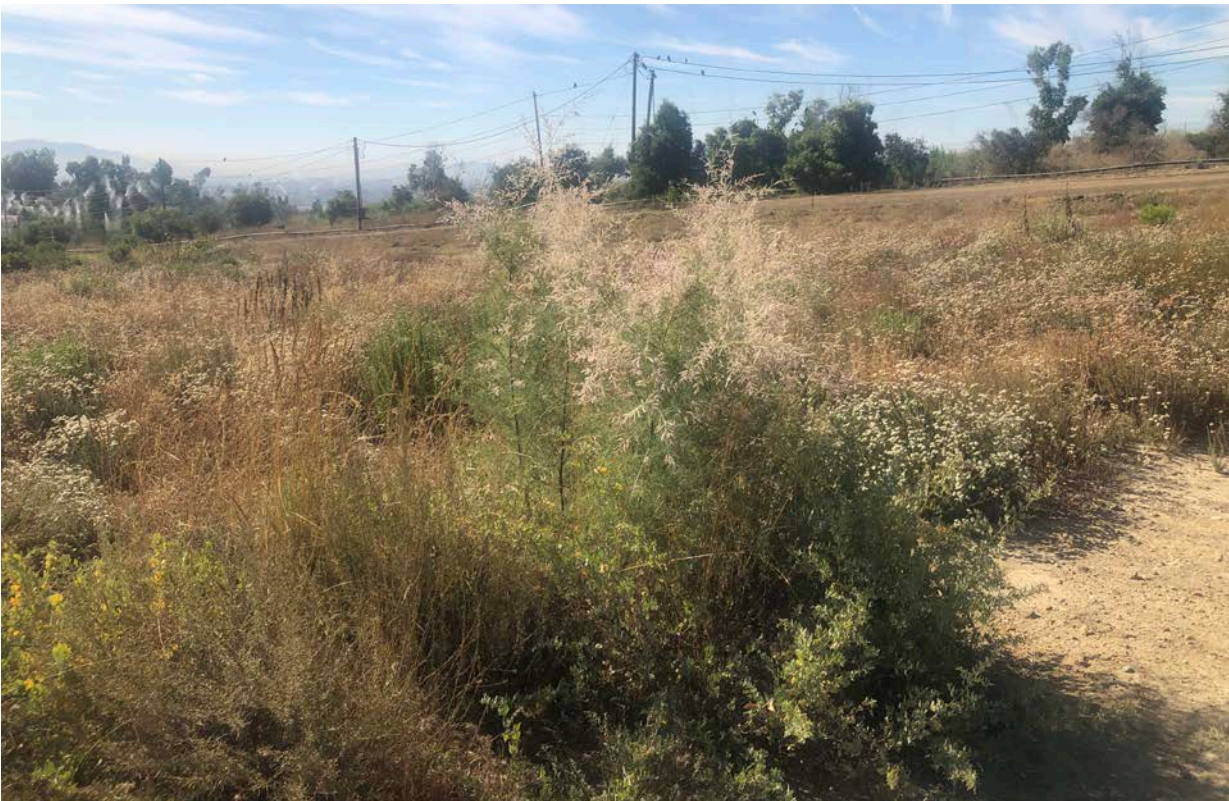
Tamarisk Tree (to be removed)

- Some larger invasive species are actively growing on the decks and should be removed to prevent the possibility of overturn and cap damage due to high winds. These species include Eucalyptus and Tamarisk Trees.

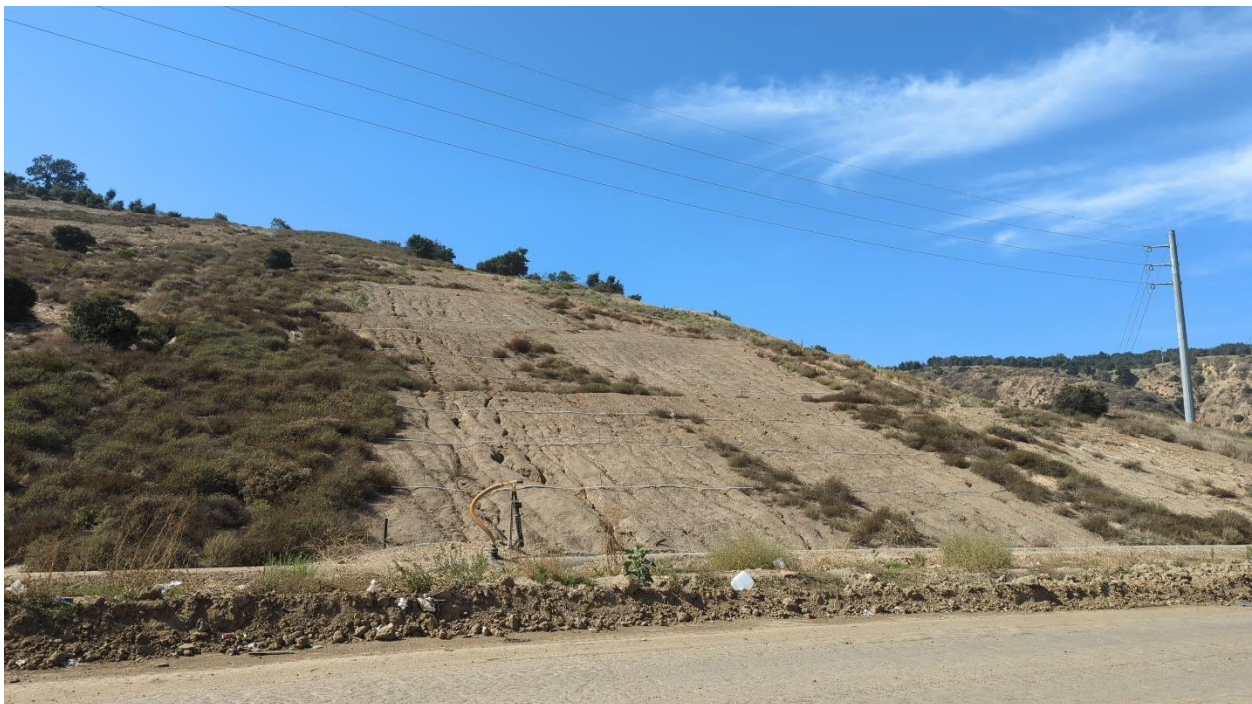
Photograph 2. Facing northwest at the northern portion of the County-Side Sage Mitigation Area where plant growth has been problematic due to poor soil conditions (September 27, 2023).

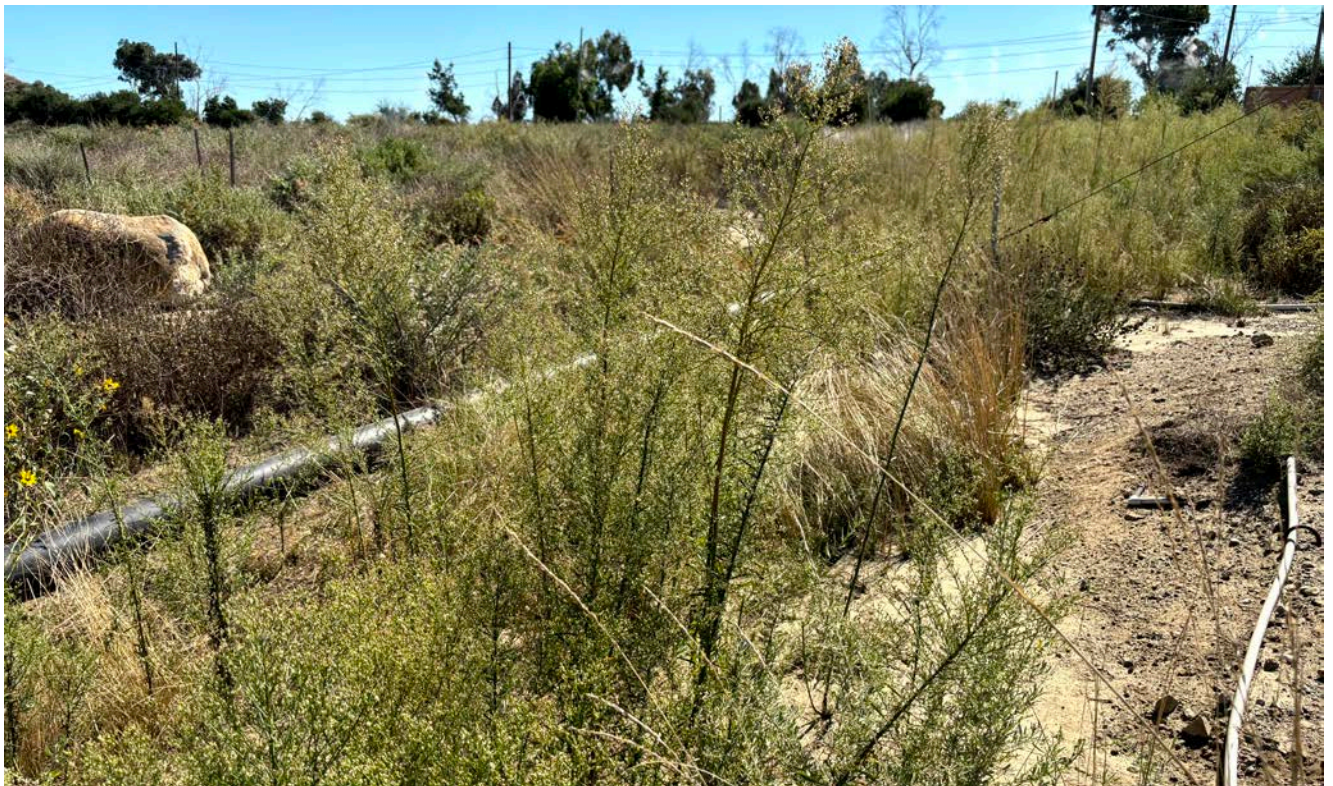
Horseweed (*Erigeron canadensis*) established and flowering within the swales where Creeping Wild Rye previously existed.

- Past maintenance of scalping the dormant native Creeping Rye Grass (*Leymus triticoides*) has allowed an increase of Horseweed (*Erigeron canadensis*) to establish. This weed should be removed as soon as possible. The native Creeping Rye Grass should be left to reestablish without cutting so that it will shade out potential weeds.
- Upon inspection of the PM10 Coast Live Oak trees, many are established with canopies extending up to 15'-20'. Those that died or that were severely damaged by the Saddleridge Fire, have not recovered.
- Recent grading efforts at the north west corner of Deck C should be stabilized with crushed recycled asphalt or graded roadbed to minimize ponding and rutting at the vehicular access road.

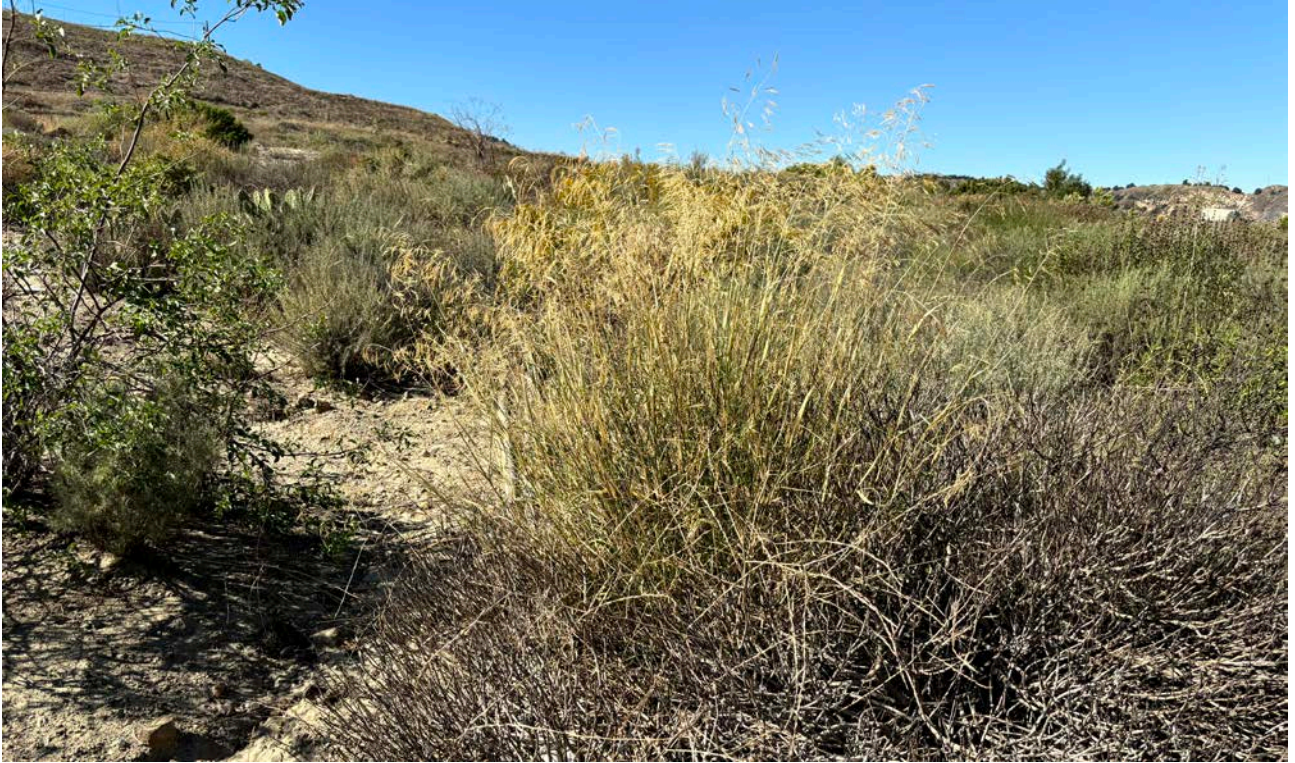
Invasive Smilo Grass (*Piptatherum miliaceum*)

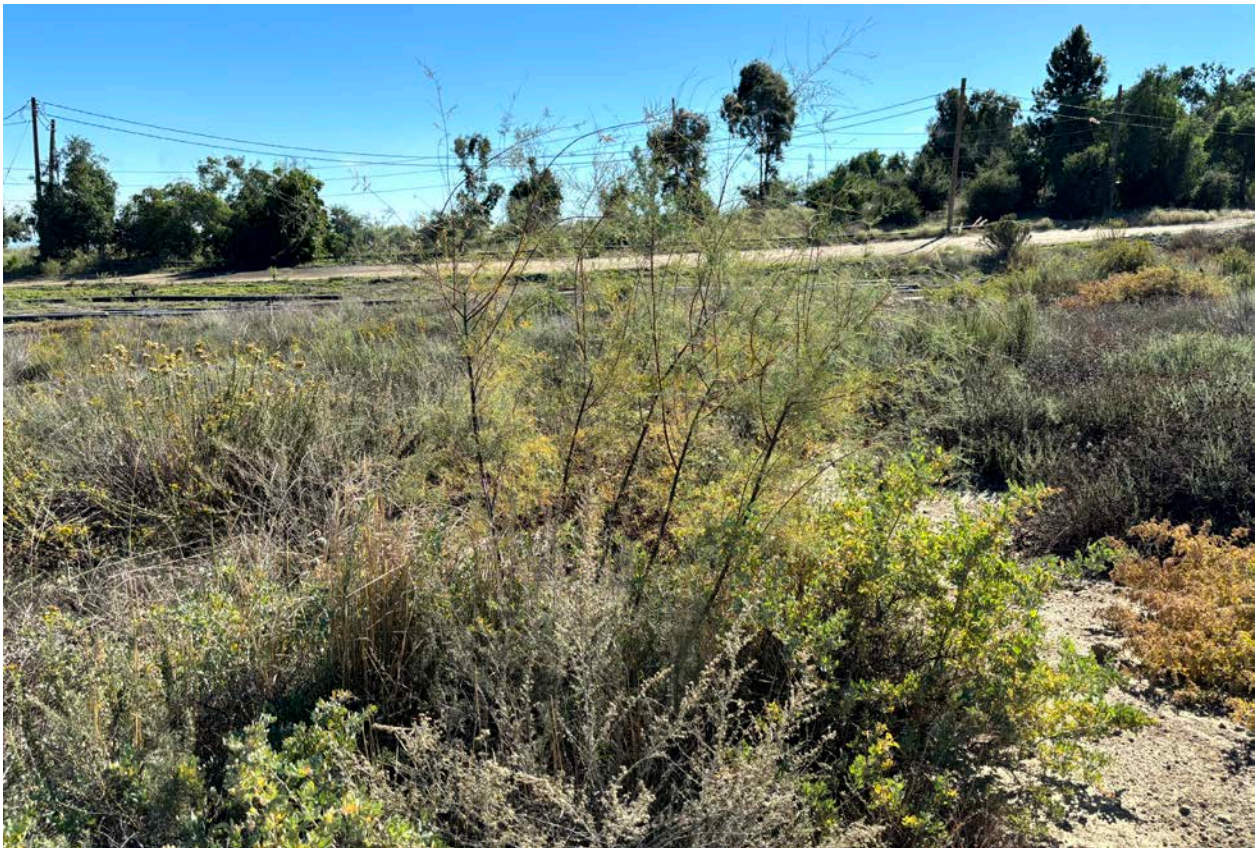
Invasive Salt Cedar (*Tamarix* species)

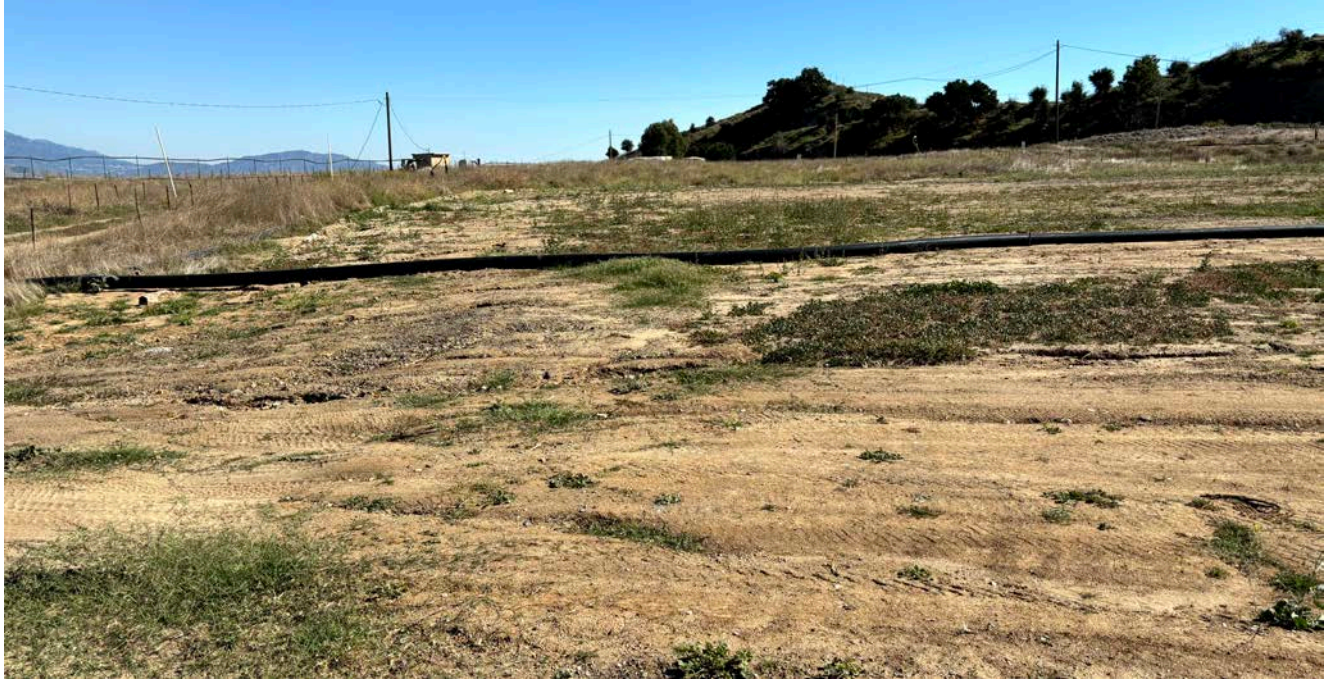
- Soils testing was recently completed for the fill dirt area of Deck A. Results are favorable for seeding of VCSS native species with some minor soil amendment recommendations. Below are images of the fill-dirt site; Soils testing is included at end of report.

Existing conditions of Deck A
