Subject: Report to the Joint Sunshine Canyon Landfill Technical Advisory

Committee SCL TAC Meeting Date - March 4th, 2025

Subject: Report to the Joint Sunshine Canyon Landfill Technical Advisory Committee

SCL TAC Meeting Date - March 4, 2025

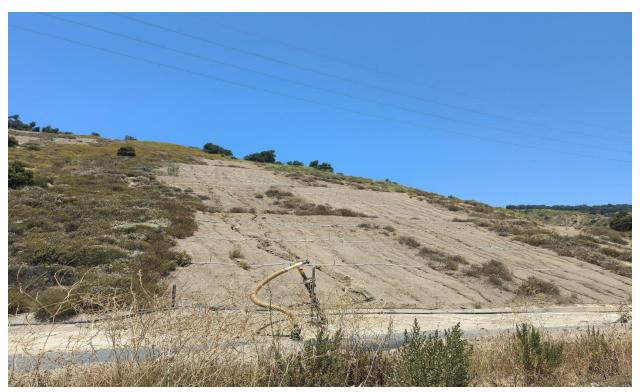
Photograph 2. Facing northwest at the northern portion of the County-Side Sage Mitigation Area where plant growth has been problematic due to poor soil conditions (June 19, 2024).

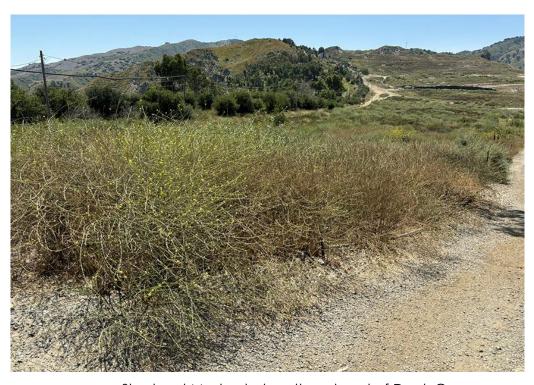
Shortpod Mustard at northeast end of Deck C

- Some larger invasive species are actively growing on the decks and should be removed to prevent the possibility of overturn and cap damage due to high winds. These species include Eucalyptus, California Pepper and Tamarisk Trees.

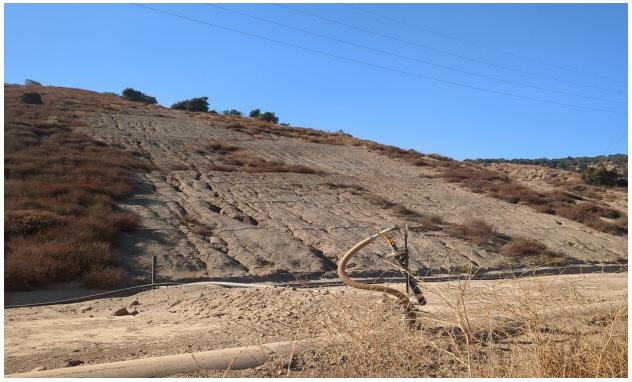
Photograph 2. Facing northwest at the northern portion of the County-Side Sage Mitigation Area where plant growth has been problematic due to poor soil conditions (September 27, 2024).

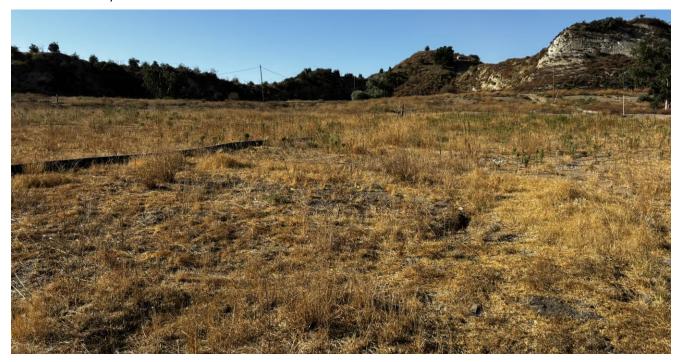
Existing conditions of Deck A

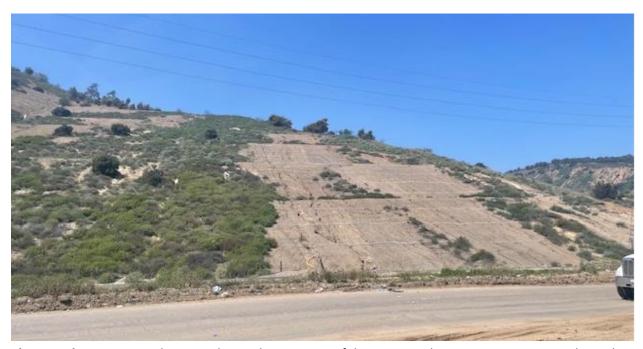
Photograph 2. Facing northwest at the northern portion of the County-Side Sage Mitigation Area where plant growth has been problematic due to poor soil conditions (March 21, 2024).

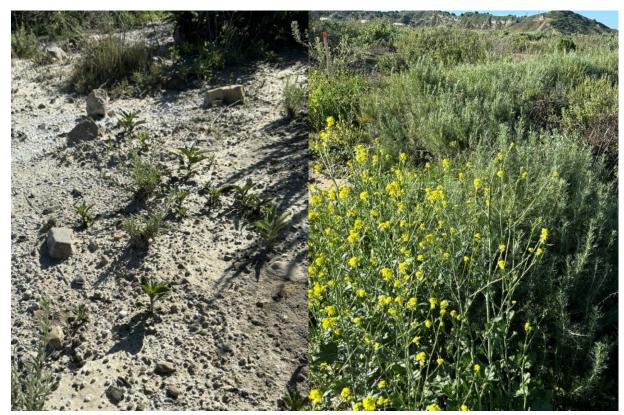
New native seedlings of California Sagebruch (Artemisia californica) and Yerba Santa (Eriodictyon californicum) on left and invasive Shortpod Mustard (Hirschfeldia incana) on right

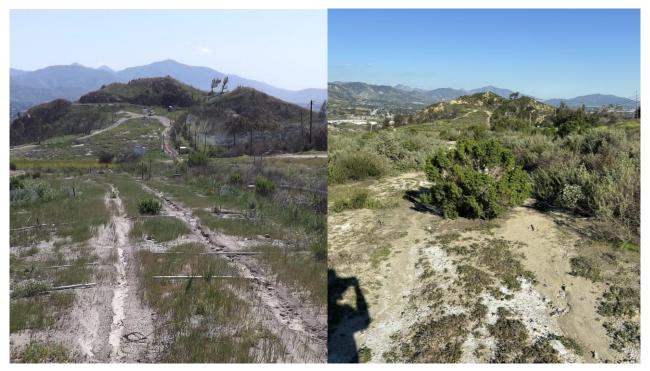
Side by side comparison of revegetated former gas well access road (image on left from April 2020, image on the right from April 2024)

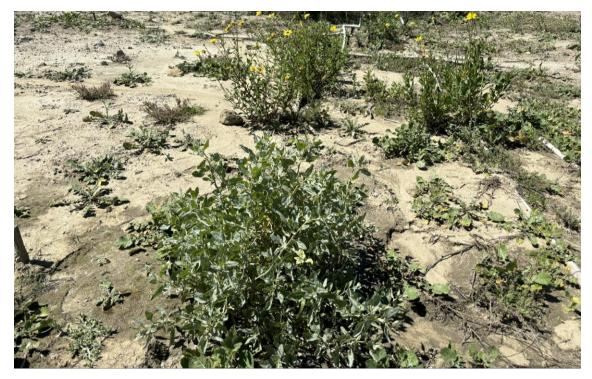
Saltbush and California Sunflower sprout up amongst Shortpod Mustard

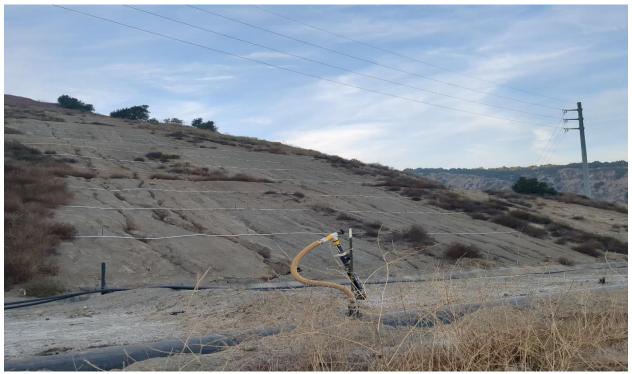
Photograph 2. Facing northwest at the northern portion of the County-Side Sage Mitigation Area where plant growth has been problematic due to poor soil conditions (December 23, 2024).

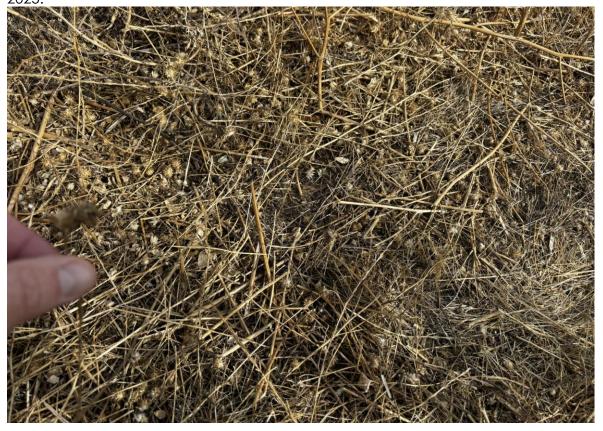
Weed seed debris left behind after scalping and removal of invasive Mustard

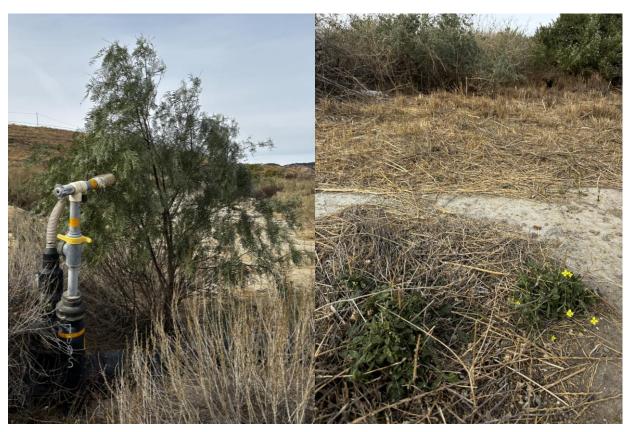
Invasive California Pepper Tree (Schinis molle) near gas well previously noted for removal (right) and new growth and weed debris of Shortpod Mustard (Hirschfeldia incana) on right

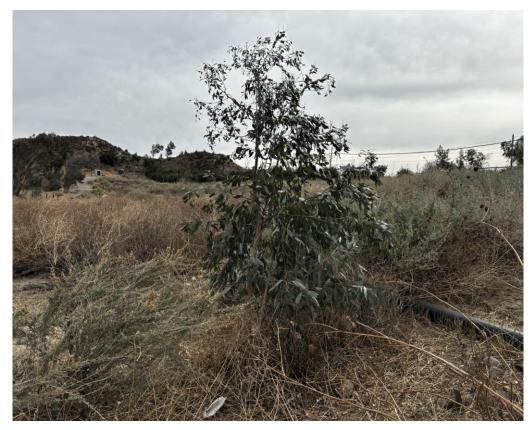
Invasive Eucalyptus species previously noted for removal on Deck C
