**Sunshine Canyon Landfill
Independent Monitor
Quarterly Site Monitoring Status Report
July 1, 2014 – September 30, 2014**

City of Los Angeles Department of City Planning

County of Los Angeles Department of Regional Planning

UltraSystems
environmental | management | planning

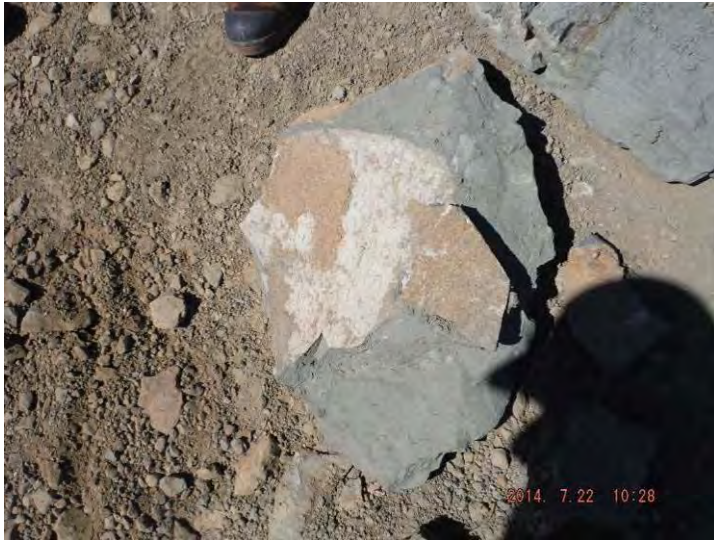
Photo 5: Whale Bone Fragments in Grading West of Office: July 22, 2014

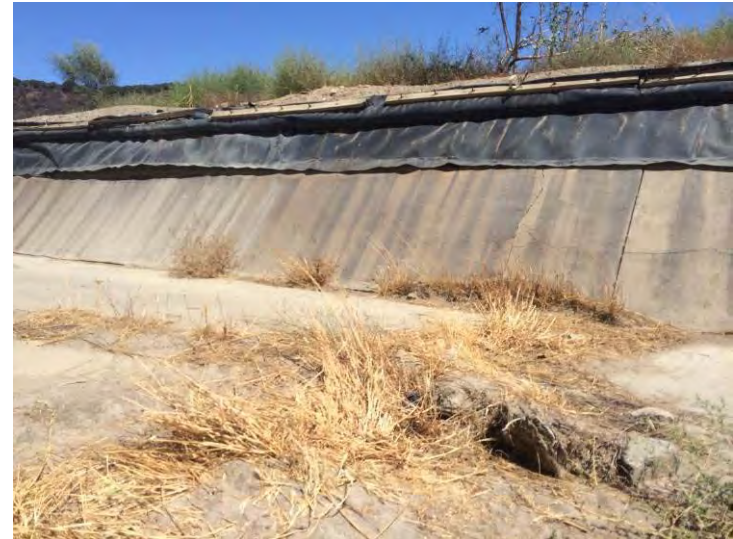
Photo 25: Westside Drainage Channel: August 27, 2014

Current Status/Comments – During the January 15, 2014 site monitoring, it was observed that along a portion of the westside drainage channel between Basin A and Basin D, the floor of the basin is uplifted in the middle with large cracks and weeds growing. Cracks mentioned in previous visits on the westside (native soil side) of the channel are getting worse, with concrete spalling and pieces falling off.

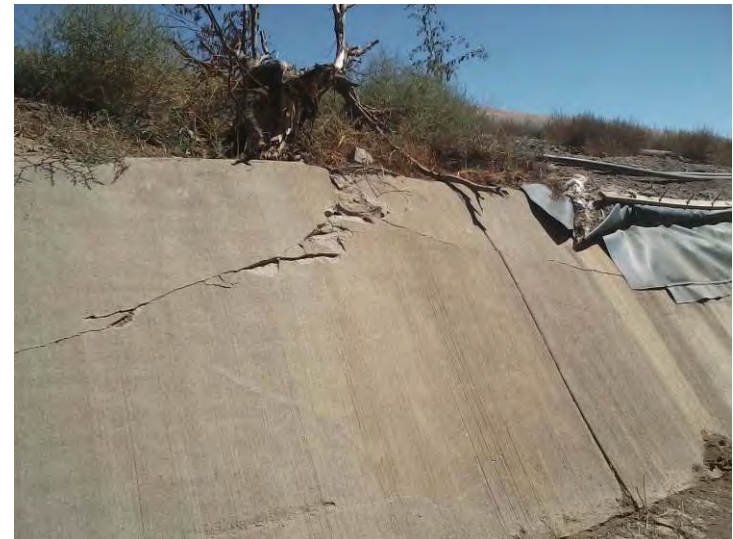
Photo 27: Westside Drainage Channel: September 23, 2014

During the September 23, 2014 site monitoring, it was observed that the floor of the channel uplifted more and portions of the concrete walls spalling increased. There appears to be no sign of eminent failure. However, maintenance should be scheduled.

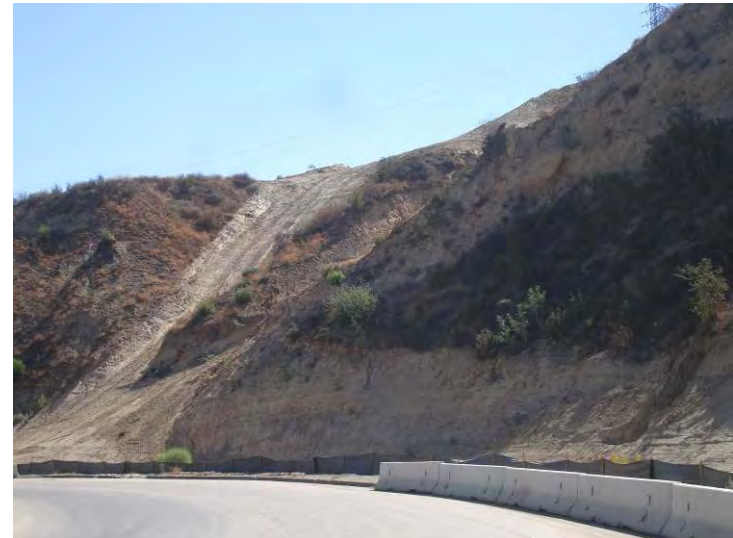
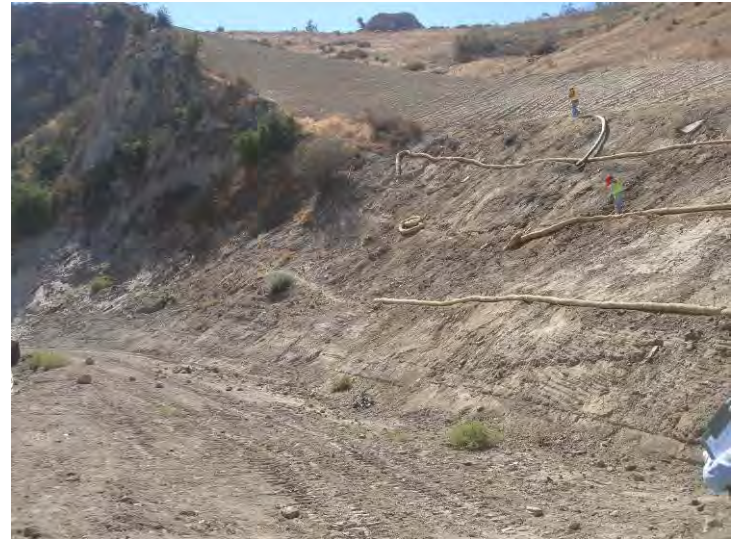
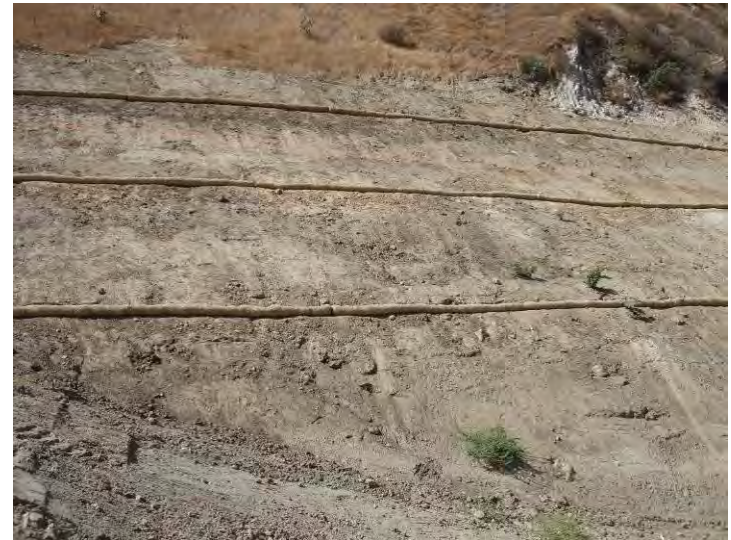
Photo 123: Access Road Realignment Area: September 23, 2014

Current Status/Comments – The access road realignment project has been stopped and the current contractor is being replaced. The project is being delayed until Spring 2015. Prior to resuming grading activity that includes habitat removal, surveys should be conducted to assess the

Current Status/Comments – It was observed that grading activities were being performed outside of the cut and fill footprint of the Landfill for the realignment of the main access road. This activity is consistent with the conditions of approval. However, plans that show any grading outside of the landfill footprint should be provided to and approved by the City of Los Angeles Department of Building and Safety and the County Department of Public Works to ensure appropriate grading and vehicular safety.

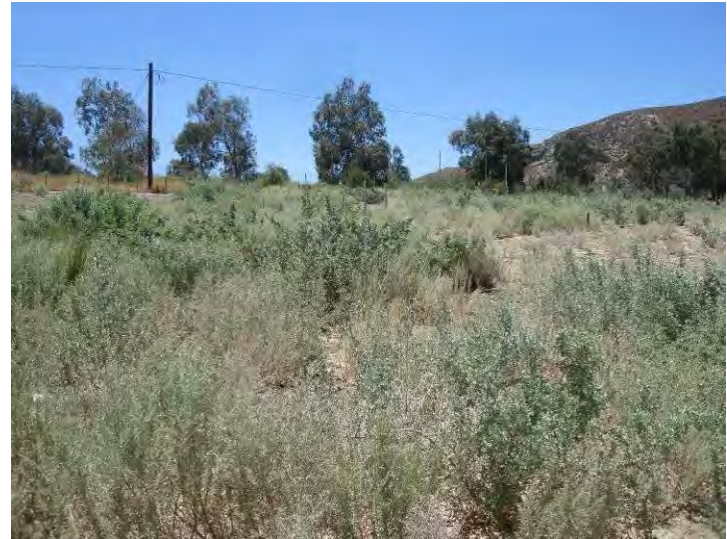
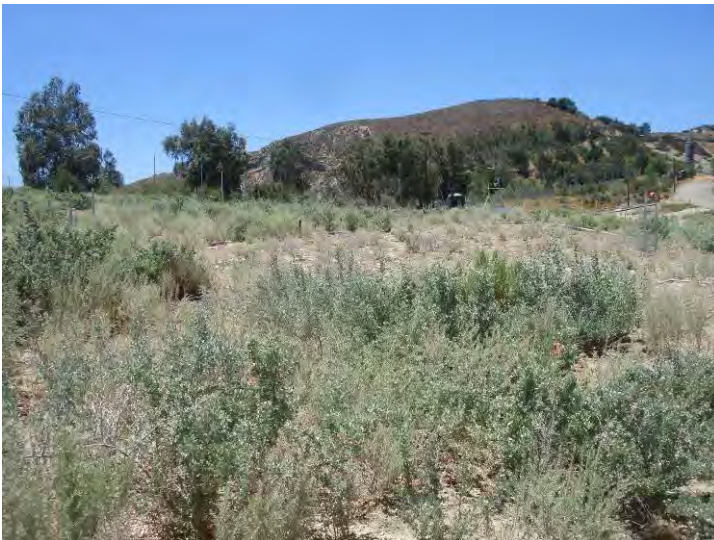
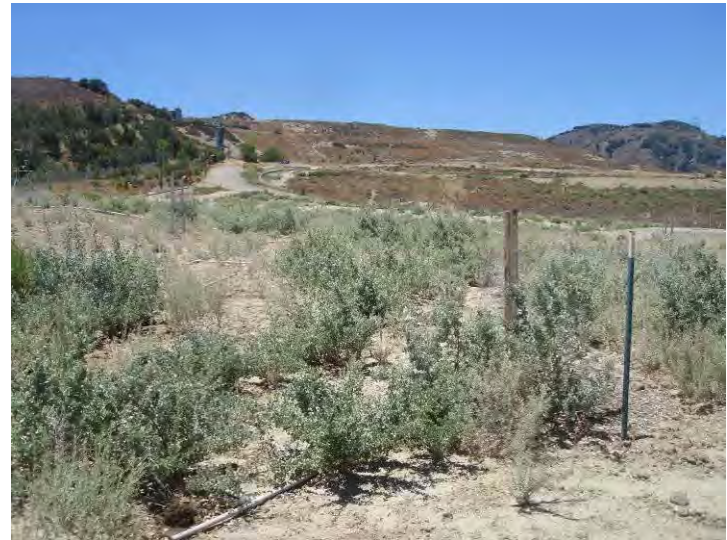
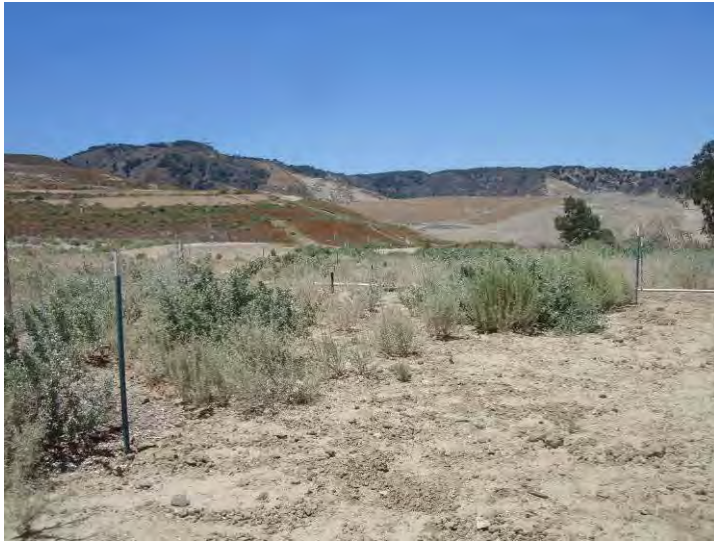
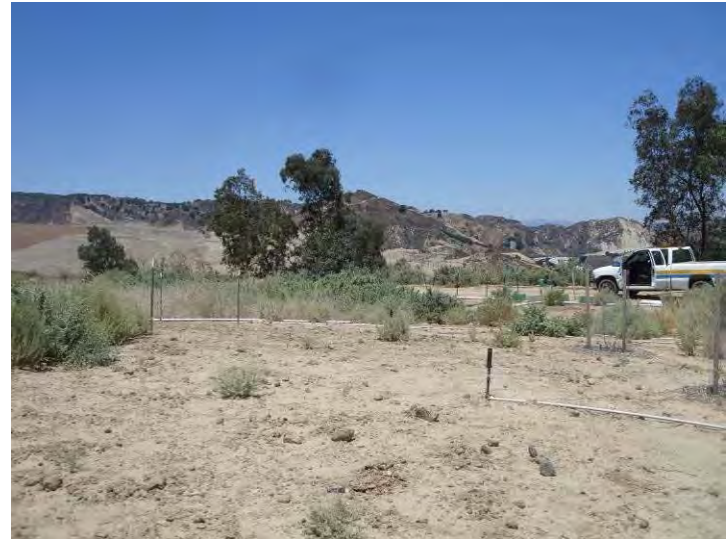
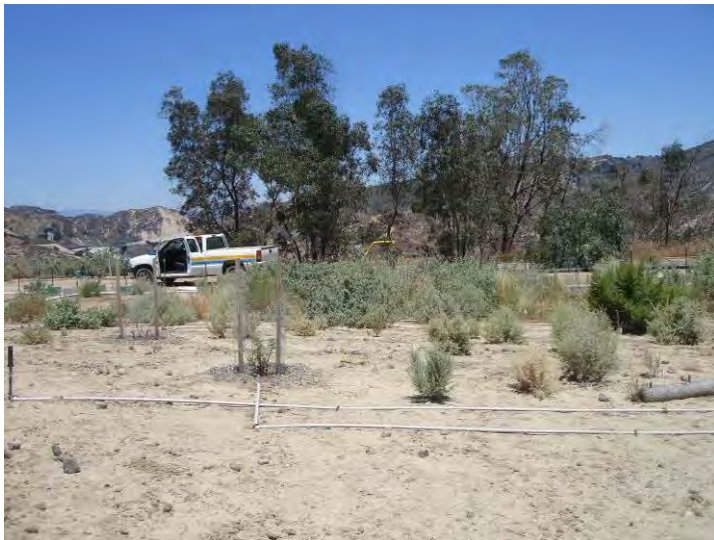
Photo 181: City Sage Mitigation Deck C: July 22, 2014

- City Deck C was inspected for planting success and overall conditions. It appears that the Atriplex species are doing well. The *Artemisia californica* may be in summer dormancy. Many of the other species have died back. It appears that the site may be a bit overwatered as noted by mud and surface water at the site. It also appears that the site does not receive water in a balanced way with water pooling in some areas and completely missing other necessary areas, which could explain the high rate of dieback by many species. Suggested watering schedule is 45min 6am and 8pm M W F during the summer for the first year. Once plants are established, the water should be removed completely.

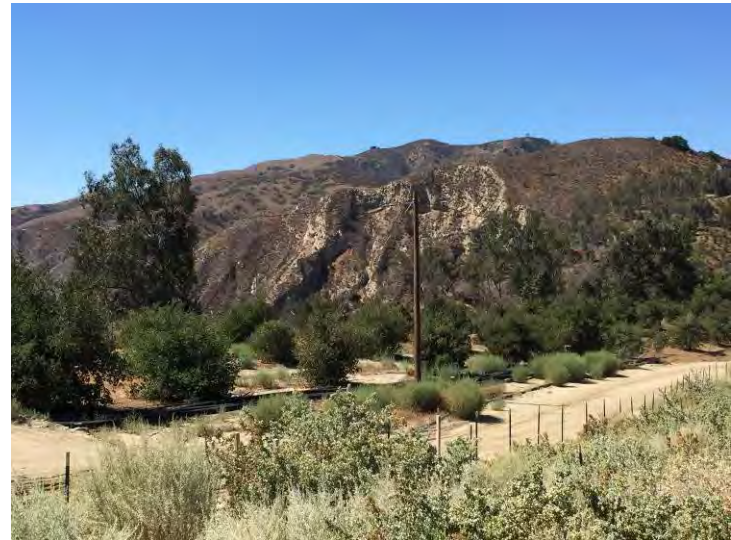
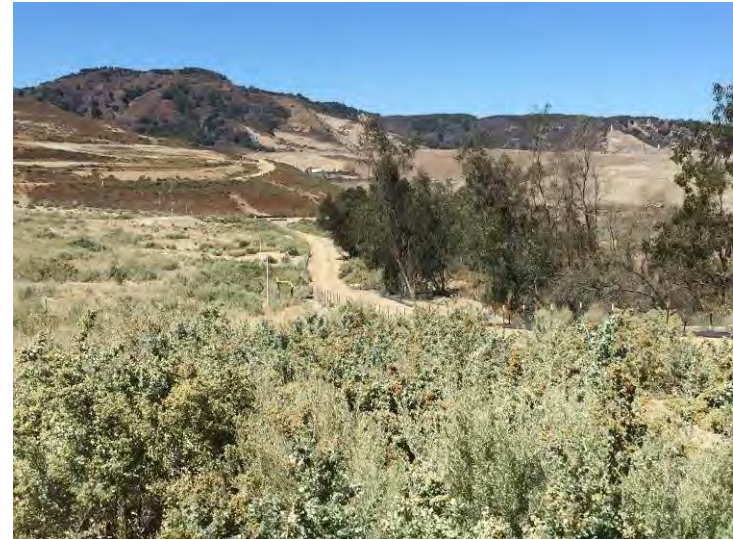
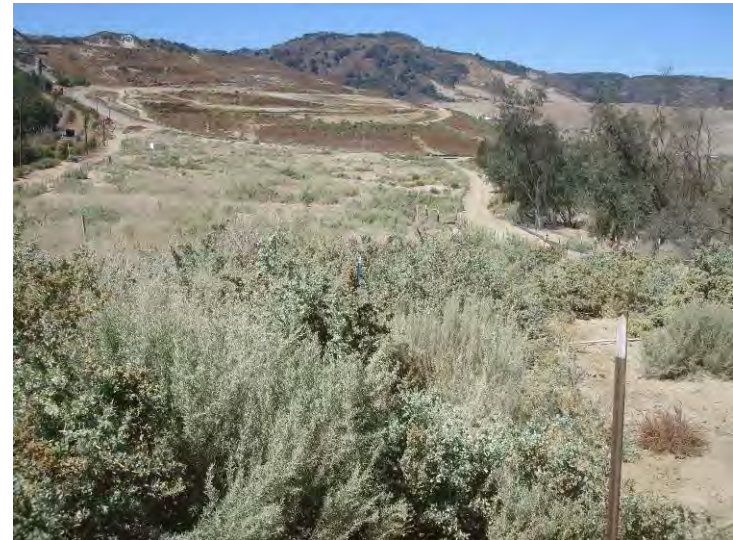
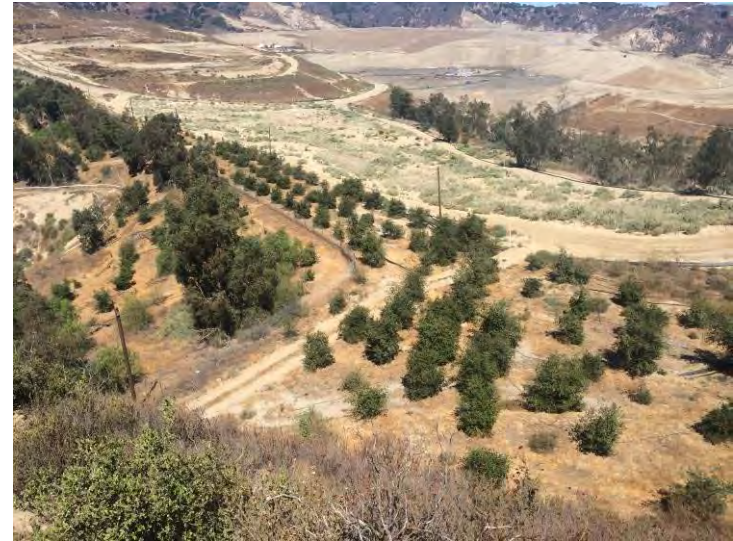
Current Status/Comments – During the 2nd Quarter site monitoring, the City Deck C sage mitigation area was observed and the salt and quail bush was growing and accounted for approximately 70-80% of the surviving plants. Sage and other plants had spotty success. The County sage area was much greener and appeared more filled-in with vegetative growth due to the February 2014 rains.

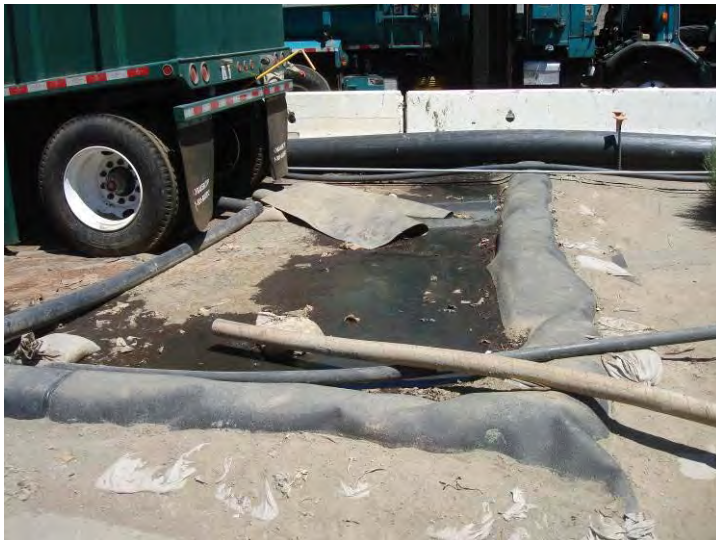
Photo 223: Condensate Treatment Facility: August 27, 2014

3. Observed standing water pond (~20' x 8') at Bypass Road construction site. Water flowed from Condensate Treatment Plant above excavated area.	
4. Observed transient person hiking down into below Oil Field access road. George Kasikarin called Republic operations to assist with trespassing issue.

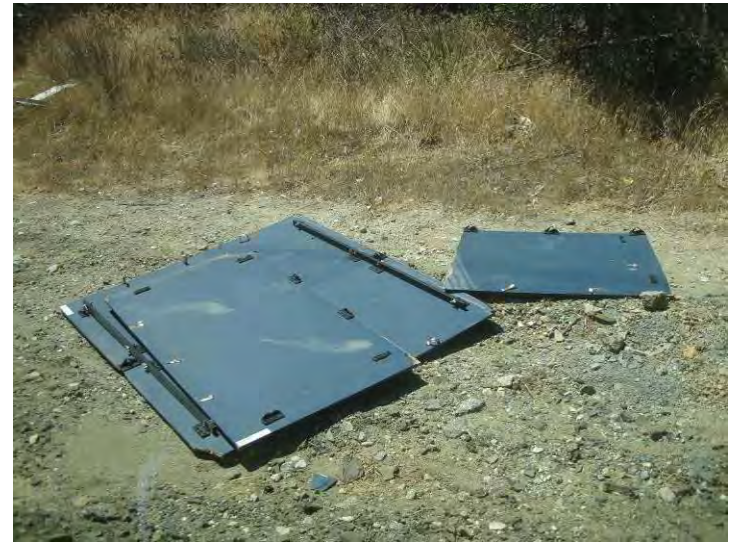
Photo 227: Sierra Highway near I-14: August 27, 2014

Current Status/Comments – On August 27, 2014, illegal dumping of a cabinet was observed on Sierra Highway north of the I-14 overpass. The area had no wind-blown litter. On September 23, 2014, the illegally dumped cabinet that was observed on the prior site monitoring visit was still on the side of the road.
