May 25, 2017

**Subject:** Historical Resources CEQA Impacts Report for 4529 Sherman Oaks Avenue, Los Angeles, California

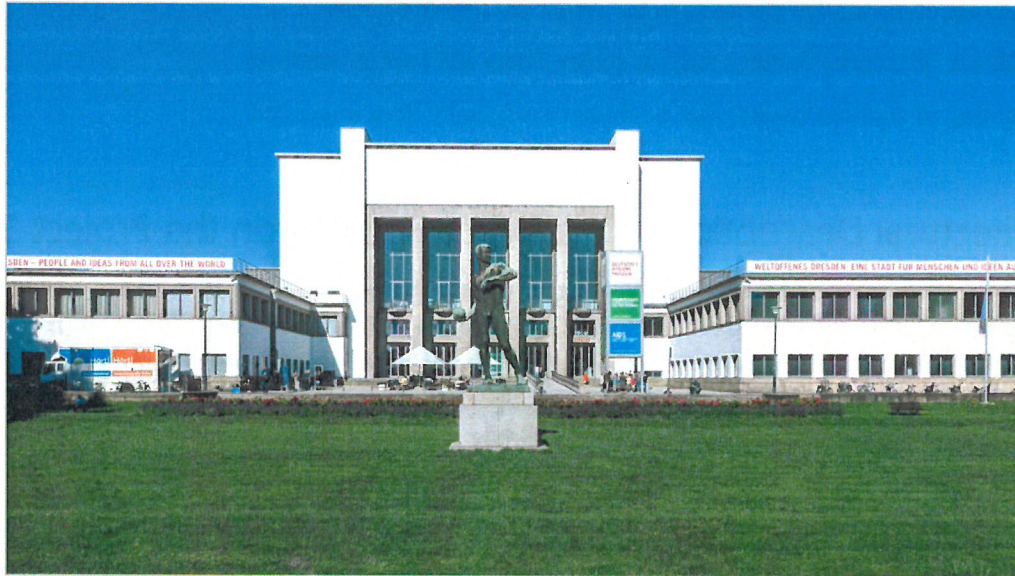
**Figure 1**  
Deutsches Hygiene Museum, Dresden, Wilhelm Kreis, 1930

Finally, the Subject Property appears to make a direct design reference to the 1930 German Hygiene Museum by Wilhelm Kreis (**Figure 1**), an early icon of both Modernism and hygienic architecture. Like the stripped

classicism of the Museum, the Office Building combines one-and two-story wings, smooth wall surfaces, projecting fins, and a window wall defined by vertical bays framed within the larger structure.

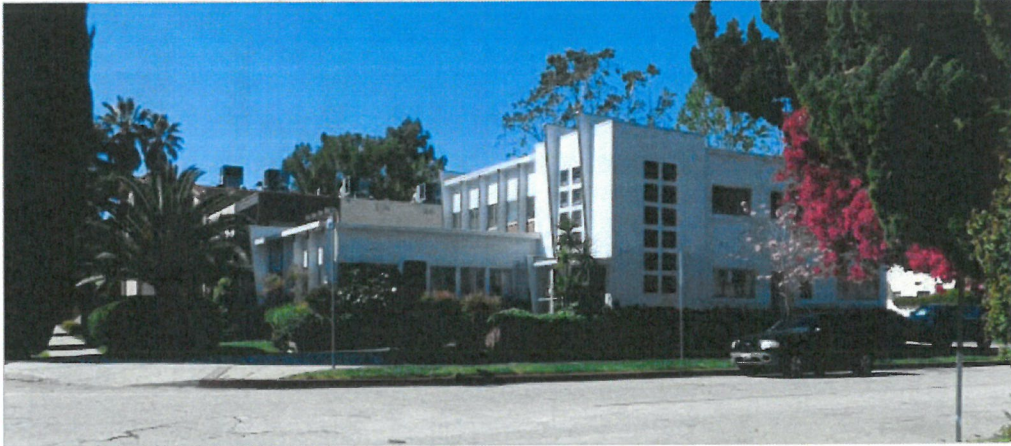
**Figure 2**  
Primary (east) and secondary (north) elevations, view southwest

The subject Office Building employs a three-part massing, comprising (**Figure 2**) a projecting single story office pavilion at the front of the site, a two-story office building at the rear of the site, and a two-story stair-tower with an attached one-story glass vestibule. Each of these one- and two-story components has a flat roof. The exterior envelope is faced with popcorn stucco (alteration to texture) painted white; the narrow profile edge of the angled south end wall and decorative fins on the east elevation are painted black; the square louvered vents on the east and north elevations are painted black; red Roman-brick planters are integrated along the base of the east and north elevations including along the entry path.

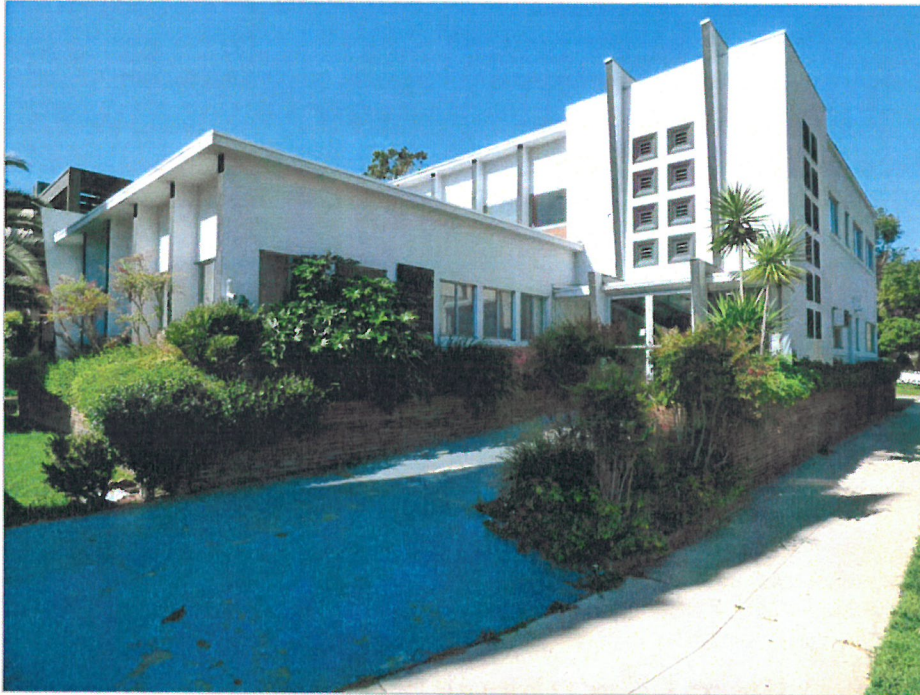
**Figure 3**  
Primary (east) elevation and main pedestrian entry, view southwest

The primary (east) facade (**Figures 3, 4, and 5**) is notable for its orthogonal character, especially the use of vertical fins, deep overhangs, and painted vents as decorative and organizing elements. The south end wall of the building, at both the one- and two-story sections, is angled forward to project beyond the plane of the front wall and above the level of the roof. This end wall intersects with overhangs that frame bays of office windows on the south side of the façade at the first and second floor levels. Within this frame, five straight vertical fins define orthogonal bays at the first and at the set-back second floors. Each bay is proportioned to hold a single three-part metal casement window with a fixed center pane and two operable side panes. There is a stucco panel above each window with decorative tile wainscot below. On the first floor, the center of the five bays is blank stucco – it appears that a window may have been removed (alteration) – which now contains a wood plaque with the building address. The first floor bays are seated above a low Roman-brick planter that runs the full width of the wing. On the second floor, the two-bays adjacent to the stair tower have had their metal casement windows replaced with fixed wood-frame single-pane units (alteration).

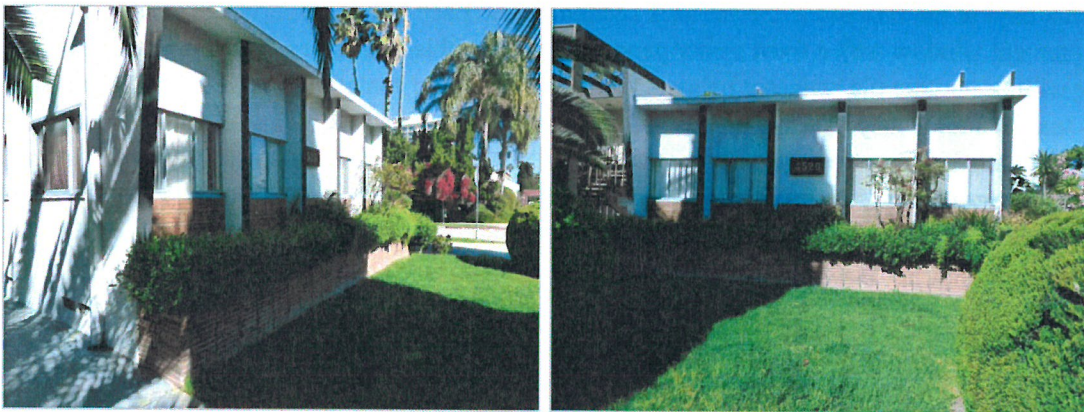
**Figure 4**  
East elevation of one-story wing, view northwest (left) and view west (right)

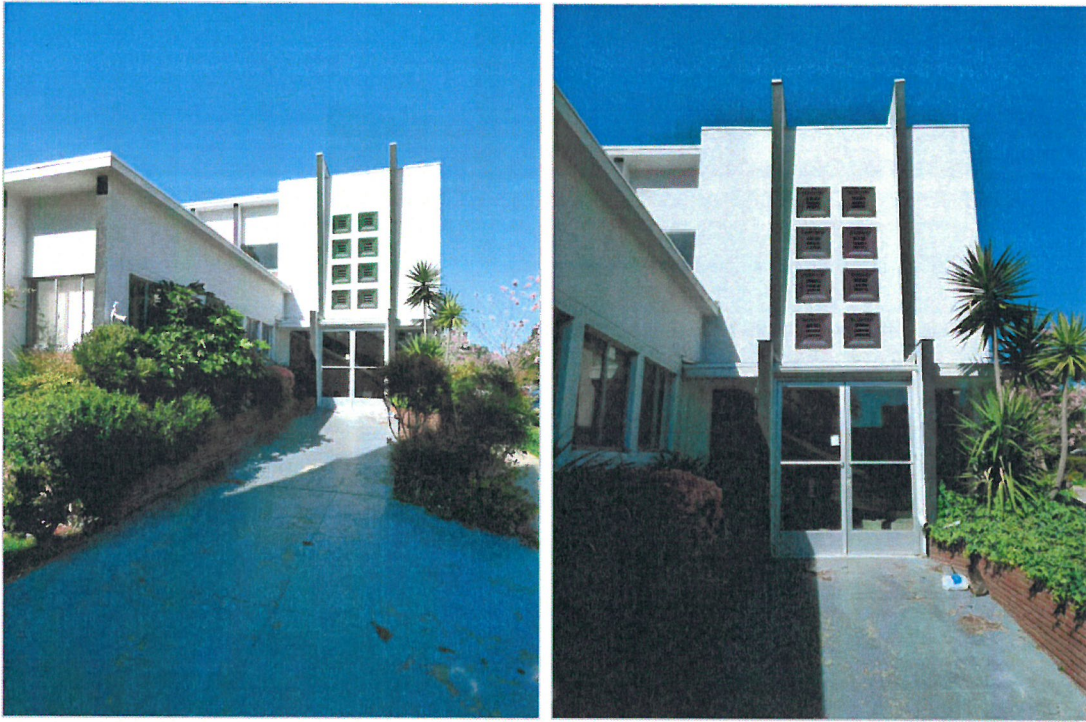
**Figure 6**  
Detail, east elevation, showing entry pavilion, stair tower, and walkway, view west

The building is accessed by two paved walkways – a primary approach from the sidewalk and street at the northeast corner and a service approach from the sidewalk along the south side of the parcel. Both are constructed of incised concrete that has been painted in layers of green, red, and then grey (alteration) over time. The primary walkway is flanked by low Roman-brick planters. The planter to the north along the public sidewalk continues along the base of the north elevation. That planter terminates, at its east end, into a shallow planting bed (**Figure 7**).

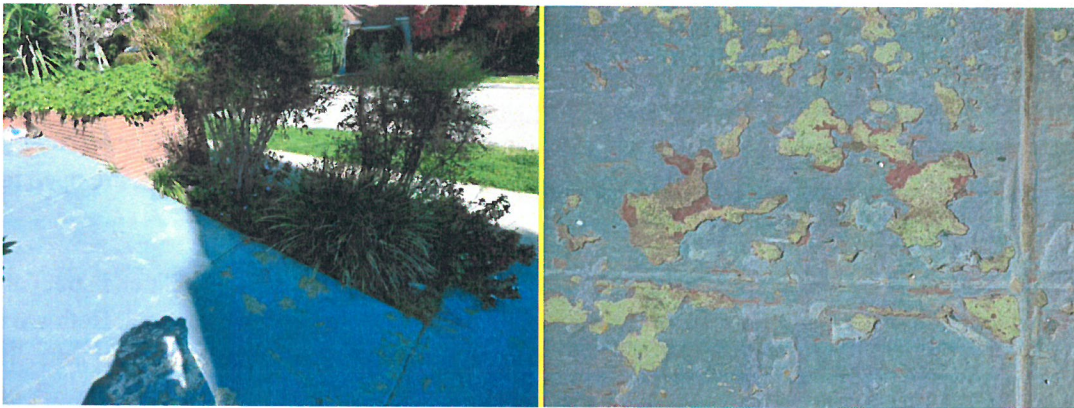
**Figure 7**  
Detail, colored incised paving at walkway entries to building, east side

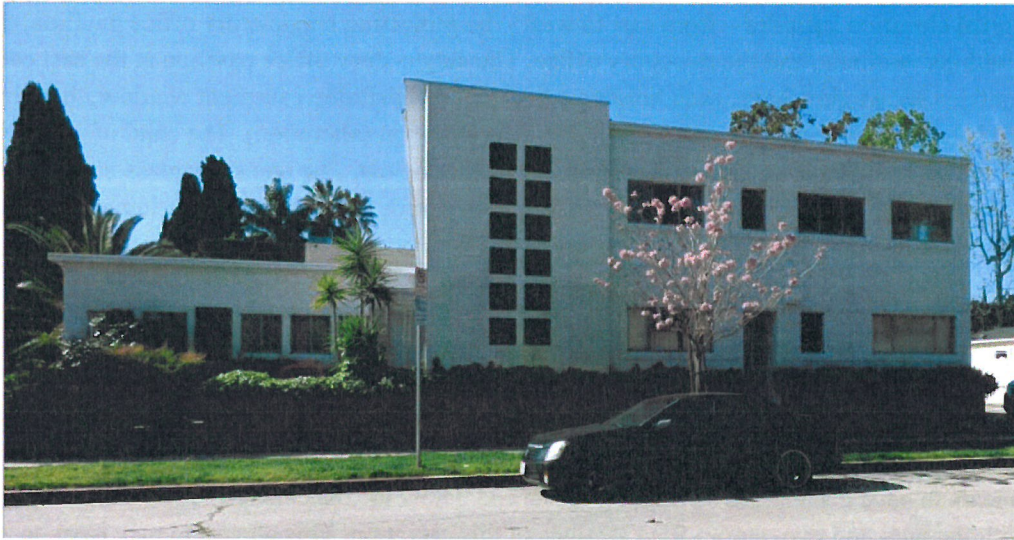
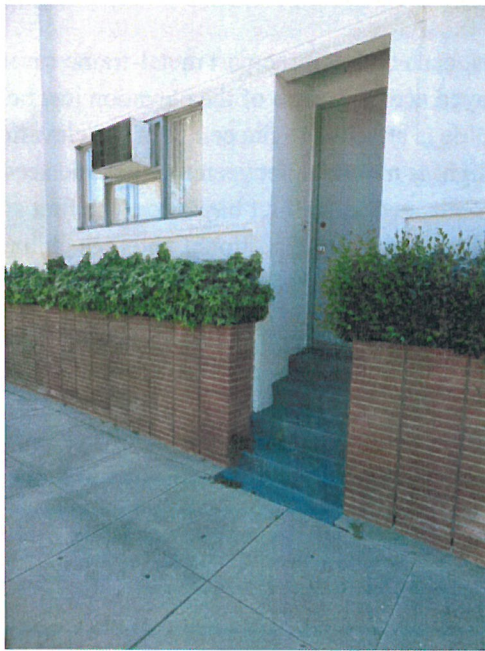
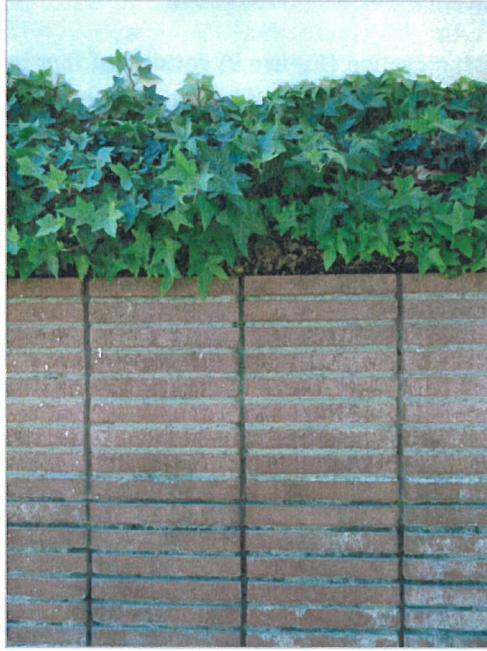
**Figure 8**  
North elevation, view south (top) and detail of side entry door, metal-frame window, integrated Roman-brick planters (bottom)

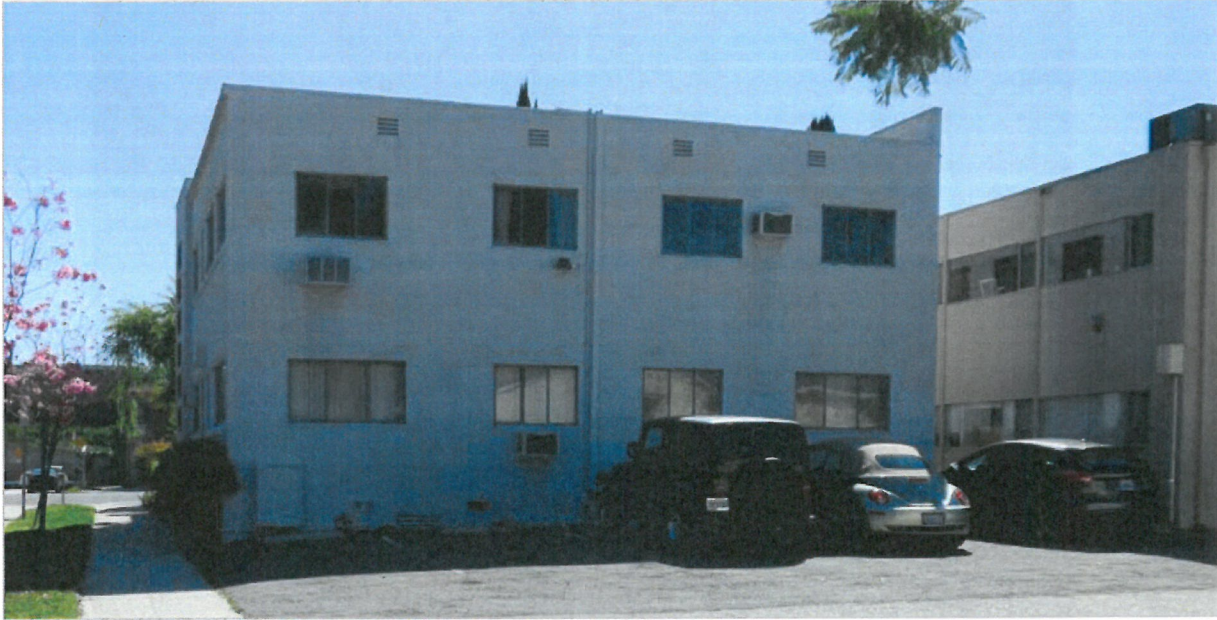
**Figure 9**  
Rear (west) elevation, view east

The rear (west) elevation (**Figure 9**) consists of four bays, each with a three-part metal-frame casement window at the first and second floor. Inset louvered vents are arrayed across the top of the elevation just below the cornice line and at the bottom just above the pavement; a stand-pipe is attached to the center of the elevation and runs vertically from the ground to the roof. A single security light is mounted between the first and second floors in the second bay from the north and a small utility cupboard is attached in the first bay below the first story window at the north edge of the wall. From north to south, three wall-mounted air conditioner units punch into the wall at the first, second, and between the third and fourth bays.

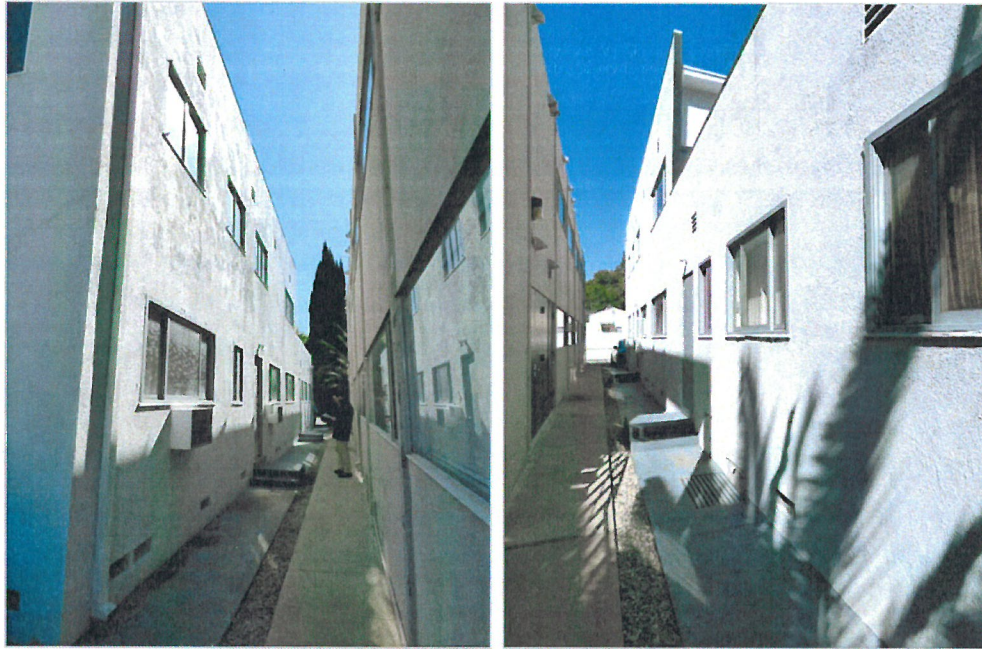
**Figure 10**  
Secondary (south) elevation, view east from back to front (left) and  
view west from front to back (right)

The side (south) elevation (**Figure 10**) comprises a single long wall that steps down, from west to east, from two stories to one. It is unadorned but for the projecting angled profile at the end of the second and first story walls. The elevation is populated with one-, two- and three-part windows – metal-frame casements at the second floor and wood frame sliding windows along the first floor with proportions similar to the metal-frame casements (replacement). As on the rear elevation, inset louvered vents are arrayed below the cornice at the second floor and screened vents are arrayed at the base just above a paved service walkway. Two metal service doors are accessed via simple two-stair concrete platforms at the center of the two story section of the elevation and at the transition between two- and one-story sections of the building. The service walkways between the subject property and the neighboring building to the south are separated by a gravel-filled channel.

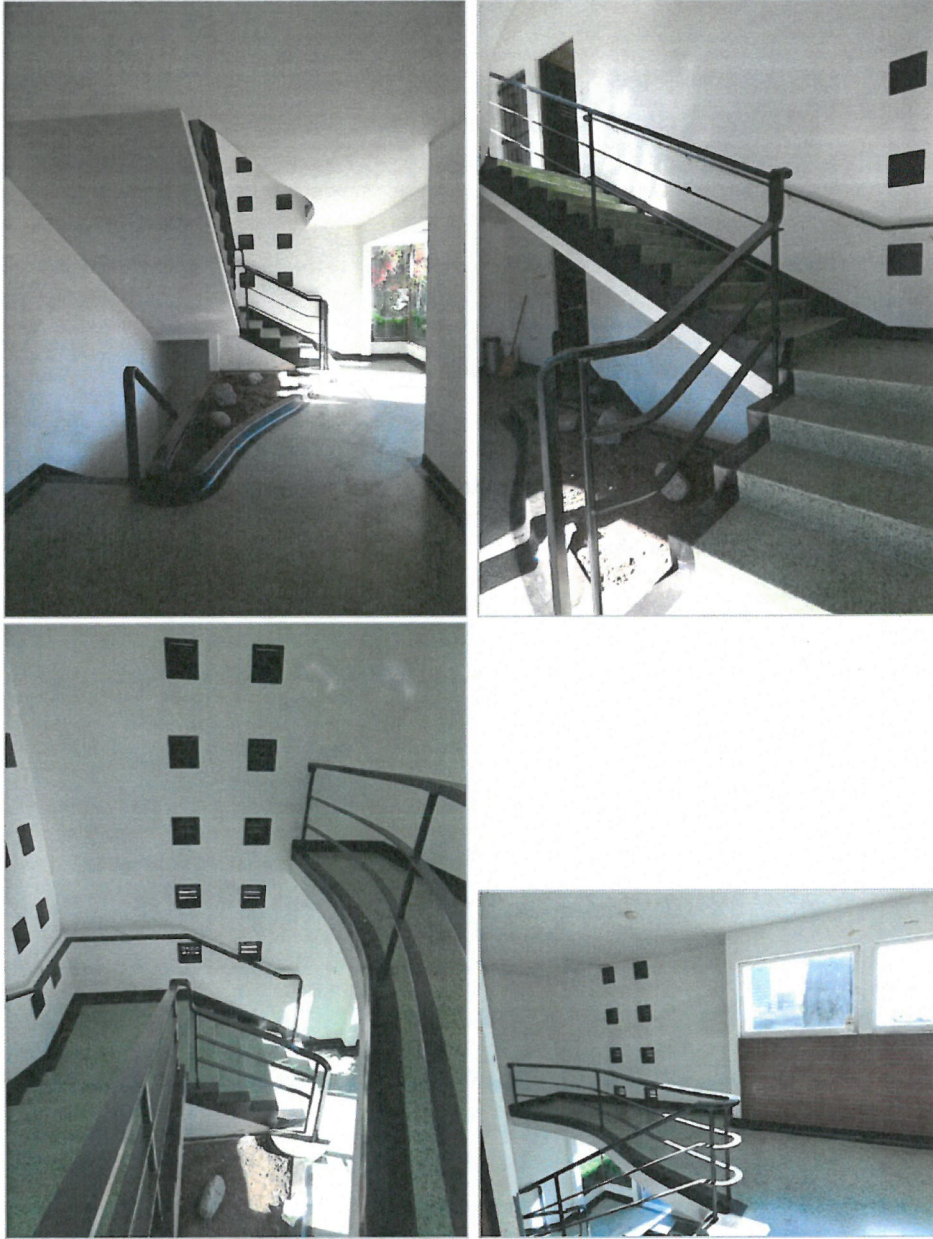
**Figure 11**  
Entry lobby first floor (top); entry lobby second floor (bottom)

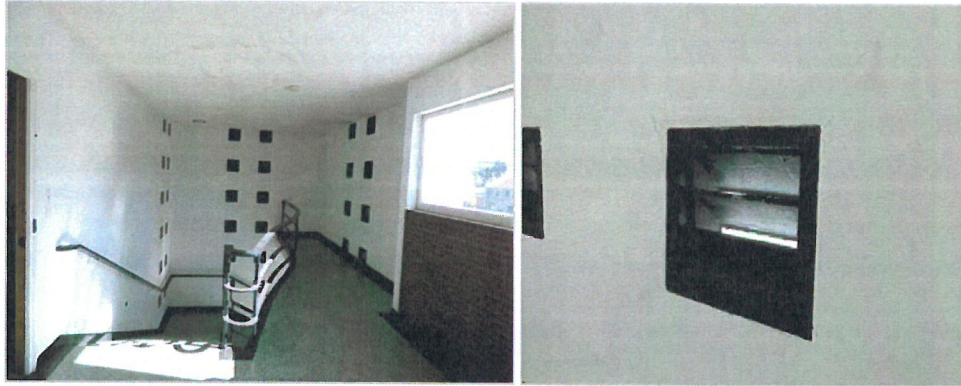
**Figure 12**  
Detail, entry lobby second floor, showing the square louvers and the painted square accents in the stair tower (left); typical louver open to the outside (right)

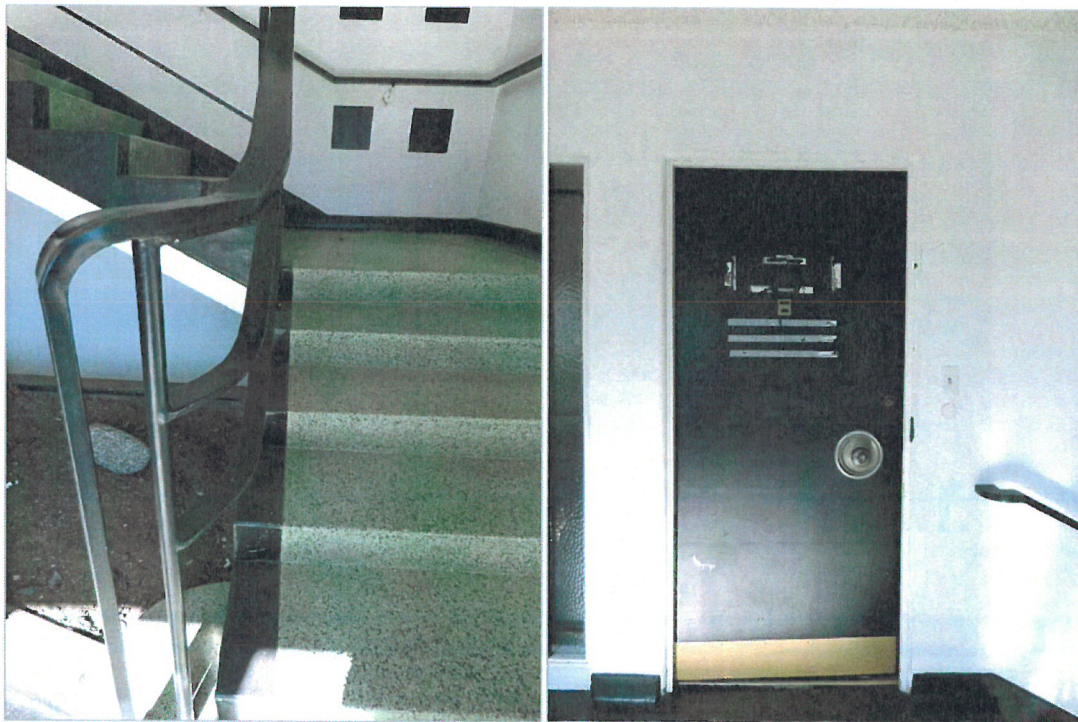
**Figure 13**  
Detail, entry lobby first floor, showing terrazzo flooring and curved handrail (left); typical slab door entry to office suites with oversize round hardware (right)

The first and second levels and stair of the lobby space (**Figure 13**) are paved with green terrazzo floors flecked with white and black chips. The edges of the floor are painted black (alteration) and intersect with black coving where the floor meets each wall. Each floor has two individual doors that open to private practice suites. These slab doors feature oversized round hardware.

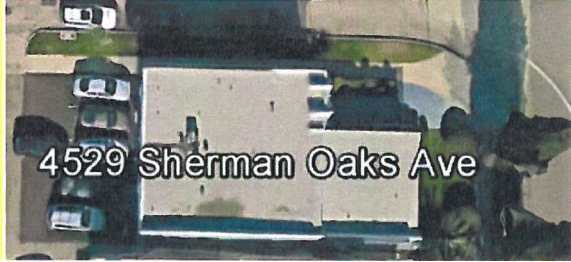
Type/Area	Feature	Photograph	Character Defining Feature (Primary or Contributing)
1. Overall Footprint	L- Shaped footprint

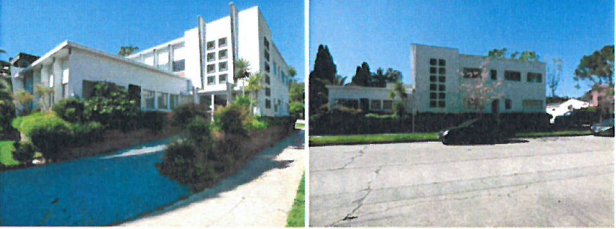
Primary
2. Overall Massing	<p>Three-part massing:</p> <ul style="list-style-type: none"> <li>• One-story front projecting office pavilion</li> <li>• Two-story stair tower with one-story entry vestibule</li> <li>• Two story main building (including two-story front elevation approximately one structural bay deep and two-story body of building approximately four bays deep)</li> </ul>

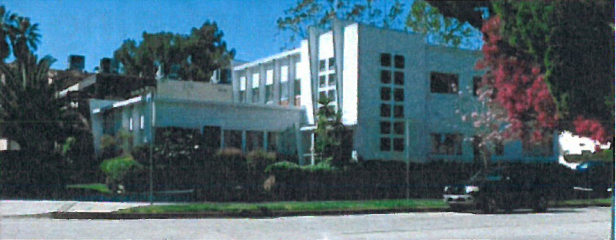
3. Roof	<p>Flat composition roof on one and two-story components, stair tower and entry vestibule</p> <ul style="list-style-type: none"> <li>• Deep boxed roof overhangs on front elevation of one-story office pavilion and on front elevation at second floor front of two-story office building</li> <li>• Flat roof finished with coping at all edges</li> </ul>

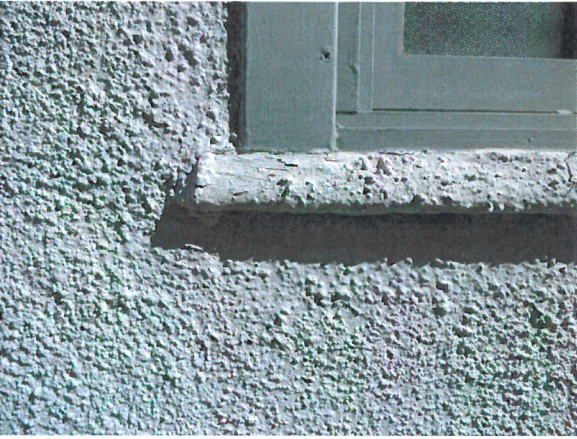
4. Finish	Stucco finish (current stucco finish is altered changing the original wall texture and covering wood sills. Research is needed to determine original stucco texture. Stucco on wood should be removed and returned to a painted finish.)

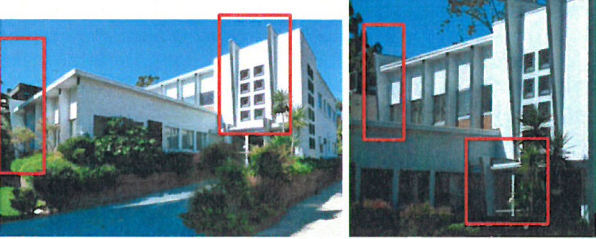
5. East Elevation (Sherman Oaks Avenue): Primary	<p>Angled fins:</p> <ul style="list-style-type: none"> <li>• Wood frame and stucco fins, edges painted contrasting black</li> <li>• South end wall at first-floor and at recessed second floor angled forward to create projecting fin shape</li> <li>• Two angled fins attached symmetrically to front second floor of stair tower</li> <li>• Two angled fins attached symmetrically to first floor entry vestibule</li> <li>• Tops of angled fins return and extend narrow profile above roof height</li> </ul>

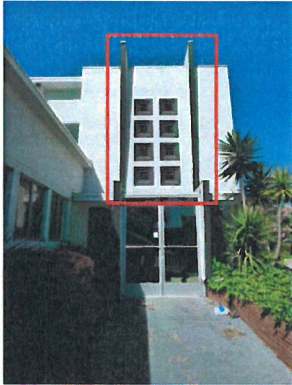
Type/Area	Feature	Photograph	Character Defining Feature (Primary or Contributing)
<p>11. East Elevation (Sherman Oaks Avenue): Primary</p>	<p>Two story stair tower with one-story entry vestibule</p> <ul style="list-style-type: none"> <li>• Eight paired (2 x 4) square louvered vents on stair tower second floor</li> </ul>

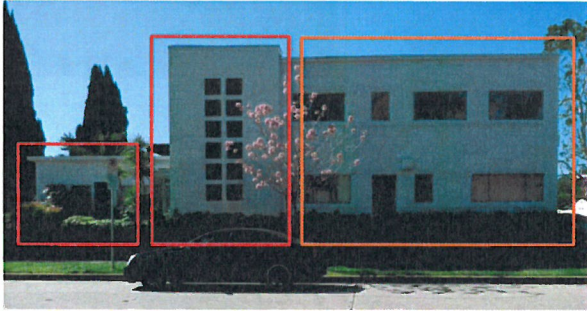
<p>Primary</p>
<p>12. North Elevation (Dickens Street)</p>	<p>Three-part massing:</p> <ul style="list-style-type: none"> <li>• One-story front projecting office pavilion</li> <li>• Two-story stair tower with one-story entry vestibule</li> <li>• Two story main building (including two-story front elevation approximately one structural bay deep and two-story body of building approximately four bays deep)</li> </ul>

<p>Primary (red):</p> <ul style="list-style-type: none"> <li>• One-story front</li> <li>• Two-story tower</li> </ul> <p>Contributing (orange):</p> <ul style="list-style-type: none"> <li>• Two story main</li> </ul>

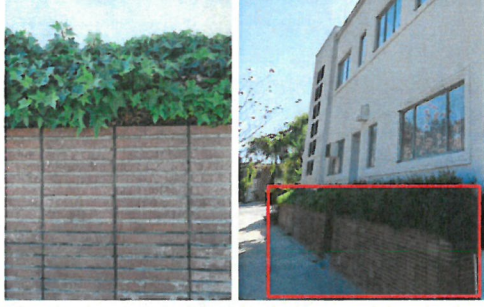
Type/Area	Feature	Photograph	Character Defining Feature (Primary or Contributing)
15. North Elevation (Dickens Street)	Integrated Roman-brick planters at base of wall

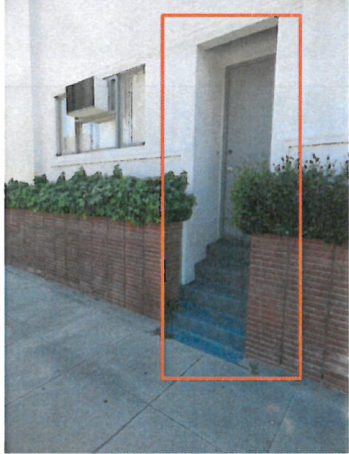
Primary
16. North Elevation (Dickens Street)	Centered entry opening and stair

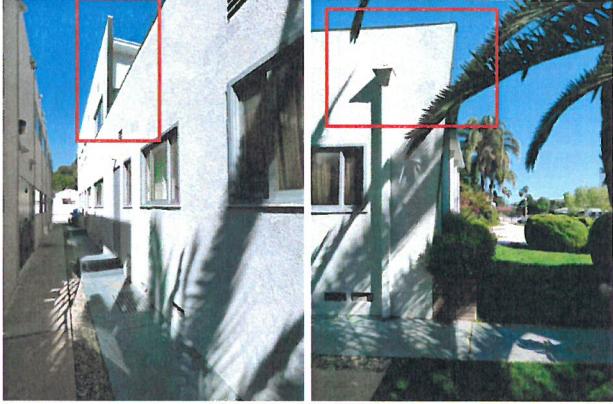
Type/Area	Feature	Photograph	Character Defining Feature (Primary or Contributing)
18. South Elevation	Angled fin profile at end wall first and second floors

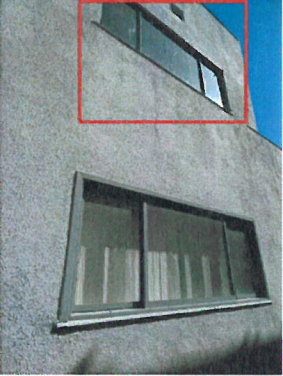
Primary
19. South Elevation	Three-part casement windows set in regular pattern (Alteration: wood windows on first floor are not original)

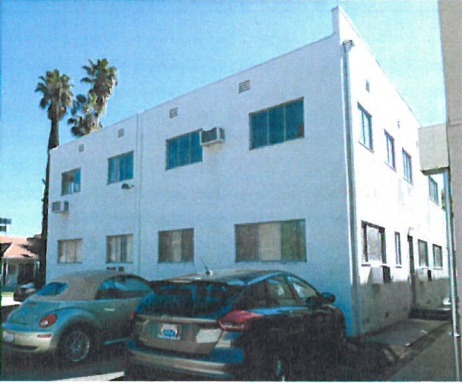
Contributing
21. West Elevation	Symmetrical arrangement upper and lower windows

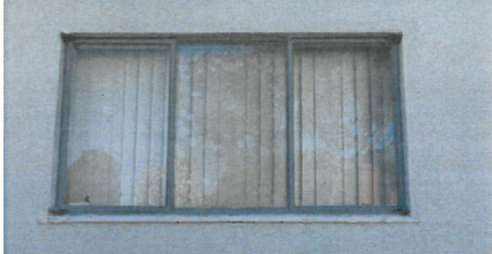
Type/Area	Feature	Photograph	Character Defining Feature (Primary or Contributing)
22. West Elevation	Three-part metal-frame casement windows

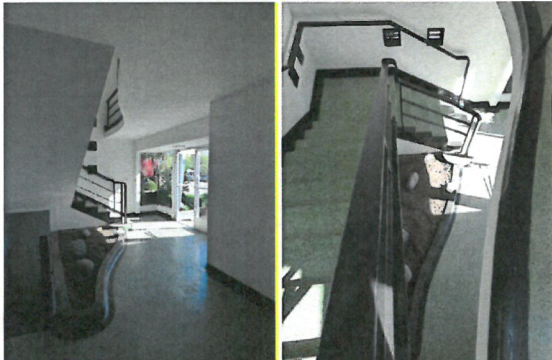
Contributing
23. Interior	Double-height entry lobby with mezzanine

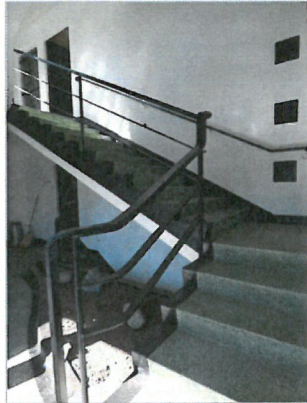
Primary
24. Interior	Floating stair with flat curved handrails

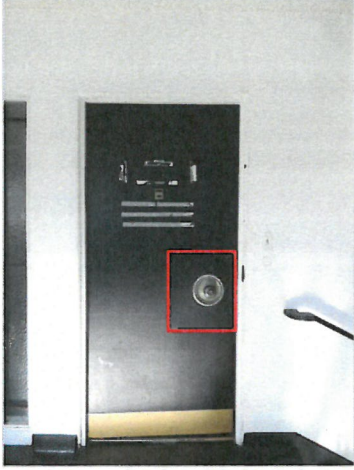
Type/Area	Feature	Photograph	Character Defining Feature (Primary or Contributing)
30. Interior	Slab doors with oversize round hardware

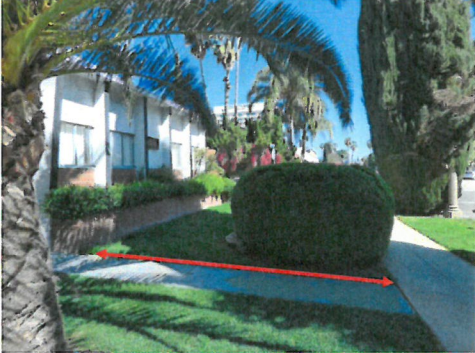
Contributing
31. Landscape Features and Hardscape	Deep landscaped setback from sidewalk and residential parkway

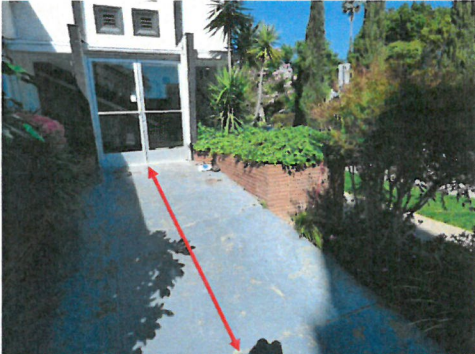
Primary
32. Landscape Features and Hardscape	Offset landscaped entry path at northwest corner

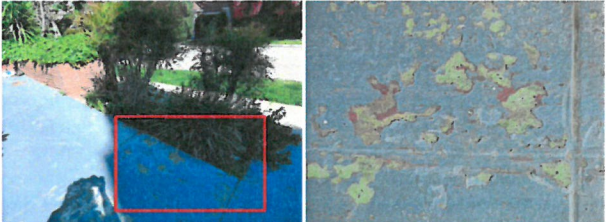
Primary
33. Landscape Features and Hardscape	Painted color on concrete primary entry path and south service path
