BOLLMAN HOUSE Historic Structure Report

**1530 North Ogden Drive
Los Angeles, California**

Final Report

August 25, 2015
WJE No. 2015.1764

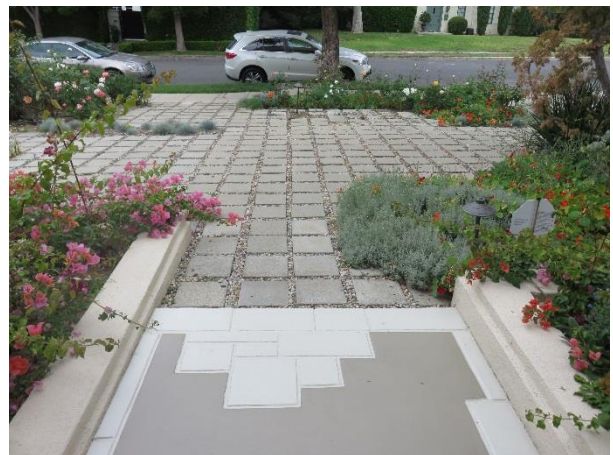
At an earlier date the front yard had flagstone pavers leading from the entry to the driveway, and mown turf throughout. A demolition plan from March 29, 2004, indicates that a portion of the flagstone entry was removed and replaced with a concrete entry; the drawings noted the flagstone was not original. These March 2004 drawings were produced by MacMar, Inc., Architects and Engineers for Mimi London, who was the owner at the time. The 2004 as-built plan indicates that the concrete pavers were already in place in 2004

FIGURE 5. View of the front yard pavers from the main entrance.

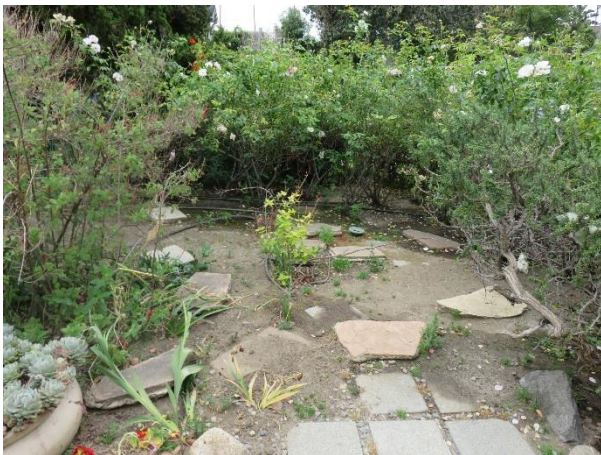
FIGURE 7. Flagstone pavers at the south side of the front yard.

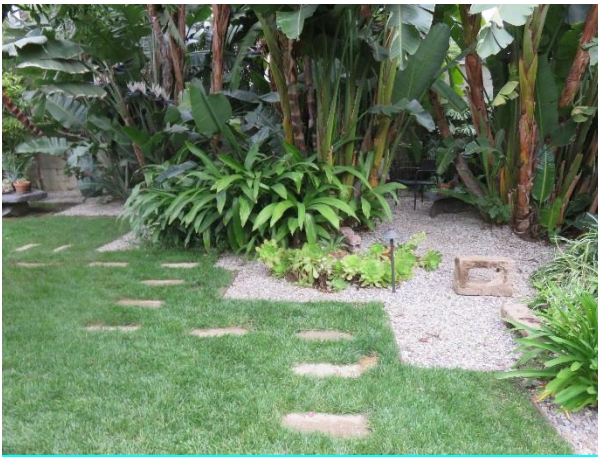
The backyard has 18 inch by 8 inch concrete pavers that are reported to be original concrete block that was salvaged from the building. These blocks are used as pavers that lead east from the patio outside the living room through the mown turf and connect to pavers leading from the back door near the kitchen (Figure 11).

FIGURE 11. The southeast corner of the backyard, where the concrete pavers turn towards the north.

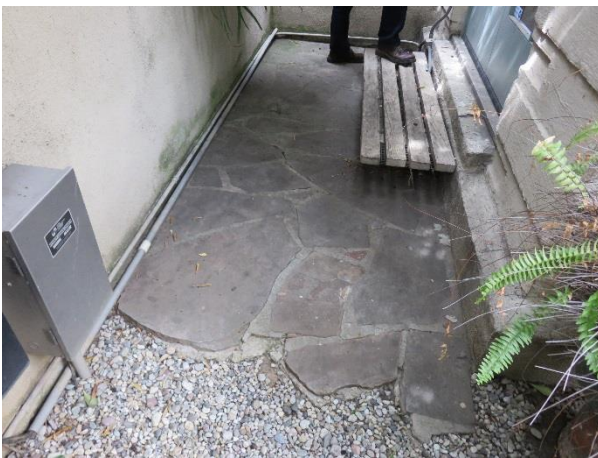
A portion of the southwest corner of the backyard still has flagstone leading from the south door of the living room across to the site wall separating the front and back yards (Figure 12). The flagstone

FIGURE 12. Southwest corner of the backyard with flagstone paving.

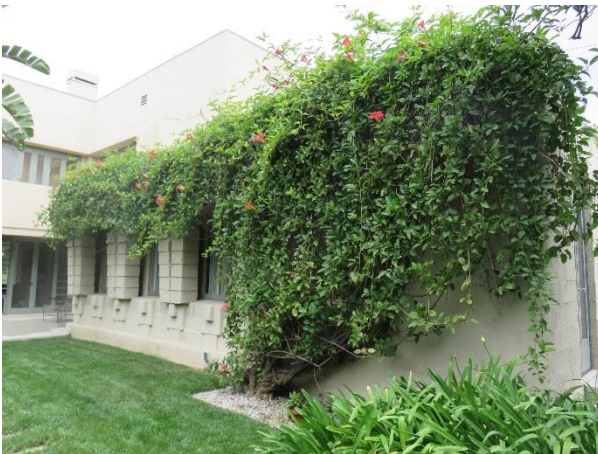
FIGURE 13. Madame Galen trumpet vine extending along the south facade.

There is a large flowering Madame Galen trumpet vine extending along the south facade, which extends across the roof and down the top side of the concrete block walls (Figure 13).

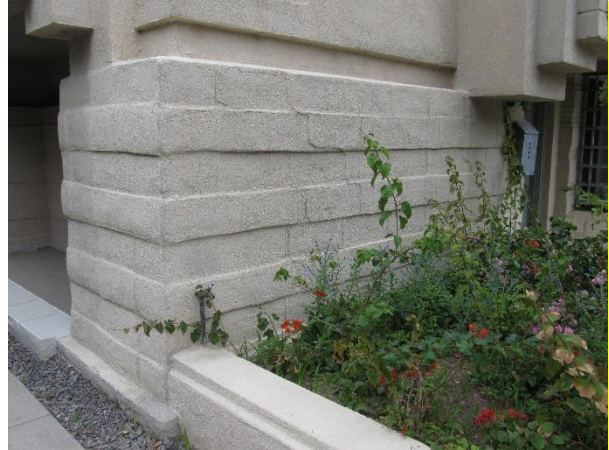
Concrete Block. The concrete blocks that comprise the first floor, single-wythe wall system at the main portion of the residence are typically 17 inches wide by 8 inches tall and 12 inches thick (Figure 19). At the south exterior wall surrounding the kitchen, the concrete block wall is constructed adjacent to the windows as columns with angled sides (Figure 25). Joints are typically 1/4 inch wide.

FIGURE 19. Concrete block wall construction at the south wall.

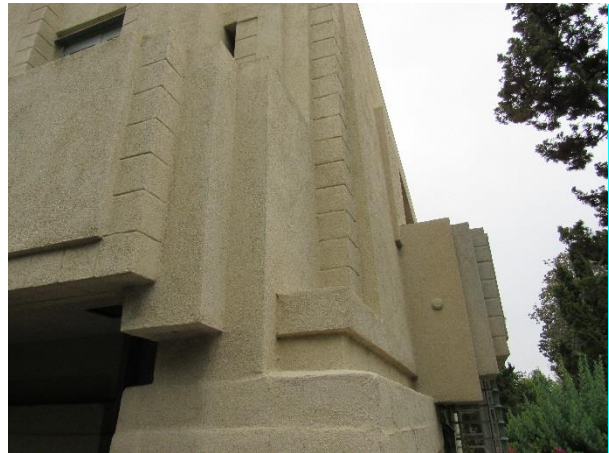
FIGURE 20. Concrete block wall construction at the balconies.

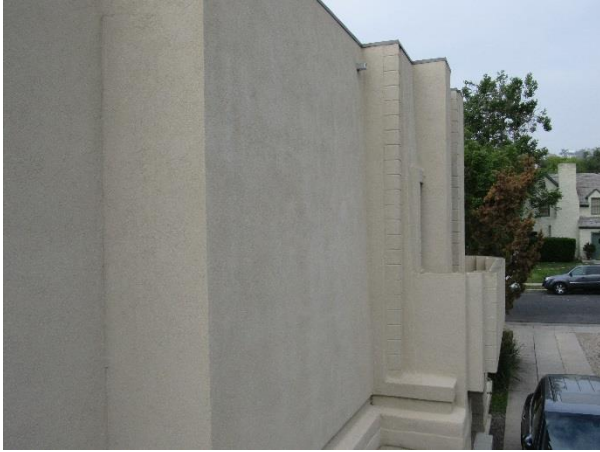
structure. The north and south upper walls are angled inward slightly (Figure 26).

FIGURE 26. Stucco clad exterior wall at north elevation. Note the slight inward slope of the wall.

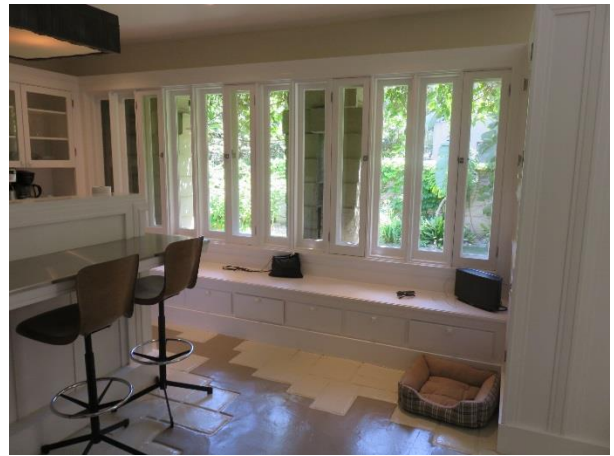
The replacement windows generally replicate the original sash and frame configurations. During the 2004 kitchen remodeling the windows at the south wall of the kitchen were replaced but the arrangement of window openings was only slightly modified. The window opening modified was at the existing sink, where the modification consisted of lowering the sill height to match that of the adjacent windows (the original sill height at the sink). The replacement windows were made to match typical existing windows (Figure 29 and Figure 30). The windows at the dish pantry were not replaced during the remodeling; however, the hardware has been replaced. During previous modifications prior to 2004, two windows were installed on the east wall at the area of the original garage. (The original drawings indicate that a single door existed on the back wall of the garage. The 2004 kitchen renovation drawings do not

FIGURE 29. Replacement casement windows at the south wall of the kitchen.

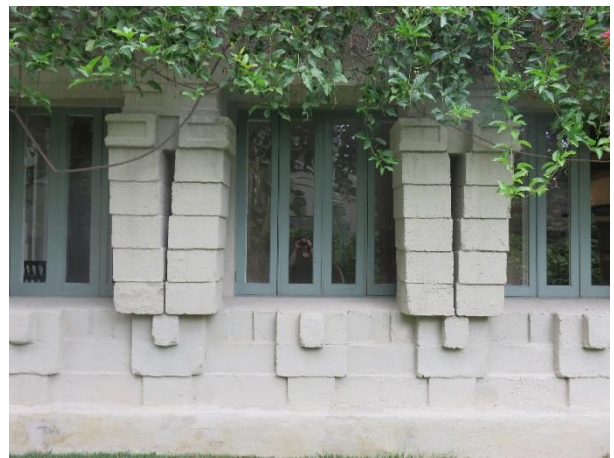
FIGURE 30. Exterior view of replacement casement windows at the kitchen.

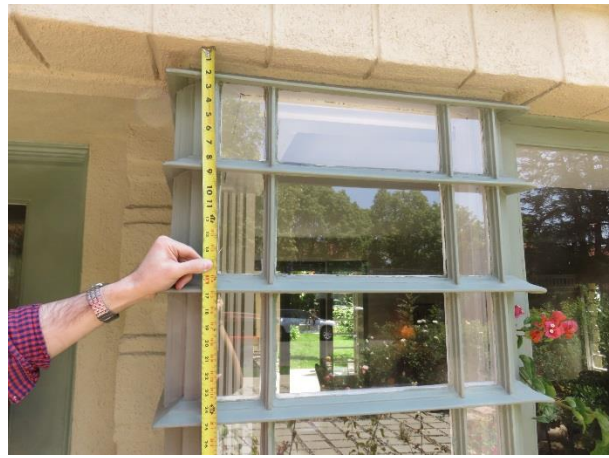
The window muntins are spaced 8 inches apart vertically, which aligns the muntins with the concrete block joints (Figure 35). The wood muntins are sloped at a downward angle, creating pointed corners with mitered joints (Figure 36).

FIGURE 35. Muntin spacing is 8 inches vertically, matching the concrete block joints.

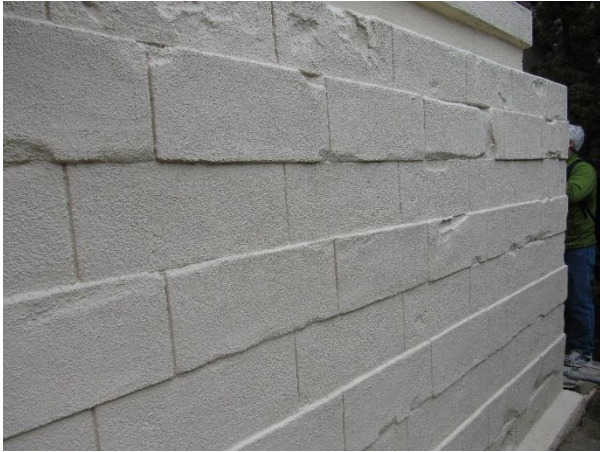
- The concrete blocks are typically sound with some surface deterioration.
- Surface scaling and spalling that has been covered with the coating was noted (Figure 58).
- Previous repairs to the concrete block include installation of a cementitious parge coat to the surface in some locations. This has obscured the original detailing and texture of the surface.
- Blistered and delaminated coating was noted at some locations of the concrete block (Figure 59).
- In some locations at the north and east elevations of the original garage, a thicker layer of cementitious parge coat has been installed; joints to replicate the existing concrete block joint pattern have been scored into the surfacing (Figure 60). At some locations this surfacing was noted to be delaminating from the concrete block substrate.

FIGURE 58. Spalls and surface scaling that has been covered with coating at the west elevation.

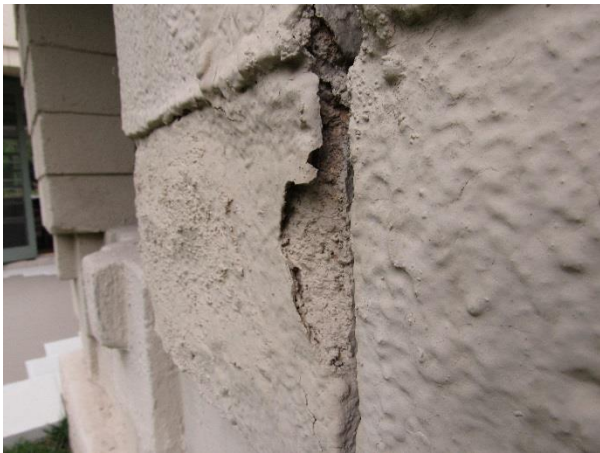
FIGURE 59. Example delaminated coating.

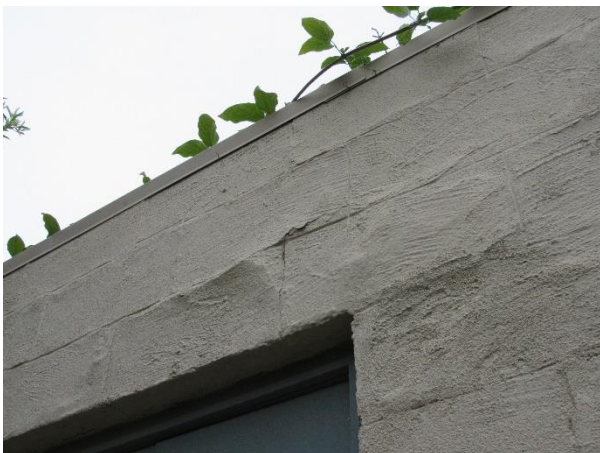
FIGURE 60. Cementitious parge coat surfacing at east elevation. Note delamination of surfacing and scoring of joint lines to match concrete block joints.

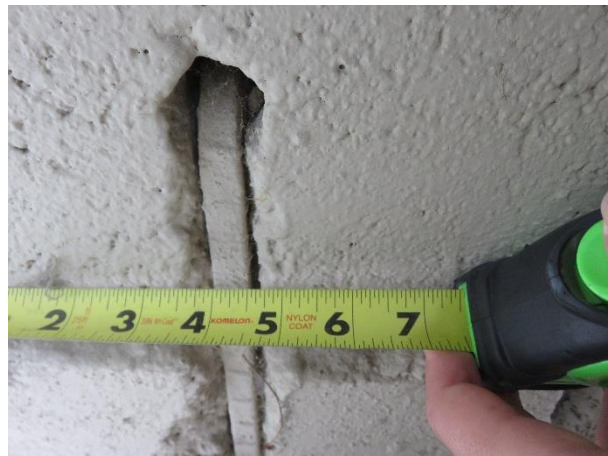
- Exposed reinforcing steel exists at the north elevation at the concrete block columns (Figure 61). Corrosion of the exposed reinforcement was not observed.

FIGURE 61. Exposed reinforcement in concrete block.

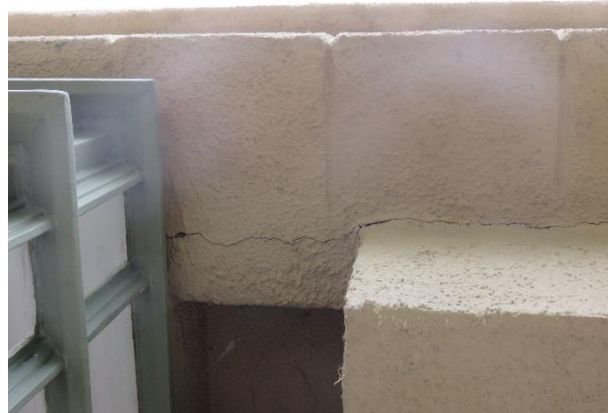
- The stucco generally appears to be in good condition, with some localized areas of cracking noted at changes of plane and at transitions to concrete block (Figure 62 and Figure 63).
- The coating was peeling in some localized areas, but appeared to be generally intact.

FIGURE 62. Cracking at a change of plane.

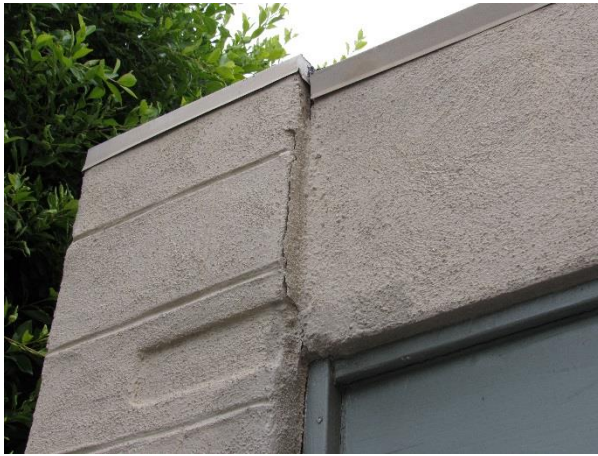
Figure 63. Cracking at a change of plane in the exterior wall.

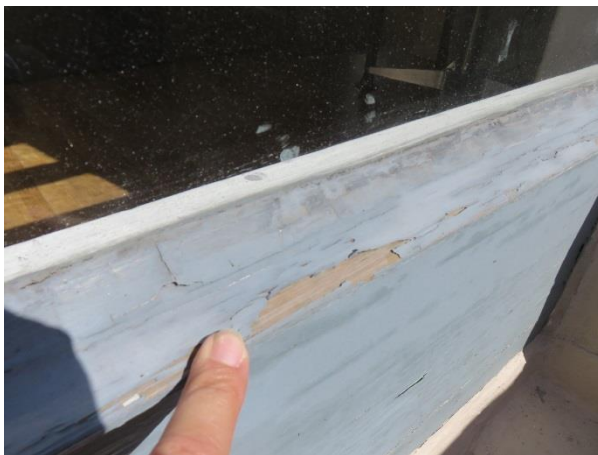
- Typically the windows and doors are in good condition.
- Areas of peeling/delaminated paint and some wood deterioration were observed, mostly on the second floor windows and doors (Figure 64 and Figure 65).
- Two lights were cracked on the second floor west door sidelights (Figure 66).
- Signs of water intrusion were noted on the sill at the hallway door on the second floor. It appears the door sill flashing has been replaced to correct this issue, but a gap is visible between the wood floorboards and stainless steel sill flashing (Figure 67).

FIGURE 64. Peeling paint on the west balcony doors.

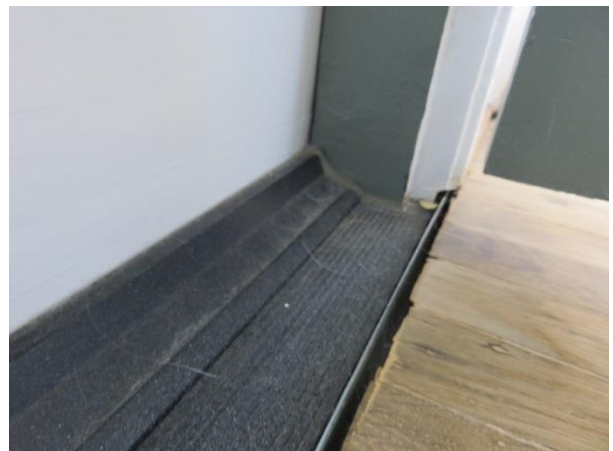
FIGURE 67. Gap between the floor boards and sill flashing on the east balcony doors.

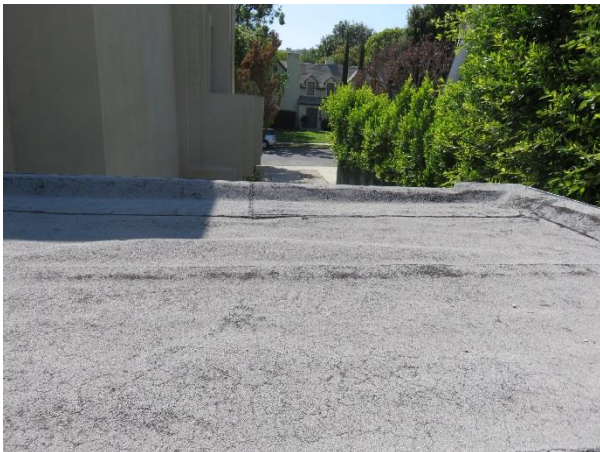
- The first floor roof had several blisters and areas of visible delamination (
- **FIGURE 68**).
- The flashing at the stucco to roof transition was deteriorated and bent, and the asphalt on the flashing is cracked and deteriorated. The drainage condition in this area is unknown (Figure 69).
- The membrane around the drain depression was cracked and deteriorated throughout (Figure 70).

FIGURE 68. Area where the roof membrane is blistered and not bonded to the substrate.

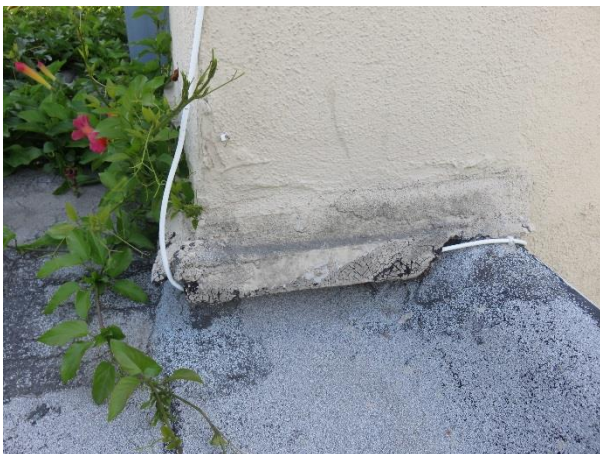
FIGURE 69. Deteriorated flashing at the roof to stucco-clad wall transition.

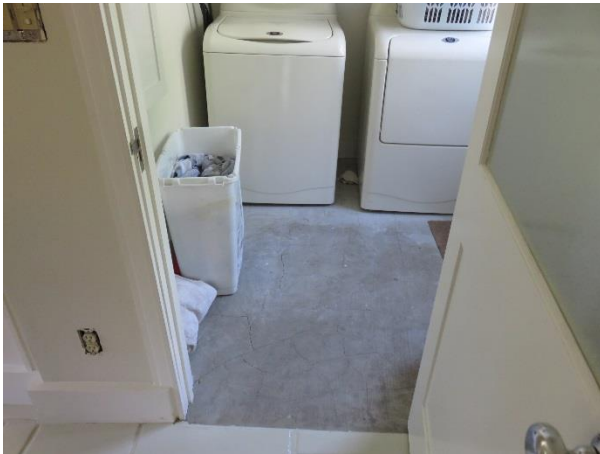
FIGURE 93. View of the laundry room floor transition from the kitchen finished concrete floor.

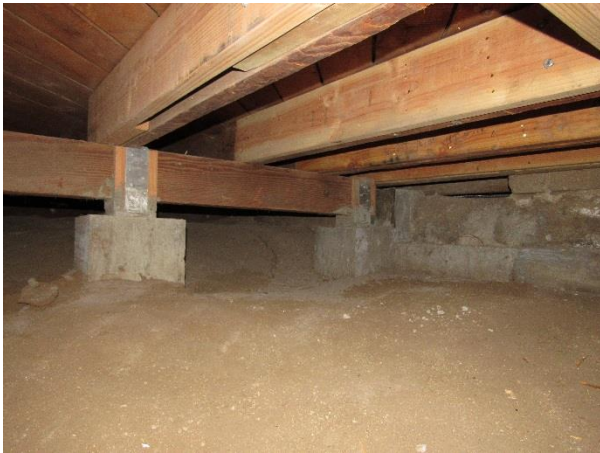
At the southeast crawlspace, located under the living room, strengthening of the wood floor was completed previously (Figure 106, Figure 107 and

Figure 108). Strengthening measures include the installation of a beam comprised of two 2x7s running in the north-south direction at mid-span of the original joists; joists are not directly connected to the beam. This beam is supported by four 12 inch square footings. In addition, at the thickened foundation, supplemental plates are bolted to the foundation. The joists are connected to the additional plates with supplemental anchors and connections. Some joists have been sistered (sistering is the reinforcement of joists by nailing, bolting, or attaching alongside the existing joist another joist or reinforcing member).

FIGURE 106. Typical wood framing at the southeast crawlspace. Note supplemental beam and strengthening of existing joists.

- The floor framing observed within the crawlspaces is in good condition with limited deterioration.
- The strengthening measures completed provide some upgrades in strength and seismic resistance; these upgrades appear to have been based on basic engineering design.
- The second floor has some downward slope to the south, indicating there may have been some prior settlement.
- The concrete slab-on-grade located at the main entrance (northwest corner of the residence) is experiencing some cracking and delamination or upwards bowing (Figure 109 and Figure 110). Some repairs to the slab have been completed including sawcutting at a crack location. The cause of the distress is unknown.

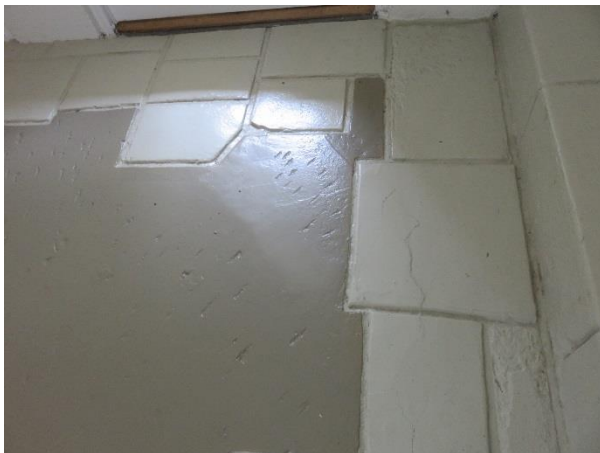
FIGURE 109. Cracks in the concrete entry slab.

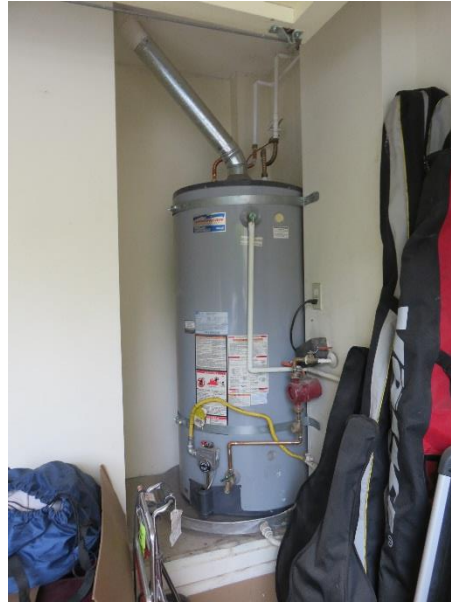
FIGURE 114. Water heater located in the garage.

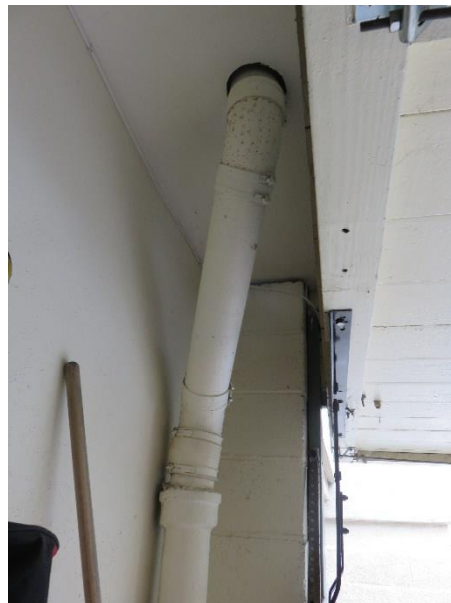
FIGURE 115. Cast iron roof drain pipe.

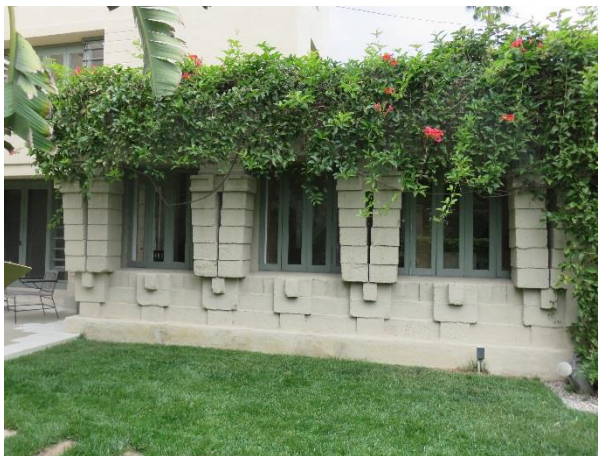
FIGURE 116. Madame Galen trumpet vine hanging along the south facade.

1. Retain the visual connection between the Bollman House and the surrounding landscape features.
2. Retain and maintain the historic patterns of spatial organization that includes the remaining hardscape paved areas that provide access to the house, driveway, and the surrounding gardens and terrace areas.
3. Consider separating planting features such as soil and lawn areas that are in contact with the building. As well, consider lifting and placing hanging vines on trellises or frames along wall areas of the Bollman House.

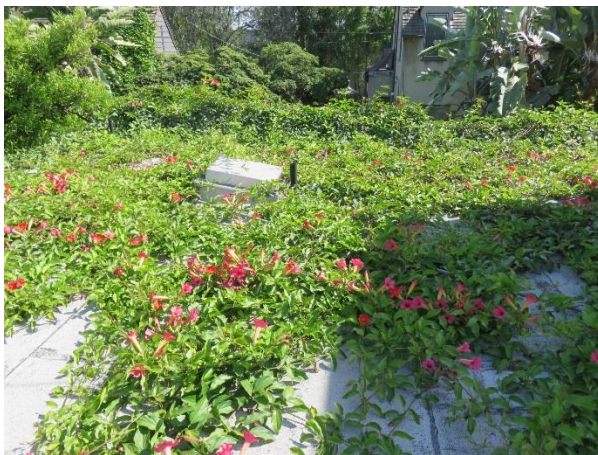
FIGURE 117. Trumpet vine creeping onto the roof setback area from the south facade.

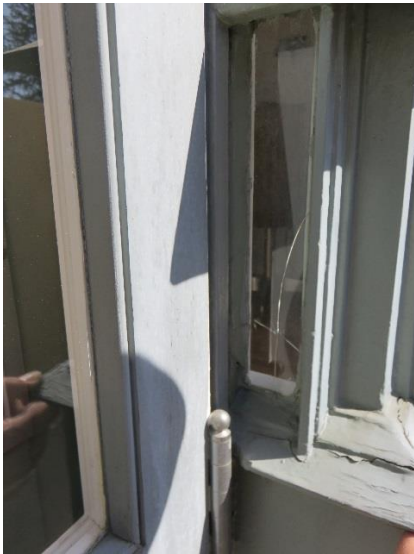
FIGURE 118. Cracked glass on the west balcony doors.

- Consideration should be given to localized areas of wood deterioration, including wood rot, peeling paint observed primarily at original second floor windows and doors.
- Cracked glass lights observed at isolated locations at the second floor should be repaired in-kind with single glazing to match the original remaining glass.

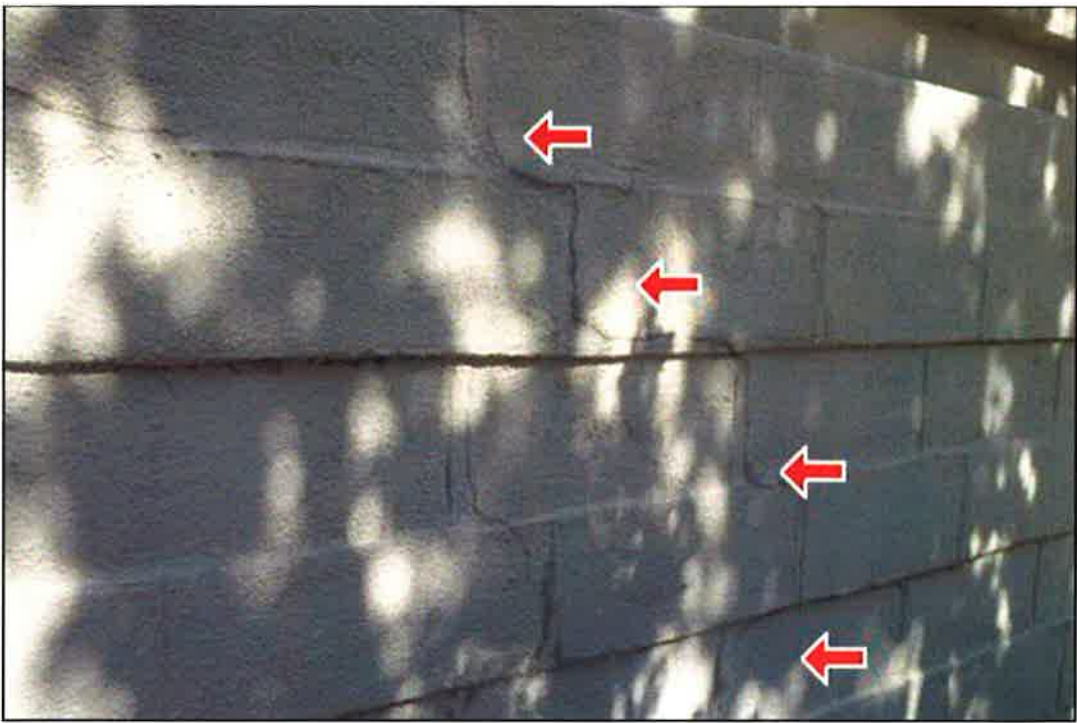
1.1 Picture 2

- Cracks and peeling paint noted at exterior walls. Have it checked by a qualified painting contractor
- Settlement type cracks found at front elevation block walls - have it checked by a qualified Geo - Tech and structural Engineer(Picture 2)

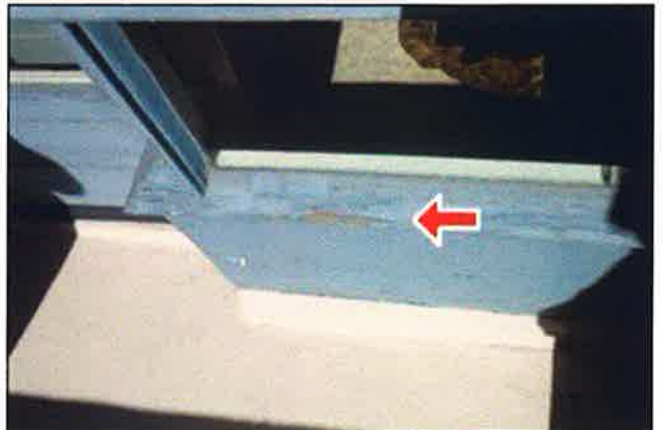
1.2 Picture 2

- Moisture stains, peeling paint noted at front elevation windows - have it checked by a qualified termite inspector and painting contractor.

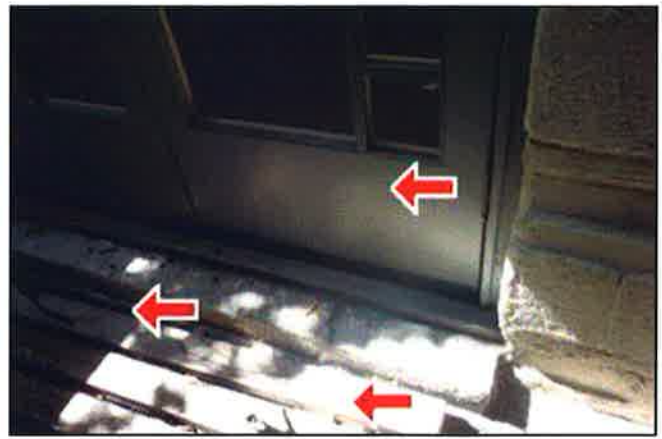
1.3 Picture 3

- Recommend to install awnings at exterior doors to prevent water seepage/ damage. (Picture 1). Some water stains noted at Lower Bathroom door - possible seepage from door. Have it checked. Recommend to install proper threshold at exterior doors to prevent water seepage(Picture 2)
- Exterior doors open over step - a trip hazard; door is hinged on the exterior with loose pin hinges(recommend to replace with pick proof type hinges) - a security concern.
- Missing proper landing at rear right side door noted(Picture 3)(Picture 4)

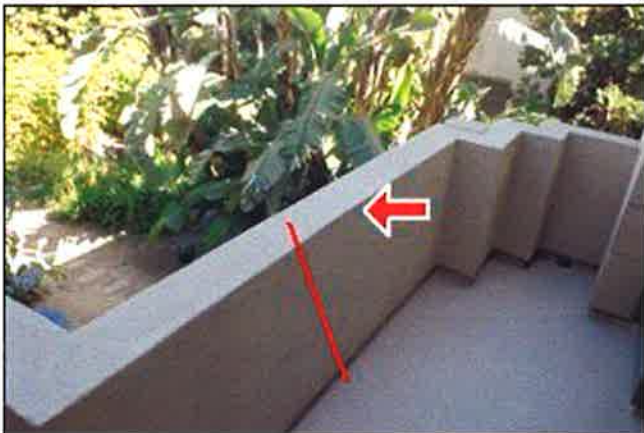
1.4 Picture 3

- Newer paint noted at the decks. Some soft spots noted at the time. Check the records/ warranties
- Railing at exterior is not to current safety standards - height is too low (this is a safety upgrade). (Picture 3)

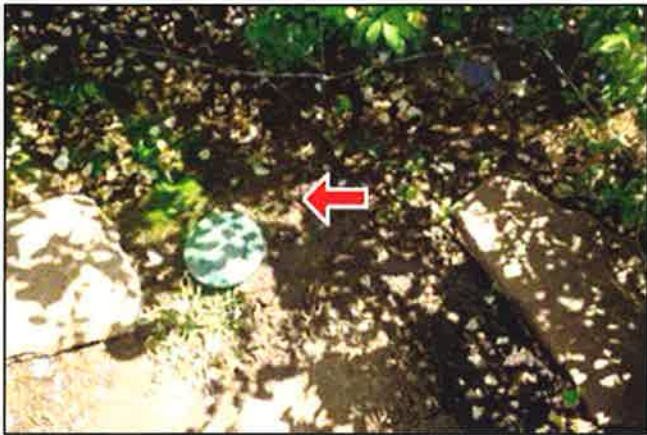
2.0 Picture 3

- Drain pipes and sump pump/ pit noted at front yard. Pump was functional at the time, terminates at front yard(Picture 3). Periodic acre/ maintenance required. Check the records
- Area drain noted at driveway area - terminates at street curb(Picture 4)(Picture 6, 7)(FYI).
- Plants touch structure, sprinklers set too close to the house/foundation. . Recommend to move sprinklers and vegetation minimum 2' away from house/foundation.

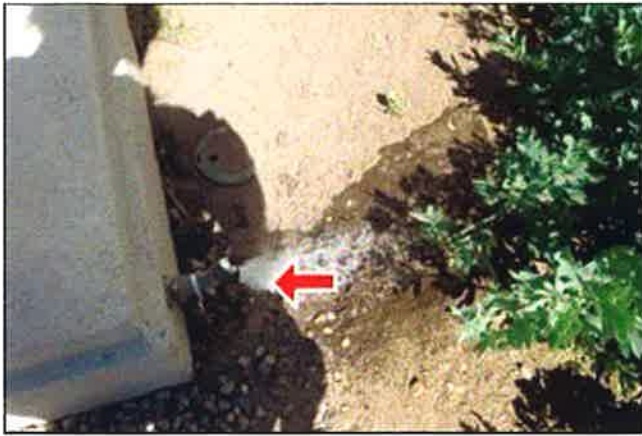
3.1 Picture 1

- Water main. *Most of the Main water piping is located underground - not visible to comment. Check the records for any known defects/repair.*
- Hose Bibs: missing anti-siphon valve at hose bibs (An anti-siphon (or, anti-siphon) valve is a device that prevents liquid from returning to the line from which it came if a siphon action occurs)(Picture 1). Recommend to install.
- Recommend to check the records/permits on copper main re-piping.

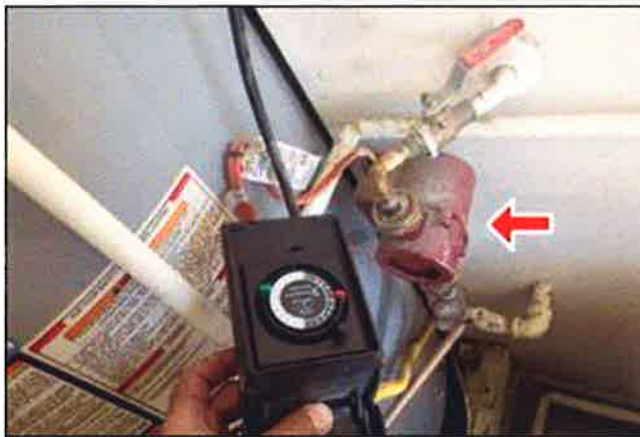
3.3 Picture 3

- Gas line at water heater without drip leg/sediment trap (this type installation is common for the area/age). Lack of drip leg may void warranties - check with your Home Warranty provider
- The adequacy or efficiency of the hot water heater cannot be determined in a limited time visual inspection. It is not known how hot the water will get or how long it will last (this is many times a matter of personal preference).
- Circulating pump noted on water heater. Pump was operational at the time(FYI).(Picture 3)

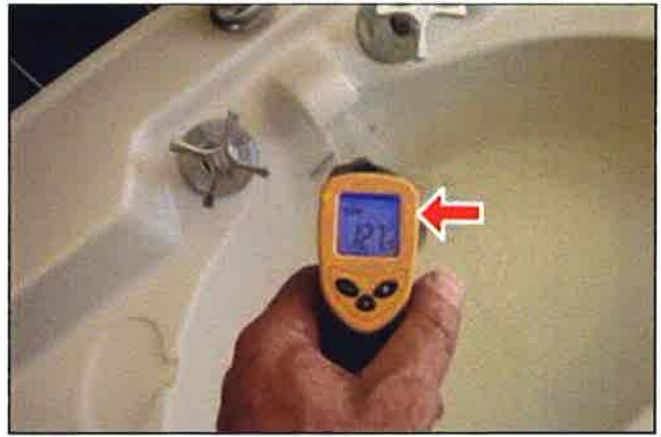
3.3 Picture 6

- Seismic straps are too loose.
- Missing combustion air vents on garage door - recommend to install
- Unit is near end of life due to age (existing is 9 years old type, life span of this type units are 10 to 12 years). Recommend to monitor/replace.
- Thermostat was set too high - keep water temperature below 120F(Picture 6)

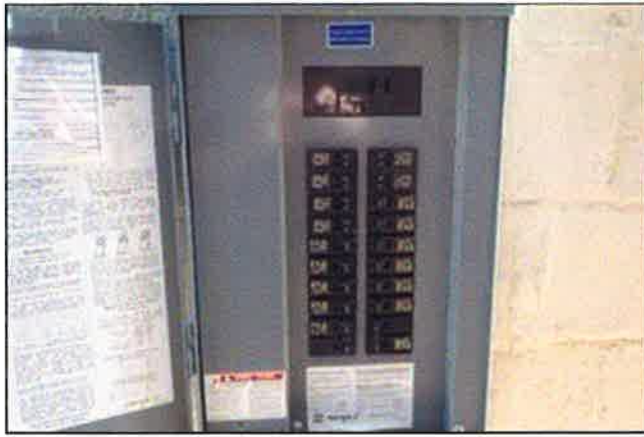
4.1 Picture 1

- Electrical Service panel.
- Newer installation or upgraded panel noted - recommend to check the records/permits.

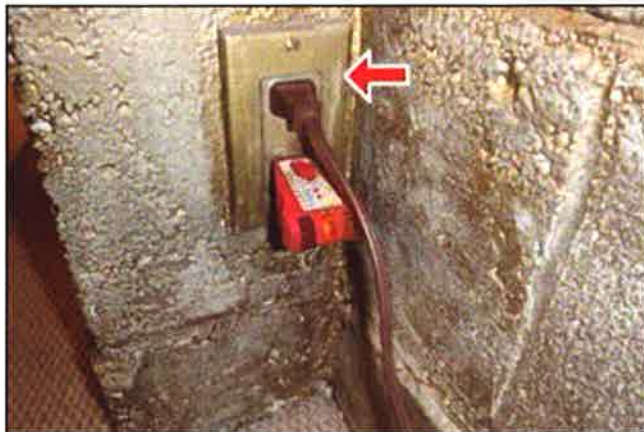
4.4 Picture 1

- 3 prong Non grounded outlets noted - recommend to upgrade. Have it checked by a qualified electrician. (Picture 1)
- Painted outlets/ switches noted - recommend to replace for fire safety. (Picture 1)

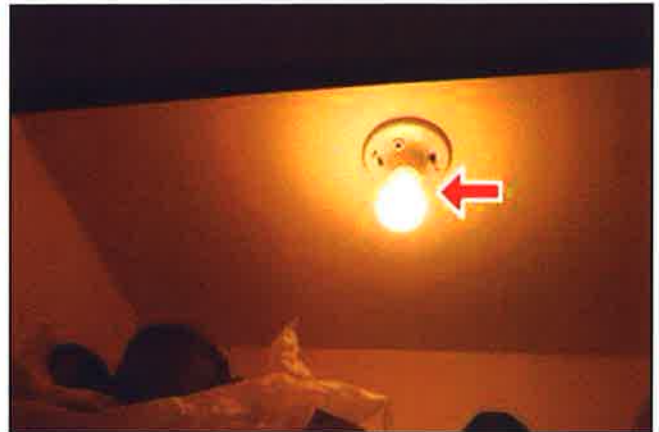
4.4 Picture 2

- Closet lights noted - missing lens - subject to damage. Recommend to upgrade the fixture for safety(Picture 2).
- Lack of outlets noted

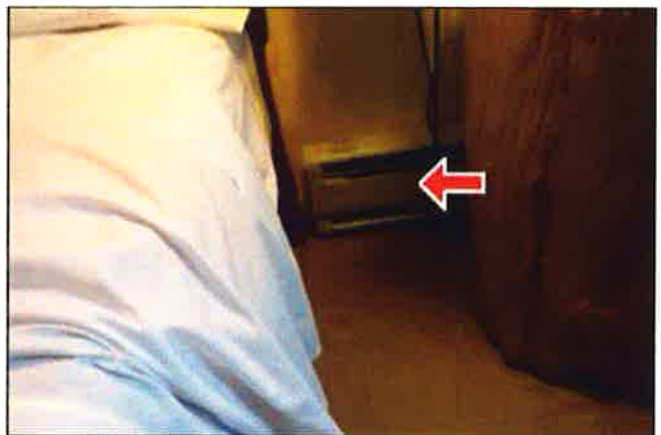
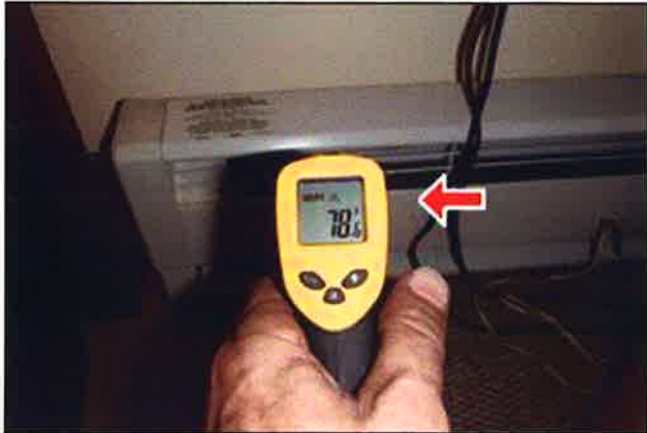
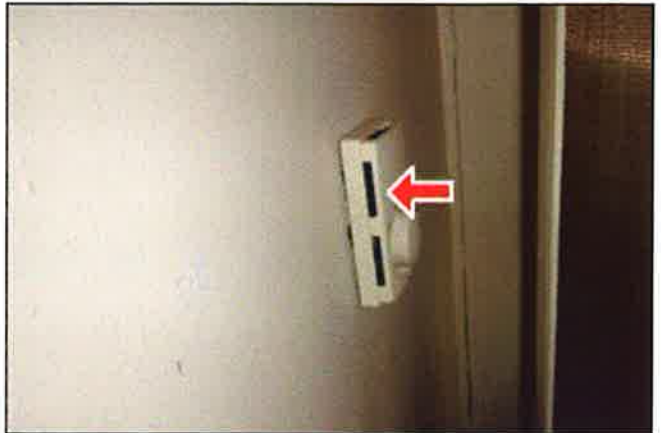
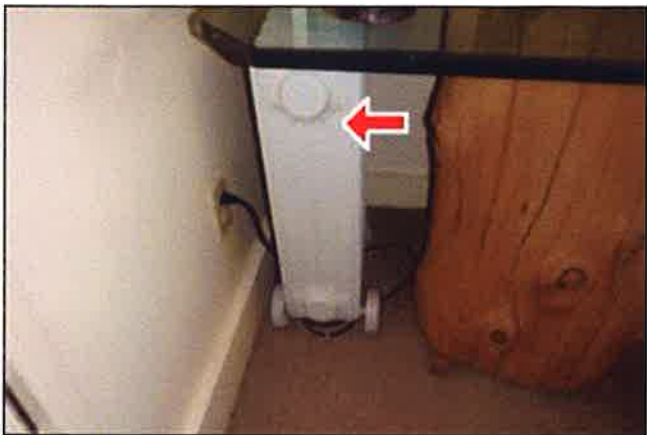
- *Recommend to check the service history with the Seller and to have the unit serviced by a qualified HVAC Contractor if not performed in the past year. No service tags noted at the time.*
- *Air flow/ balance is not a part of this inspection. Recommend to check the disclosures regarding day to day functionality.*
- *Annual service/ evaluation is recommended with gas fired furnaces.*
- Heaters area tested and Units operated at heat mode at the time(FYI).
- (Picture 1) Package unit for upper floor on the roof (Picture 9)
- (Picture 2) Floor heater at dining room (Picture 3)(Picture 8)
- Living room area without heater, has fireplace
- Electric baseboard type heater noted at lower bedroom - did not work at the time. Have it checked (portable electric heater noted) (Picture 4) (Picture 5)(Picture 6)(Picture 7)

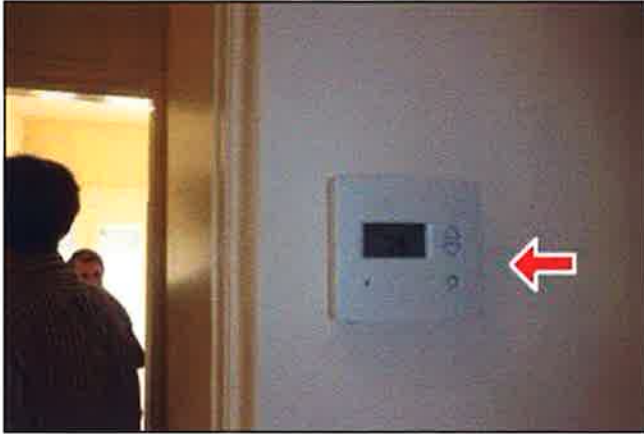
5.1 Picture 1

- Thermostat was operational at the time of inspection.(FYI)(Picture 1)

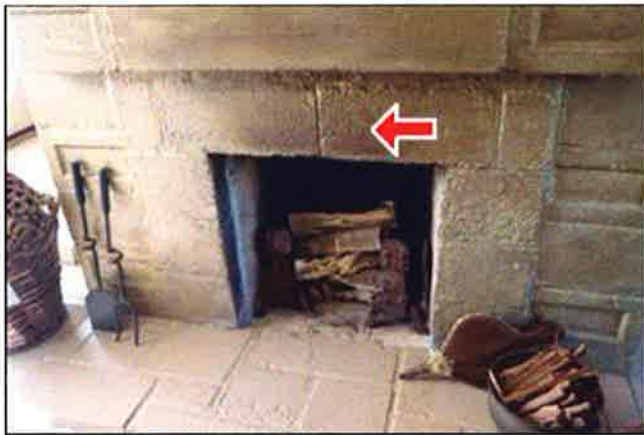
5.4 Picture 1

- Recommend further and complete evaluation by a qualified Chimney Inspector (this is a safety and fire concern).
- Video inspection of the flue by qualified Chimney Inspector is recommended.
- Soot build up noted at walls/ mantel - indicates improper venting - have it checked by a qualified specialist. This is a safety/ fire concern.(Picture 1)
- Repairs noted at chimney and fireplace - check the records.

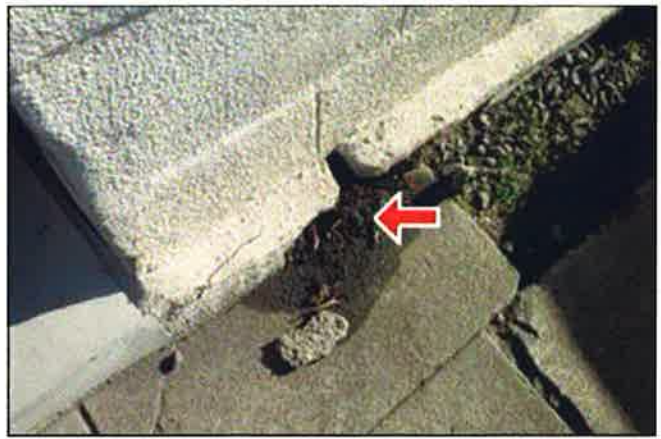
7.2 Picture 2

- Roof drains in need of cleaning/ service
- Roof drain terminates at driveway(Picture 2) - needs cleaning

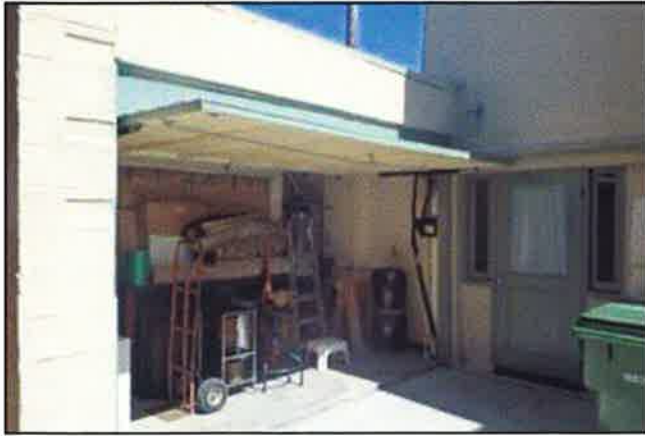
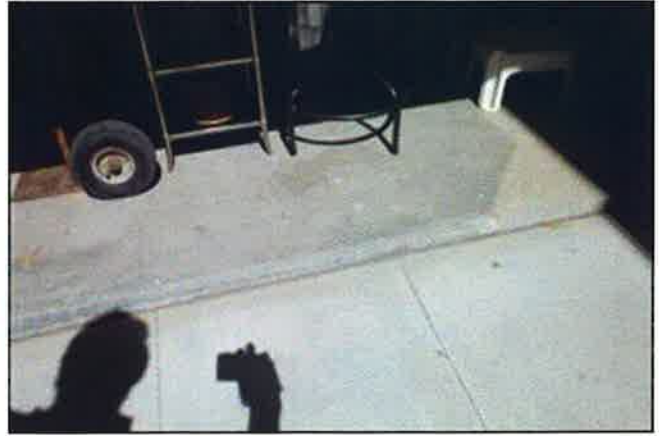
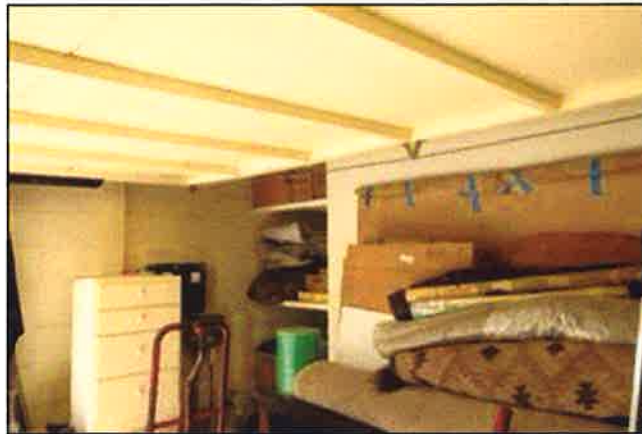
- No automatic opener present - manual vehicle door type(FYI)
- **No Garage is present at the inspected property. Possible that Garage was converted into living area - check the records/ permits.**

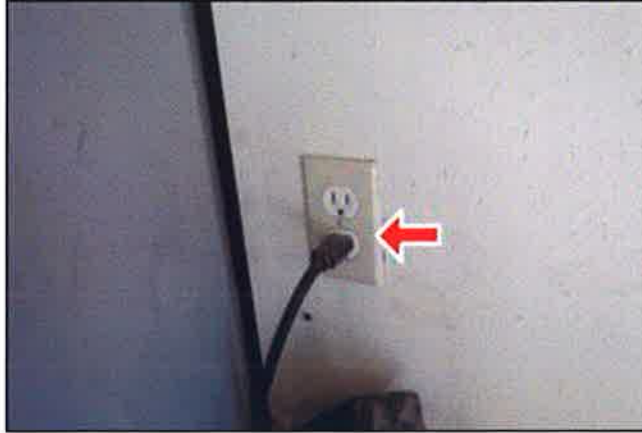
8.5 Picture 1

- Recommend GFCI protected electrical outlets as a safety upgrade.

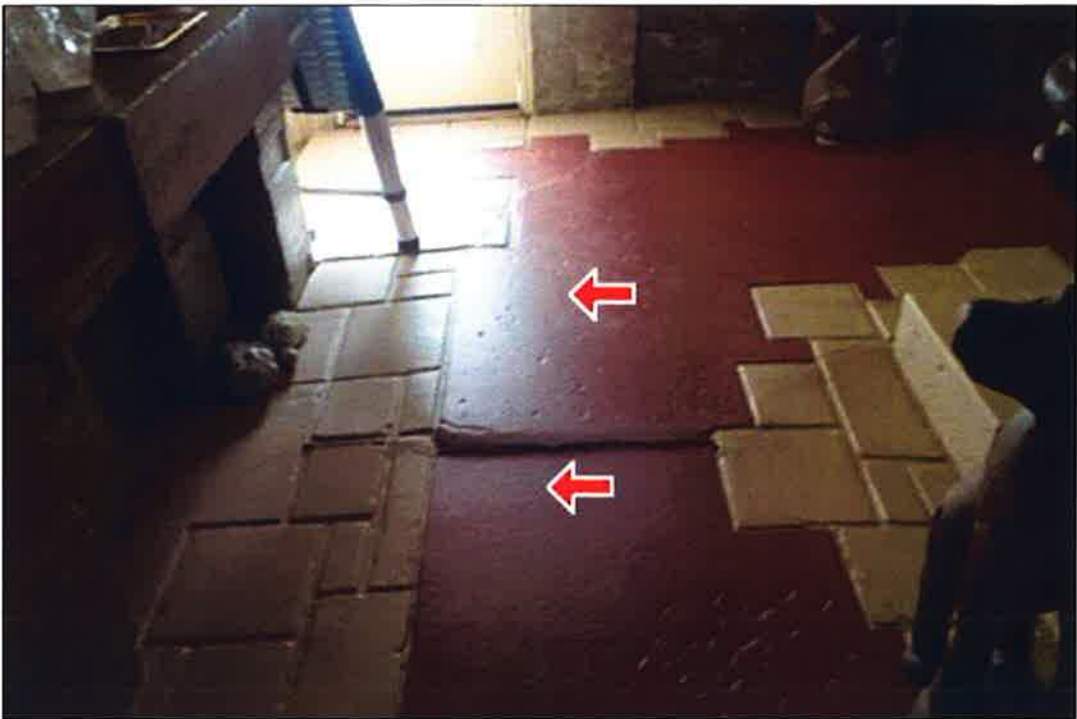
9.2 Picture 2

- House was occupied at the time of the inspection (walls/floors were not fully visible) - recommend to check the records for any known defects/repairs.
- Squeaky sub floors at various areas noted at the time.
- Sloped flooring noted at upper and lower floors. No tests/ engineering done at this type inspections. Have it checked by a qualified specialist(s)
- Settlement type cracks noted at entry hall area(Picture 2)

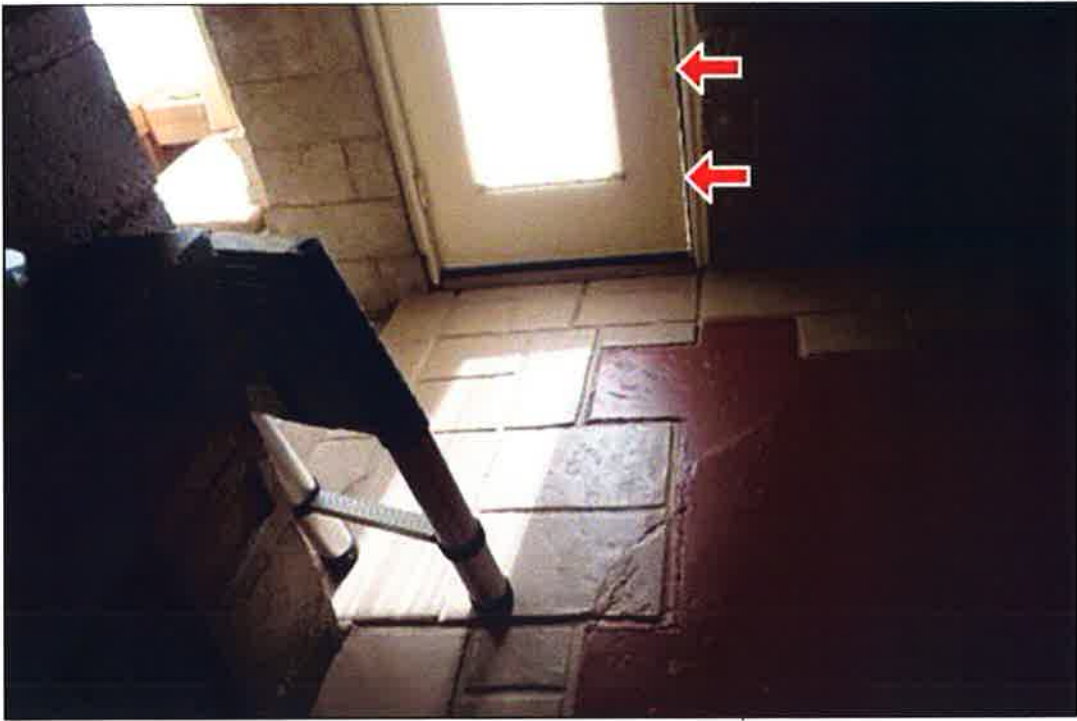
9.3 Picture 3

- Door frames were not square - an indication of settlement or movement - further evaluation and corrections by qualified Contractor are recommended.
- Large gap noted at entry door due to settlement.(Picture 3)

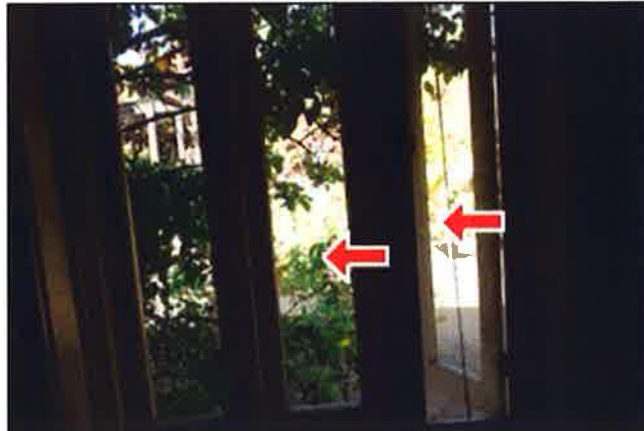
9.4 Picture 1

- Lower Bedroom window openings not with today's fire safety standards. Recommend to upgrade.(Picture 1)

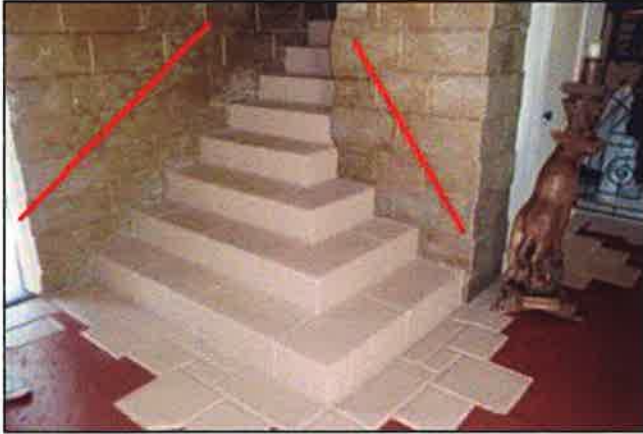
10.0 Picture 1

- Railings are recommended at all stair locations of three or more steps as a safety upgrade. (Picture 1)
- Loose steps noted at wood stairs (Picture 2) (Picture 3)

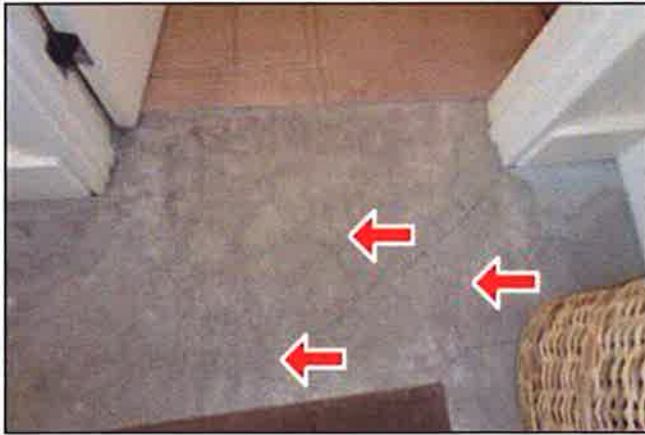
10.1 Picture 5

- View behind the equipment was limited due to equipment location / space restrictions.
- Laundry machines and drainage are not part of this inspection. Machines area note tested at this inspection. We inspect and report installation defects. Check with the seller about functionality of the machines.
- Washing machine/ laundry area without catch pan and or drainage pipes. Recommend to install if possible to prevent damage when machines leak.
- Cracked floor slab noted(Picture 5)

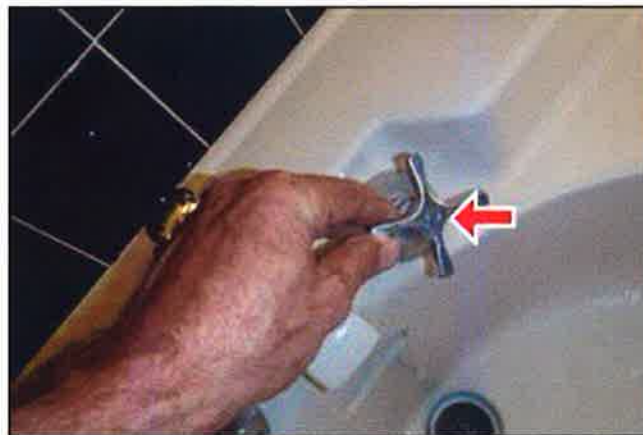
11.1 Picture 1

- Bathroom at Upper Floor; defective cold water faucet noted(Picture 1). Crack noted at sink(Picture 2), sink stopper did not work

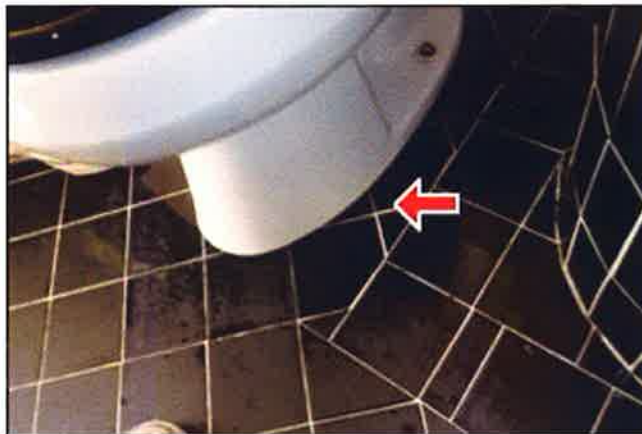
11.2 Picture 1

- Bathroom at Upper Floor; Missing caulking at the base of toilet noted - recommend to caulk. (Picture 1)

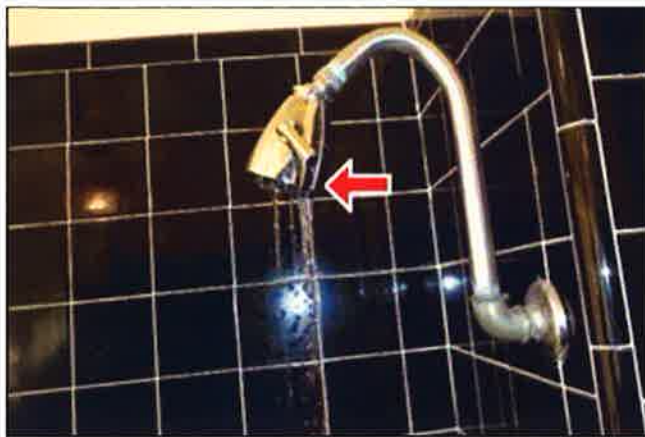
11.3 Picture 1

- **Bathroom at Upper Floor;** low water flow noted at shower head. Have it checked(Picture 1)
- **Bathroom at Lower Floor;** Wall tiles were installed at tub ledge - unable to determine if proper flashing was used at tub to wall to prevent water seepage/damage. This type tubs not designed to be used as shower. Under tub area was not fully visible at the time of the inspection. No major water stains/ damage found at visual part of the tub walls at the time(FYI). Check the records for any known defects/ repairs. (Picture 2). Some stains noted at tub area exterior wall - possible seepage from exterior door and or wall. Have it checked.(Picture 3)
