BOLLMAN HOUSE Historic Structure Report

**1530 North Ogden Drive
Los Angeles, California**

Final Report

August 25, 2015
WJE No. 2015.1764

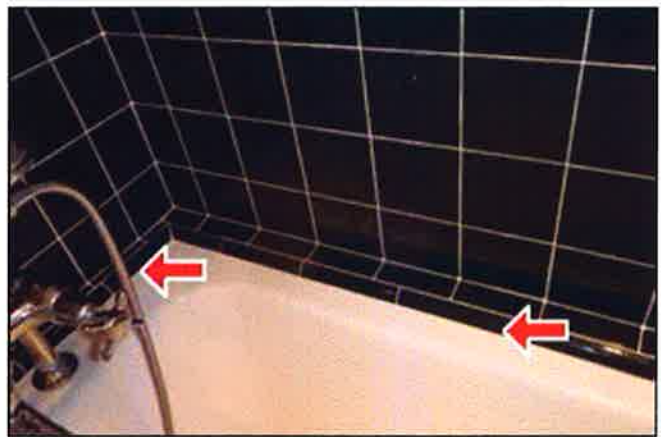
11.3 Picture 2

- **Bathroom at Upper Floor;** low water flow noted at shower head. Have it checked(Picture 1)
- **Bathroom at Lower Floor;** Wall tiles were installed at tub ledge - unable to determine if proper flashing was used at tub to wall to prevent water seepage/damage. This type tubs not designed to be used as shower. Under tub area was not fully visible at the time of the inspection. No major water stains/ damage found at visual part of the tub walls at the time(FYI). Check the records for any known defects/ repairs. (Picture 2). Some stains noted at tub area exterior wall - possible seepage from exterior door and or wall. Have it checked.(Picture 3)

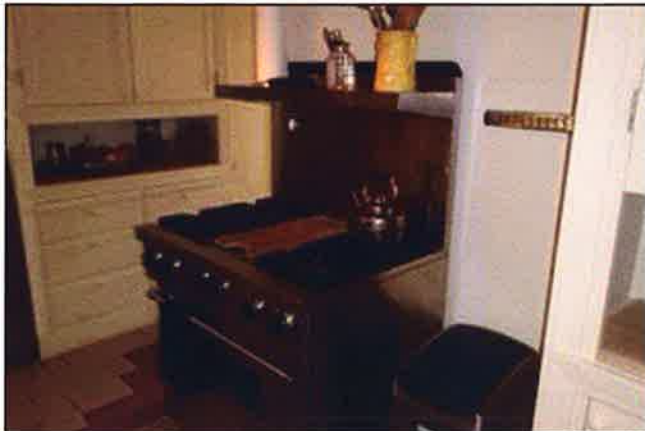
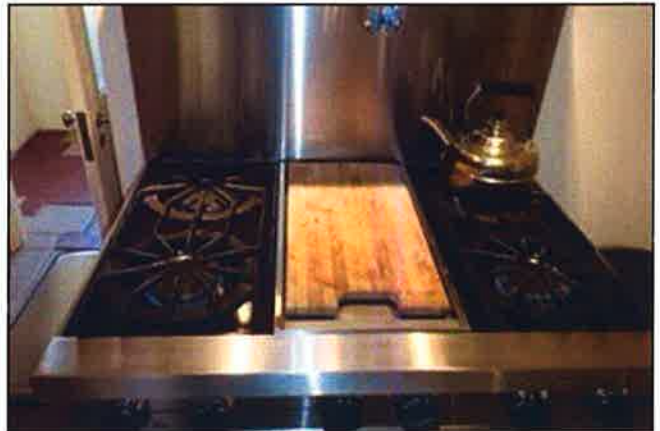
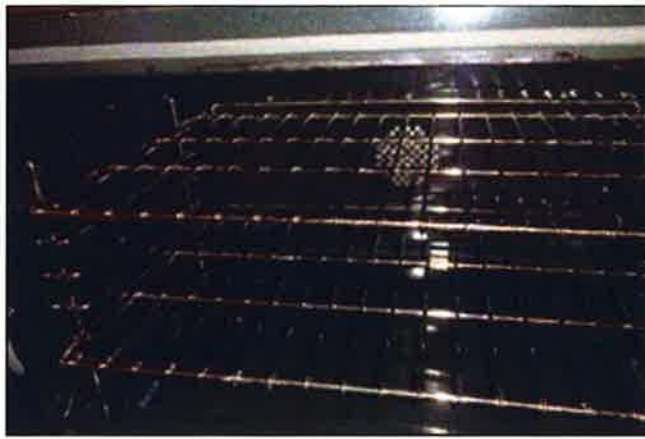
- "Missing Anti-Tip Device at the freestanding range. Recommend to add for safety concerns. Consult a licensed professional for proper installation."

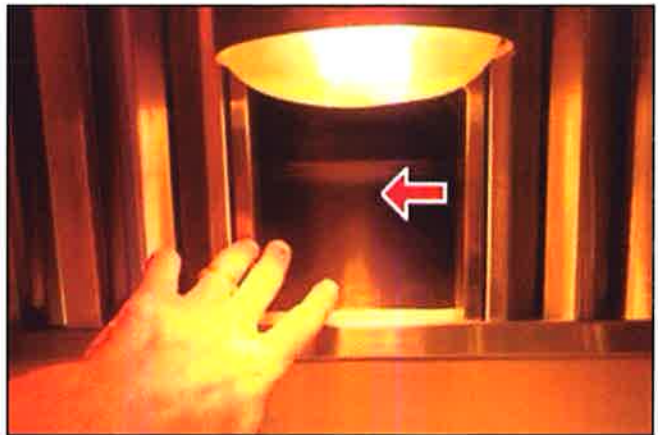
12.5 Picture 2

- Missing filter/ cover plate noted at the hood(Picture 2)

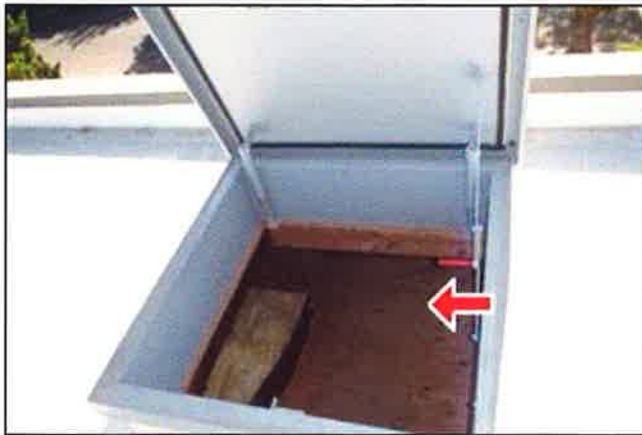
13.0 Picture 1

- Two roof hatches noted on upper roof (FYI)(Picture 1) (Picture 2)
- Attic lights did not work at the time(Picture 3)

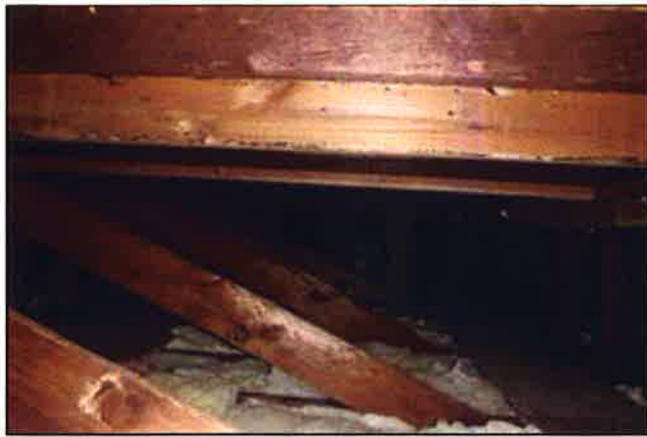
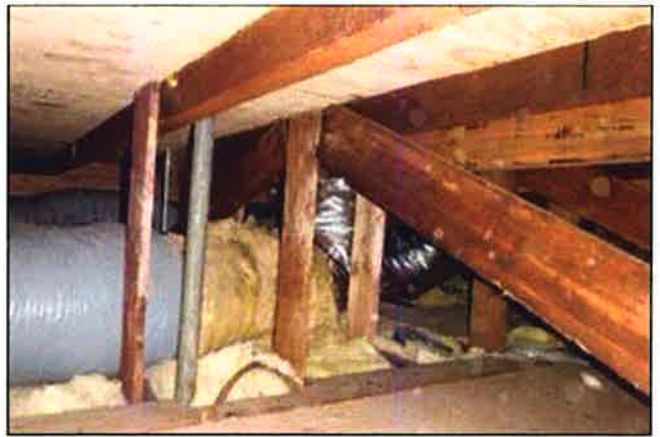
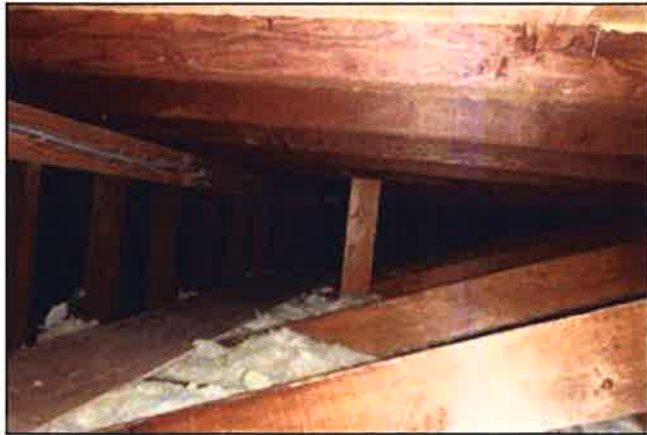
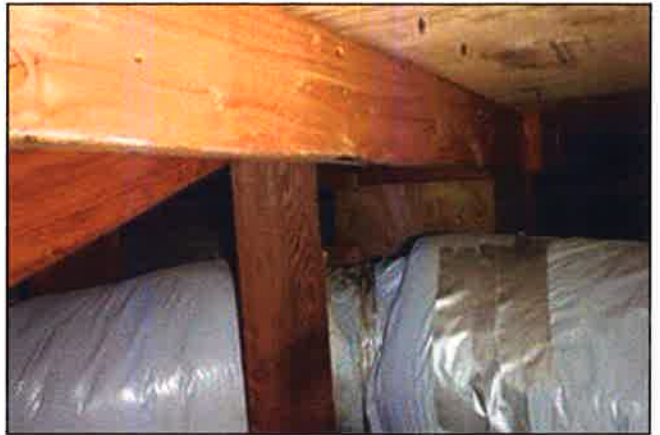
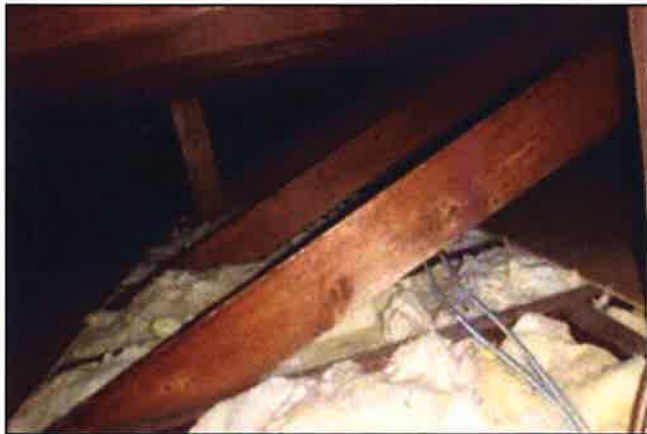
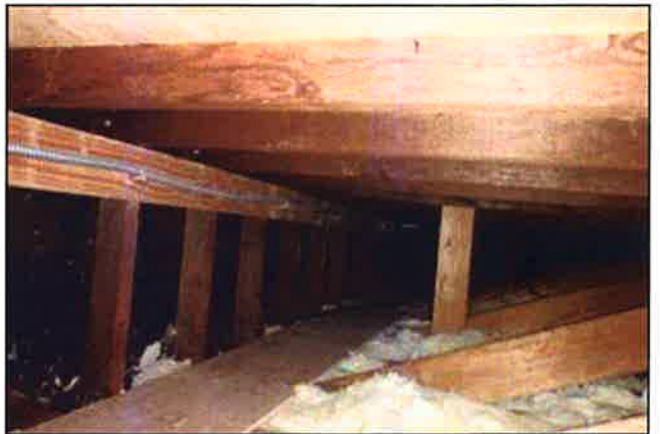
- Ceiling joists were not fully visible to comment due to insulation. No major damage found at visual part of the structure at the time. Check the records for any known defects/ repairs.
- Newer roof sheathing noted - check the records

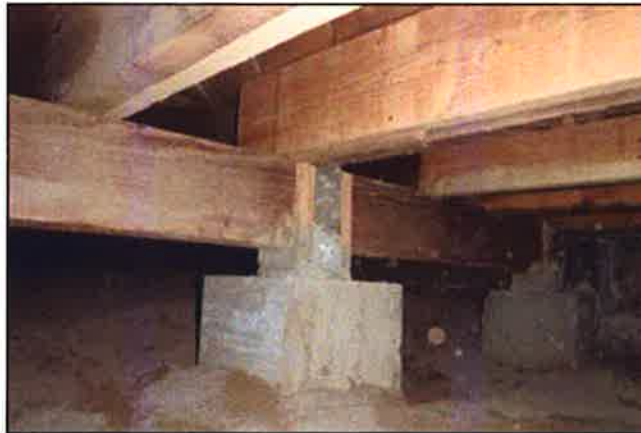
14.1 Picture 1

- Newer piers, posts noted

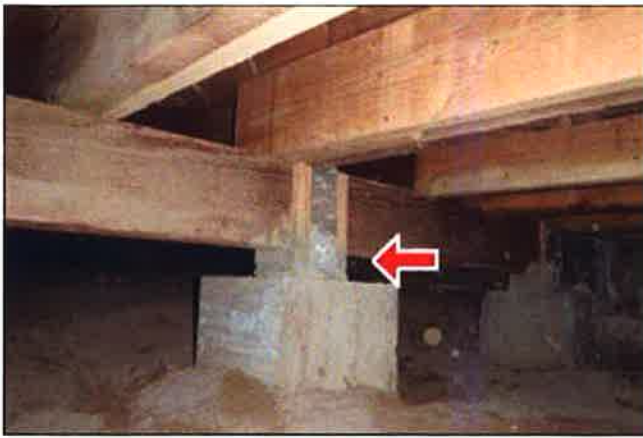
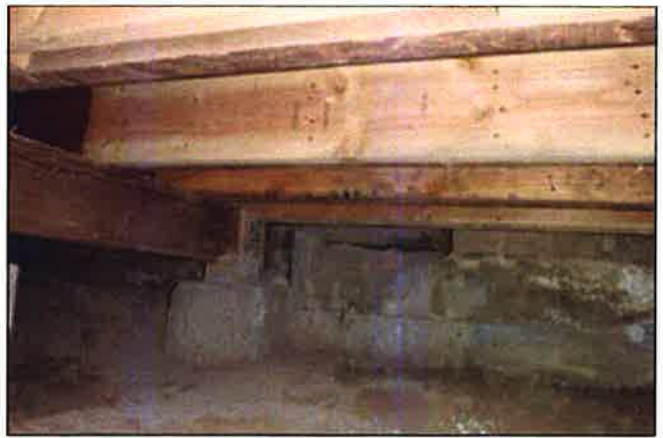
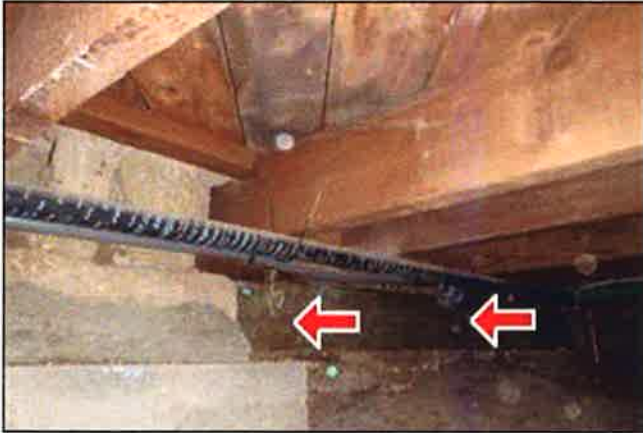
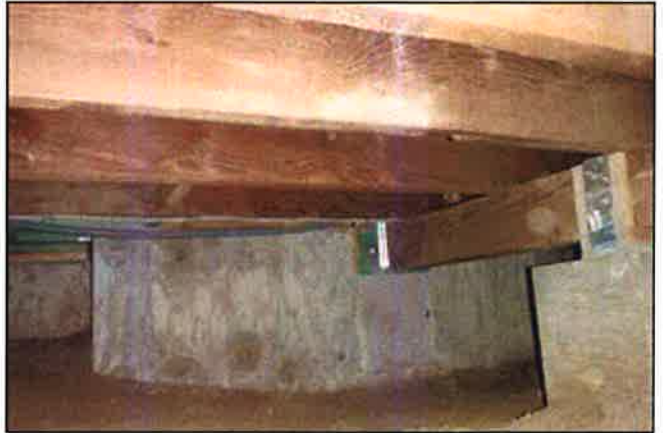
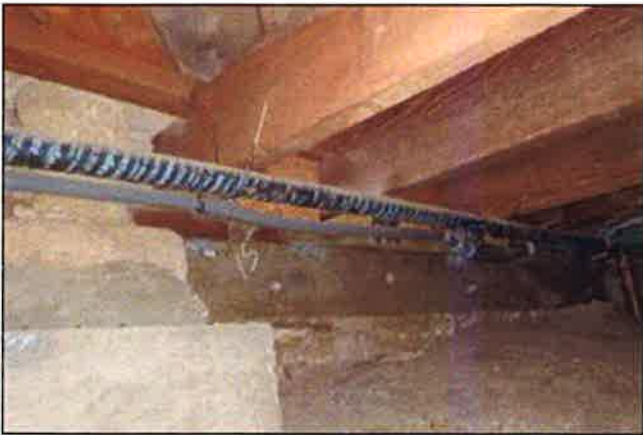
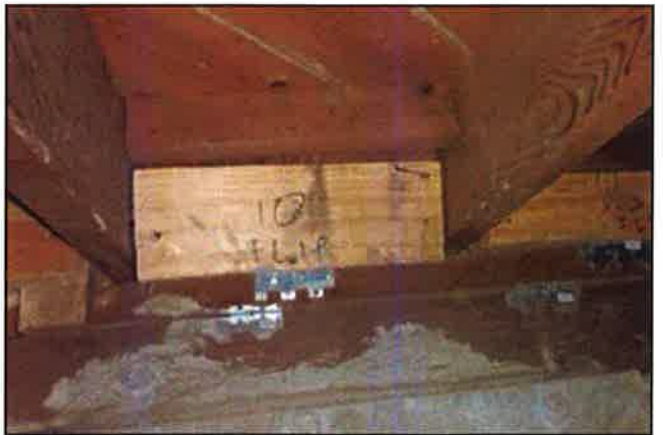
- Newer foundation walls and bolts/ straps noted - check the records/ permits.
