ARCADY APARTMENTS (HCM #1124)
2615-2627 West Wilshire Boulevard
CHC-2017-2795-MAEX

RECOMMENDATION REPORT

CASE NO.: CHC-2017-2795-MAEX

PROJECT: 2615-2627 West Wilshire Boulevard; 622-630 South Rampart Boulevard
Arcady Apartments, Historic-Cultural Monument (HCM) #1124

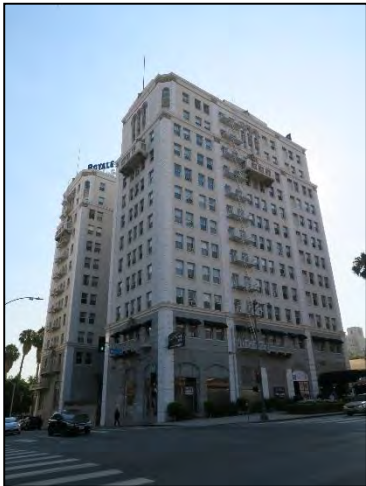
Primary, west and south elevations, view northeast (2017)

The south and west elevations of the subject property exhibit many character-defining features of the Beaux-Arts style, namely the strong vertical appearance and decorative motifs. The vertical appearance is accentuated by the full-height piers that stretch from the foundation to the cornice. Balconies cantilever from exterior walls at the tenth floor. However, as is typical with Beaux-Arts style, the façade is separated horizontally into a podium comprising of the first two floors, a shaft comprising of the third through tenth floors and a capital comprising of the uppermost floors.

The building has a flat roof with a built-up asphalt surface and is accessible through the central stairwell. The parapets have been secured by brace framing. The surface material appears to be in good condition; however the drainage and gutter systems are poor. There are two open panel roof signs and flag poles on the roof.

The building has experienced a number of alterations. At the podium level, a few of the original store front windows and doors have been replaced, some of the openings infilled, and other openings have extensive modifications. The original primary entrance was relocated from Rampart Boulevard to Wilshire Boulevard. Also, a majority of the original wood windows of the residential units were replaced with either vinyl or aluminum without muntins separating the glass panes, and many windows have air conditioning units installed.

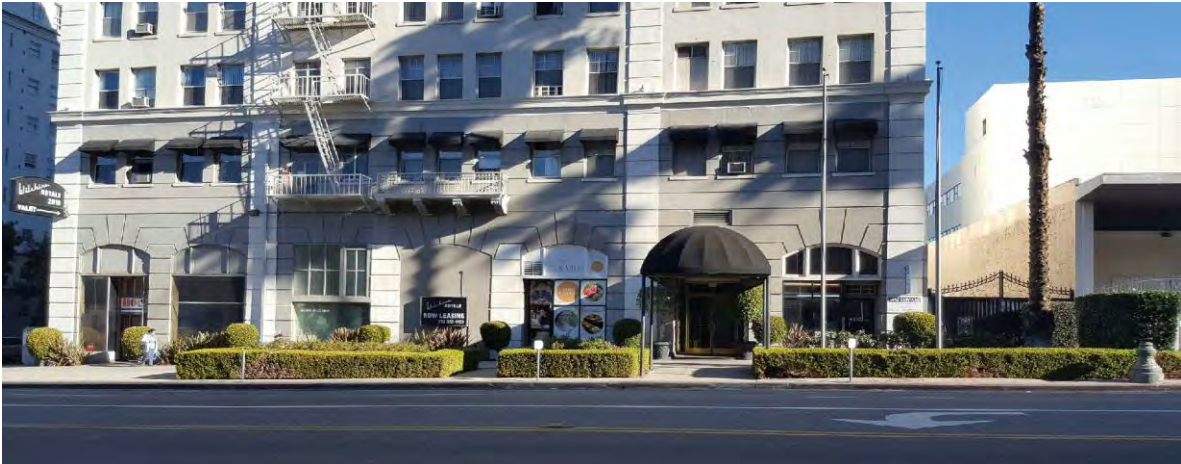
The new entrance is located along Wilshire Boulevard. Although this is still a primary elevation in terms of architectural importance, the entry is not as dramatic as the original location. This reorientation occurred in 1979, according to permit data.

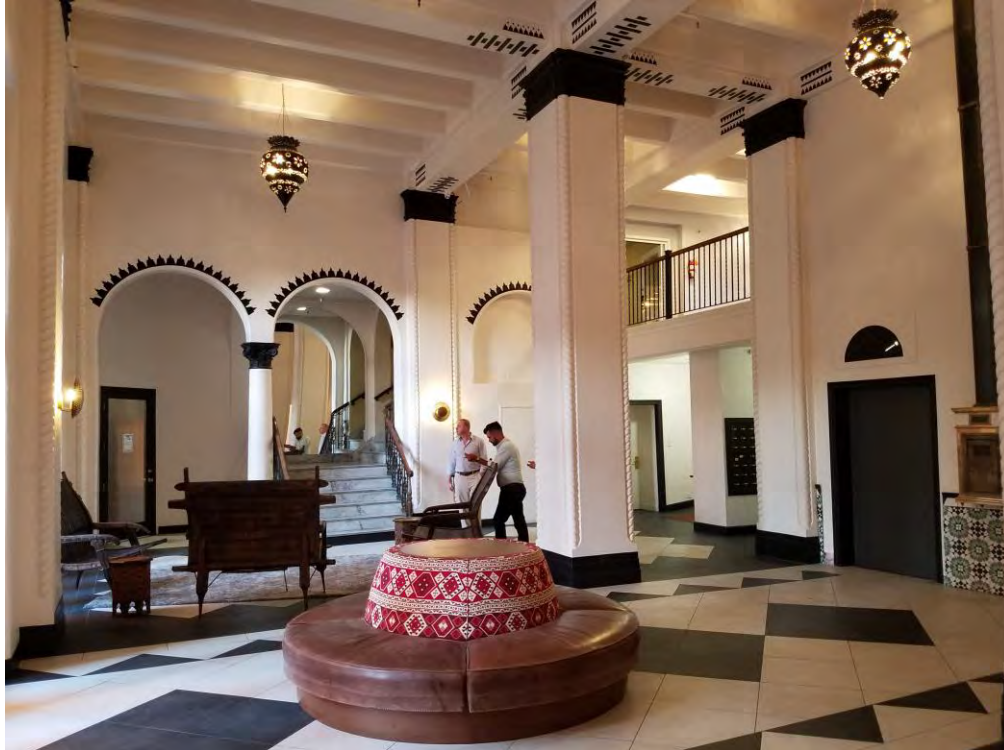
Current lobby space, as painted in Fall of 2016. Although the paint scheme and current décor have diminished the integrity of the appearance, the architectural fabric and details remain in place. The lobby could be at least partially restored to its original character in the future as long as these elements remain in place.

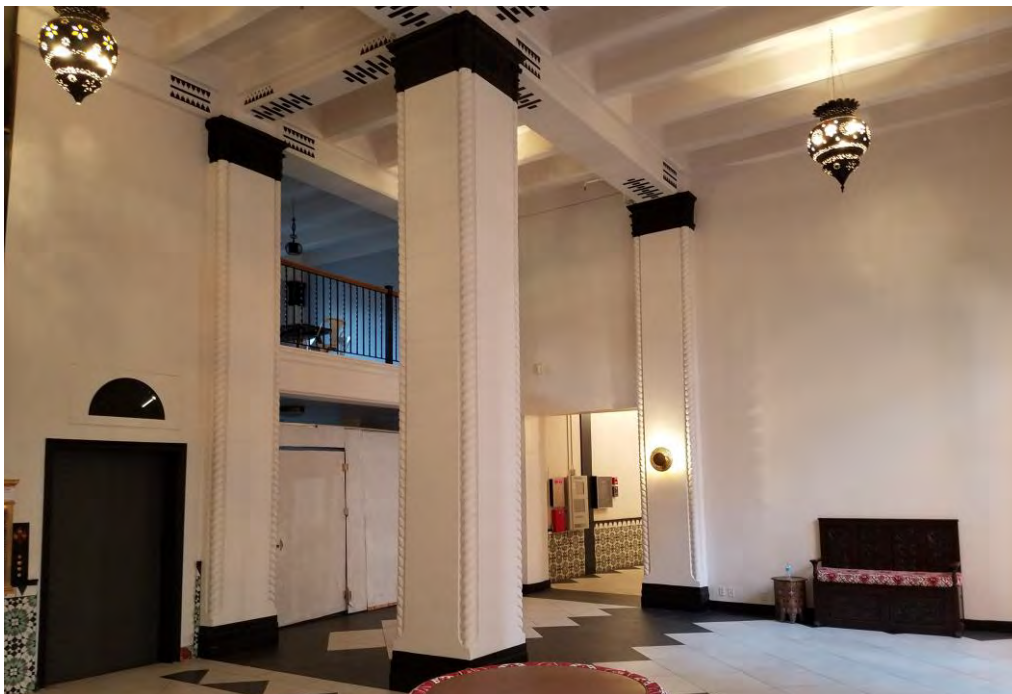
Lobby, as modified, Fall 2016. Future changes include installation of a new desk area in rear corner (now plywood) with millwork based on historic photo, (prior page, same view) and cabinetry in original cafe/retail space (still extant).

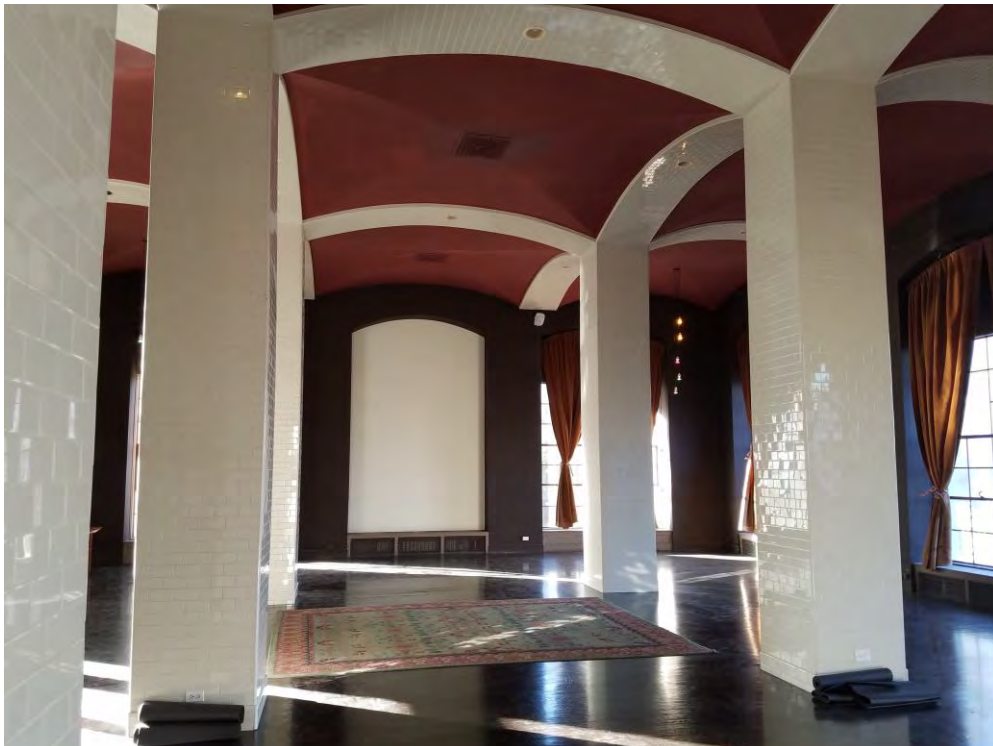
Dining Hall, Current appearance, modified by prior owner, prior to 2016. Ceiling form and hardwood flooring is still in place

The former Dining Hall was modified by the prior owner when this area was leased to a restaurant tenant. The windows were infilled, and the main piers sheathed with white ceramic subway tile,

obscuring the original painted plaster surface. Again, while the surfaces are more recent, the form of the room remains intact, and is a potentially reversible condition.

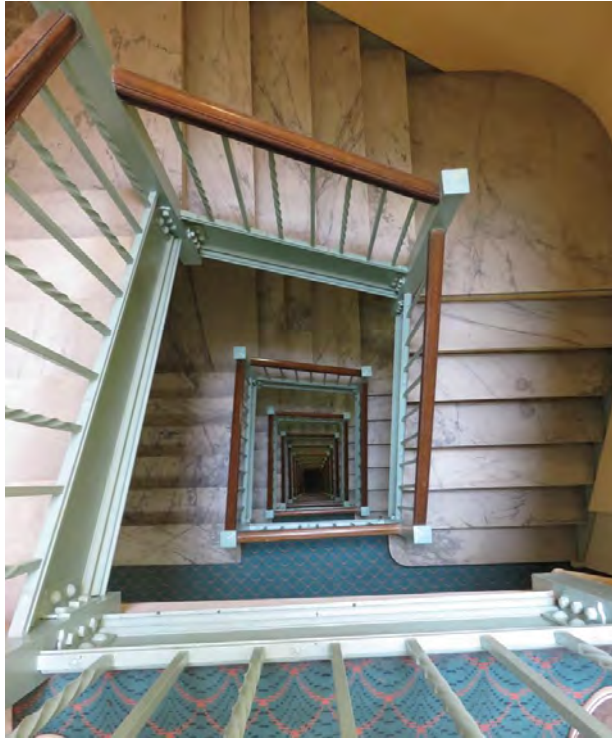
Stairway 1 winds through the upper stories. The marble stair treads and balustrade with stained natural wood bannister are original and should be retained.

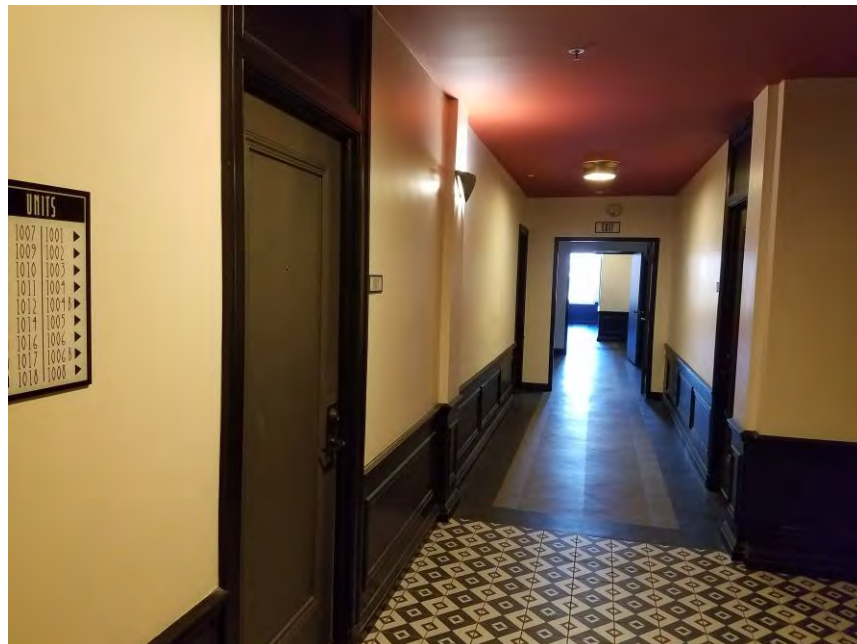
The upper floors are being renovated in sequence, starting with the top floor in 2016. Floors 12 through 8 are completed. Lower floors will be updated to match beginning in 2017. The work recaptures the ceiling height, and retains the original millwork, and is overall a compatible approach that works well with the building.

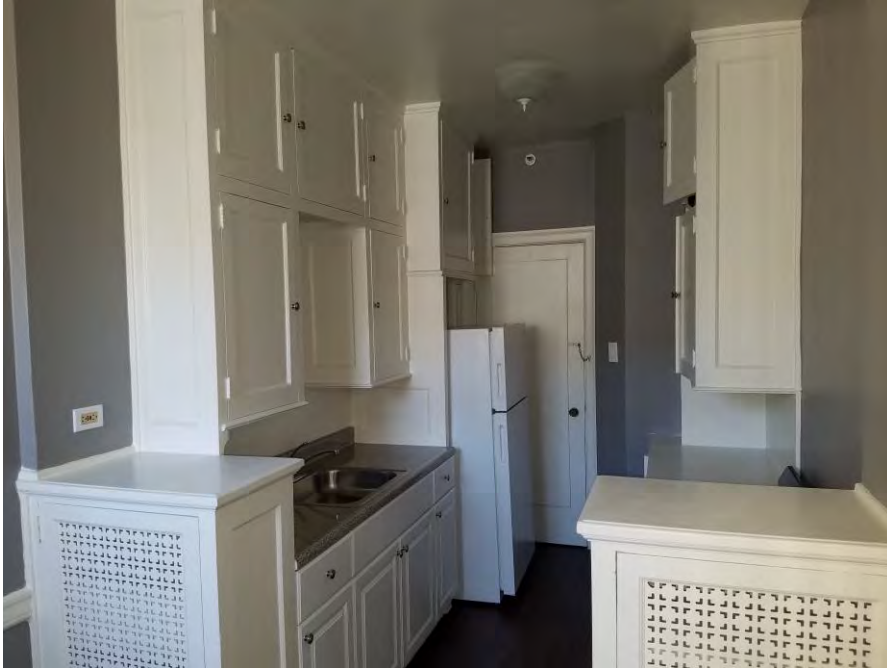
Kitchen Units have been upgraded in the majority of rooms. Appliances and countertops have been replaced, but upper cabinetry is original, and in good condition.

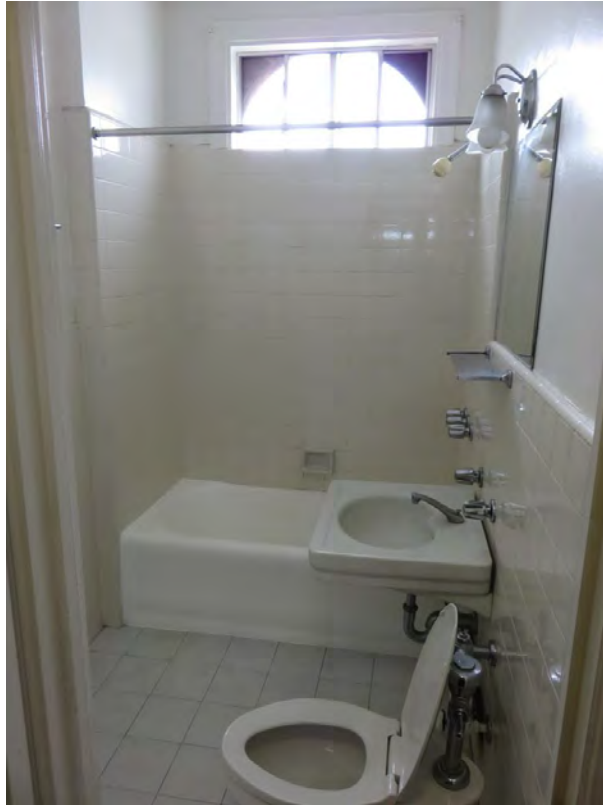
Bathroom Units have also been upgraded in most of the apartments, including replacement of plumbing fixtures and floor tile.
