**921 SOUTH BEACON STREET**  
Harbor View House, Historic-Cultural Monument (HCM) #252  
Contributor to the Vinegar Hill Historic Preservation Overlay Zone (HPOZ)  
CHC-2019-1291-MAEX

## RECOMMENDATION REPORT

CASE NO.: CHC-2019-1291-MAEX

## CHARACTER-DEFINING FEATURES & EXISTING CONDITIONS SURVEY

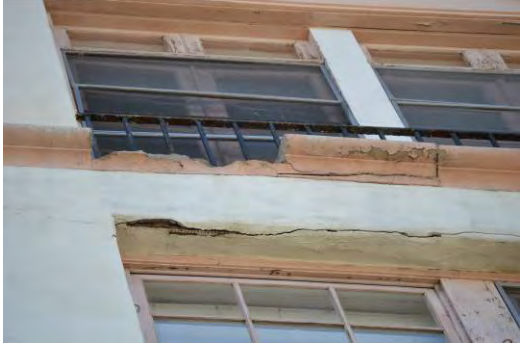
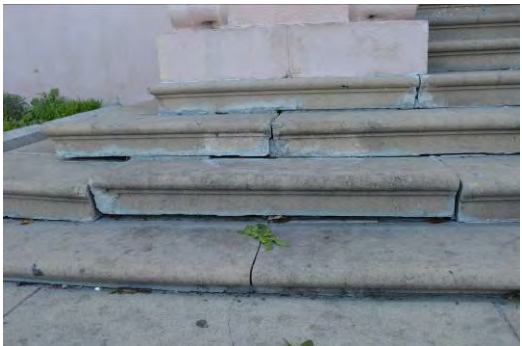
| EXTERIOR | | | | | | |
|---|---|---|---|---|---|---|
| | | <p>windows with projecting subsills at second, third, and fourth stories</p> <p>Recessed loggia at fifth story with corbelled balcony, paneled parapet and corbelled columns</p> <p>Wood sash, divided-light French windows with transom lights and metal balconettes at fifth story</p> | | | | |
| Exterior | North Facade | <p>Asymmetrical composition</p> <p>Smooth cement plaster veneer</p> <p>Classical articulation of base, shaft, and capital</p> <p>Molded water table</p> <p>Sill courses under second- and fifth-story windows</p> <p>Stacked quoins</p> | Fair | Primary | <p>One vertical stack of windows has been infilled.</p> <p>Two round-arched openings at ground floor (location of former swimming pool) have been infilled; three round-arched openings have original wood sash windows with concrete bulkhead; however, the transom lights have been removed and infilled.</p> | |

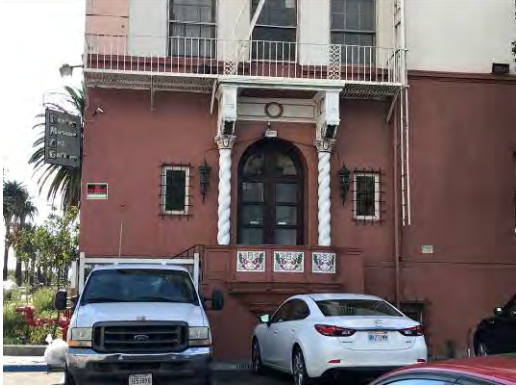
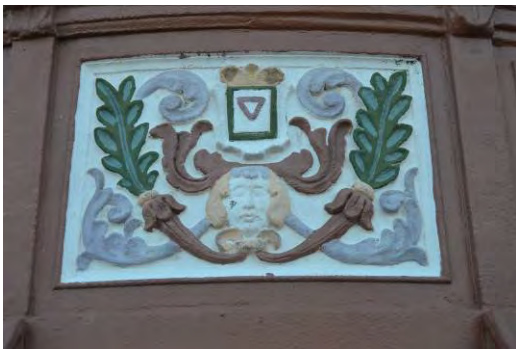
| EXTERIOR | | | | | | |
|---|---|---|---|---|---|---|
| | | <p>Cast stone entrance portal at east end with spiral columns and scrolled brackets supporting U-shaped entablature</p> <p>Cast concrete entrance steps with metal hand railing and decorative cast stone balustrade</p> <p>Recessed entrance wood double door with glazed panels and round-arched transom light</p> <p>Projecting metal window grilles flanking entrance portal</p> <p>Decorative wall mounted metal lanterns flanking entrance portal</p> <p>Five round-arched openings at west end of first story; three openings with paired six-over-six double hung wood sash windows</p> <p>Recessed, paired and single six-over-six double hung wood sash windows with projecting subsills at first, second, third, and fourth stories</p> <p>Wood sash, divided-light French windows with transom lights at fifth story</p> <p>Metal fire escape at east end</p> | | | <p>Surface staining on plaster and cast stone surfaces</p> <p>Peeling paint</p> <p>Cracking and losses in cement plaster veneer</p> <p>Cracking and losses in decorative cast stone</p> <p>Over paint of decorative cast stone</p> <p>Cracks and losses in cast stone subsills, quoins, and sill courses</p> <p>Weathered and broken wood window assemblies, many windows non-operable, missing hardware, and exhibit termite damage</p> | |

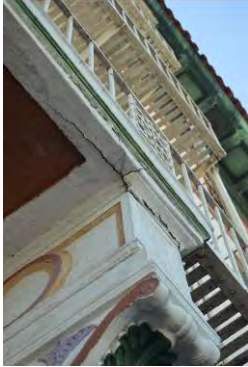
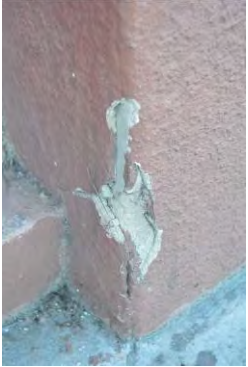
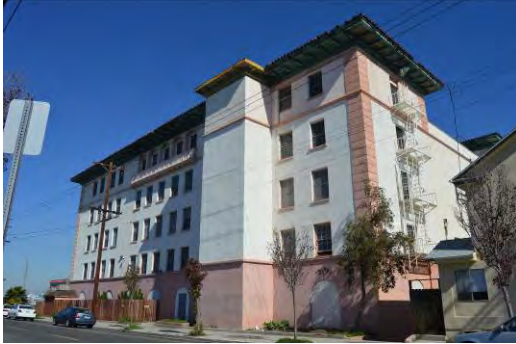
| EXTERIOR | | | | | | |
|---|---|---|---|---|---|---|
| Exterior | West Facade | <p>Symmetrical composition</p> <p>Smooth cement plaster veneer</p> <p>Classical articulation of base, shaft, and capital</p> <p>Molded water table</p> <p>Sill courses under second- and fifth-story windows</p> <p>Stacked quoins</p> <p>Seven round-arched openings at ground floor</p> <p>Recessed, single six-over-six double hung wood sash windows with projecting subsills at second, third, fourth, and fifth stories</p> <p>Shallow, recessed loggia with corbelled balconette, paneled parapet and corbelled columns</p> | Fair | Primary | <p>The stair tower on the south portion of the west façade was added between 1972 and 1980.</p> <p>All round-arched windows at ground floor have been infilled.</p> <p>Surface staining on plaster and cast stone surfaces</p> <p>Peeling paint</p> <p>Cracking and losses in cement plaster veneer</p> <p>Cracks and losses in cast stone subsills, quoins, and sill courses</p> <p>Weathered and broken wood window assemblies, many windows non-operable, missing hardware, and exhibit termite damage</p> | |

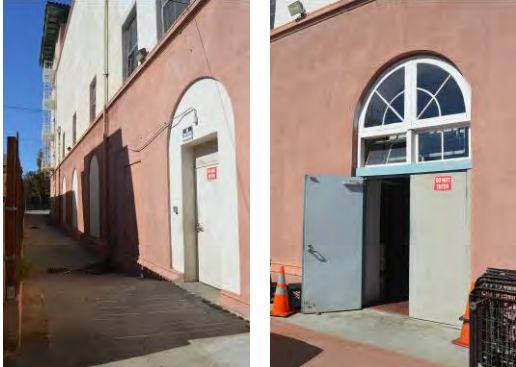
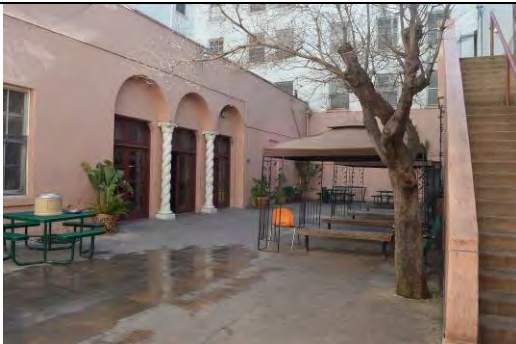
| EXTERIOR | | | | | | |
|---|---|---|---|---|---|---|
| Exterior | Courtyard | <p>Location, configuration and spatial relationships</p> <p>Scored concrete paving</p> <p>Smooth cement plaster walls</p> <p>Triple-arched entrance with spiral columns</p> <p>Shouldered doorways with divided-light glazed wood doors and transom lights</p> <p>Double staircase with solid parapet and corbeled balcony at landing</p> <p>Recessed window with plaster embrasure and ceramic tile planter</p> <p>Decorative overdoor at theater door</p> <p>Recessed, six-over-six double hung wood sash windows with projecting subsills</p> | Fair | Primary | <p>Surface staining on plaster and cast stone surfaces</p> <p>Peeling paint</p> <p>Cracking and losses in plaster</p> <p>Cracks and losses in cement subsills</p> <p>Weathered wood window assemblies, many windows non-operable, missing hardware, and exhibit termite damage</p> <p>A/C units installed in some windows</p> <p>Window panes replaced with louvers</p> <p>Weathered wood doors and thresholds</p> | |

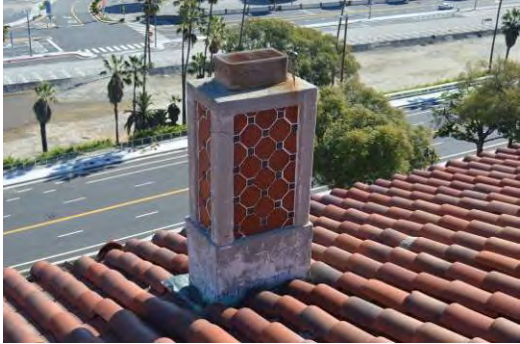
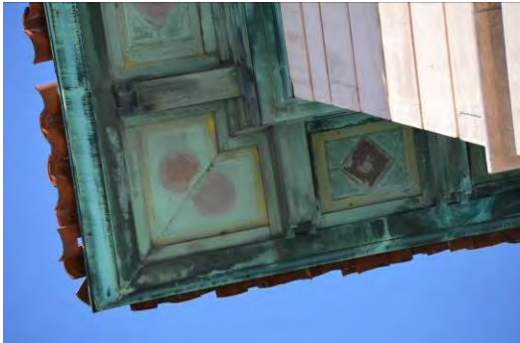
| EXTERIOR | | | | | | |
|---|---|---|---|---|---|---|
| Exterior | Roof | Flat roofs with parapets over lobby, former handball court, former locker room, and theater of inner court | Fair | Secondary | Some staining and pooling of water on flat roofs<br>Built up roofing with previous repairs and patching with mastic<br>Roof vents and penetrations<br>Added mechanical equipment<br>Broken rain leader pipe<br>Missing parapet roof tile coping | |

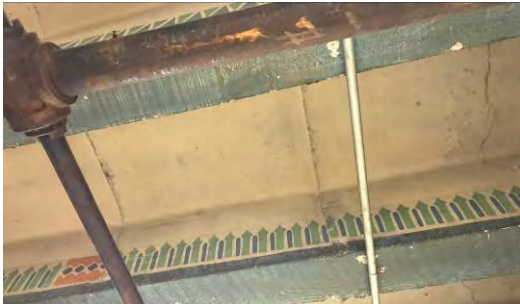
| INTERIOR | | | | | | |
|---|---|---|---|---|---|---|
| Basement | General | <p>Stamped concrete flooring</p> <p>Plaster walls</p> <p>Tile wainscot</p> <p>Stenciled concrete beamed ceiling</p> | Fair | Secondary | <p>The northeast portion of the basement was historically finished with materials similar to the first story.</p> <p>Tile wainscot has been painted over but appears intact.</p> | |

- Engage the services of a specialist to restore decorative paint and stencil work on ceilings in lobby, physical therapy room, and basement where damaged or missing. Investigate presence of other decorative beams hidden by suspended acoustical tile ceilings in the basement, and restore as appropriate.

- Investigate and document extent and condition of glazed ceramic tile in the basement. Retain original ceramic tile if intact, and determine scope of tile restoration in consultation with the Office of Historic Resources.

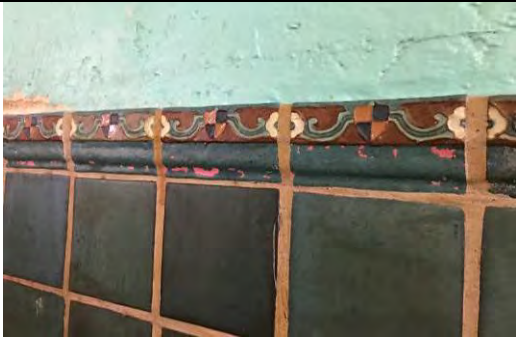
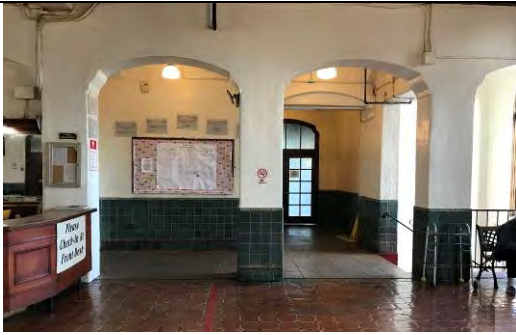
| INTERIOR | | | | | | |
|---|---|---|---|---|---|---|
| Ground Floor | Elevator Lobby (former North Lounge Vestibule) | <p>Stamped and stained concrete floor</p> <p>Textured plaster walls</p> <p>Ceramic tile wainscot</p> <p>Groin-vaulted plaster ceiling</p> <p>Decorative pendant light fixture</p> <p>Pocket door between Lobby and former North Lounge</p> | Fair | Primary | <p>Permit records indicate that the elevator was installed in 1955; the space was originally part of main Lobby</p> <p>Missing, replacement, and broken ceramic tiles at wainscot</p> | |

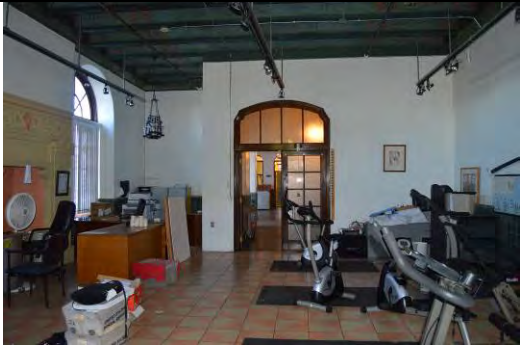
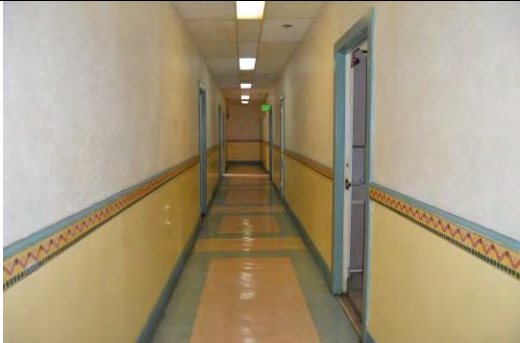
| INTERIOR | | | | | | |
|---|---|---|---|---|---|---|
| Ground Floor | Corridors | <p>Location, configuration, and spatial relationships</p> <p>Stained and stamped concrete flooring, where remaining</p> <p>Textured plaster walls</p> <p>Ceramic tile wainscot, where remaining</p> <p>Two-panel wood doors with metal hardware, where remaining</p> <p>Remaining interior divided-light wood sash windows of former swimming pool</p> | Fair | Primary | <p>Many portions of the corridors have been altered with resilient tile flooring, suspended ceilings, and added or replaced doors and hardware</p> <p>Corridor to east of Physical Therapy room is not original</p> | |

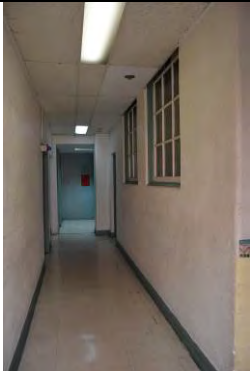
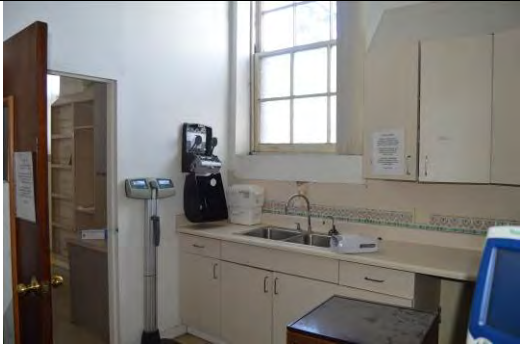
| INTERIOR | | | | | | |
|---|---|---|---|---|---|---|
| Ground Floor | Offices | N/A | N/A | Not significant | Offices at northwest portion of building were added when the swimming pool and lockers were removed<br><br>Doctor offices along north wall of the building are in their original location; however, finishes have been updated | |

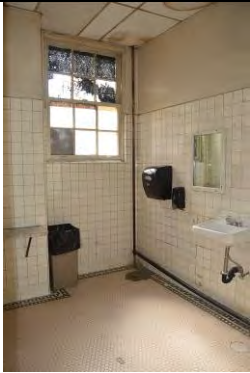
| INTERIOR | | | | | | |
|---|---|---|---|---|---|---|
| Ground Floor | Ladies' Restroom | Location, configuration, and spatial relationships<br><br>Ceramic hex tile flooring with mosaic meander border<br><br>Smooth plaster walls | Fair | Secondary | Non-original wall tile, fixtures, suspended ceiling, and flush door | |

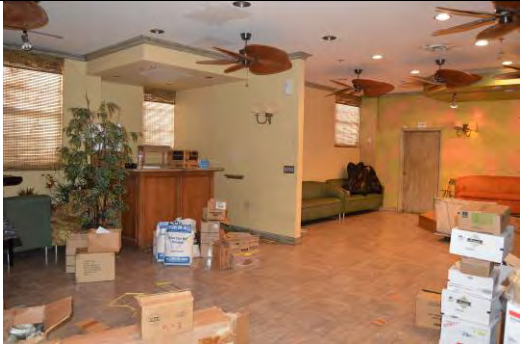
| INTERIOR | | | | | | |
|---|---|---|---|---|---|---|
| Ground Floor | Game Room (former Check Room) | Location, configuration, and spatial relationships | Fair | Secondary | The interior has been substantially altered, and all finishes have been replaced | |

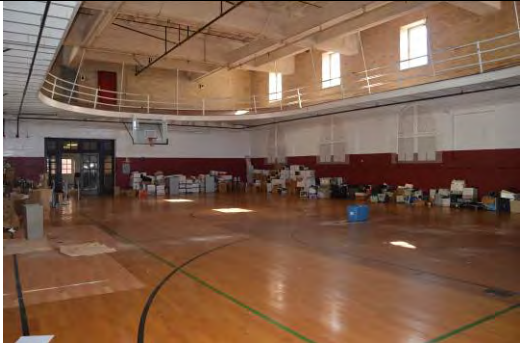
| INTERIOR | | | | | | |
|---|---|---|---|---|---|---|
| Ground Floor | Gymnasium | Location, configuration, and spatial relationships<br>Two-story volume<br>Maple flooring<br>Brick walls<br>Exposed concrete ceiling structure<br>Suspended wood running track with pipe metal guardrail<br>Divided-light, wood sash casement windows with round-arched transom lights<br>Divided-light, glazed wood doors with sidelights and transom lights<br>Wall-mounted drinking fountain in round-arched niche | Fair | Primary | Several windows have been infilled at the exterior, but the windows remain in place<br><br>Water damage to maple flooring; and previous repairs<br><br>Water damage to wood running track<br><br>Water infiltration from concrete ceiling | <br> |

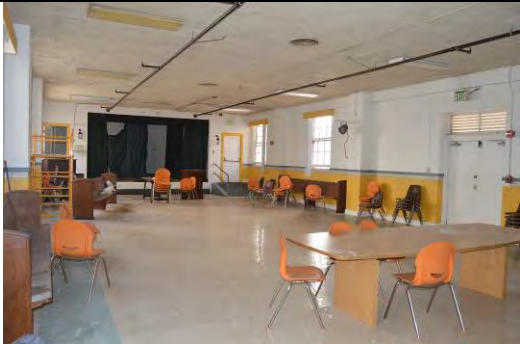
| INTERIOR | | | | | | |
|---|---|---|---|---|---|---|
| Second Floor | Theater | Location, configuration, and spatial relationships | Fair | Secondary | The interior has been substantially altered, and all finishes have been replaced. | |

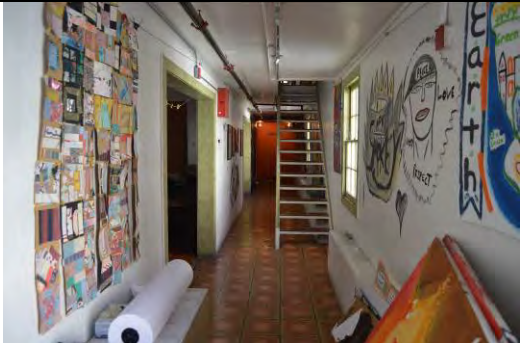
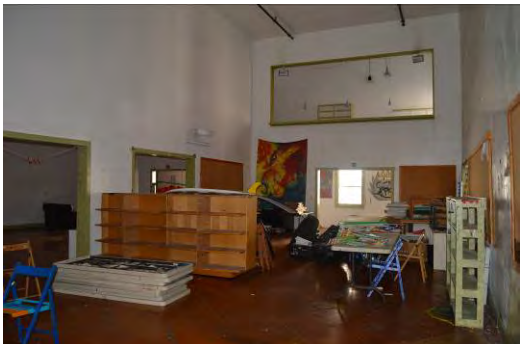
| INTERIOR | | | | | | |
|---|---|---|---|---|---|---|
| Third Floor | Art Room (Former Handball Courts) | Location, configuration, and spatial relationships<br>Double height space with mezzanine | Fair | Secondary | The interior has been substantially altered and all finishes have been replaced | |

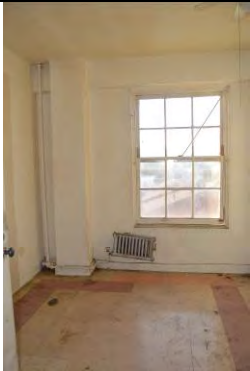
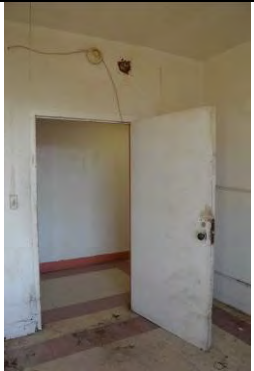
| INTERIOR | | | | | | |
|---|---|---|---|---|---|---|
| Second, Third, Fourth, and Fifth Floor | Typical Dwelling Units | Location, configuration, and spatial relationships<br>Single-occupancy rooms<br>Single-occupancy rooms with shared bathroom<br>Textured and smooth plaster walls and ceilings<br>Scored concrete flooring, where remaining<br>Wood and concrete baseboards<br>Radiators | Fair to poor | Secondary | Some rooms have been altered with the addition of resilient tile flooring and suspended ceilings<br>Peeling paint<br>Surface stains and graffiti on plaster walls<br>Water infiltration at windows and water damage to plaster<br>Termite damage to wood windows | |

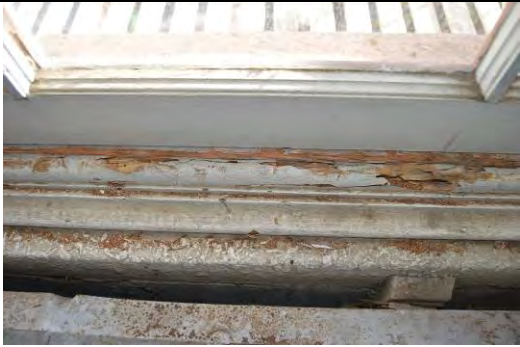
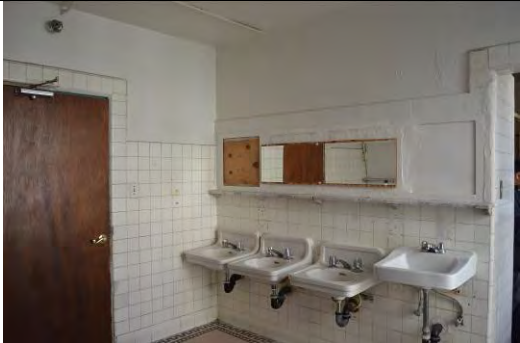
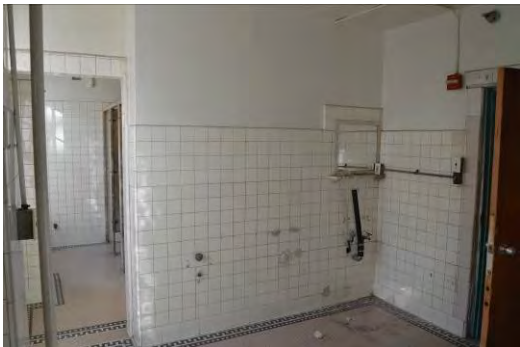
| INTERIOR | | | | | | |
|---|---|---|---|---|---|---|
| Second, Third, Fourth, and Fifth Floor | Typical Communal Restrooms | <p>Location, configuration, and spatial relationship</p> <p>Ceramic hex tile flooring with mosaic meander border</p> <p>Plaster walls and ceiling</p> <p>Marble partitions</p> | Poor | Secondary | <p>Ceramic tile wainscot appears to be a later addition</p> <p>Typically, fittings and fixtures have been replaced</p> | |

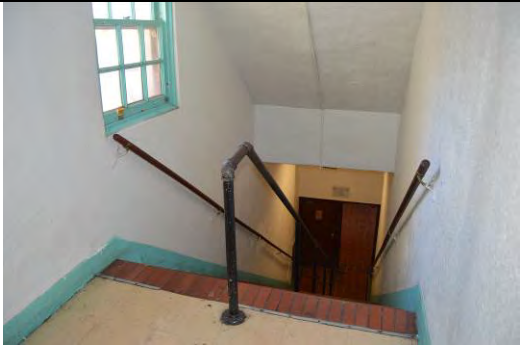
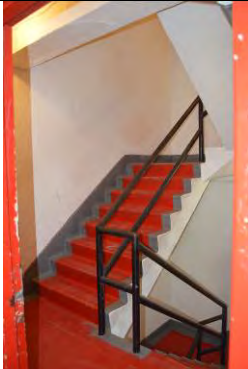
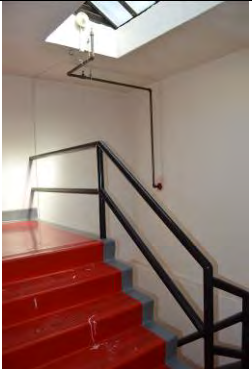
| INTERIOR | | | | | | |
|---|---|---|---|---|---|---|
| Circulation | Stairwell (southeast) | Stair from second floor to roof<br>Location, configuration, and spatial relationship<br>Poured concrete treads and risers<br>Smooth plaster walls<br>Metal pipe handrails<br>Wire glass skylight | Fair | Primary | Surface soiling and staining | |

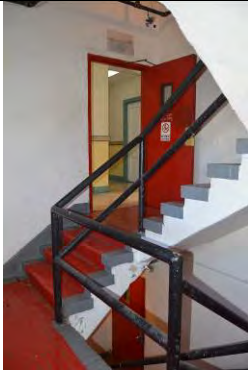
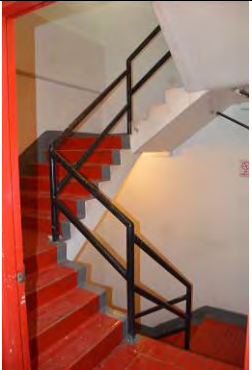
| INTERIOR | | | | | | |
|---|---|---|---|---|---|---|
| Circulation | Stairwell (north) | Stair from basement to fifth floor<br>Location, configuration, and spatial relationship<br>Glazed brick treads and risers<br>Concrete treads and risers above second floor<br>Textured plaster walls<br>Smooth plaster walls above second floor<br>Metal pipe handrails | Fair | Primary | Brick treads and risers have been over painted<br>Broken and chipped edges on brick treads<br>Surface soiling and staining | |
