GPA Consulting (GPA) was retained to prepare this report to help guide the rehabilitation of the Tokio Florist/Sakai-Kozawa Residence in compliance with the Standards. It includes a summary of the property's significance and history as well as an illustrated inventory of character-defining features and recommendations for treatment. The Tokio Florist/Sakai-Kozawa Residence was exclusively a residential property from 1929 to 1960 and a mixed-use, residential and commercial property from 1960 to 2006. A proposed project involves adaptively reusing the property for commercial office use.

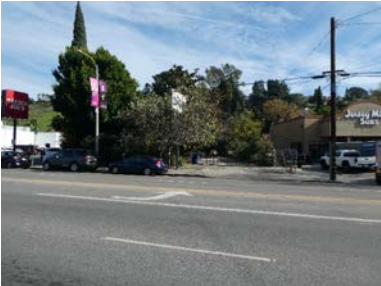
| Type | Feature | Photo (If Applicable) | Importance: Reason | Condition: Treatment |
|---|---|---|---|---|
| Spatial Organization & Land Uses | <b>Immediate Setting</b> <ul style="list-style-type: none"> <li>Abuts sidewalk to west</li> <li>Driveway and entry gate on N. Hyperion Avenue</li> <li>Bordered by perimeter fencing</li> <li>Single-family residence and ancillary buildings set back from west property boundary</li> <li>Landscape features, such as Japanese-style garden, upper terrace, and perimeter vegetation</li> </ul> | | Primary: Dates from the period of significance under Criteria 1 and 3, highly visible, and retains integrity. | Good: Retain the historic relationship between buildings and landscape features of the immediate setting overall. New construction should be visually distinguishable and compatible in size, scale, and massing. |

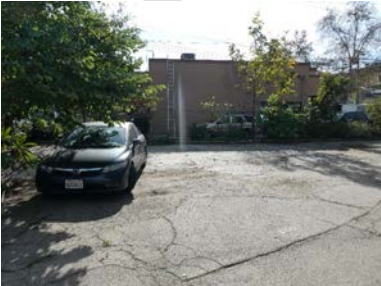
| Type | Feature | Photo (If Applicable) | Importance: Reason | Condition: Treatment |
|---|---|---|---|---|
| | <b>Surface Parking</b> <ul style="list-style-type: none"> <li>Located at west end of property</li> <li>Bordered by fencing</li> <li>Asphalt paving</li> </ul> | | Secondary: Dates from the period of significance under Criterion 1 and retains integrity overall, but functional feature that does not display quality of design or craftsmanship. | Good: Surface parking may be retained and/or reconfigured as necessary for new use. New circulation features and paving materials should be compatible with the historic character of the property. |

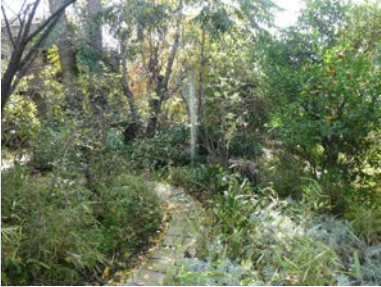
| Type | Feature | Photo (If Applicable) | Importance: Reason | Condition: Treatment |
|---|---|---|---|---|
| | <b>Japanese-Style Garden</b> <ul style="list-style-type: none"> <li>Located to east of surface parking and west of residence</li> <li>Bordered by fencing to north and west</li> <li>Various mature plantings</li> <li>Winding foot paths</li> <li>Foot bridges</li> <li>Water features</li> </ul> | | Primary: Dates from the period of significance under Criterion 1, highly visible, and retains integrity. | Good: Vegetation should be surveyed by a qualified professional and retained to the extent possible. Dead or unhealthy plants may be removed. New vegetation or landscape features should be compatible with the Japanese style. |

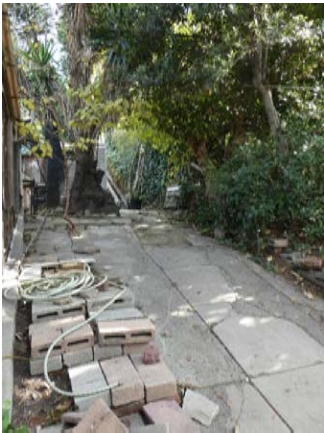
| Type | Feature | Photo (If Applicable) | Importance: Reason | Condition: Treatment |
|---|---|---|---|---|
| Spatial Organization & Land Uses | Perimeter Landscaping <ul style="list-style-type: none"> <li>Located at property boundaries to north, south, east, and west</li> <li>Bordered by concrete block or brick curbs</li> <li>Various mature plantings</li> </ul> | | Primary: Dates from the period of significance under Criterion 1, highly visible, and retains integrity. | Good: Vegetation should be surveyed by a qualified professional and retained to the extent possible. Dead or unhealthy plants may be removed. New vegetation or landscape features should be compatible with the Japanese style. |

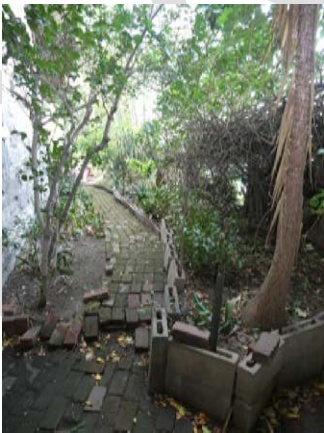
| Type | Feature | Photo (If Applicable) | Importance: Reason | Condition: Treatment |
|---|---|---|---|---|
| | Pedestrian Circulation <ul style="list-style-type: none"> <li>Located throughout property</li> <li>Brick, concrete, or flagstone paving, depending on location</li> </ul> | | Secondary: Dates from the period of significance under Criteria 1 and 3 and retains integrity overall, but functional feature that does not display quality of design or craftsmanship as well as not visible from the public right-of-way. | Good: Pedestrian circulation may be retained and/or reconfigured as necessary for new use. New circulation features and paving materials should be compatible with the historic character of the property. |

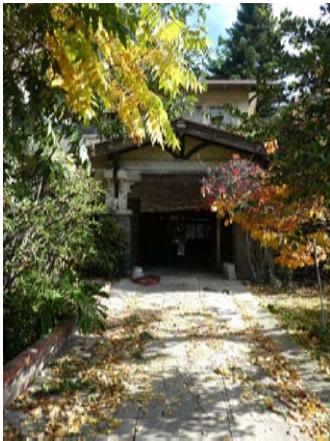
| Type | Feature | Photo (If Applicable) | Importance: Reason | Condition: Treatment |
|---|---|---|---|---|
| Spatial Organization & Land Uses | Vehicular Circulation <ul style="list-style-type: none"> <li>Located adjacent to south property boundary</li> <li>Concrete paving</li> </ul> | | Secondary: Dates from the period of significance under Criteria 1 and 3 and retains integrity overall, but functional feature that does not display quality of design or craftsmanship as well as not visible from the public right-of-way. | Good: Vehicular circulation may be retained and/or reconfigured as necessary for new use. New circulation features and paving materials should be compatible with the historic character of the property. |

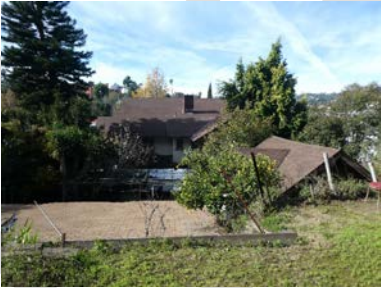
| Type | Feature | Photo (If Applicable) | Importance: Reason | Condition: Treatment |
|---|---|---|---|---|
| | Buildings & Structures <ul style="list-style-type: none"> <li>Two-story single-family residence</li> <li>One-story greenhouse</li> <li>One-story two-car garage</li> <li>One-story three-car garage</li> </ul> | | Primary: Dates from the period of significance under Criteria 1 and 3, highly visible, and retains integrity. | Good: Retain the historic relationship of the immediate setting overall. New construction should be visually distinguishable and compatible in size, scale, and massing. |

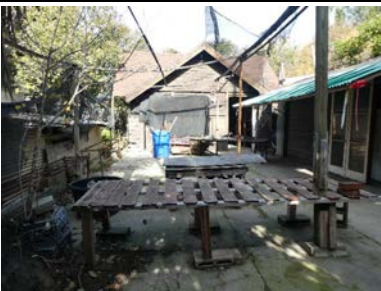
| Type | Feature | Photo (If Applicable) | Importance: Reason | Condition: Treatment |
|---|---|---|---|---|
| Topography | <b>Lower Terrace</b> <ul style="list-style-type: none"> <li>Located to east of single-family residence</li> <li>Bordered by concrete block retaining wall to west</li> </ul> | | Secondary: Dates from the period of significance under Criteria 1 and 3 and retains integrity, but not visible from the public right-of-way. | Good: Retain lower terrace. |

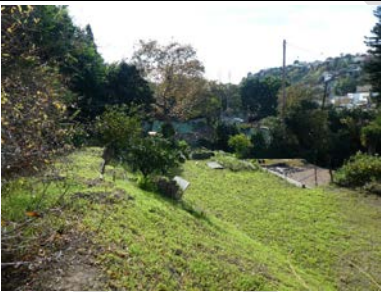
| Type | Feature | Photo (If Applicable) | Importance: Reason | Condition: Treatment |
|---|---|---|---|---|
| | <b>Upper Terrace</b> <ul style="list-style-type: none"> <li>Located at east end of property</li> <li>Bordered by concrete retaining wall to west</li> </ul> | | Secondary: Dates from the period of significance under Criteria 1 and 3 and retains integrity, but not visible from the public right-of-way. | Good: Retain upper terrace. |

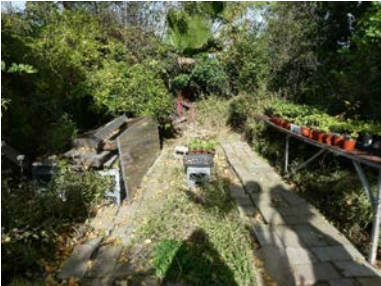
| Type | Feature | Photo (If Applicable) | Importance: Reason | Condition: Treatment |
|---|---|---|---|---|
| Circulation | Garden Paths <ul style="list-style-type: none"> <li>Located within Japanese garden</li> <li>Concrete block or stone paving, depending on location</li> </ul> | | Secondary: Dates from the period of significance under Criterion 1 and retains integrity overall, but functional feature that does not display quality of design or craftsmanship as well as not visible from the public right-of-way. | Fair to Poor: Garden paths may be retained and/or reconfigured as necessary for new use. Stone paving should be salvaged and reused to the extent possible. New circulation features and paving materials should be compatible with the historic character of the property. |

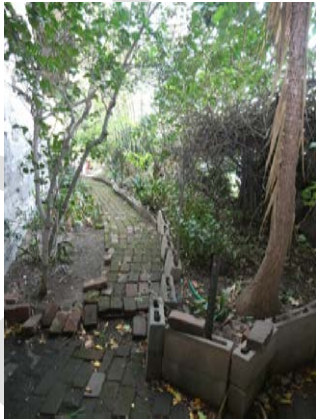
| Type | Feature | Photo (If Applicable) | Importance: Reason | Condition: Treatment |
|---|---|---|---|---|
| | North Path <ul style="list-style-type: none"> <li>Located to north of residence</li> <li>Brick paving</li> </ul> | | Secondary: Dates from the period of significance under Criteria 1 and 3 and retains integrity overall, but functional feature that does not display quality of design or craftsmanship as well as not visible from the public right-of-way. | Poor: North path may be retained and/or reconfigured as necessary for new use. Brick paving should be salvaged and reused to the extent possible. |

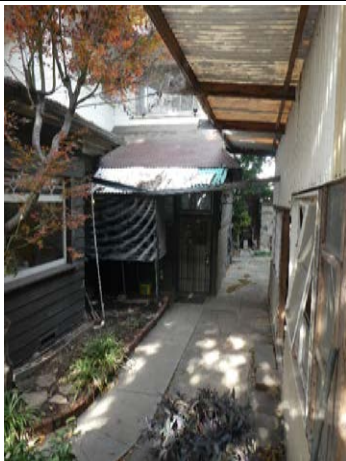
| Type | Feature | Photo (If Applicable) | Importance: Reason | Condition: Treatment |
|---|---|---|---|---|
| Circulation | East Path <ul style="list-style-type: none"> <li>Located to east of residence</li> <li>Concrete or flagstone paving, depending on location</li> </ul> | | Secondary: Dates from the period of significance under Criteria 1 and 3 and retains integrity overall, but functional feature that does not display quality of design or craftsmanship as well as not visible from the public right-of-way. | Good: East path may be retained and/or reconfigured as necessary for new use. Flagstone paving should be salvaged and reused to the extent possible. |

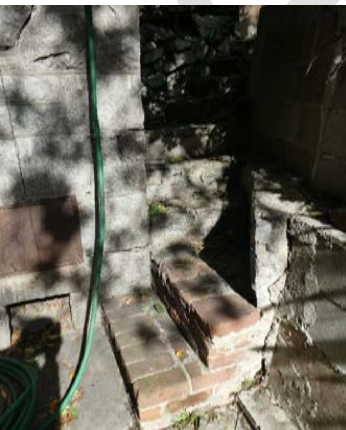
| Type | Feature | Photo (If Applicable) | Importance: Reason | Condition: Treatment |
|---|---|---|---|---|
| | Lower Terrace Steps <ul style="list-style-type: none"> <li>Located adjacent to north property boundary</li> <li>Brick and stone treads and risers</li> </ul> | | Secondary: Dates from the period of significance under Criteria 1 and 3 and retains integrity overall, but functional feature that does not display quality of design or craftsmanship as well as not visible from the public right-of-way. | Good: Lower terrace steps may be retained and/or reconfigured as necessary for new use. Stone and brick paving should be salvaged and reused to the extent possible. |

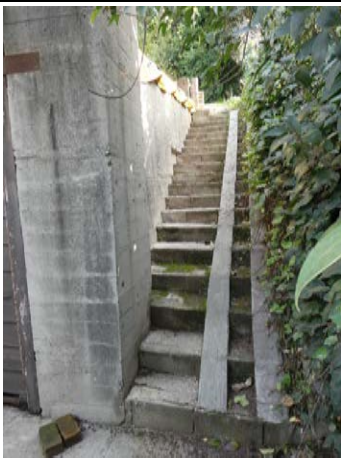
| Type | Feature | Photo (If Applicable) | Importance: Reason | Condition: Treatment |
|---|---|---|---|---|
| Circulation | Upper Terrace Steps <ul style="list-style-type: none"> <li>Located adjacent to south property boundary</li> <li>Concrete treads and risers</li> <li>Concrete curbs</li> </ul> | | Secondary: Dates from the period of significance under Criteria 1 and 3 and retains integrity overall, but functional feature that does not display quality of design or craftsmanship as well as not visible from the public right-of-way. | Good: Upper terrace steps may be retained and/or reconfigured as necessary for new use. Concrete curbs should be retained to the extent possible. |

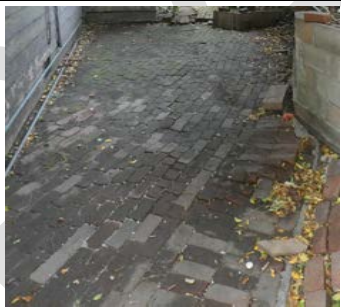
| Type | Feature | Photo (If Applicable) | Importance: Reason | Condition: Treatment |
|---|---|---|---|---|
| | Brick Paving <ul style="list-style-type: none"> <li>Located at north path</li> </ul> | | Secondary: Dates from the period of significance under Criteria 1 and 3 and retains integrity overall, but functional feature that does not display quality of design or craftsmanship as well as not visible from the public right-of-way. | Fair to Poor: Salvage and reuse brick paving to the extent possible. |

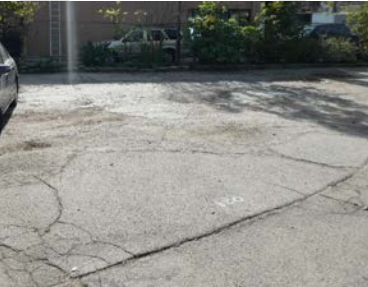
| Type | Feature | Photo (If Applicable) | Importance: Reason | Condition: Treatment |
|---|---|---|---|---|
| | Asphalt <ul style="list-style-type: none"> <li>Located at surface parking lot and driveway</li> </ul> | | Secondary: Dates from the period of significance under Criterion 1 and retains integrity overall, but functional feature that does not display quality of design or craftsmanship. | Poor: Asphalt paving may be removed and/or replaced with new compatible material as required for new use. New circulation features and paving materials should be compatible with the historic character of the property. |

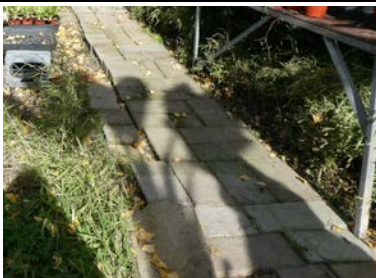
| Type | Feature | Photo (If Applicable) | Importance: Reason | Condition: Treatment |
|---|---|---|---|---|
| Circulation | Concrete Block Paving <ul style="list-style-type: none"> <li>Located at garden paths</li> </ul> | | Secondary: Dates from the period of significance under Criteria 1 and 3 and retains integrity overall, but functional feature that does not display quality of design or craftsmanship as well as not visible from the public right-of-way. | Fair: Concrete block paving may be removed and/or replaced with new compatible material as required for new use. New circulation features and paving materials should be compatible with the historic character of the property. |

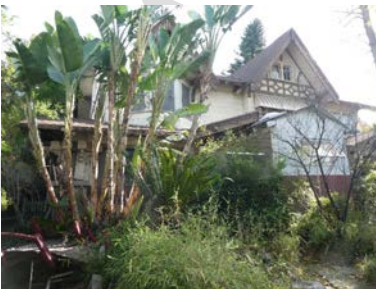
| Type | Feature | Photo (If Applicable) | Importance: Reason | Condition: Treatment |
|---|---|---|---|---|
| | Single-Family Residence <ul style="list-style-type: none"> <li>Located at center of property</li> <li>Two stories in height</li> <li>Irregular in plan</li> <li>Gable roof with projecting cross gables</li> <li>Craftsman style with Tudor Revival features</li> <li>Stone, wood siding, and asbestos shingles</li> </ul> | | Primary: Dates from the period of significance under Criteria 1 and 3, highly visible, and retains integrity. | Fair: Retain residence and repair as necessary. |

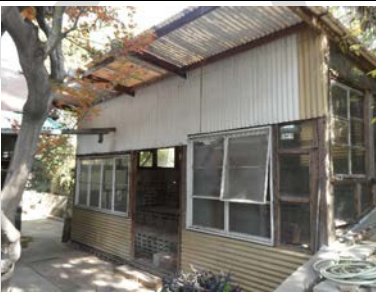
| Type | Feature | Photo (If Applicable) | Importance: Reason | Condition: Treatment |
|---|---|---|---|---|
| Buildings & Structures | Greenhouse <ul style="list-style-type: none"> <li>Located to east of residence</li> <li>One story in height</li> <li>Rectangular in plan</li> <li>Flat roof with awning</li> <li>Corrugated fiberglass and concrete block</li> </ul> | | Secondary: Dates from the period of significance under Criterion 1 and retains integrity overall, but functional feature that does not display quality of design or craftsmanship. | Poor: Greenhouse may be removed and/or replaced with new compatible ancillary building as required for new use. |

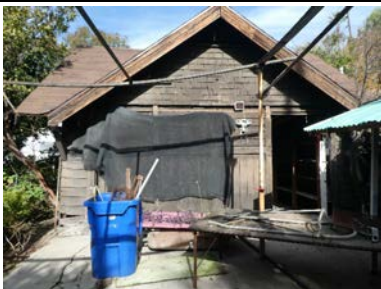
| Type | Feature | Photo (If Applicable) | Importance: Reason | Condition: Treatment |
|---|---|---|---|---|
| Buildings & Structures | <b>Two-Car Garage</b> <ul style="list-style-type: none"> <li>Located at lower terrace</li> <li>One story in height</li> <li>Rectangular in plan</li> <li>Gable roof</li> <li>Wood siding</li> </ul> | | Secondary: Dates from the period of significance under Criteria 1 and 3, and retains integrity, but not visible from the public right-of-way. | Fair to Poor: Retain two-car garage and repair as necessary. If deteriorated beyond repair, two-car garage should be reconstructed using salvaged materials to the extent possible. |

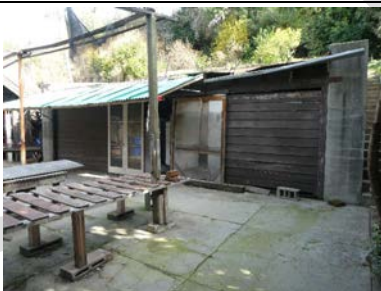
| Type | Feature | Photo (If Applicable) | Importance: Reason | Condition: Treatment |
|---|---|---|---|---|
| | <b>Three-Car Garage</b> <ul style="list-style-type: none"> <li>Located at lower terrace</li> <li>One story in height</li> <li>Rectangular in plan</li> <li>Flat roof with awning</li> <li>Wood siding</li> </ul> | | Not: Post dates period of significance. | Not Applicable: Non-character-defining features may be removed and/or replaced with new compatible ancillary building as required for new use. |

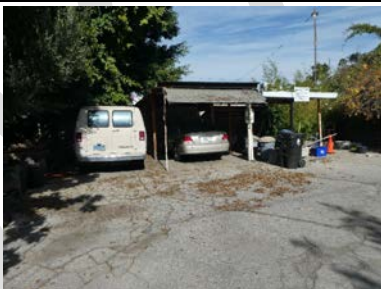
| Type | Feature | Photo (If Applicable) | Importance: Reason | Condition: Treatment |
|---|---|---|---|---|
| | <b>Carport</b> <ul style="list-style-type: none"> <li>Located at surface parking lot</li> <li>One story in height</li> <li>Flat roof with awning</li> <li>Wood or metal columns, depending on location</li> </ul> | | Secondary: Dates from the period of significance under Criterion 1 and retains integrity overall, but functional feature that does not display quality of design or craftsmanship. | Poor: Carport may be removed and/or replaced with new compatible feature as required for new use. |

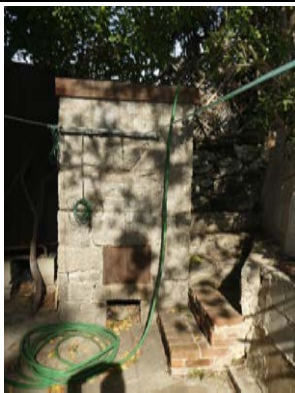
| Type | Feature | Photo (If Applicable) | Importance: Reason | Condition: Treatment |
|---|---|---|---|---|
| Buildings & Structures | Incinerator <ul style="list-style-type: none"> <li>Located to northeast of residence</li> <li>Square in plan</li> <li>Granite</li> </ul> | | Secondary: Dates from the period of significance under Criterion 3 and retains integrity overall, but functional feature that does not display quality of design or craftsmanship. | Fair: Incinerator may be removed and/or replaced with new compatible feature as required for new use. |

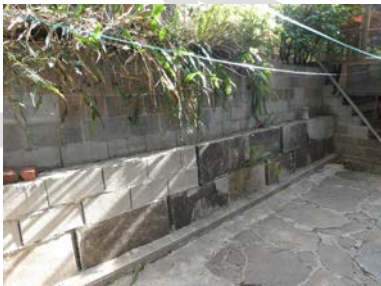
| Type | Feature | Photo (If Applicable) | Importance: Reason | Condition: Treatment |
|---|---|---|---|---|
| | Lower Retaining Wall <ul style="list-style-type: none"> <li>Located to east of residence</li> <li>Concrete block</li> </ul> | | Secondary: Dates from the period of significance under Criteria 1 and 3, and retains integrity, but not visible from the public right-of-way. but functional feature that does not display quality of design or craftsmanship. | Fair: Lower retaining wall may be removed and/or replaced with new compatible feature as required for new use. |

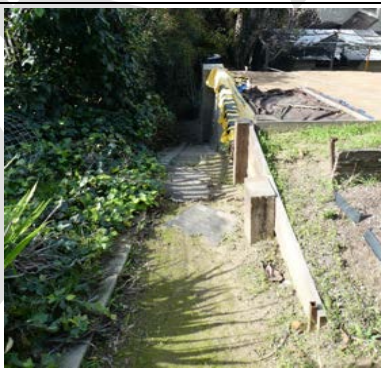
| Type | Feature | Photo (If Applicable) | Importance: Reason | Condition: Treatment |
|---|---|---|---|---|
| | Upper Retaining Wall <ul style="list-style-type: none"> <li>Located to east of lower terrace</li> <li>Board-formed concrete</li> </ul> | | Secondary: Dates from the period of significance under Criteria 1 and 3, and retains integrity, but not visible from the public right-of-way. | Fair: Upper retaining wall may be removed and/or replaced with new compatible feature as required for new use. |

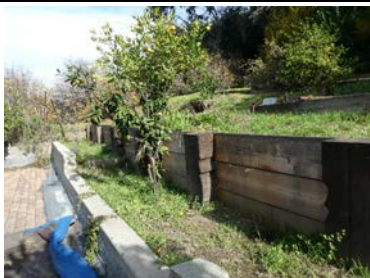
| Type | Feature | Photo (If Applicable) | Importance: Reason | Condition: Treatment |
|---|---|---|---|---|
| Buildings & Structures | Wood Retaining Wall <ul style="list-style-type: none"> <li>• Located at upper terrace</li> <li>• Wood boards</li> </ul> | | Secondary: Dates from the period of significance under Criterion 1 and retains integrity overall, but functional feature that does not display quality of design or craftsmanship. | Fair to Poor: Wood retaining wall may be removed and/or replaced with new compatible feature as required for new use. |

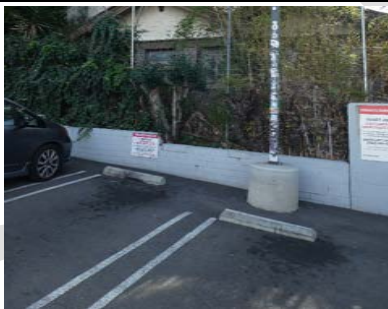
| Type | Feature | Photo (If Applicable) | Importance: Reason | Condition: Treatment |
|---|---|---|---|---|
| | North Perimeter Wall <ul style="list-style-type: none"> <li>• Located at north property boundary</li> <li>• Concrete block</li> </ul> | | Not: Post dates period of significance. | Not Applicable: Non-character-defining features may be removed and/or replaced as required for new use. |

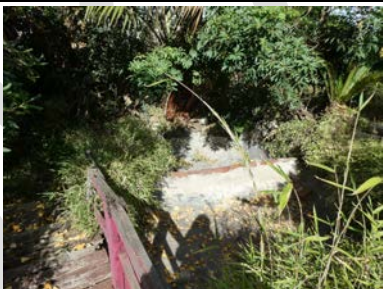
| Type | Feature | Photo (If Applicable) | Importance: Reason | Condition: Treatment |
|---|---|---|---|---|
| Water Features | West Koi Pond <ul style="list-style-type: none"> <li>• Located at north end of Japanese garden</li> <li>• Concrete lining</li> <li>• Brick border</li> </ul> | | Primary: Dates from the period of significance under Criterion 1, highly visible, and retains integrity.<br>Not sure it display quality of design or craftsmanship. | Poor: Reconstruct pond using materials that convey the same visual appearance. |

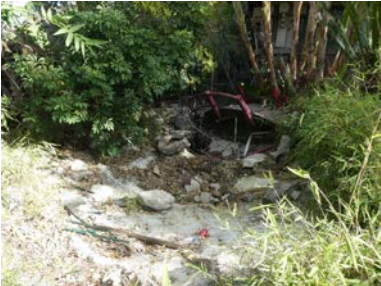
| Type | Feature | Photo (If Applicable) | Importance: Reason | Condition: Treatment |
|---|---|---|---|---|
| Water Features | East Koi Pond <ul style="list-style-type: none"> <li>Located at north end of Japanese garden</li> <li>Concrete lining</li> <li>Stone ornament</li> </ul> | | Primary: Dates from the period of significance under Criterion 1, highly visible, and retains integrity. | Poor: Reconstruct pond using materials that convey the same visual appearance. |

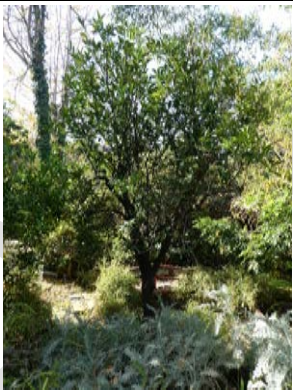
| Type | Feature | Photo (If Applicable) | Importance: Reason | Condition: Treatment |
|---|---|---|---|---|
| | Trees <ul style="list-style-type: none"> <li>Located throughout property</li> <li>Various species of trees</li> </ul> | | Primary: Dates from the period of significance under Criterion 1, highly visible, and retains integrity. | Fair to Poor: Vegetation should be surveyed by a qualified professional and retained to the extent possible. Dead or unhealthy plants may be removed. New vegetation or landscape features should be compatible with the historic character of the property. |

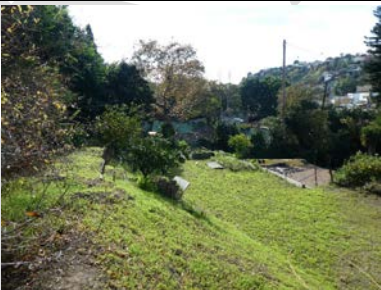
| Type | Feature | Photo (If Applicable) | Importance: Reason | Condition: Treatment |
|---|---|---|---|---|
| Vegetation | Grasses <ul style="list-style-type: none"> <li>Located throughout property</li> <li>Various species of grasses</li> </ul> | | Secondary: Dates from the period of significance under Criterion 1, highly visible, and retains integrity but does not display quality of design as well as not visible from the public right-of-way. | Fair to Poor: Vegetation should be surveyed by a qualified professional and retained to the extent possible. Dead or unhealthy plants may be removed. New vegetation or landscape features should be compatible with the historic character of the property. |

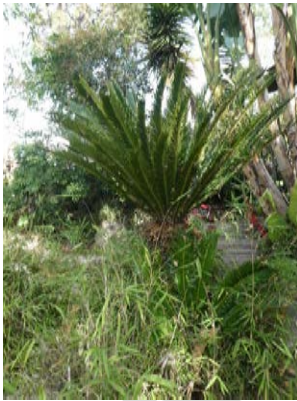
| Type | Feature | Photo (If Applicable) | Importance: Reason | Condition: Treatment |
|---|---|---|---|---|
| Vegetation | Perennial Plants <ul style="list-style-type: none"> <li>Located throughout property</li> <li>Various species of perennial plants</li> </ul> | | Primary: Dates from the period of significance under Criterion 1, highly visible, and retains integrity. | Fair to Poor: Vegetation should be surveyed by a qualified professional and retained to the extent possible. Dead or unhealthy plants may be removed. New vegetation or landscape features should be compatible with the historic character of the property. |

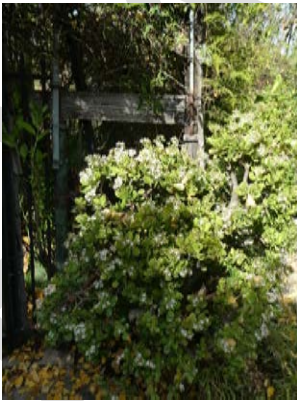
| Type | Feature | Photo (If Applicable) | Importance: Reason | Condition: Treatment |
|---|---|---|---|---|
| | Succulents & Shrubs <ul style="list-style-type: none"> <li>Located throughout property</li> <li>Various species of succulents and shrubs</li> </ul> | | Primary: Dates from the period of significance under Criterion 1, highly visible, and retains integrity. | Fair to Poor: Vegetation should be surveyed by a qualified professional and retained to the extent possible. Dead or unhealthy plants may be removed. New vegetation or landscape features should be compatible with the historic character of the property. |

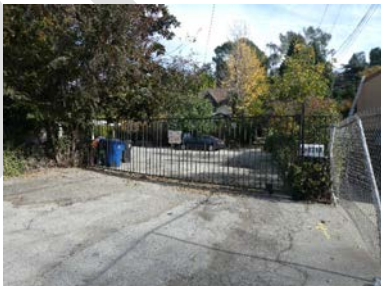
| Type | Feature | Photo (If Applicable) | Importance: Reason | Condition: Treatment |
|---|---|---|---|---|
| Small-Scale Features | Vehicle Gate <ul style="list-style-type: none"> <li>Setback form west property boundary</li> <li>Metal</li> <li>Sliding</li> </ul> | | Secondary: Dates from the period of significance under Criterion 1 and retains integrity overall, but functional feature that does not display quality of design or craftsmanship. | Fair: Vehicle gate may be removed and/or replaced with new compatible feature as required for new use. |

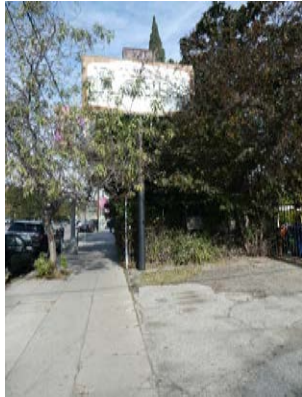
| Type | Feature | Photo (If Applicable) | Importance: Reason | Condition: Treatment |
|---|---|---|---|---|
| Small-Scale Features | <b>Pole Sign</b> <ul style="list-style-type: none"> <li>Located at west property boundary</li> <li>Metal pole</li> <li>Rectangular signage</li> <li>Lettering reads "Tokio Florist, Flowers for All Occasions"</li> </ul> | | Primary: Dates from the period of significance under Criterion 1, highly visible, and retains integrity. | Good: Retain existing pole sign and repair as necessary. |

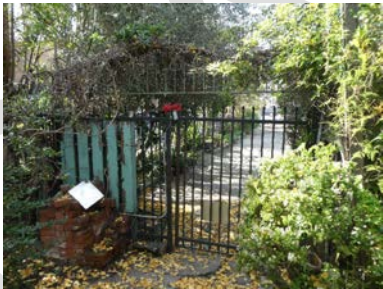
| Type | Feature | Photo (If Applicable) | Importance: Reason | Condition: Treatment |
|---|---|---|---|---|
| | <b>Main Entrance Gate</b> <ul style="list-style-type: none"> <li>Located to southeast of surface parking lot</li> <li>Metal pickets</li> <li>Swinging</li> </ul> | | Secondary: Dates from the period of significance under Criterion 1 and retains integrity overall, but functional feature that does not display quality of design or craftsmanship. | Fair to Poor: Main entrance gate may be removed and/or replaced with new compatible feature as required for new use. |

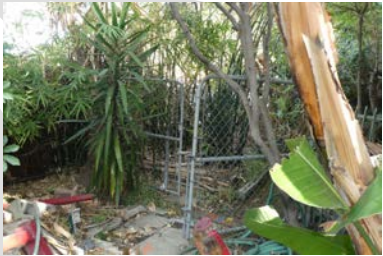
| Type | Feature | Photo (If Applicable) | Importance: Reason | Condition: Treatment |
|---|---|---|---|---|
| | <b>Side Entrance Gate</b> <ul style="list-style-type: none"> <li>Located to northeast of Japanese garden</li> <li>Metal chain-link</li> <li>Swinging</li> </ul> | | Secondary: Dates from the period of significance under Criterion 1 and retains integrity overall, but functional feature that does not display quality of design or craftsmanship. | Fair: Side entrance gate may be removed and/or replaced with new compatible feature as required for new use. |

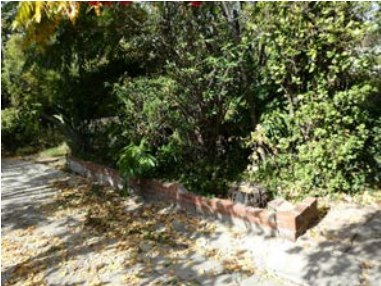
| Type | Feature | Photo (If Applicable) | Importance: Reason | Condition: Treatment |
|---|---|---|---|---|
| Small-Scale Features | <b>Brick Curbs</b> <ul style="list-style-type: none"> <li>Located throughout property</li> <li>Bordering landscape</li> <li>Common red brick</li> </ul> | | Secondary: Dates from the period of significance under Criterion 1 and retains integrity overall, but functional feature that does not display quality of design or craftsmanship. | Fair: Brick curbs may be removed and/or replaced with new compatible feature as required for new use. |

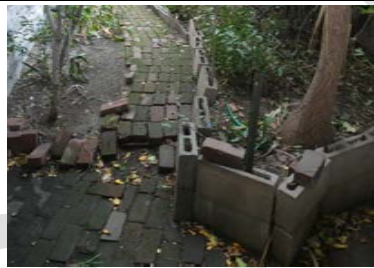
| Type | Feature | Photo (If Applicable) | Importance: Reason | Condition: Treatment |
|---|---|---|---|---|
| | <b>Concrete Block Curbs</b> <ul style="list-style-type: none"> <li>Located throughout property</li> <li>Bordering landscape</li> </ul> | | Secondary: Dates from the period of significance under Criterion 1 and retains integrity overall, but functional feature that does not display quality of design or craftsmanship. | Fair to Poor: Concrete block curbs may be removed and/or replaced with new compatible feature as required for new use. |

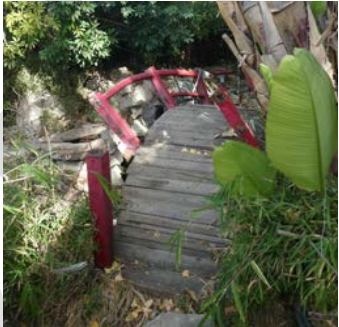
| Type | Feature | Photo (If Applicable) | Importance: Reason | Condition: Treatment |
|---|---|---|---|---|
| | <b>Foot Bridges</b> <ul style="list-style-type: none"> <li>Located at east and west koi ponds</li> <li>Wood plank decking</li> <li>Wood railing</li> </ul> | | Primary: Dates from the period of significance under Criterion 1, highly visible, and retains integrity. | Poor: Reconstruct foot bridges using materials that convey the same visual appearance. |

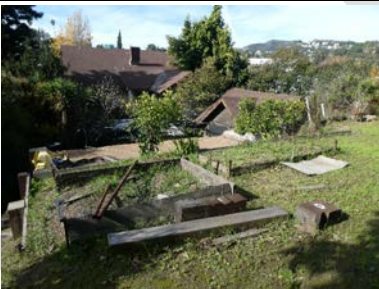
| Type | Feature | Photo (If Applicable) | Importance: Reason | Condition: Treatment |
|---|---|---|---|---|
| | Wood Raised Planters <ul style="list-style-type: none"> <li>Located at upper terrace</li> <li>Wood plank</li> </ul> | | Secondary: Dates from the period of significance under Criterion 1 and retains integrity overall, but functional feature that does not display quality of design or craftsmanship. | Poor: Wood raised planters may be removed to accommodate new use. |

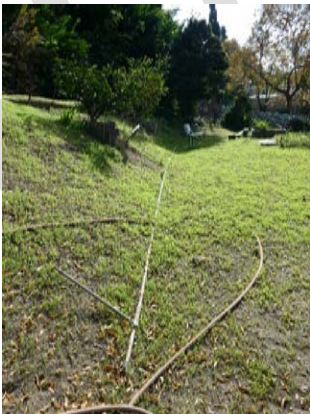
| Type | Feature | Photo (If Applicable) | Importance: Reason | Condition: Treatment |
|---|---|---|---|---|
| | Irrigation System <ul style="list-style-type: none"> <li>Located at upper terrace</li> <li>Metal pipes</li> </ul> | | Secondary: Dates from the period of significance under Criterion 1 and retains integrity overall, but functional feature that does not display quality of design or craftsmanship. | Fair to Poor: Irrigation system may be removed and/or replaced with new compatible feature as required for new use. |

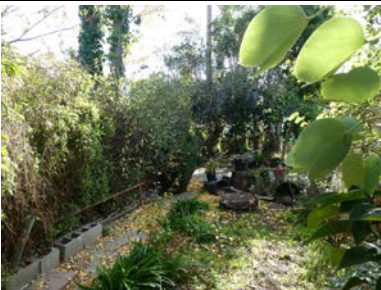
| Type | Feature | Photo (If Applicable) | Importance: Reason | Condition: Treatment |
|---|---|---|---|---|
| Small-Scale Features | Pipe Railing <ul style="list-style-type: none"> <li>Located to east of surface parking lot</li> <li>Metal</li> </ul> | | Secondary: Dates from the period of significance under Criterion 1 and retains integrity overall, but functional feature that does not display quality of design or craftsmanship. | Fair: Pipe railing may be removed and/or replaced with new compatible feature as required for new use. |

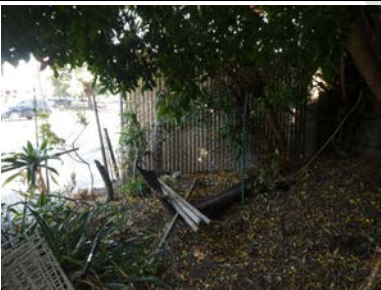
| Type | Feature | Photo (If Applicable) | Importance: Reason | Condition: Treatment |
|---|---|---|---|---|
| | Perimeter Fencing <ul style="list-style-type: none"> <li>Located at perimeter of property</li> <li>Metal chain-link, metal wire, wood trellis, or metal-and-wood slat, depending on location</li> </ul> | | Secondary: Dates from the period of significance under Criterion 1 and retains integrity overall, but functional feature that does not display quality of design or craftsmanship. | Fair to Poor: Perimeter fencing may be removed and/or replaced with new compatible feature as required for new use. |

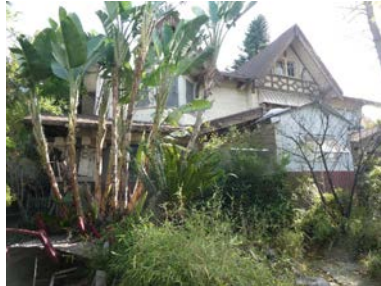
| Type | Feature | Photo (If Applicable) | Importance: Reason | Condition: Treatment |
|---|---|---|---|---|
| Overall Visual Character | Massing <ul style="list-style-type: none"> <li>Irregular plan</li> <li>Two-and-a-half stories</li> <li>Gable roof with projecting cross gables</li> <li>Porch at west elevation</li> <li>Porte-cochère at west elevation</li> </ul> | | Primary: Dates from the period of significance under Criterion 3, highly visible, and retains integrity. | Good: Retain primacy of residence. |

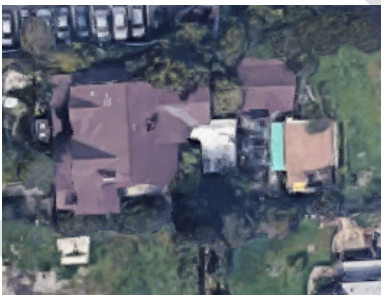
| Type | Feature | Photo (If Applicable) | Importance: Reason | Condition: Treatment |
|---|---|---|---|---|
| | Roof Design <ul style="list-style-type: none"> <li>Gable roof with projecting cross gables</li> <li>Overhanging eaves</li> <li>Exposed rafter tails</li> <li>Decorative brackets</li> <li>Two chimneys</li> </ul> | | Primary: Dates from the period of significance under Criterion 3, highly visible, and retains integrity. | Good: Retain historic roof design. |

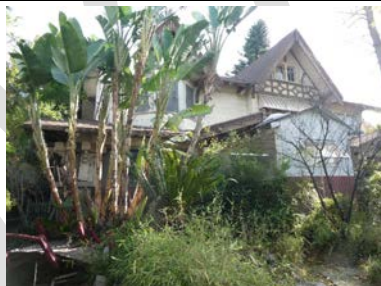
| Type | Feature | Photo (If Applicable) | Importance: Reason | Condition: Treatment |
|---|---|---|---|---|
| | N. Hyperion Avenue (West) Elevation <ul style="list-style-type: none"> <li>Street facing</li> <li>Two-and-a-half stories</li> <li>Asymmetrical composition</li> <li>Craftsman style with Tudor Revival features</li> </ul> | | Primary: Dates from the period of significance under Criterion 3, highly visible, and retains integrity. | Fair: Retain overall elevation design. Enhance integrity of residence by removing non-original features. |

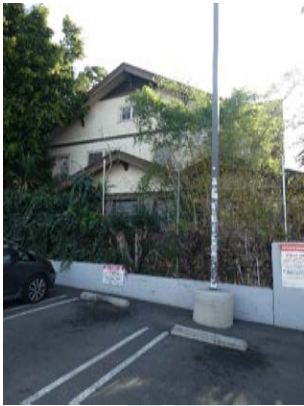
| Type | Feature | Photo (If Applicable) | Importance: Reason | Condition: Treatment |
|---|---|---|---|---|
| Overall Visual Character | North Elevation <ul style="list-style-type: none"> <li>Side facing</li> <li>Two-and-a-half stories</li> <li>Asymmetrical composition</li> <li>Craftsman style with Tudor Revival features</li> </ul> | | Secondary: Dates from the period of significance under Criterion 3 and retains integrity, but not visible from the public right-of-way. | Fair: Retain overall elevation design. Enhance integrity of residence by removing non-original features. |

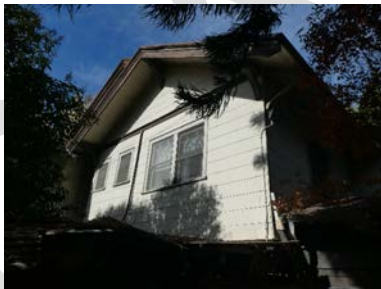
| Type | Feature | Photo (If Applicable) | Importance: Reason | Condition: Treatment |
|---|---|---|---|---|
| | South Elevation <ul style="list-style-type: none"> <li>Side facing</li> <li>Two-and-a-half stories</li> <li>Asymmetrical composition</li> <li>Craftsman style with Tudor Revival features</li> </ul> | | Secondary: Dates from the period of significance under Criterion 3 and retains integrity, but not visible from the public right-of-way. | Fair: Retain overall elevation design. Enhance integrity of residence by removing non-original features. |

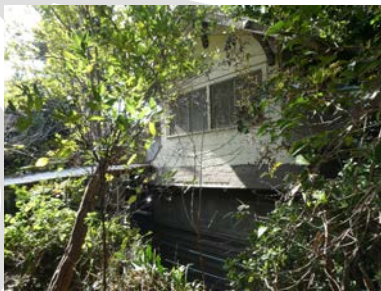
| Type | Feature | Photo (If Applicable) | Importance: Reason | Condition: Treatment |
|---|---|---|---|---|
| | East Elevation <ul style="list-style-type: none"> <li>Rear facing</li> <li>Two-and-a-half stories</li> <li>Asymmetrical composition</li> <li>Craftsman style with Tudor Revival features</li> </ul> | | Secondary: Dates from the period of significance under Criterion 3 and retains integrity, but not visible from the public right-of-way. | Fair: Retain overall elevation design. Enhance integrity of residence by removing non-original features. |

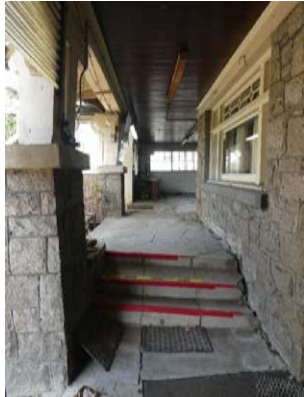
| Type | Feature | Photo (If Applicable) | Importance: Reason | Condition: Treatment |
|---|---|---|---|---|
| Overall Visual Character | Porch <ul style="list-style-type: none"> <li>West elevation</li> <li>One story</li> <li>Shed roof with projecting gable</li> <li>Plywood walls</li> <li>Stone-and-wood columns</li> <li>Scored concrete steps and floor</li> </ul> | | Primary: Dates from the period of significance under Criterion 3, highly visible, and retains integrity. | Poor: Retain porch and repair as necessary. If severity of deterioration requires replacement, refer to appropriate recommended treatment in Section 6.2. |

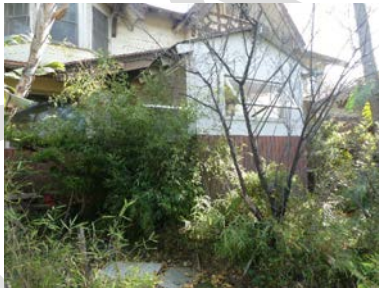
| Type | Feature | Photo (If Applicable) | Importance: Reason | Condition: Treatment |
|---|---|---|---|---|
| | West Addition <ul style="list-style-type: none"> <li>West elevation</li> <li>One story</li> <li>Gable roof</li> <li>Plywood and wood plank siding</li> </ul> | | Secondary: Dates from the period of significance under Criterion 1 and retains integrity overall, but functional feature that does not display quality of design or craftsmanship. | Poor: Non-original features may be removed to enhance integrity of residence under Criterion 3. |

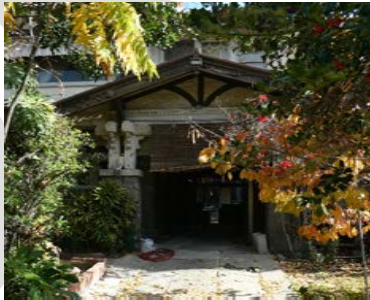
| Type | Feature | Photo (If Applicable) | Importance: Reason | Condition: Treatment |
|---|---|---|---|---|
| | Porte-Cochère <ul style="list-style-type: none"> <li>West elevation</li> <li>One story</li> <li>Gable roof</li> <li>Stone-and-wood columns</li> </ul> | | Primary: Dates from the period of significance under Criterion 3, highly visible, and retains integrity. | Fair: Retain porte-cochère and repair as necessary. |

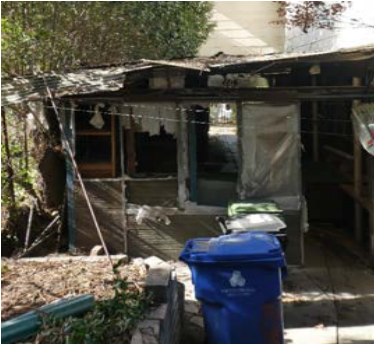
| Type | Feature | Photo (If Applicable) | Importance: Reason | Condition: Treatment |
|---|---|---|---|---|
| Overall Visual Character | South Addition <ul style="list-style-type: none"> <li>• South elevation</li> <li>• One story</li> <li>• Flat roof</li> <li>• Metal columns</li> </ul> | | Secondary: Dates from the period of significance under Criterion 1 and retains integrity overall, but functional feature that does not display quality of design or craftsmanship. | Poor: Non-original features may be removed to enhance integrity of residence under Criterion 3. |

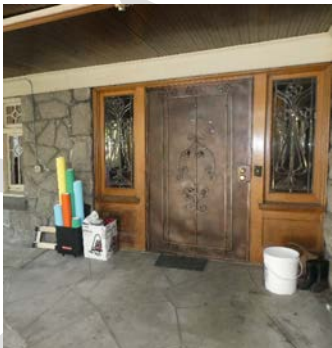
| Type | Feature | Photo (If Applicable) | Importance: Reason | Condition: Treatment |
|---|---|---|---|---|
| | Main Entrance Configuration <ul style="list-style-type: none"> <li>• West elevation</li> <li>• First story</li> <li>• Centralized</li> <li>• Rectangular door opening</li> <li>• Flanked by sidelights</li> </ul> | | Primary: Dates from the period of significance under Criterion 3, highly visible, and retains integrity. | Good: Retain main entrance configuration. Non-original security gate may be removed to enhance integrity of residence. |

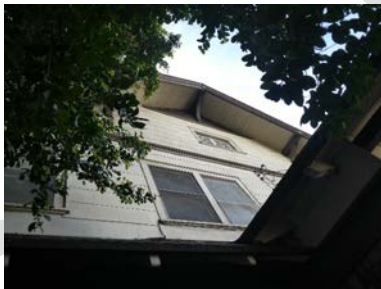
| Type | Feature | Photo (If Applicable) | Importance: Reason | Condition: Treatment |
|---|---|---|---|---|
| | North Elevation Windows (All) <ul style="list-style-type: none"> <li>All stories</li> <li>Paired</li> <li>Singular</li> </ul> | | Secondary: Dates from period of significance under Criterion 3 and retains integrity, but not visible from the public right-of-way. | Good: Retain windows on north elevation and repair as necessary. |

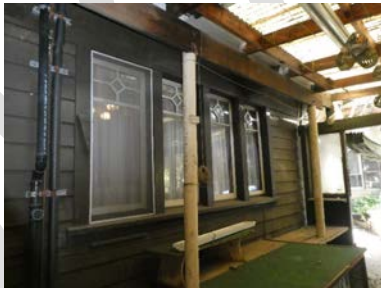
| Type | Feature | Photo (If Applicable) | Importance: Reason | Condition: Treatment |
|---|---|---|---|---|
| | South Elevation Windows (All) <ul style="list-style-type: none"> <li>All stories</li> <li>Row</li> <li>Paired</li> <li>Singular</li> </ul> | | Secondary: Dates from period of significance under Criterion 3 and retains integrity, but not visible from the public right-of-way. | Good: Retain windows on south elevation and repair as necessary. |

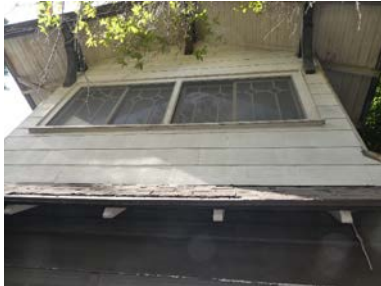
| Type | Feature | Photo (If Applicable) | Importance: Reason | Condition: Treatment |
|---|---|---|---|---|
| Overall Visual Character | East Elevation Windows (All) <ul style="list-style-type: none"> <li>All stories</li> <li>Row</li> <li>Paired</li> <li>Singular</li> <li>Bay</li> </ul> | | Secondary: Dates from period of significance under Criterion 3 and retains integrity, but not visible from the public right-of-way. | Good: Retain windows on east elevation and repair as necessary. |

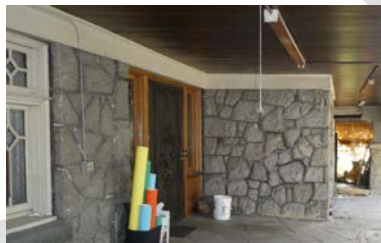
| Type | Feature | Photo (If Applicable) | Importance: Reason | Condition: Treatment |
|---|---|---|---|---|
| Exterior Materials and Craftsmanship | Stone <ul style="list-style-type: none"> <li>West, north, and south elevations</li> <li>First story</li> <li>Cladding</li> </ul> | | Primary: Dates from the period of significance under Criterion 3, highly visible, and retains integrity. | Good to Fair: Retain stone cladding and repair as necessary. |

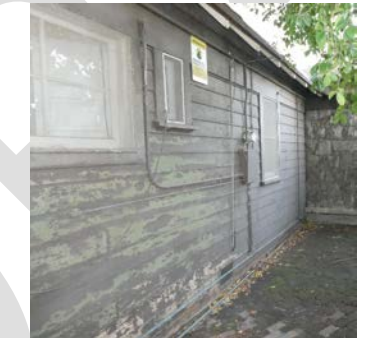
| Type | Feature | Photo (If Applicable) | Importance: Reason | Condition: Treatment |
|---|---|---|---|---|
| | Wood <ul style="list-style-type: none"> <li>All elevations</li> <li>All stories</li> <li>Cladding</li> <li>Ornament</li> <li>Doors</li> <li>Window sashes</li> </ul> | | Primary: Dates from the period of significance under Criterion 3, highly visible, and retains integrity. | Fair to Poor: Retain wood features and cladding and repair as necessary. If severity of deterioration requires replacement, refer to appropriate recommended treatment in Section 6.2. |

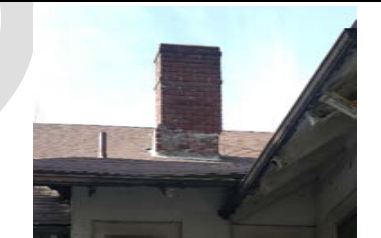
| Type | Feature | Photo (If Applicable) | Importance: Reason | Condition: Treatment |
|---|---|---|---|---|
| | Brick <ul style="list-style-type: none"> <li>Roof and south elevation</li> <li>Chimneys</li> <li>Common red brick</li> </ul> | | Secondary: Dates from period of significance under Criterion 3 and retains integrity, but not visible from the public right-of-way. | Fair to Poor: Retain brick features and repair as necessary. If severity of deterioration requires replacement, refer to appropriate recommended treatment in Section 6.2. |

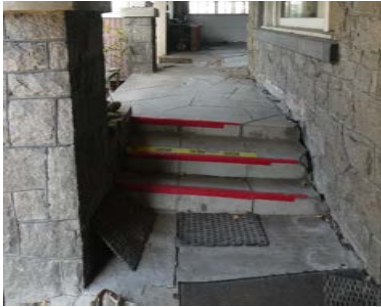
| Type | Feature | Photo (If Applicable) | Importance: Reason | Condition: Treatment |
|---|---|---|---|---|
| Exterior Materials and Craftsmanship | Concrete <ul style="list-style-type: none"> <li>All elevations</li> <li>First story</li> <li>Foundation</li> <li>Window sills</li> <li>Paving</li> </ul> | | Secondary: Dates from period of significance under Criterion 3 and retains integrity, but not visible from the public right-of-way. | Fair to Poor: Retain concrete features and repair as necessary. If severity of deterioration requires replacement, refer to appropriate recommended treatment in Section 6.2. |

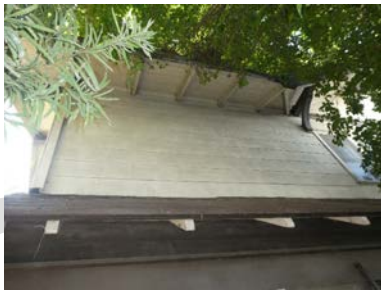
| Type | Feature | Photo (If Applicable) | Importance: Reason | Condition: Treatment |
|---|---|---|---|---|
| | Asbestos <ul style="list-style-type: none"> <li>All elevations</li> <li>Secondary story</li> <li>Cladding</li> </ul> | | Secondary: Dates from the period of significance under Criterion 1 and retains integrity overall, but functional feature that does not display quality of design or craftsmanship. | Fair to Poor: Non-original features may be removed and replaced as required to comply with current code. Retain historic cladding material if extant under non-original asbestos shingles or replace original material in kind if beyond repair. |

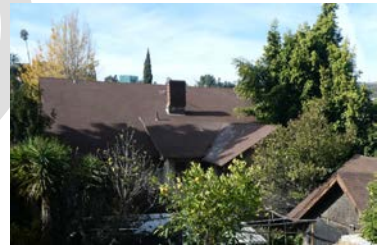
| Type | Feature | Photo (If Applicable) | Importance: Reason | Condition: Treatment |
|---|---|---|---|---|
| | Asphalt <ul style="list-style-type: none"> <li>Roof</li> </ul> | | Secondary: Dates from the period of significance under Criterion 1 and retains integrity overall, but functional feature that does not display quality of design or craftsmanship. | Fair to Poor: Non-original features may be removed and replaced with new compatible material as required to comply with current code and energy efficiency standards. |

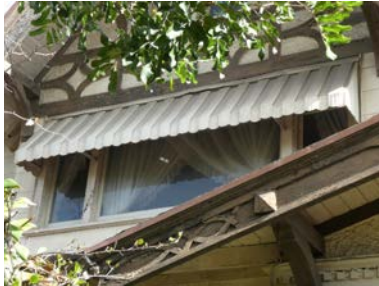
| Type | Feature | Photo (If Applicable) | Importance: Reason | Condition: Treatment |
|---|---|---|---|---|
| Exterior Materials and Craftsmanship | Metal <ul style="list-style-type: none"> <li>West and east elevations</li> <li>First and second stories</li> <li>Awning</li> <li>Security gates</li> </ul> | | Secondary: Dates from the period of significance under Criterion 1 and retains integrity overall, but functional feature that does not display quality of design or craftsmanship. | Good: Non-original features may be removed to enhance integrity of residence under Criterion 3. |

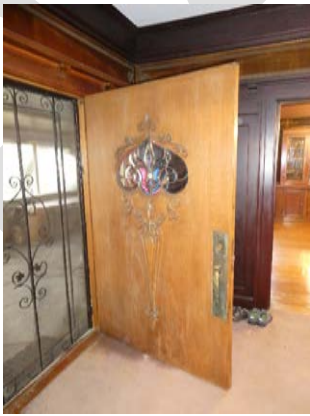
| Type | Feature | Photo (If Applicable) | Importance: Reason | Condition: Treatment |
|---|---|---|---|---|
| | West Elevation – Main Entrance Door <ul style="list-style-type: none"> <li>First story</li> <li>Single</li> <li>Wood slab door</li> <li>Irregularly-shaped beveled-glass light</li> <li>Floral low relief</li> <li>Metal hardware</li> </ul> | | Primary: Dates from the period of significance under Criterion 3, highly visible, and retains integrity. | Fair: Retain existing main entrance door and repair as necessary. |

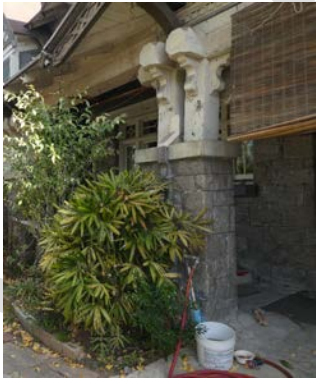
| Type | Feature | Photo (If Applicable) | Importance: Reason | Condition: Treatment |
|---|---|---|---|---|
| | West Elevation – Columns <ul style="list-style-type: none"> <li>First story</li> <li>Porch and porte-cochere</li> <li>Stone</li> <li>Wood</li> </ul> | | Primary: Dates from the period of significance under Criterion 3, highly visible, and retains integrity. | Fair: Retain existing columns and repair as necessary. |

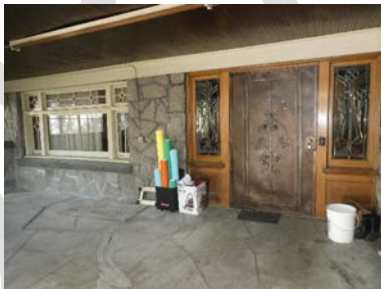
| Type | Feature | Photo (If Applicable) | Importance: Reason | Condition: Treatment |
|---|---|---|---|---|
| | West Elevation – Cornice <ul style="list-style-type: none"> <li>First story</li> <li>Porch</li> <li>Wood</li> </ul> | | Primary: Dates from the period of significance under Criterion 3, highly visible, and retains integrity. | Good: Retain existing cornice and repair as necessary. |

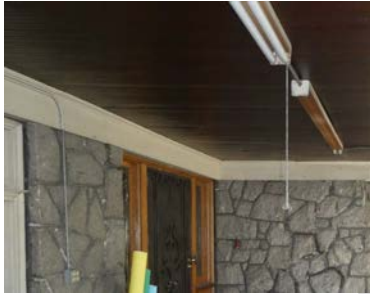
| Type | Feature | Photo (If Applicable) | Importance: Reason | Condition: Treatment |
|---|---|---|---|---|
| Exterior Materials and Craftsmanship | West Elevation – Ceiling <ul style="list-style-type: none"> <li>First story</li> <li>Porch and porte-cochere</li> <li>Wood plank</li> </ul> | | Primary: Dates from the period of significance under Criterion 3, highly visible, and retains integrity. | Good: Retain existing ceiling and repair as necessary. |
| | West Elevation – Fluorescent Lighting <ul style="list-style-type: none"> <li>First story</li> <li>Porch and porte-cochere</li> </ul> | (See Above) | Secondary: Dates from the period of significance under Criterion 1 and retains integrity overall, but functional feature that does not display quality of design or craftsmanship. | Fair: Non-original features may be removed to enhance integrity of residence under Criterion 3. |

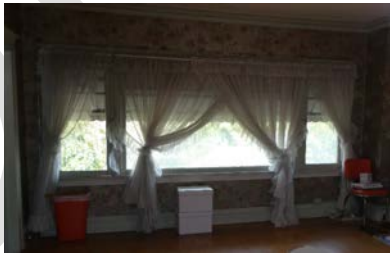
| Type | Feature | Photo (If Applicable) | Importance: Reason | Condition: Treatment |
|---|---|---|---|---|
| | West Elevation – Tripartite Window Sashes <ul style="list-style-type: none"> <li>Second story</li> <li>Fixed center sash</li> <li>Casement side sashes with diamond pattern</li> <li>Wood</li> </ul> | | Primary: Dates from the period of significance under Criterion 3, highly visible, and retains integrity. | Good to Fair: Retain existing window sashes and repair as necessary. |

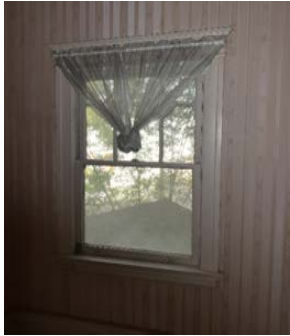
| Type | Feature | Photo (If Applicable) | Importance: Reason | Condition: Treatment |
|---|---|---|---|---|
| Exterior Materials and Craftsmanship | West Elevation – Single-Hung Window Sashes <ul style="list-style-type: none"> <li>• Second story</li> <li>• Single-light lower sash</li> <li>• Diamond-pattern upper sash</li> <li>• Wood</li> </ul> | | Primary: Dates from the period of significance under Criterion 3, highly visible, and retains integrity. | Good to Fair: Retain existing window sashes and repair as necessary. |

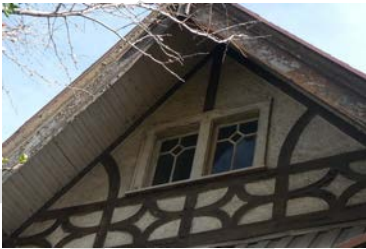
| Type | Feature | Photo (If Applicable) | Importance: Reason | Condition: Treatment |
|---|---|---|---|---|
| | West Elevation – Casement Window Sashes <ul style="list-style-type: none"> <li>• Attic story</li> <li>• Diamond pattern</li> <li>• Wood</li> </ul> | | Primary: Dates from the period of significance under Criterion 3, highly visible, and retains integrity. | Good to Fair: Retain existing window sashes and repair as necessary. |

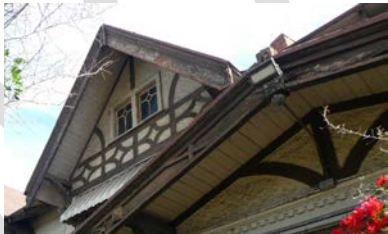
| Type | Feature | Photo (If Applicable) | Importance: Reason | Condition: Treatment |
|---|---|---|---|---|
| | West Elevation – Half-Timbering <ul style="list-style-type: none"> <li>• All stories</li> <li>• Wood</li> </ul> | | Primary: Dates from the period of significance under Criterion 3, highly visible, and retains integrity. | Fair to Poor: Retain existing wood features and repair as necessary. If severity of deterioration requires replacement, refer to appropriate recommended treatment in Section 6.2. |

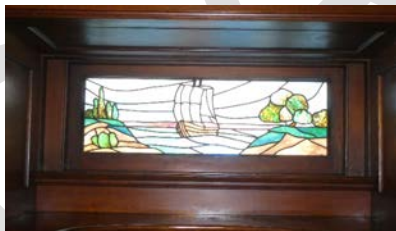
| Type | Feature | Photo (If Applicable) | Importance: Reason | Condition: Treatment |
|---|---|---|---|---|
| | North Elevation – Stained Glass Window <ul style="list-style-type: none"> <li>First story</li> <li>Fixed</li> </ul> | | Primary: Dates from the period of significance under Criterion 3, highly visible, and retains integrity. | Good: Retain existing stained glass window and repair as necessary. |

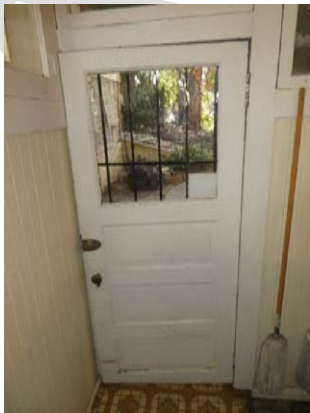
| Type | Feature | Photo (If Applicable) | Importance: Reason | Condition: Treatment |
|---|---|---|---|---|
| | South Elevation – Rear Entrance Door <ul style="list-style-type: none"> <li>First story</li> <li>Single</li> <li>Wood paneled</li> <li>Partially glazed</li> <li>Metal hardware</li> </ul> | | Secondary: Dates from period of significance under Criterion 3 and retains integrity, but not visible from the public right-of-way. | Good to Fair: Retain existing rear entrance door and repair as necessary. |

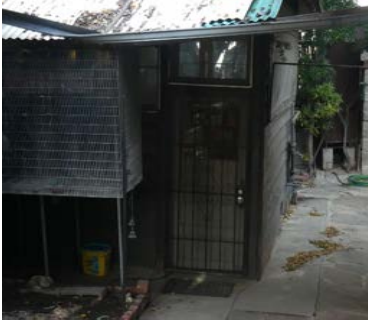
| Type | Feature | Photo (If Applicable) | Importance: Reason | Condition: Treatment |
|---|---|---|---|---|
| Exterior Materials and Craftsmanship | South Elevation – Security Door <ul style="list-style-type: none"> <li>• First story</li> <li>• Metal</li> </ul> | | Secondary: Dates from the period of significance under Criterion 1 and retains integrity overall, but functional feature that does not display quality of design or craftsmanship. | Fair: Non-original features may be removed to enhance integrity of residence under Criterion 3. |

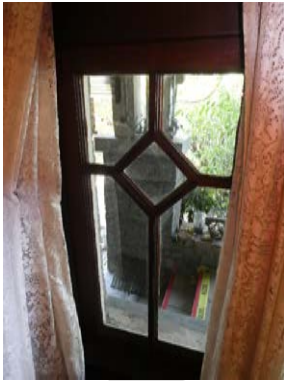
| Type | Feature | Photo (If Applicable) | Importance: Reason | Condition: Treatment |
|---|---|---|---|---|
| Exterior Materials and Craftsmanship | North & South Elevations – Casement Window Sashes <ul style="list-style-type: none"> <li>• First story</li> <li>• Diamond pattern</li> <li>• Wood</li> </ul> | | Secondary: Dates from period of significance under Criterion 3 and retains integrity, but not visible from the public right-of-way. | Fair: Retain existing window sashes and repair as necessary. |

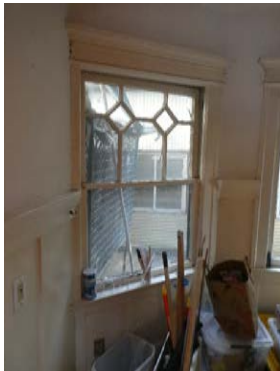
| Type | Feature | Photo (If Applicable) | Importance: Reason | Condition: Treatment |
|---|---|---|---|---|
| Exterior Materials and Craftsmanship | North, South, & West Elevations –<br>Single-Hung Window Sashes <ul style="list-style-type: none"> <li>• First and second stories</li> <li>• Single-light lower sash</li> <li>• Diamond pattern upper sash</li> <li>• Wood</li> </ul> | | Secondary: Dates from period of significance under Criterion 3 and retains integrity, but not visible from the public right-of-way. | Fair: Retain existing window sashes and repair as necessary. |
