GPA Consulting (GPA) was retained to prepare this report to help guide the rehabilitation of the Tokio Florist/Sakai-Kozawa Residence in compliance with the Standards. It includes a summary of the property's significance and history as well as an illustrated inventory of character-defining features and recommendations for treatment. The Tokio Florist/Sakai-Kozawa Residence was exclusively a residential property from 1929 to 1960 and a mixed-use, residential and commercial property from 1960 to 2006. A proposed project involves adaptively reusing the property for commercial office use.

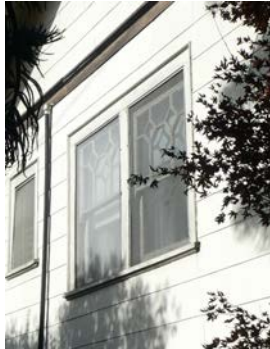
| Type | Feature | Photo (If Applicable) | Importance: Reason | Condition: Treatment |
|---|---|---|---|---|
| Exterior Materials and Craftsmanship | North, South, & West Elevations – Window Frames <ul style="list-style-type: none"> <li>All stories</li> <li>Wood</li> </ul> | | Secondary: Dates from period of significance under Criterion 3 and retains integrity, but not visible from the public right-of-way. | Fair: Retain existing window frames and repair as necessary. |
| | All Elevations – Window Screens <ul style="list-style-type: none"> <li>All stories</li> </ul> | (See Above) | Secondary: Dates from the period of significance under Criterion 1 and retains integrity overall, but functional feature that does not display quality of design or craftsmanship. | Fair: Non-original features may be removed to enhance integrity of residence under Criterion 3. |

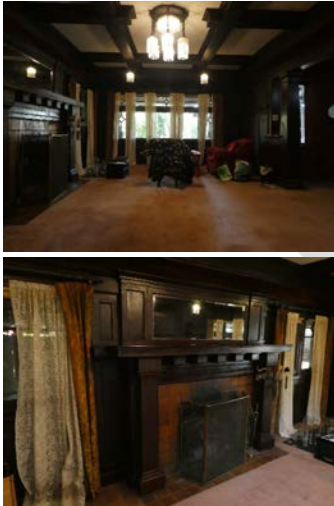
| Type | Feature | Photo (If Applicable) | Importance: Reason | Condition: Treatment |
|---|---|---|---|---|
| Interior Spaces, Features, and Finishes | First Floor – Living Room<br>Original Space, Features, & Finishes <ul style="list-style-type: none"> <li>• Located to south of foyer</li> <li>• Wood paneling</li> <li>• Fireplace with wood-and-tile mantle</li> <li>• Velvet flocked wallpaper border</li> <li>• Wood crown molding</li> <li>• Wood door and window casings</li> <li>• Coffered plaster-and-wood ceiling</li> <li>• Chandelier light fixtures</li> </ul> | | Primary: Dates from the period of significance under Criterion 3, highly visible, and retains integrity. | Good to Fair: Retain original space, features, and finishes, and repair as necessary. If severity of deterioration requires replacement, refer to appropriate recommended treatment in Section 6.2. |
| | First Floor – Living Room<br>Non-Original Features & Finishes <ul style="list-style-type: none"> <li>• Carpet</li> </ul> | | Secondary: Dates from the period of significance under Criterion 1 and retains integrity overall, but functional feature that does not display quality of design or craftsmanship. | Fair: Non-original features may be removed to enhance integrity of residence under Criterion 3. Retain historic wood plank floor if extant under non-original carpeting. |

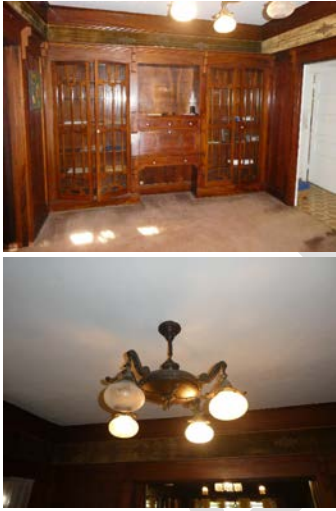
| Type | Feature | Photo (If Applicable) | Importance: Reason | Condition: Treatment |
|---|---|---|---|---|
| Interior Spaces, Features, and Finishes | First Floor – Family Room<br>Original Space, Features, & Finishes <ul style="list-style-type: none"> <li>• Located to east of living room</li> <li>• Wood paneling</li> <li>• Built-in wood cabinetry</li> <li>• Velvet flocked wallpaper border</li> <li>• Wood crown molding</li> <li>• Wood door and window casings</li> <li>• Plaster ceiling</li> <li>• Chandelier light fixture</li> </ul> | | Primary: Dates from the period of significance under Criterion 3, highly visible, and retains integrity. | Good to Poor: Retain original space, features, and finishes, and repair as necessary. If severity of deterioration requires replacement, refer to appropriate recommended treatment in Section 6.2. |
| | First Floor – Family Room<br>Non-Original Features & Finishes <ul style="list-style-type: none"> <li>• Carpet</li> </ul> | | Secondary: Dates from the period of significance under Criterion 1 and retains integrity overall, but functional feature that does not display quality of design or craftsmanship. | Fair: Non-original features may be removed to enhance integrity of residence under Criterion 3. Retain historic wood plank floor if extant under non-original carpeting. |

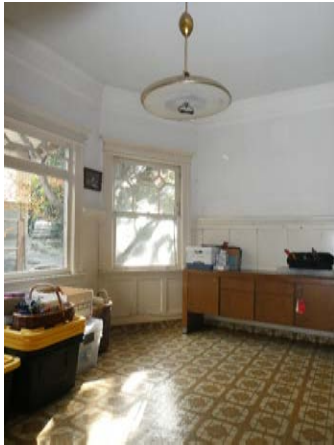
| Type | Feature | Photo (If Applicable) | Importance: Reason | Condition: Treatment |
|---|---|---|---|---|
| Interior Spaces, Features, and Finishes | First Floor – Breakfast Room<br>Original Space, Features, & Finishes <ul style="list-style-type: none"> <li>• Located to east of family room</li> <li>• Board and batten wainscoting</li> <li>• Plaster walls</li> <li>• Wood crown molding</li> <li>• Wood door and window casings</li> <li>• Plaster ceiling</li> </ul> | | Secondary: Dates from the period of significance under Criterion 3 and retains integrity overall, but functional space that services the building. | Good to Fair: Retain original space. Retain original features, and finishes to the extent possible, and repair as necessary. Alterations to secondary spaces, features, finishes, or materials may be permitted if necessary for new use. |
| | First Floor – Breakfast Room<br>Non-Original Features & Finishes <ul style="list-style-type: none"> <li>• Vinyl flooring</li> <li>• Hanging light fixture</li> </ul> | | Secondary: Dates from the period of significance under Criterion 1 and retains integrity overall, but functional feature that does not display quality of design or craftsmanship. | Fair: Non-original features may be removed to enhance integrity of residence under Criterion 3. |

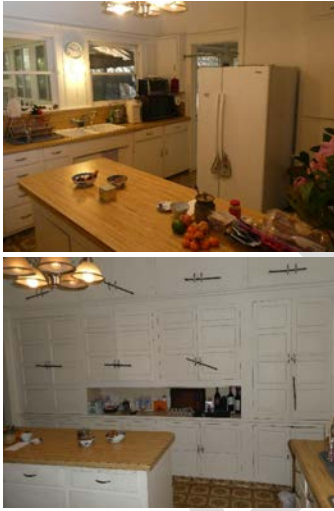
| Type | Feature | Photo (If Applicable) | Importance: Reason | Condition: Treatment |
|---|---|---|---|---|
| Interior Spaces, Features, and Finishes | First Floor – Kitchen<br>Original Space, Features, & Finishes <ul style="list-style-type: none"> <li>• Located to east of dining room</li> <li>• Wood treads and risers</li> <li>• Built-in cabinetry</li> <li>• Plaster walls</li> <li>• Wood door and window casings</li> <li>• Plaster ceiling</li> </ul> | | Secondary: Dates from the period of significance under Criterion 3 and retains integrity overall, but functional space that services the building. | Good to Fair: Retain original space. Retain original features, and finishes to the extent possible, and repair as necessary. Alterations to secondary spaces, features, finishes, or materials may be permitted if necessary for new use. |
| | First Floor – Kitchen<br>Non-Original Features & Finishes <ul style="list-style-type: none"> <li>• Vinyl flooring</li> <li>• Kitchen counters</li> <li>• Hanging light fixture</li> </ul> | | Secondary: Dates from the period of significance under Criterion 1 and retains integrity overall, but functional feature that does not display quality of design or craftsmanship. | Fair: Non-original features may be removed to enhance integrity of residence under Criterion 3. |

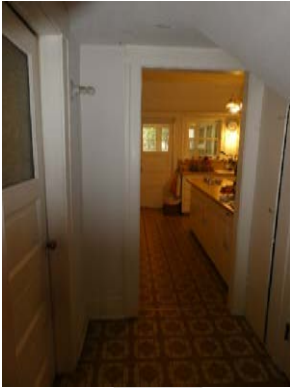
| Type | Feature | Photo (If Applicable) | Importance: Reason | Condition: Treatment |
|---|---|---|---|---|
| Interior Spaces, Features, and Finishes | First Floor – Kitchen Foyer<br>Original Space, Features, & Finishes <ul style="list-style-type: none"> <li>Located to east of dining room</li> <li>Wood baseboard</li> <li>Plaster walls</li> <li>Wood door casings</li> <li>Plaster ceiling</li> </ul> | | Secondary: Dates from the period of significance under Criterion 3 and retains integrity overall, but functional space that services the building. | Good to Fair: Retain original space. Retain original features, and finishes to the extent possible, and repair as necessary. Alterations to secondary spaces, features, finishes, or materials may be permitted if necessary for new use. |
| | First Floor – Kitchen Foyer<br>Non-Original Features & Finishes <ul style="list-style-type: none"> <li>Vinyl flooring</li> </ul> | (See Above) | Secondary: Dates from the period of significance under Criterion 1 and retains integrity overall, but functional feature that does not display quality of design or craftsmanship. | Fair: Non-original features may be removed to enhance integrity of residence under Criterion 3. |

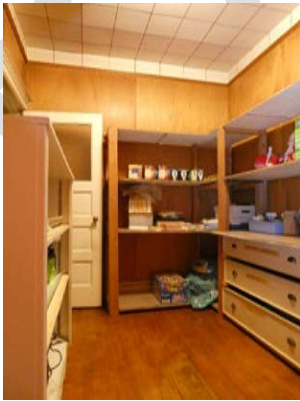
| Type | Feature | Photo (If Applicable) | Importance: Reason | Condition: Treatment |
|---|---|---|---|---|
| | First Floor – Bedroom A<br>Original Space, Features, & Finishes <ul style="list-style-type: none"> <li>Located to north of kitchen foyer</li> <li>Wood plank floor</li> <li>Wood door and window casings</li> </ul> | | Secondary: Dates from the period of significance under Criterion 3 and retains integrity overall, but functional space that services the building. | Good to Fair: Retain original space. Retain original features, and finishes to the extent possible, and repair as necessary. Alterations to secondary spaces, features, finishes, or materials may be permitted if necessary for the building's new use. |

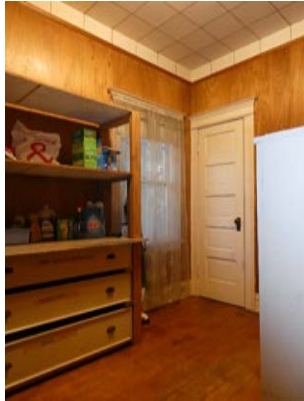
| Type | Feature | Photo (If Applicable) | Importance: Reason | Condition: Treatment |
|---|---|---|---|---|
| Interior Spaces, Features, and Finishes | First Floor – Bedroom A<br>Non-Original Features, & Finishes <ul style="list-style-type: none"> <li>• Wood veneer wall paneling</li> <li>• Acoustic tile ceiling</li> </ul> | | Secondary: Dates from the period of significance under Criterion 1 and retains integrity overall, but functional feature that does not display quality of design or craftsmanship. | Fair: Non-original features may be removed to enhance integrity of residence under Criterion 3. |

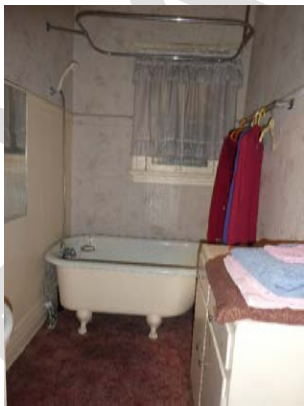
| Type | Feature | Photo (If Applicable) | Importance: Reason | Condition: Treatment |
|---|---|---|---|---|
| | First Floor – Bathroom A<br>Original Space, Features, & Finishes <ul style="list-style-type: none"> <li>• Clawfoot tub</li> <li>• Pedestal sink</li> <li>• Built-in cabinets</li> <li>• Wood plank wall paneling</li> <li>• Plaster walls and ceiling</li> </ul> | | Secondary: Dates from the period of significance under Criterion 3 and retains integrity overall, but functional space that services the building. | Good to Fair: Bathrooms may be updated or removed as necessary for new use. |
| | First Floor – Bathroom A<br>Non-Original Features & Finishes <ul style="list-style-type: none"> <li>• Carpeting</li> <li>• Wallpaper</li> </ul> | (See Above) | Secondary: Dates from the period of significance under Criterion 1 and retains integrity overall, but functional feature that does not display quality of design or craftsmanship. | Fair: Non-original features may be removed to enhance integrity of residence under Criterion 3. Retain original flooring if extant under non-original carpet. |

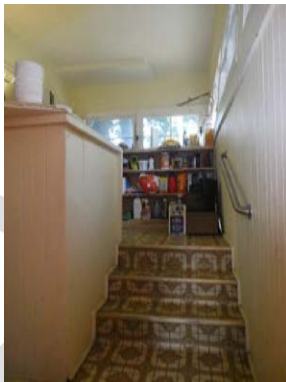
| Type | Feature | Photo (If Applicable) | Importance: Reason | Condition: Treatment |
|---|---|---|---|---|
| Interior Spaces, Features, and Finishes | First Floor – Service Porch<br>Original Space, Features, & Finishes <ul style="list-style-type: none"> <li>• Located to east of kitchen</li> <li>• Wood plank railing</li> <li>• Wood plank wall paneling</li> <li>• Wood door and window casings</li> <li>• Plaster walls and ceiling</li> </ul> | | Secondary: Dates from the period of significance under Criterion 3 and retains integrity overall, but functional space that services the building. | Good to Fair: Retain original space. Retain original features, and finishes to the extent possible, and repair as necessary. Alterations to secondary spaces, features, finishes, or materials may be permitted if necessary for new use. |
| | First Floor – Service Porch<br>Non-Original Features & Finishes <ul style="list-style-type: none"> <li>• Vinyl flooring</li> <li>• Metal handrail</li> <li>• Fluorescent light fixtures</li> </ul> | | Secondary: Dates from the period of significance under Criterion 1 and retains integrity overall, but functional feature that does not display quality of design or craftsmanship. | Fair: Non-original features may be removed to enhance integrity of residence under Criterion 3. |

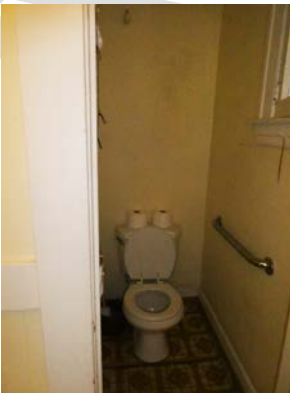
| Type | Feature | Photo (If Applicable) | Importance: Reason | Condition: Treatment |
|---|---|---|---|---|
| | First Floor – Bathroom B<br>Original Space, Features, & Finishes <ul style="list-style-type: none"> <li>• Located to northwest of service porch</li> <li>• Porcelain sink</li> <li>• Plaster walls and ceiling</li> </ul> | | Secondary: Dates from the period of significance under Criterion 3 and retains integrity overall, but functional space that services the building. | Good to Fair: Bathrooms may be updated or removed as necessary for the building's new use. |

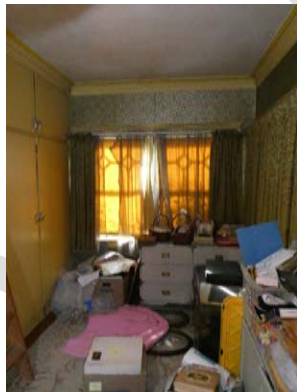
| Type | Feature | Photo (If Applicable) | Importance: Reason | Condition: Treatment |
|---|---|---|---|---|
| | Second Floor – Walk-In Closet<br>Original Space, Features, & Finishes <ul style="list-style-type: none"> <li>Located to south of Bedroom C</li> <li>Wood plank floor</li> <li>Wood baseboard</li> <li>Plaster walls</li> <li>Wood crown molding</li> <li>Built-in wood cabinetry</li> <li>Wood door and window casings</li> <li>Plaster ceiling</li> </ul> | | Secondary: Dates from the period of significance under Criterion 3 and retains integrity overall, but private space that is less visible. | Good to Fair: Retain original space. Retain original features, and finishes to the extent possible, and repair as necessary. Alterations to secondary spaces, features, finishes, or materials may be permitted if necessary for new use. |
| | Second Floor – Walk-In Closet<br>Non-Original Features & Finishes <ul style="list-style-type: none"> <li>Wall paper</li> </ul> | (See Above) | Secondary: Dates from the period of significance under Criterion 1 and retains integrity overall, but functional feature that does not display quality of design or craftsmanship. | Fair: Non-original features may be removed to enhance integrity of residence under Criterion 3. |

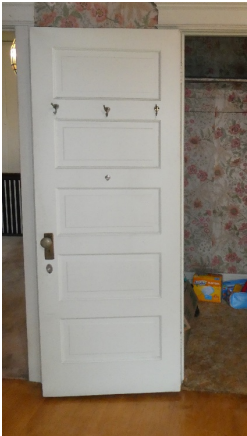
| Type | Feature | Photo (If Applicable) | Importance: Reason | Condition: Treatment |
|---|---|---|---|---|
| Interior Spaces, Features, and Finishes | <b>Door C</b> <ul style="list-style-type: none"> <li>Located throughout first and second</li> <li>Multi-paneled</li> <li>Wood</li> <li>Metal hardware</li> </ul> | | Secondary: Dates from the period of significance under Criterion 3 and retains integrity overall, but located in private and functional spaces that service the building. | Good: Retain original features, and repair as necessary. |
