GROUP DELTA

February 12, 2015
GDC Project LA-1183E

Subject: RESPONSE TO CITY OF LOS ANGELES GEOLOGY CORRECTION LETTER #85579
Reference: Fault Activity Investigation
Yucca-Argyle Apartments - Champion Site
SE Corner of Yucca Street and Argyle Avenue
1756 and 1760 Argyle Avenue
Hollywood District, City of Los Angeles, California

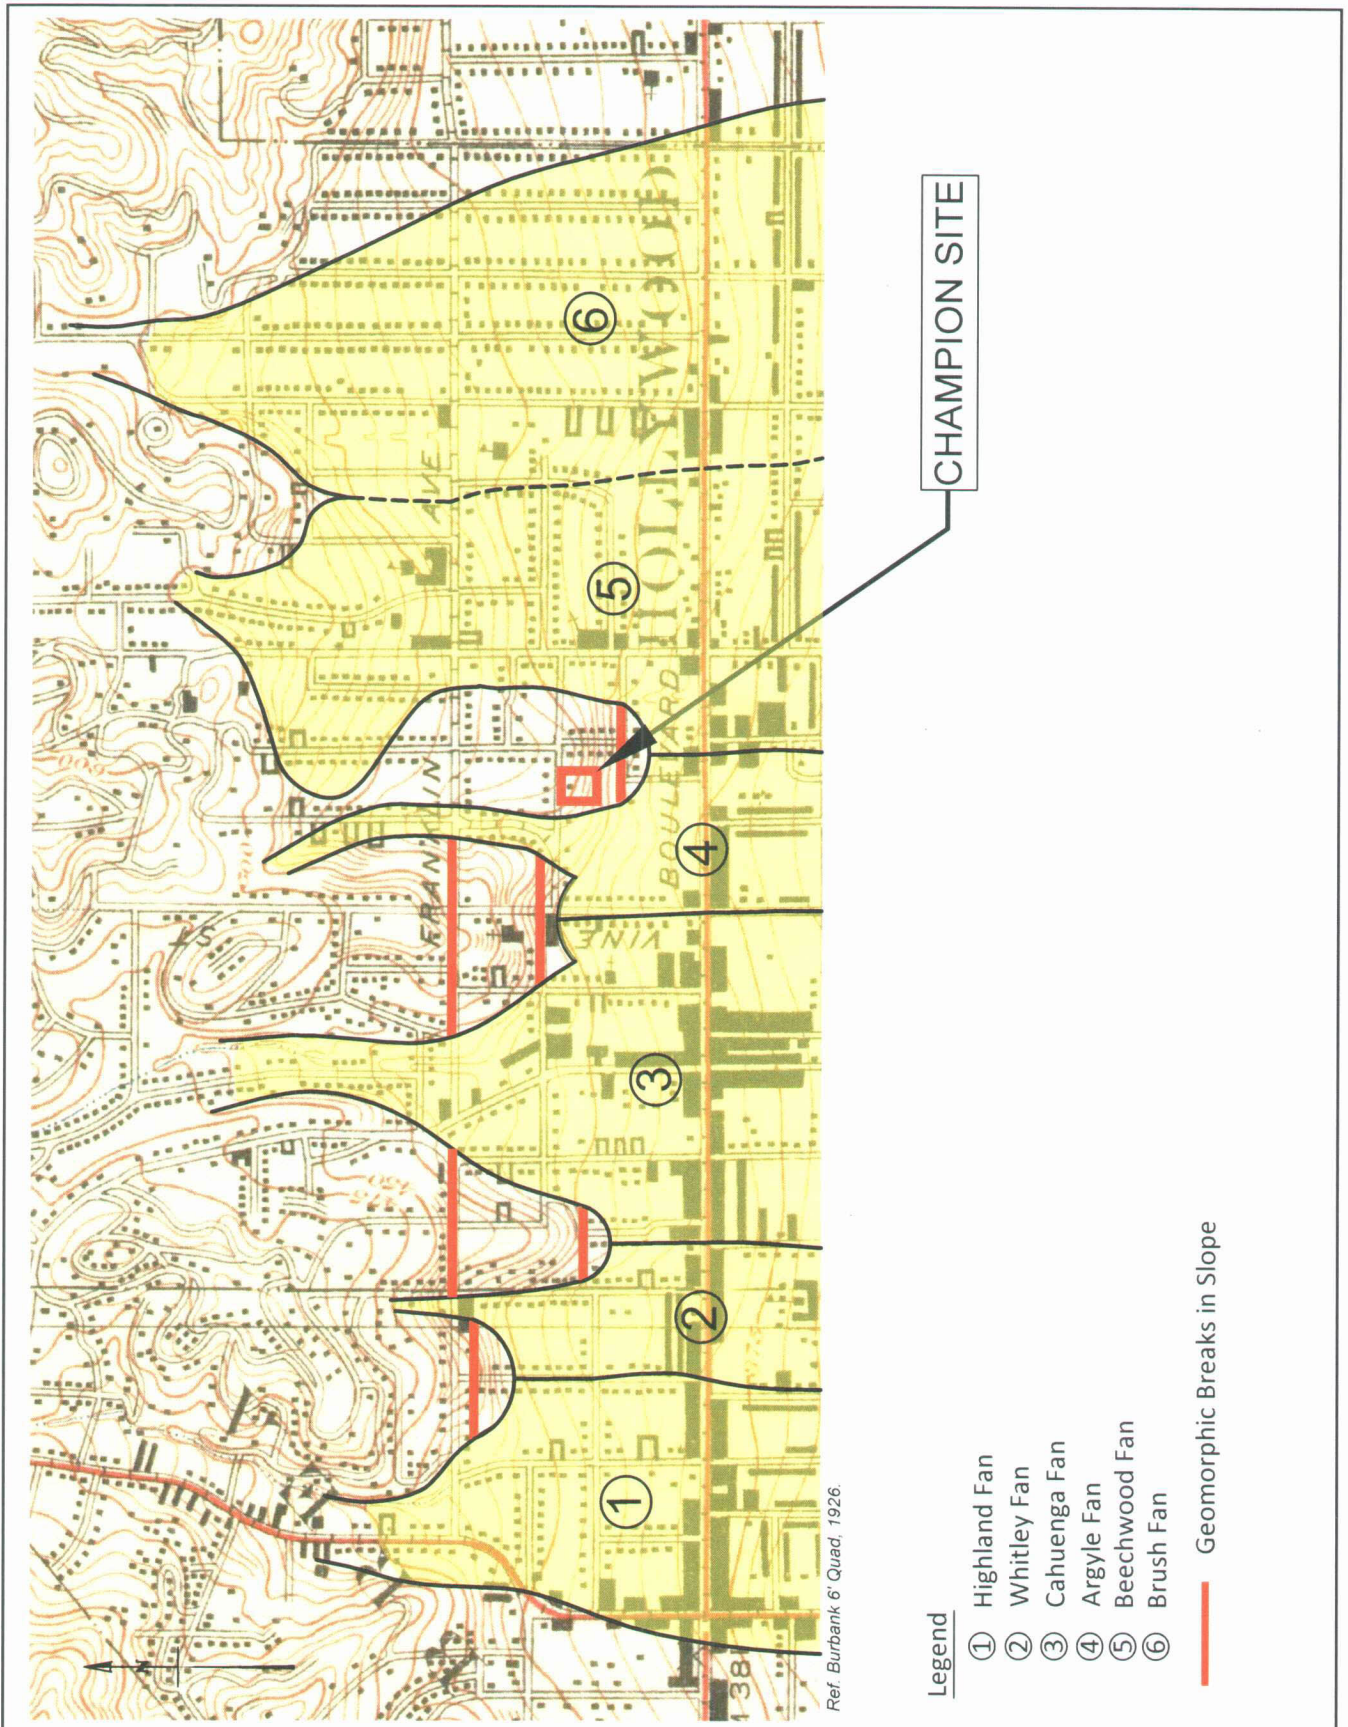
GROUP DELTA CONSULTANTS, INC 370 Amapola Ave. Suite 212 Torrance, CA. 90501	MAP ILLUSTRATING GEOMORPHIC FEATURES NEAR THE CHAMPION SITE		PROJECT NUMBER LA1183E
REVISION 10/31/2014	APPROVED BY SK				SCALE NO SCALE
REVISION 2/6/2015	Modified from GDC, 2014a		CHAMPION SITE		FIGURE NUMBER 5

Figure 5 of the report shows a lineament of truncated ridges north of the site. As indicated in the comment above, the original 1926 map provides a good resource to assess the natural topography of the site area. This topographic map shows several other truncated ridges outside of the lineament. Revise the figure at a more detailed scale that shows all of the truncated ridges in the area, as well other significant geomorphic features. Based on Comment 6, the geomorphology to the east and northeast should be assessed in detail. Show the alluvial fans surrounding the site as well as their source canyons.

An updated Figure 5, first submitted in the GDC response to City comments on the GDC (2014c) "Yucca" Site report, is attached. Inspection of the figure reveals that the truncations, regardless of causation, are risers within a flight of terraces carved on a rising (relatively) slope. Notice the dissected treads that cap the terrace risers.

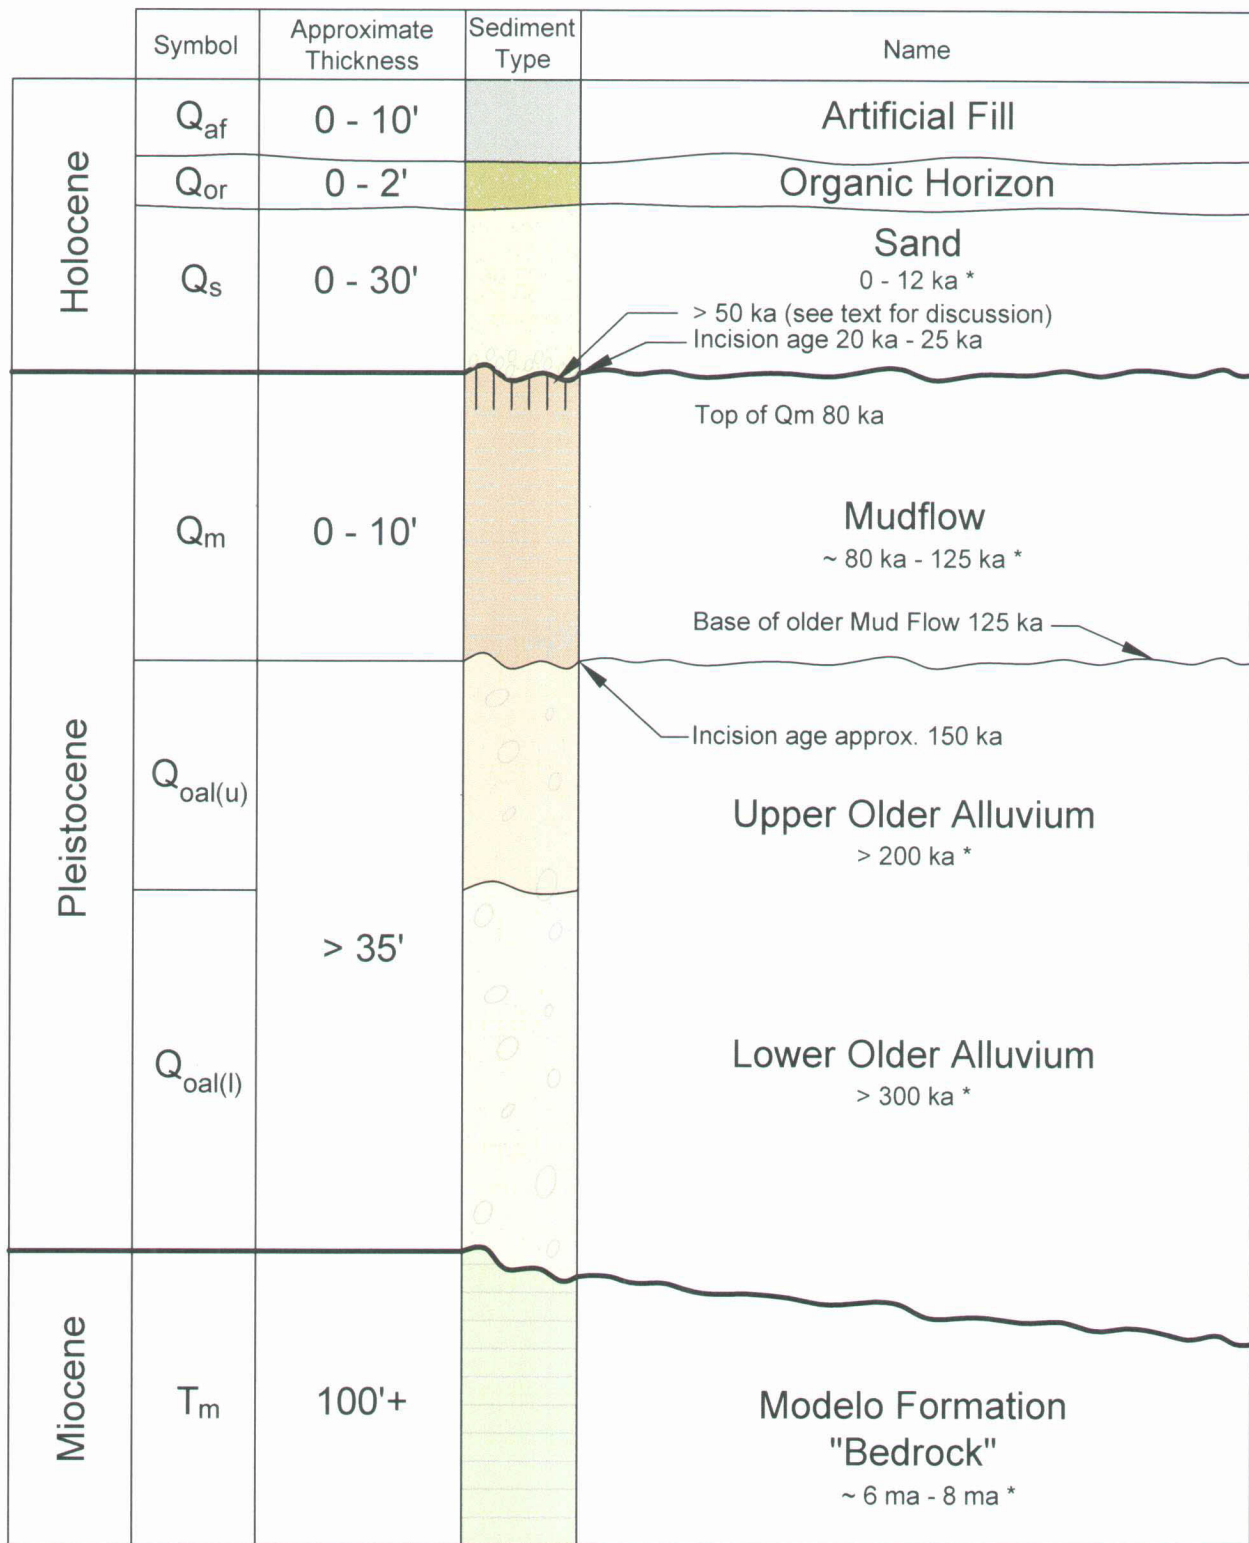
Figure 10

Locations of the explorations are shown on Plate 1 and the logs of the three bucket auger borings (BA-1, BA-2, and BA-3) and three coreholes (B-6 through B-8) are attached in Appendix A. To assess local fault activity, GDC graphically logged BA-3 (Plate 8A). The east wall of the supplemental trench (Champion East Trench), approximately 30 feet long and up to 10 feet deep, was graphically logged at a scale of 1 inch equals 2 feet (Plate 8A; Photograph 1). Dr. R.J. Shlemon, (Appendix B, attached) logged a representative soil-stratigraphic section at Station 19 of the trench, using soil stratigraphy techniques and obtained a minimal age of approximately 135ka for unbroken upper older alluvium [Qaol(u) in Figure 10] overlying the anticline-related faults.

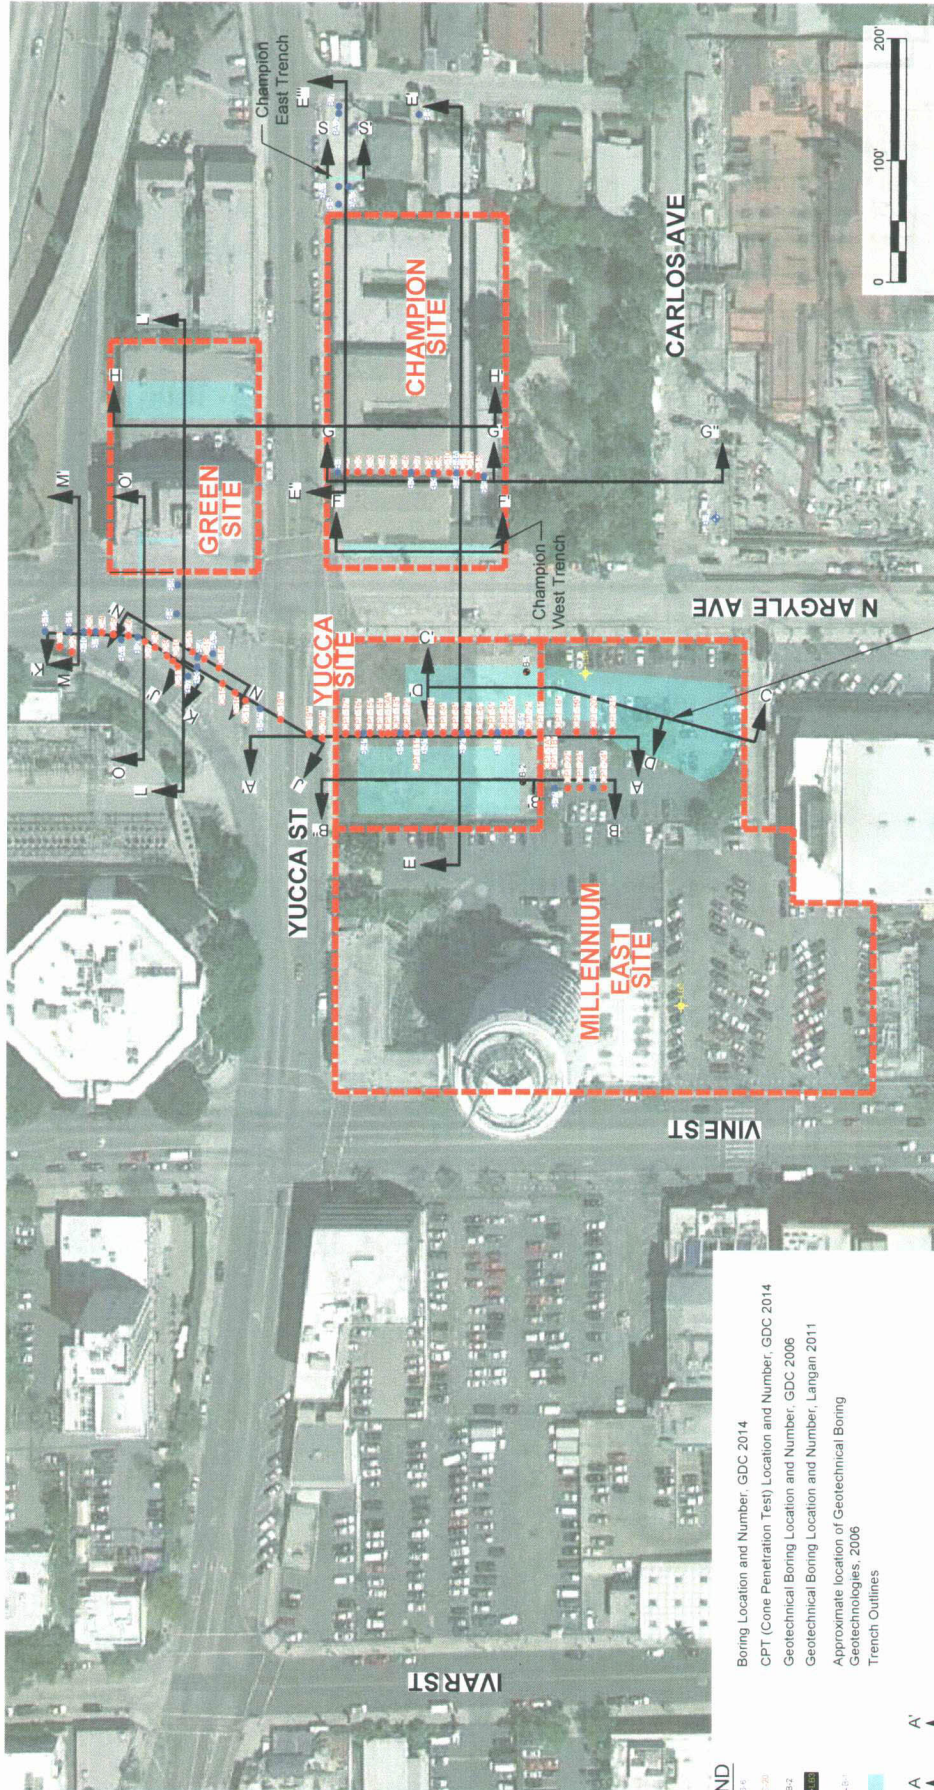
DATE	8/5/2014	DRAWN BY	KM	GROUP	GROUP DELTA CONSULTANTS, INC	BORING, CPT, CROSS SECTION AND TRENCH LOCATIONS	PROJECT NUMBER	LA1183E
REVISION	9/4/2014	APPROVED BY	MR		370 Amapola Ave. Suite 212 Torrance, CA. 90501		SCALE	AS SHOWN
REVISION	2/11/2015			DELTA		CHAMPION SITE	PLATE NUMBER	1

GDC logged three bucket auger borings, three coreholes and one fault trench in the eastern part of the Champion site (Plate 1, attached) to confirm the presence, character, and activity level of small-displacement, anticline-related faults found in the Champion West Trench (Plates 1 and 10) and in a trench north of Yucca Street (Plate 1). GDC now demonstrates that the faults are bending-moment and small-scale shear faults associated with the folding of the Yucca Street Anticline, which ceased prior to middle to late Pleistocene time.

GDC (this study) undertook a supplemental investigation of the east part of the Champion site. The investigation included three bucket-auger borings and one fault trench placed as shown on Plate 1. Siting of the excavations was based on the GDC structural interpretation of the presence of an east-southeast-trending anticline crest and associated shear and bending-moment faults. The bucket auger borings were primarily excavated to locate sections of uppermost Pleistocene deposits that would be useful for dating the last slip of the anticline-associated faults in the eastern part of the study site. After identifying such deposits, GDC placed a north-trending trench (Champion East Trench) roughly perpendicular to the faults trends extrapolated from the Champion West Trench as shown on Plate 12 with the purpose of intercepting such faults and documenting their existence and activity level.
