**Sunshine Canyon Landfill  
Independent Monitor  
Quarterly Site Monitoring Status Report  
July 1, 2016 – September 30, 2016**

**City of Los Angeles Department of City Planning**

**County of Los Angeles Department of Regional Planning**

December 22, 2016

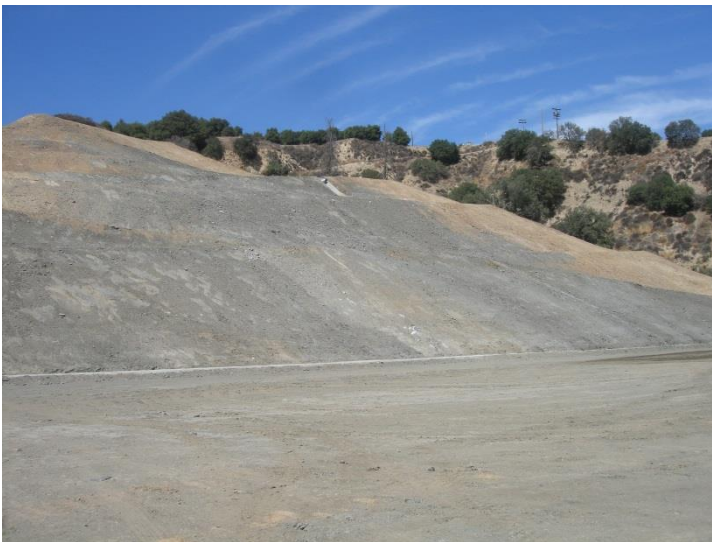
**Photo 122: Flare 11 Site Grading: September 27, 2016**
