**Sunshine Canyon Landfill  
Independent Monitor  
Quarterly Site Monitoring Status Report  
April 1, 2017 – June 30, 2017**

**City of Los Angeles Department of City Planning**

**County of Los Angeles Department of Regional Planning**

October 10, 2017

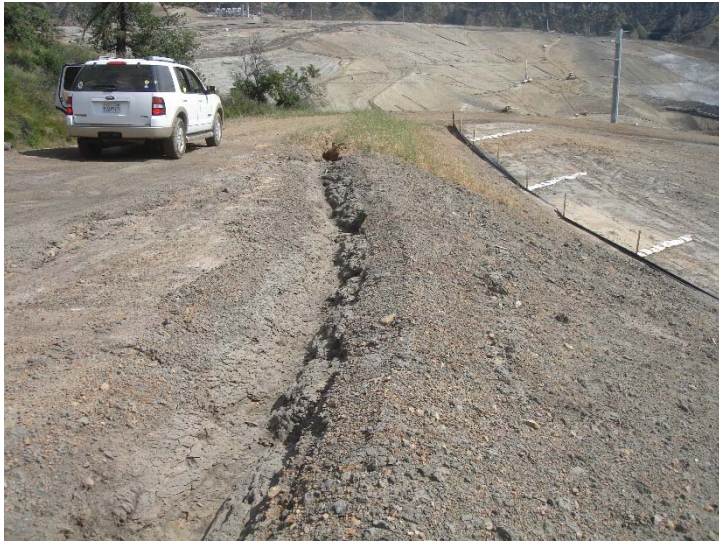
**Photo 80: Flare 3 Access Road Erosion Ruts: April 18, 2017**
