Tree Inventory Report

REXFORD L.A.X. INDUSTRIAL
9000 Airport Boulevard
Los Angeles, California

February 21, 2024

**Subject: Arborist tree survey and Report for Rexford LAX Industrial Project 9000 Airport Boulevard
Los Angeles, California**

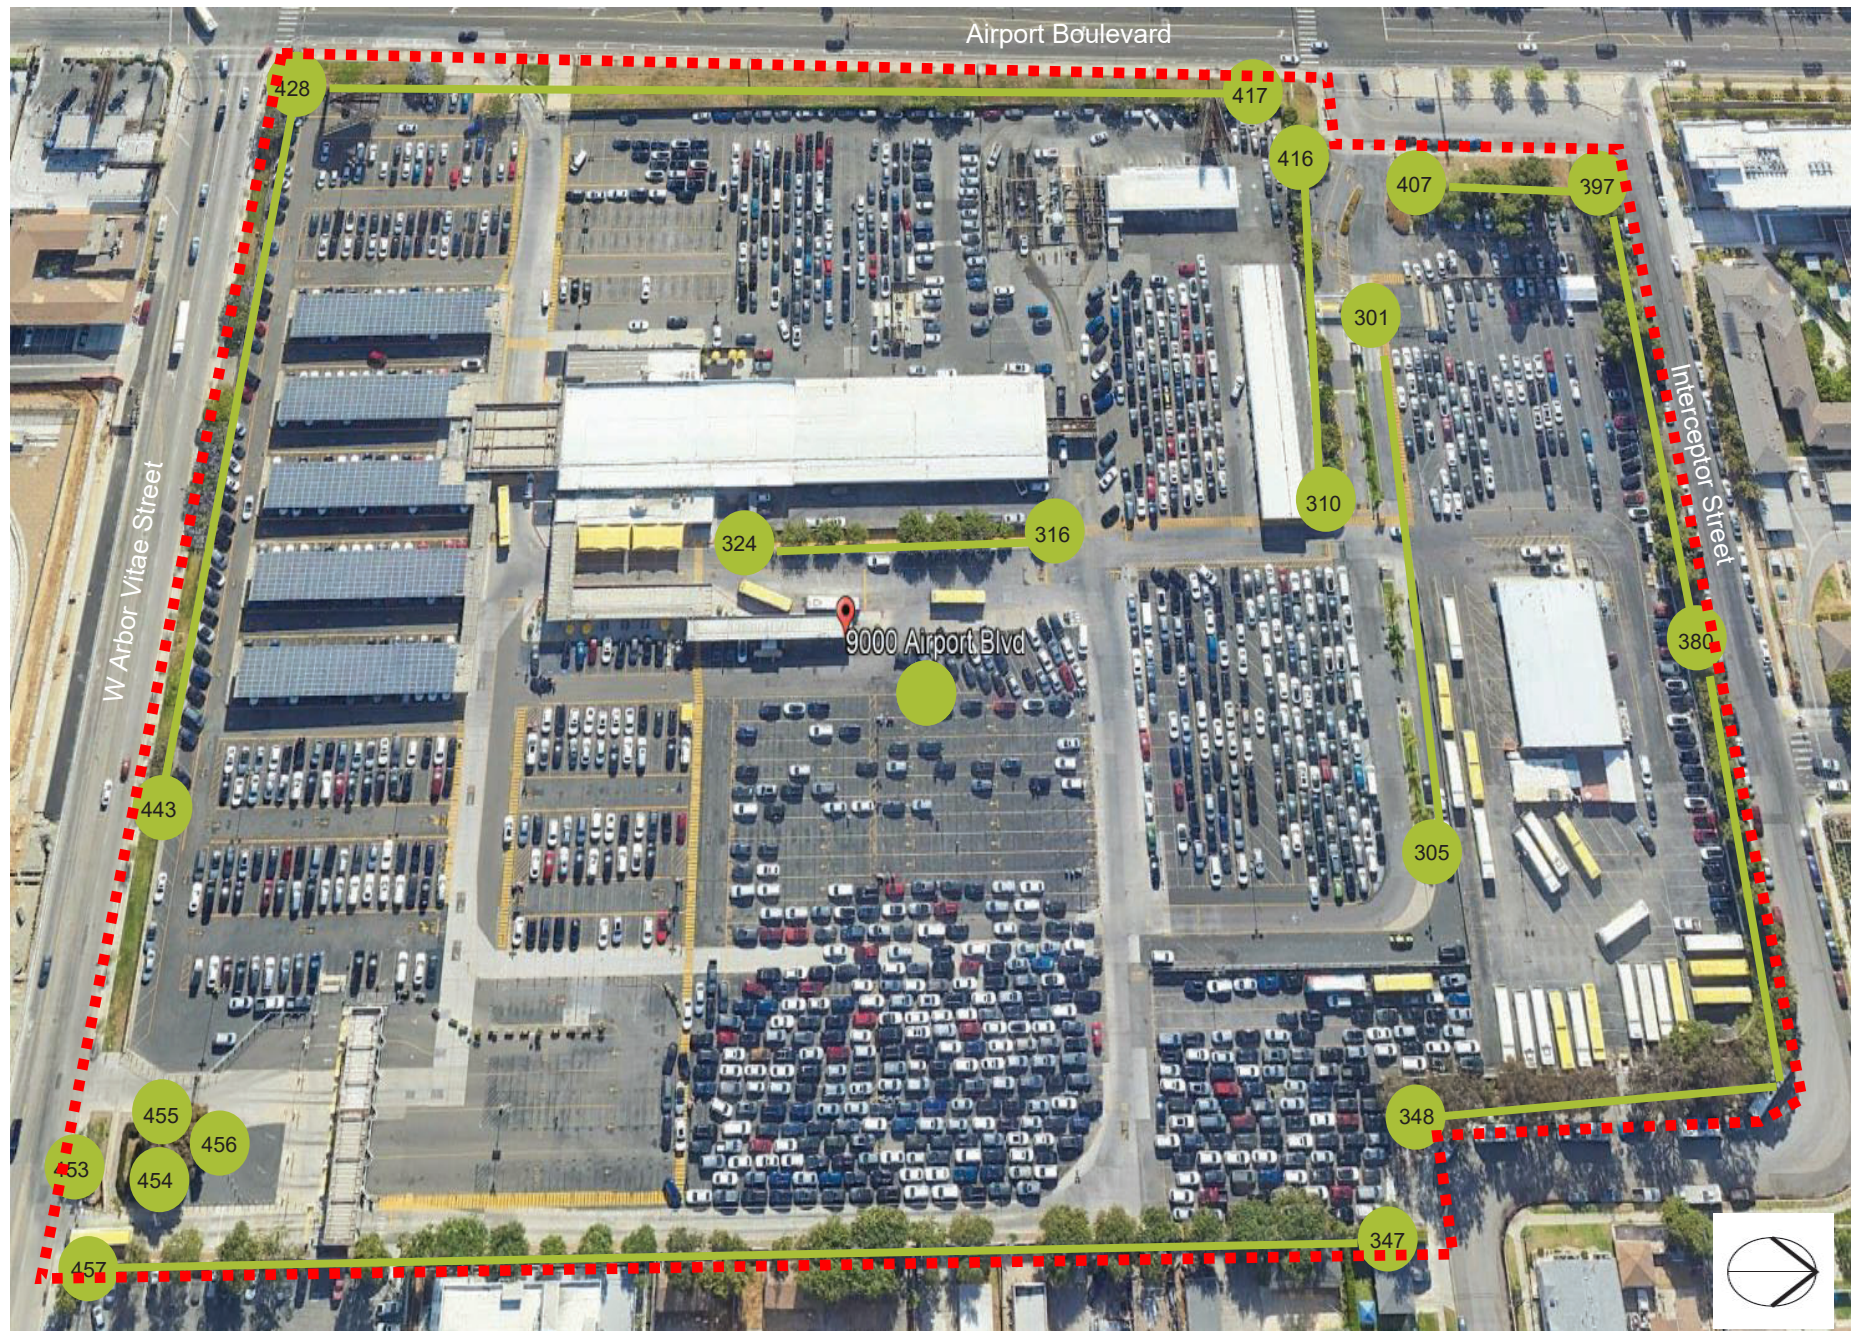
Tree location map / number tags affixed to each tree / August 2023

All tree locations are approximate to allow reader to locate and inspect specific trees growing at the project site
