**Sunshine Canyon Landfill  
Independent Monitor  
Quarterly Site Monitoring Status Report  
July 1, 2022 – September 30, 2022**

**City of Los Angeles Department of City Planning**

**County of Los Angeles Department of Regional Planning**

January 9, 2023

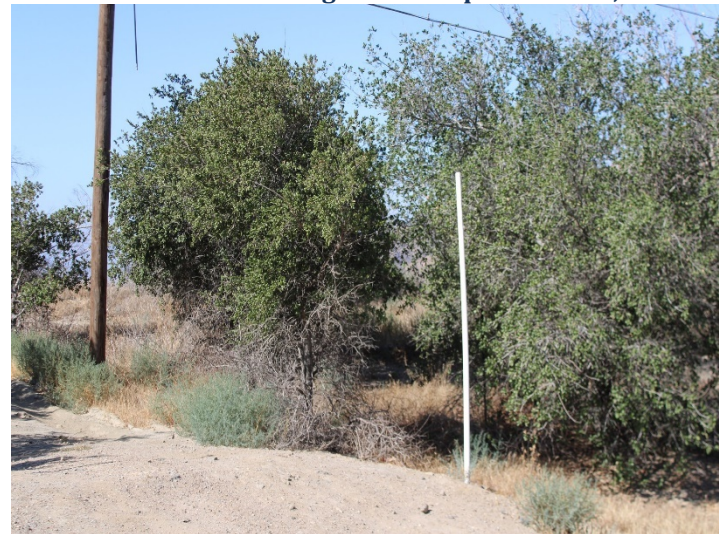
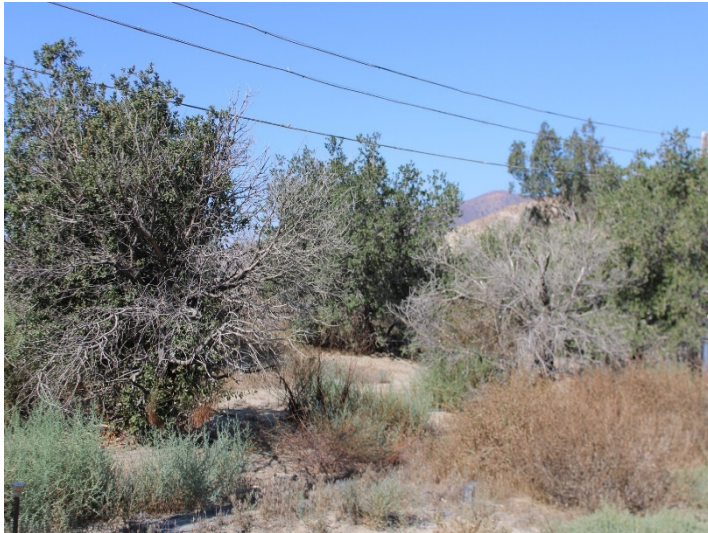
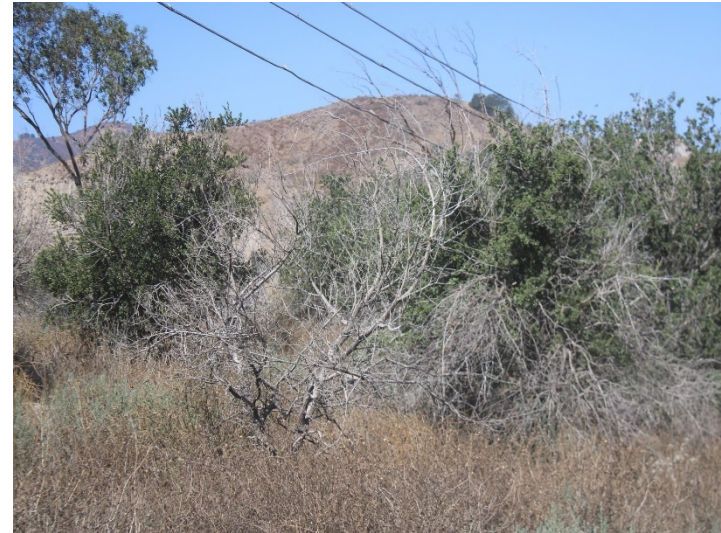
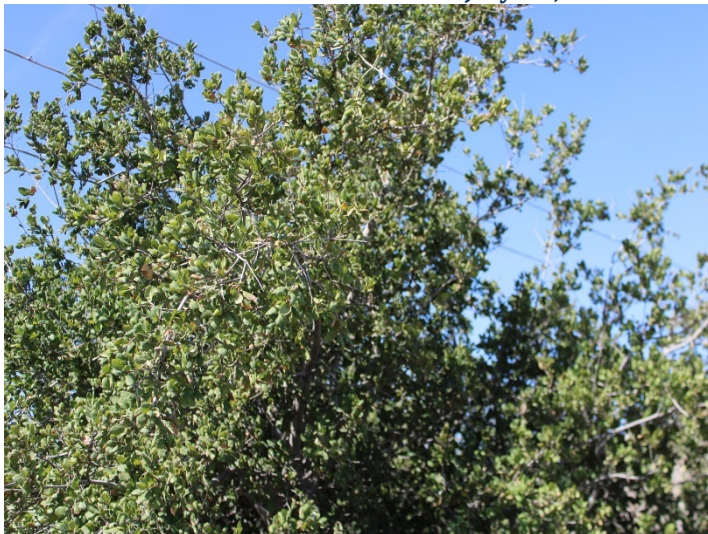
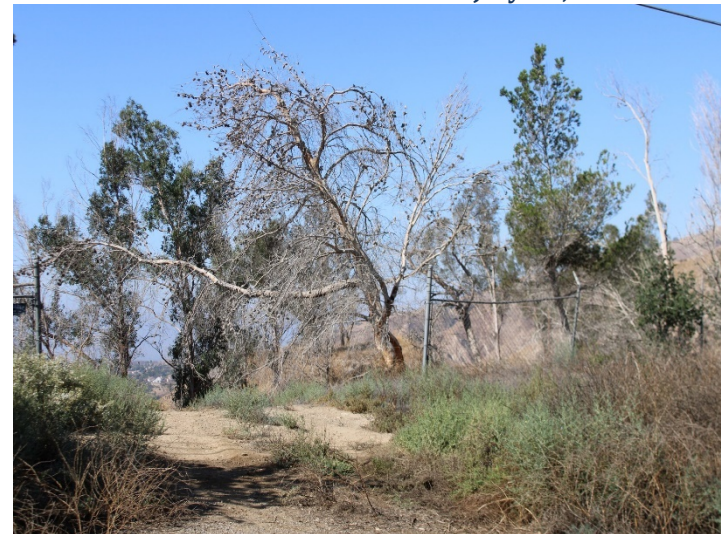
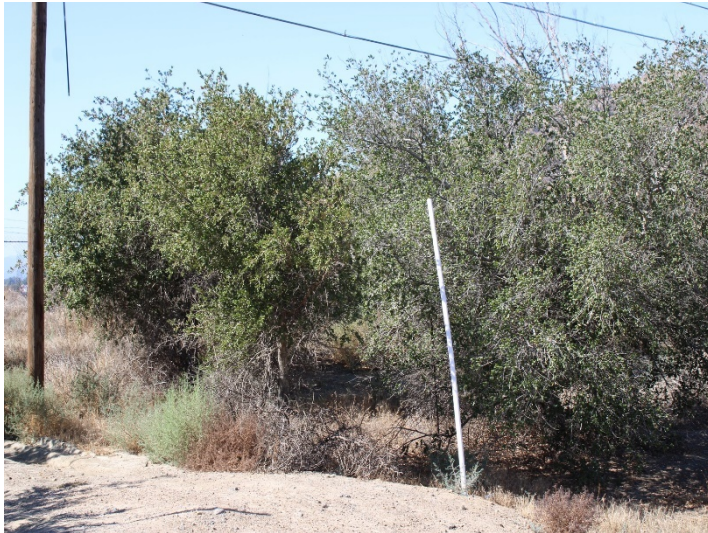
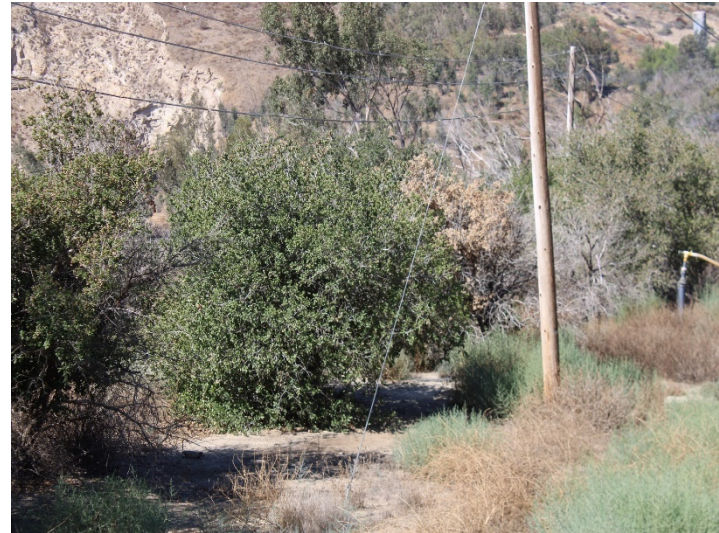
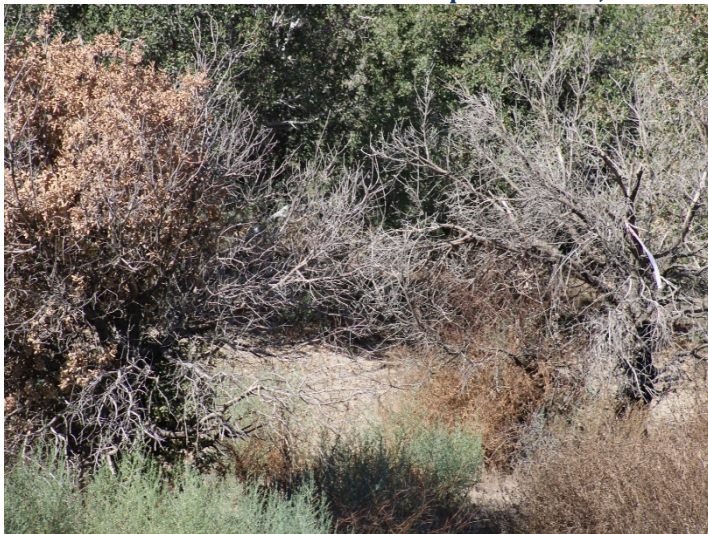
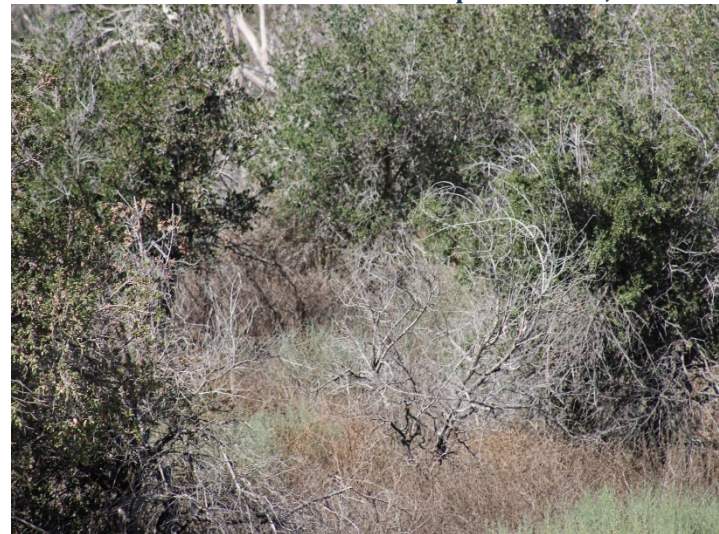
**Photo 579: PM-10 Oak Trees: July 25, 2022**

40. Water misters are operating along the southern perimeter.
41. The PM-10 oak trees are in good condition, but with several dead trees present.
42. City decks C and B sage mitigation areas have new green growth throughout.

1. Notify transfer truck operators not to queue San Fernando Road waiting for the 6 am entry time.
2. Clear the road drain at the Adler tank farm.
3. Remove vegetation from eastside drainage channel.
4. Unblock eastside drainage culvert southeast of sediment basin B
5. Clear drainage below flare pad of soil and tree.
6. Remove yellow mustard weed from City sage mitigation decks.
7. Replace dead oak trees at PM-10 berm.
