**Sunshine Canyon Landfill
Independent Monitor
Quarterly Site Monitoring Status Report
October 1, 2018 – December 31, 2018**

January 9, 2019

CERTIFICATION STATEMENT

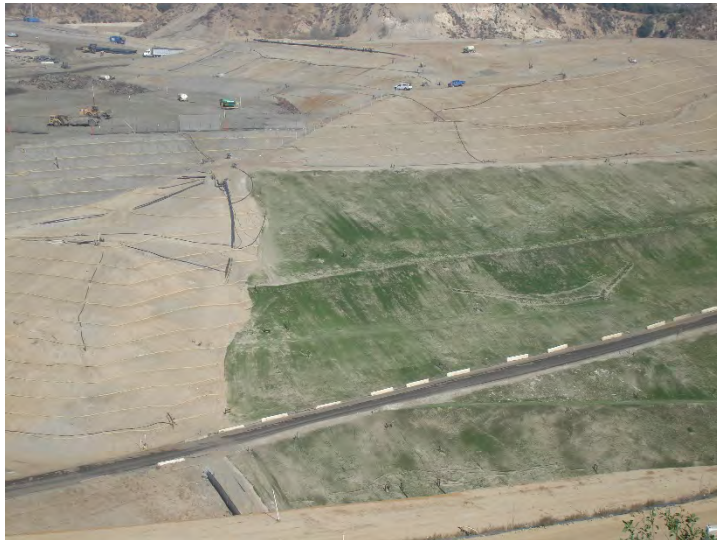
Photo 158: Posi-Shell and Closure Turf: November 6, 2018

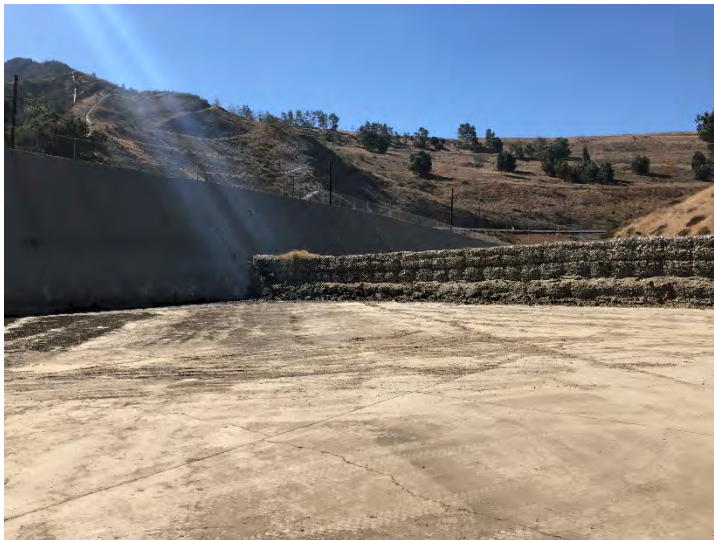
Photo 386: Terminal Basin: October 23, 2018

- Well 3013D was hot to the touch and had a burnt odor.
- The dirt slopes adjacent to the westside inlet channel into the terminal basin were graded and repaired.
- The terminal basin had ponding water around the outlet risers. The slopes below the main access road were graded and covered with jute netting.
- Sage mitigation Deck B was being irrigated to condition the soil to raise the pH.
- The prior Deck A subsurface oxidation near PCW 224 was extinguished.
