August 5, 2013

**Sunshine Canyon Landfill
Independent Monitor
Quarterly Site Monitoring Status Report
April 1, 2013 – June 30, 2013**

Sunshine Canyon Landfill Mitigation Monitoring – 2013 Second Quarter Summary/ City
(see Excel spreadsheets)

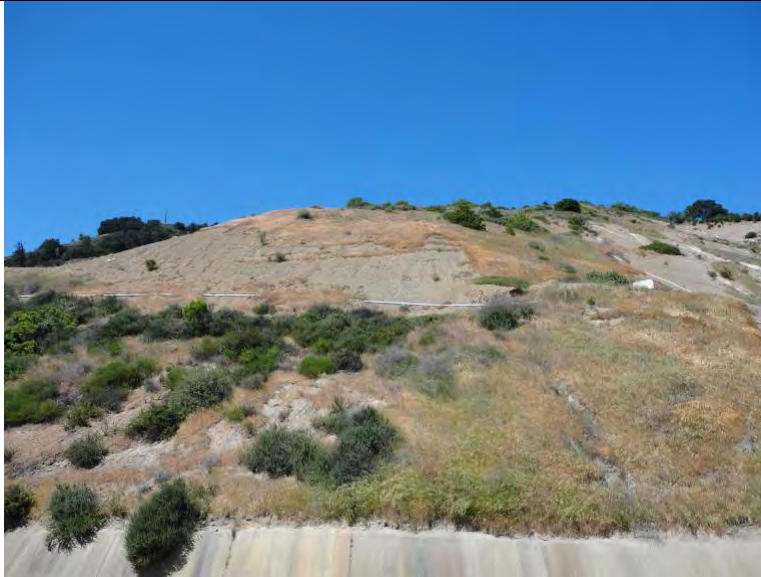
Photo 81: County Sage Mitigation Area: April 10, 2013

Discipline	City Condition Reference # / Mitigation #	County Condition Reference #/ Mitigation #	Responsible Agency	Further Review Needed-Comments
Biologist		Biota - 4.27	County Planning	I-g and I-i: The county sage mitigation has had minimal success. A plan to stabilize and retain the loose erosive soils along with a revegetation plan should be investigated. Re-activating the irrigation system may be beneficial.

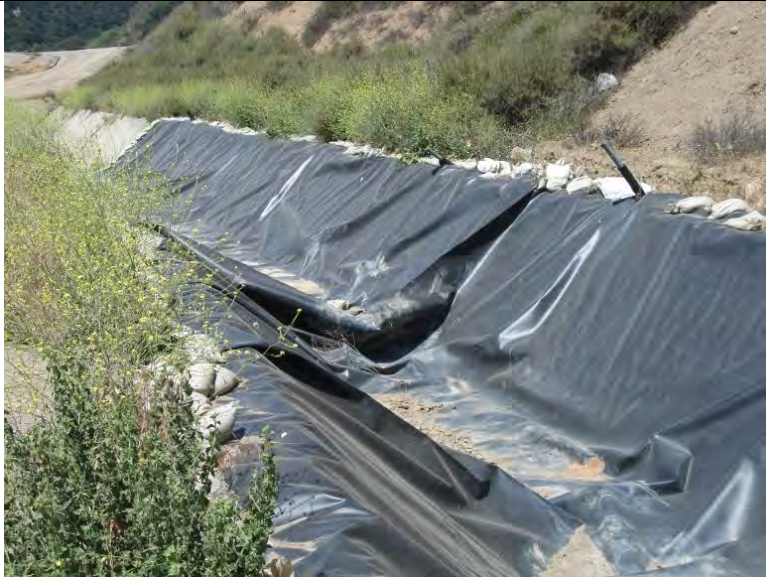
Photo 109: Basin D North Drainage: May 1, 2013

Discipline	City Condition Reference # / Mitigation #	County Condition Reference #/ Mitigation #	Responsible Agency	Further Review Needed-Comments
Hydrologist	M - 4.3.1/ 46		City Planning	<p>I-h: The Basin D North drainage v-ditch HDPE liner material was windblown and crumpled, causing a potential drainage blocking. The terminal basin exterior side wall facing the entrance road has a crack that had worsened since it was first observed. A preventative maintenance program should be implemented.</p> <p>I-i: The western drainage into Basin A is partially plugged. The westside drainage system's concrete had areas with sidewall and bottom cracking and spalling. Trees in two areas could possibly be causing the sidewall cracking. The Basin D North Drainage v-ditch HDPE liner was windblown and crumpled, causing a potential drainage blockage. The terminal basin exterior sidewall facing the entrance road has a crack that had worsened since it was first observed. A preventative maintenance program with a schedule should be implemented.</p> <p>I-j: See I-h above.</p> <p>I-k: See I-h above.</p>

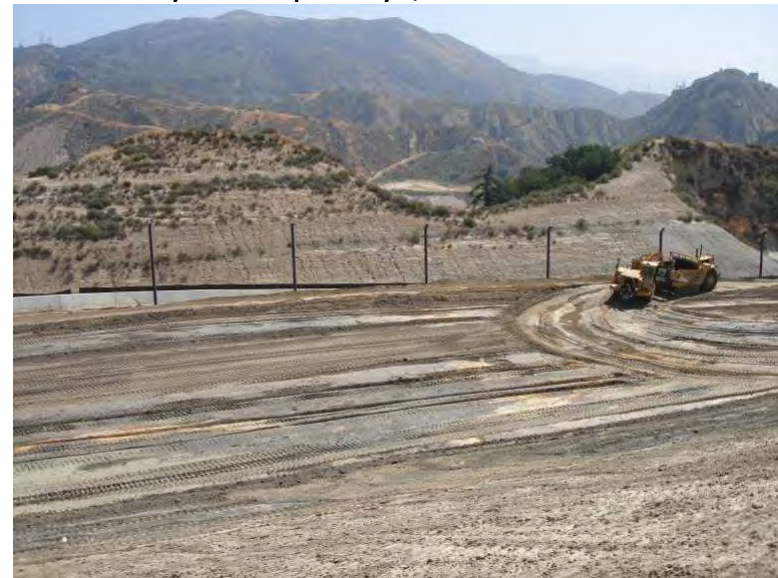
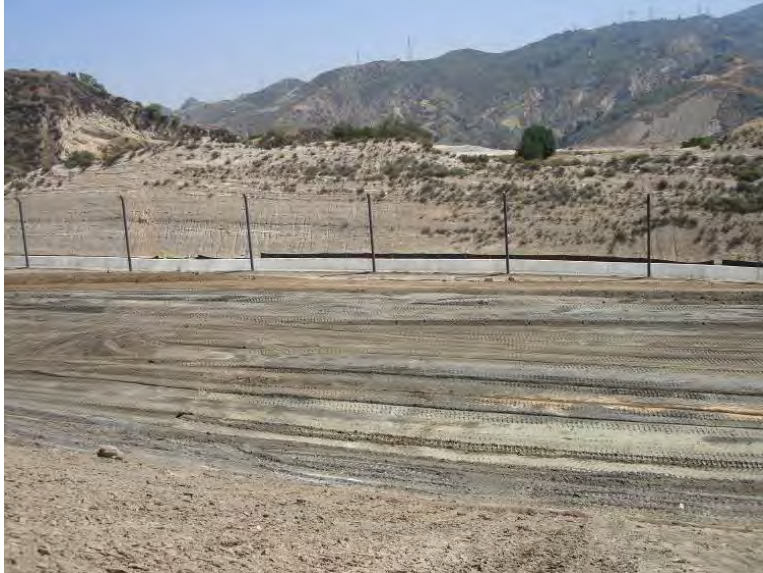
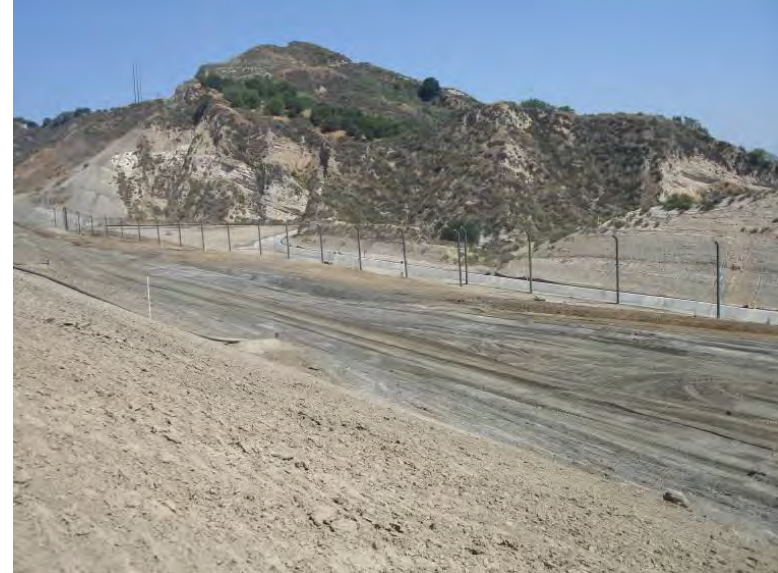
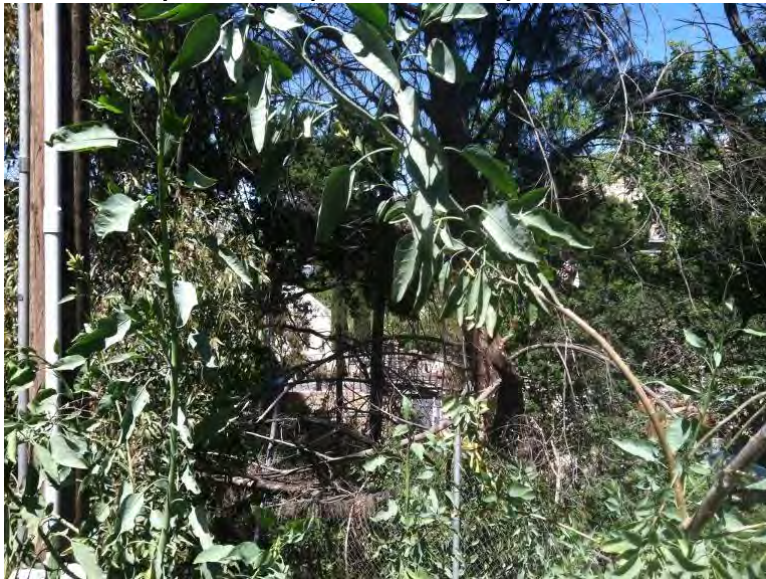
Photo 215: City North Stockpile Removal: May 1, 2013

Photo 216: City North Stockpile Removal: May 1, 2013

Photo 217: City North Stockpile Removal: May 1, 2013

Photo 218: City North Stockpile Removal: May 1, 2013

FURTHER REVIEW NEEDED	
<ul style="list-style-type: none"> Piping supports on Flare 1 skid to verify that they meet seismic design requirements. Top deck of Old City North fill to meet closure requirements now that stockpiled soil has been removed. Revegetation plan for interim and inactive fill area Revegetation plan for county sage mitigation slopes. Clean-up of areas adjacent to the terminal basin. Maintenance list and schedule for drainage system repair. Flare 8 conduit repair and weed abatement. 	
COMMENTS	
Signed:

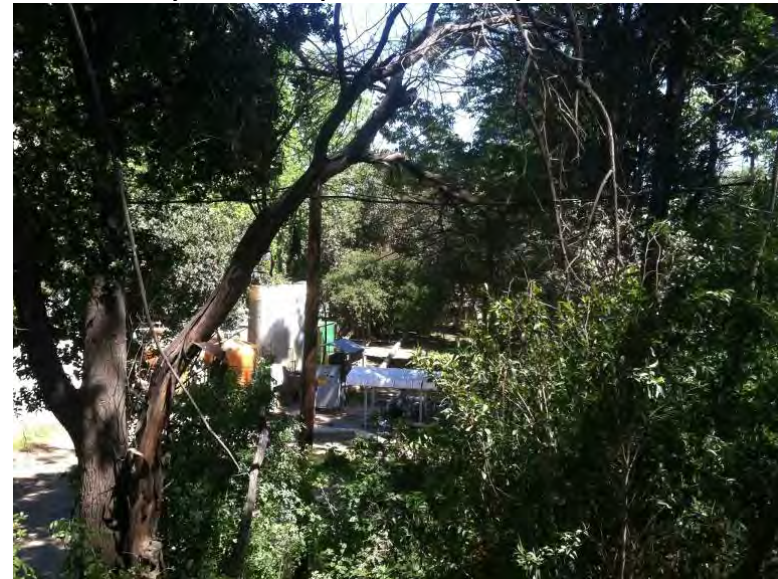
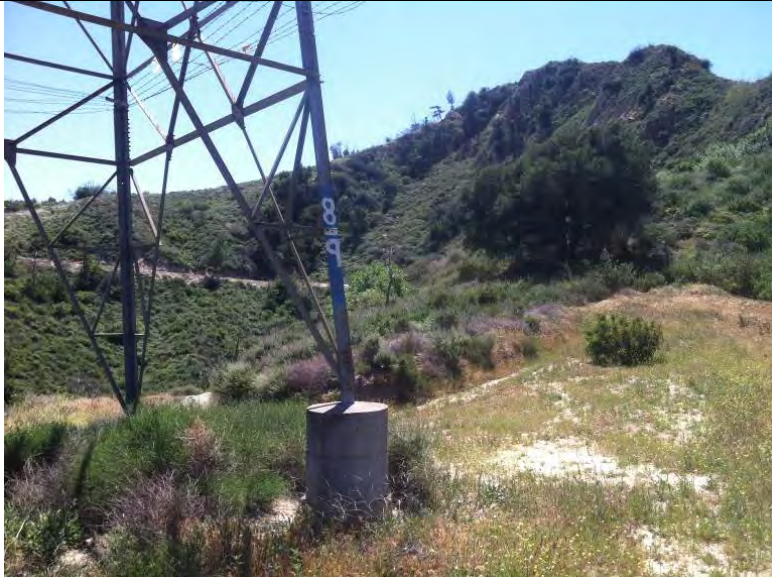
Photo 219: Leachate Treatment Electrical Lines: April 10, 2013

Photo 220: Leachate Treatment Electrical Lines: April 10, 2013

Monitor: Mike Lindsay	Page 1 of 1
Discipline: Environmental Engineer	Date: 04-10-13
Site Conditions: Sunny, clear, 64/82°F, 5-15 mph	
SITE LOG	
<ol style="list-style-type: none"> 1. Met with John Nelson and Rogelio Gamino (LACDPW), Jim Addekas and Joe Thompson (UltraSystems). 2. Checked in at office with Patty Costa and Achaya Kelapanda (Republic Services). 3. Measured County Top Deck elevations using a Trimble GHX 2008 GPS device (± 0.1 meter). 4. Observed oil drip pans under equipment at maintenance yard by office. 5. Observed northwest storage yard to be in good order. 6. Observed new 36-inch header pipe and valves for gas collection on County Top Deck. 7. Flare 9 operating at 3522 scfm and 1704°F. Gas sample measured at 34.2% Vol CH₄, 3.8% Vol O₂, and over 500 ppm CO. 8. Slopes above Flare 9 are at 48° (~1:1 slope). They are hydroseeded but no growth is visible. 9. Observed City Deck C vegetation preparation (below PM10 berm) with soil grade at final elevation. 10. Observed proposed new access road route, noting trees and vegetation that will be removed (by transmission line tower no. 89 above lower leachate tanks). 11. Observed lower leachate tanks to be in good order. 12. Tree branches have fallen on power lines by lower leachate tanks.

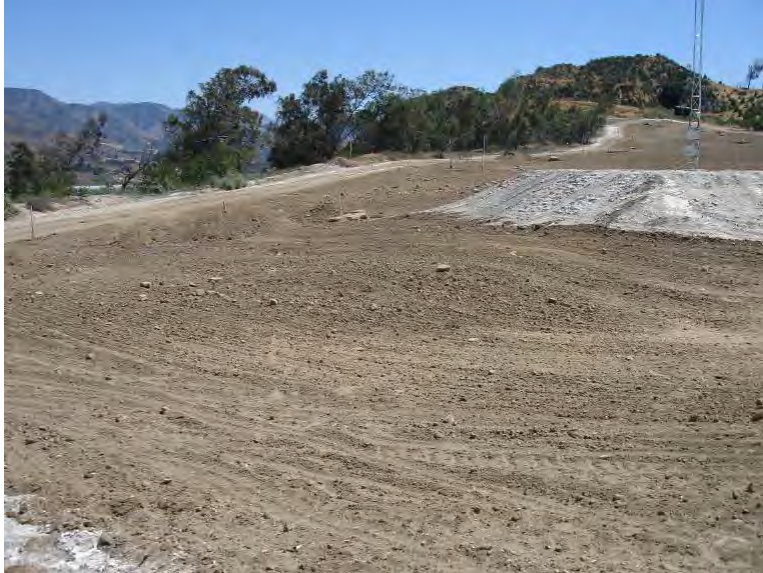
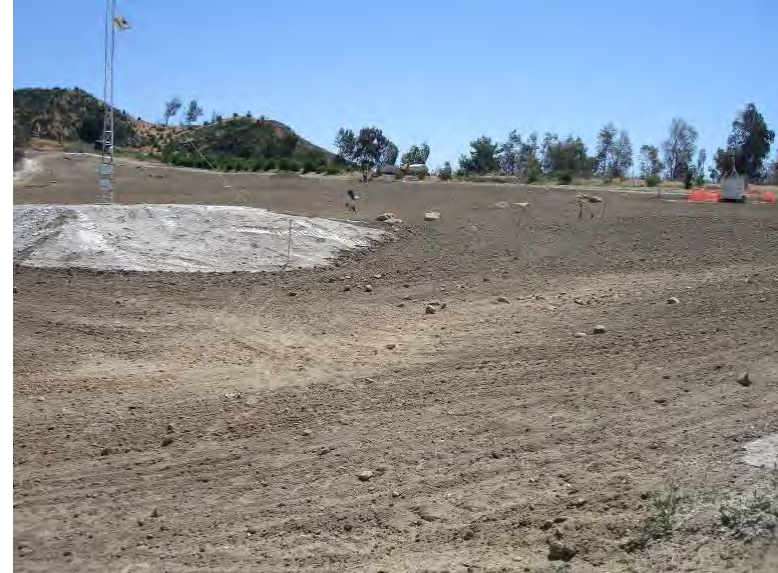
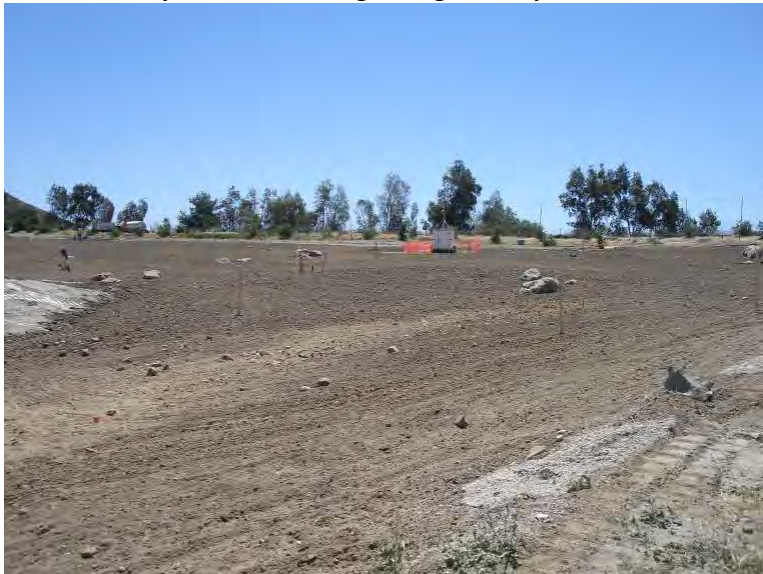
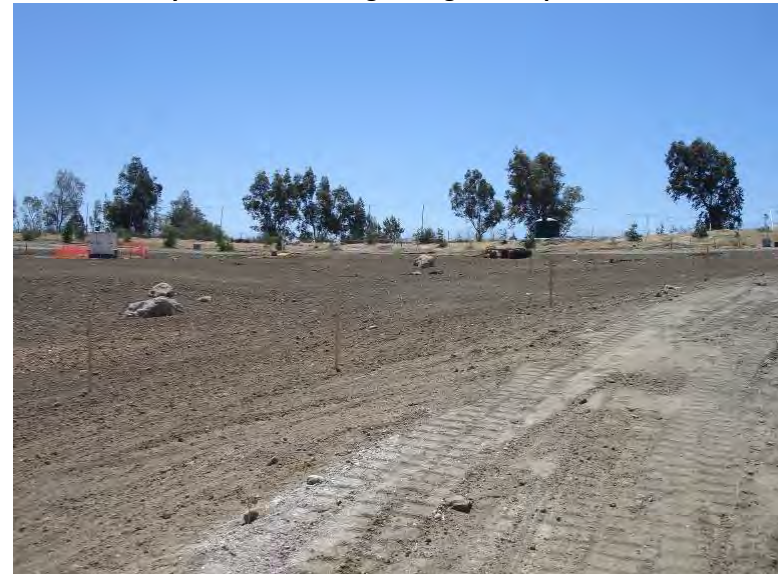
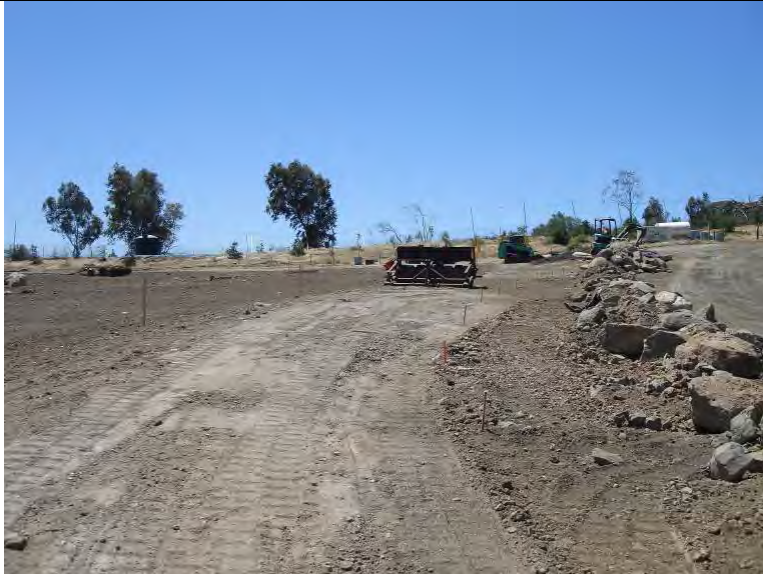
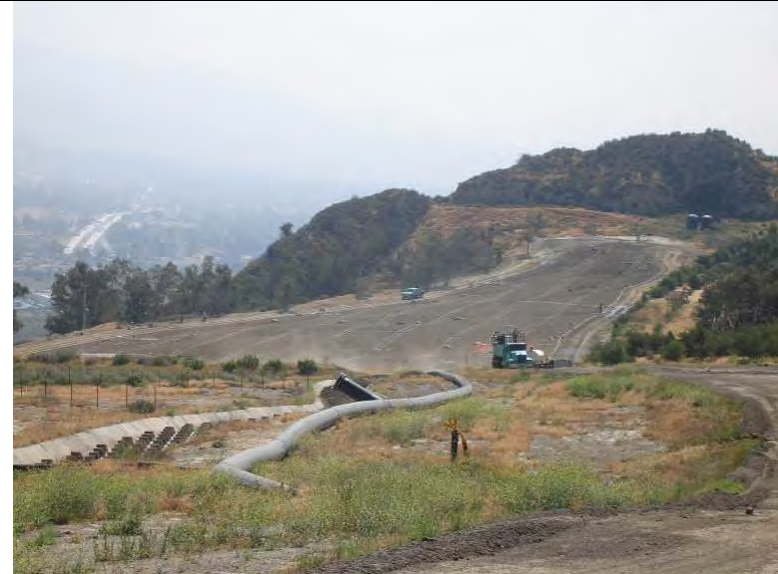
Photo 236: City South Deck C Sage Mitigation: April 10, 2013

Photo 237: City South Deck C Sage Mitigation: April 10, 2013

Photo 238: City South Deck C Sage Mitigation: April 10, 2013

Photo 239: City South Deck C Sage Mitigation: April 10, 2013

Photo 240: City South Deck C Sage Mitigation: April 10, 2013

Photo 241: City South Deck C Sage Mitigation: April 10, 2013

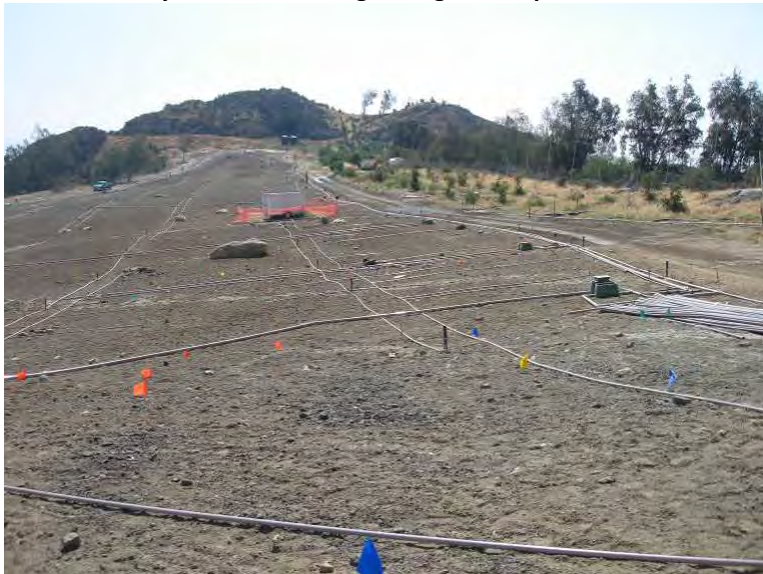
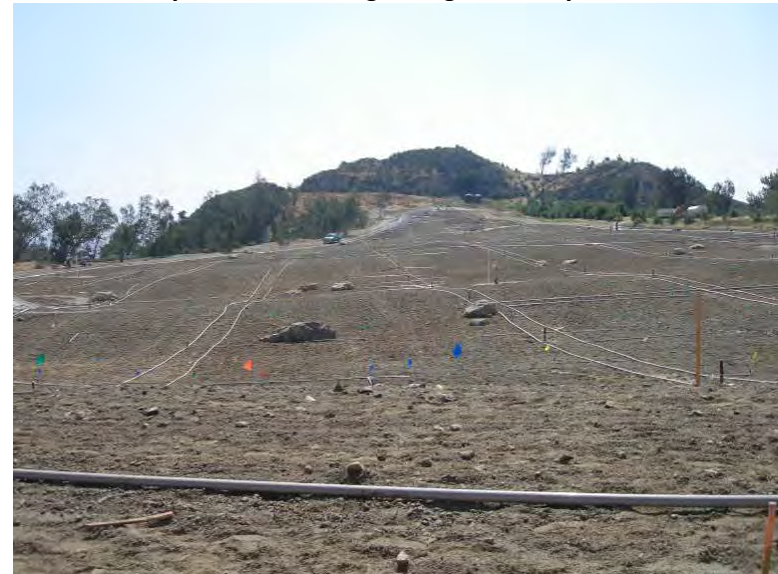
Photo 242: City South Deck C Sage Mitigation: May 1, 2013

Photo 243: City South Deck C Sage Mitigation: May 1, 2013

Monitor: Joe Thompson	Page: 1 of 2
Discipline: Biology	Date: 5-1-2013
Site Conditions: 0% CC, Winds NE 10 MPH, 72 degrees F.	
SITE LOG	
<ul style="list-style-type: none"> • Evaluated site conditions at Deck C. Irrigation equipment consisting of galvanized metal pipes and sprinkler heads had recently been installed for upcoming planting. • • Evaluated west slope mitigation area at County Top Deck. The coastal sage vegetation community does not appear to have had any activity since the April 10, 2013 visit. Therefore, conditions have not changed. Vegetation cover was nearly 100 percent absolute cover near the center drainage and < 1 percent 100 feet north and south of drainage for a total CSS coverage of <5 percent. Significant erosion was observed in areas with spotty or no vegetative cover. • Evaluated steep slopes at Flare 9. It did not appear that any activity had taken place at this site since the April 10, 2013 site visit, so conditions had not changed. Past hydromulch treatments were still evident and there was no evidence of recent erosion. Vegetation was scant and consisted of non-native grasses and forbs.

FURTHER REVIEW NEEDED	
<p><u>Deck C, City Mitigation Site.</u> The newly installed irrigation system should be fully functioning with a reliable water source prior to planting activities. A wind fence would be beneficial, particularly if the City plans to do the planting during the spring or early summer. The preferred option would be to plant in the fall, after the first gentle rains.</p> <p><u>County Sage Mitigation Site.</u> The County Sage Mitigation Site would benefit from a more intensive overall planting and maintenance strategy.</p> <p>Recommendations to control erosion include close placement of lateral straw wattles and erosion control blankets held in place by anchored wire mesh. Hydromulching may not be practical due to difficult access for trucks.</p> <p>The irrigation system should be in place and fully functioning prior to any new plantings and should have a reliable water supply, particularly during periods of drought.</p> <p>Management should be adaptive. This would require frequent monitoring and the ability to repair</p>

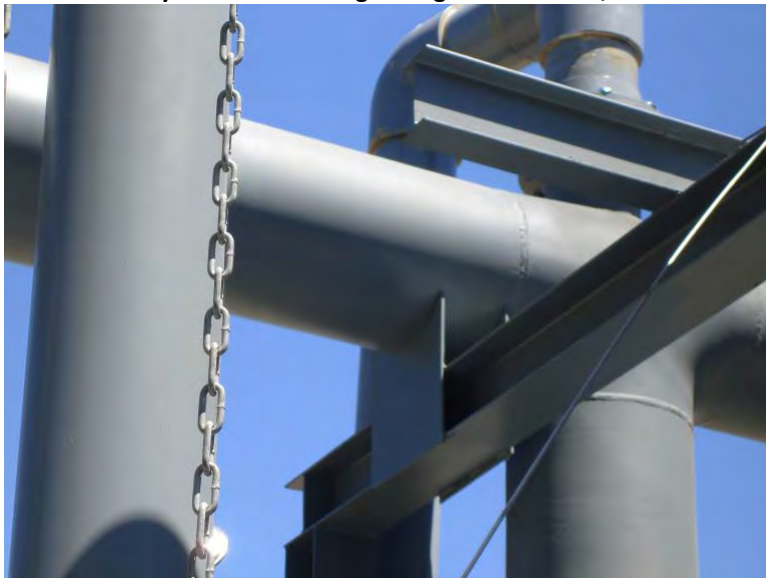
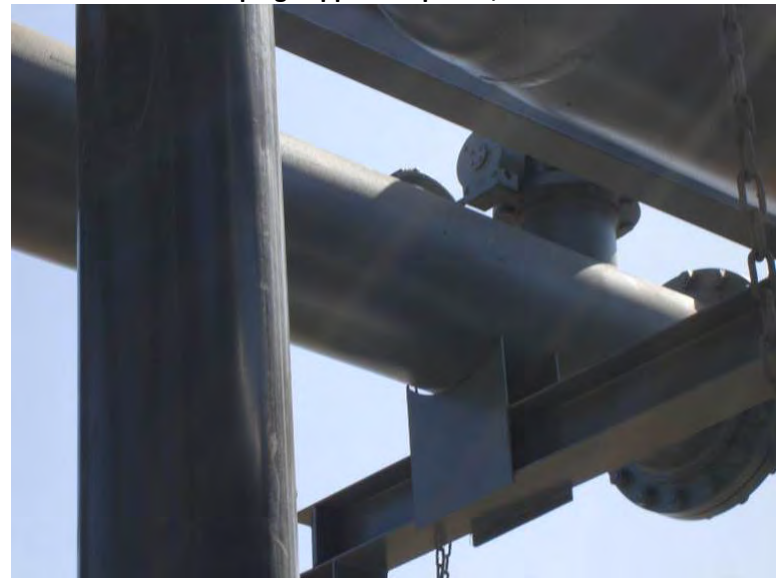
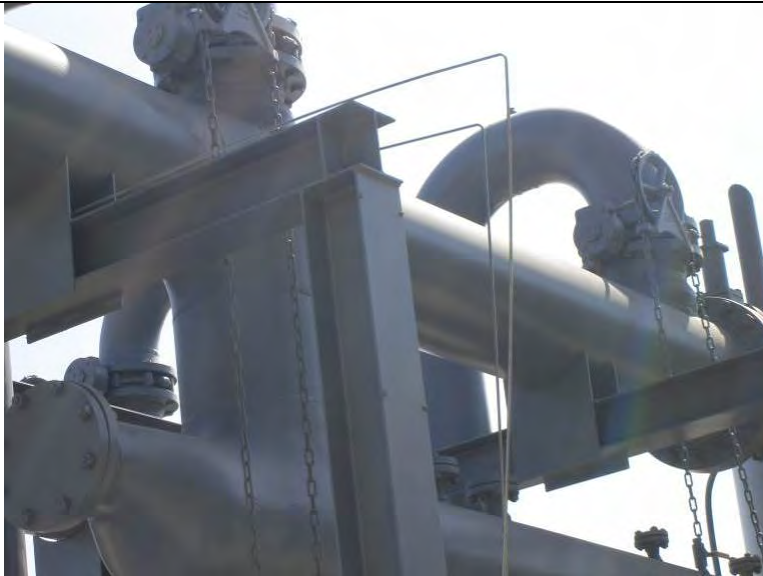
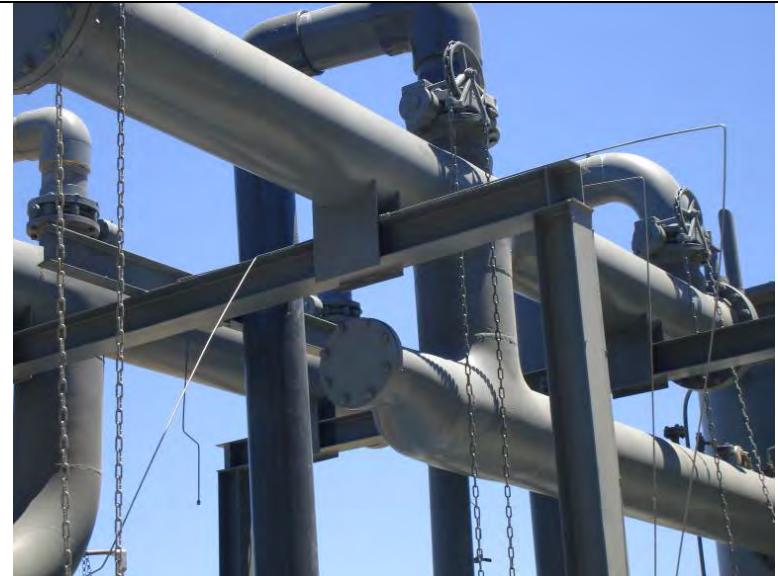
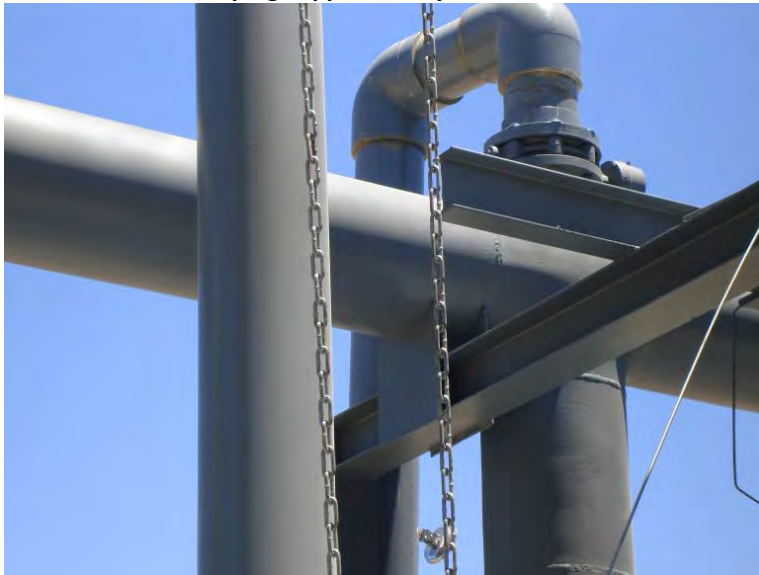
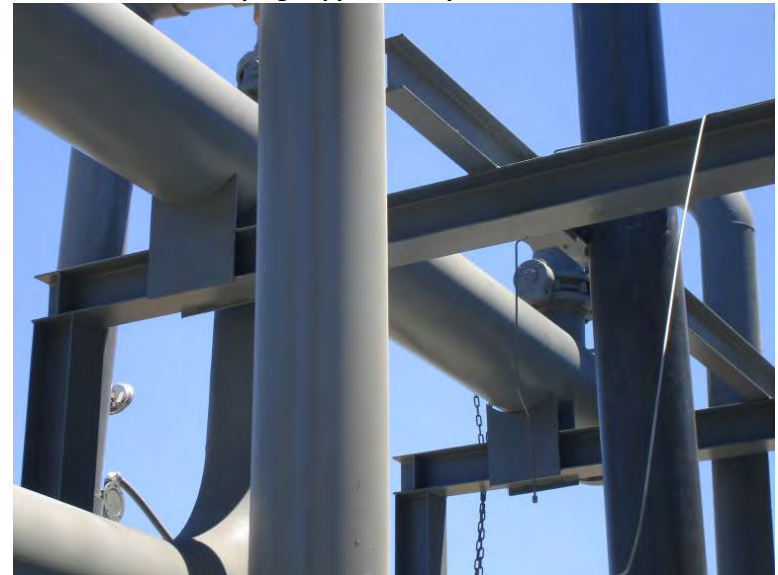
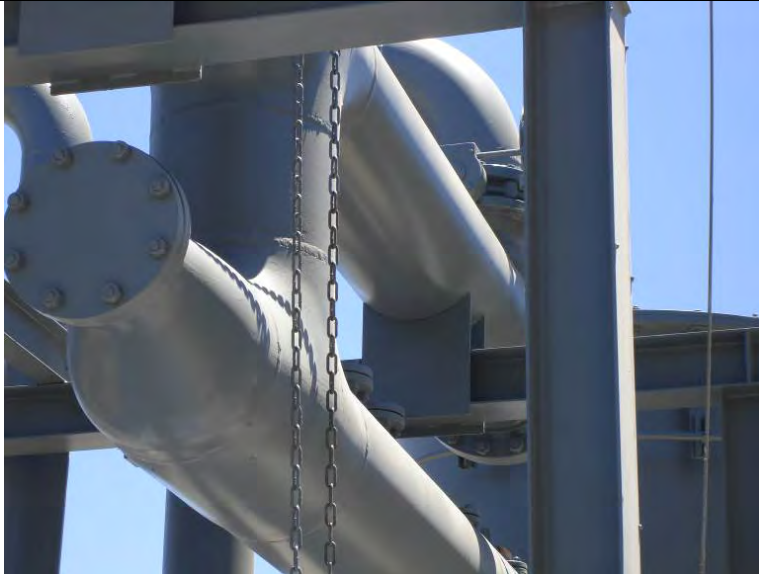
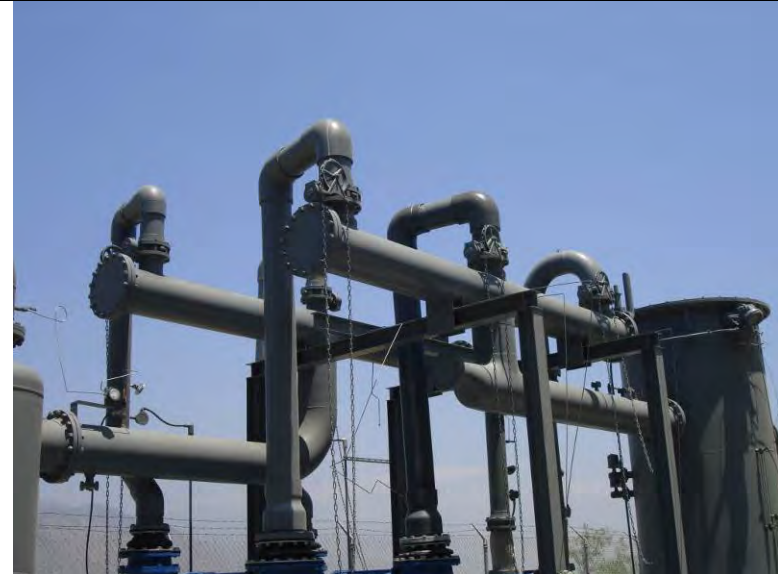
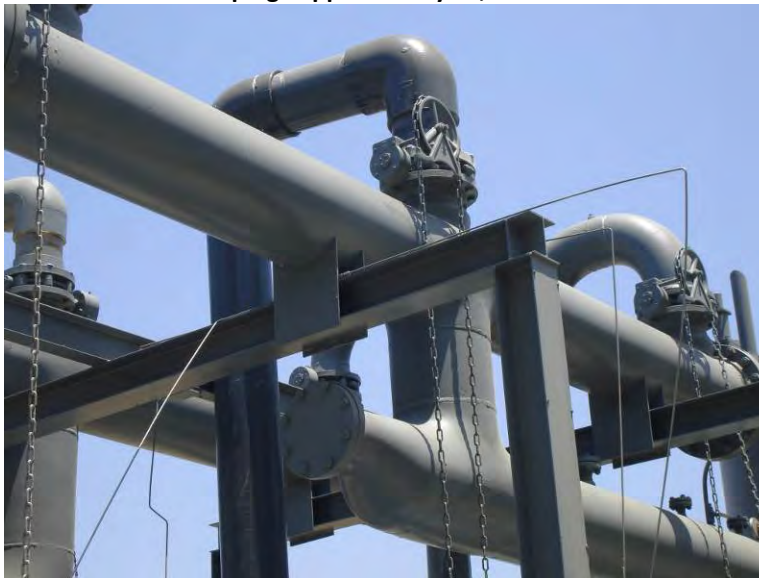
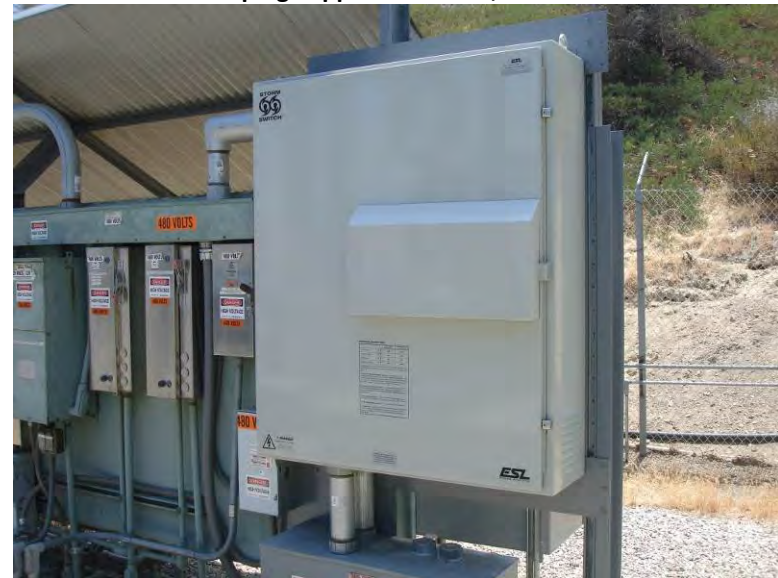
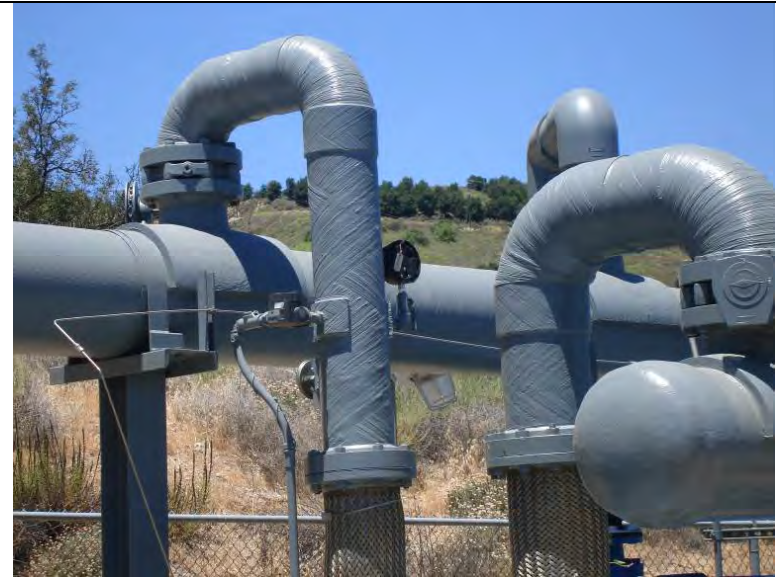
Photo 290: Flare 1 Piping Supports: April 10, 2013

- Removal of litter from Basin A hillside vegetation
- Use of soil sealant in areas like Basin D before the start of the Santa Ana winds
- Piping supports of Flare 1 skid to verify that they meet seismic design requirements
- Top deck of old City North fill to meet closure requirements now that stockpiled soil has been removed
- Revegetation plan for interim and inactive fill area
- Revegetation plan for county sage mitigation slopes
- Maintenance list and schedule for drainage system repair

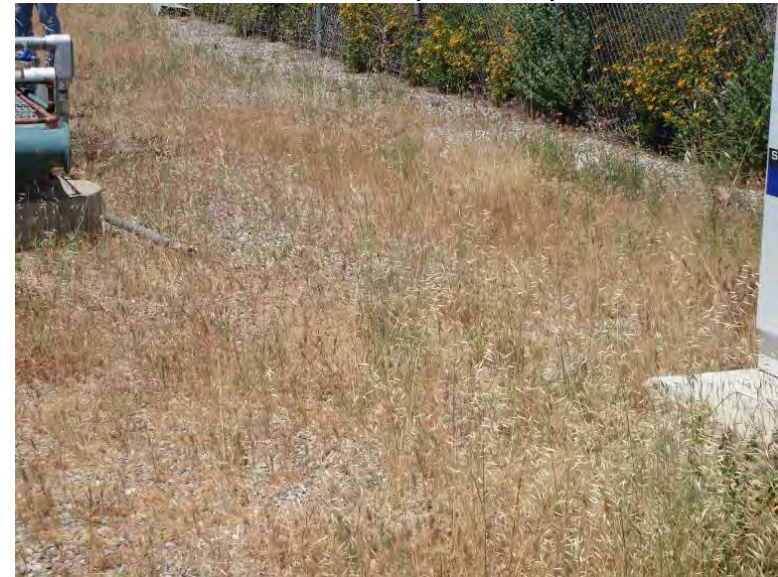
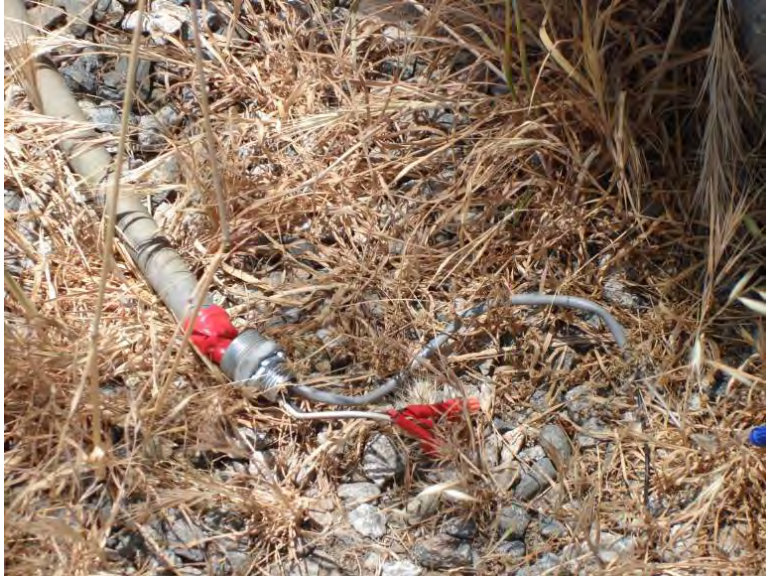
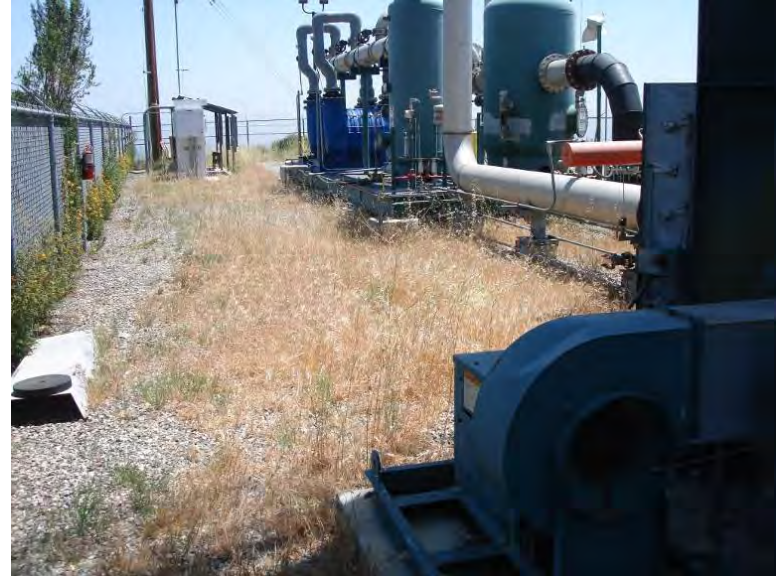
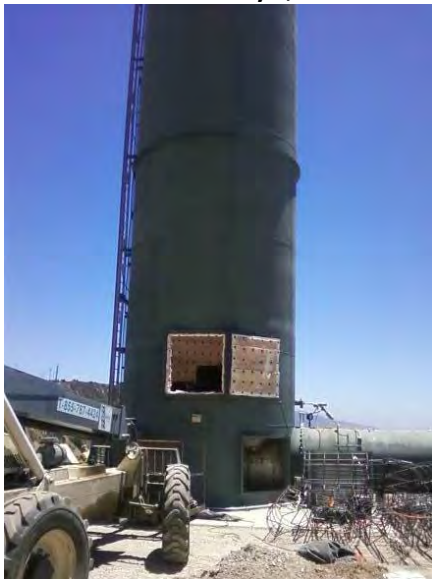
Photo 307: Flare 8: May 1, 2013

Monitor: James Aidukas	Page: 2 of 2
Discipline: Project Manager	Date: May 1, 2013
SITE LOG	
<ul style="list-style-type: none"> Flare 8 was observed and operating. A conduit with loose wires with taped ends was noted lying on the ground. This condition was reported to Republic. The area within the fence at Flare 8 had high dry grass that should be cut for fire safety. Flare 9 was observed and operating. No unusual conditions were noted. The temporary flare was observed and operating. There was no ambient odor noted in the general area. Flare 3 was observed and operating. No unusual conditions were noted. Flare Operating Conditions: <ul style="list-style-type: none"> Temporary Flare - 1692°F, 1476 SCFM <ul style="list-style-type: none"> Flare 1 - 1687°F, 4007 SCFM Flare 3 - 1644°F, 3651 SCFM Flare 8 - 1694°F, 2931 SCFM Flare 9 - 1698°F, 4521 SCFM, -50" vacuum <p>Had a post-meeting discussion with Achaya Kelapanda, Republic's Gas Systems Environmental Manager, and discussed the gas recovery and flare systems, and the gas-to-energy facility scheduled activities.</p>

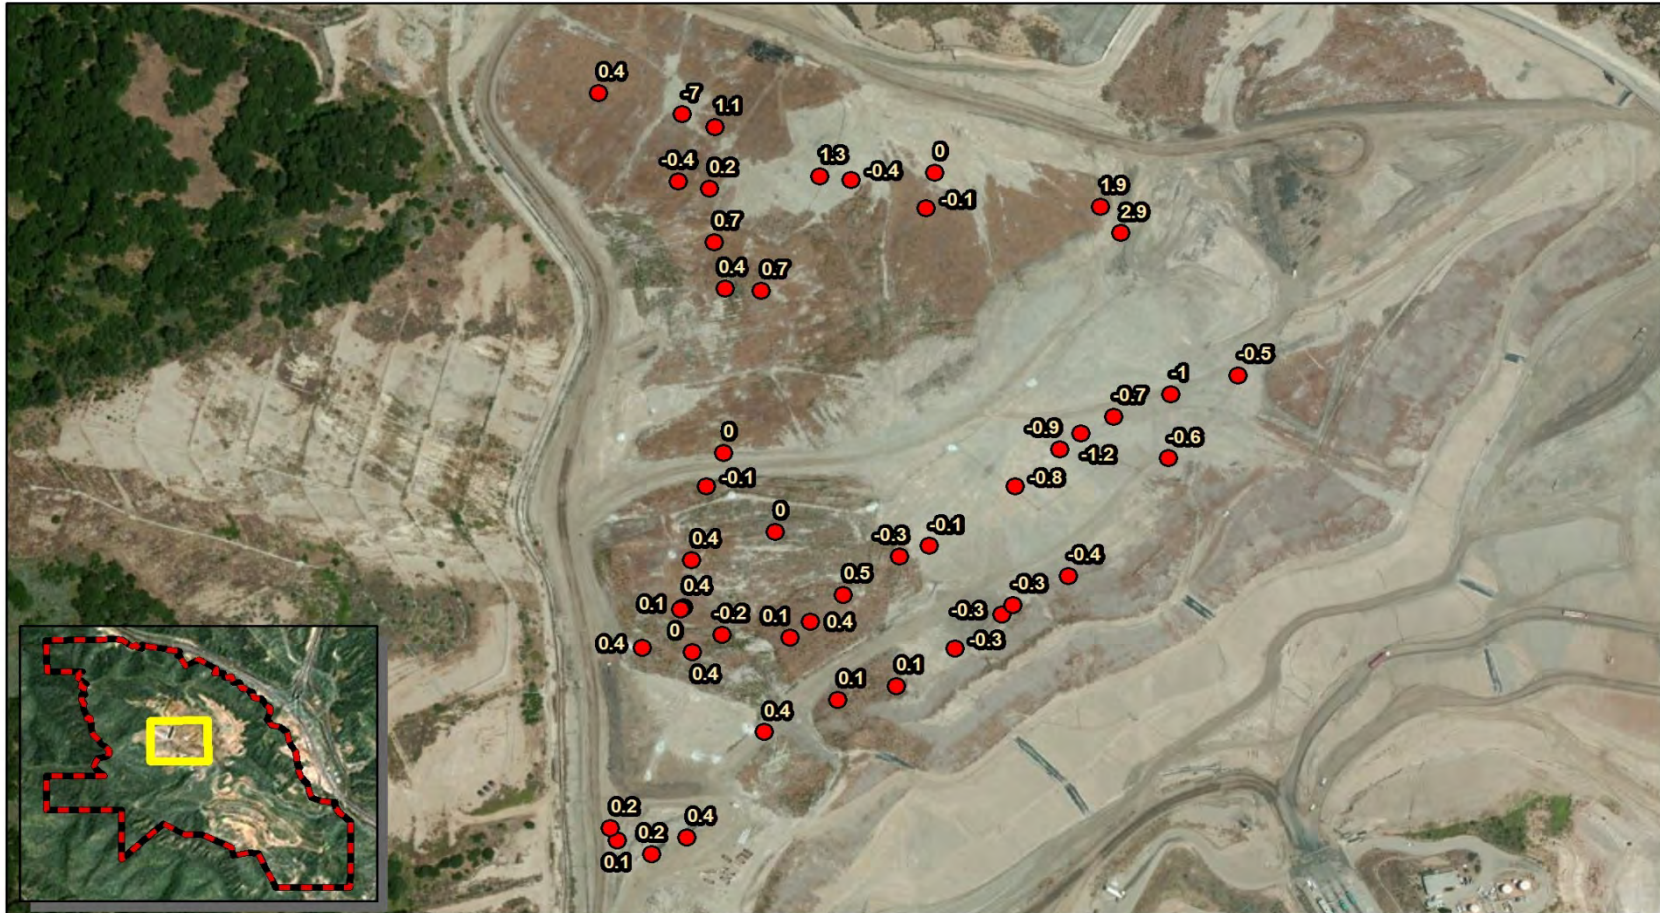
County Top Deck
GPS Elevation Data Comparison
Change of Elevations Between
from February 1 to April 10, 2013

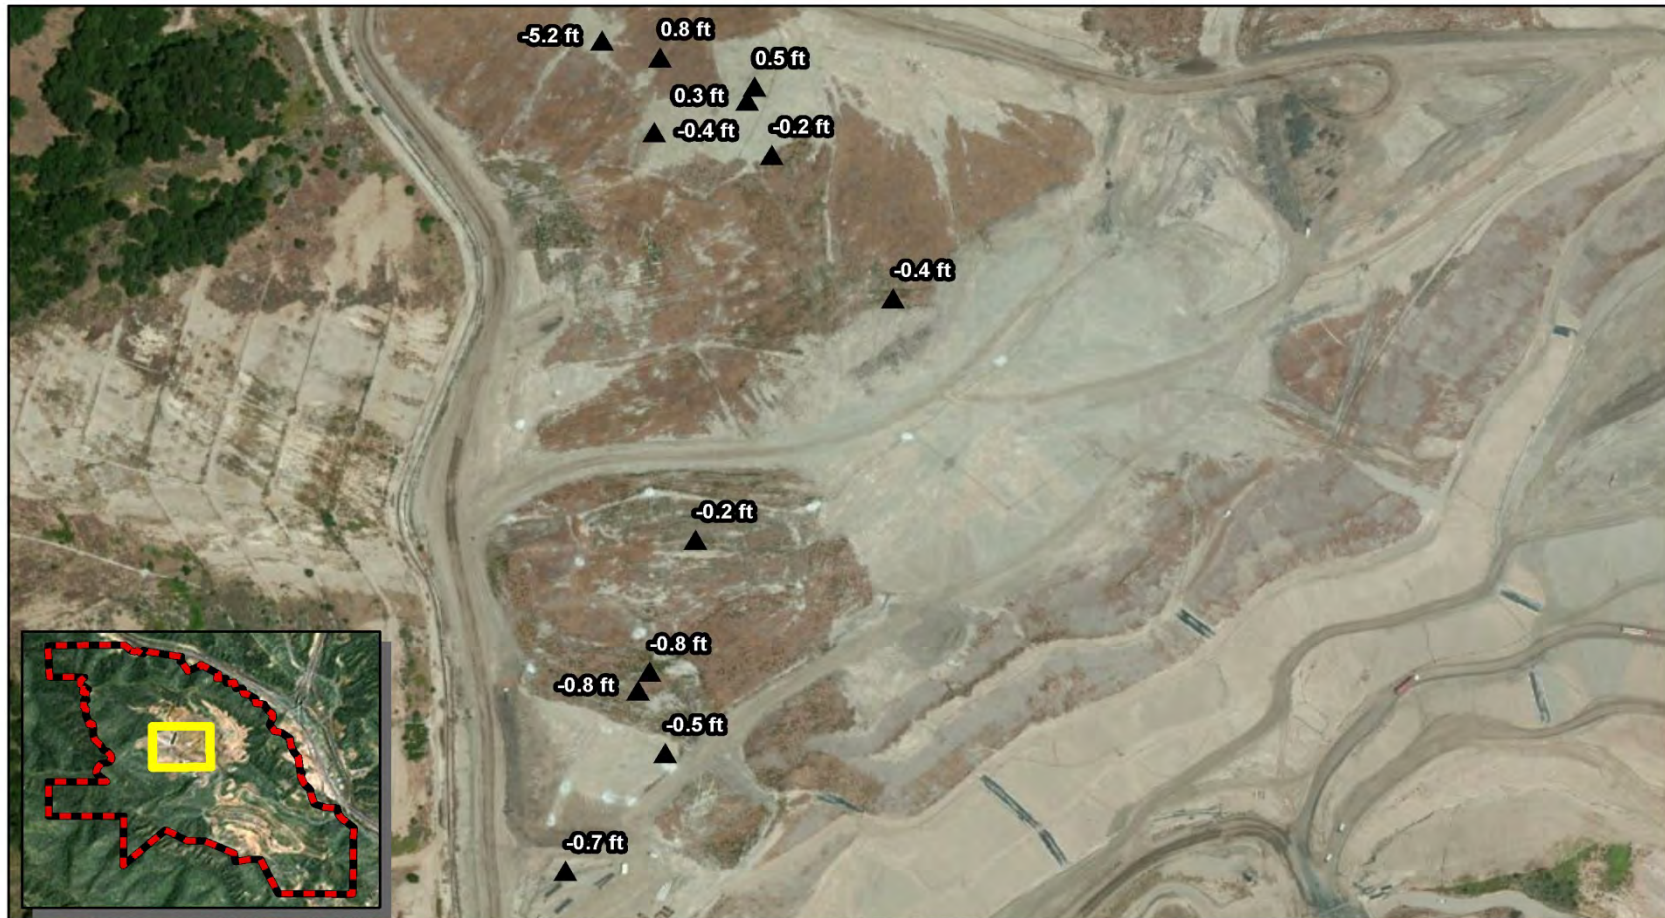
County Top Deck
Change of Elevations (in feet)
From May 1, 2013 to May 29, 2013

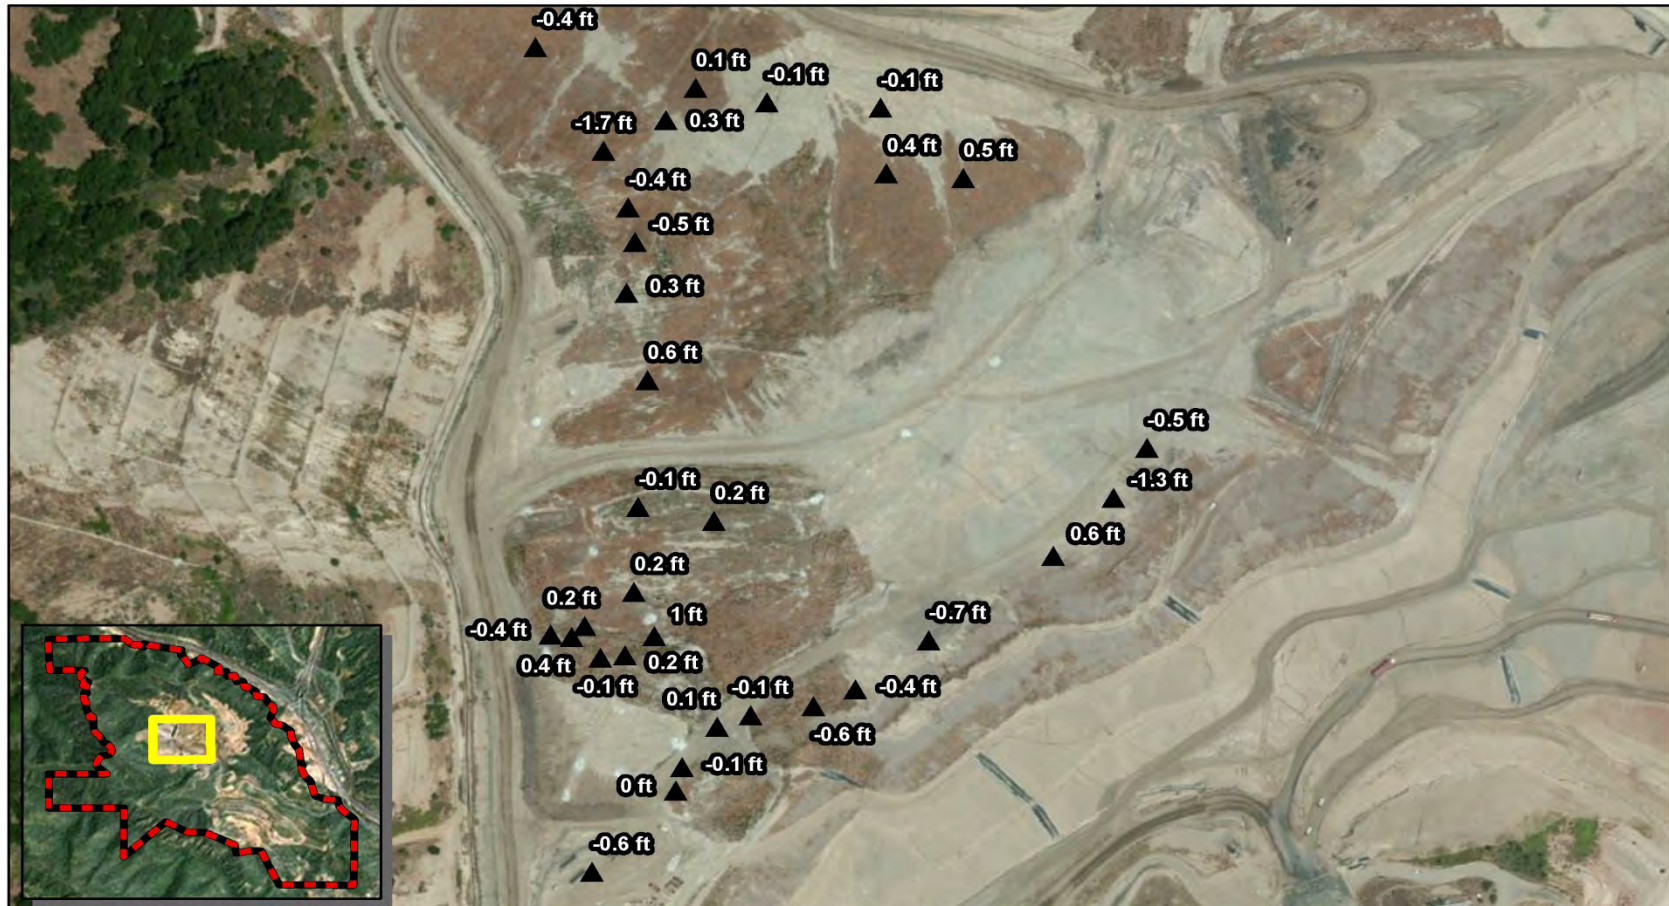
County Top Deck
Change of Elevations From
June 12, 2013 to April 10, 2013

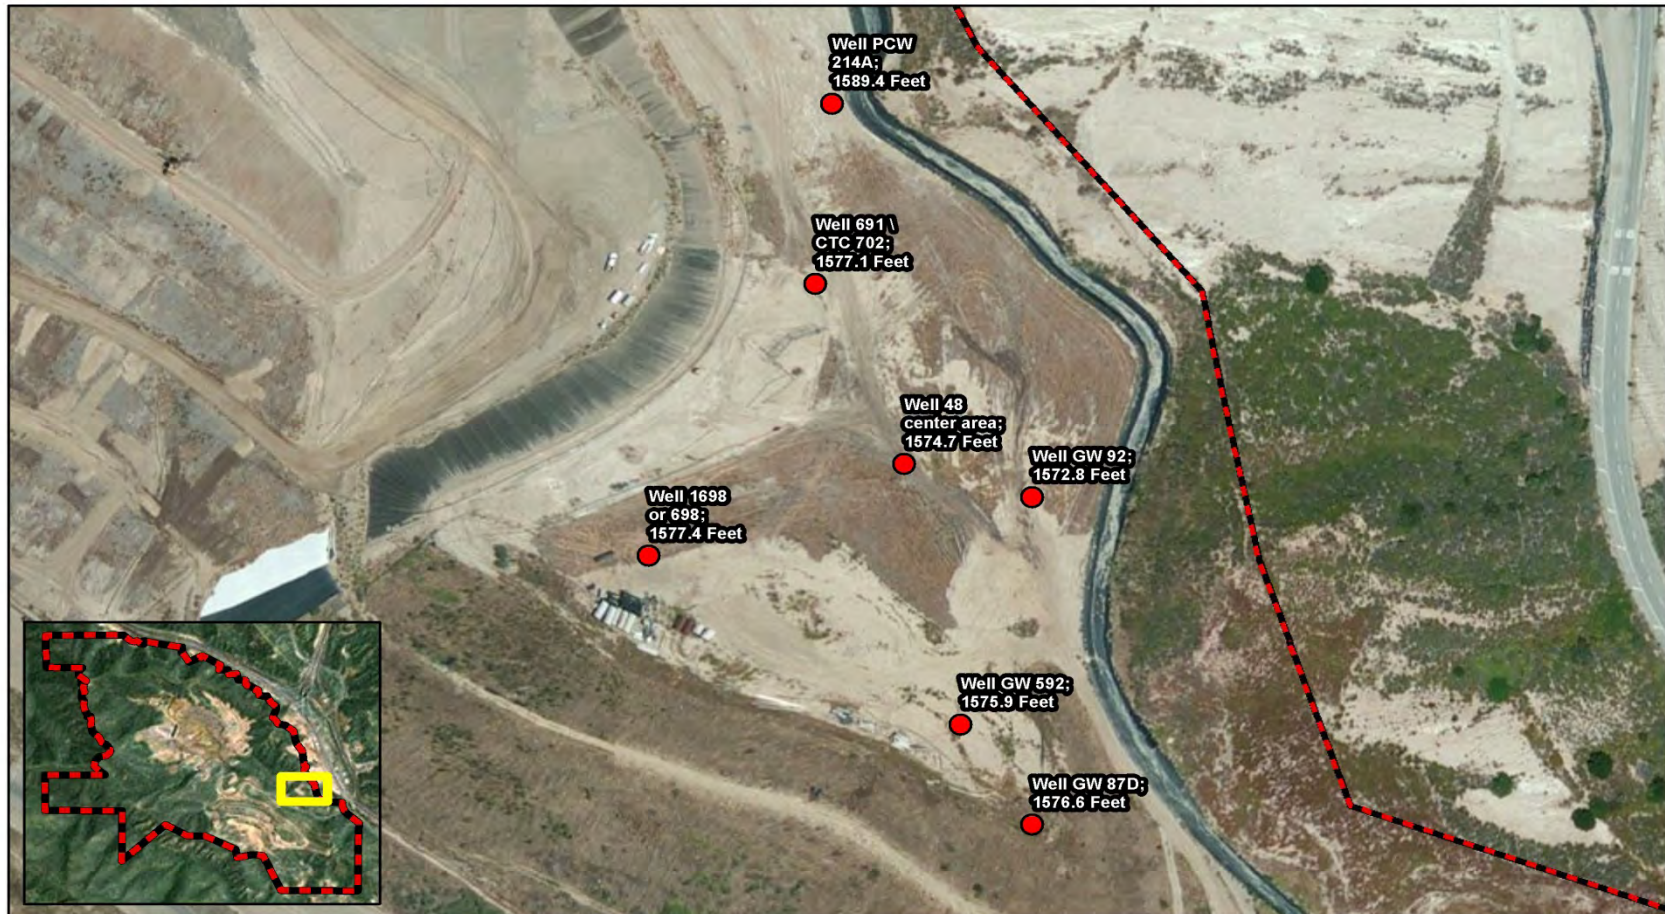
County Top Deck
Change of Elevations From
June 12, 2013 to May 29, 2013
