**Sunshine Canyon Landfill  
Independent Monitor  
Quarterly Site Monitoring Status Report  
July 1, 2018 – September 30, 2018**

**City of Los Angeles Department of City Planning**

**County of Los Angeles Department of Regional Planning**

November 5, 2018

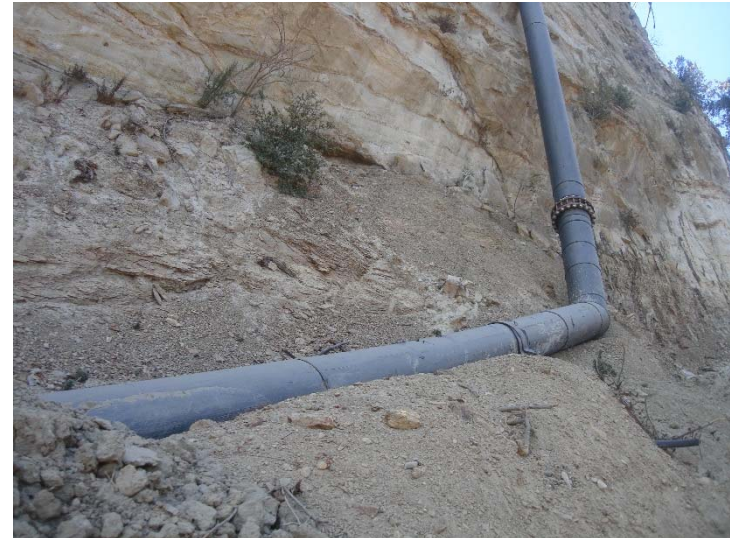
**Photo 363: Flare 3 Pipeline Cut at Basin A: September 25, 2018**
