**Sunshine Canyon Landfill
Independent Monitor
Quarterly Site Monitoring Status Report
January 1, 2016 – March 31, 2016**

City of Los Angeles Department of City Planning

County of Los Angeles Department of Regional Planning

May 16, 2016

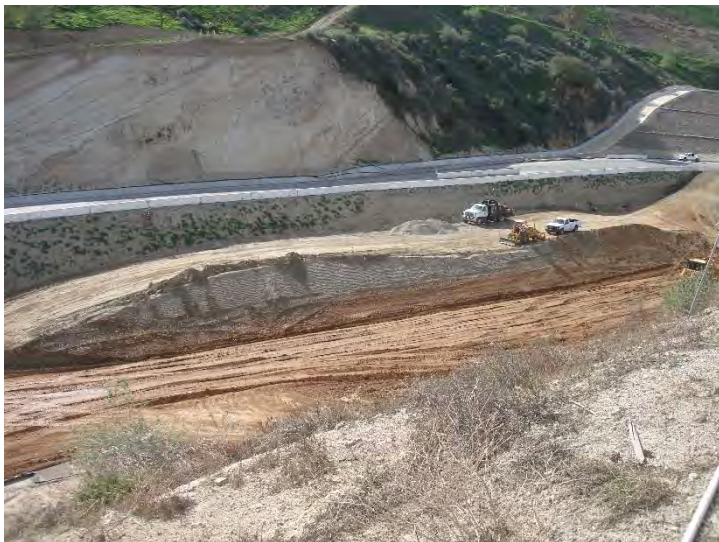
Photo 278: City Cell CC3B Construction: January 27, 2016

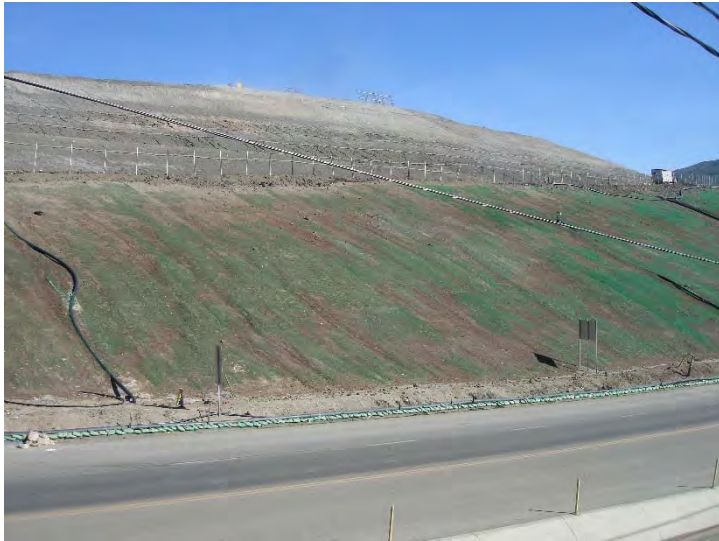
Photo 360: City Slope Erosion Control: February 24, 2016
