**Sunshine Canyon Landfill
Independent Monitor
Quarterly Site Monitoring Status Report
April 1, 2022 – June 30, 2022**

August 5, 2022

CERTIFICATION STATEMENT

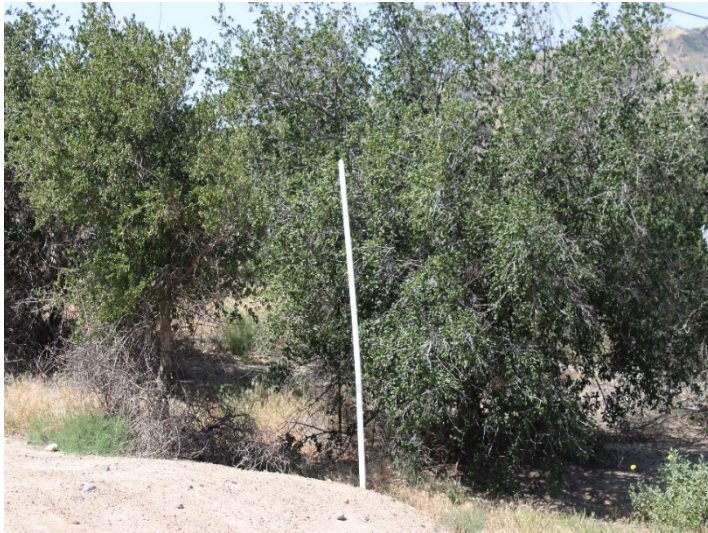
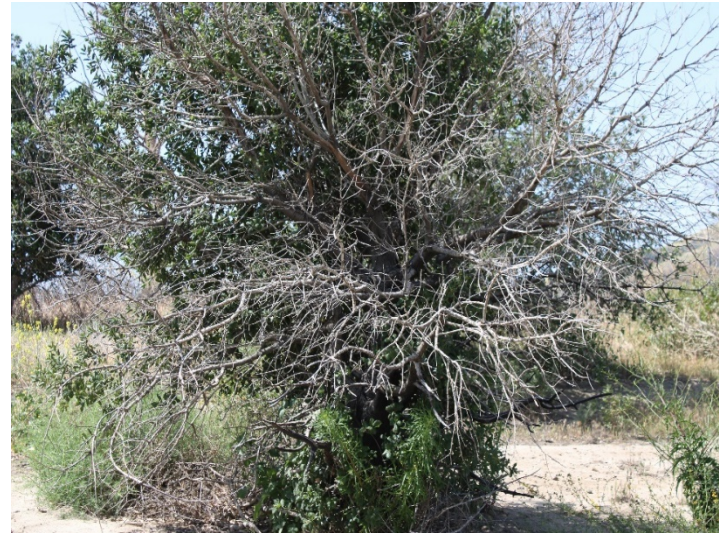
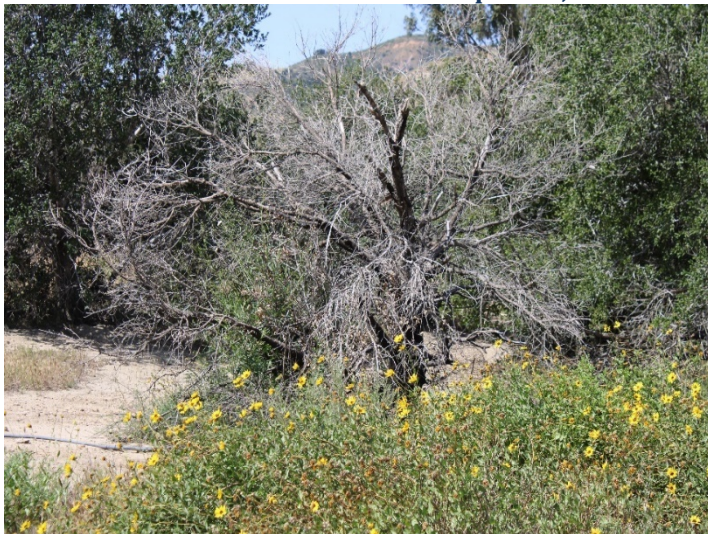
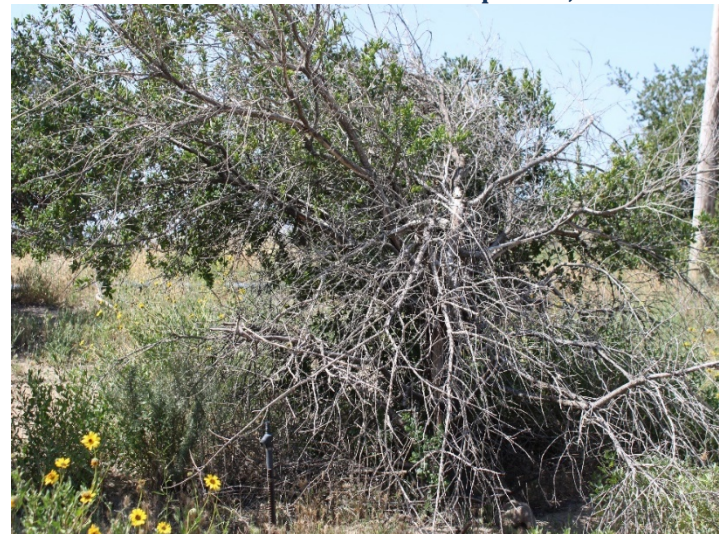
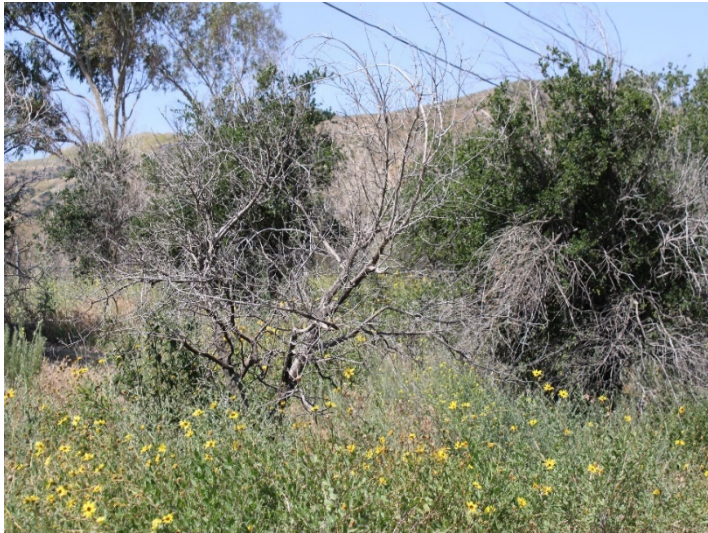
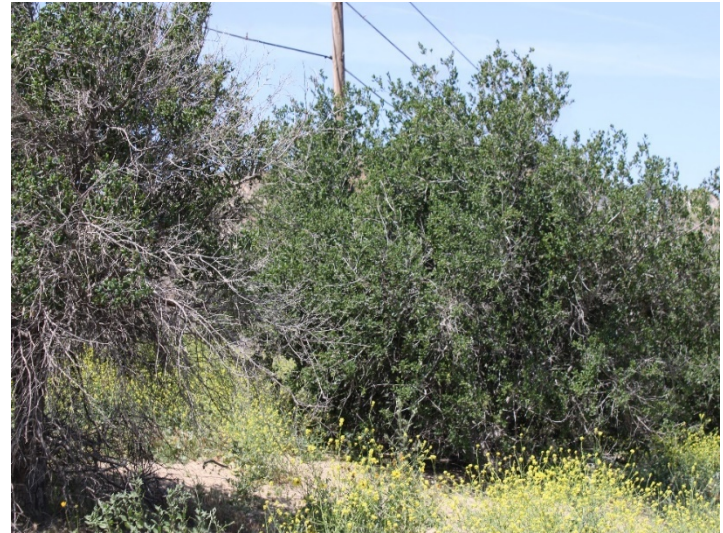
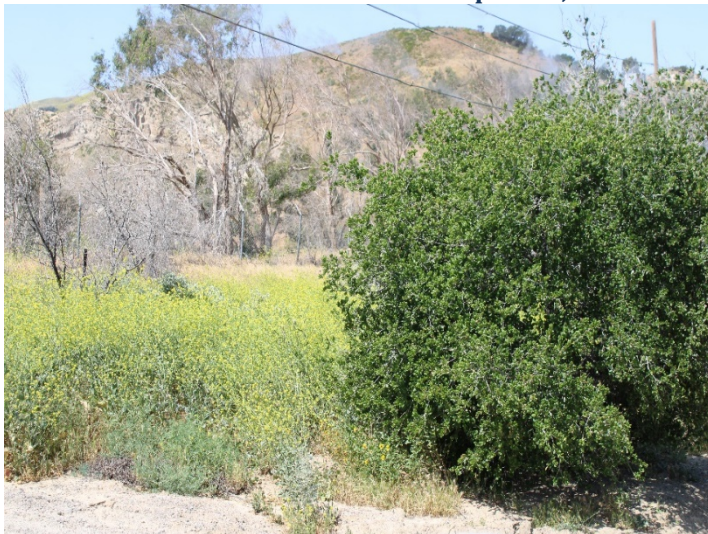
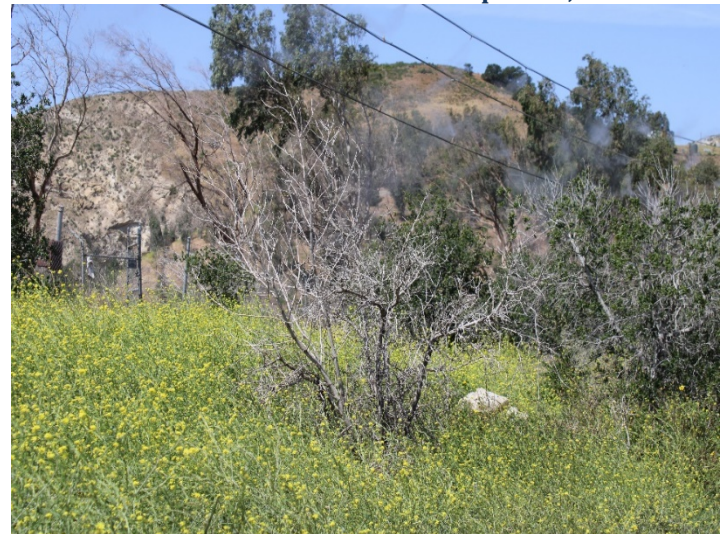
Photo 600: PM-10 Oak Trees: April 25, 2022

- PM-10 tree area has had no activity; replacement of dead trees has not occurred
- The upper deck of Cell CC-4 Part 4A was active accepting waste

1. Cover ADC with soil after each Saturday's operations.
2. Remove yellow mustard weed from City sage mitigation decks.
3. Replace dead oak trees at PM-10 berm.
4. Backfill the concrete V-ditch northeast of the new basin.
5. Remove trash and debris from the terminal basin outlet channel.
6. Repair the concrete-cracked sidewall at eastside drainage channel.
7. Remove soil and vegetation from the remaining eastside drainage culverts.
8. Repair blower number 5 outlet flange gas leak.
