DRAFT ENVIRONMENTAL IMPACT REPORT MOUNTAINGATE

Vesting Tentative Tract No. 53072

GEOTECHNICAL INVESTIGATION REPORT 2ND REVISED DETAIL VESTING TENTATIVE TRACT MAP NO. 53072 (SCALE OF 1 INCH = 100 FEET) CITY OF LOS ANGELES, CALIFORNIA

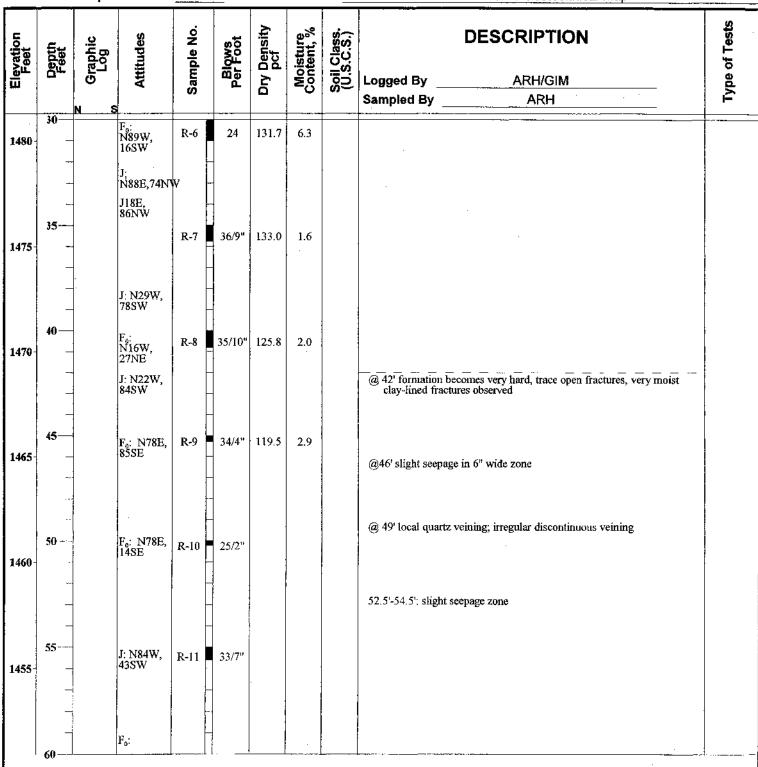
Sheet 2 of 3 3-13-01 Date Project No. **Project** Mountaingate, Tract 53072 03-0381-001 Driffing Co. Tri-Valley Drilling Type of Rig **Bucket-Auger** Hole Diameter Drive Weight-28=5952 lbs, 28-55=3921 lbs, 55-84=2531 lbs, 84-114=1407 lbarop 12" **Elevation Top of Hole** 1511' Location Refer to Geotechnical Map

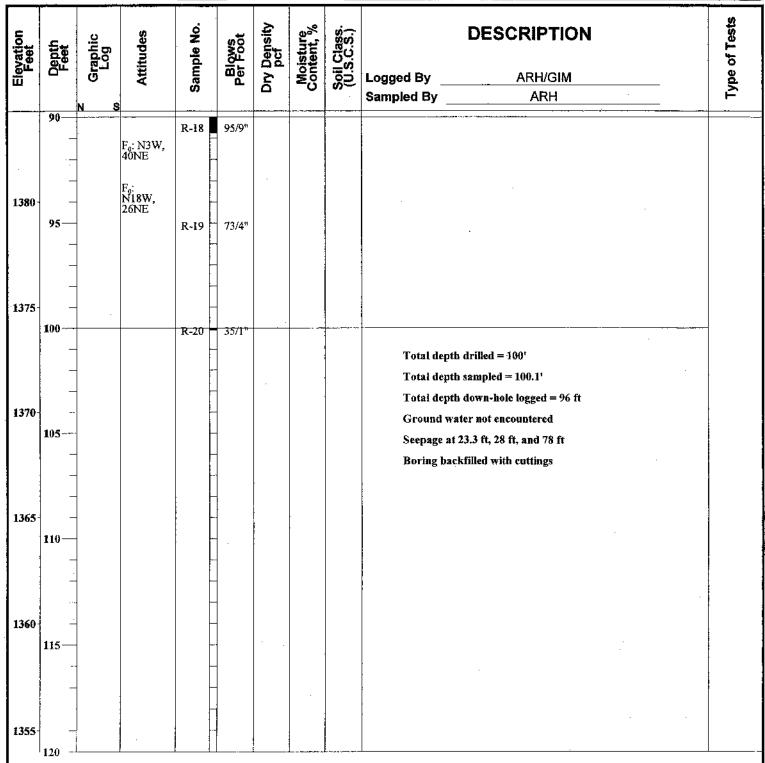
3-19-01 Sheet 4 of Date Mountaingate, Tract 53072 Project No. 03-0381-001 **Project** Tri-Valley Drilling Drilling Co. Type of Rig Bucket-Auger Drive Weight-28=5952 lbs, 28-55=3921 lbs, 55-84=2531 lbs, 84-114=1407 literop 12" Hole Diameter **Elevation Top of Hole** 1474' Location Refer to Geotechnical Map

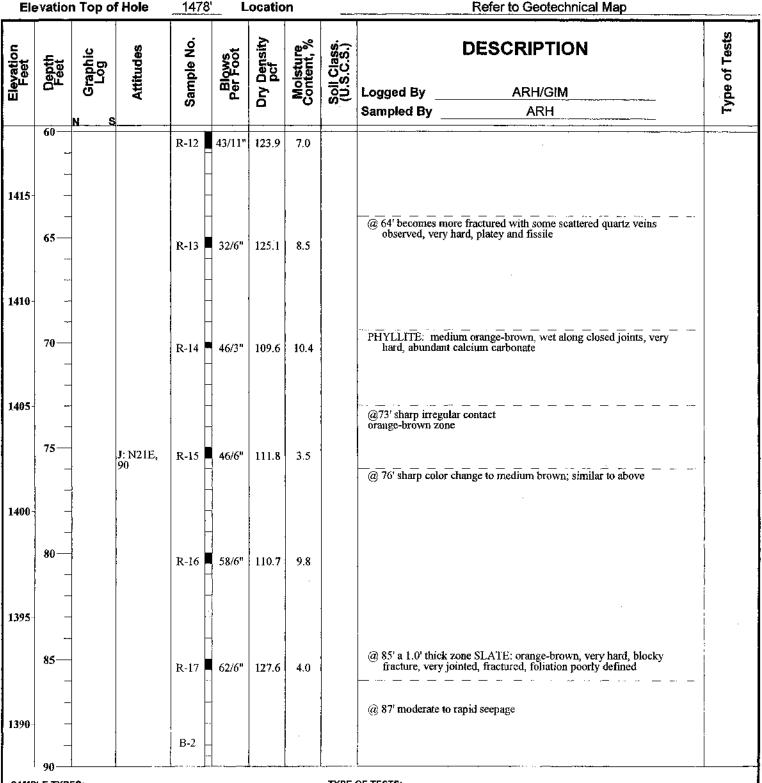
Date 3-26-	01		Sheet 3	of <u>4</u>
Project	M	lountaingate, Tract 53072	Project No.	03-0381-001
Drilling Co.		Tri-Valley Drilling	Type of Rig	Bucket-Auger
Hole Diameter	24"	Drive Weight-28=5952 lbs.	28-55=3921 lbs, 55-84=2531 lbs, 84-114=	=1407 lb3rop 12"
Elevation Top of Hole	1478'	Location	Refer to Geotechnical Map

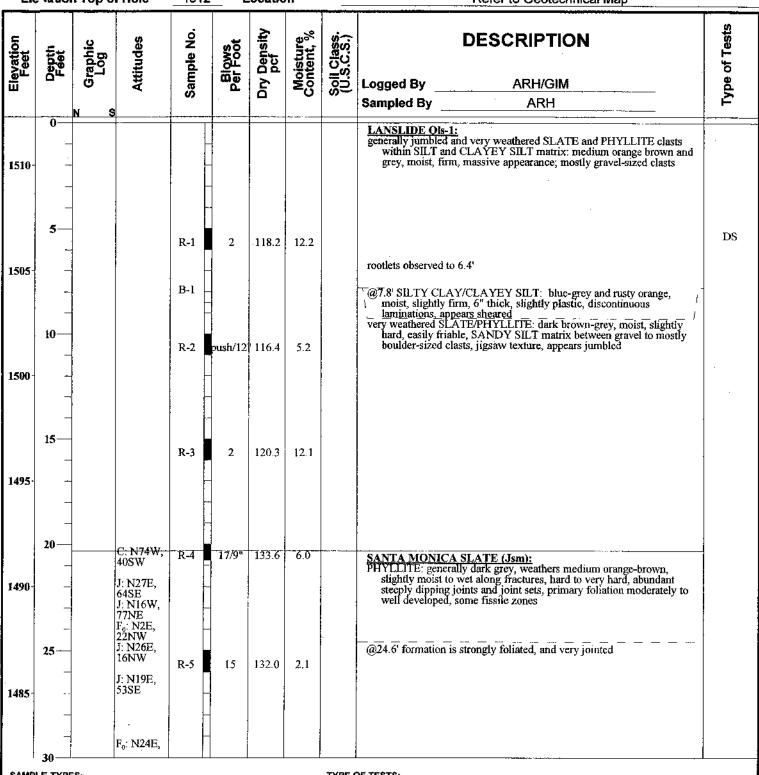
G			HI	IUA	BURING LUG LB-/					
Date		3-29-01						Sheet 1	of 4				
Project				Mou	ntaing	ate, Tr	act 530	72 Project No.	03-038	1-001			
Drilling	Co.				Tri-	Valley	Drillin	Type of Rig	Bucket-	-Auger			
Hoi e Dia	meter	2	24"	_ [rive V	Veight:	28=59	2 lbs, 28-55=3921 lbs, 55-84=2531 lbs, 84-114=					
Elevatio	n Top of	Hole	1512	_ L	.ocatic	n		Refer to Geotechnical Map					
5	j.	ş	No.	ot.	sity	Φ%.	iss. S.)	DESCRIPTION		ests
