**Sunshine Canyon Landfill
Independent Monitor
Quarterly Site Monitoring Status Report
April 1, 2020 – June 30, 2020**

The attached Quarterly Site Monitoring Status Report for the Sunshine Canyon Landfill dated November 4, 2020 is the Second Quarterly Report for 2020, issued by UltraSystems. This report covers the monitoring period from April 1, 2020 through June 30, 2020 and is prepared for the City of Los Angeles Department of City Planning and the County of Los Angeles Department of Regional Planning.

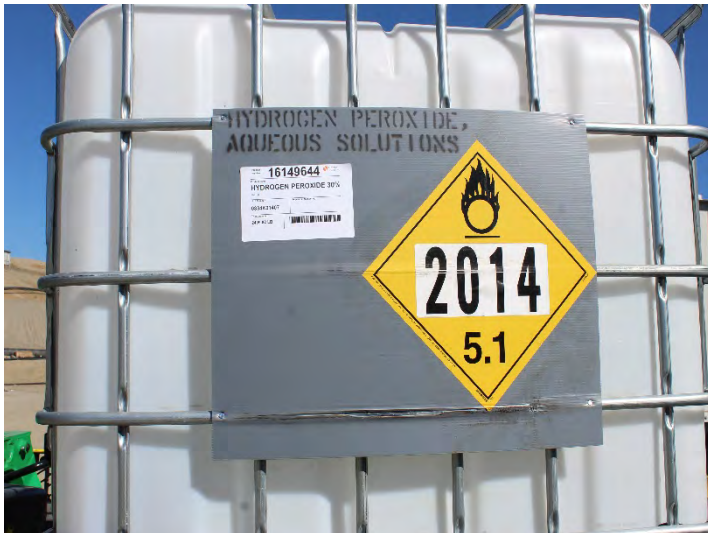
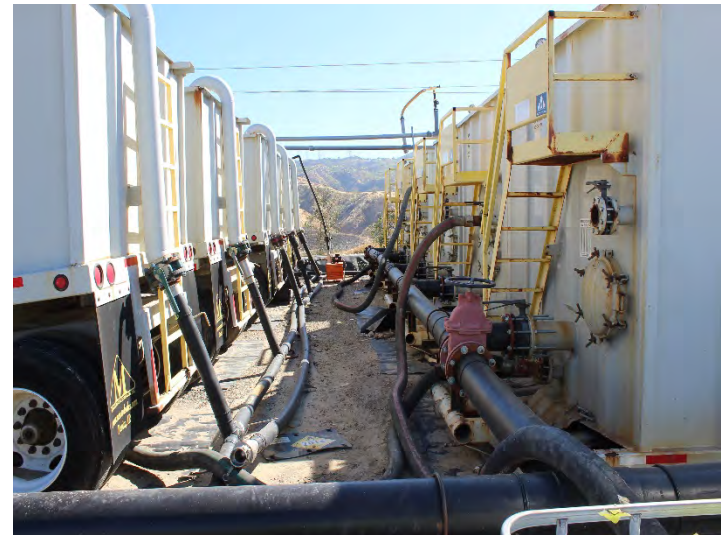
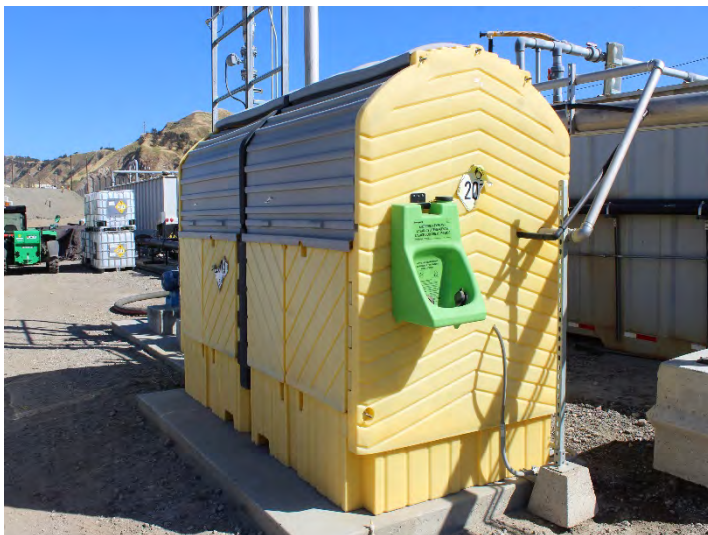
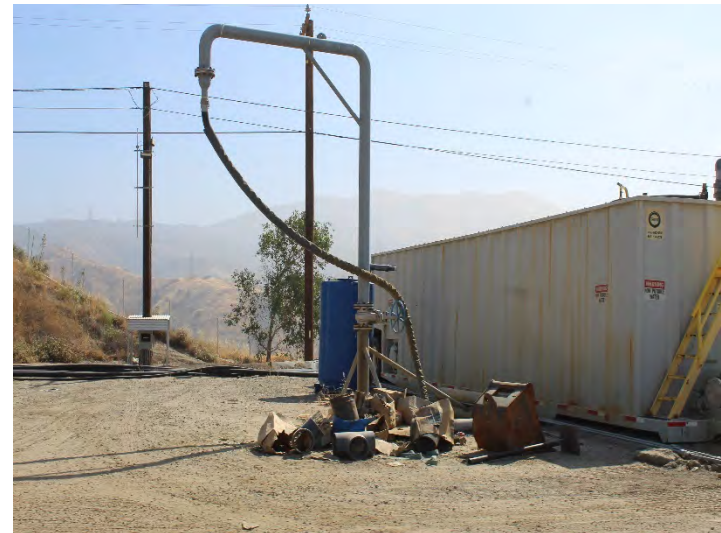
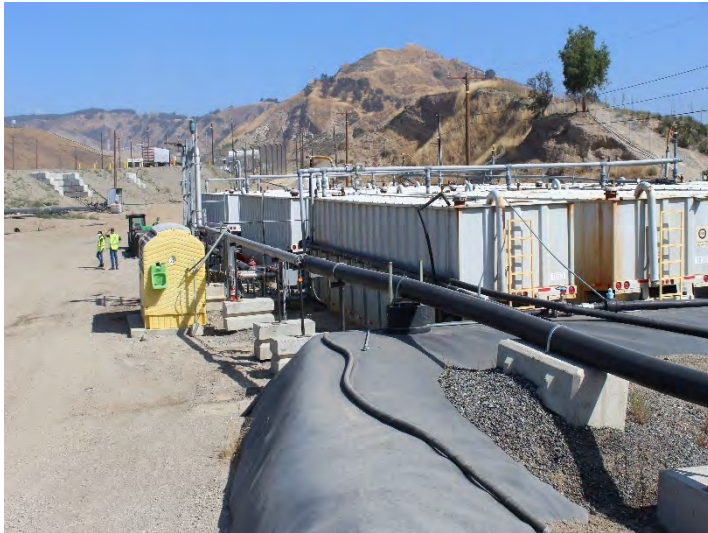
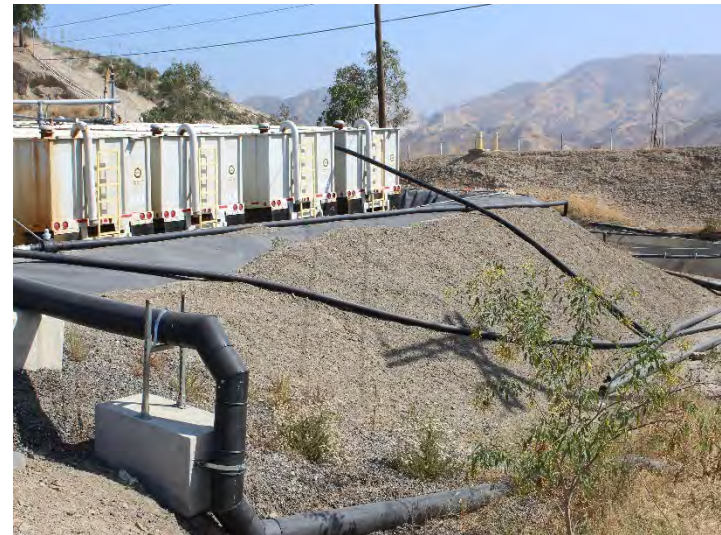
Photo 232: Adler Tank Liquids Treatment System: May 26, 2020

Photo 233: Adler Tank Liquids Treatment System: May 26, 2020

Photo 234: Adler Tank Liquids Treatment System: May 26, 2020

Photo 235: Adler Tank Liquids Treatment System: May 26, 2020

Photo 236: Adler Tank Liquids Treatment System: June 23, 2020

Photo 237: Adler Tank Liquids Treatment System: June 23, 2020

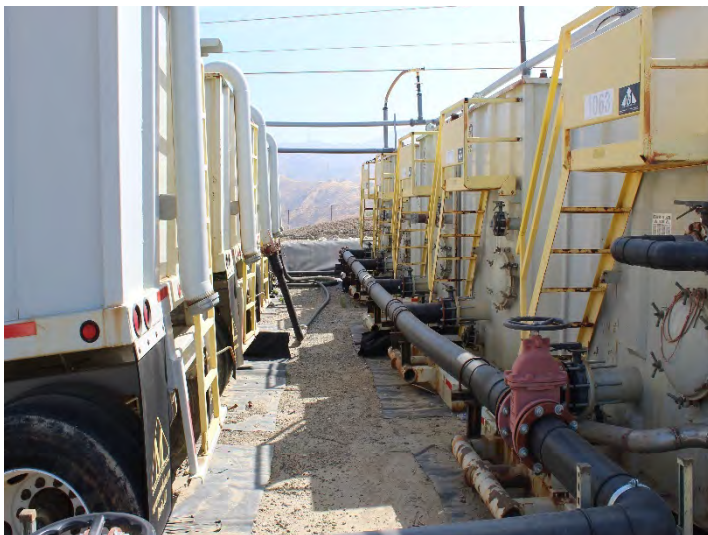
Photo 238: Adler Tank Liquids Treatment System: June 23, 2020
