Sunshine Canyon Landfill Independent Monitor Quarterly Site Monitoring Status Report January 1, 2022 – March 31, 2023

City of Los Angeles Department of City Planning

County of Los Angeles Department of Regional Planning

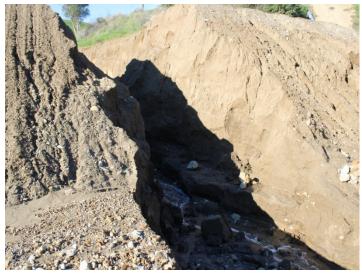
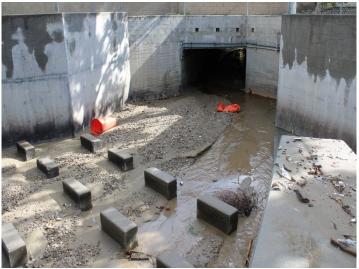
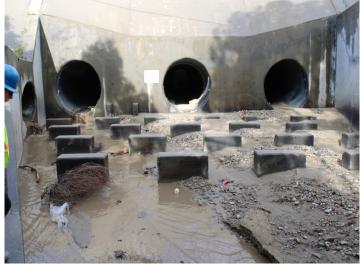
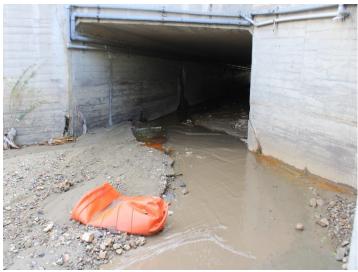
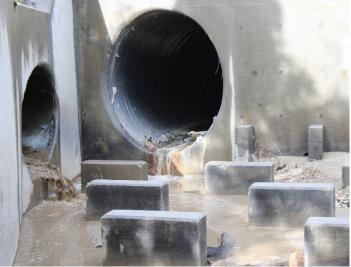
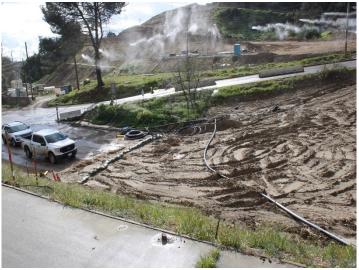
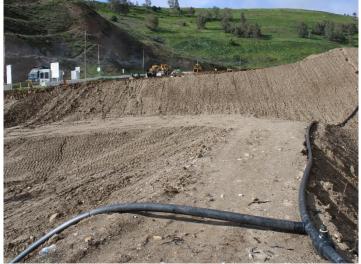
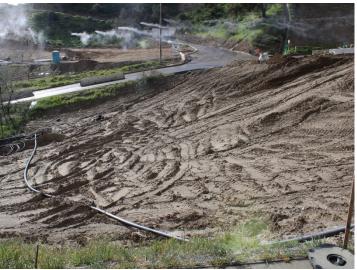
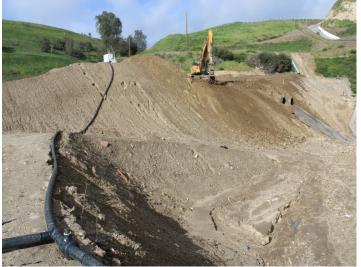
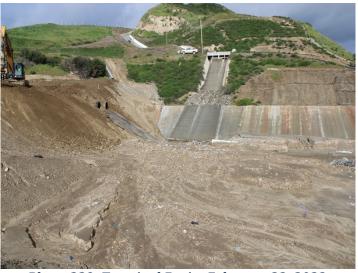
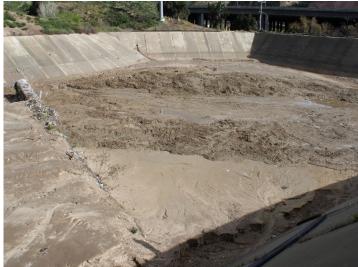
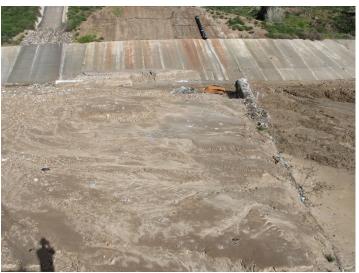
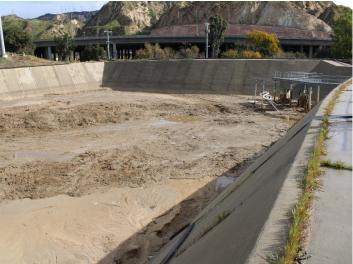
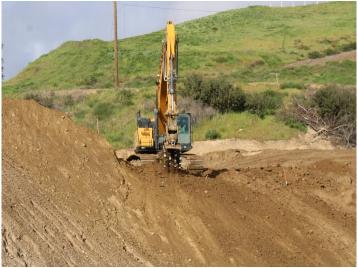
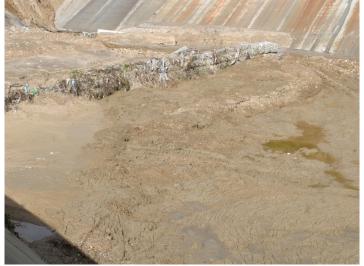
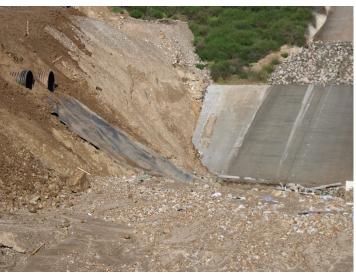
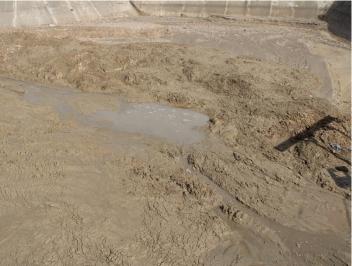
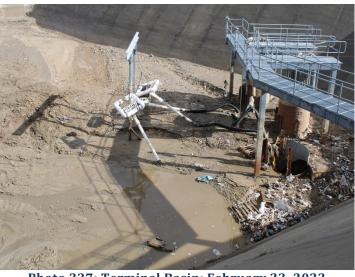
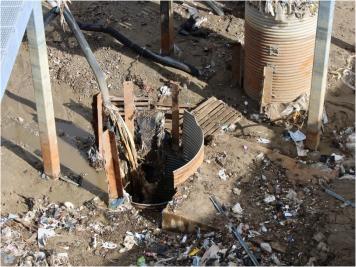
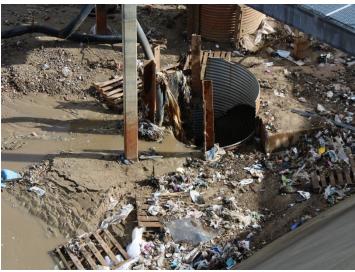
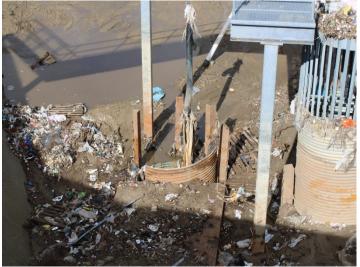
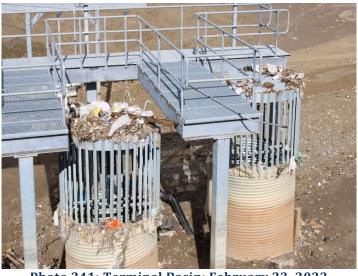
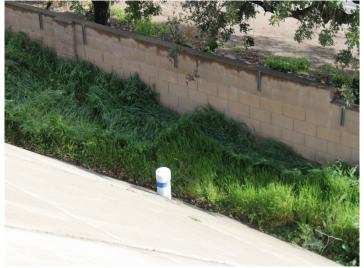
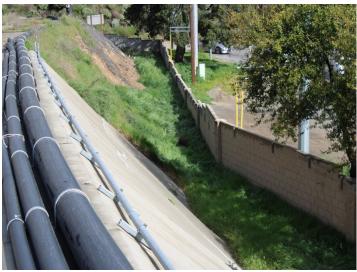
Photo 219: Terminal Basin: February 23, 2023

Photo 220: Terminal Basin: February 23, 2023

Photo 221: Terminal Basin: February 23, 2023

Photo 223: Terminal Basin: February 23, 2023

Photo 222: Terminal Basin: February 23, 2023

Photo 224: Terminal Basin: February 23, 2023

Photo 225: Terminal Basin: February 23, 2023

Photo 227: Terminal Basin: February 23, 2023

Photo 226: Terminal Basin: February 23, 2023

Photo 228: Terminal Basin: February 23, 2023

Photo 229: Terminal Basin: February 23, 2023

Photo 231: Terminal Basin: February 23, 2023

Photo 230: Terminal Basin: February 23, 2023

Photo 232: Terminal Basin: February 23, 2023

Photo 233: Terminal Basin: February 23, 2023

Photo 235: Terminal Basin: February 23, 2023

Photo 234: Terminal Basin: February 23, 2023

Photo 236: Terminal Basin: February 23, 2023

Photo 237: Terminal Basin: February 23, 2023

Photo 239: Terminal Basin: February 23, 2023

Photo 238: Terminal Basin: February 23, 2023

Photo 240: Terminal Basin: February 23, 2023

Photo 241: Terminal Basin: February 23, 2023

Photo 243: Terminal Basin: February 23, 2023

12. The admin and LEA facility are in good order.						
	ne outlet channel due to a damaged vertical riser drain.					
_	ninal basin outlet channel due to uncontrolled storm					
water.

- 1. Repair terminal basin vertical drain riser, and clear the outlet channel of sediment and rock.
- 2. Clear drainage below flare pad of soil and tree.
