**Sunshine Canyon Landfill
Independent Monitor
Quarterly Site Monitoring Status Report
January 1, 2021 – March 31, 2021**

City of Los Angeles Department of City Planning

County of Los Angeles Department of Regional Planning

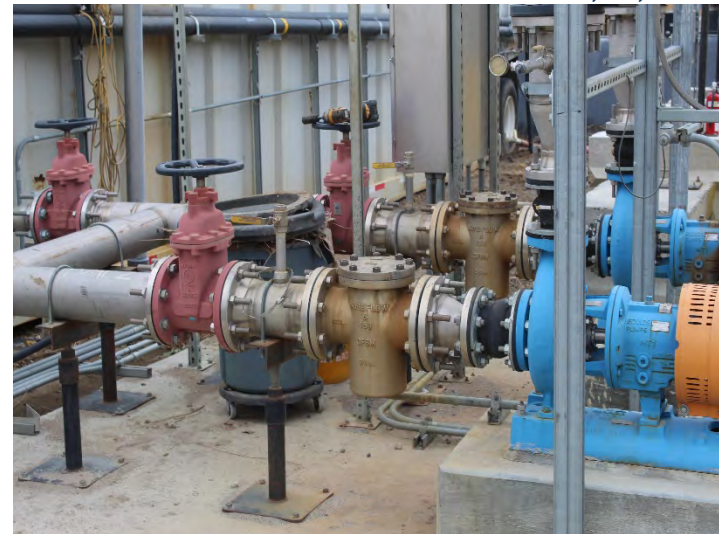
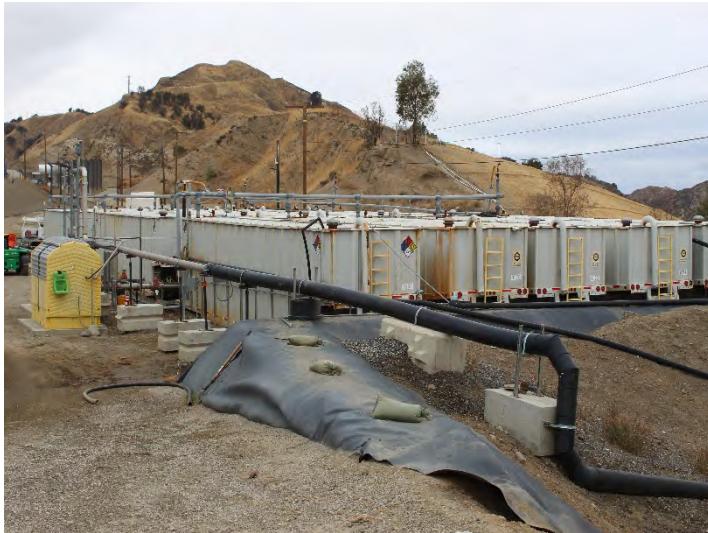
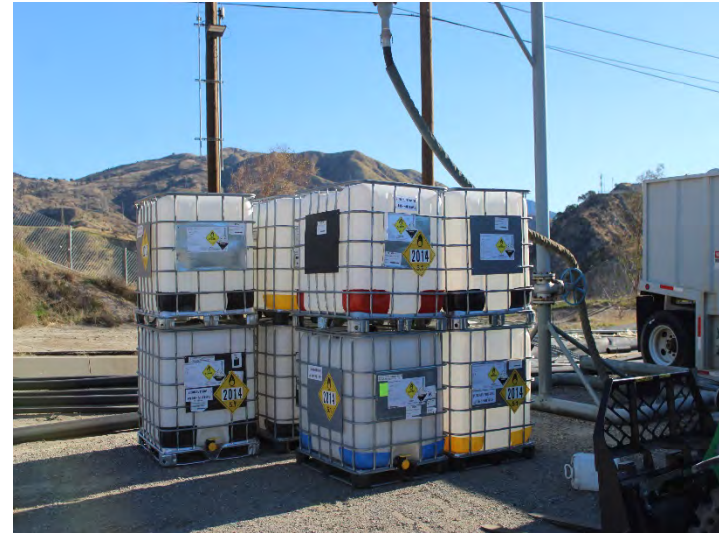
**Photo 163: Alder Tank Liquids Treatment System:
January 27, 2021**

**Photo 164: Alder Tank Liquids Treatment System:
January 27, 2021**

**Photo 165: Alder Tank Liquids Treatment System:
January 27, 2021**

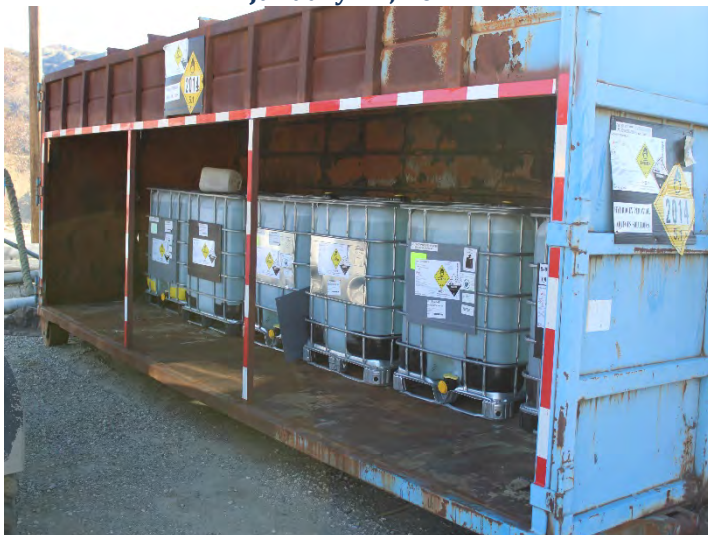
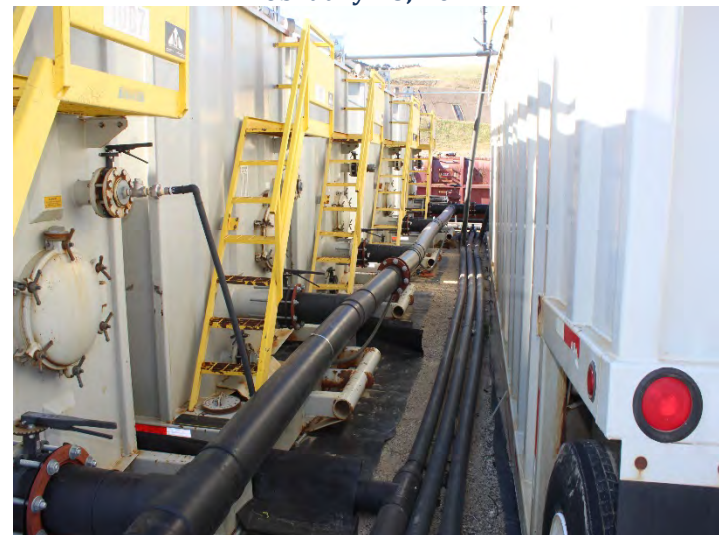
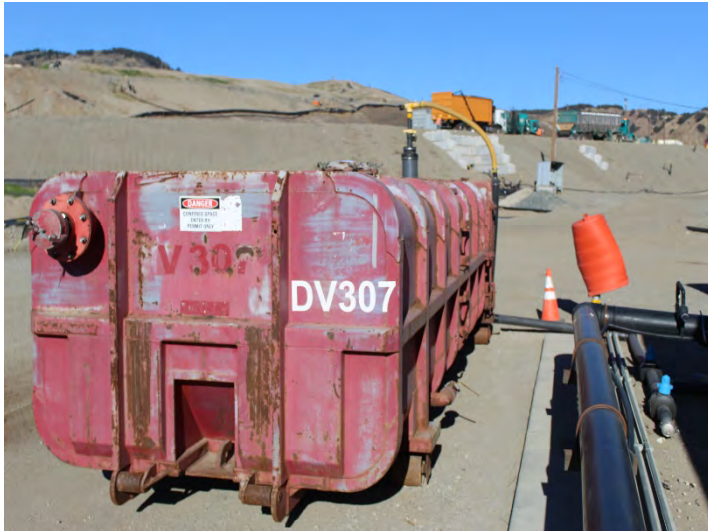
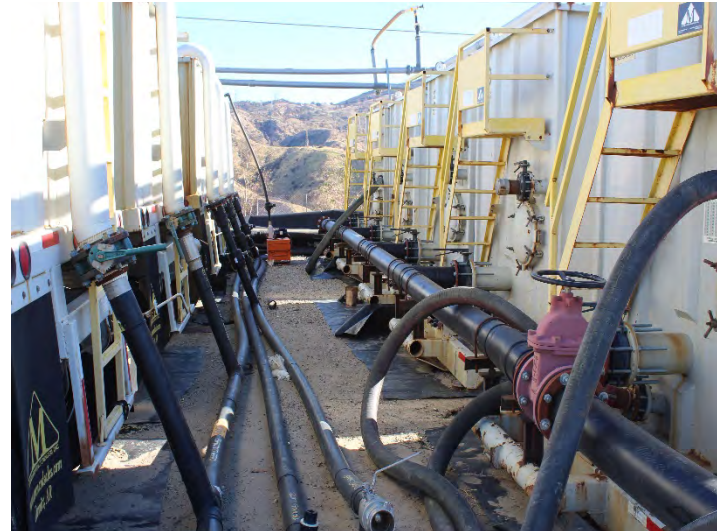
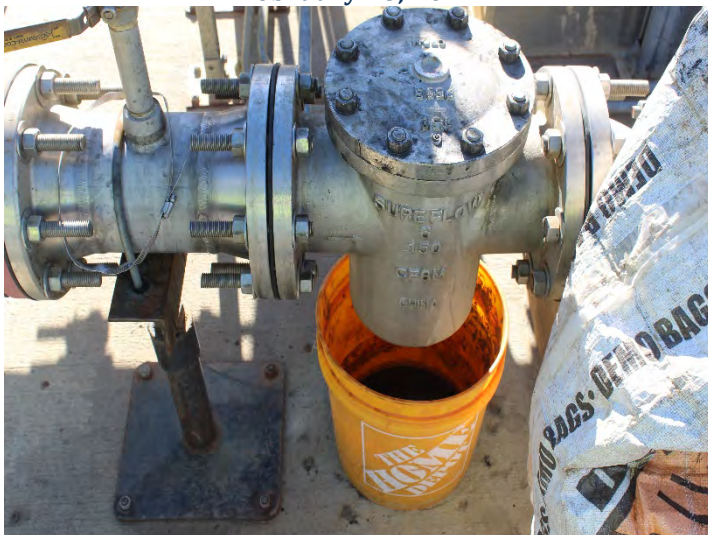
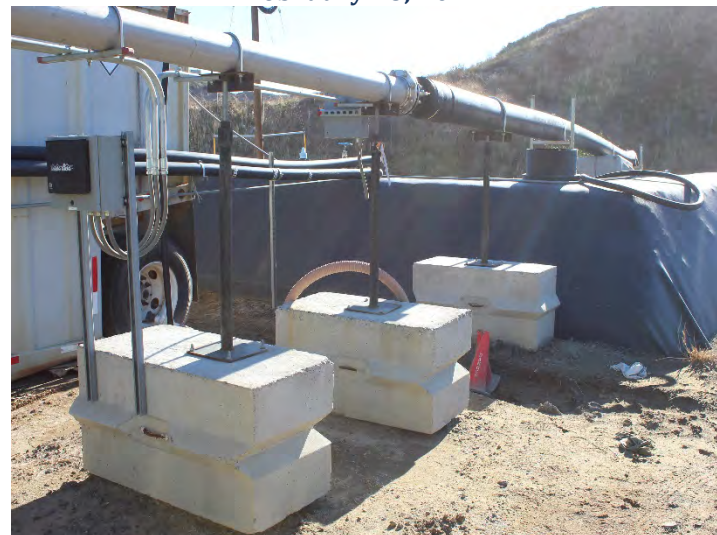
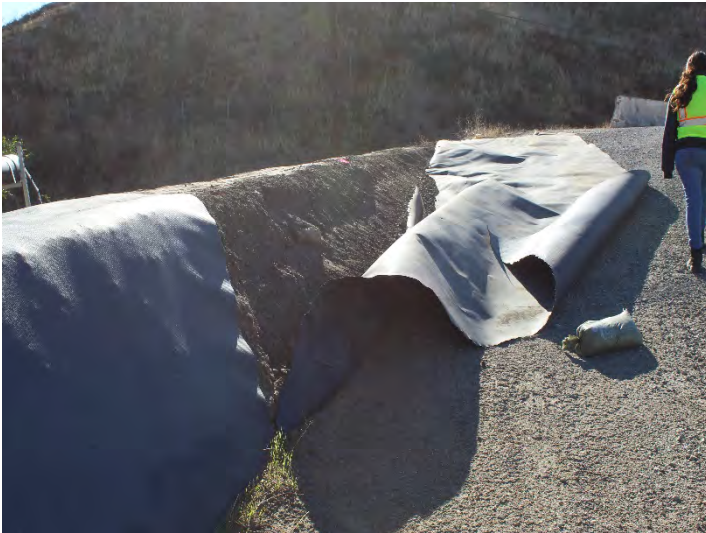
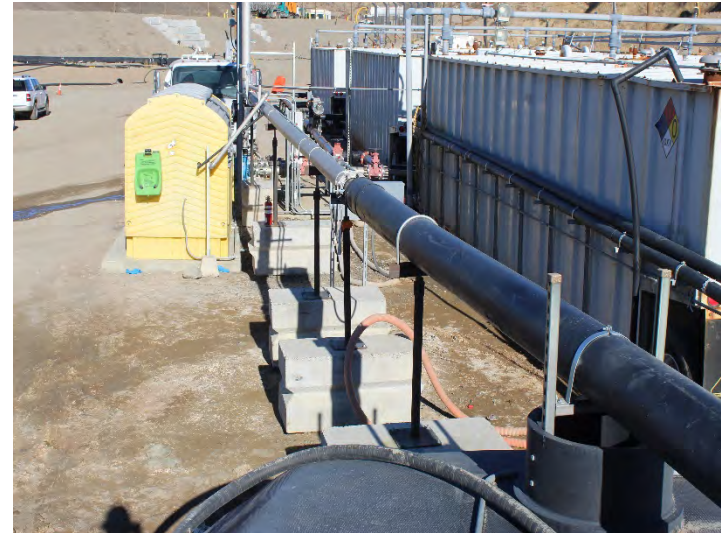
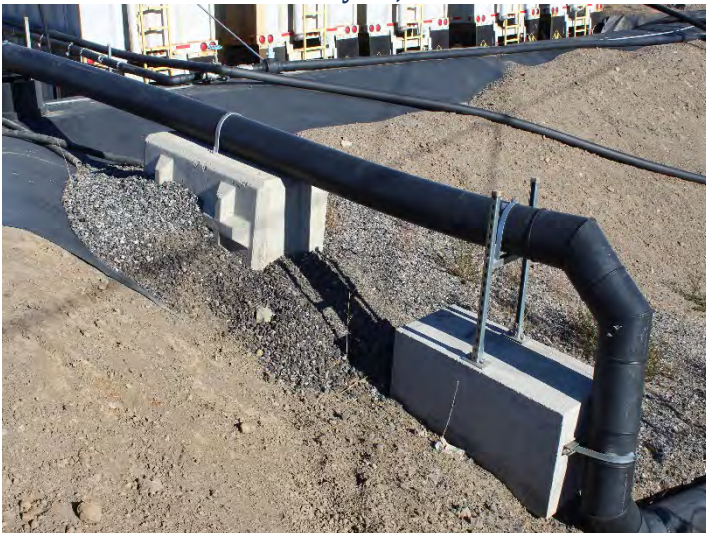
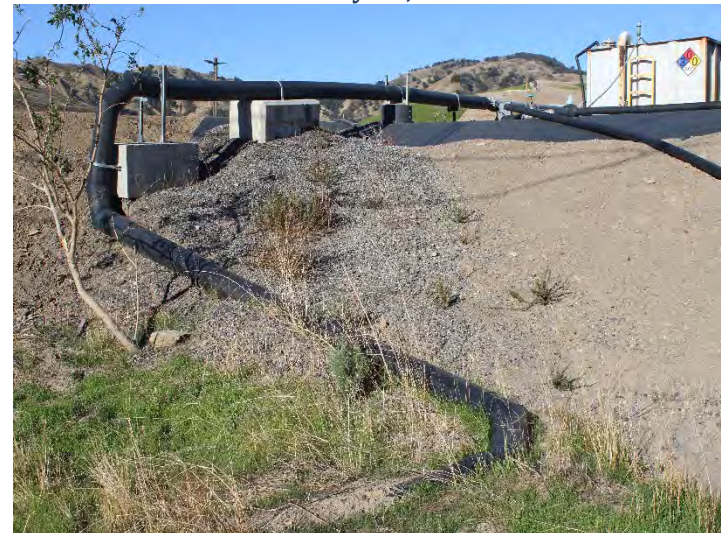
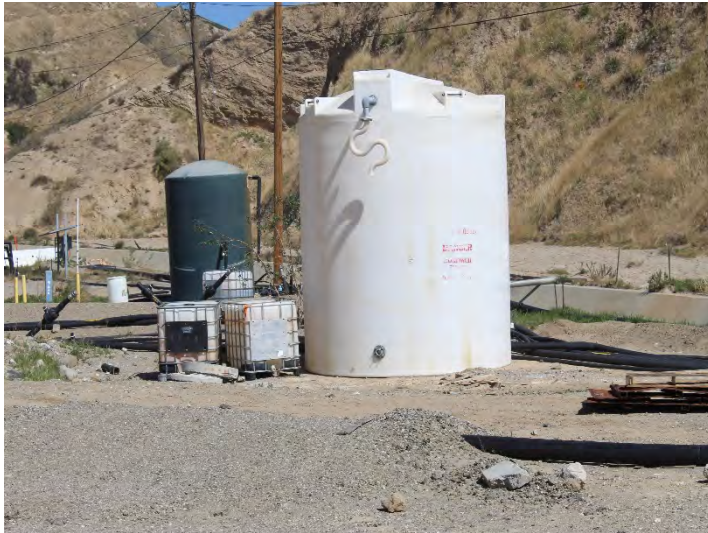
**Photo 166: Alder Tank Liquids Treatment System:
February 18, 2021**

**Photo 167: Alder Tank Liquids Treatment System:
February 18, 2021**

**Photo 168: Alder Tank Liquids Treatment System:
February 18, 2021**

**Photo 169: Alder Tank Liquids Treatment System:
February 18, 2021**

**Photo 170: Alder Tank Liquids Treatment System:
February 18, 2021**

**Photo 171: Alder Tank Liquids Treatment System:
February 18, 2021**

**Photo 172: Alder Tank Liquids Treatment System:
February 18, 2021**

**Photo 173: Alder Tank Liquids Treatment System:
February 18, 2021**

**Photo 174: Alder Tank Liquids Treatment System:
February 18, 2021**

**Photo 175: Alder Tank Liquids Treatment System:
February 18, 2021**

**Photo 176: Alder Tank Liquids Treatment System:
February 18, 2021**

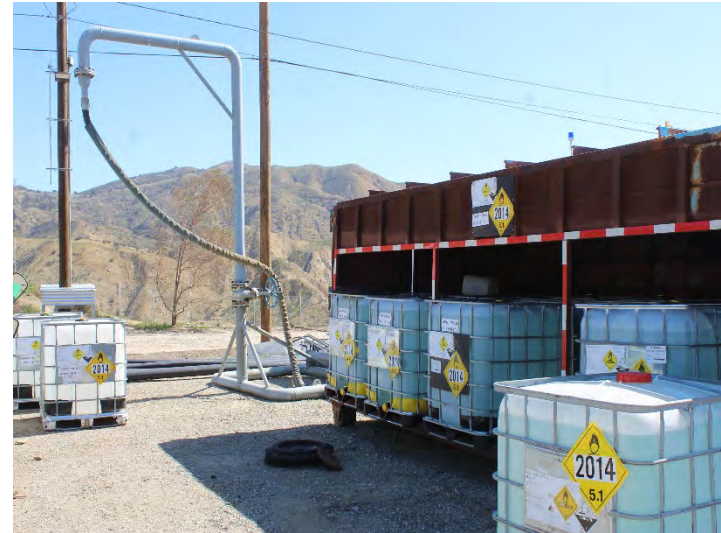
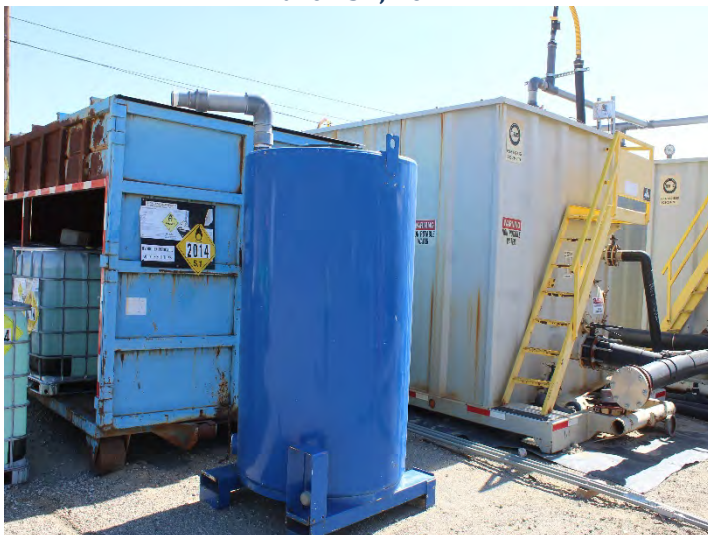
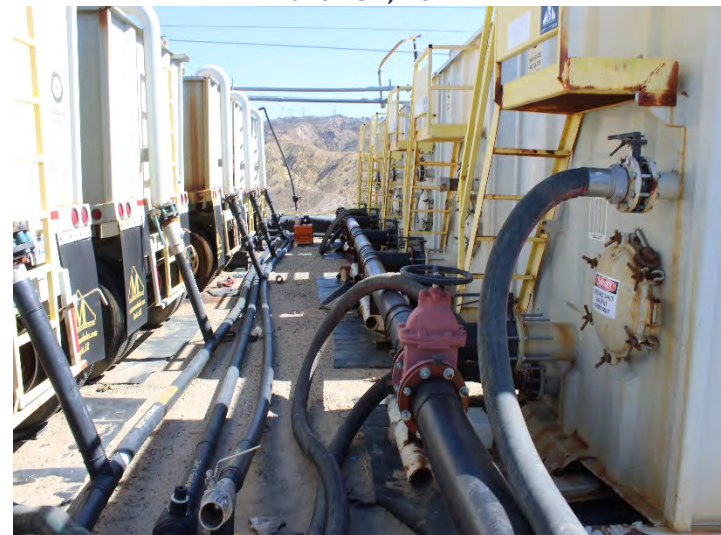
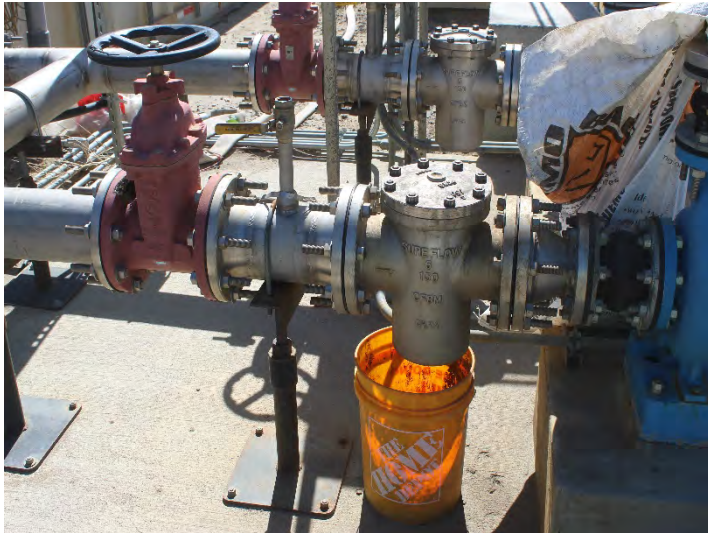
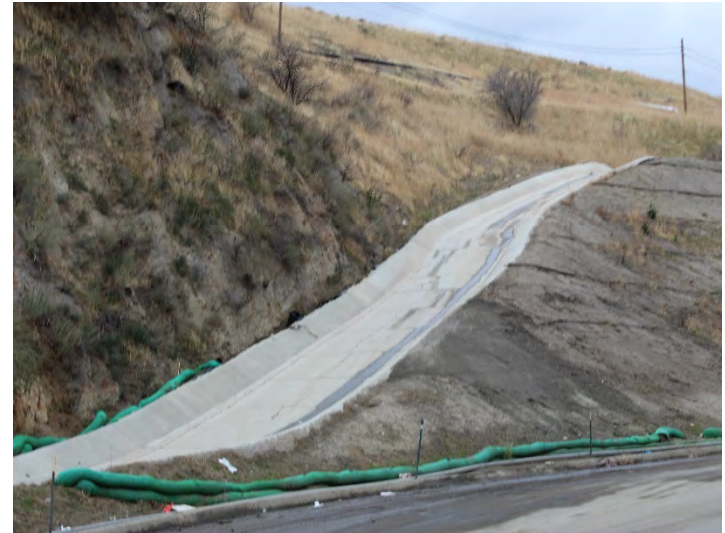
**Photo 177: Alder Tank Liquids Treatment System:
March 31, 2021**

**Photo 178: Alder Tank Liquids Treatment System:
March 31, 2021**

**Photo 179: Alder Tank Liquids Treatment System:
March 31, 2021**

**Photo 180: Alder Tank Liquids Treatment System:
March 31, 2021**

**Photo 181: Alder Tank Liquids Treatment System:
March 31, 2021**

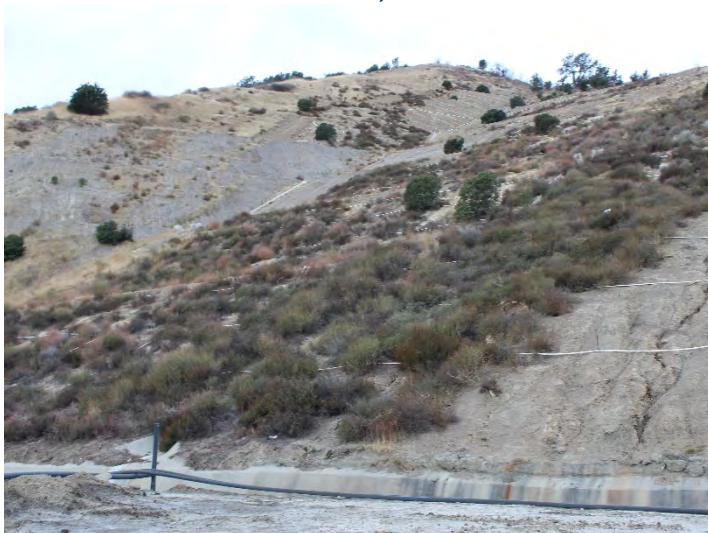
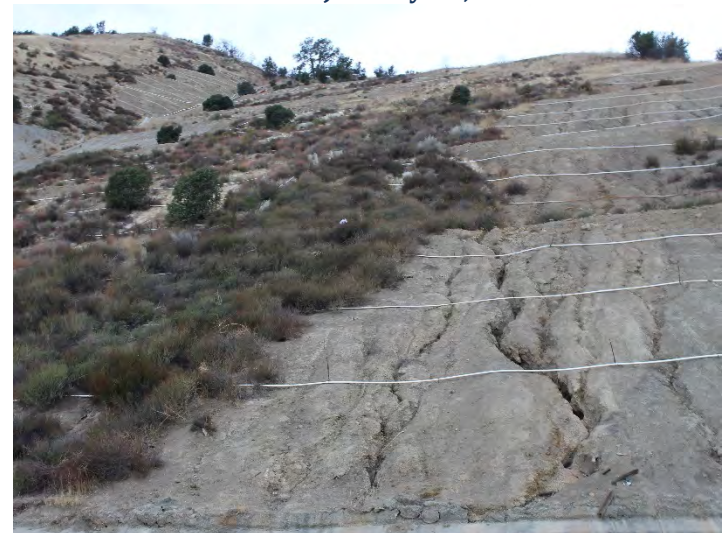
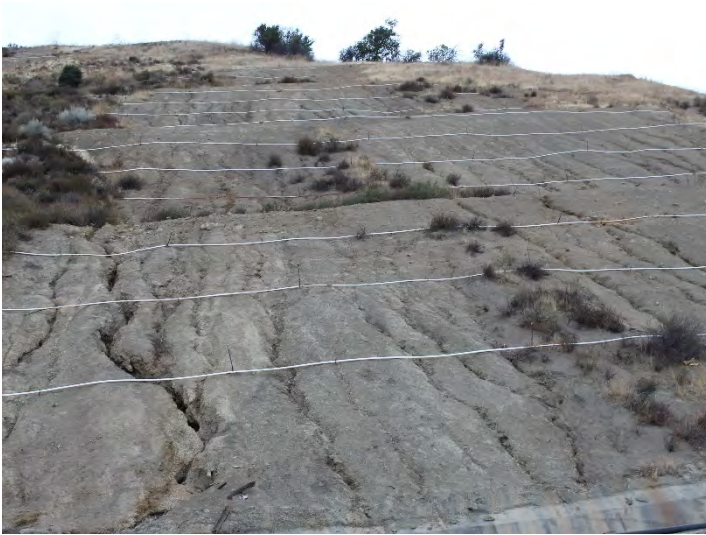
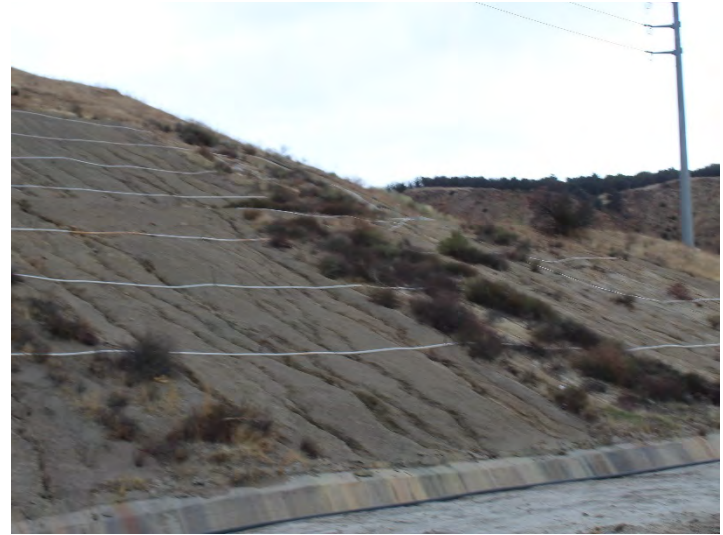
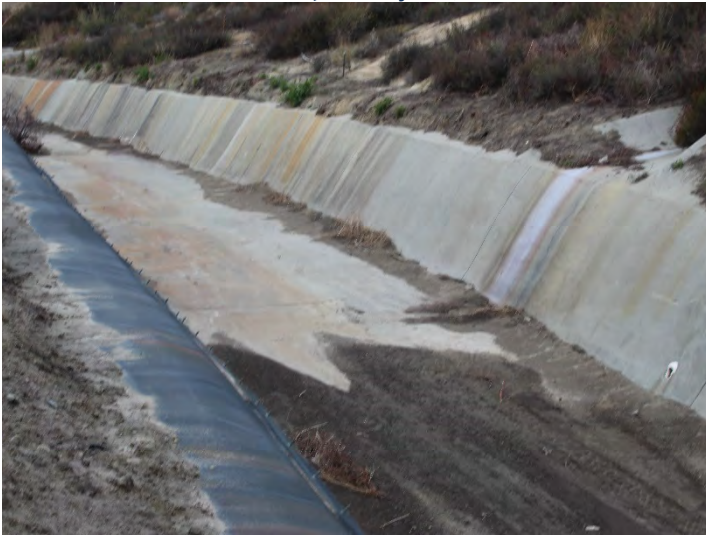
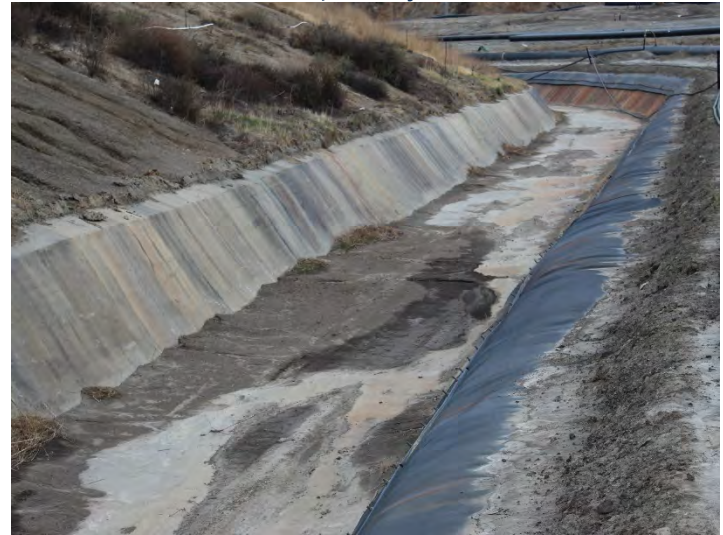
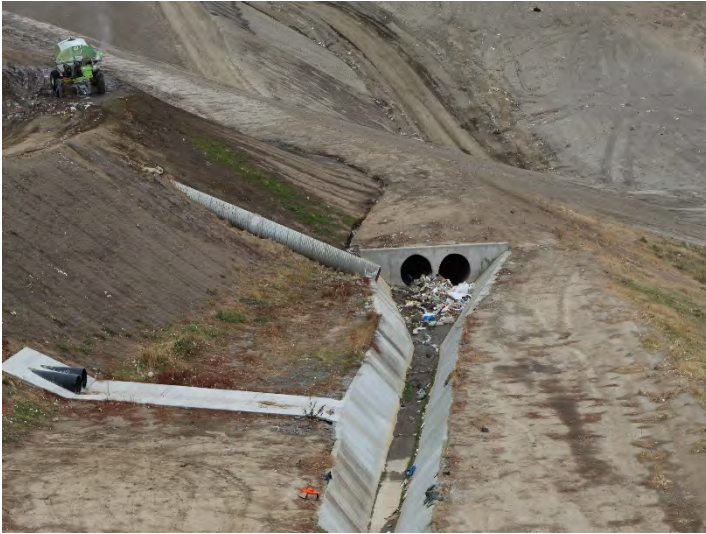
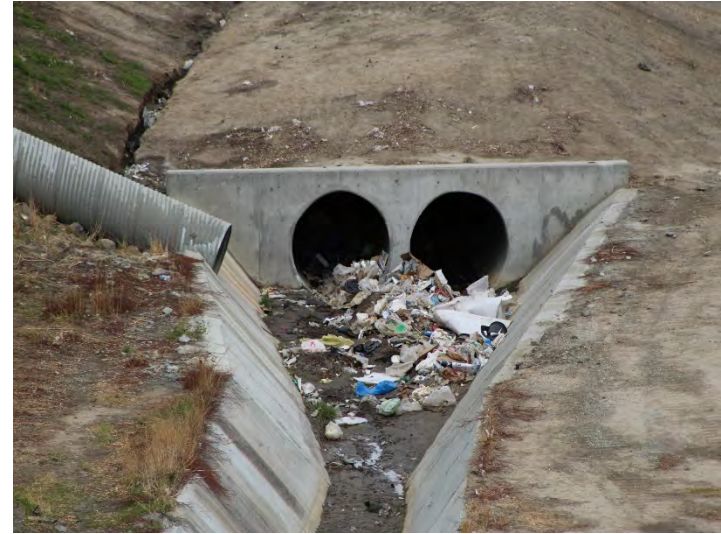
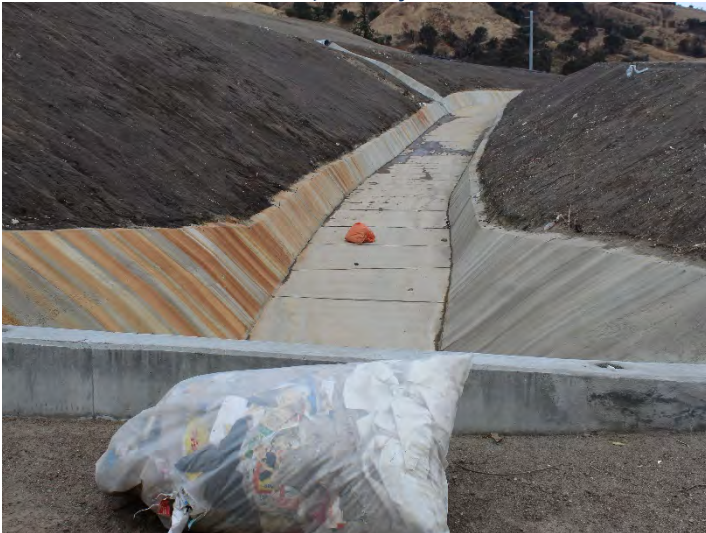
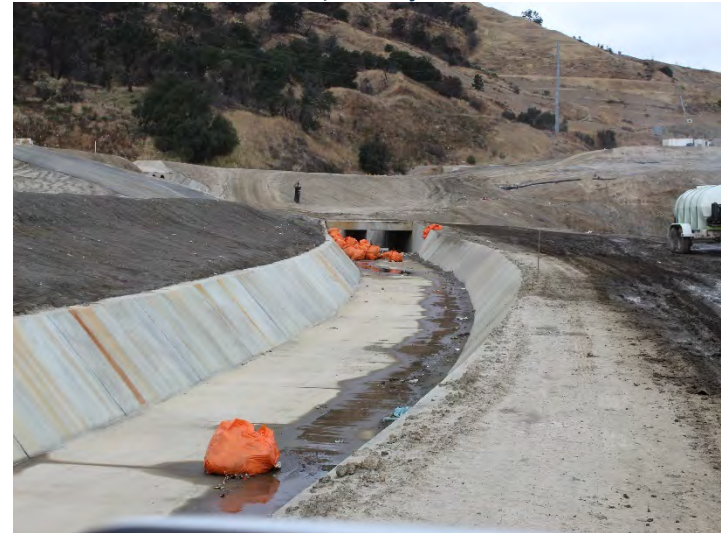
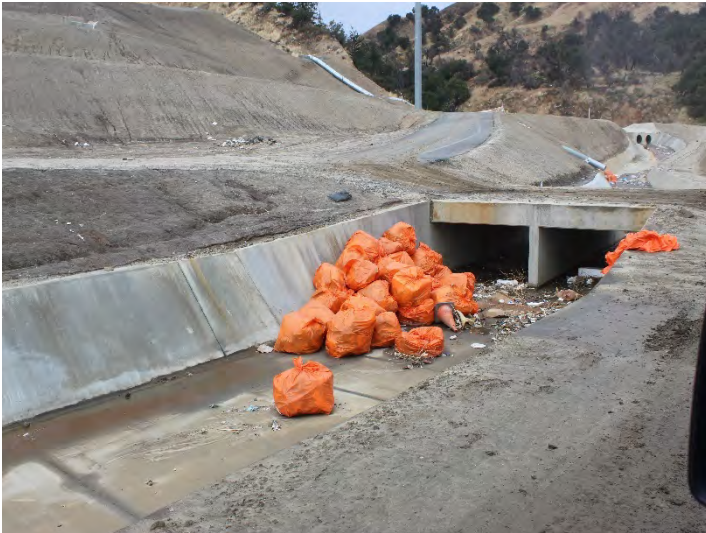
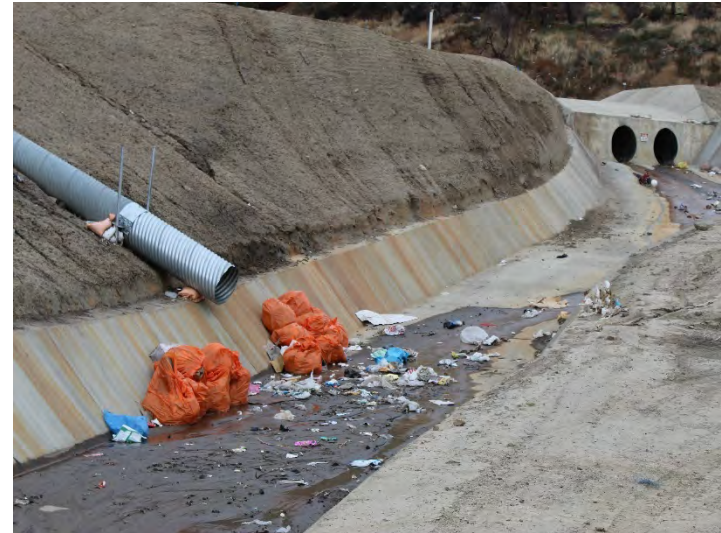
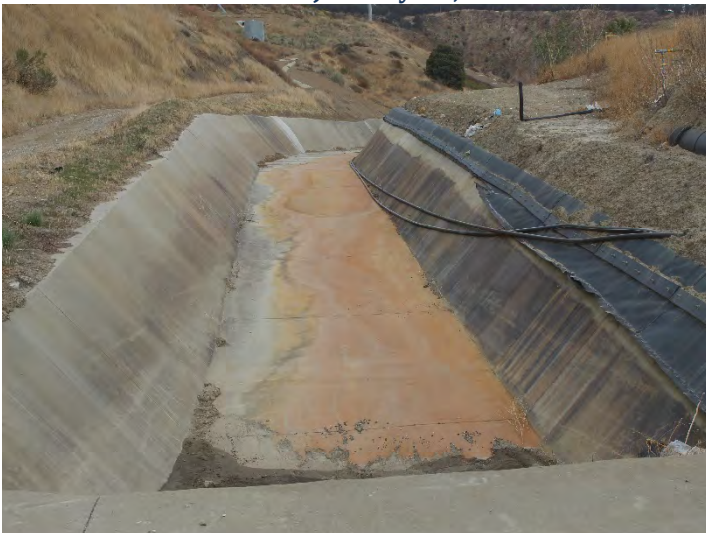
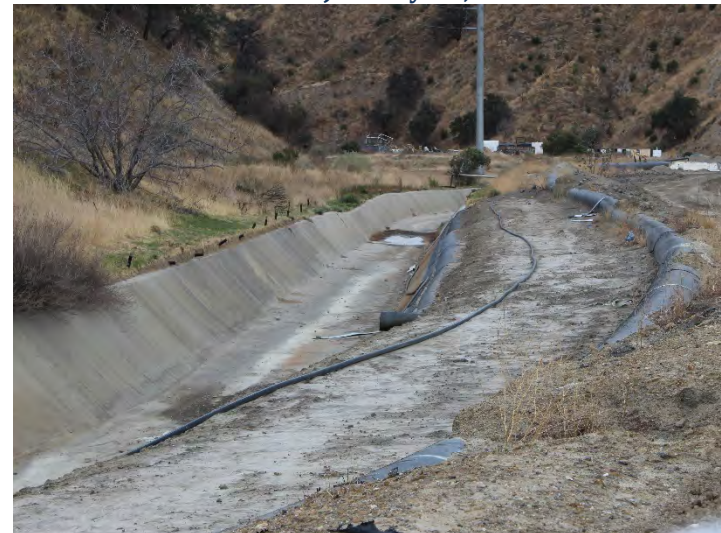
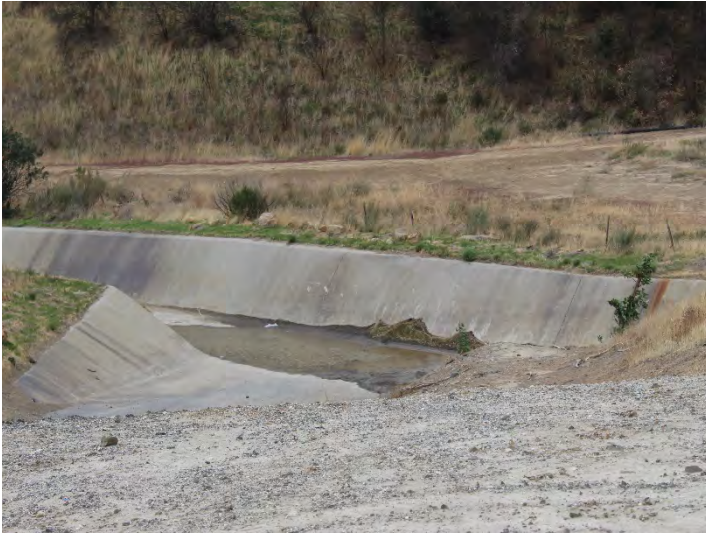
**Photo 182: County Sage Mitigation and Westside Drainage
Channels: January 27, 2021**

**Photo 183: County Sage Mitigation and Westside Drainage
Channels: January 27, 2021**

**Photo 184: County Sage Mitigation and Westside Drainage
Channels: January 27, 2021**

Photo 185: County Sage Mitigation and Westside Drainage Channels: January 27, 2021

Photo 186: County Sage Mitigation and Westside Drainage Channels: January 27, 2021

Photo 187: County Sage Mitigation and Westside Drainage Channels: January 27, 2021

Photo 188: County Sage Mitigation and Westside Drainage Channels: January 27, 2021

Photo 189: County Sage Mitigation and Westside Drainage Channels: January 27, 2021

Photo 190: County Sage Mitigation and Westside Drainage Channels: January 27, 2021

Photo 191: County Sage Mitigation and Westside Drainage Channels: January 27, 2021

Photo 192: County Sage Mitigation and Westside Drainage Channels: January 27, 2021

Photo 193: County Sage Mitigation and Westside Drainage Channels: January 27, 2021

Photo 194: County Sage Mitigation and Westside Drainage Channels: January 27, 2021

Photo 195: County Sage Mitigation and Westside Drainage Channels: January 27, 2021

Photo 196: County Sage Mitigation and Westside Drainage Channels: January 27, 2021

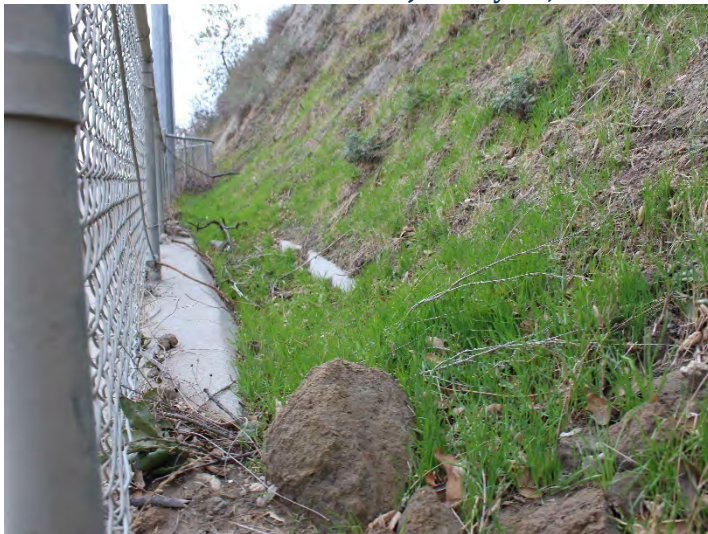
Photo 406: Retaining Wall at Entrance: January 27, 2021

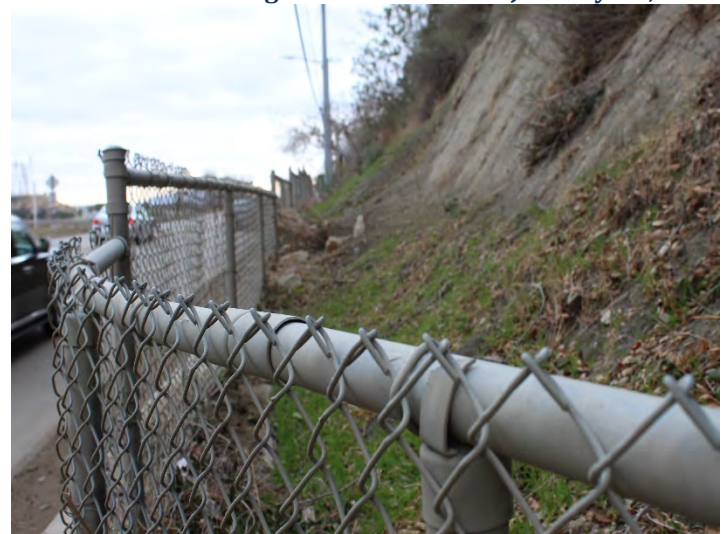
Photo 407: Retaining Wall at Entrance: January 27, 2021

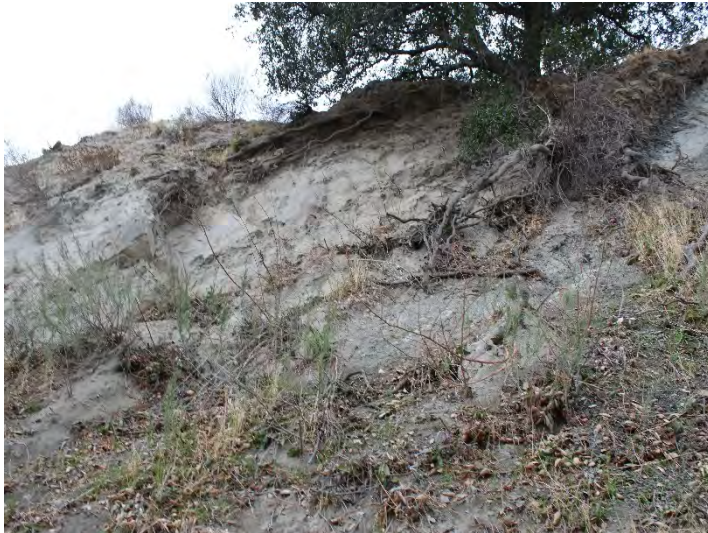
Photo 408: Retaining Wall at Entrance: January 27, 2021

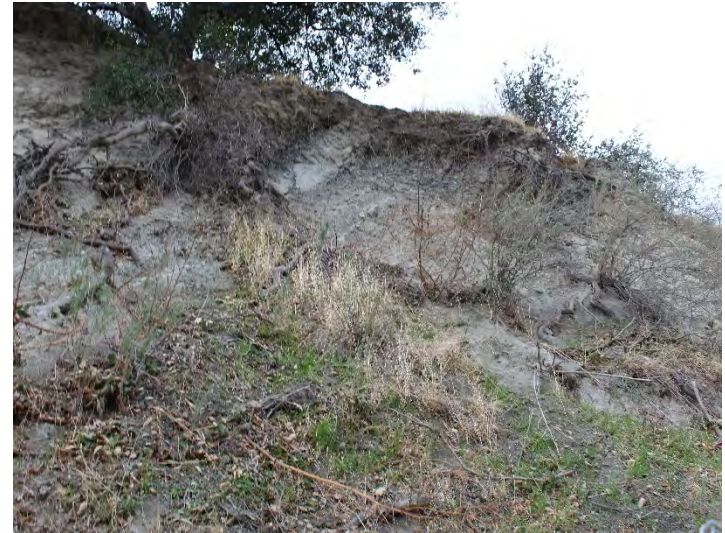
Photo 409: Retaining Wall at Entrance: January 27, 2021

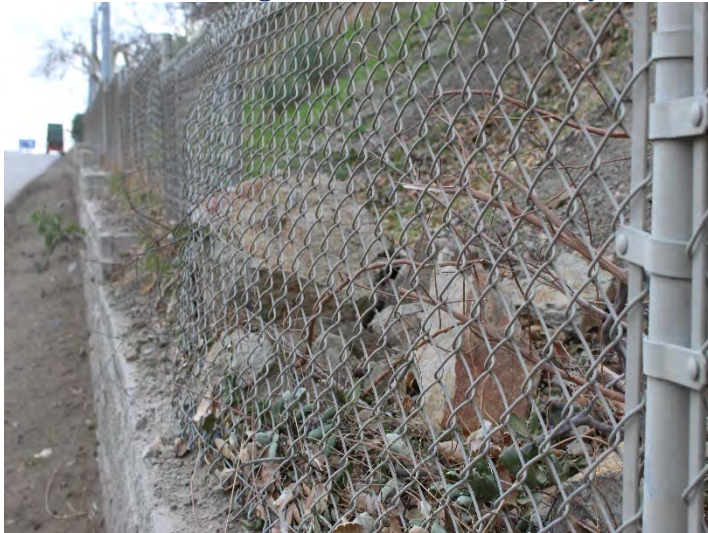
Photo 410: Retaining Wall at Entrance: January 27, 2021

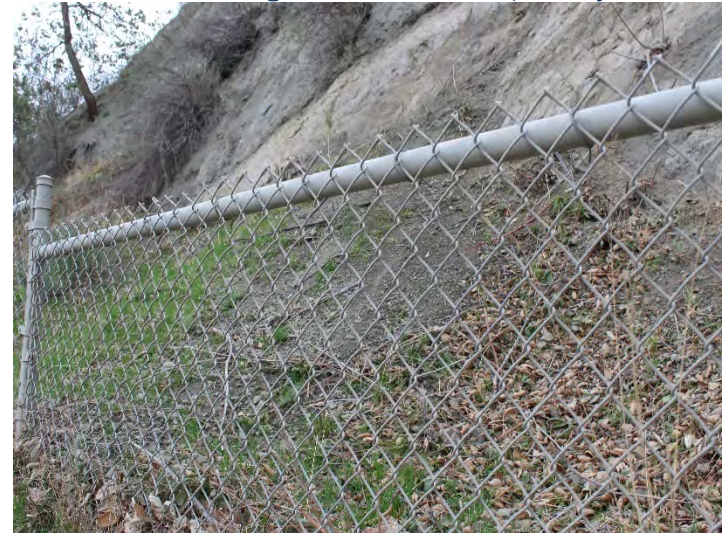
Photo 411: Retaining Wall at Entrance: January 27, 2021

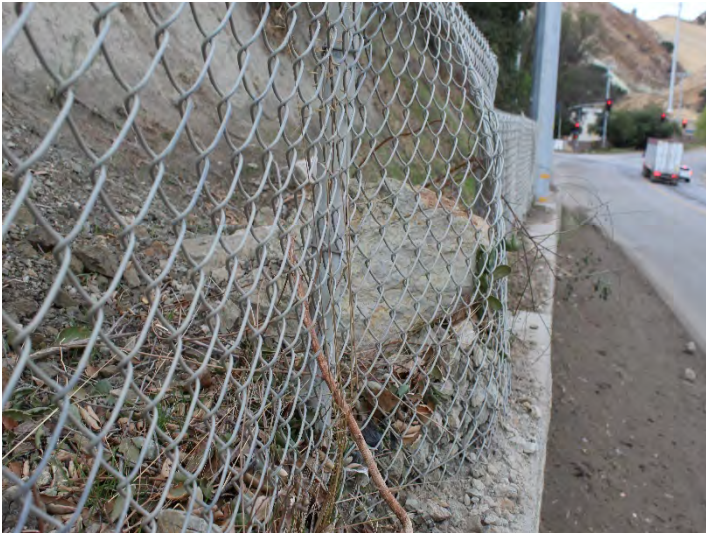
Photo 412: Retaining Wall at Entrance: January 27, 2021

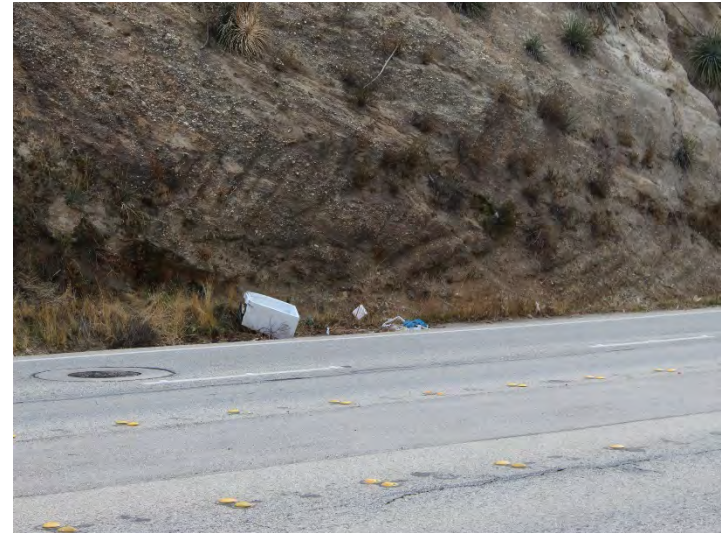
Photo 413: Retaining Wall at Entrance: January 27, 2021

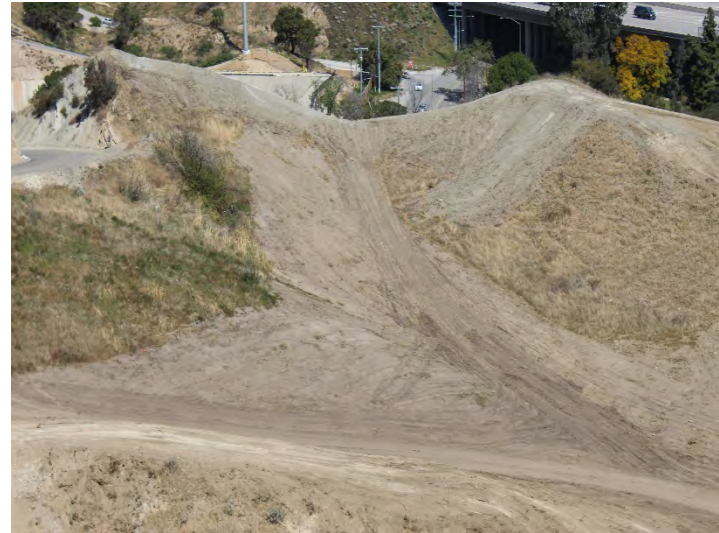
Photo 598: Road Realignment : March 31, 2021

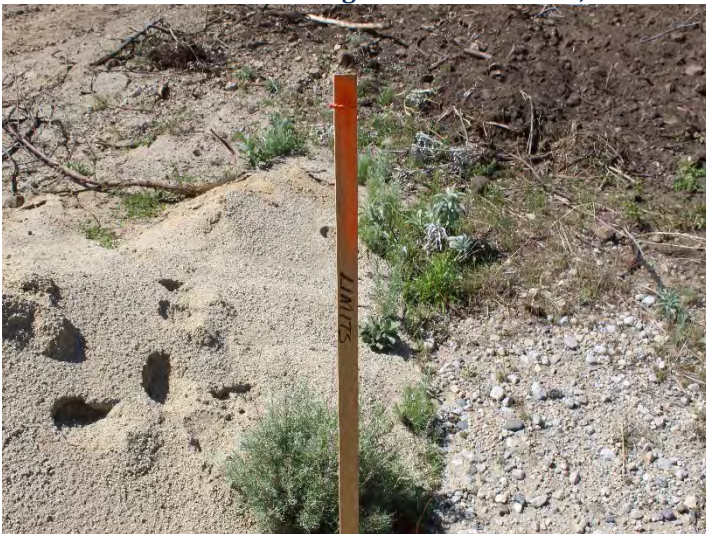
Photo 599: Road Realignment : March 31, 2021

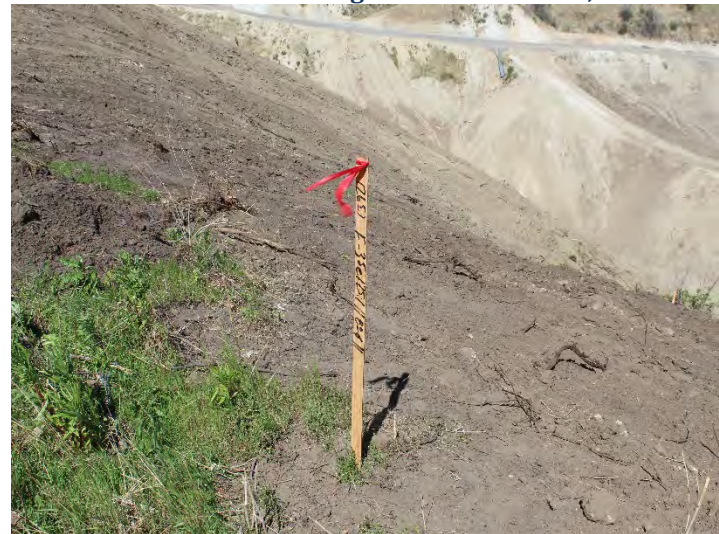
Photo 600: Road Realignment : March 31, 2021
