Subject: Report to the Joint Sunshine Canyon Landfill Technical Advisory Committee SCL TAC Meeting Date - July 17<sup>th</sup>, 2024

This report provides an update of items requested to be included in the report to the Joint Sunshine Canyon Landfill Technical Advisory Committee (TAC) for the meeting to be held on July 17, 2024. Sunshine Canyon Landfill Team provided a draft copy of the report to the City of Los Angeles Department of City Planning on July 1<sup>st</sup>, 2024, for review. This report covers October 1<sup>st</sup>, 2023, through March 31<sup>st</sup>, 2024.

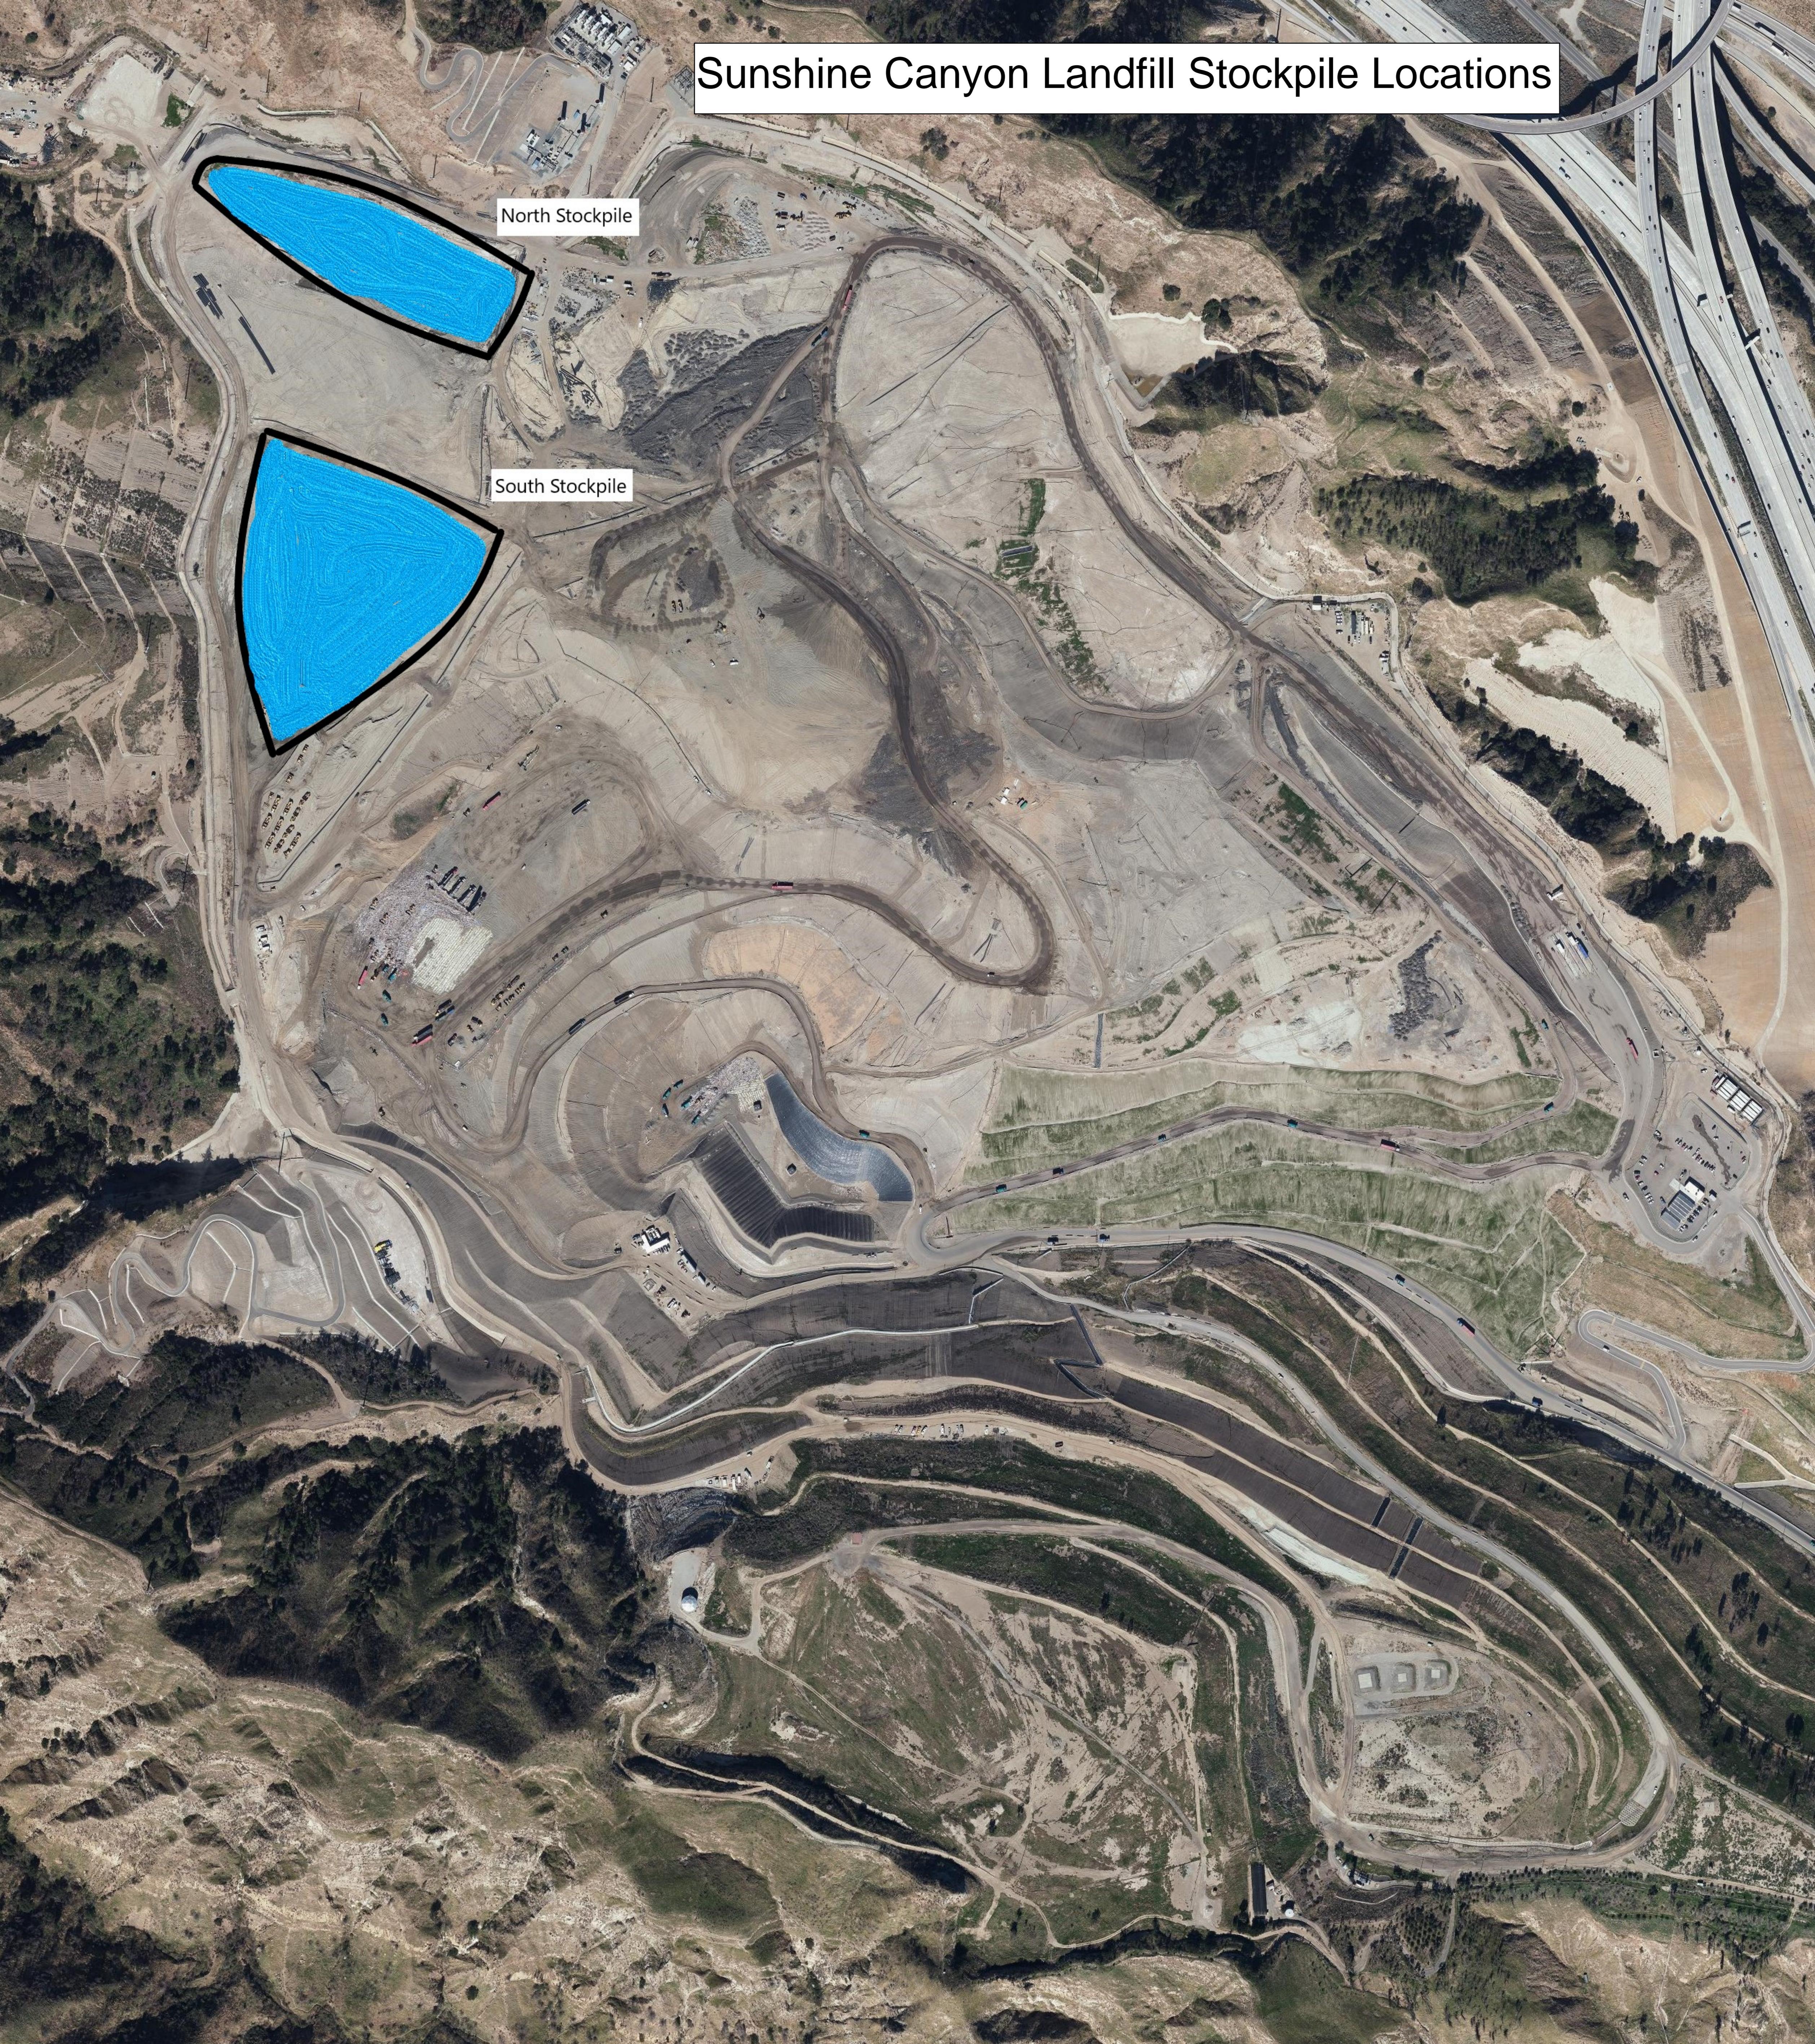
# ATTACHMENT B

Placement and subsequent removal of stockpile material is an operational activity that occurs over the life of the landfill. There are two primary stockpile areas on site that have been designated for such purpose, which primarily includes imported soil and is used for either daily cover, intermediate cover, or construction materials. These stockpile areas are shown on the figure included in Attachment B.

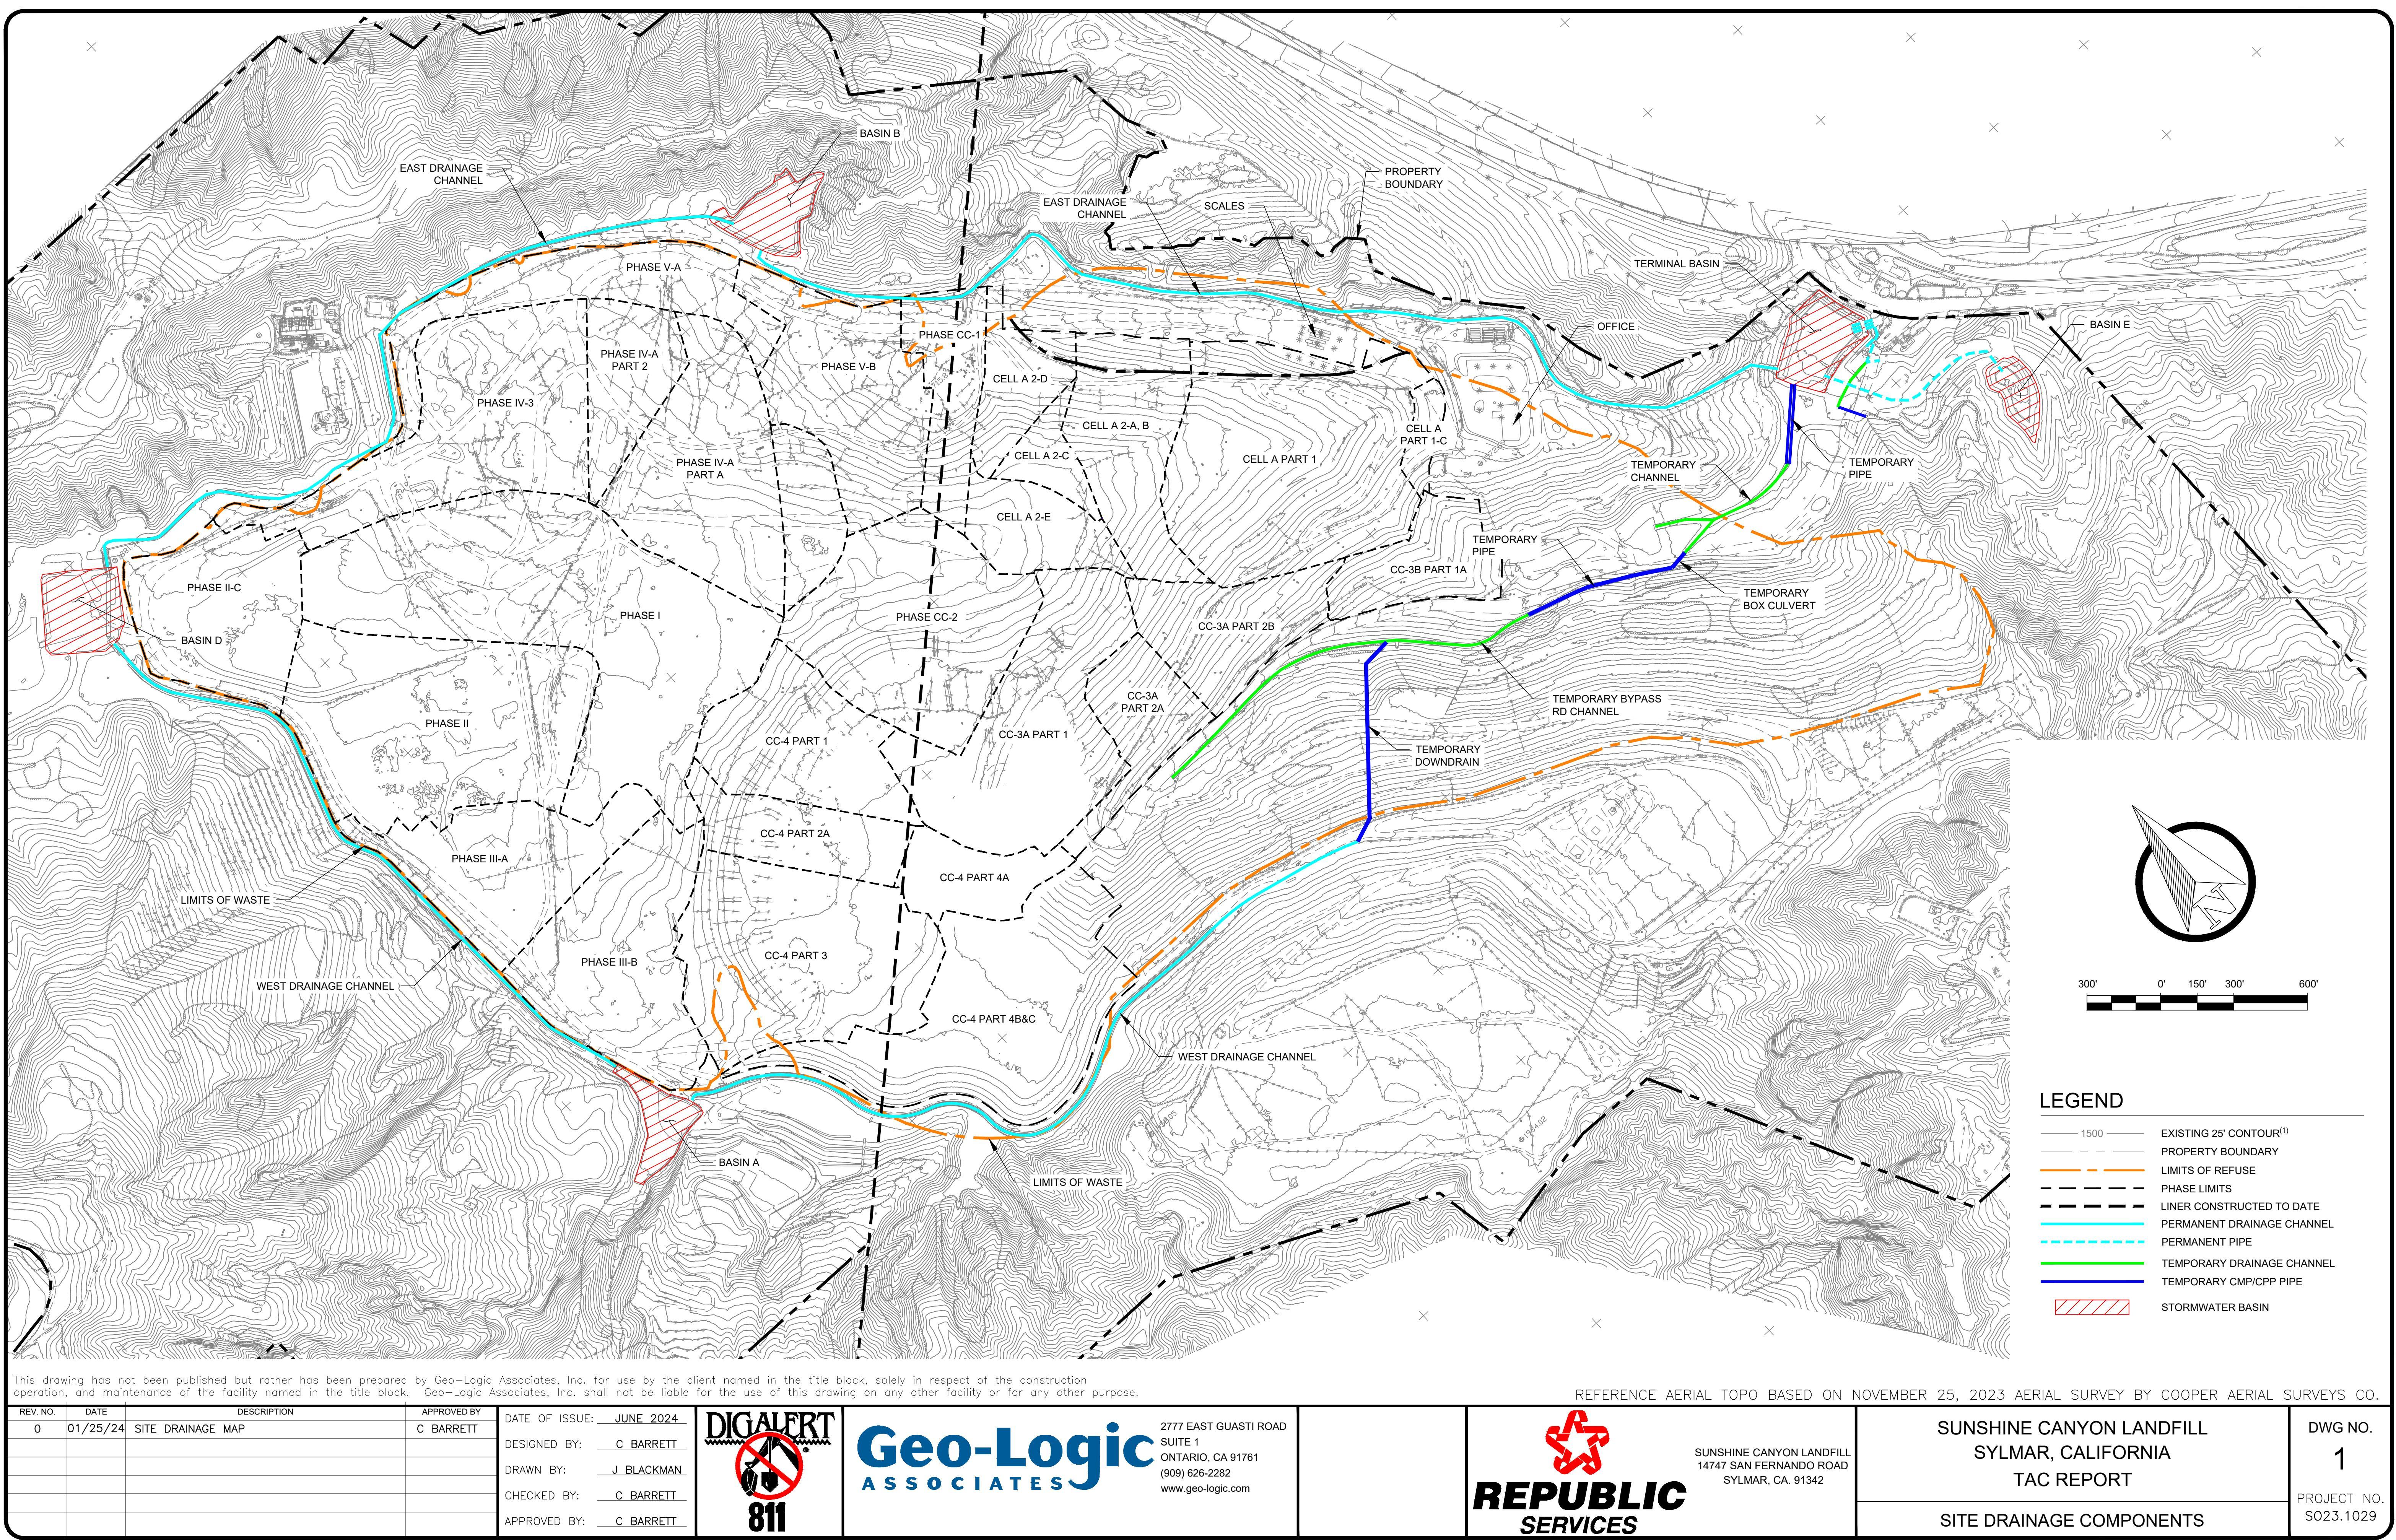
## ATTACHMENT E

1		1			
REV. NO.	DATE	DESCRIPTION	APPROVED BY	DATE OF ISSUE! .ILINE 2024		
0	01/25/24	SITE DRAINAGE MAP	C BARRETT	DATE OF 1330E		
				DESIGNED BY: <u>C BARRETT</u>		
				DRAWN BY: <u>J BLACKMAN</u>		
				CHECKED BY: <u>C BARRETT</u>		
				APPROVED BY: <u>C BARRETT</u>	811	
					▏

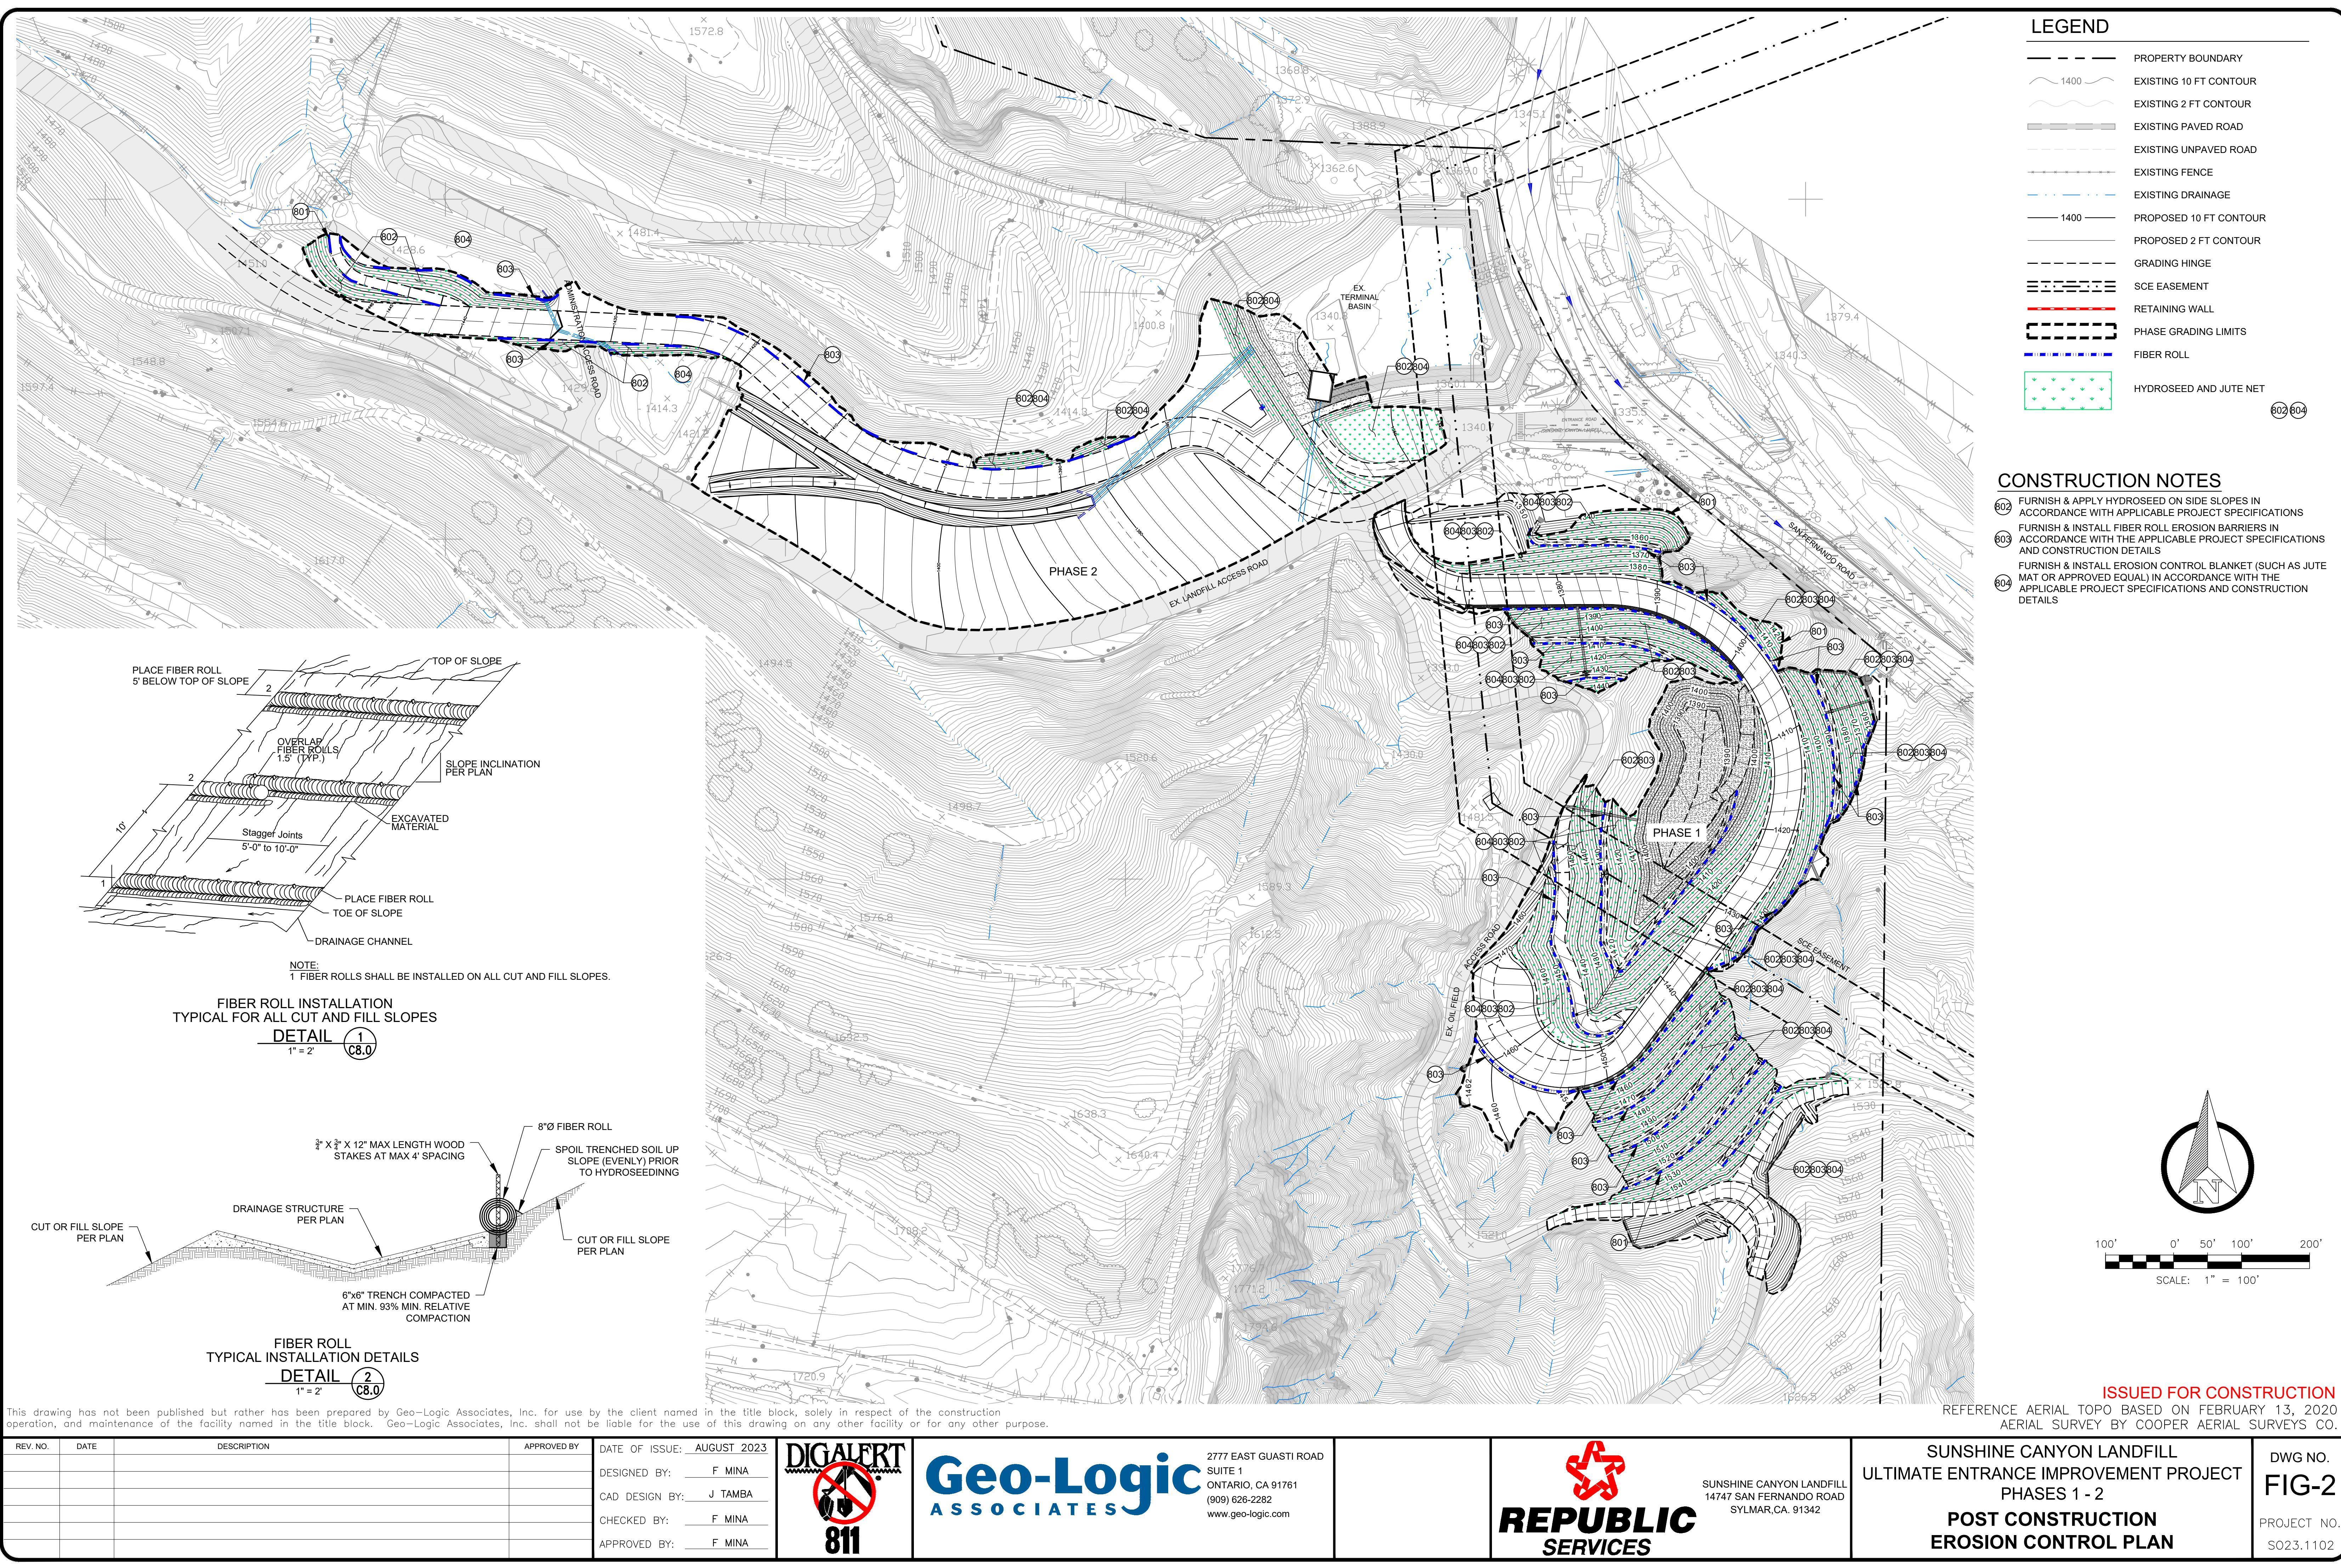
### **ATTACHMENT 1**

ENTRANCE ROAD IMPROVEMENTS CONSTRUCTION PROJECT PHASES 1 AND 2 EROSION CONTROL MEASURES

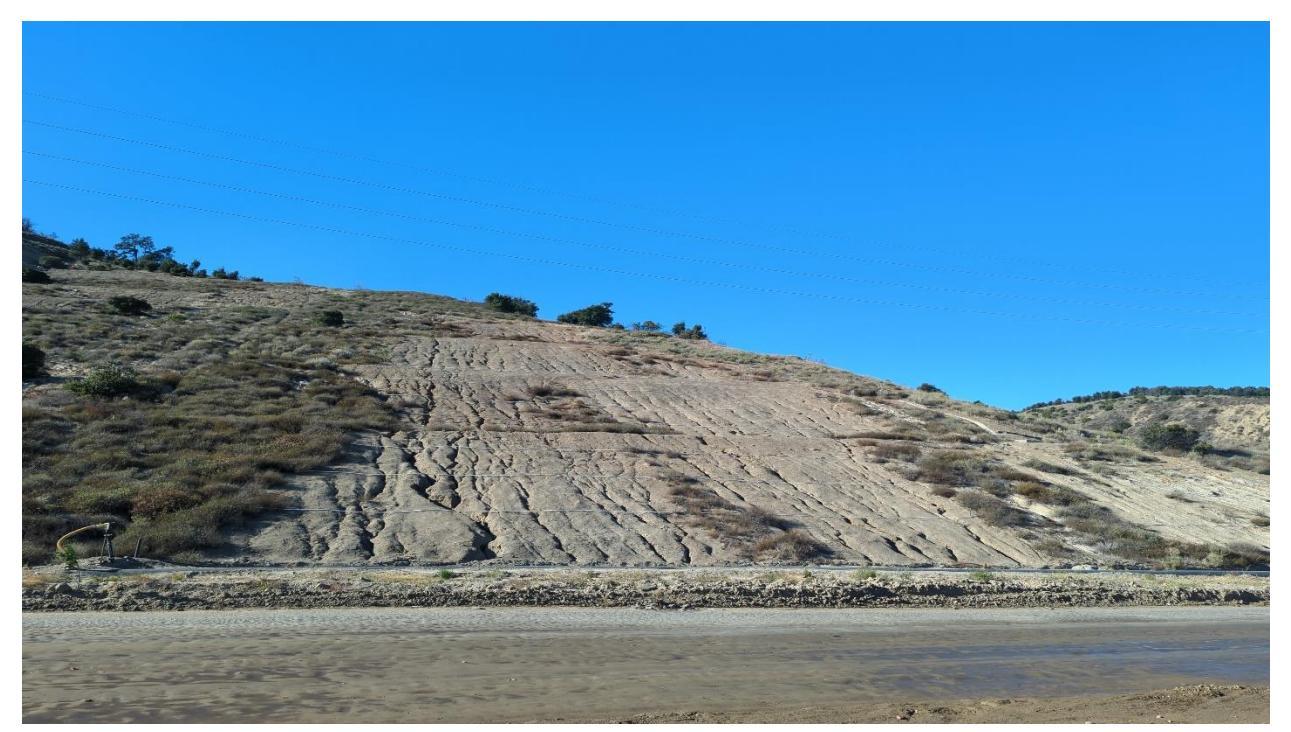
**Photograph 2.** Facing northwest at the northern portion of the County-Side Sage Mitigation Area where plant growth has been problematic due to poor soil conditions (December 13, 2023).

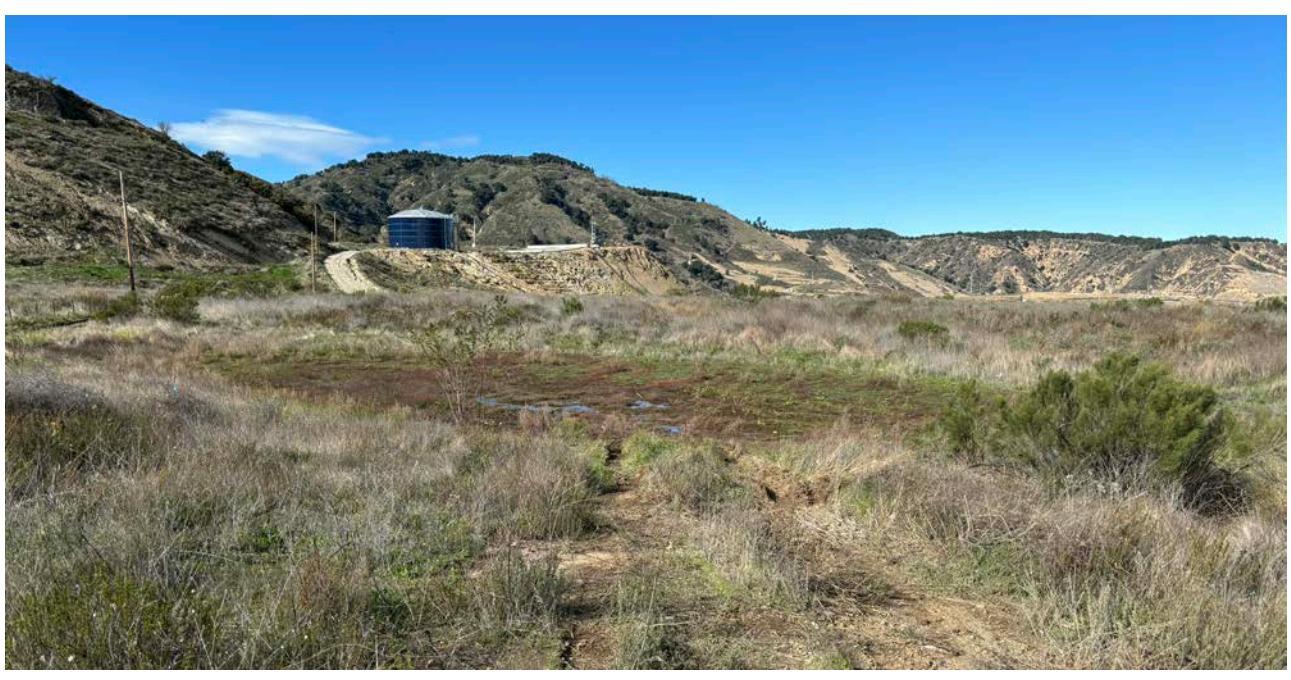
Existing subsidence conditions of Deck A

There are a number of smaller areas that are holding moisture as a result of subsidence. This year ADG will be working with Republic Services to correct these conditions with new fill dirt and seeding, similar to the repair on Deck A completed last year.

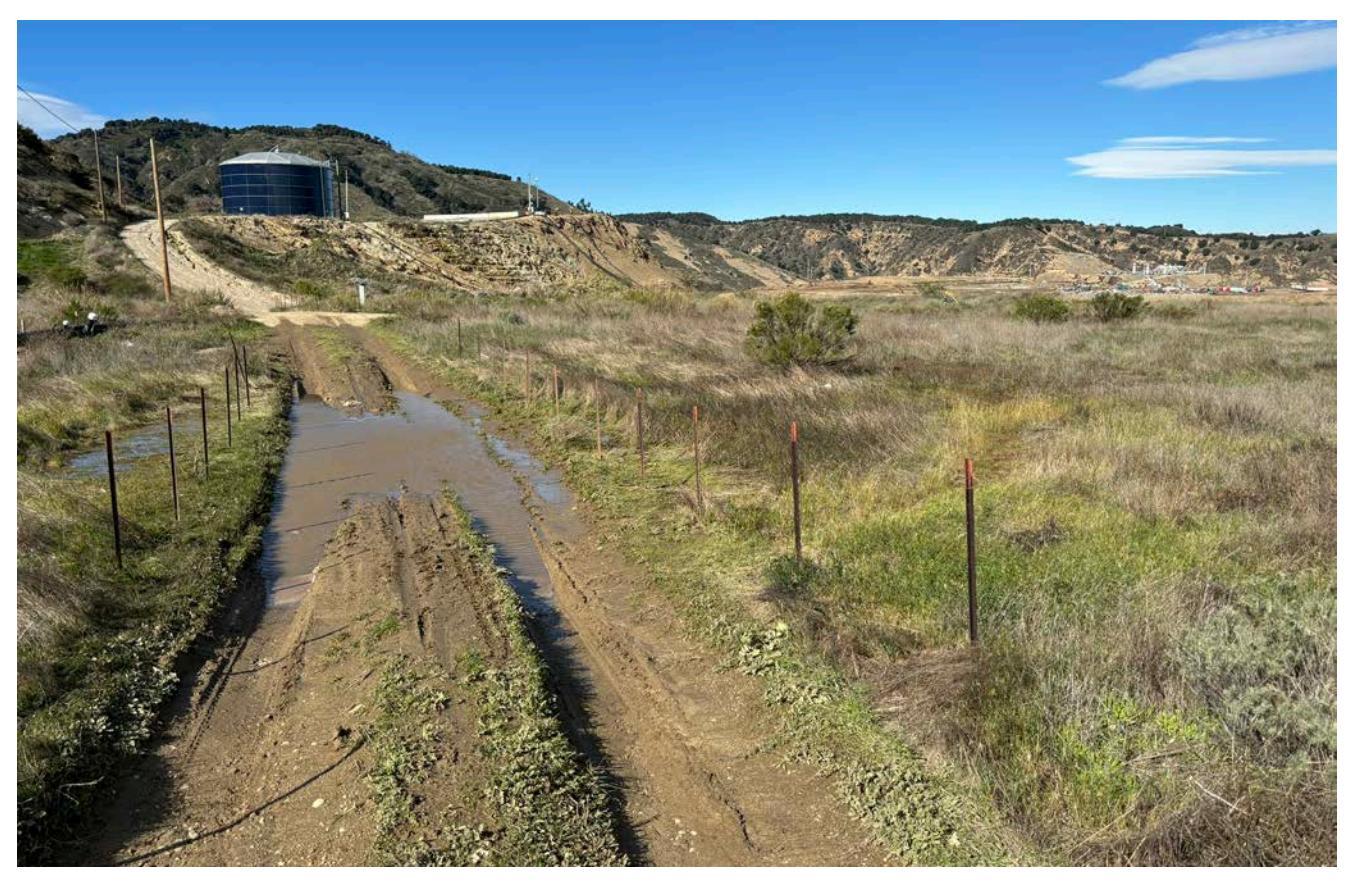
Existing subsidence conditions of Deck A

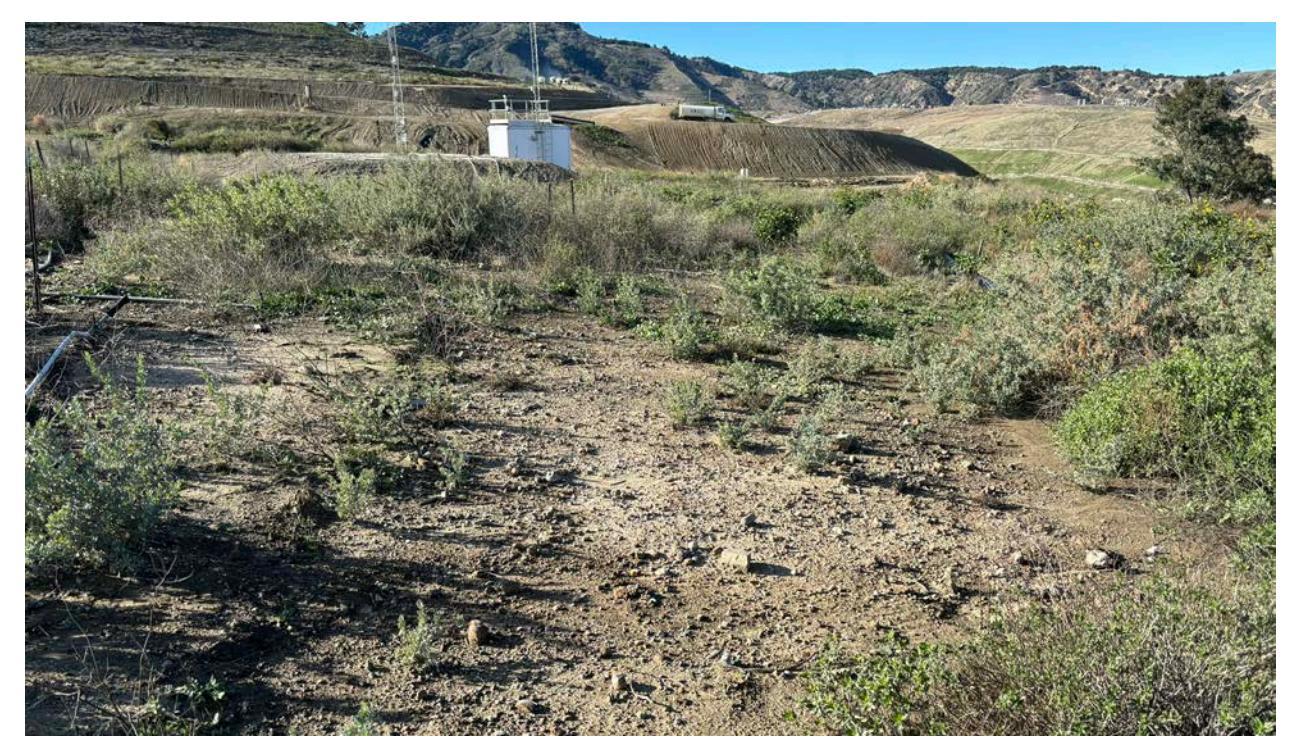
Maintenance access Road weathering on north side of Deck C

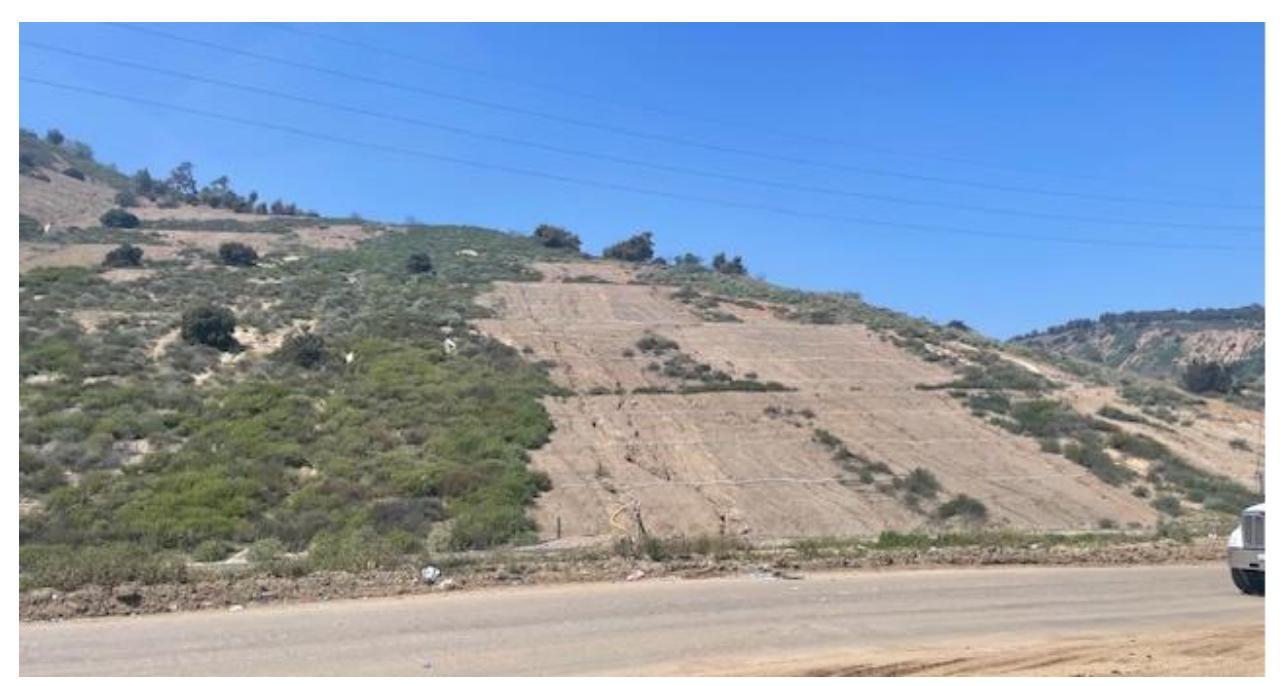
**Photograph 2.** Facing northwest at the northern portion of the County-Side Sage Mitigation Area where plant growth has been problematic due to poor soil conditions (March 21, 2024).

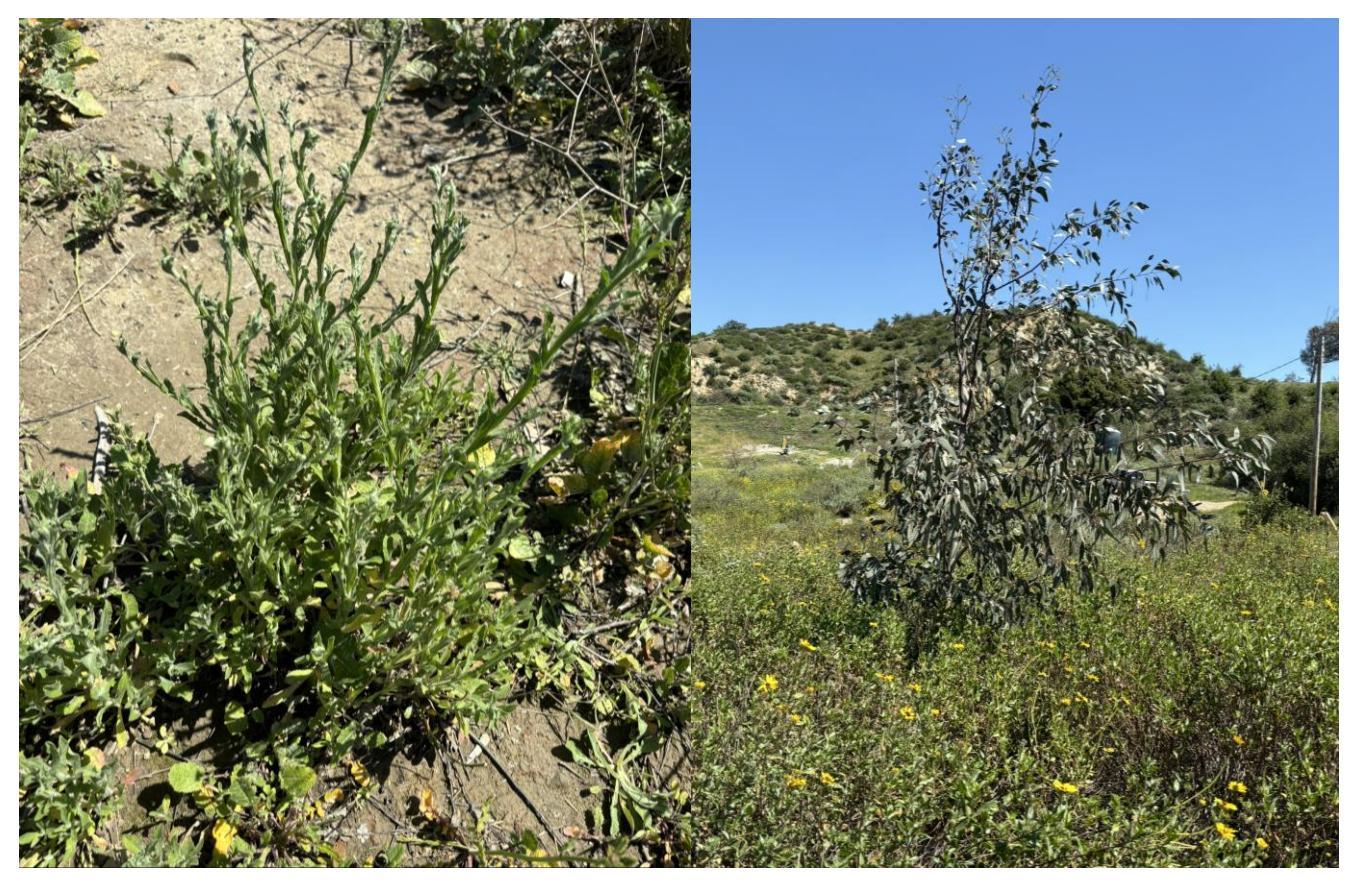
Invasive Yellow Star Thistle (Centaurea solstitialis) on left, Eucalyptus sp. on right
