Fault Activity Investigation

**Yucca-Argyle Apartments
Champion Site**

**SE Corner of Yucca Street and Argyle Avenue
1756 and 1760 Argyle Avenue
Hollywood District
City of Los Angeles, California**

**September 7, 2014
GDC Project No. LA-1183A**

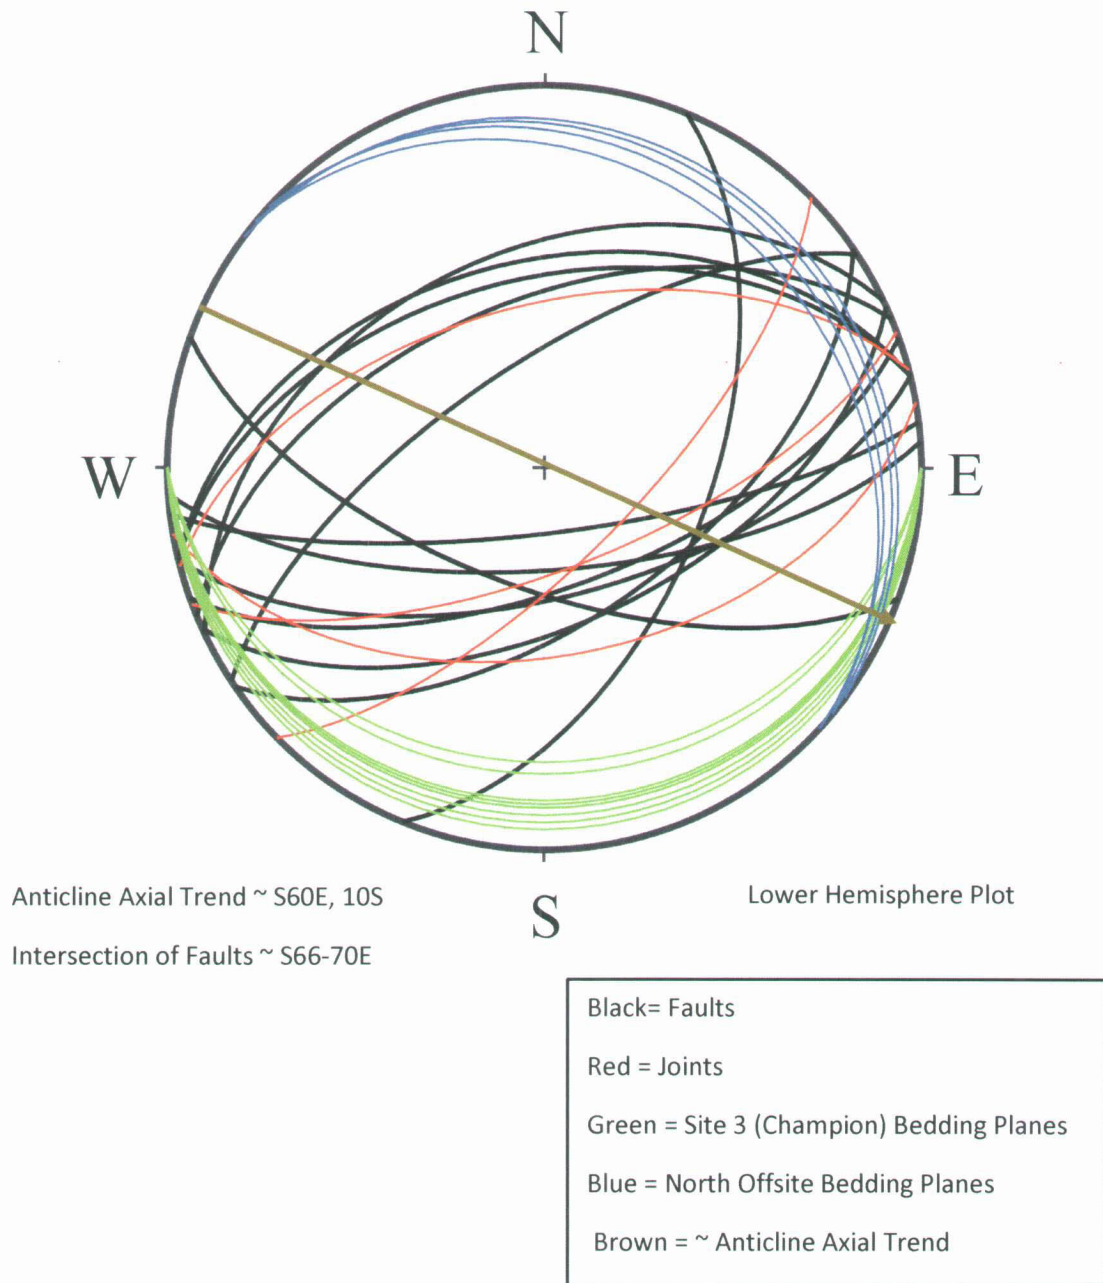
Figure 11. Stereo plot of geologic-structural elements of faults, joints and bedding planes at Proposed Yucca-Argyle Apartments.

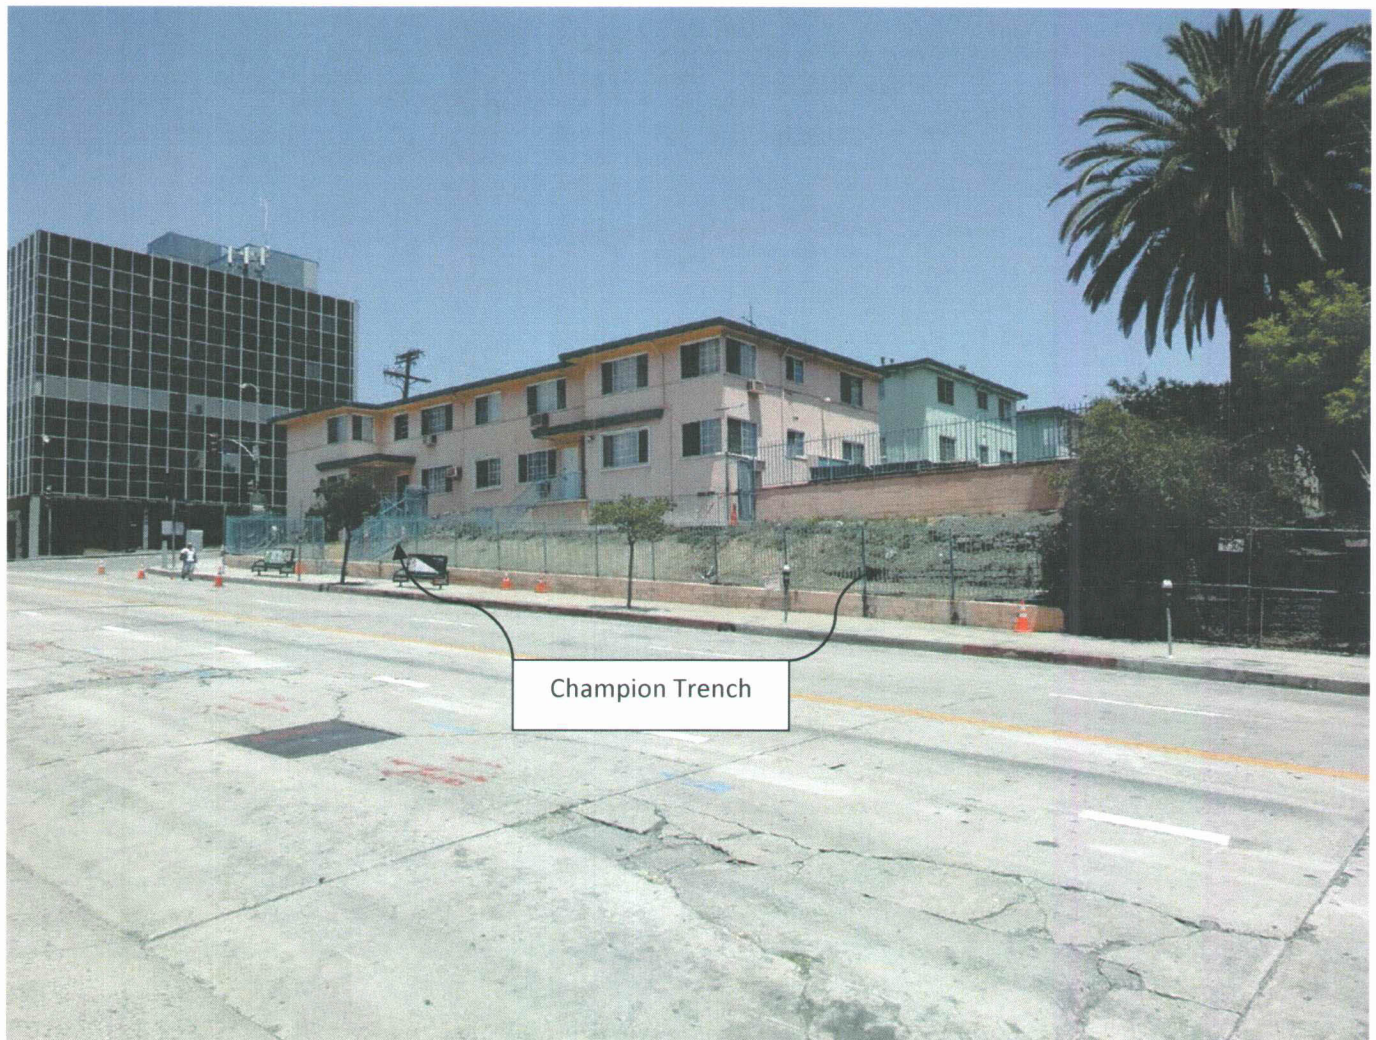
Photo 1:

Site 3. Looking northeast. Note Champion trench between Argyle Avenue sidewalk and apartment building.

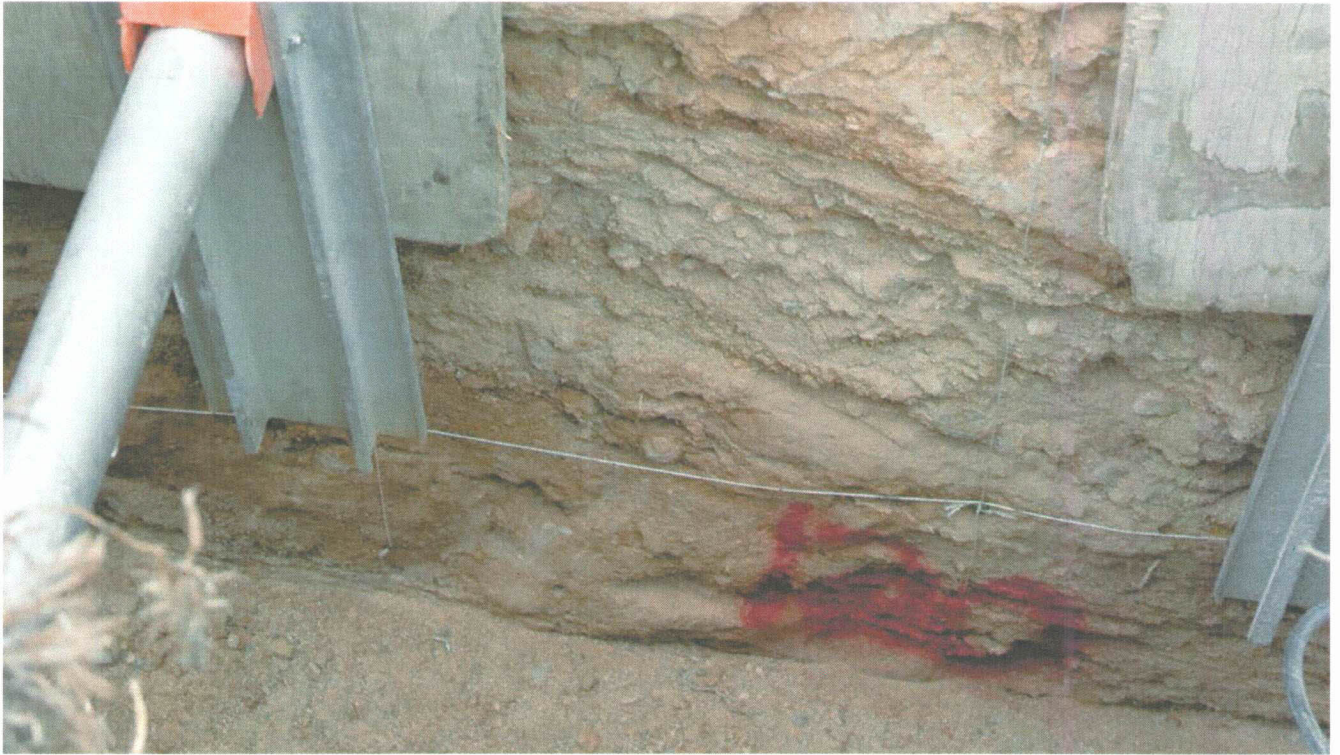
Photo 2:

Site 3 Trench. Typical older alluvium. Note the distinctive stratification that is useful for judging the presence or absence of faults.

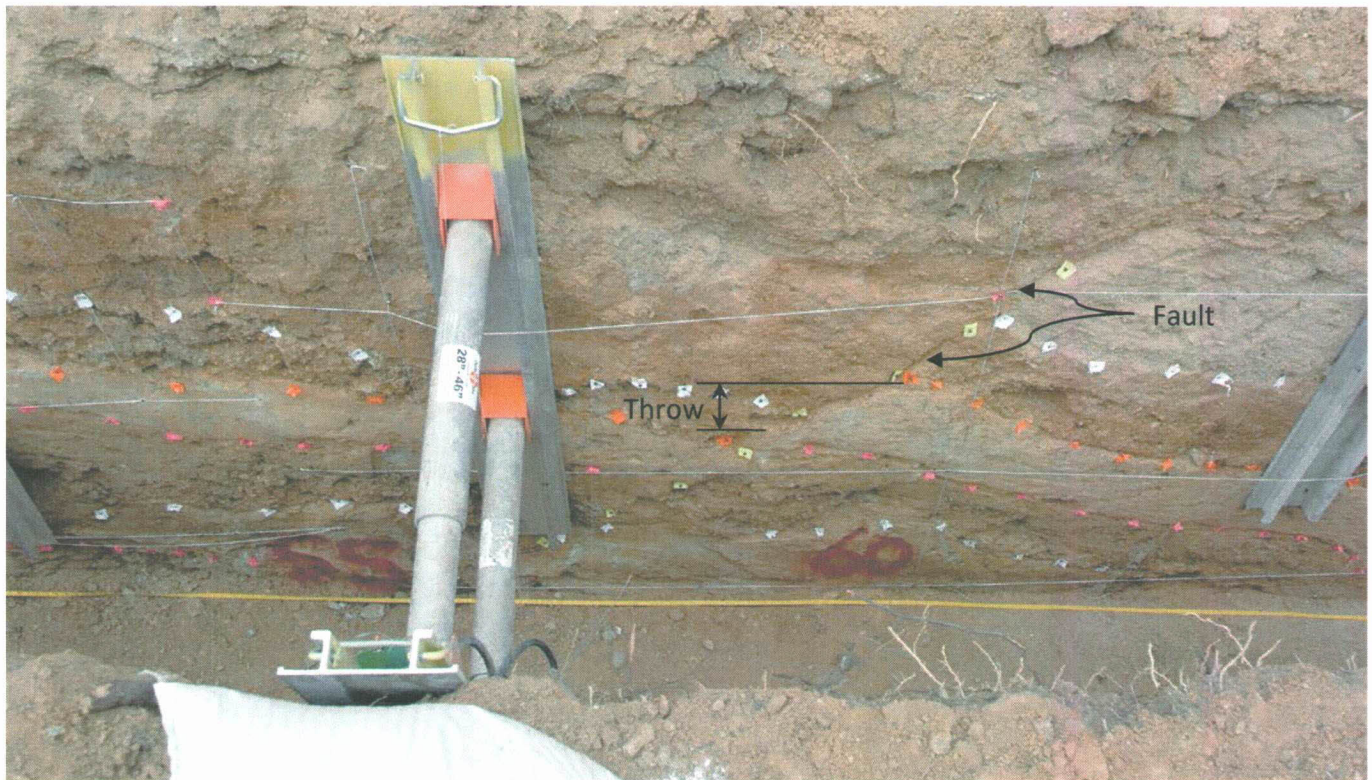
Site 3 Trench. Typical small displacement fault. Note throw. For scale, the horizontal white string lines are two feet apart.

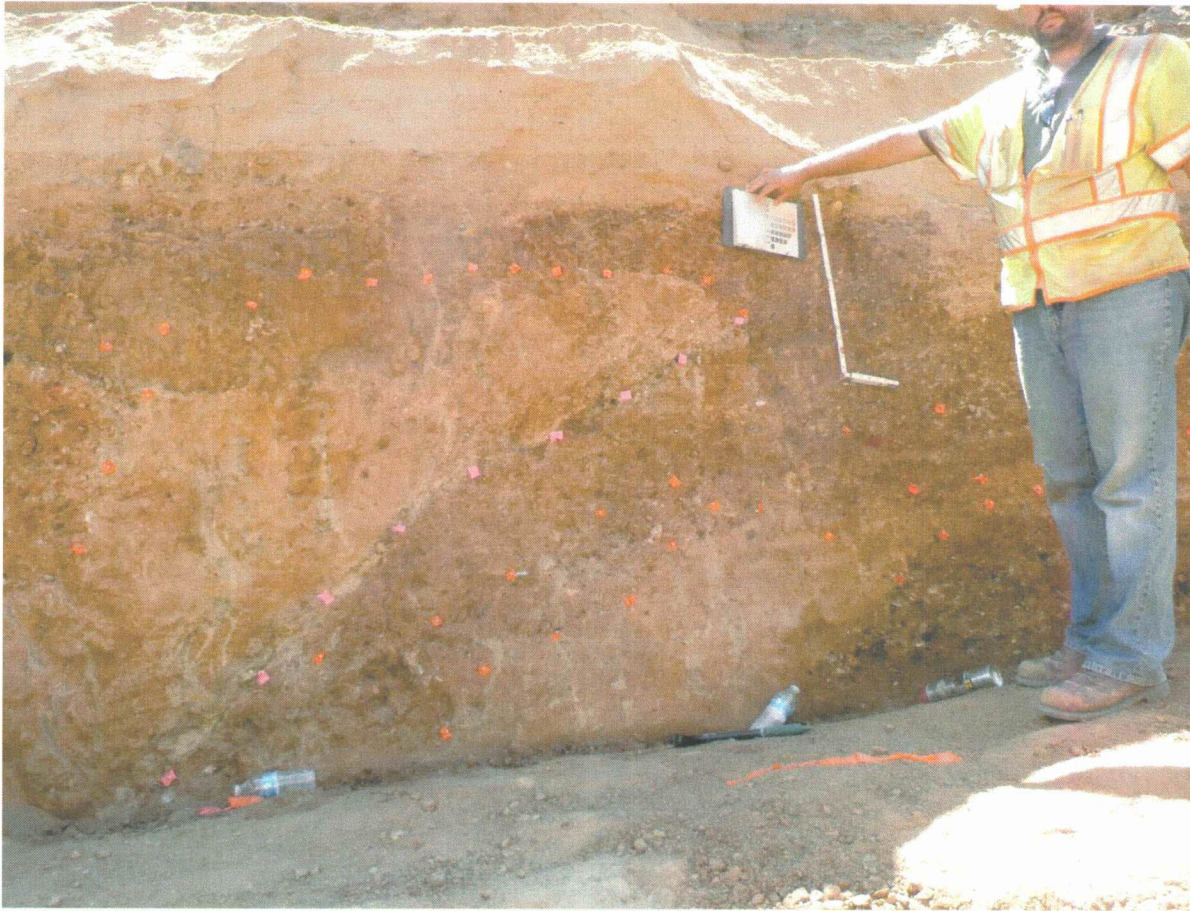
Photo 4:

Site 2 (Eastern Trench). Flexural-slip fault within tilted (folded) older debris flow beds that are unconformably overlain by four unbroken colluvial wedges that are part of the upper Pleistocene mudflow deposit that is judged to be on the order of 40bp.
