Town & Country Retail 6310-6360 W. Third Street Los Angeles, California 90036

May 26, 2017

Arcadis U.S., Inc.

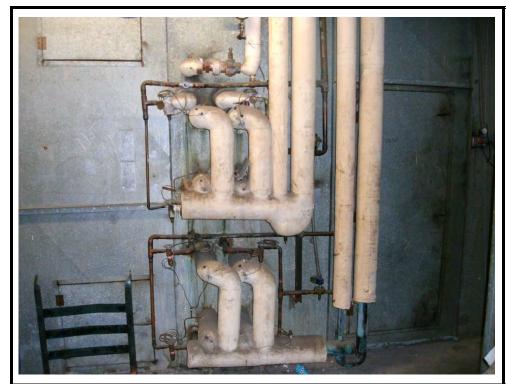
<u>Description of Photograph:</u> View of potential asbestos insulation in air handling room.

The buildings are of wood, steel, and concrete construction, with some brick support walls. Interior building materials consist of ceramic floor tiles, wood laminate flooring, vinyl floor tiles, carpeting, drywall, plaster, suspended ceiling tiles, and glue-on ceiling tiles. The building materials were observed to be in conditions varying from good to significantly damaged. Most of the building materials are in aged condition. Suspect asbestos-containing materials (ACMs) were observed in the Kmart building and include 12"x12" and 9"x9" vinyl floor tiles, black mastic, carpet mastic, pipe insulation, and glue-on ceiling tiles. There were some identifying labels on the doors indicating a prior ACM inspection. Other onsite buildings may also contain ACMs.

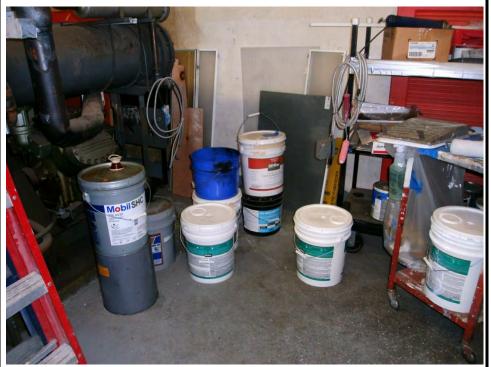
Photograph #8

<u>Description of Photograph</u>: View of the paint and lubricating oil in air handling room.

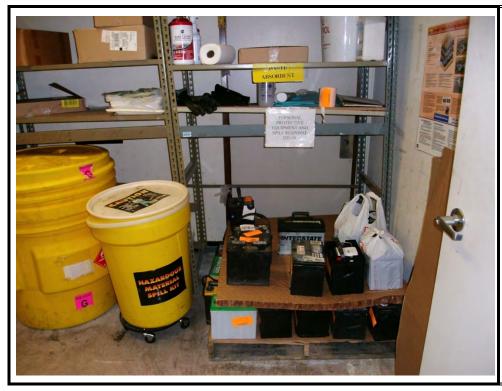
View of the used batteries stored in the hazardous materials storage room in the Kmart building.

Used automotive batteries are stored in a hazardous materials room located on the second floor of the building. The batteries were observed to be stored on wooden pallets. Poly drums of hazardous materials are also stored in the room. The hazardous materials consist of damaged aerosols such as hair spray, soaps and cleaners, waxes and polishes, makeup, etc. The poly drums are labeled stating their contents. No evidence of releases or staining was observed in the hazardous materials room.

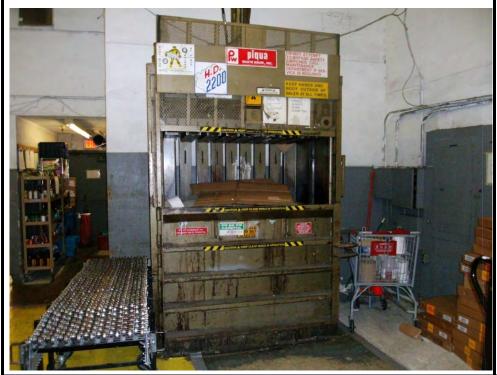
<u>Description of Photograph:</u> View of the box compactor in the Kmart building.

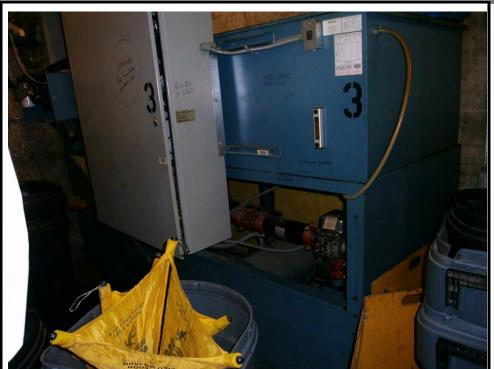
Photograph #12

<u>Description of Photograph:</u> View of the hydraulic service elevator equipment room.

Three elevators and a series of escalators provide access to the floors of the building. Two of the elevators are traction-type. A service elevator is hydraulic. An inspection of the elevator equipment rooms did not reveal evidence of spills or releases of hydraulic fluid or unusual odors. The equipment appeared to be in aged condition.

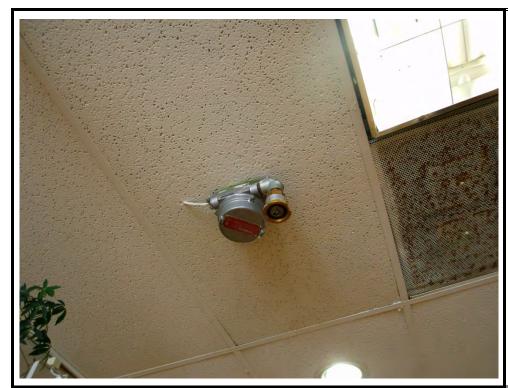
<u>Description of Photograph</u>: View of a typical methane monitor at the Site.

EBI stated that the Site is located in the Salt Lake Oil Field and north of the La Brea Tar and Fossil Pits, which are sources of methane gas. Reportedly, accumulation of methane gas caused an explosion at the east adjacent Ross retail store in 1985. As a result of the explosion, the Los Angeles City Fire Department (LAFD) issued a methane ordinance requiring methane monitoring and mitigation measures in the "high potential methane zone" centered on the Salt Lake Oil Field. As the Site is located within this zone, a methane mitigation and monitoring system was implemented on the Site and has been in effect since 1990. EBI stated that the onsite methane gas monitoring system includes 12 street probes, seven gas vents and 10 parking lot gas vents, six wells, and three onsite gas probes. EBI stated that the site, in accordance with LAFD requirements, conducts semi-weekly methane gas monitoring and gas pressure monitoring and reporting. EBI reviewed a gas monitoring report for the Site dated June 2004 and methane gas concentrations ranged from non-detect to 88% of the lower explosive limit (LEL). The highest gas concentrations were reported to be in the eastern portion of the parking lot. EBI contacted a representative of the LAFD Environmental Unit, which has local agency oversight of methane compliance. The LAFD representative stated that the "current concentrations of methane gas reported in the semi-weekly methane monitoring reports are not a concern to the Fire Department at this time."

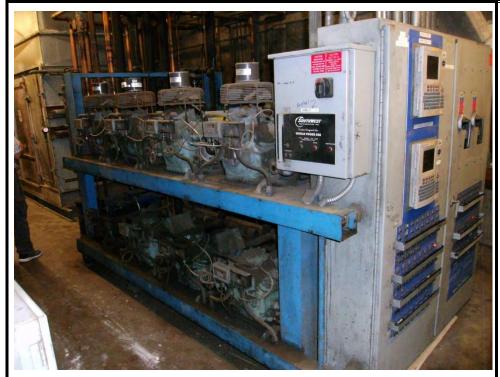
<u>Description of Photograph</u>: View of the refrigerant compressors in the Whole Foods Market.

The refrigeration equipment room contains approximately 16 compressors and large cooling equipment. The equipment and piping is labeled as containing R-404A refrigerant and Polyol Ester Lubricant. The equipment appeared to be aged but in good operating order. Dark staining was observed on and around the compressors but the staining appeared to be due to small releases over a long period of time and not from a malfunction release.

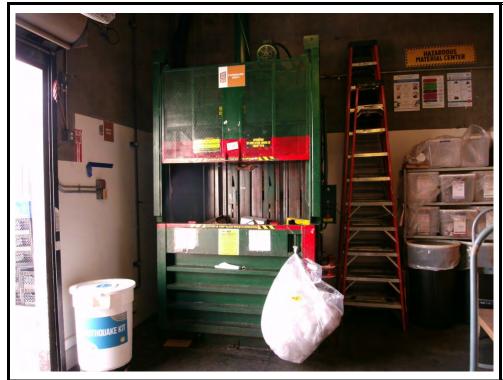
<u>Description of Photograph:</u> View of the box compactor in the Whole Foods Market.

A hydraulic box compressor is present near the loading dock. The compressor appeared to be in good operating order and no evidence of releases or significant staining was observed on the compactor or in the surrounding area.

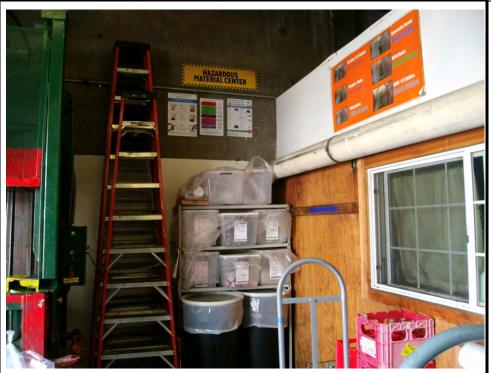
Photograph #22

<u>Description of Photograph</u>: View of the Hazardous Materials Center in the Whole Foods Market.

A hazardous materials center is located next to the box compressor. The area contained two poly 55-gallon drums and approximately seven poly bins. The containers were labeled as to their contents. The hazardous materials consist of damaged general waste. No evidence of staining or releases was observed on the containers or in the surrounding area.

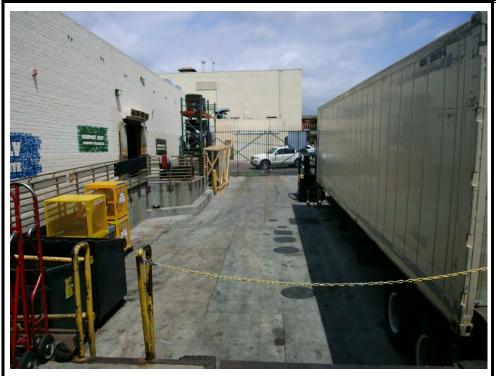
<u>Description of Photograph</u>: View of the loading dock at Whole Foods Market. Note possible clarifier.

It is a possible a clarifier is present at the south end of the Site. Based on the types of current
and historical tenant uses it is not anticipated that hazardous materials were routed through the
clarifier. It is likely that the clarifier was used for waste cooking grease from onsite restaurants.
However, evaluation of the clarifier is warranted if the Site is redeveloped.

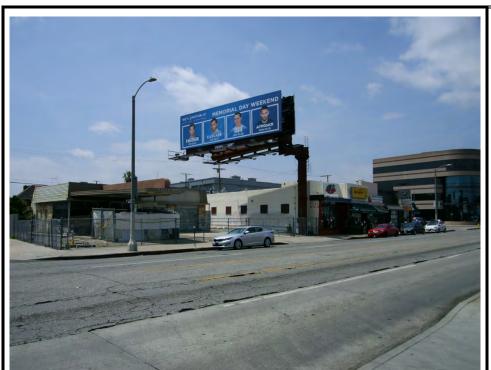
Photograph #28

<u>Description of Photograph:</u> View of the west adjacent former gasoline station.

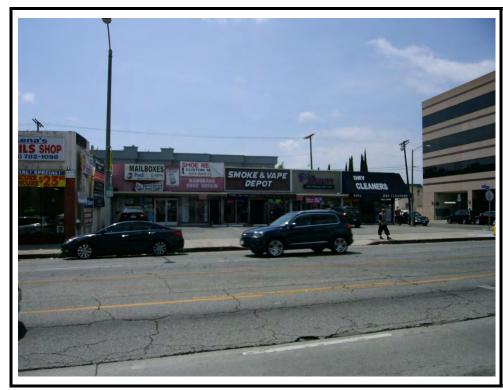
<u>Description of Photograph</u>: View of the west adjacent properties. Note dry cleaners facility.

Kings Cleaners, 349 S. Fairfax Avenue, located adjacent to the west of the Site across S. Fairfax Avenue, is listed in the RCRA-SQG, ECHO, CA HAZNET, and CA Drycleaners databases. This address is currently an operating cleaner named Fair Dry Cleaners. It is listed as a generator of hazardous waste from 1995 to 2000; the waste stream is listed as halogenated solvents which includes the dry cleaning solvent perchloroethylene (PCE). No violations are reported. This facility currently uses a non-toxic dry cleaning compound according to signage on the facility. However, the historical long-term use of PCE and

the propensity for dry cleaners to release PCE to the environment represents a potential concern for the Site due to this facility's proximity to the Site. There are no agency records of a release from this facility; however, this can simply mean that no subsurface testing has been conducted. Arcadis observed two monitoring wells near this property, one north and one west of it. However, these wells are associated with a release south of the cleaners and the plume from that release is confined to the west side of S. Fairfax Avenue according to the most recent information from the RWQCB.
