FRONT WALKWAY & STAIRS

CURRENT CONDITION

PROPOSED CHANGES

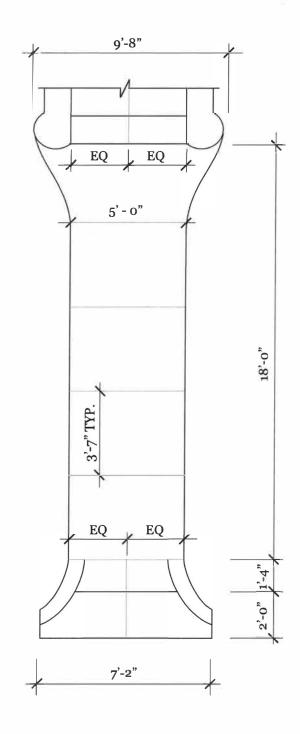
- *Adjacent line drawing depicts the measurements and shape of the current walkway
- *Proposed replacement walkway will replicate the location and dimensions of the existing walkway
- *Currently the walkway is covered in interior floor tiles and one layer of concrete which sits on top of the original, non-salvageable concrete walkway
- *Proposed walkway will be poured concrete with simple rectangular scoring per the original
- *Curved concrete pieces next to the stairs nearest the sidewalk are to remain
- *Two stairs nearest the front entry will be repoured to repair damage from settling
- *Two stairs near entrance and two stairs near sidewalk will have scoring down the center
- *Walkway will have 4 horizontal score lines placed equally apart (approximately 3'-7")
