**Sunshine Canyon Landfill  
Independent Monitor  
Quarterly Site Monitoring Status Report  
April 1, 2019 – June 30, 2019**

**City of Los Angeles Department of City Planning**

**County of Los Angeles Department of Regional Planning**

July 18, 2019

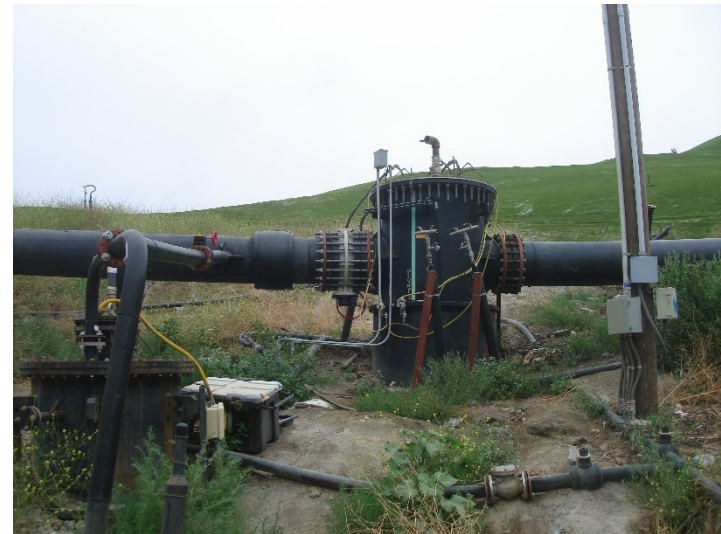
**Photo 135: CC3B East Leachate Low Point Removal: June 19, 2019**

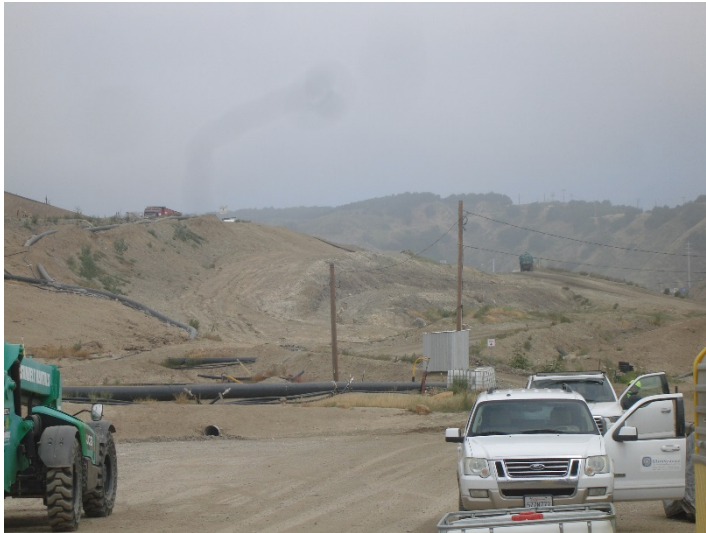
**Photo 136: CC3B East Leachate Low Point Removal: June 19, 2019**

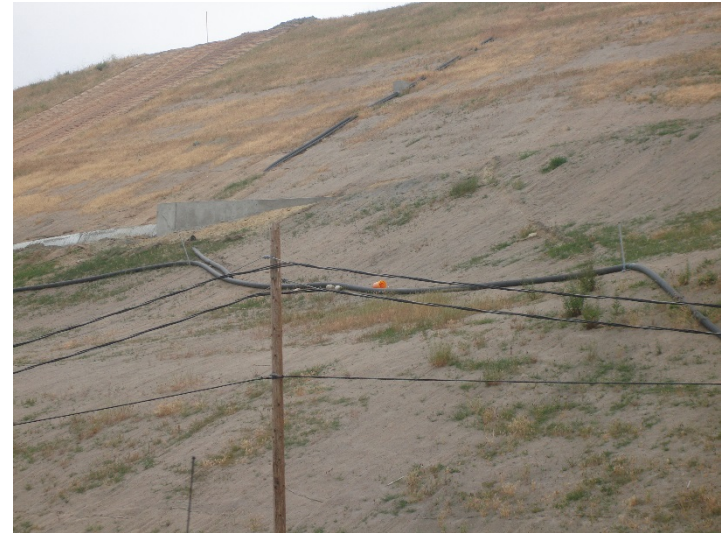
**Photo 137: CC3B East Leachate Low Point Removal: June 19, 2019**

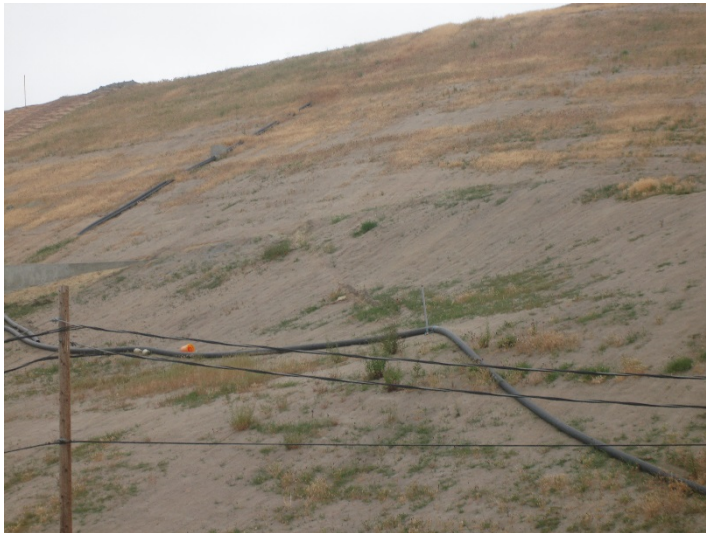
**Photo 138: Old City South Stockpiled Soil Slump: May 7, 2019**

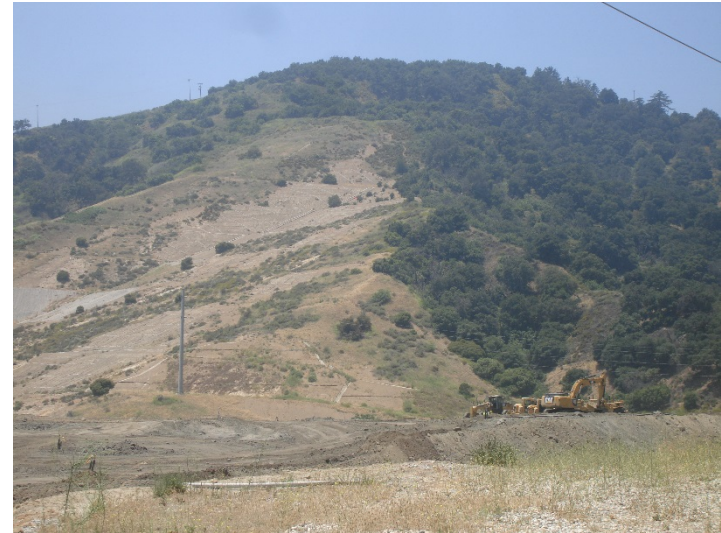
**Photo 197: County Top Deck: June 19, 2019**

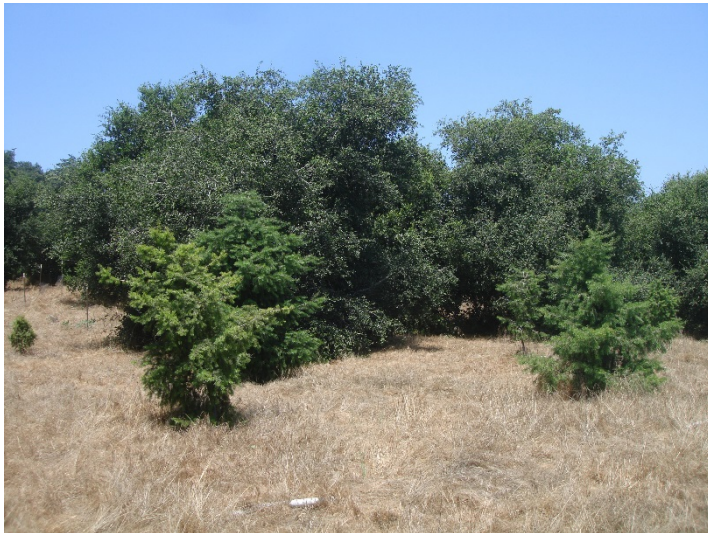
**Photo 198: County Top Deck: June 19, 2019**

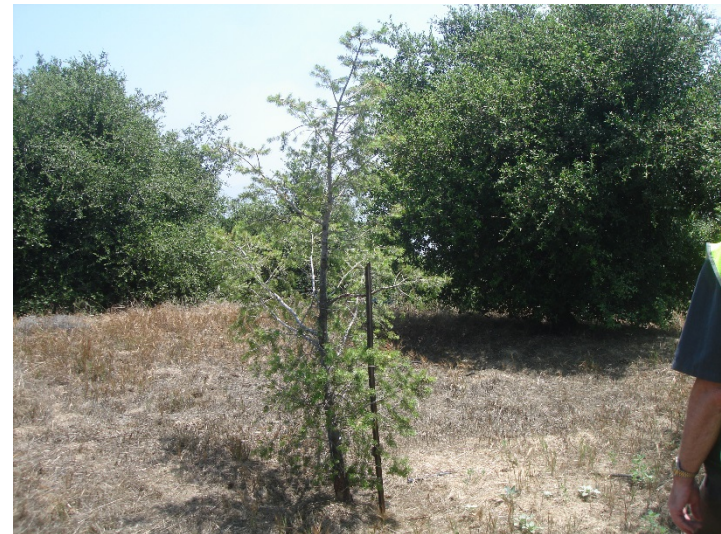
**Photo 199: Big Cone Mitigation Area: June 19, 2019**

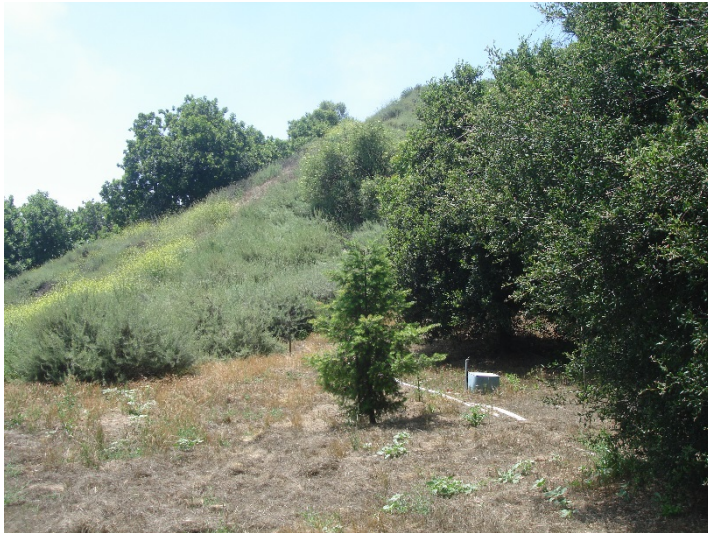
**Photo 200: Big Cone Mitigation Area: June 19, 2019**

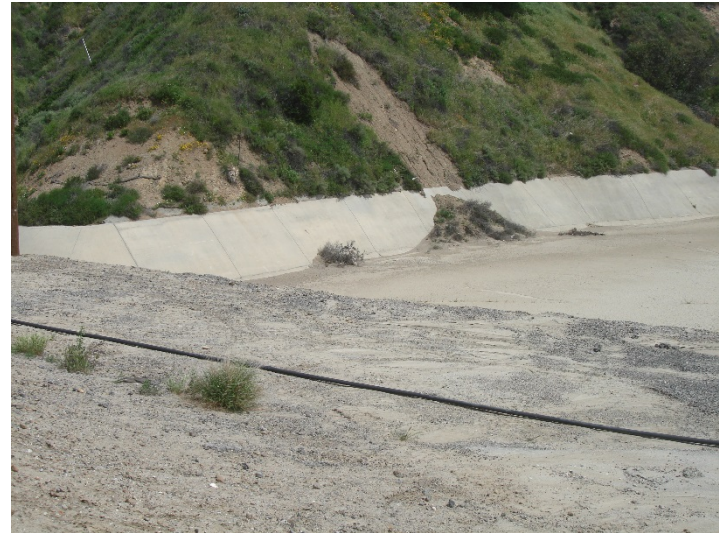
**Photo 201: Big Cone Mitigation Area: June 19, 2019**

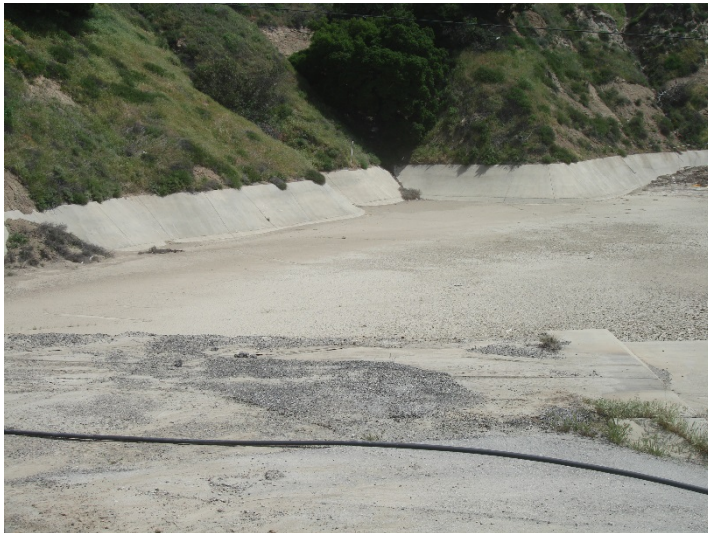
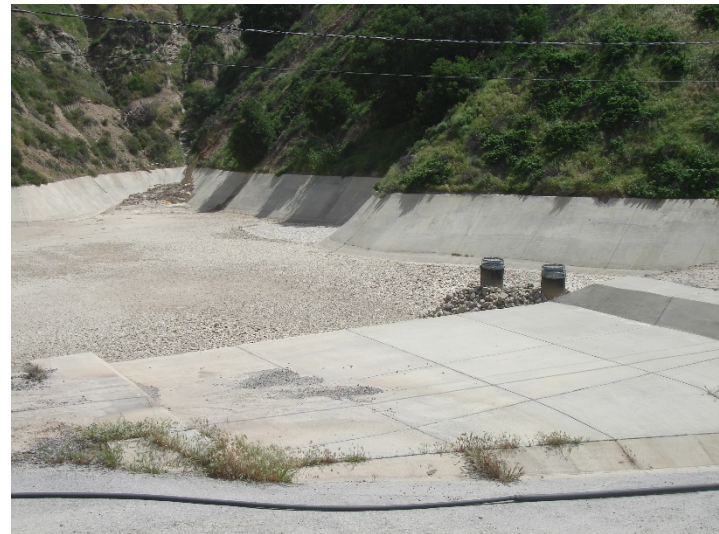
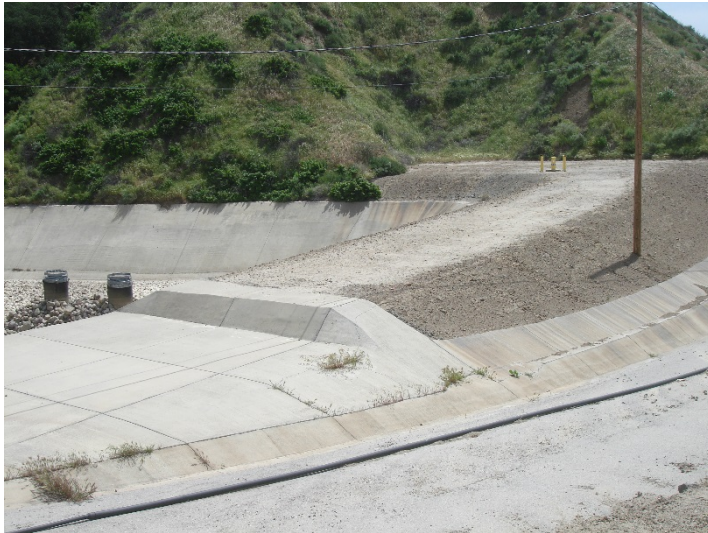
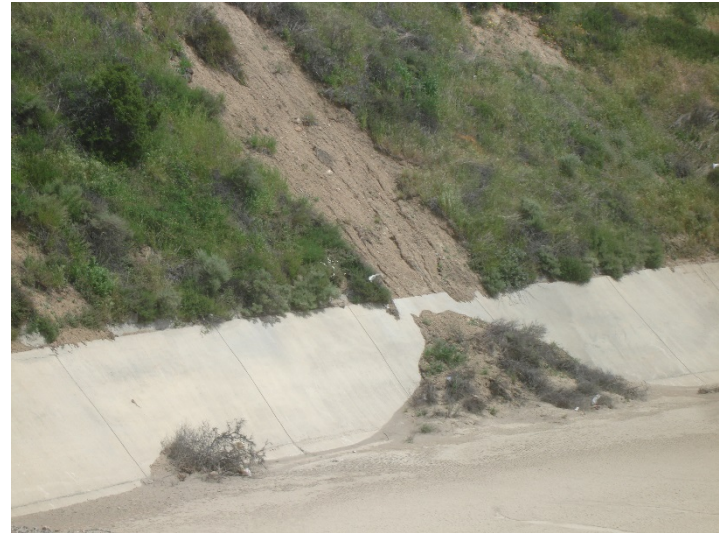
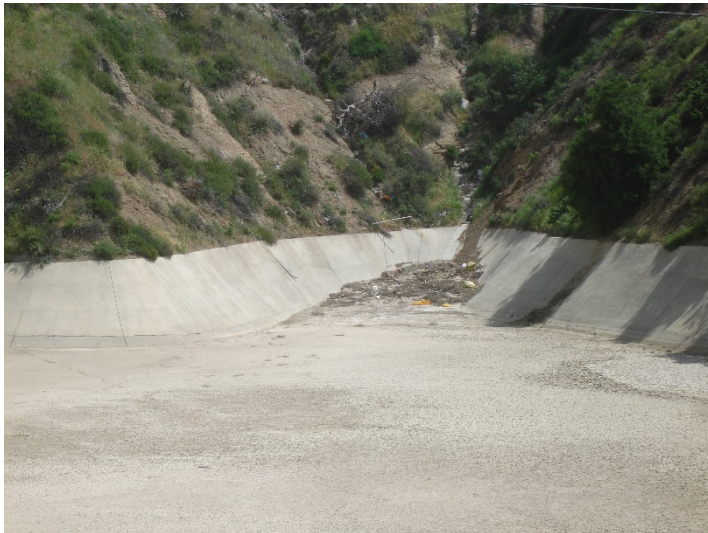
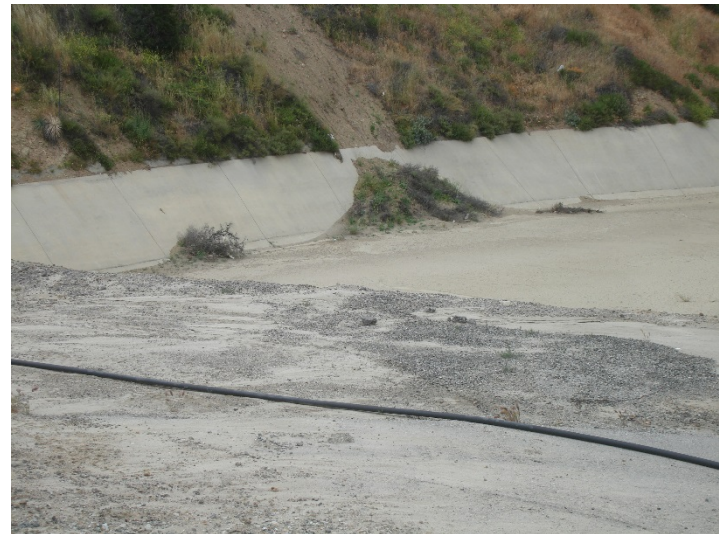
**Photo 202: Basin B: April 11, 2019**

- Basin B was dry with minimal sediment.
- SCS was repairing a broken leachate pipe on the CC-3A top deck and there were strong localized odors at approximately 12:00 p.m.

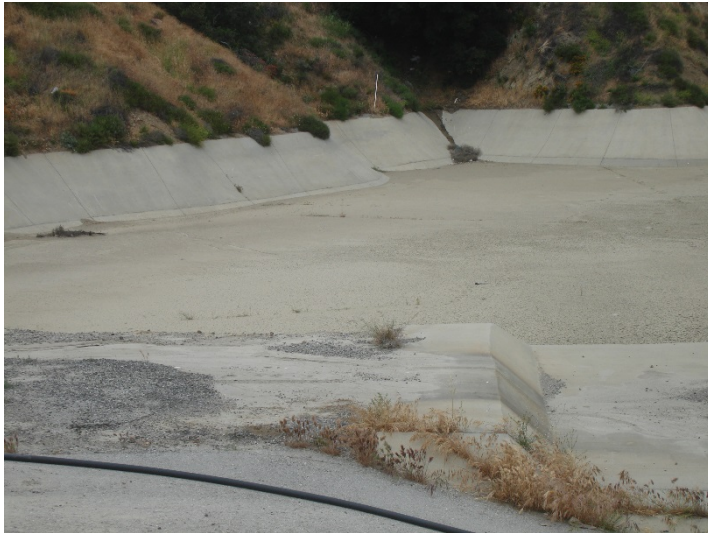
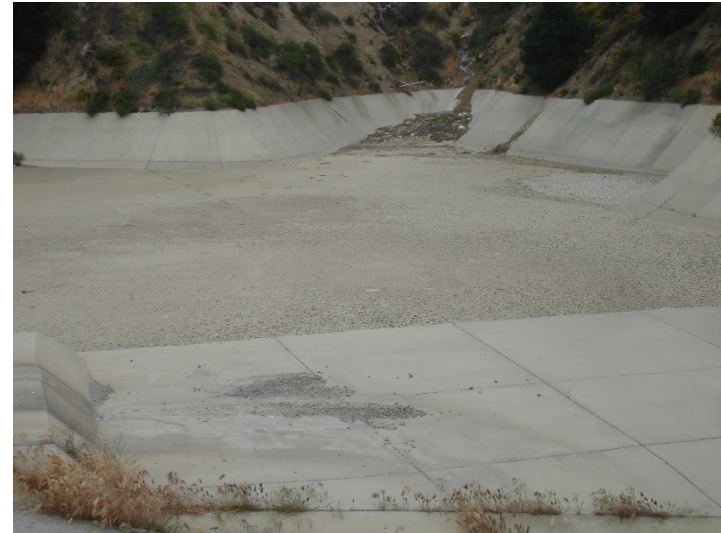
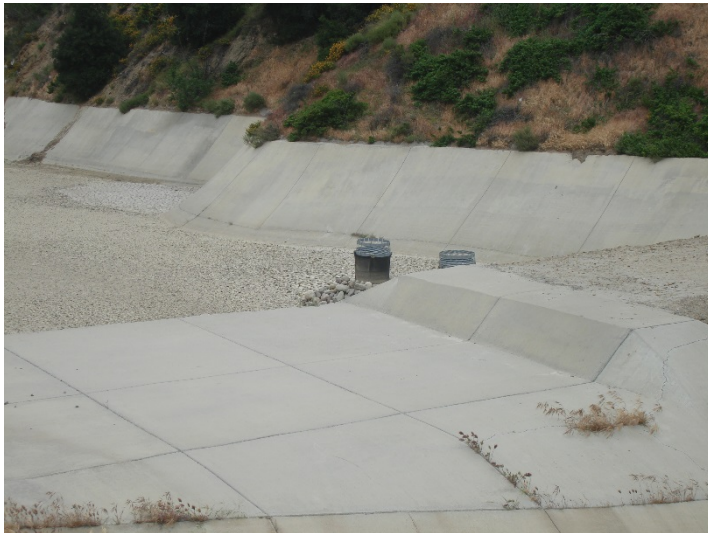
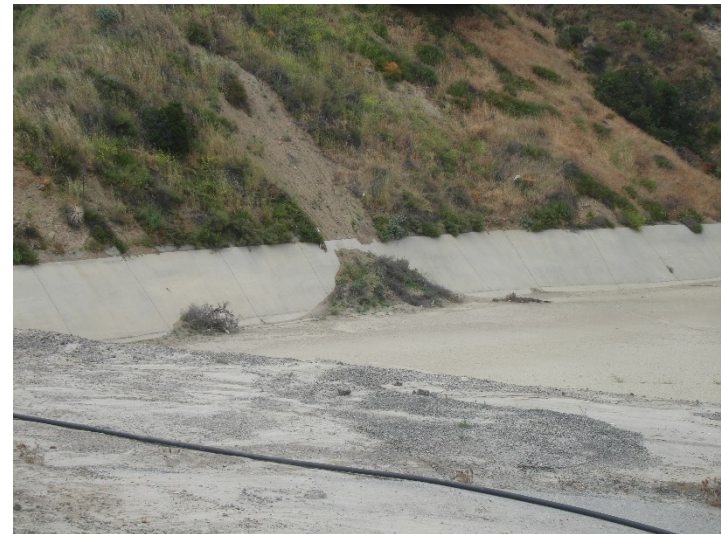
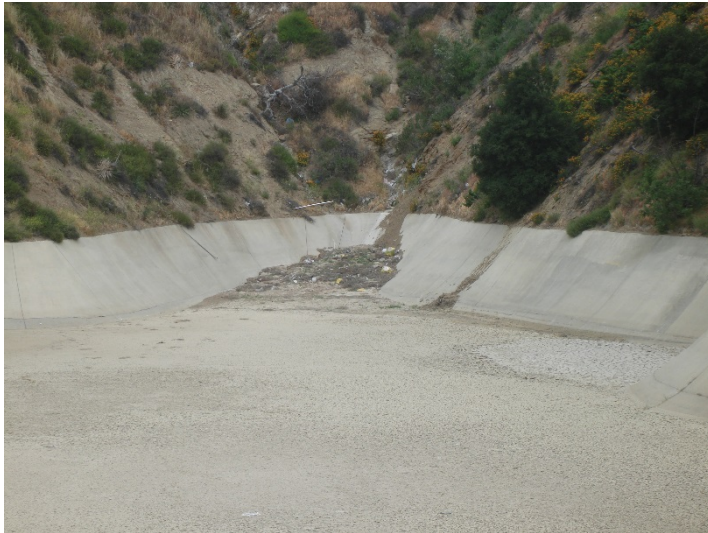
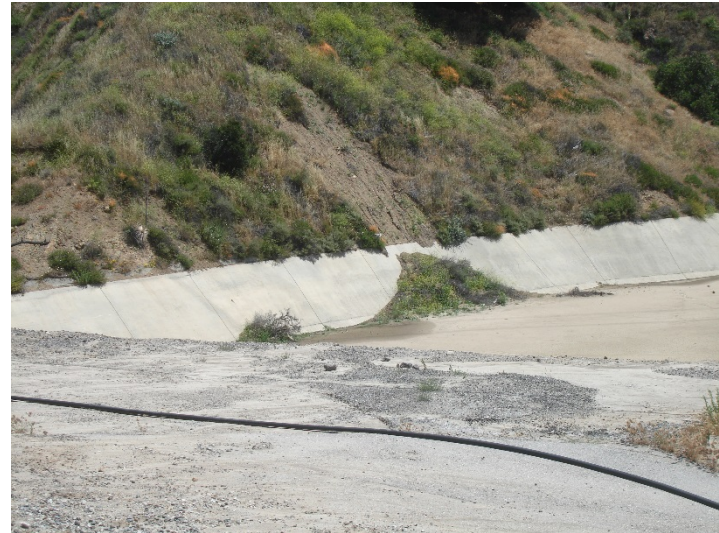
**Photo 208: Basin B: May 7, 2019**

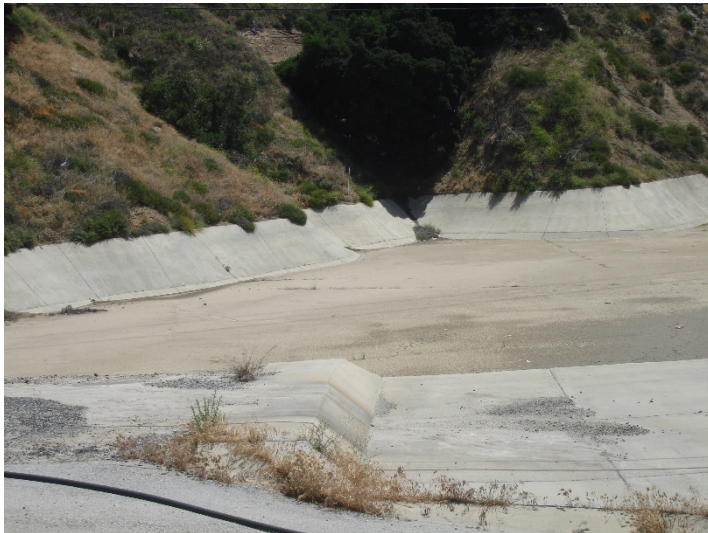
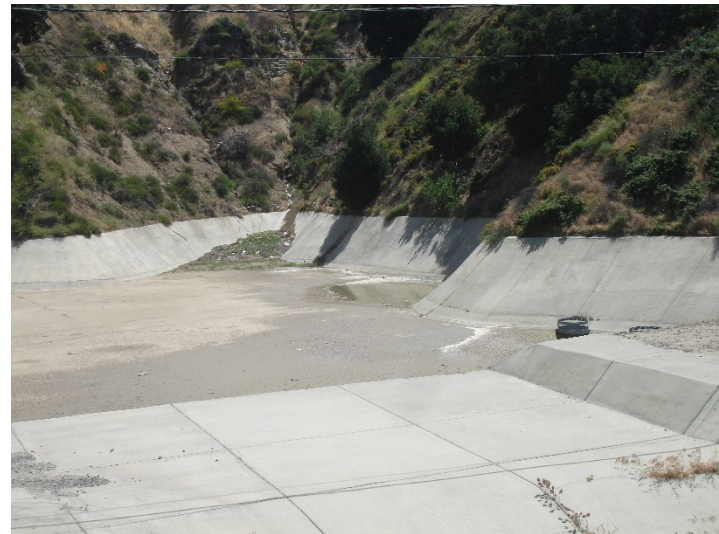
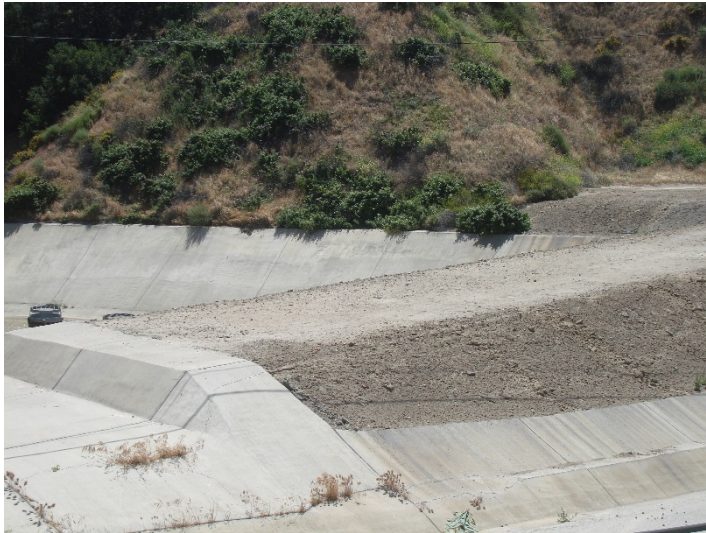
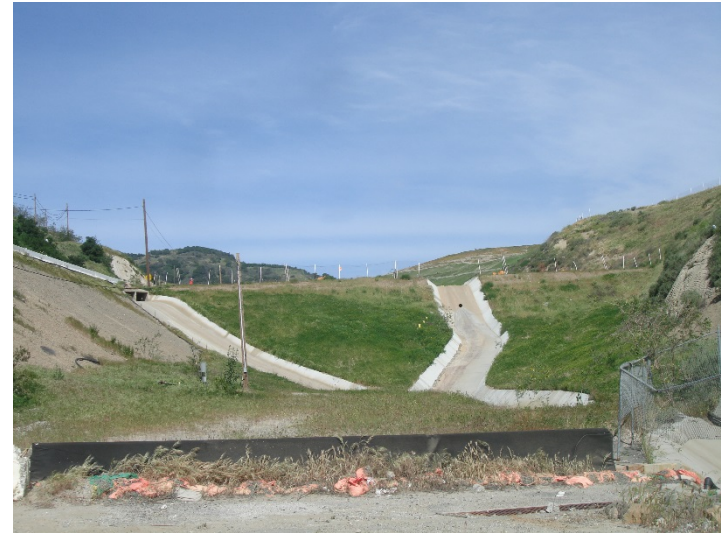
**Photo 214: Basin B: May 28, 2019**

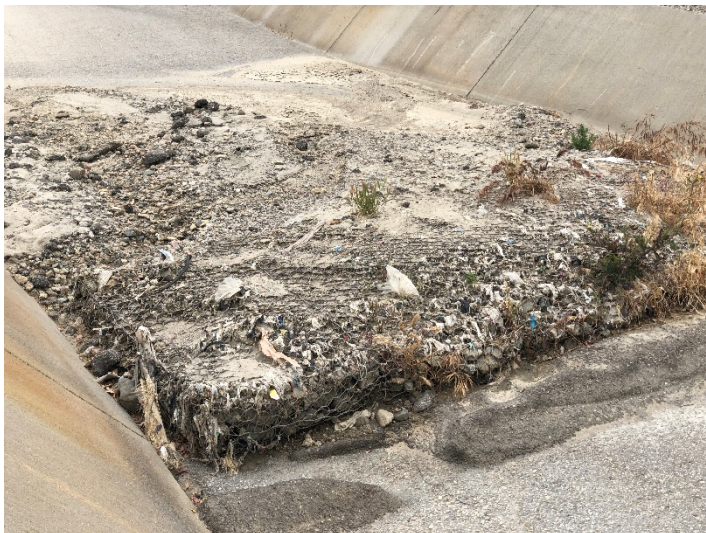
**Photo 218: Terminal Basin Westside Drainage Channel Inlet:  
April 11, 2019**

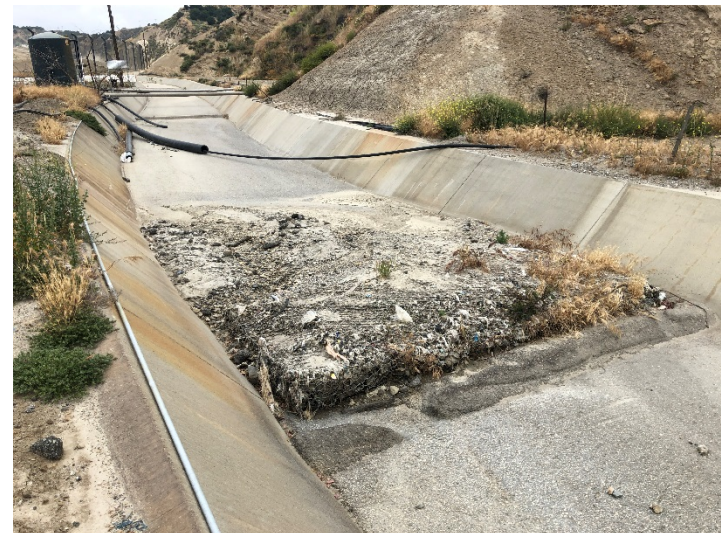
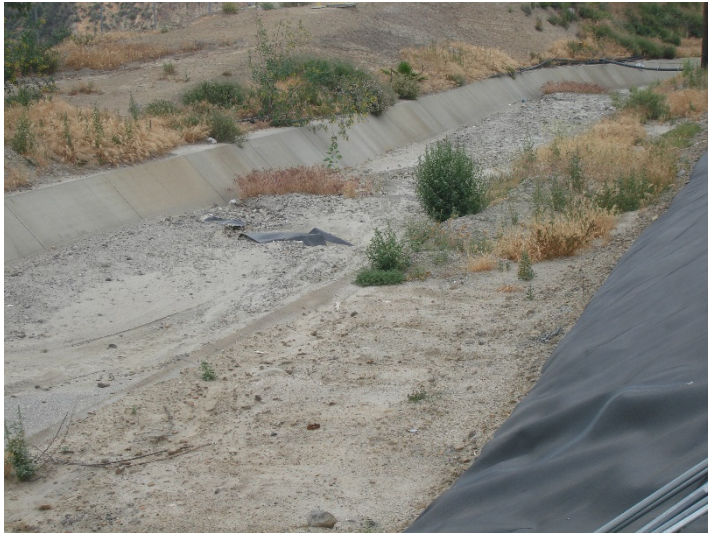
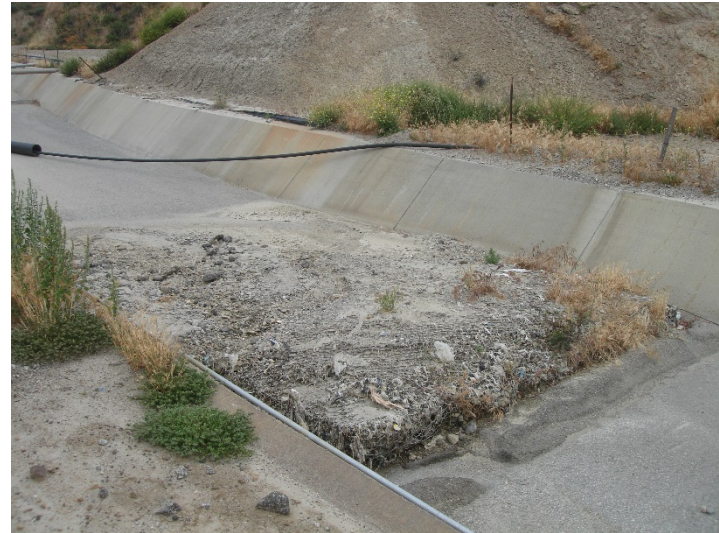
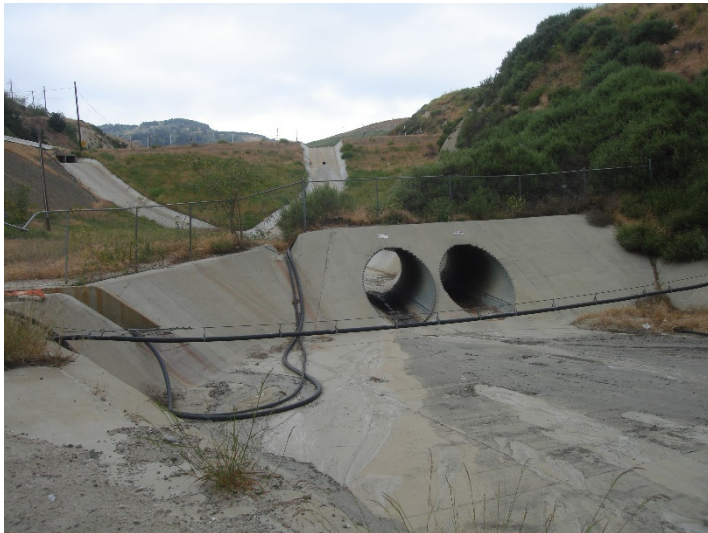
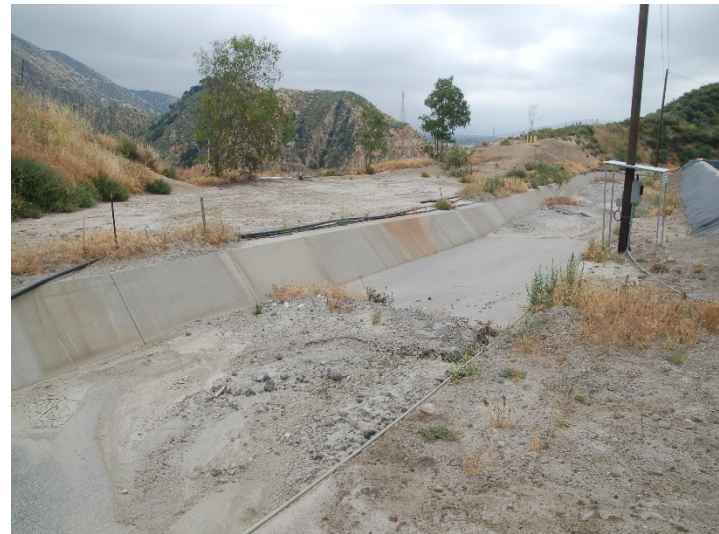
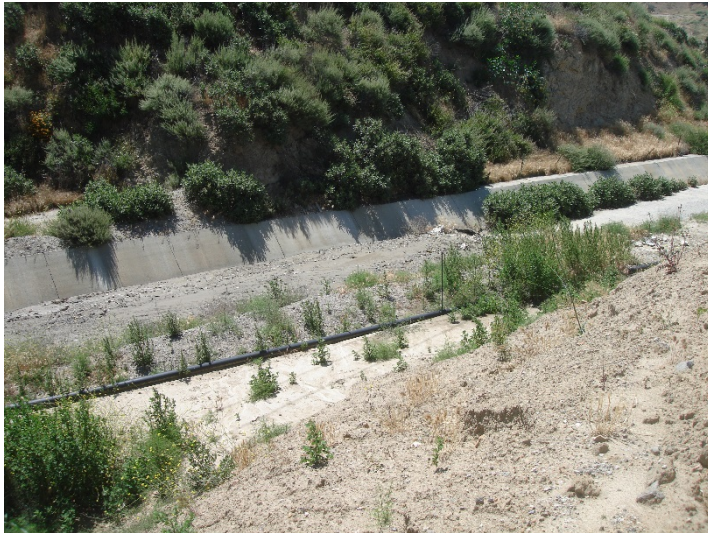
**Photo 219: Eastside Drainage Channel: May 7, 2019**

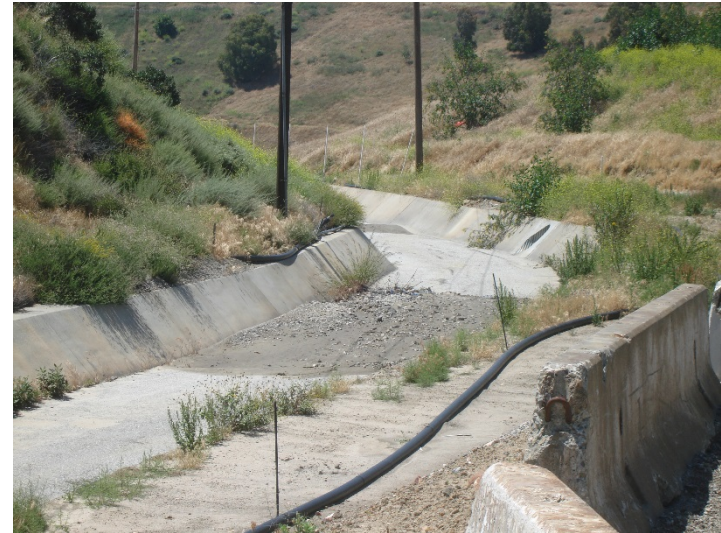
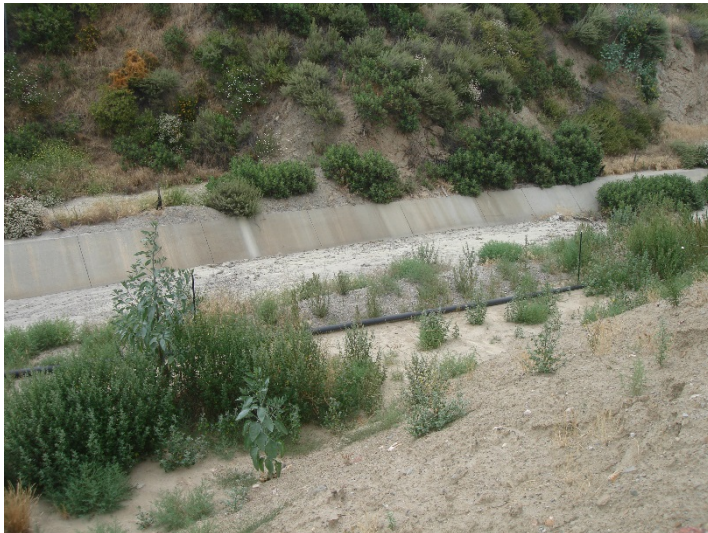
**Photo 225: Eastside Drainage Channel: May 28, 2019**

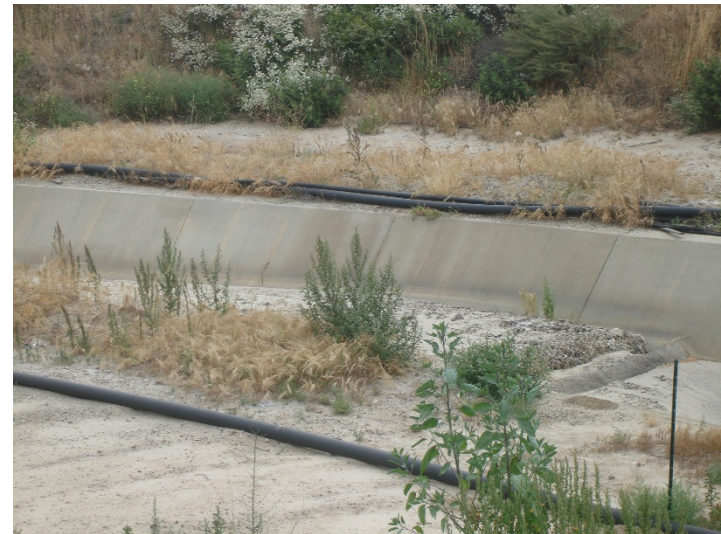
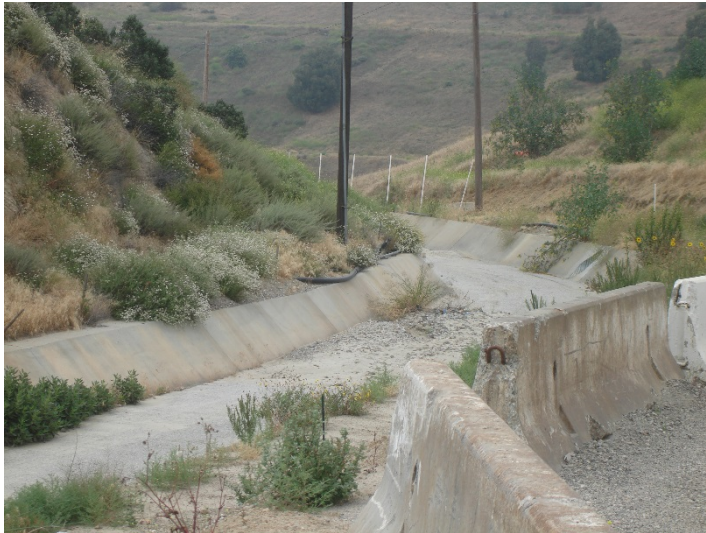
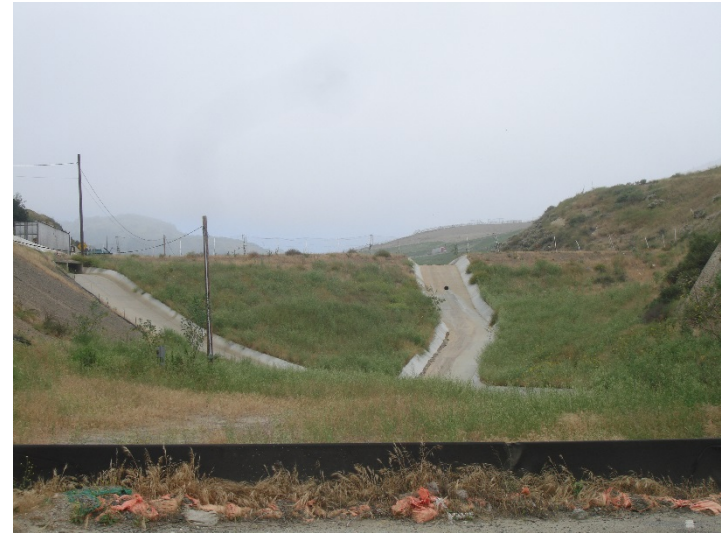
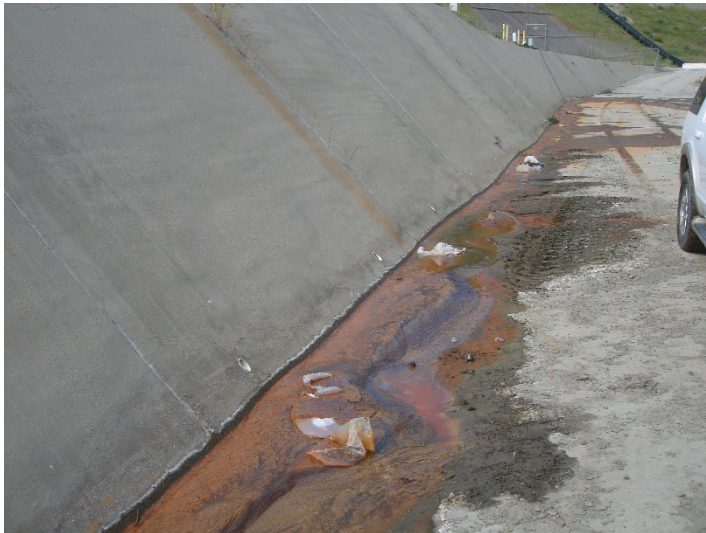
**Photo 227: Eastside Drainage Channel: June 19, 2019**

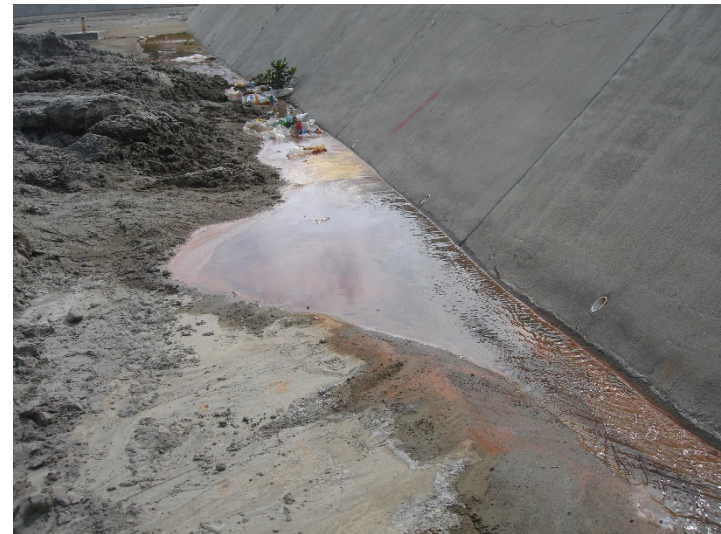
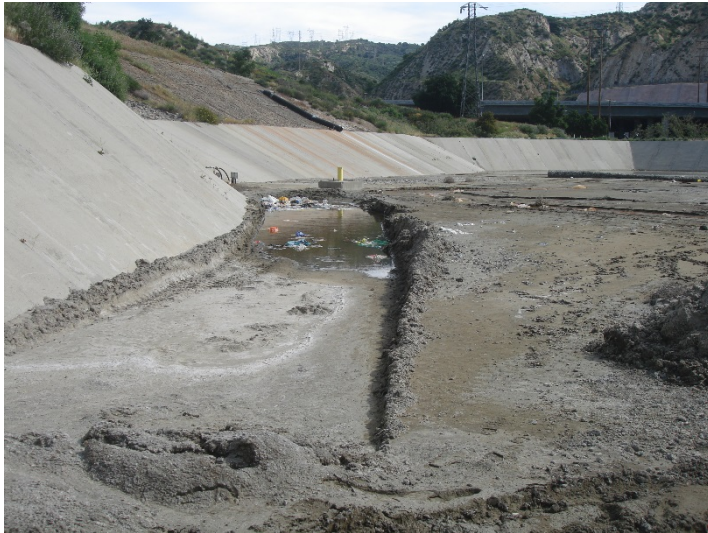
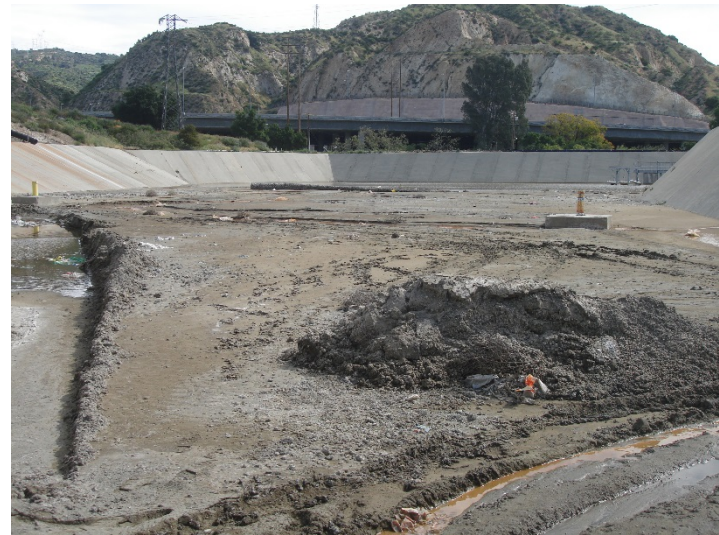
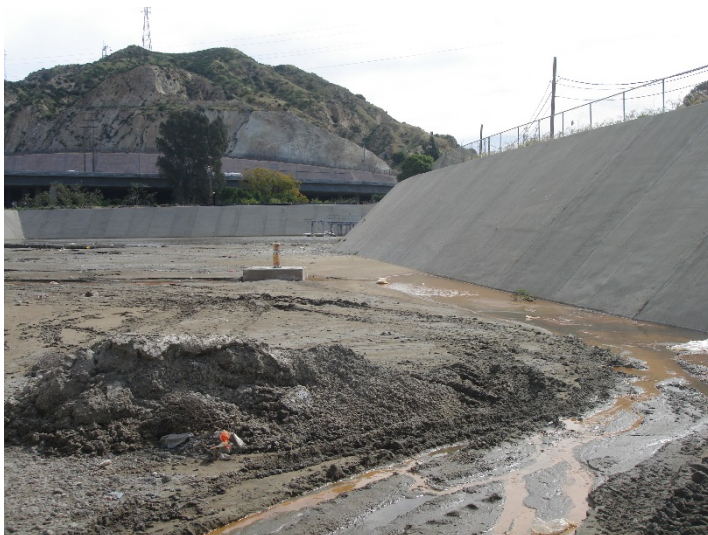
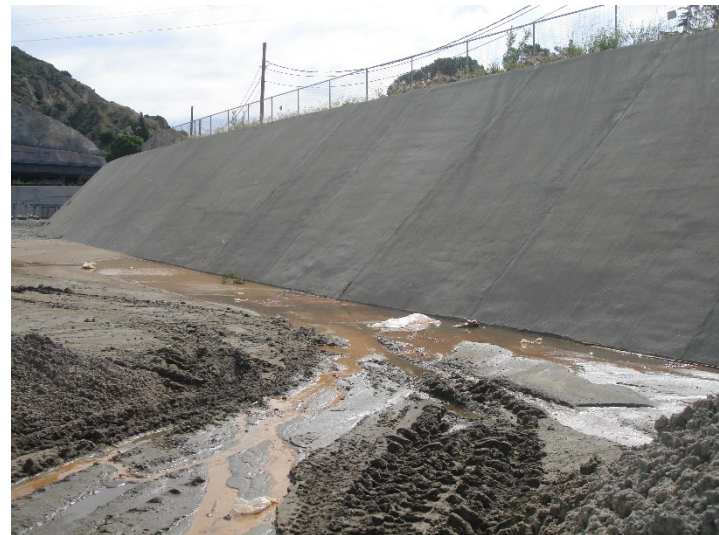
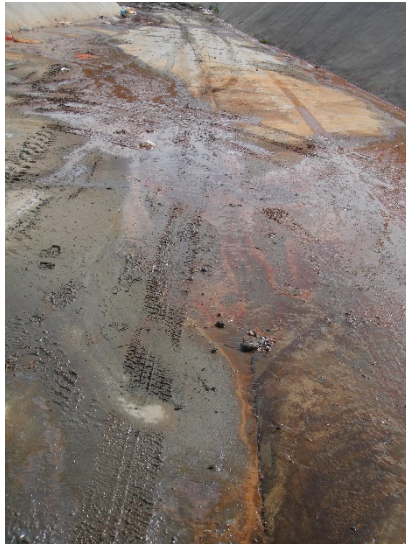
**Photo 231: Terminal Basin: April 11, 2019**

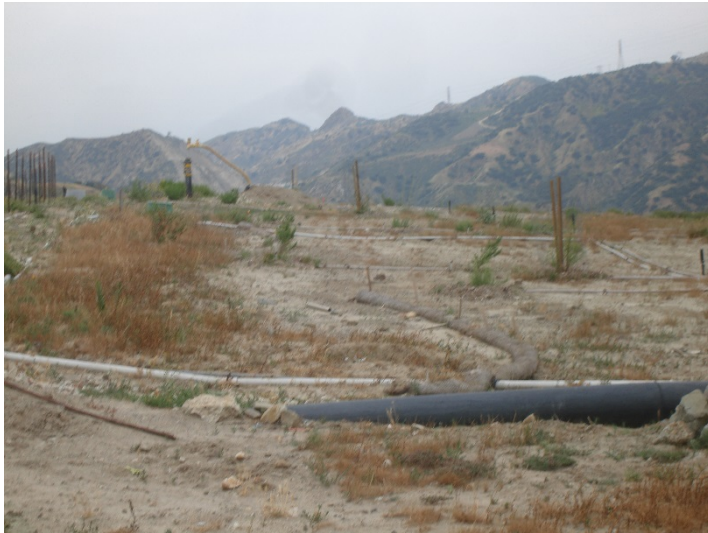
**Photo 308: Deck C Sage Mitigation Area & PM 10 Tree Areas: May 7, 2019**

Monitor: James Aidukas	Page: 1 of 2
Discipline: Project Manager	Date: 5/7/19
Site Conditions: Cloudy 55-70° F, 0-10 MPH winds	
<b>SITE LOG</b>	
<p>Republic General Manager - Chris Coyle</p> <p>Drove the Granada Hills neighborhood and school areas from 6:40 to 7:15 a.m. and there were no landfill odors detected. Met with Mike Lindsay (UltraSystems), Tarik Hadj-Hamou (SLR), Vu Truong and Daniel Wibisono (LACDPW), signed in at the office, and proceeded to monitor the site and observed the following:</p> <ul style="list-style-type: none"> <li>• The slopes in CC-4 Part 1/Part 2 were graded and in good condition. The HDPE downcomer had a section that needed repair.</li> <li>• The Old City South landfill stockpile area slump has not changed.</li> <li>• The terminal basin has alluvial iron oxide red colored water seeping into the basin through seams in the concrete floor. Standing water covers 50% of the area east of the gabion wall. Deep wet sediment (8' to 10' deep) covers most of the basin. Water being discharged is free of sediment but is iron oxide colored.</li> <li>• Sierra Highway was free of debris and trash. The abandoned motorhome has not been removed.</li> <li>• An abandoned boat and trailer was observed under the i-5 overpass on San Fernando Road. Illegally dumped wood waste, trash, and dirt was observed in the same area.</li> <li>• A significant amount of sediment was observed in the eastside channel behind velocity humps and gabions.</li> <li>• The southern perimeter oil field gate was locked.</li> <li>• Leachate and condensate liquids were being treated with 30% hydrogen peroxide in the Alder tank farm before being sewerred. A strong odor was detected near some uncapped loading hoses that were lying on the ground.</li> <li>• CC-4A Part 1/Part 2 was active accepting waste. No operational concerns were noted.</li> <li>• The old Flare 8 site has been cleared of stockpiled debris.</li> <li>• The Active working area waste odors could be detected at the old Flare 8 site.</li> <li>• Basin B was dry, with minimal sediment on the basin's floor. There were two areas of soil sloughing into the basin from native hillsides that will need to be trucked away.</li> <li>• Basin A has some standing water near the outlet risers. There is a significant amount of wet sediment in the basin.</li> <li>• The CC-4 Part 3 buttress has been completed.</li> <li>• Cell CC-4 Part 3 grading is continuing.</li> <li>• Deck C sage mitigation area is doing well. Sage and other native plants are growing in the saltbush understory. Mustard need to be removed in the area and under the PM10 trees.</li> </ul>

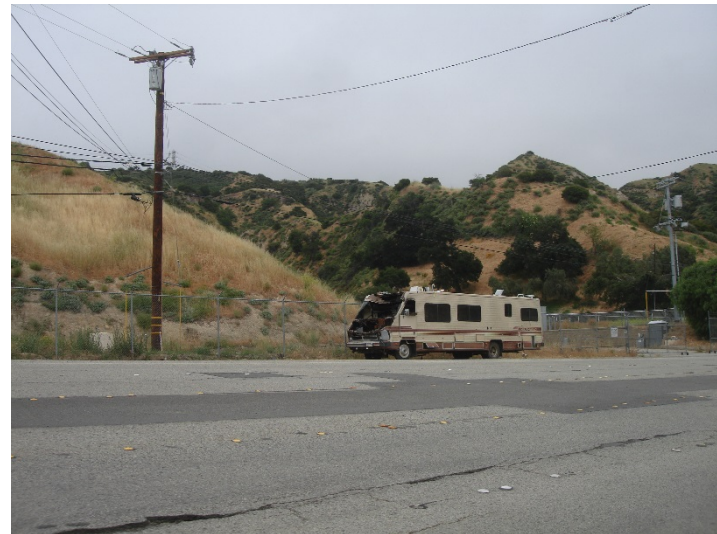
**Photo 335: Abandoned Motorhome on Sierra Highway near I-14 Overpass: April 11, 2019**

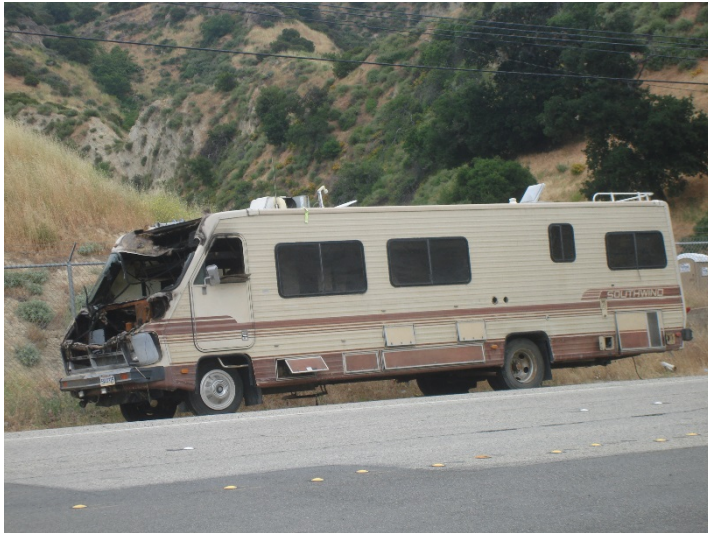
**Photo 336: Abandoned Motorhome on Sierra Highway near I-14 Overpass: May 7, 2019**

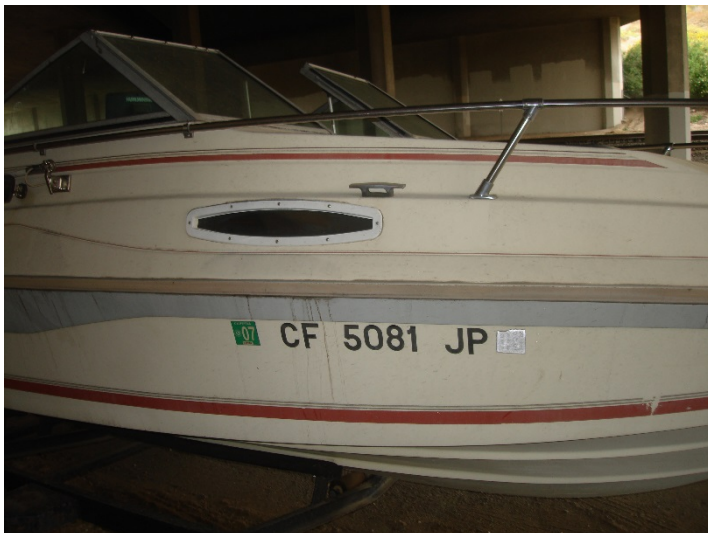
**Photo 338: Abandoned Boat on San Fernando Road under I-5 Overpass: May 7, 2019**
