# Sunshine Canyon Landfill Independent Monitor Quarterly Site Monitoring Status Report January 1, 2014 - March 31, 2014

# **City of Los Angeles Department of City Planning**

# **County of Los Angeles Department of Regional Planning**

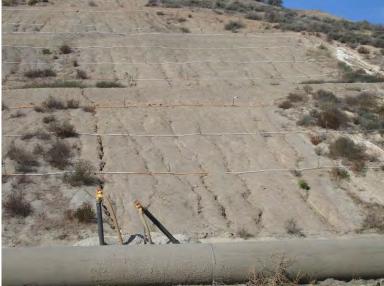
Photo 38: County Sage Mitigation Area: February 5, 2014

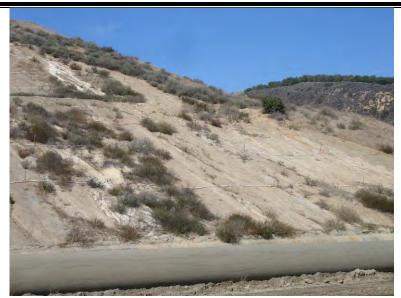
Photo 40: County Sage Mitigation Area: February 5, 2014

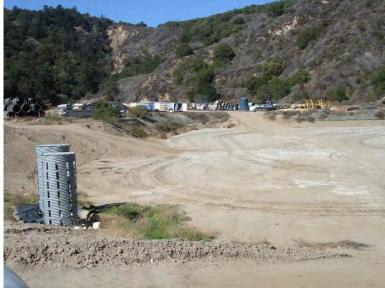
Photo 41: County Sage Mitigation Area: February 5, 2014

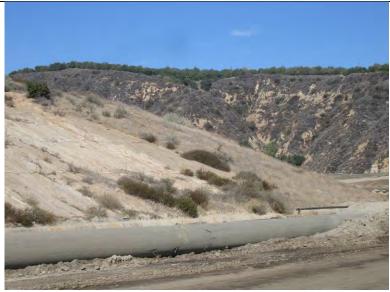
Photo 43: Basin D: February 19, 2014

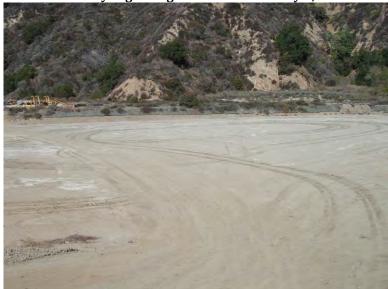
Photo 42: County Sage Mitigation Area: February 5, 2014

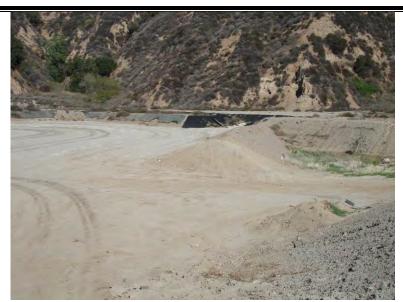
Photo 44: Basin D: February 19, 2014

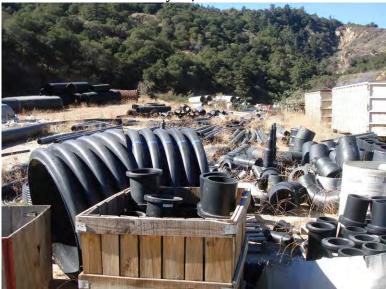
Photo 45: Basin D: February 19, 2014

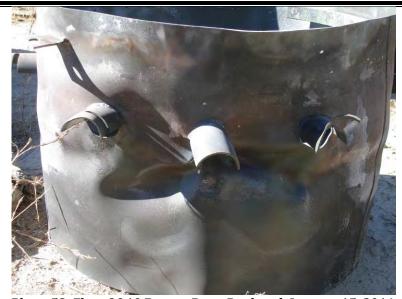
Photo 52: Flare 9&10 Burner Parts Replaced: January 15, 2014

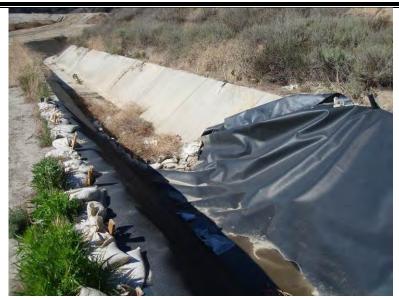
Photo 56: Basin D Outlet Channel: January 15, 2014

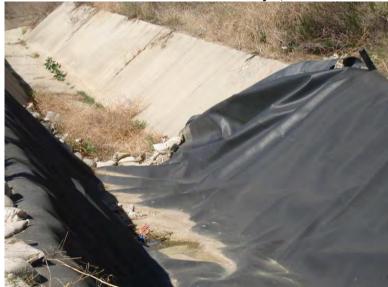
Photo 57: Basin D Outlet Channel: February 5, 2014

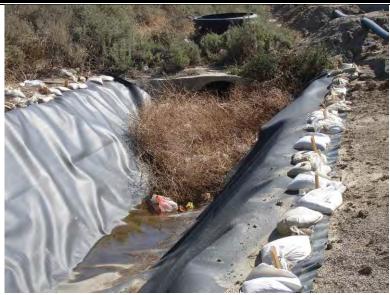
Photo 59: Basin D Outlet Channel: February 19, 2014

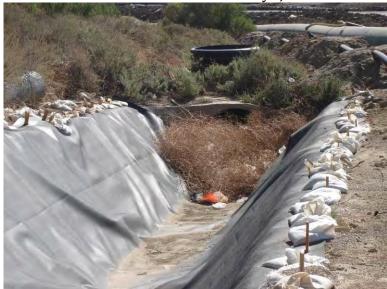
Photo 58: Basin D Outlet Channel: February 5, 2014

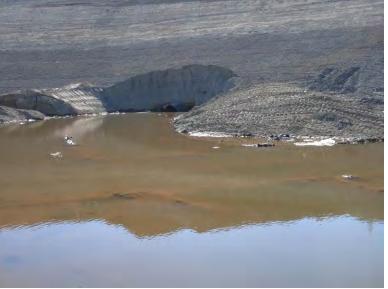
Photo 110: City South Soil Stockpile Seep: January 15, 2014

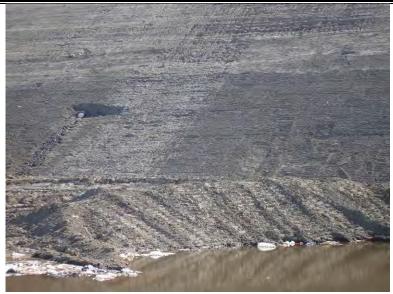
Photo 112: Seep Water Near City Soil Stockpile Area: February 5, 2014

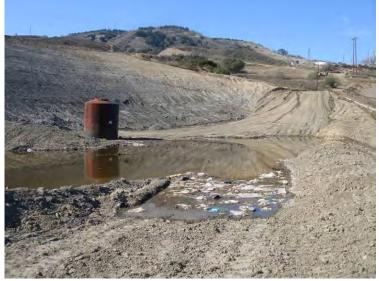
Photo 113: Seep Water Near City Soil Stockpile Area: February 5, 2014

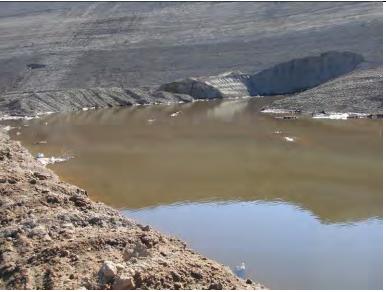
Photo 115: Seep Water Near City Soil Stockpile Area: February 5, 2014

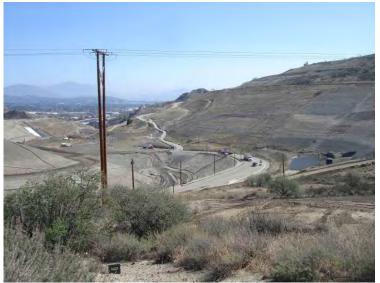
Photo 114: Seep Water Near City Soil Stockpile Area: February 5, 2014

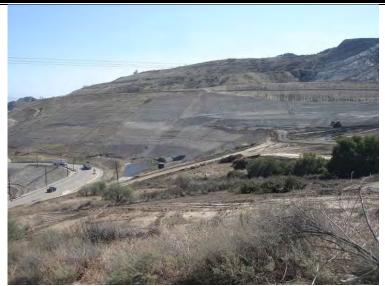
Photo 116: Seep Water Near City Soil Stockpile Area: February 19, 2014

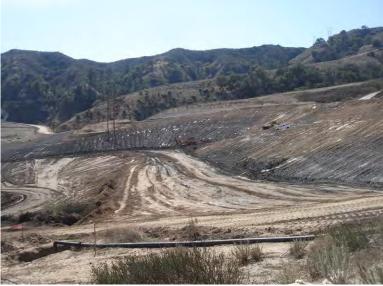
Photo 117: Seep Water Near City Soil Stockpile Area: February 19, 2014

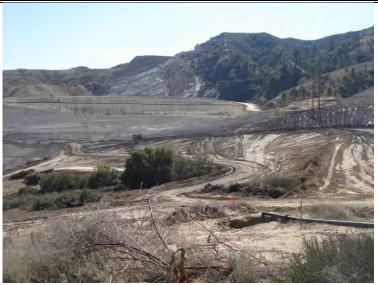
Photo 119: Seep Water Near City Soil Stockpile Area: February 19, 2014

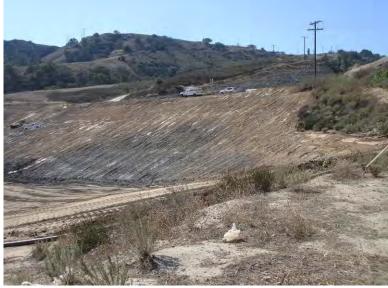
Photo 118: Seep Water Near City Soil Stockpile Area: February 19, 2014

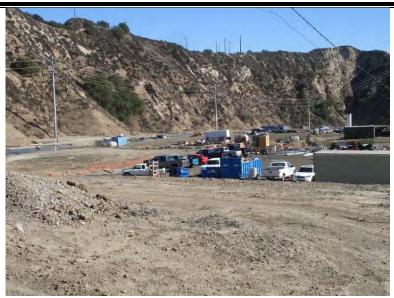
Photo 120: Seep Water Near City Soil Stockpile Area: February 19, 2014

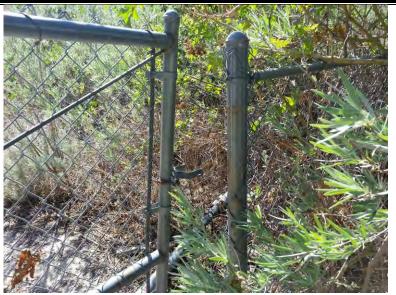
Photo 239: Southern Perimeter Gate in Oil Field Unlocked: March 12, 2014

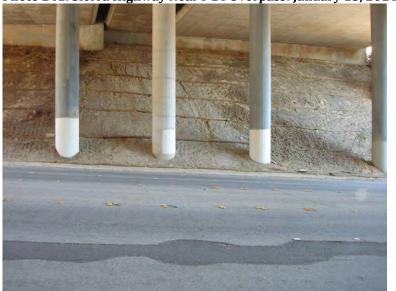
Photo 241: Sierra Highway Near I-14 Overpass: January 15, 2014

- Sierra Highway near the I-14 overpass was clean and no litter or illegal dumping was observed.

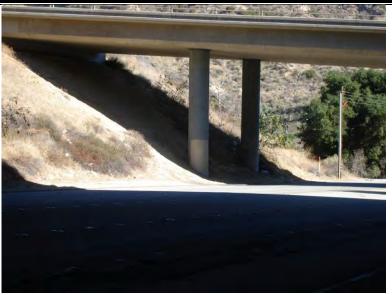
Photo 243: Sierra Highway Near I-14 Overpass: January 15, 2014

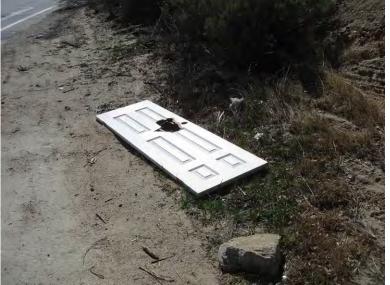
Photo 242: Sierra Highway Near I-14 Overpass: January 15, 2014

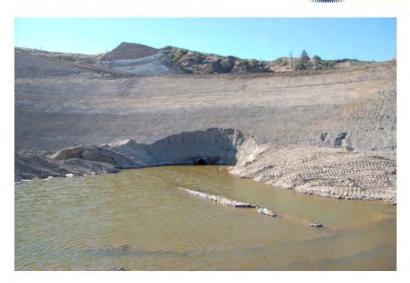
#### location of future toe berm Seep on Slope (Photo 1)

- a large diameter HDPE pipe was unearthed and a seep observed. Water is ponding at toe of vertical few feet high slope with. This should be addressed as it poses a stability risk
- a smaller seep(?) was observed to the east of the ponding water on the slope. Only impact on cover is an erosion gully

Photo 1: Seep and ponding water at toe of vertical cut under slope

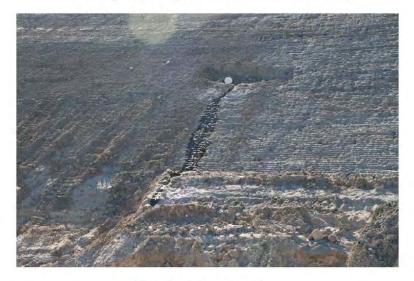
Photo 2: Erosion gully on slope
