**Sunshine Canyon Landfill
Independent Monitor
Quarterly Site Monitoring Status Report
January 1, 2018 – March 31, 2018**

City of Los Angeles Department of City Planning

County of Los Angeles Department of Regional Planning

May 25, 2018

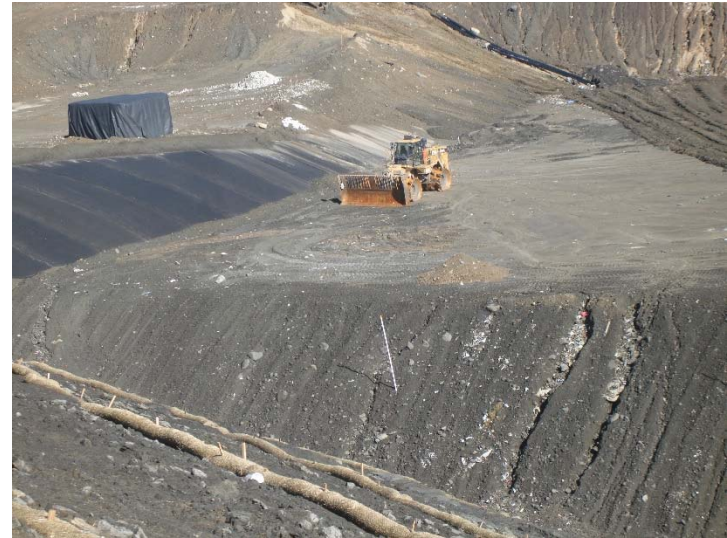
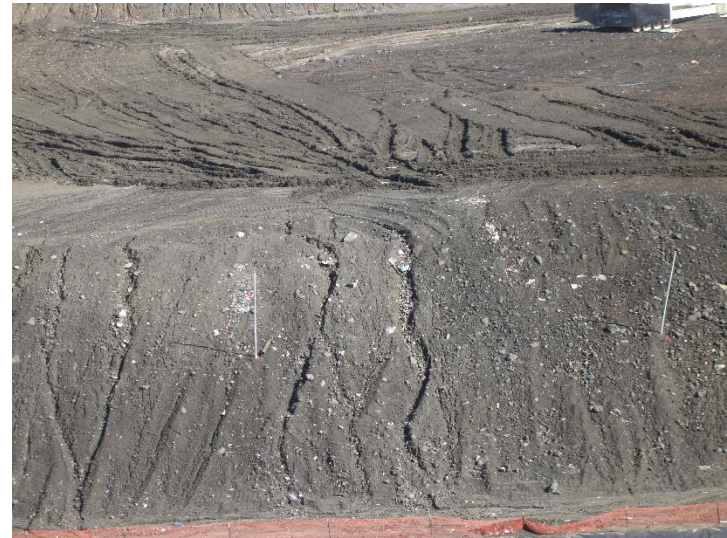
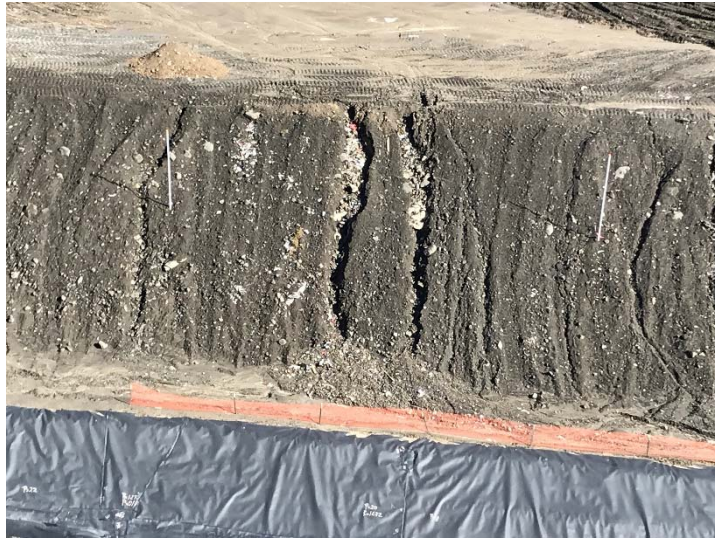
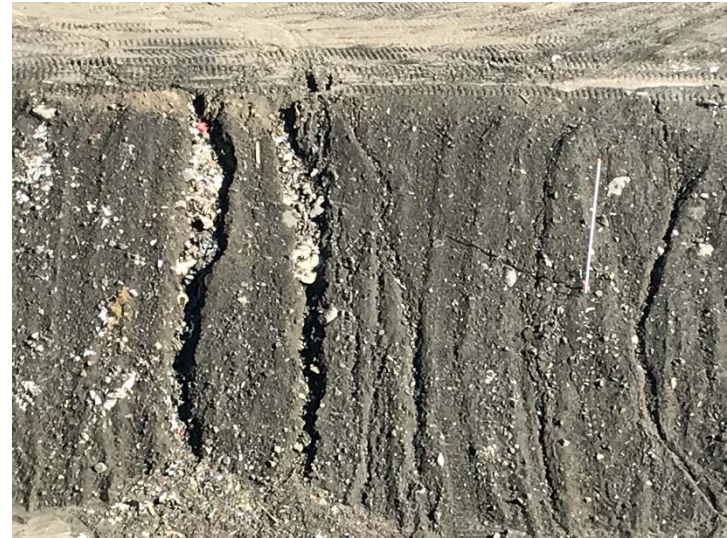
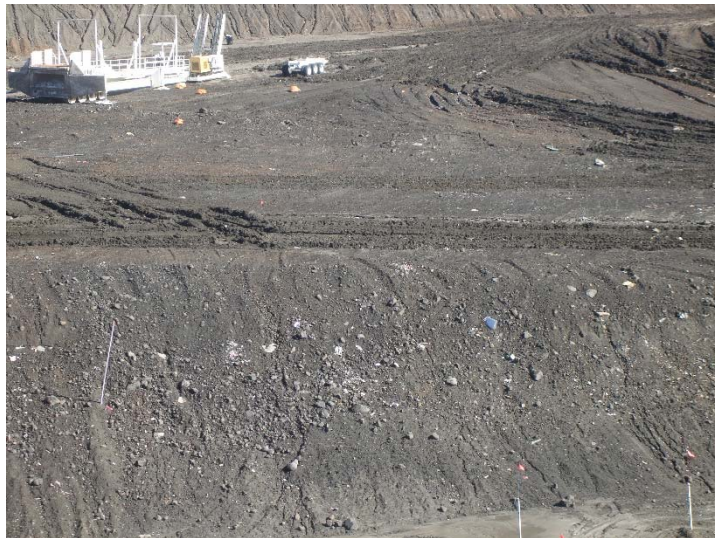
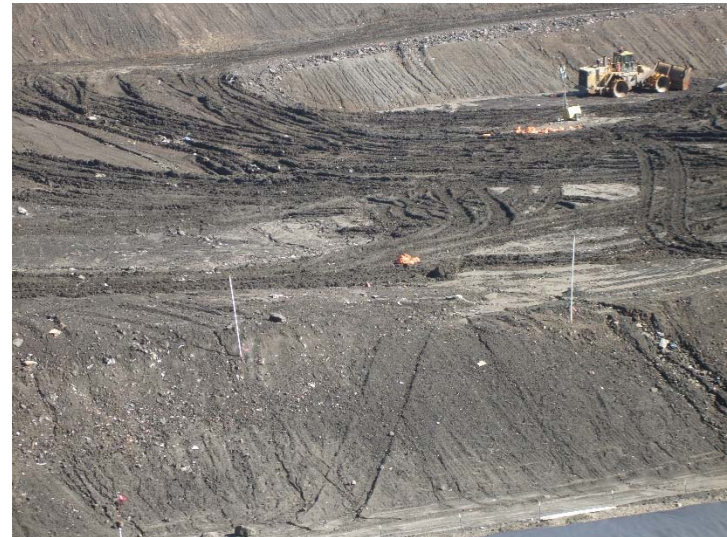
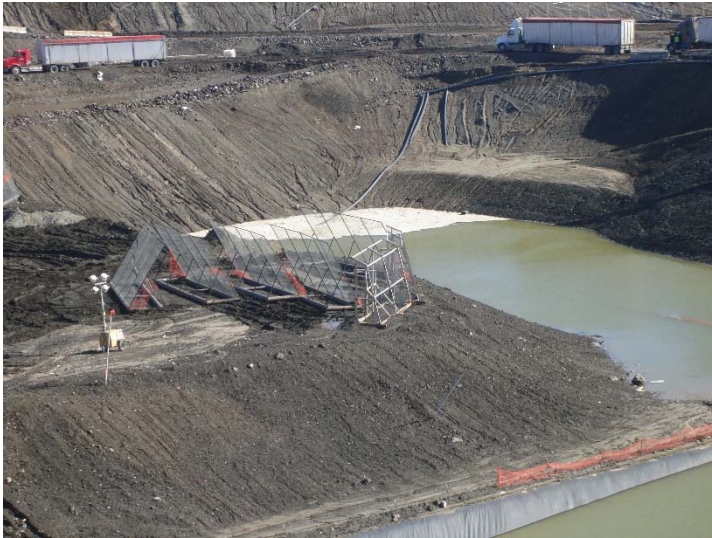
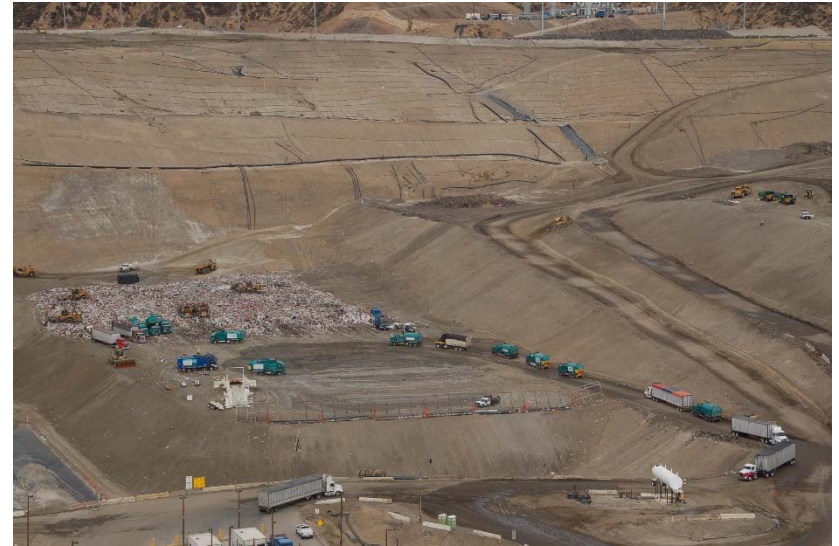
Photo 157: Site Working Area CC4A Part 2 Idle: January 10, 2018

Photo 158: Site Working Area CC4A Part 2 Idle: January 10, 2018

Photo 159: Site Working Area CC4A Part 2 Idle: January 10, 2018

Photo 160: Site Working Area CC4A Part 2 Idle: January 10, 2018

Photo 161: Site Working Area CC4A Part 2 Idle: January 10, 2018

Photo 162: Site Working Area CC4A Part 2 Idle: January 10, 2018

Photo 163: Site Working Area CC4A Part 2 Idle: January 10, 2018

Photo 164: Site Working Area CC4A Part 2 Idle: January 10, 2018

Photo 165: Site Working Area CC4A Part 2 Idle: January 10, 2018

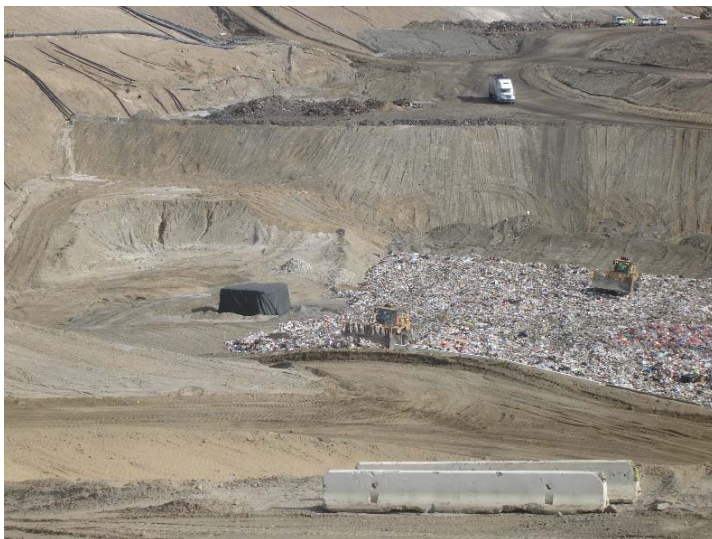
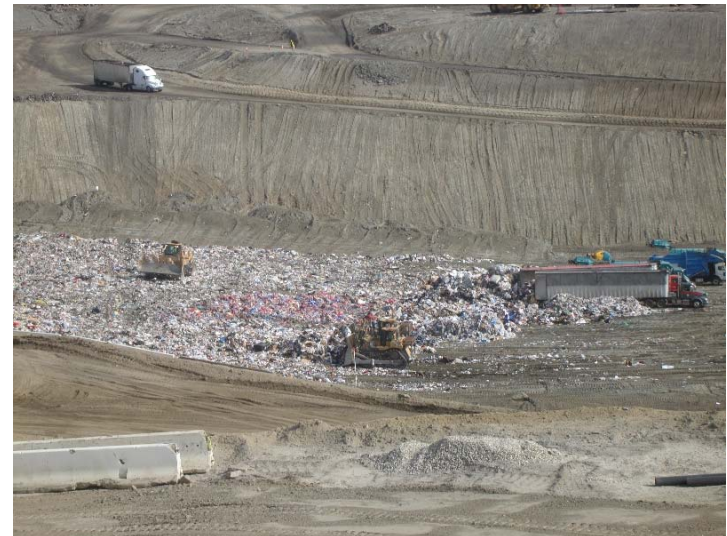
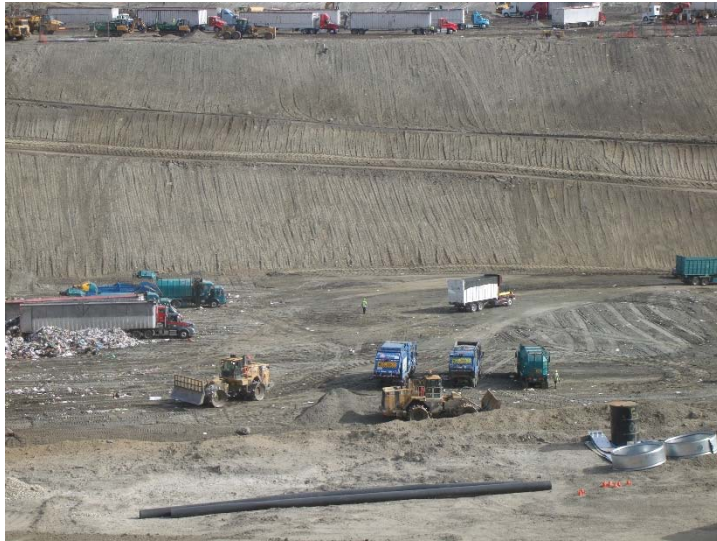
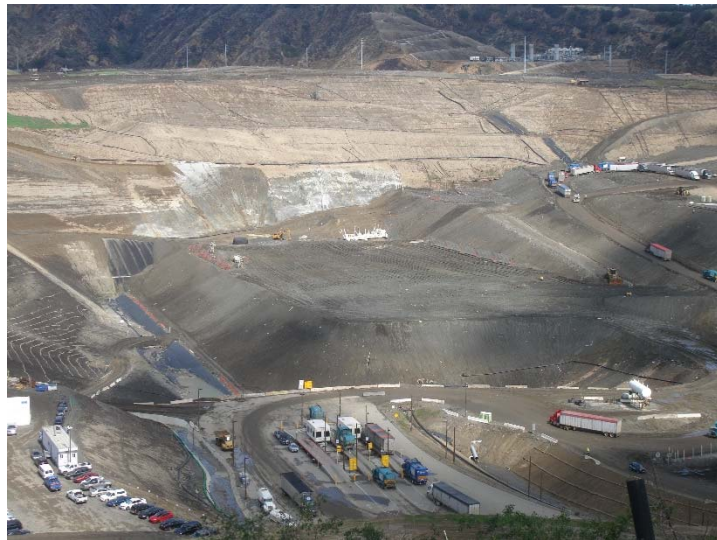
Photo 166: Site Working Area CC4A Part 2: January 30, 2018

Photo 167: Site Working Area CC4A Part 2: January 30, 2018

Photo 168: Site Working Area CC4A Part 2: January 30, 2018

Photo 169: Site Working Area CC4A Part 2: January 30, 2018

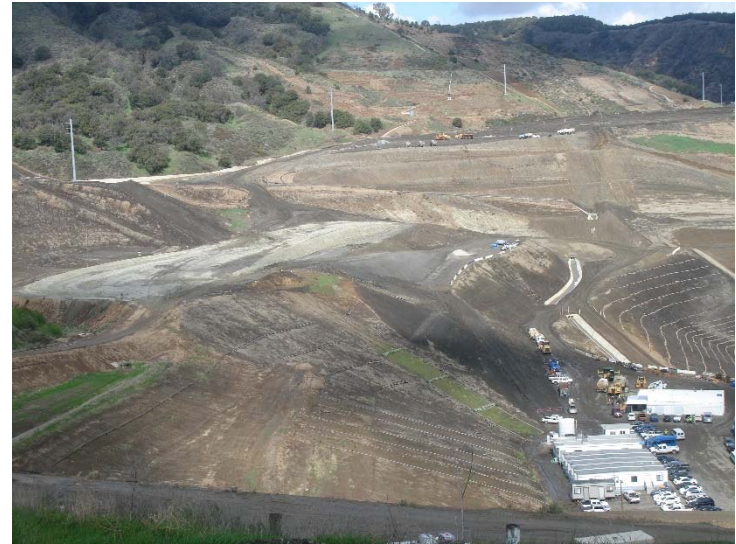
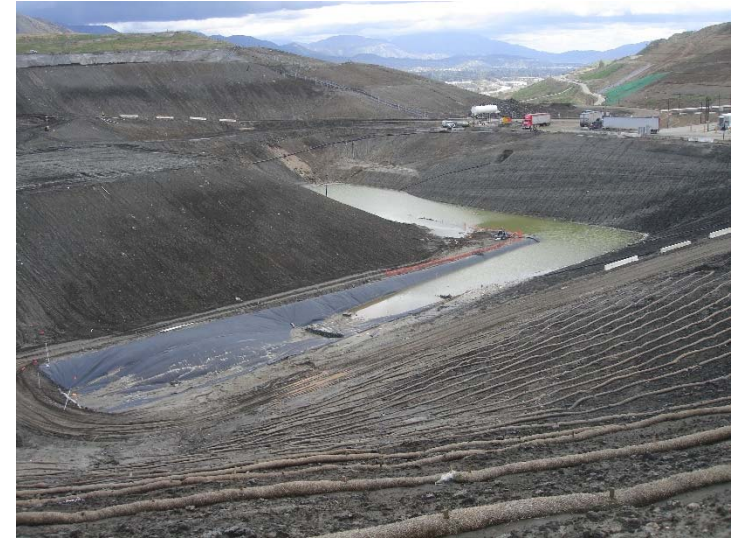
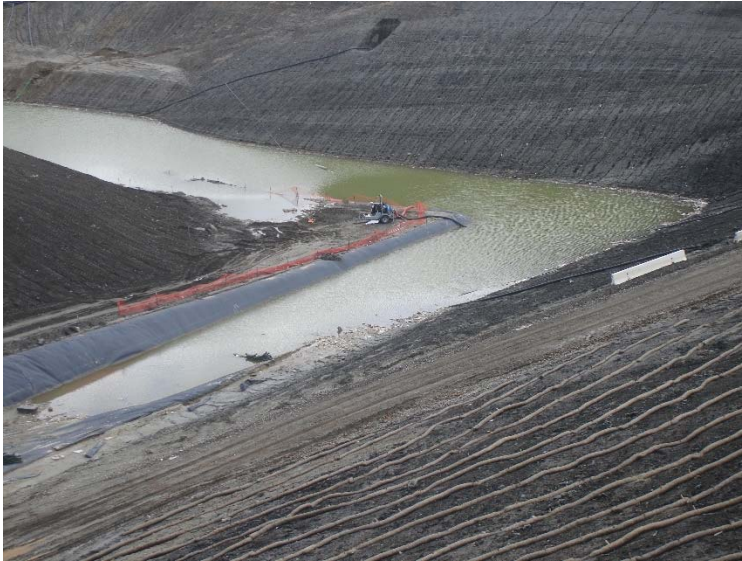
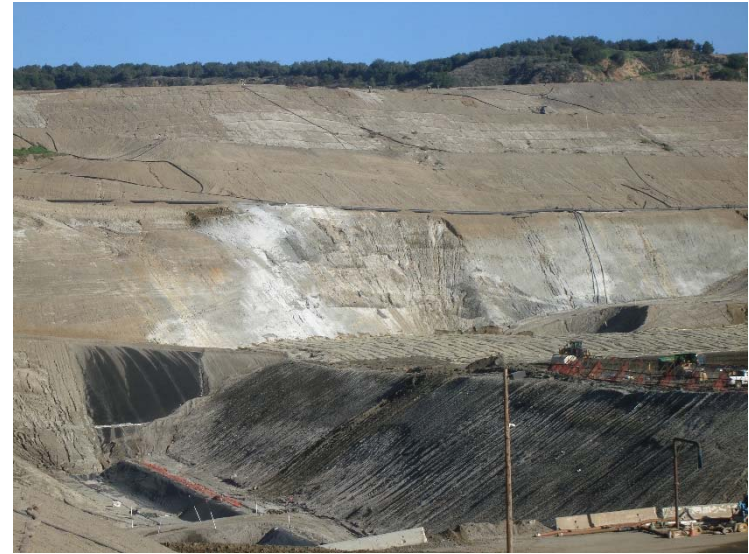
Photo 171: Site Working Area CC4A Part 2: March 14, 2018

Photo 170: Site Working Area CC4A Part 2: March 14, 2018

Photo 172: Site Working Area CC4A Part 2: March 14, 2018

Photo 173: Site Working Area CC4A Part 2: March 14, 2018

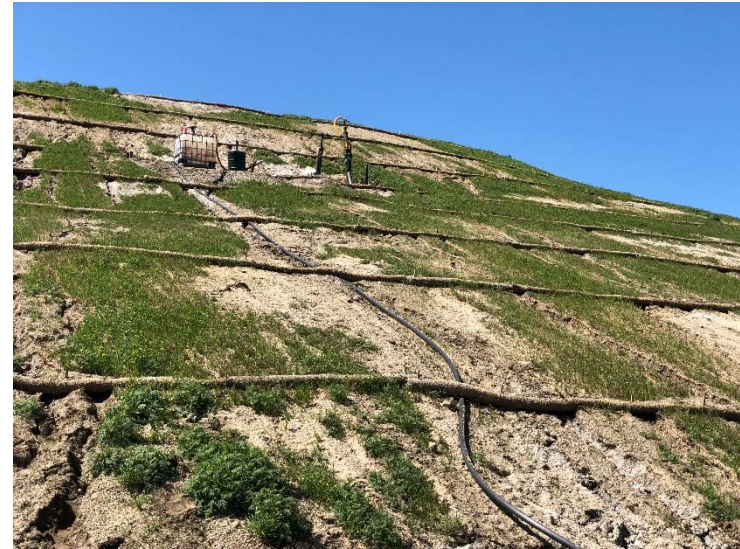
Photo 229: CC3A East Slope Localized Liquids Odors: March 29, 2018

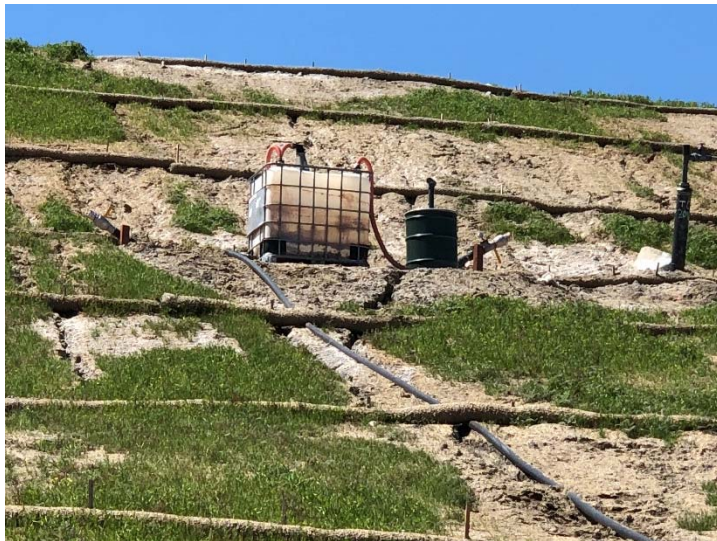
Photo 230: CC3A East Slope Localized Liquids Odors: March 29, 2018

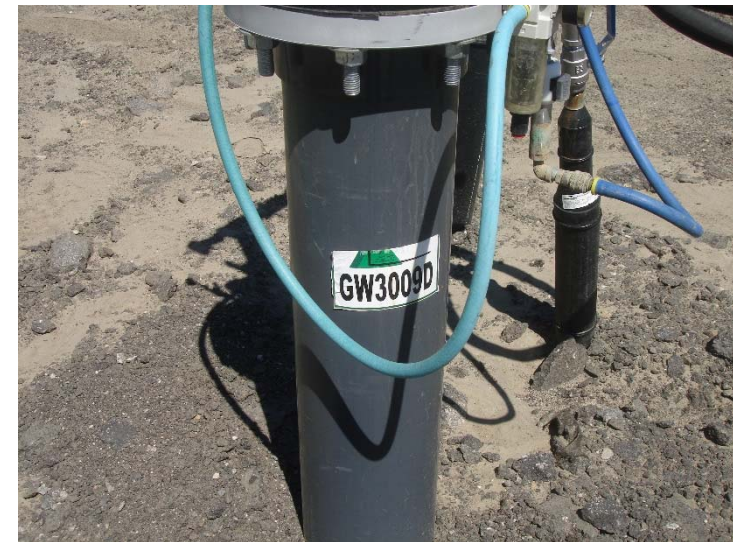
Photo 231: CC3A East Slope Localized Liquids Odors: March 29, 2018

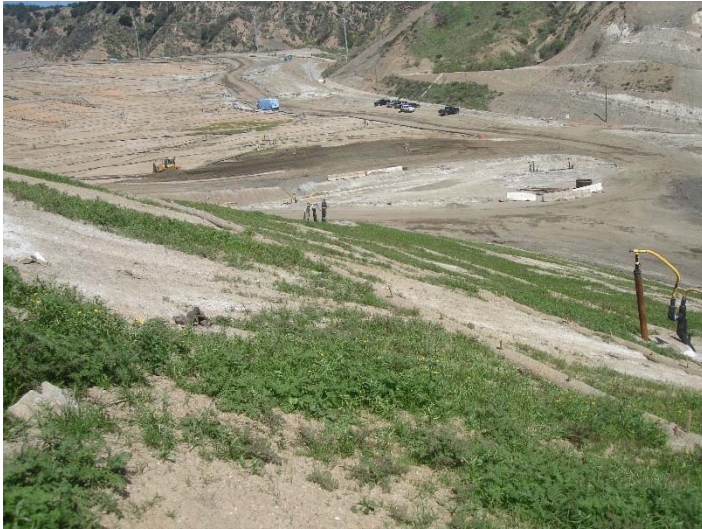
Photo 232: CC3A East Slope Localized Liquids Odors: March 29, 2018

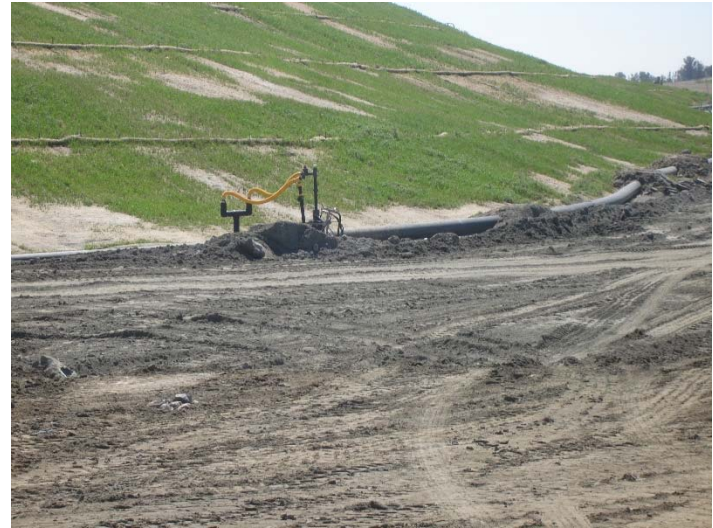
Photo 238: CC3A North Slope Revegetation: March 29, 2018

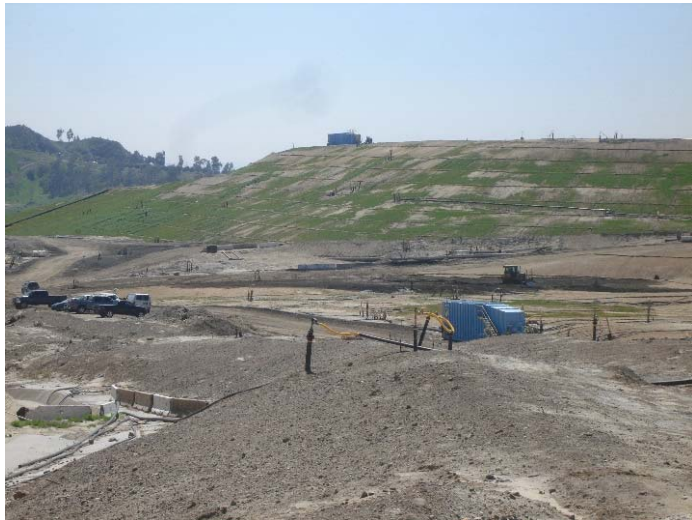
Photo 239: CC3A North Slope Revegetation: March 29, 2018

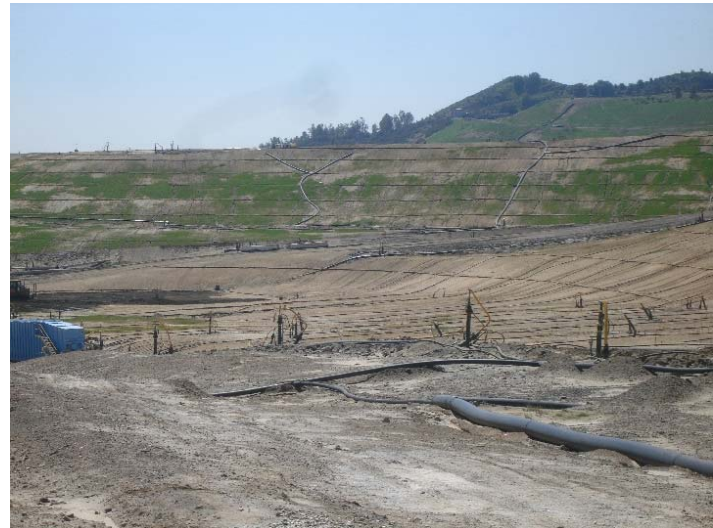
Photo 240: CC3A North Slope Revegetation: March 29, 2018

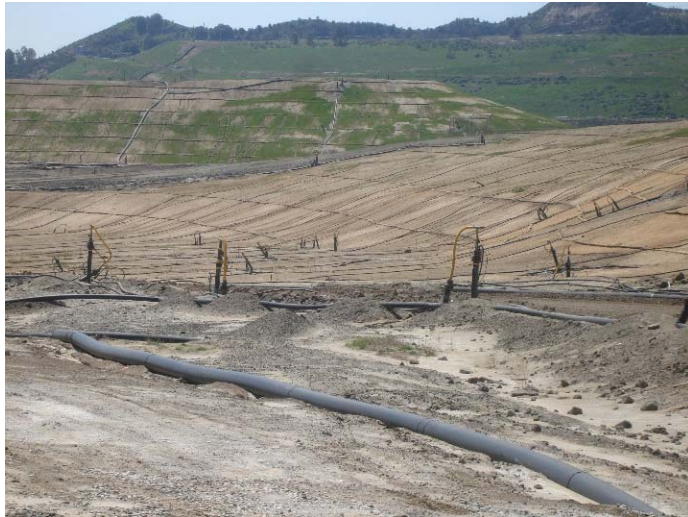
Photo 241: CC3A North Slope Revegetation: March 29, 2018

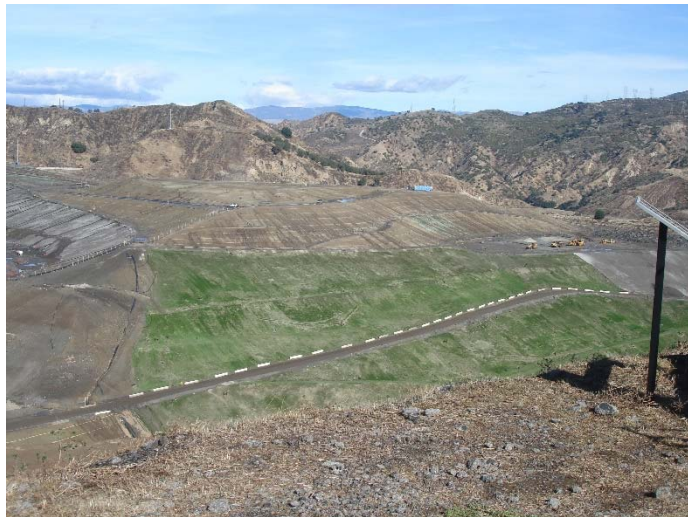
Photo 243: Closure Turf & Posi-Shell: January 10, 2018

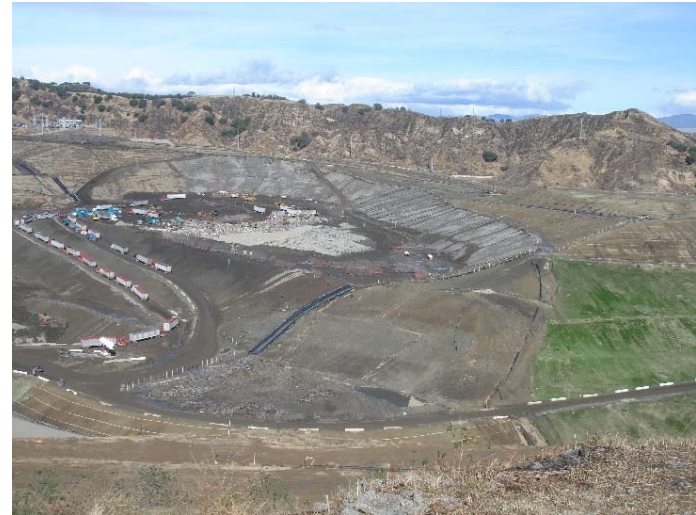
Photo 242: Closure Turf & Posi-Shell: January 10, 2018

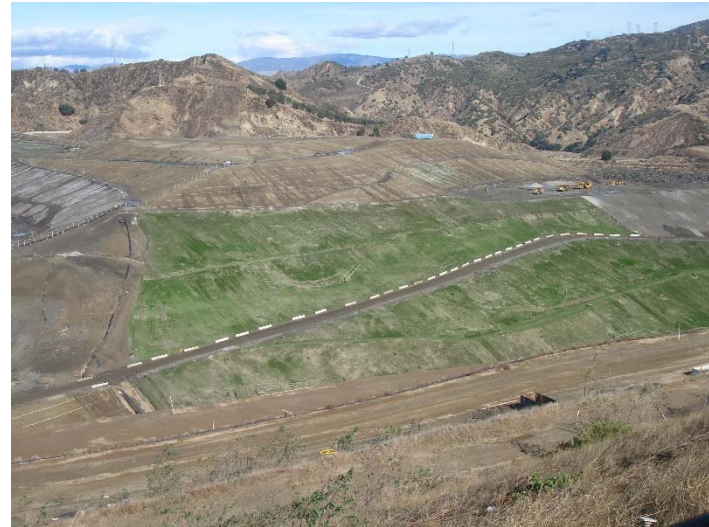
Photo 244: Closure Turf & Posi-Shell: January 10, 2018

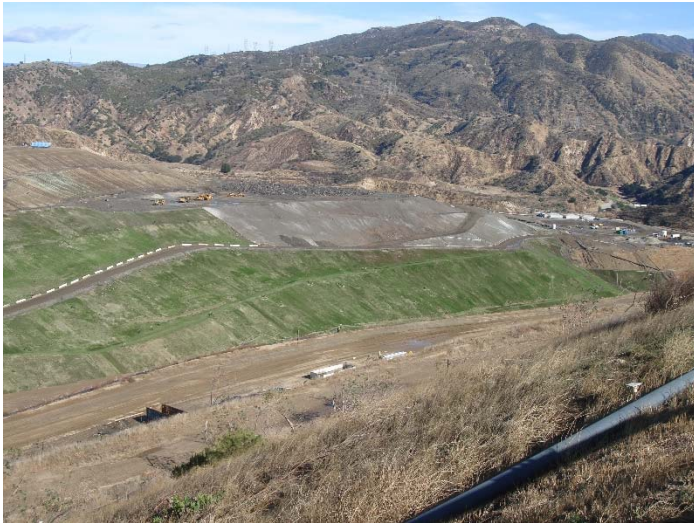
Photo 245: Closure Turf & Posi-Shell: January 10, 2018

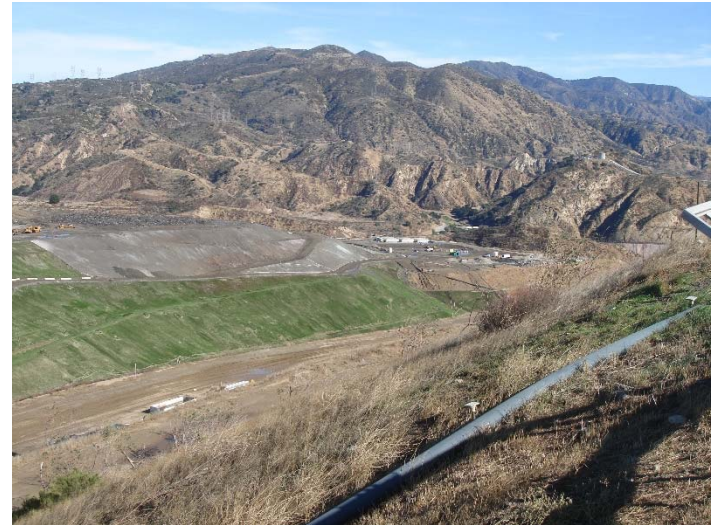
Photo 246: Closure Turf & Posi-Shell: January 10, 2018

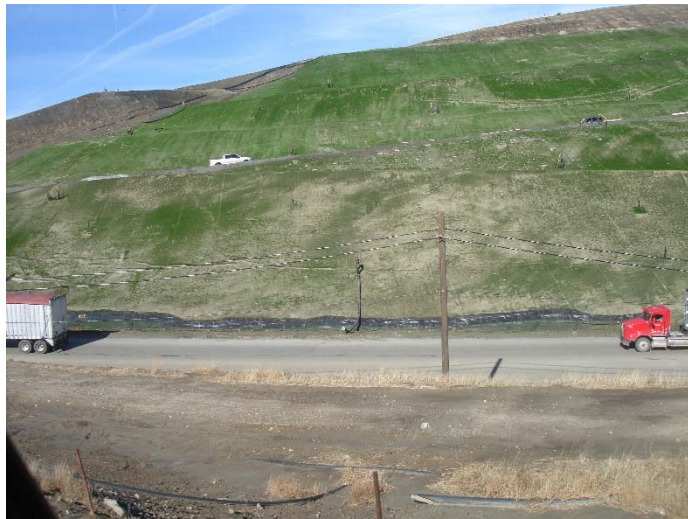
Photo 247: Closure Turf & Posi-Shell: January 10, 2018

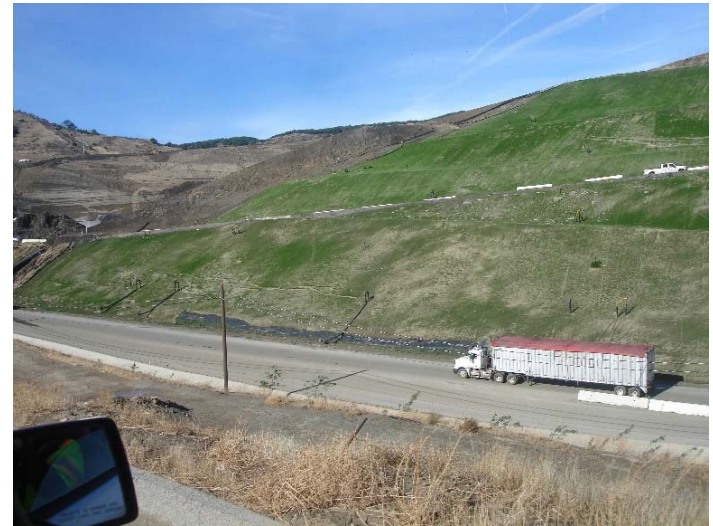
Photo 248: Closure Turf & Posi-Shell: January 10, 2018

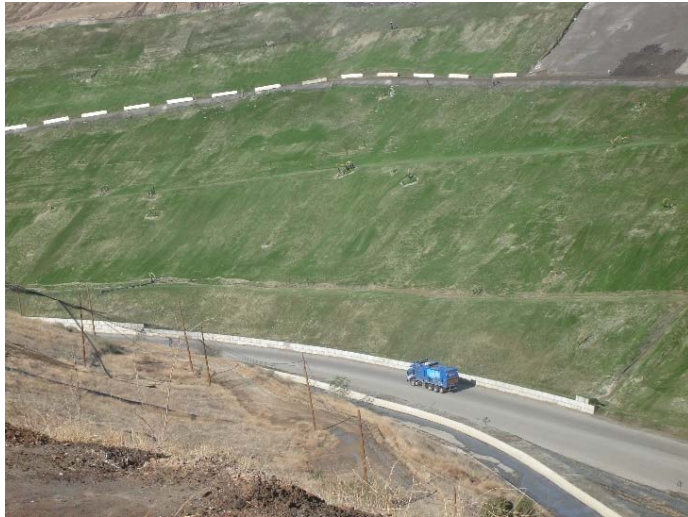
Photo 249: Closure Turf & Posi-Shell: January 10, 2018

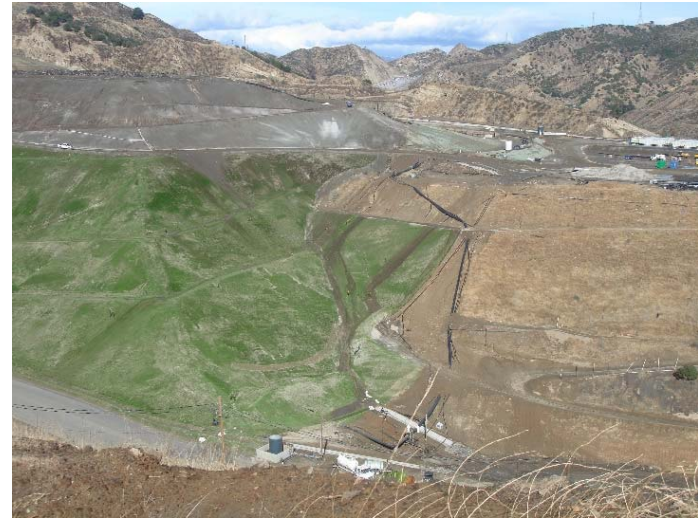
Photo 250: Closure Turf & Posi-Shell: January 10, 2018

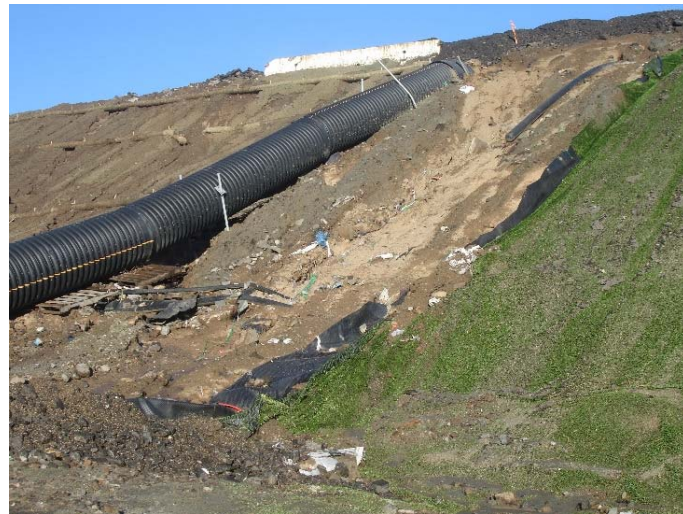
Photo 251: Closure Turf & Posi-Shell: January 10, 2018

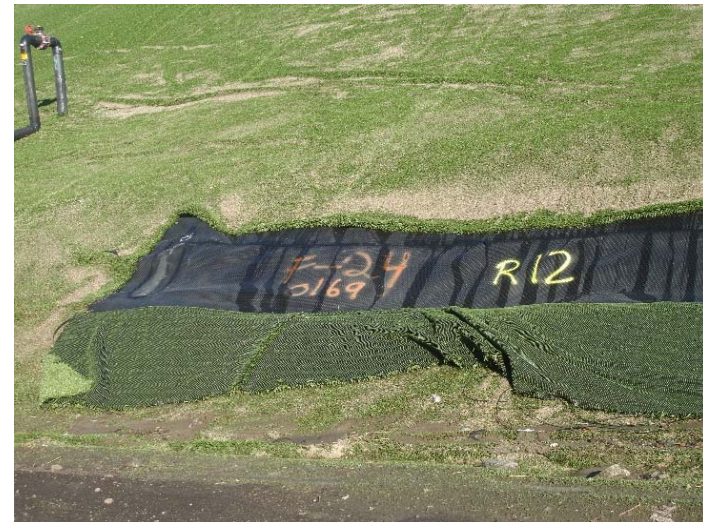
Photo 252: Closure Turf & Posi-Shell: January 10, 2018

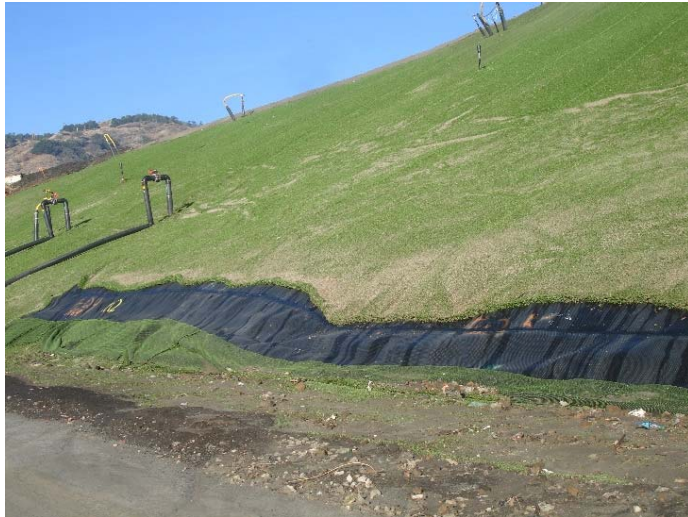
Photo 253: Closure Turf & Posi-Shell: January 10, 2018

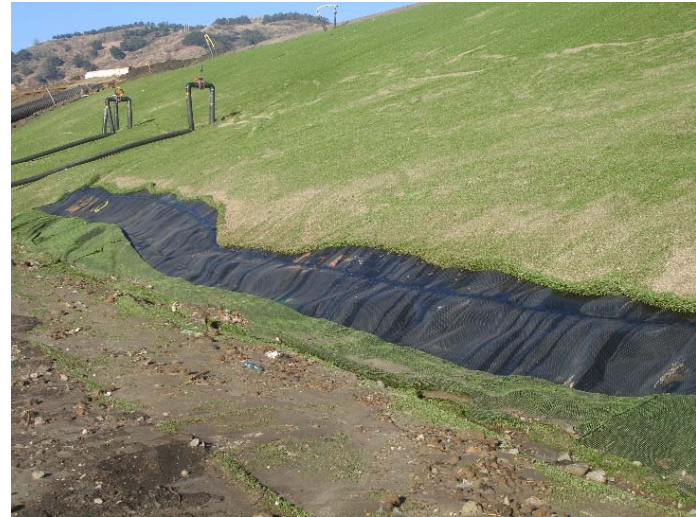
Photo 254: Closure Turf & Posi-Shell: January 10, 2018

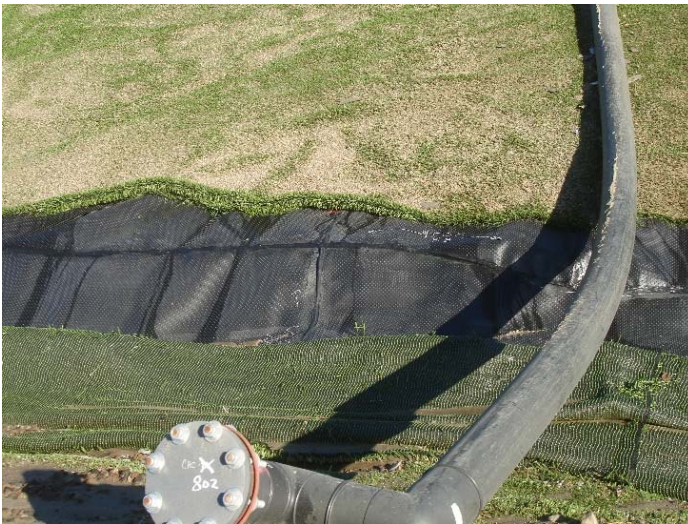
Photo 255: Closure Turf & Posi-Shell: January 10, 2018

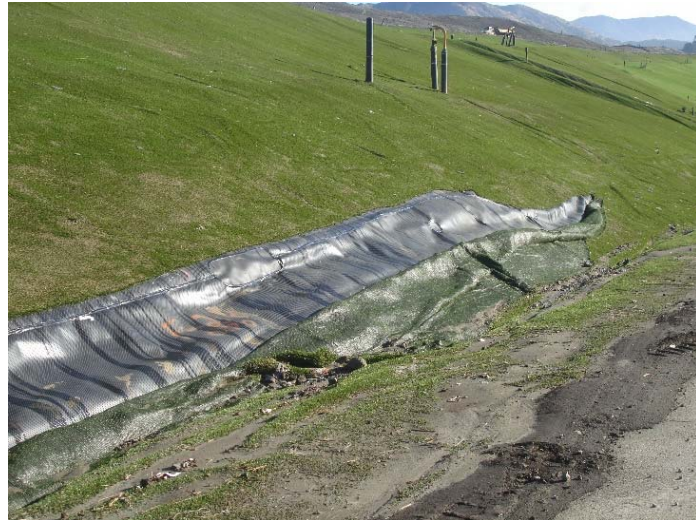
Photo 256: Closure Turf & Posi-Shell: January 10, 2018

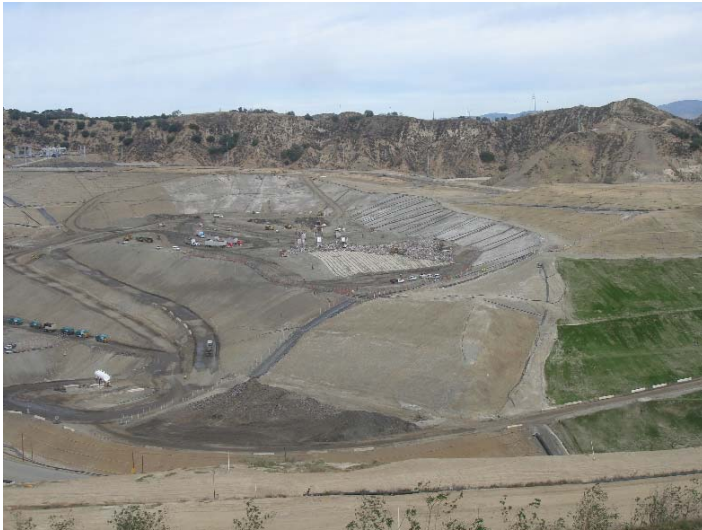
Photo 257: Closure Turf & Posi-Shell: January 30, 2018

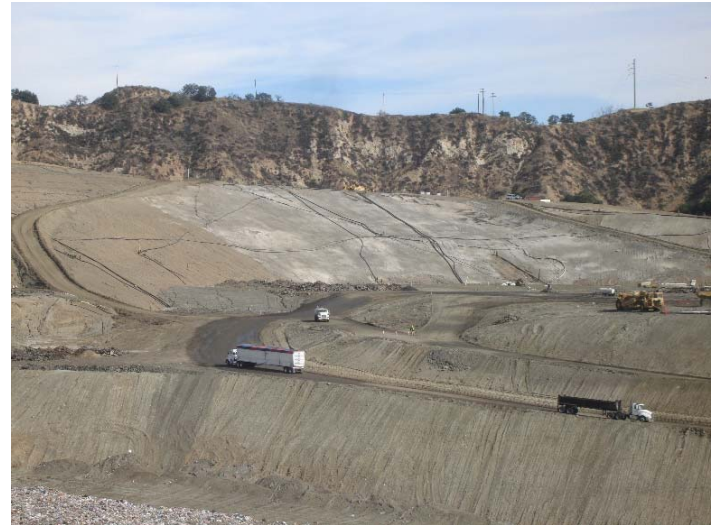
Photo 258: Posi-Shell: January 30, 2018

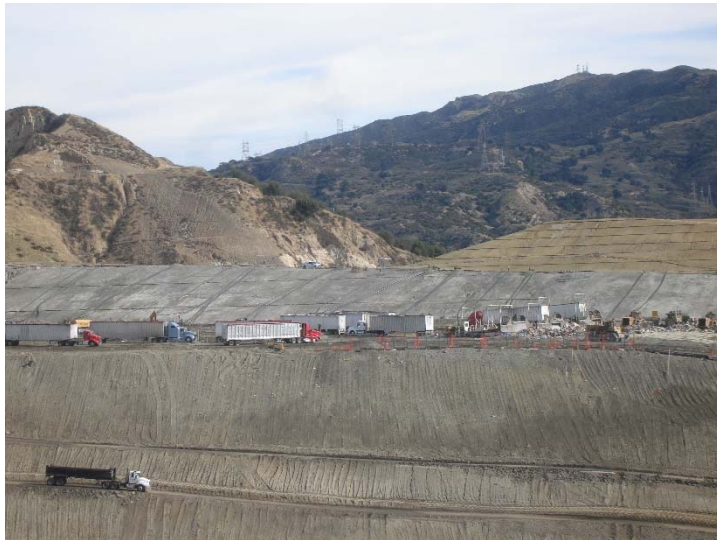
Photo 259: Posi-Shell: January 30, 2018

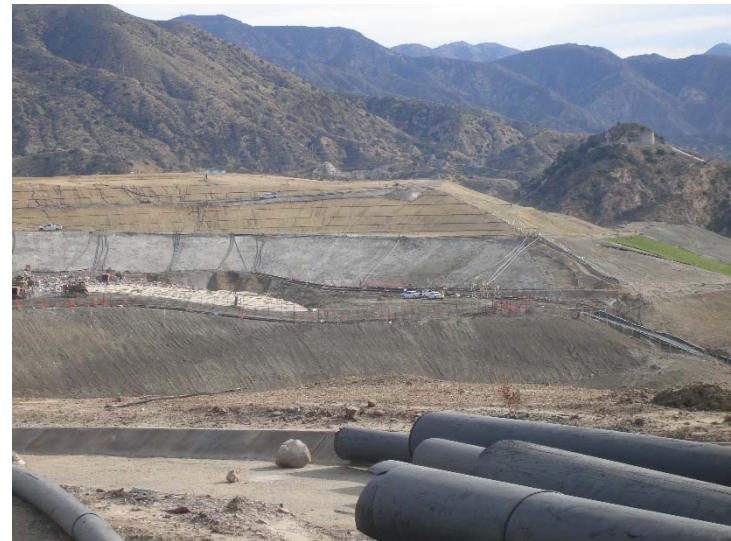
Photo 260: Posi-Shell: January 30, 2018

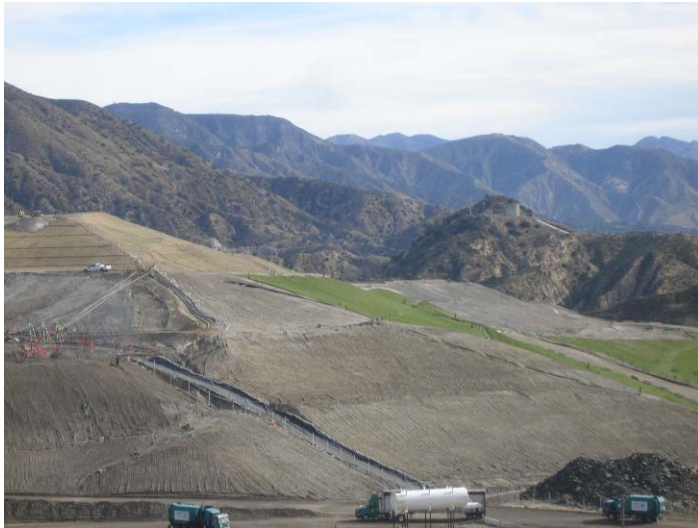
Photo 261: Closure Turf & Posi-Shell: January 30, 2018

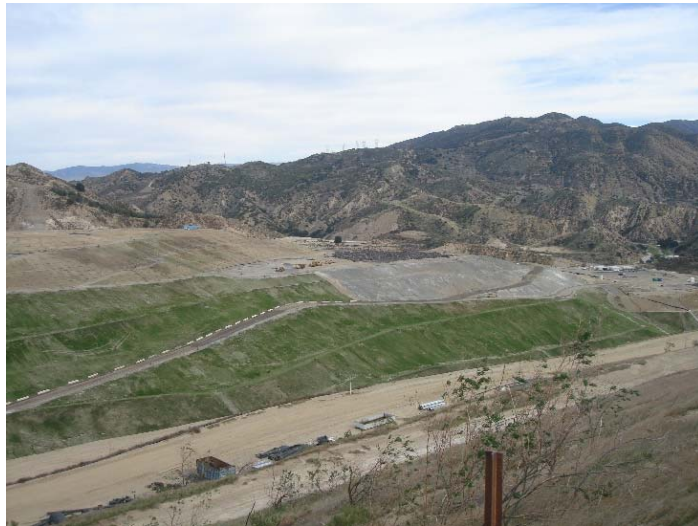
Photo 263: Closure Turf & Posi-Shell: January 30, 2018

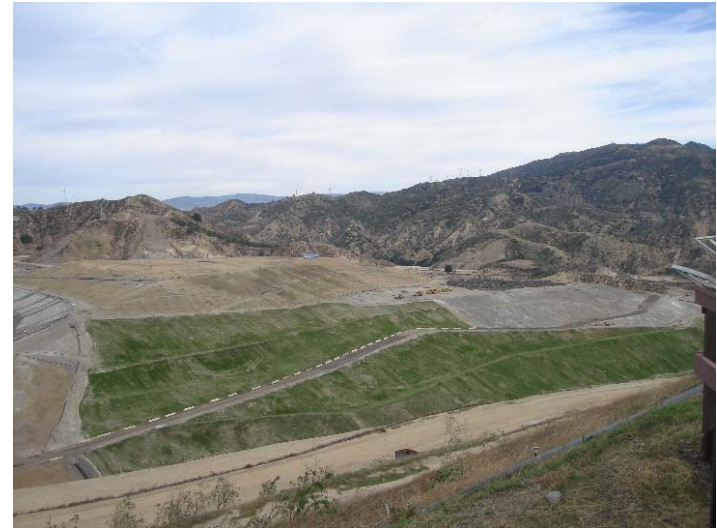
Photo 262: Closure Turf & Posi-Shell: January 30, 2018

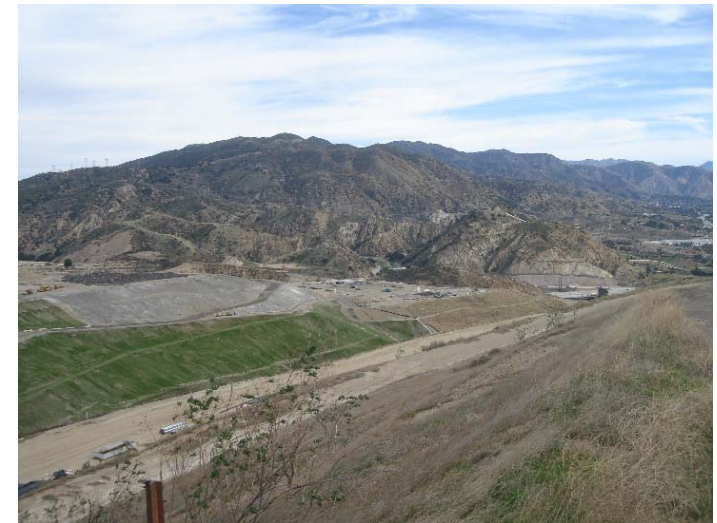
Photo 264: Closure Turf & Posi-Shell: January 30, 2018

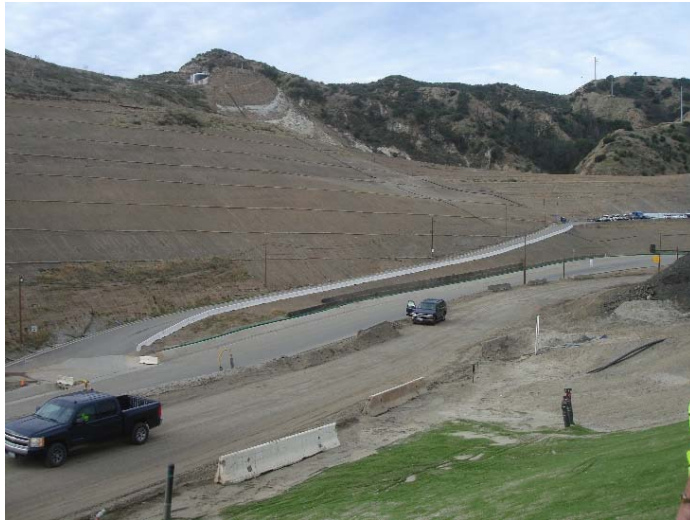
Photo 265: Closure Turf: January 30, 2018

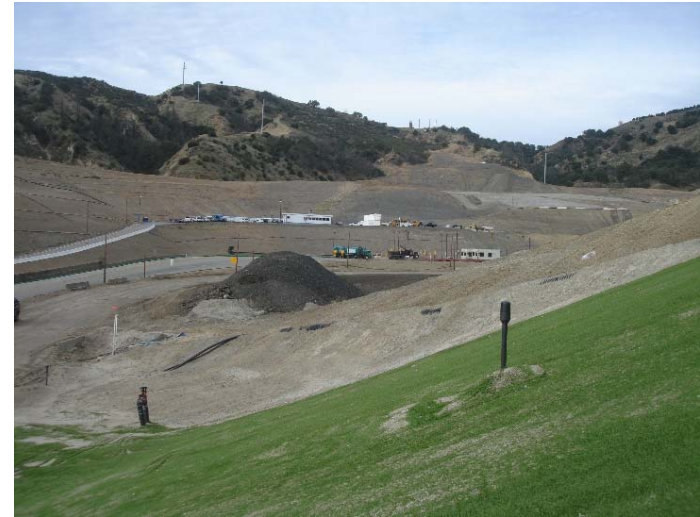
Photo 266: Closure Turf: January 30, 2018

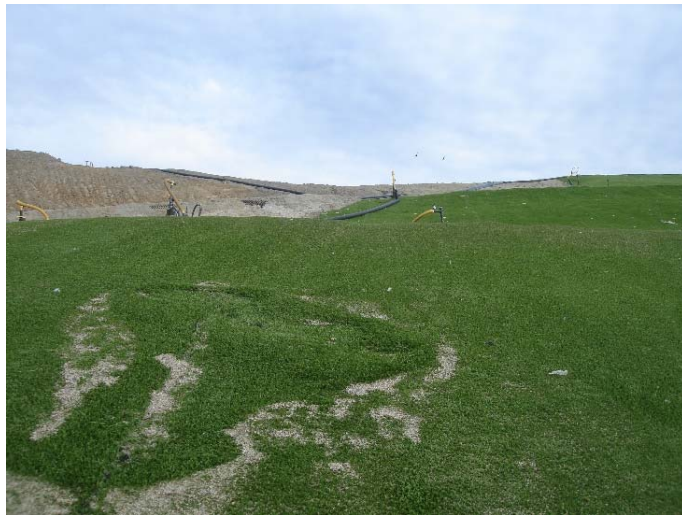
Photo 267: Closure Turf: January 30, 2018

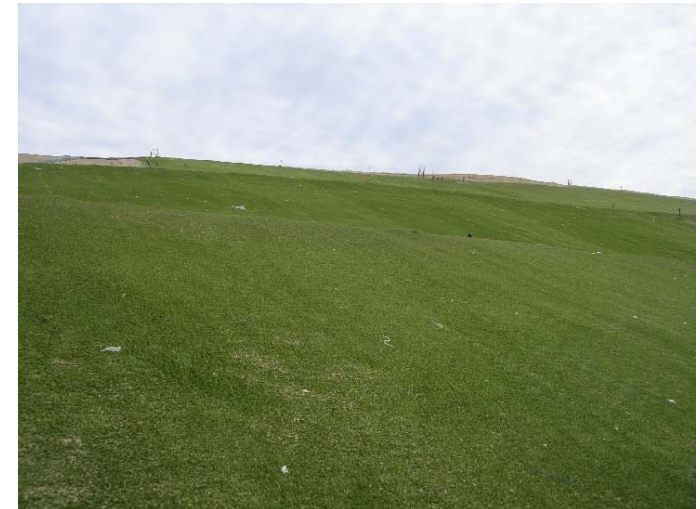
Photo 268: Closure Turf: January 30, 2018

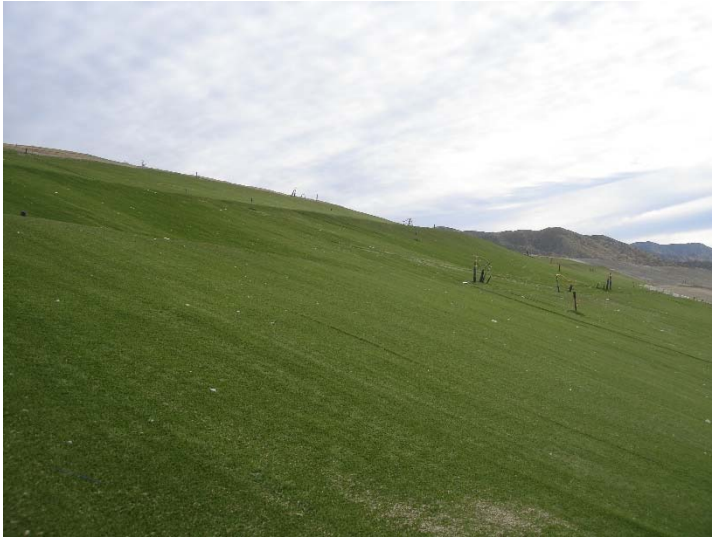
Photo 269: Closure Turf: January 30, 2018

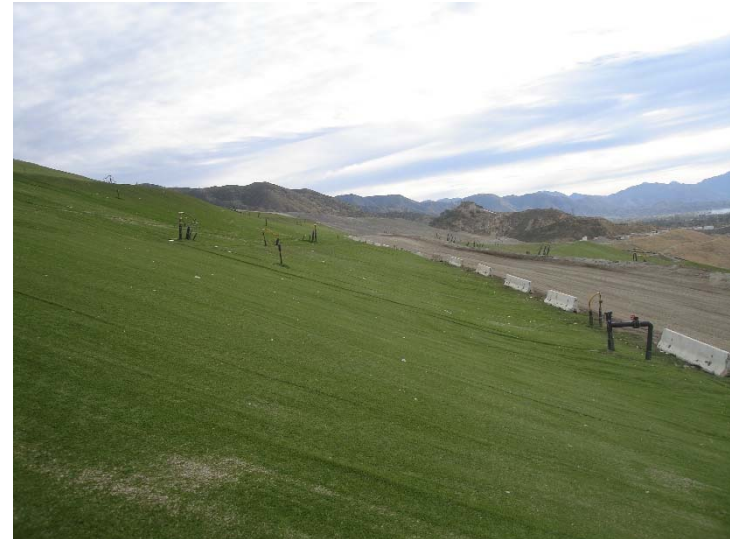
Photo 270: Closure Turf: January 30, 2018

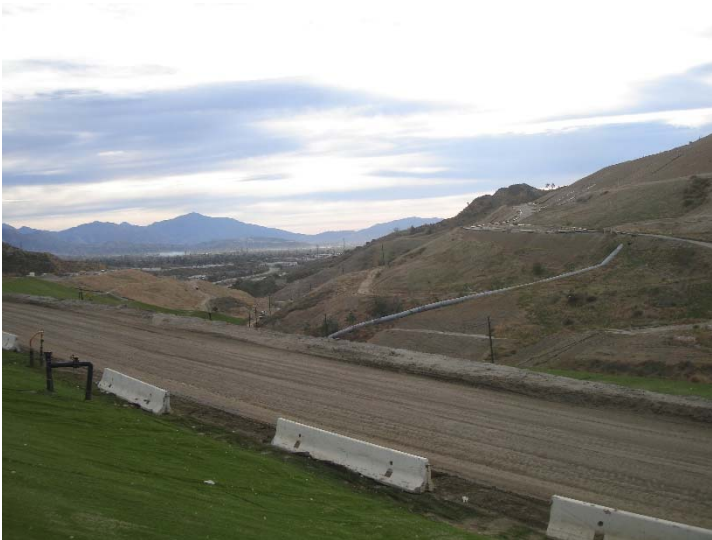
Photo 271: Closure Turf: January 30, 2018

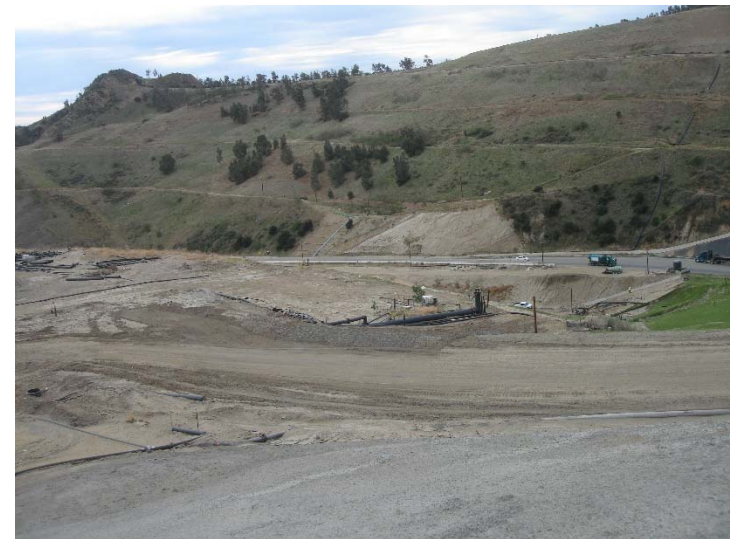
Photo 272: Closure Turf: January 30, 2018

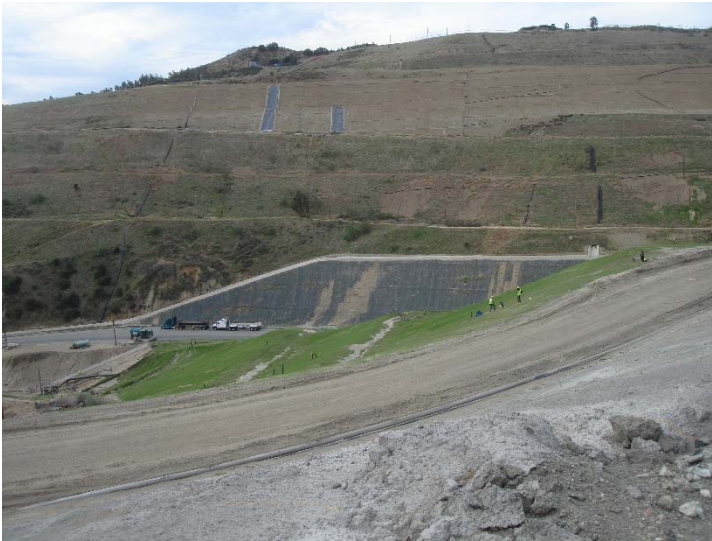
Photo 273: Closure Turf: January 30, 2018

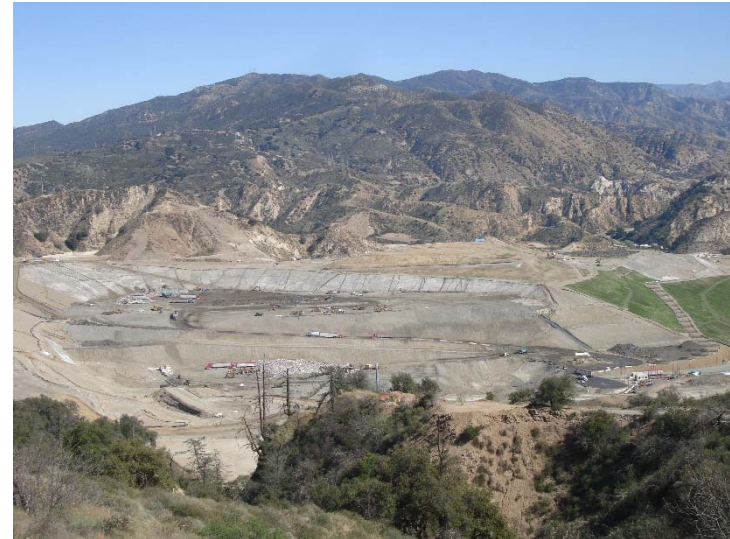
Photo 274: Posi-Shell: February 20, 2018

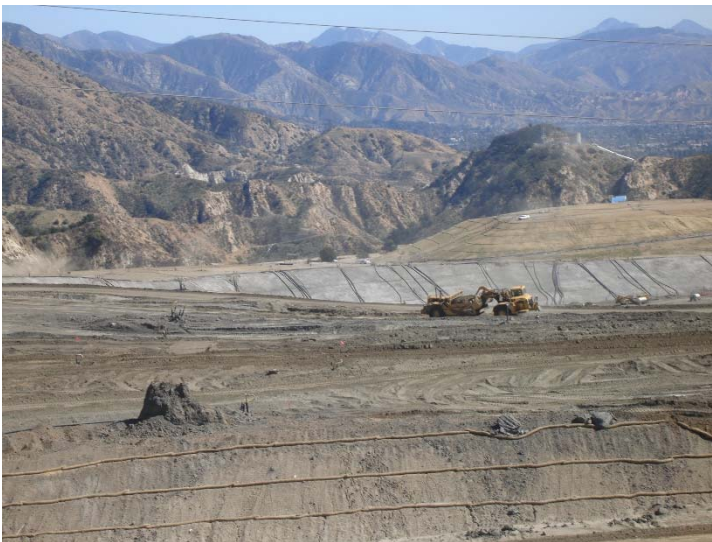
Photo 275: Posi-Shell: February 20, 2018

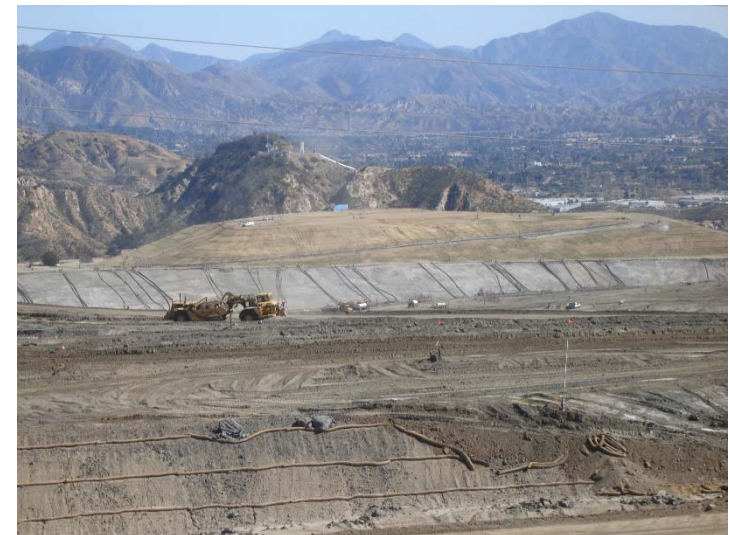
Photo 276: Posi-Shell: February 20, 2018
