**Sunshine Canyon Landfill
Independent Monitor
Quarterly Site Monitoring Status Report
January 1, 2018 – March 31, 2018**

City of Los Angeles Department of City Planning

County of Los Angeles Department of Regional Planning

May 25, 2018

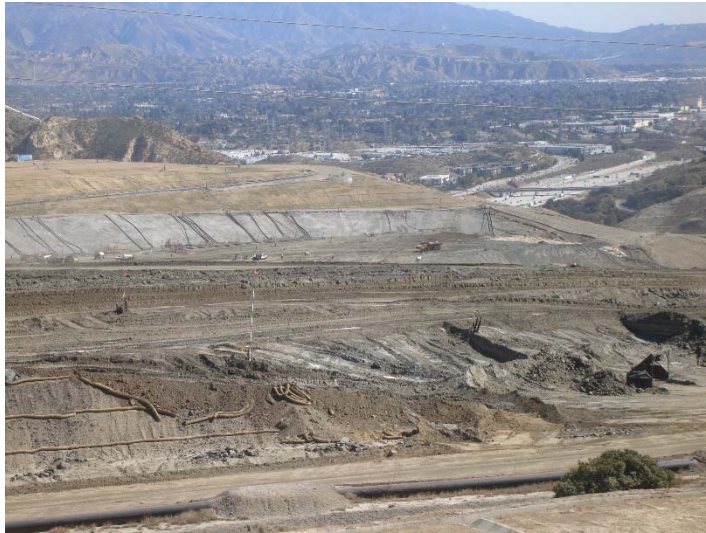
Photo 277: Posi-Shell: February 20, 2018

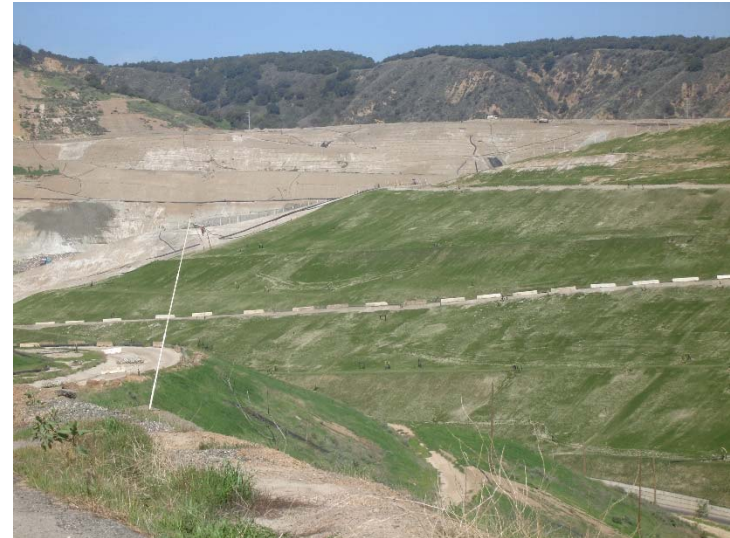
<p>I-d: There was a significant amount of slope erosion at the western and eastern edges of the Closure Turf and soil interface. The Closure Turf had no apparent impact. The sand on the Turf was washed away in some areas and observed in the terminal basin. The hydroseeded slopes above the Closure Turf had significant erosions rills. The Posi-Shell covered areas had erosion rills where uncontrolled slope drainage occurred.</p> <p>I-e: The Closure Turf had no apparent problems from the rain events. Erosion that was observed on the western and eastern edges of soil slopes on the prior monitoring was repaired. The Posi-Shell covered areas that were impacted from erosion during prior rain events were being repaired. There were a minimal amount of areas not repaired.</p>
		Surface Water - 2.03 Surface Water - 2.12	County DPW EPD/ LARWQCB SCL-LEA	I-a through I-e: See M - 4.3.1/ 37, 38 above.
	M - 4.3.1 / 39		City Planning/LARWQCB Cal Recycle	I-a through I-e: See M - 4.3.1/ 37, 38 above.

Photo 318: Closure Turf: March 29, 2018

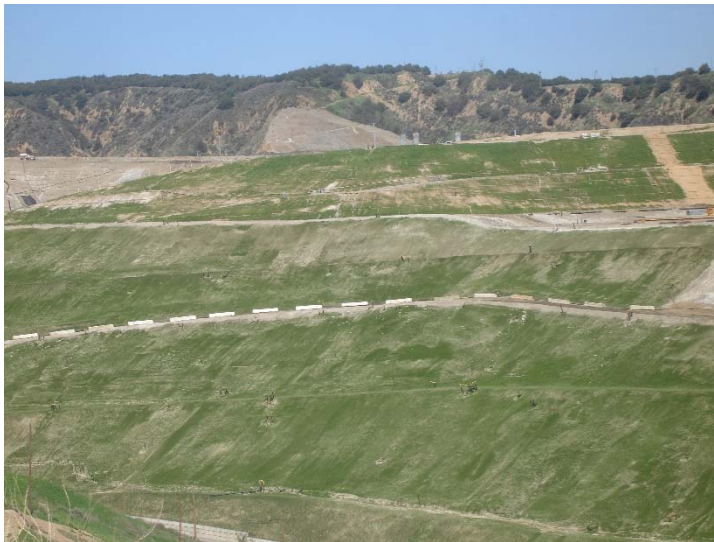
Photo 319: Closure Turf: March 29, 2018

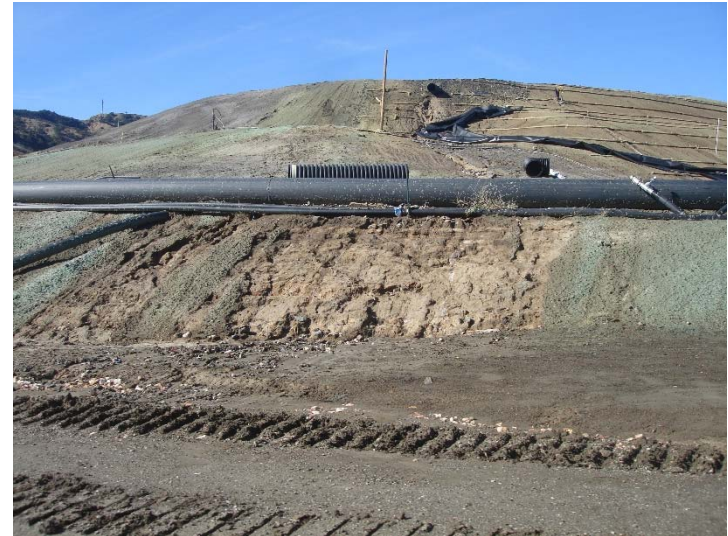
Photo 342: CC3B Slope Drainage Erosion: January 10, 2018

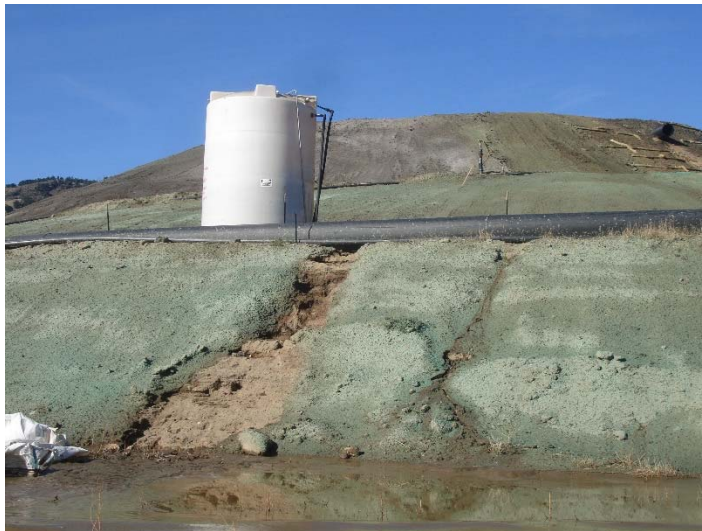
Photo 343: CC3B Slope Drainage Erosion: January 10, 2018

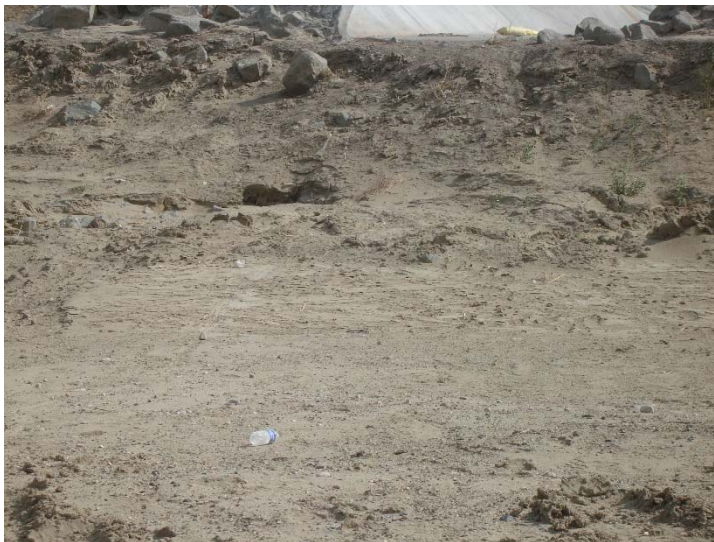
Discipline	City Condition Reference # / Mitigation #	County Condition Reference # / Mitigation #	Responsible Agency	Further Review Needed – Comments
Project Manager		Surface Water - 2.15	County DPW EPD/ LARWQCB, SCL- LEA	<p>I-a through I-e: A preventative maintenance program with inspection of facility equipment, systems, and storm water management devices to detect conditions that may cause breakdowns or failures resulting in discharge of materials into stormwater should be performed on a monthly basis, with a summary report issued on a quarterly basis. These reports should be available for agency and monitor review.</p> <p>I-a: The eastside drainage channel had an area north of Basin B where the concrete channel wall was spalling. The channel had a significant amount of sediment behind the gabions. The westside concrete channel across the main access road from the CC-3B basin was spalling and lifting. The wall was also cracking as it goes under the roadway. The CC-3B basin had standing water. The low-flow drain was plugged. The terminal basin had one skimmer riser support break and cause an uncontrolled release of sediment during the previous day's rain event. The risers were being repaired and reinforced. The San Fernando Road retaining wall top drainage channel had standing water and significant soil slough down from the hillside. Maintenance should be scheduled for soil removal and unplugging the wall's channel drains.</p> <p>I-b: The drainage channel along the paved access road to the Flare 9, 10, and 11 site had the outlet plugged. Basin D outlet channel liner leading edge was lifting and had tumbleweed and sediment under the liner. The eastside drainage channel had significant sediment and litter behind channel gabions. CC-3B basin's low flow drain was plugged.</p> <p>I-c: The Basin D outlet concrete channel just out of the basin had approximately six inches thick layer of sediment for approximately 30 feet, with vegetation growing in it. The inlet to the Basin D lined channel had sediment and tumbleweed under the leading edge of the HDPE liner. The Basin D westside outlet high flow concrete spillway and sidewall was cracked and should be epoxy sealed.</p> <p>I-d: The concrete walkway along the terminal basin's south top access had lifted approximately six inches, possibly due to soil expansion, and had pushed the concrete fence foundation out of the ground. The frontage retaining wall along San Fernando Road had some hillside soil sloughing with areas of the wall's top fence with soils and rock piled against it. Soils were also observed accumulating in front of the wall and along the curb. The v-ditch drains were plugged with soil. The main access road had areas of roadway settling and pavement cracking. The v-ditch concrete channel on the slope above the Flare 1 site was plugged with soil and blocked by vegetation. This channel was not functioning. Basin A had sediment and standing water. Minimal draining was occurring due to sediment blockage of the rock around the outlet risers. The outlet channel also had significant blockage of the drainage pipes under the temporary access road.</p> <p>I-e: Basin B had standing water covering approximately 40% of the basin. There was no discharge of water due to sediment plugging the outlet riser. Basin A had a significant amount of sediment and standing water. The outlet risers were plugged with sediment and no water was flowing out.</p>

Photo 359: Basin CC3B Plugged Low Flow-Outlet: January 30, 2018

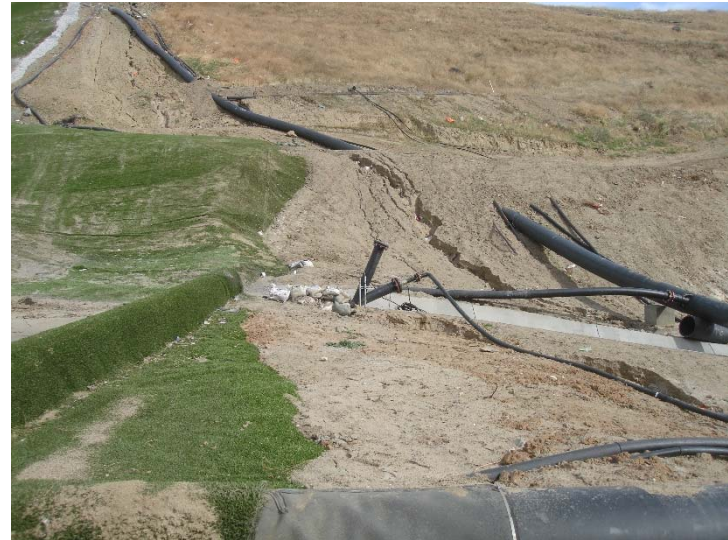
Photo 360: Liquids Handling near CC3B Basin: January 30, 2018

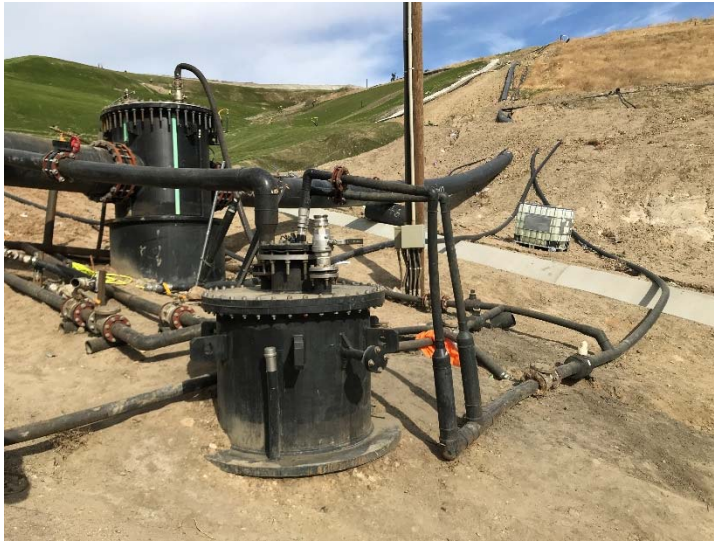
Photo 361: Liquids Handling near CC3B Basin: January 30, 2018

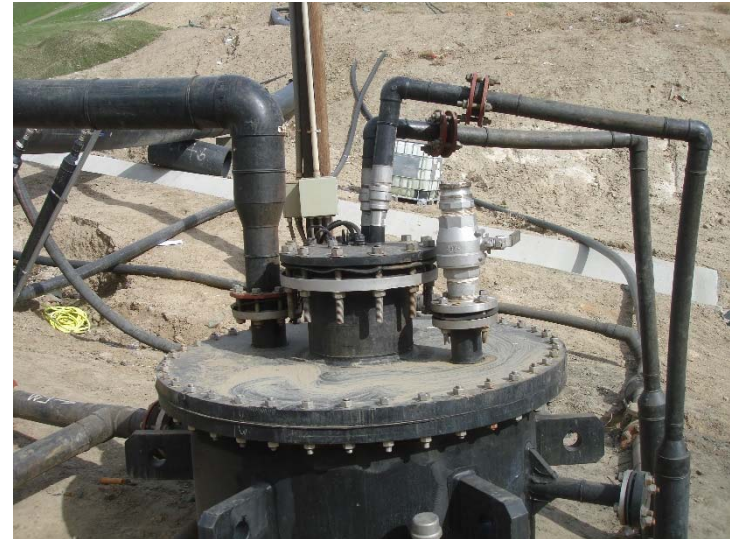
Photo 362: Liquids Handling near CC3B Basin: January 30, 2018

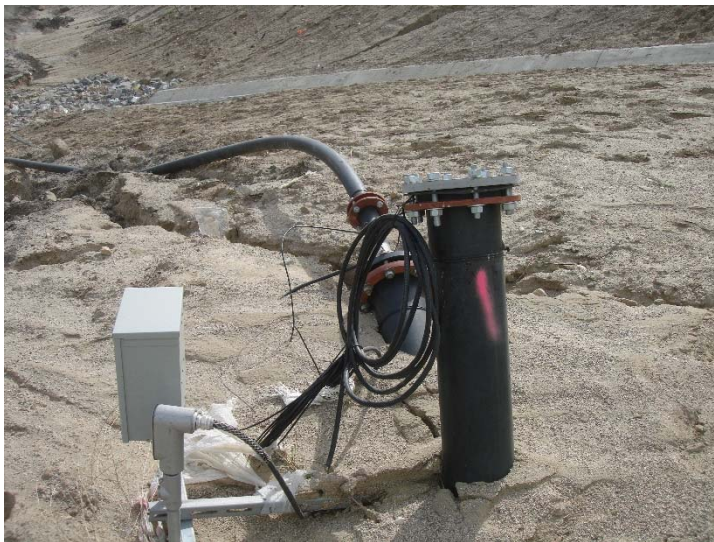
Photo 363: Liquids Handling near CC3B Basin: January 30, 2018

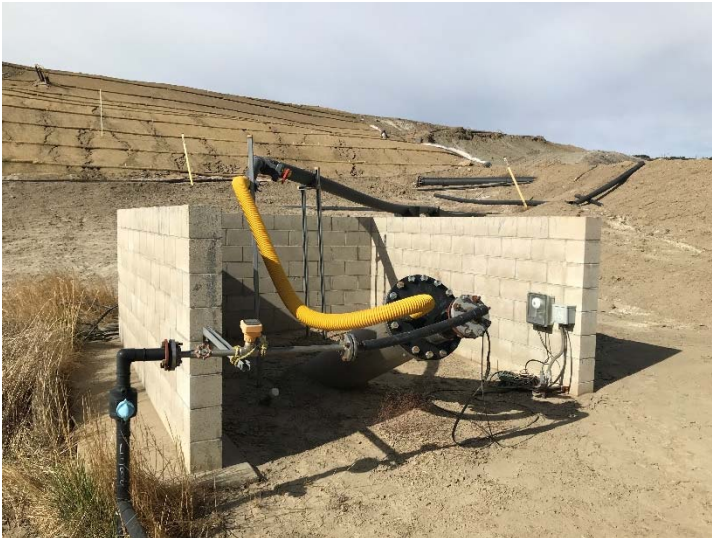
**Photo 406: Idle Liquids Handling at Old City North Top Deck:
January 30, 2018**

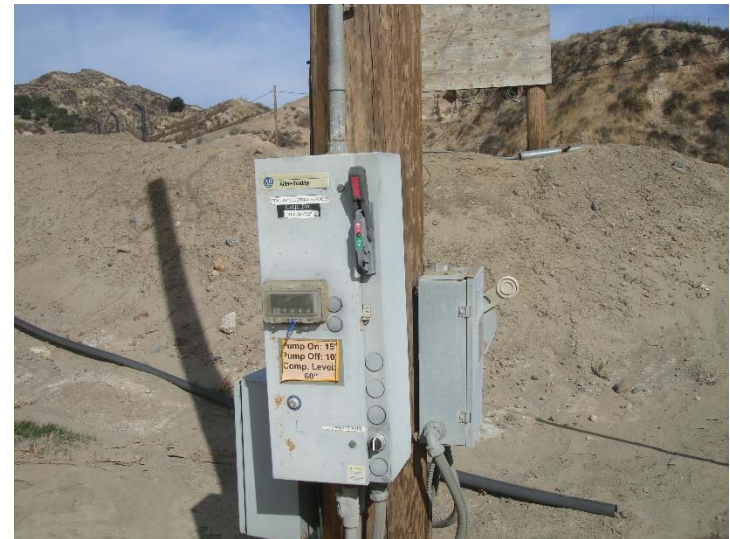
**Photo 407: Idle Liquids Handling at Old City North Top Deck:
January 30, 2018**

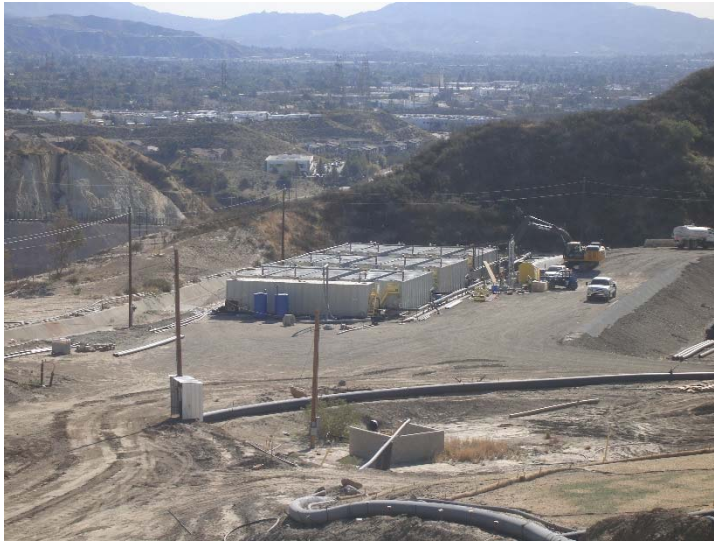
**Photo 408: Idle Liquids Handling at Old City North Top Deck:
January 30, 2018**

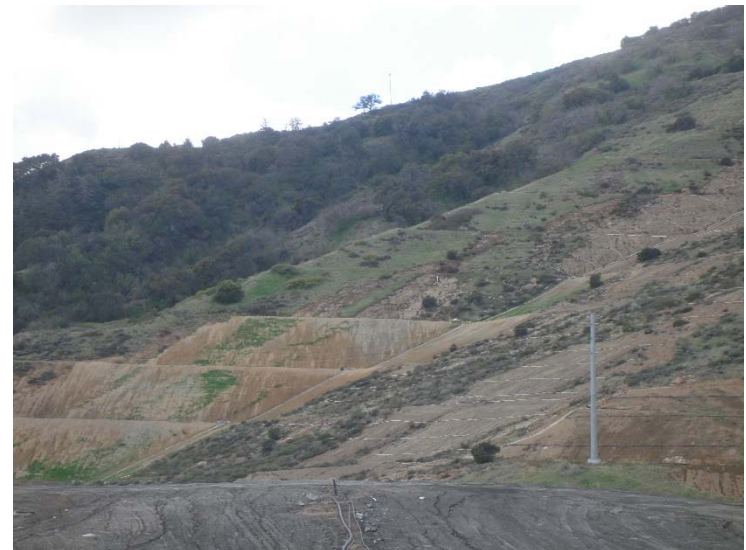
Photo 439: County Sage Mitigation Area Slope: March 14, 2018

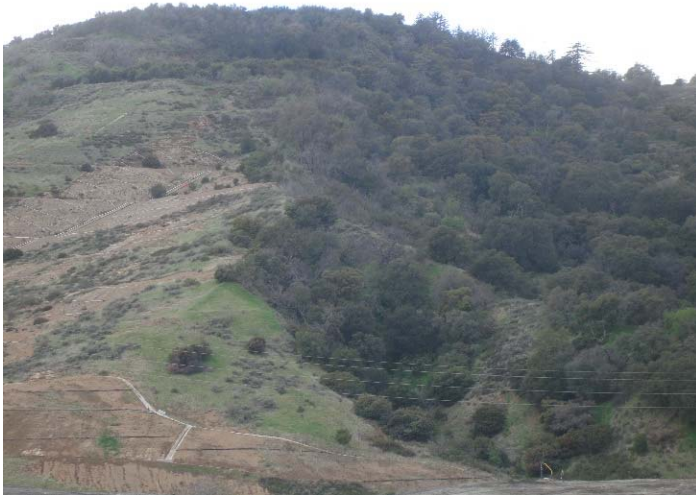
Photo 440: County Sage Mitigation Area Slope: March 14, 2018

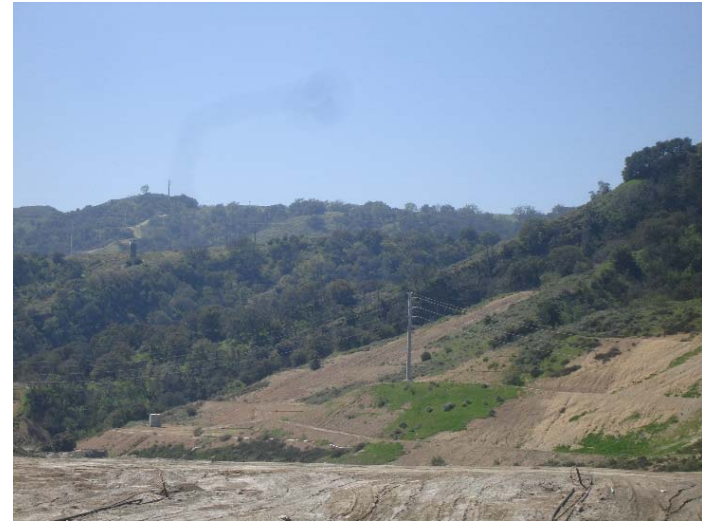
Photo 441: County Sage Mitigation Area Slope: March 14, 2018

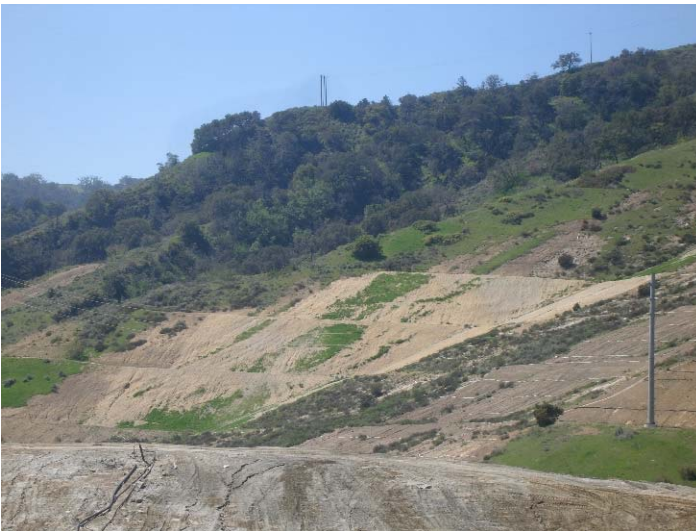
Photo 442: County Sage Mitigation Area Slope: March 29, 2018

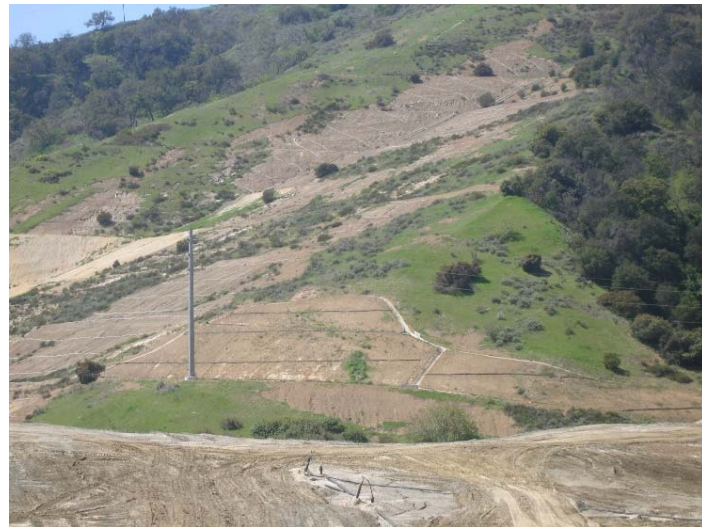
Photo 443: County Sage Mitigation Area Slope: March 29, 2018

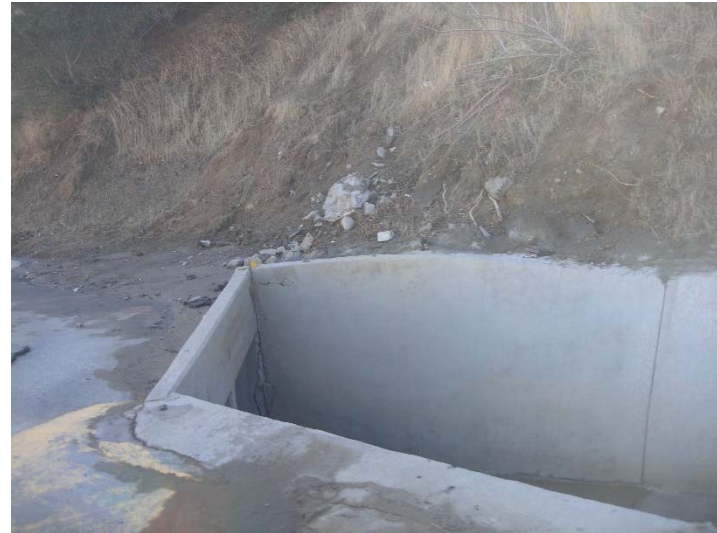
Photo 445: Westside Drainage Channel: January 10, 2018

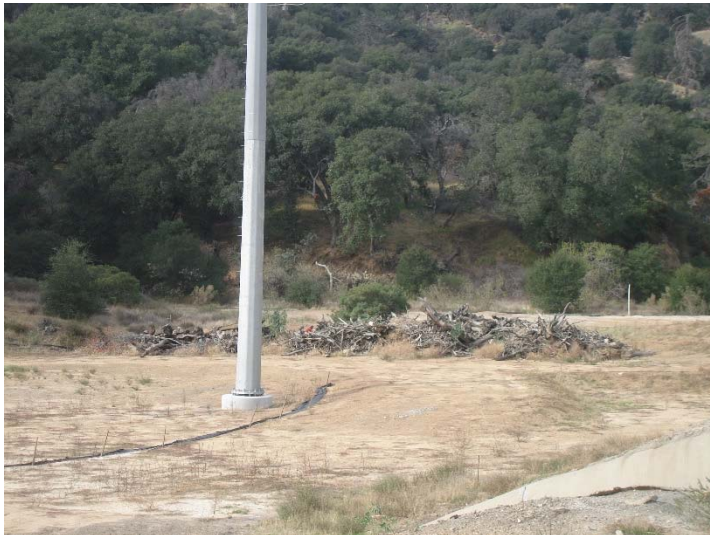
Photo 446: Westside Drainage Channel: January 10, 2018

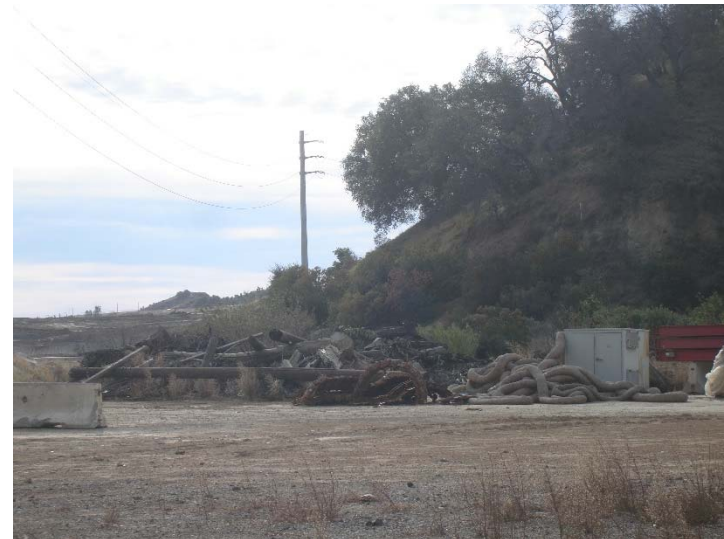
Photo 447: Waste Material near Basin D Storage Area: January 30, 2018

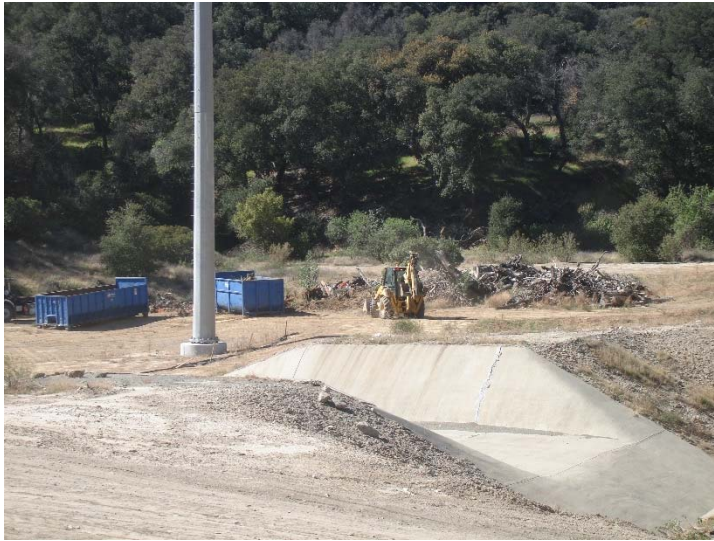
Photo 448: Waste Material in Basin D Storage Area: January 30, 2018

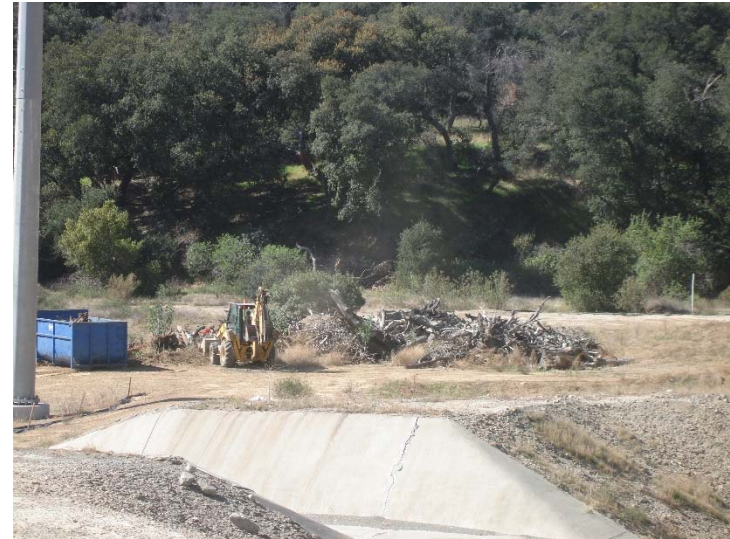
Photo 449: Waste Material in Basin D Storage Area: February 20, 2018

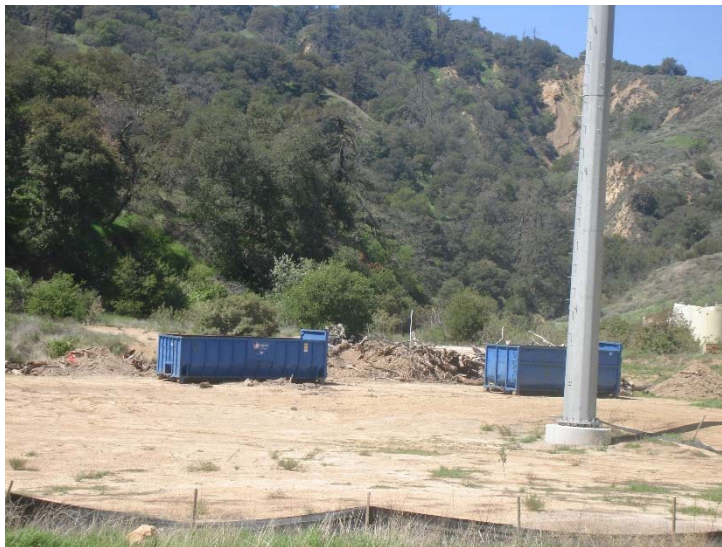
Photo 450: Waste Material in Basin D Storage Area: February 20, 2018

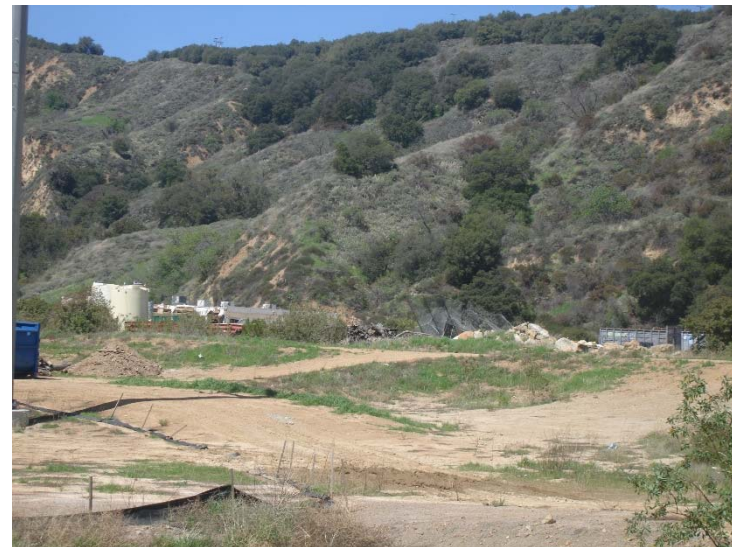
Photo 451: Basin D Deck Wood Waste Stockpile: March 29, 2018

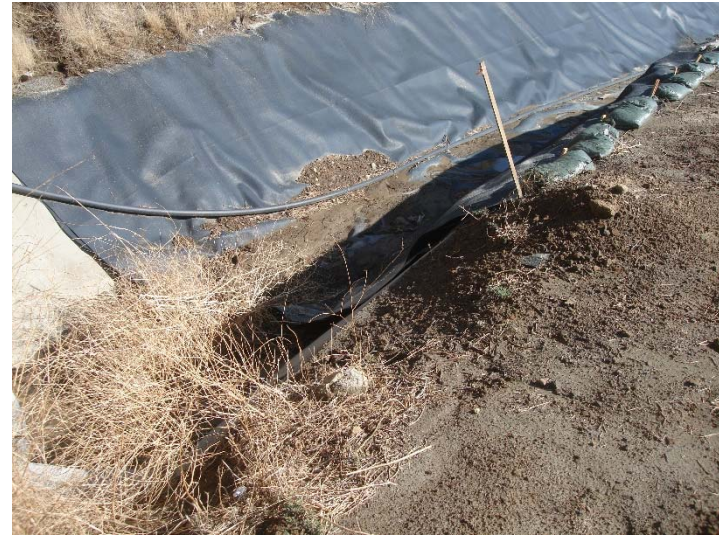
Photo 453: Basin D Outlet Channel: January 10, 2018

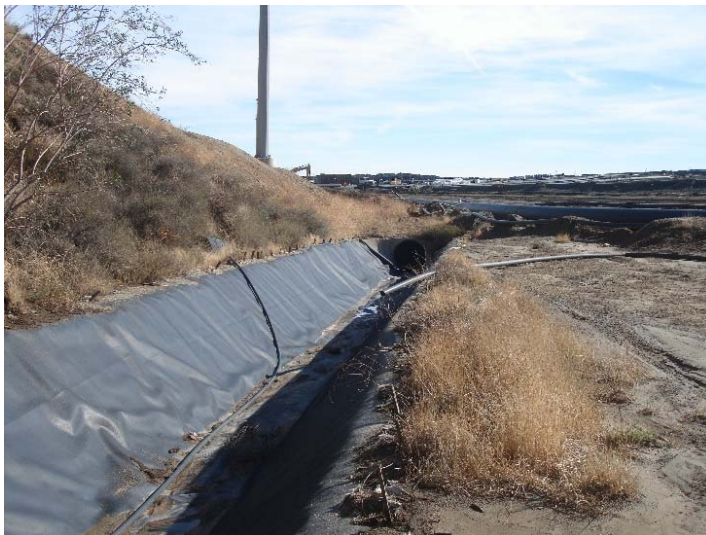
Photo 454: Basin D Outlet Channel: January 10, 2018

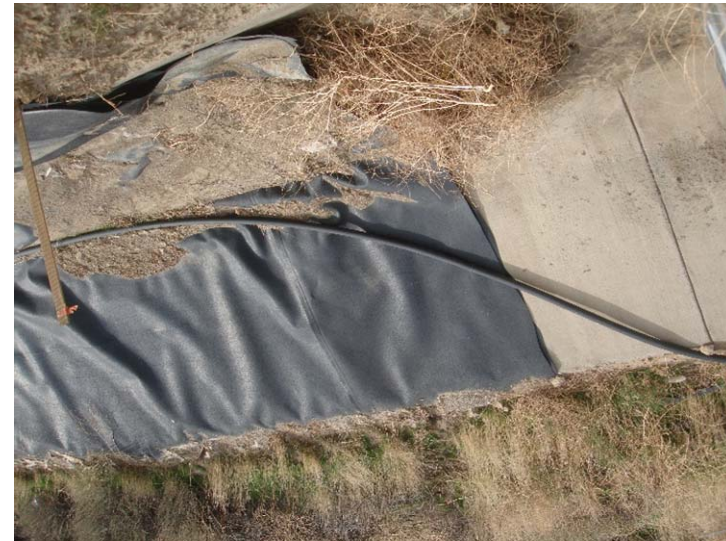
Photo 455: Basin D Outlet Channel: January 10, 2018

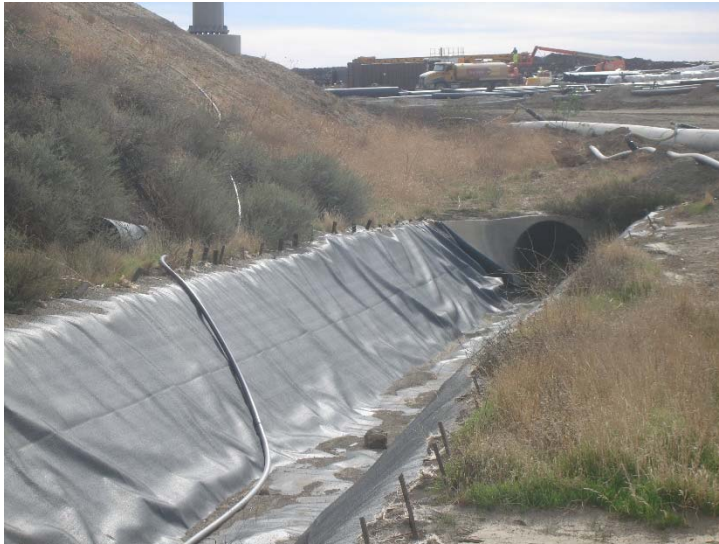
Photo 456: Basin D Outlet Channel: January 30, 2018

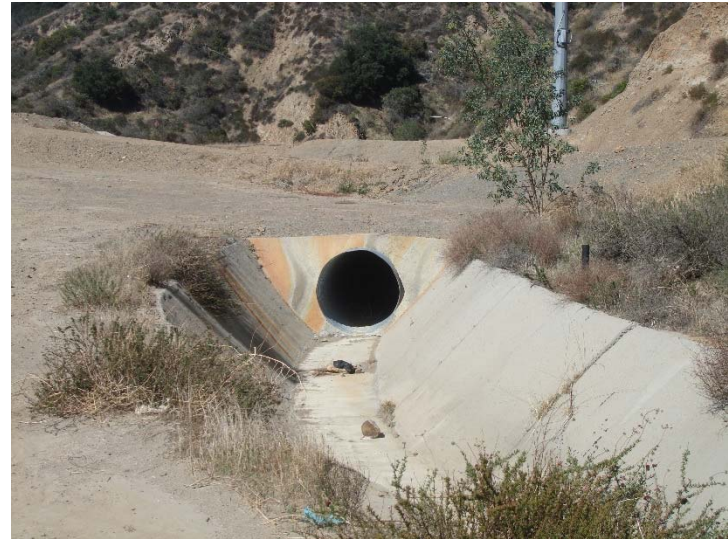
Photo 457: Basin D Outlet Channel: January 30, 2018

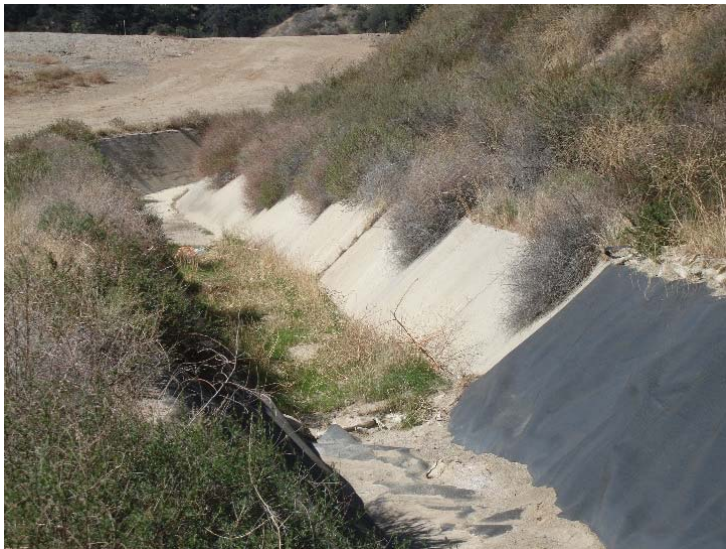
Photo 458: Basin D Outlet Channel: February 20, 2018

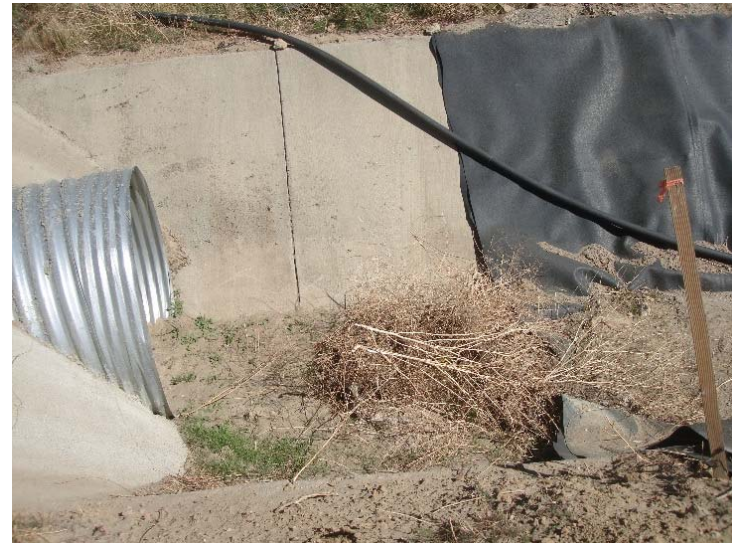
Photo 459: Basin D Outlet Channel: February 20, 2018

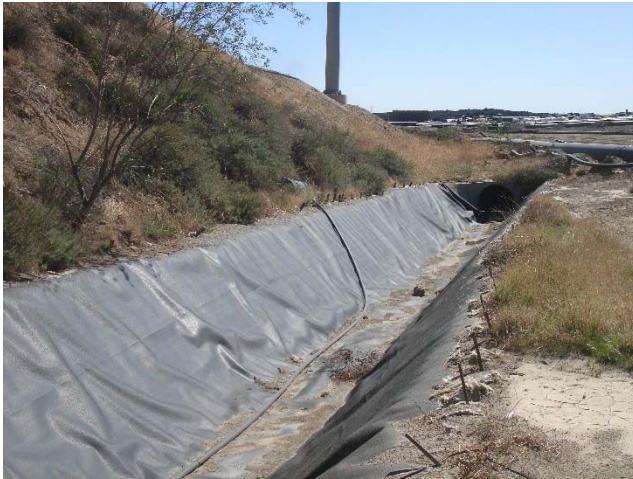
Photo 460: Basin D Outlet Channel: February 20, 2018

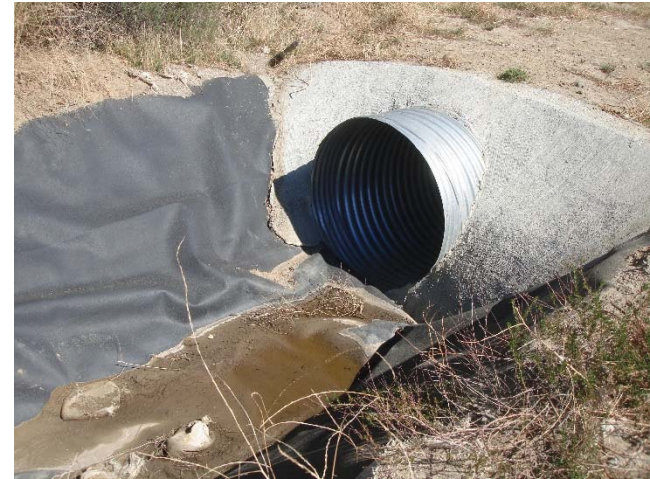
Photo 461: Basin D Outlet Channel: February 20, 2018

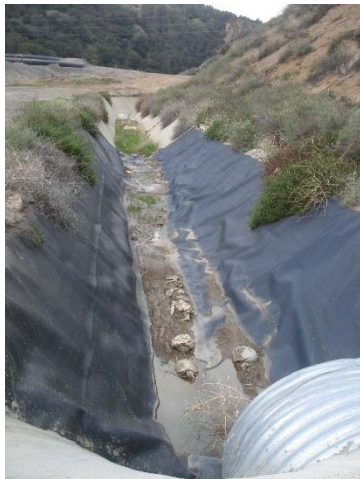
Photo 462: Basin D Outlet Channel: February 20, 2018

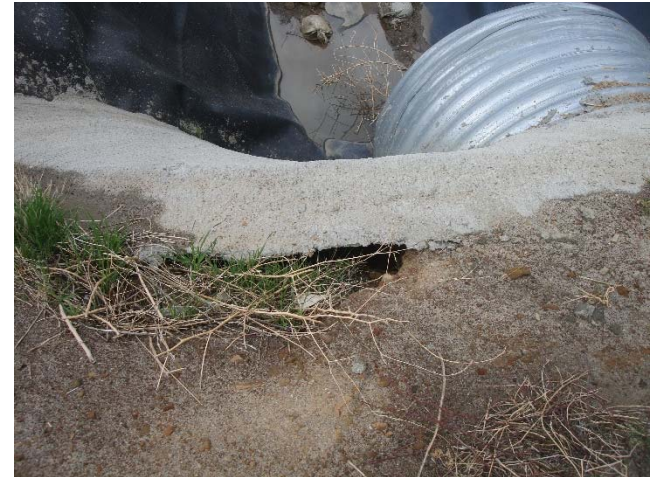
Photo 463: Basin D Outlet Channel: March 14, 2018

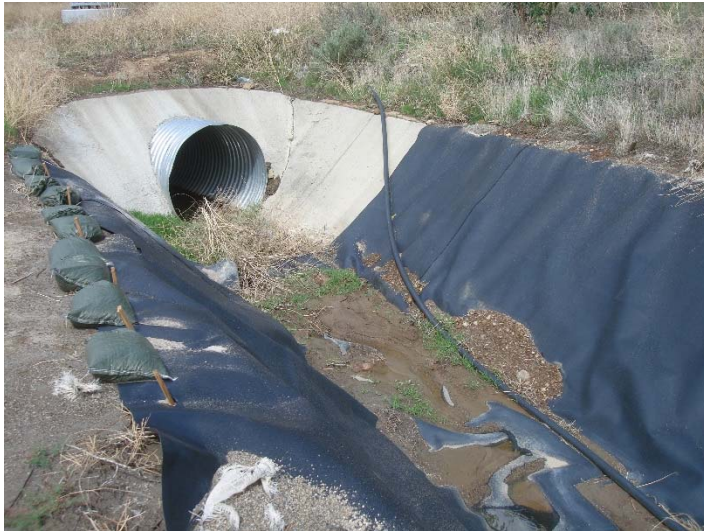
Photo 464: Basin D Outlet Channel: March 14, 2018

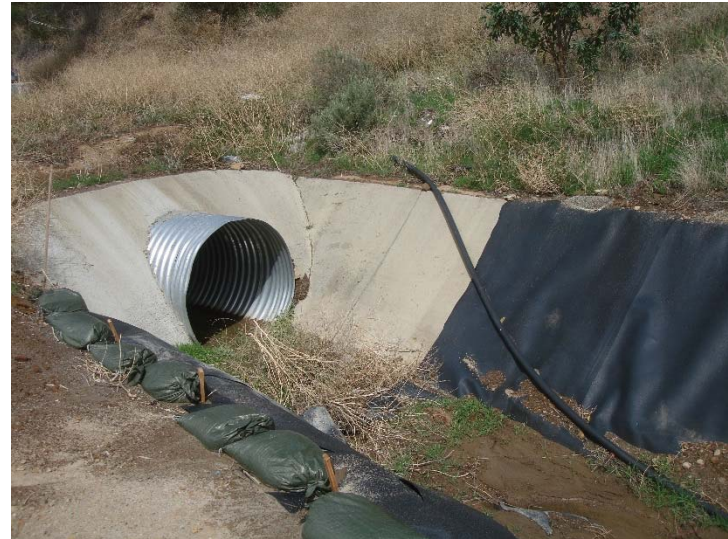
Photo 465: Basin D Outlet Channel: March 14, 2018

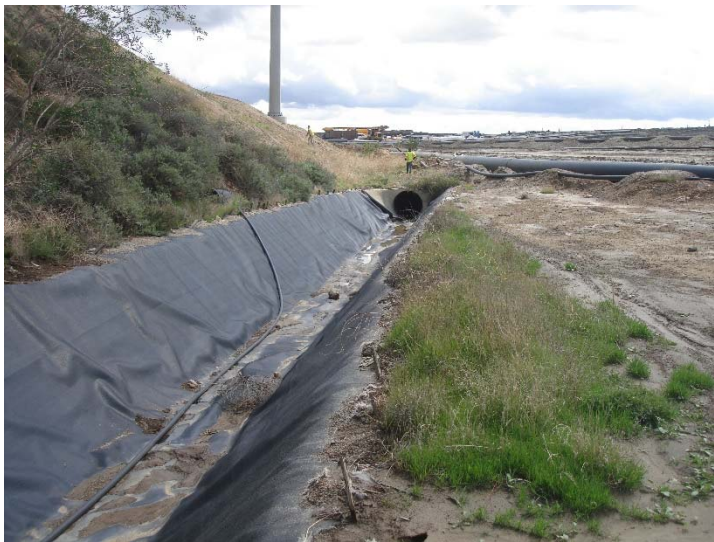
Photo 466: Basin D Outlet Channel: March 14, 2018

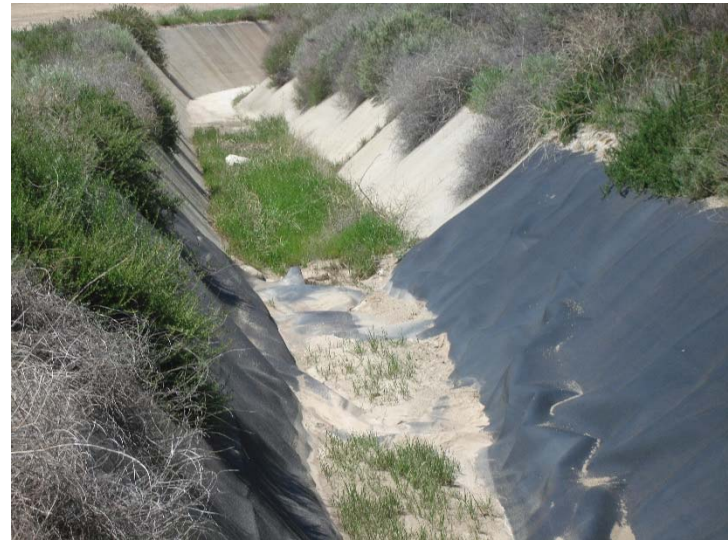
Photo 467: Basin D Outlet Channel: March 14, 2018

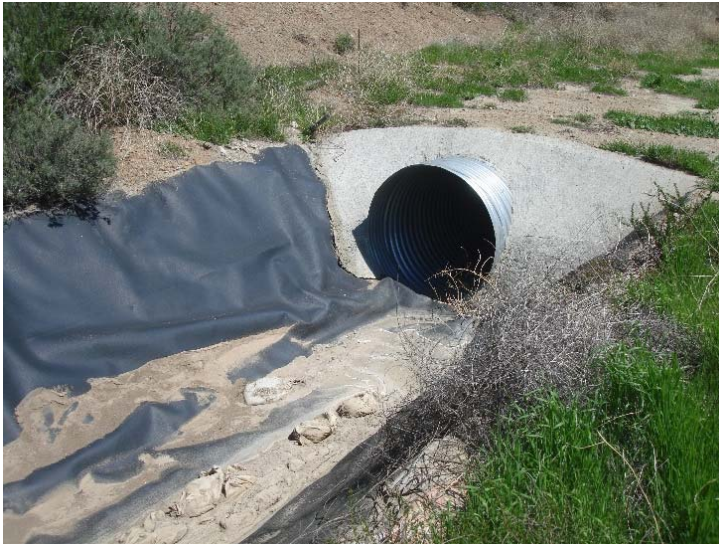
Photo 468: Basin D Outlet Channel: March 29, 2018

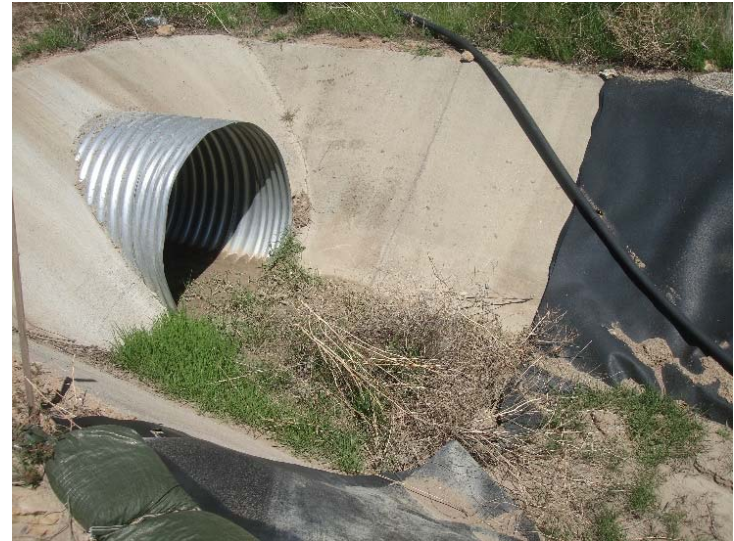
Photo 469: Basin D Outlet Channel: March 29, 2018

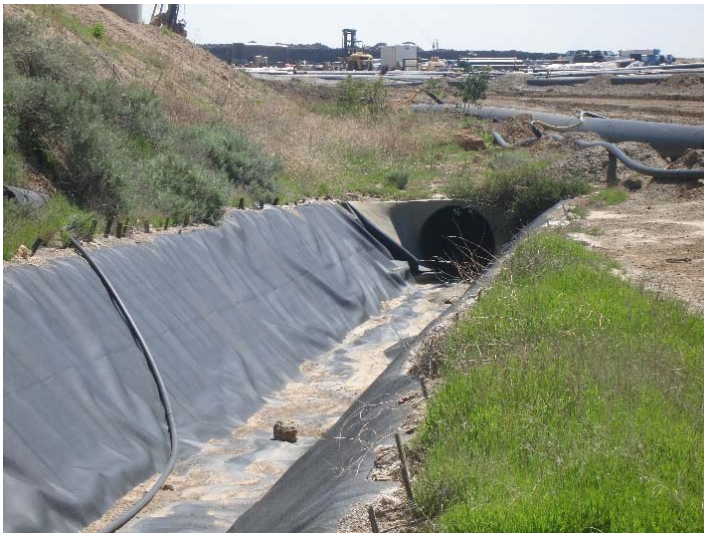
Photo 470: Basin D Outlet Channel: March 29, 2018

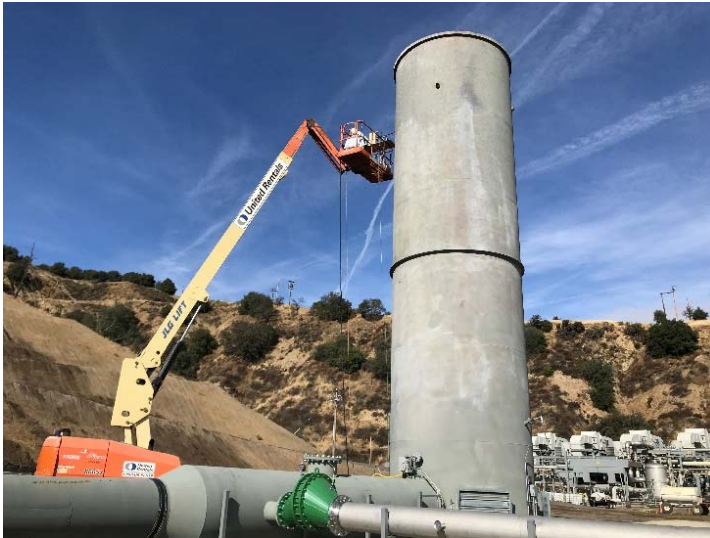
Photo 472: Flare 11 Emissions Test: January 10, 2018

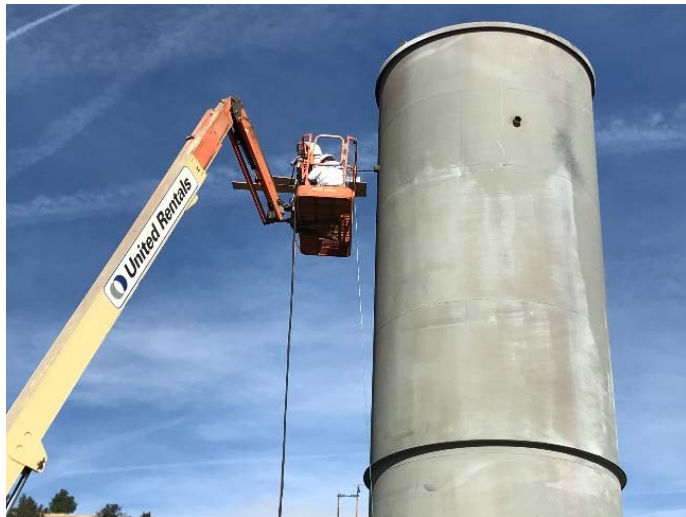
Photo 473: Flare 11 Emissions Test: January 10, 2018

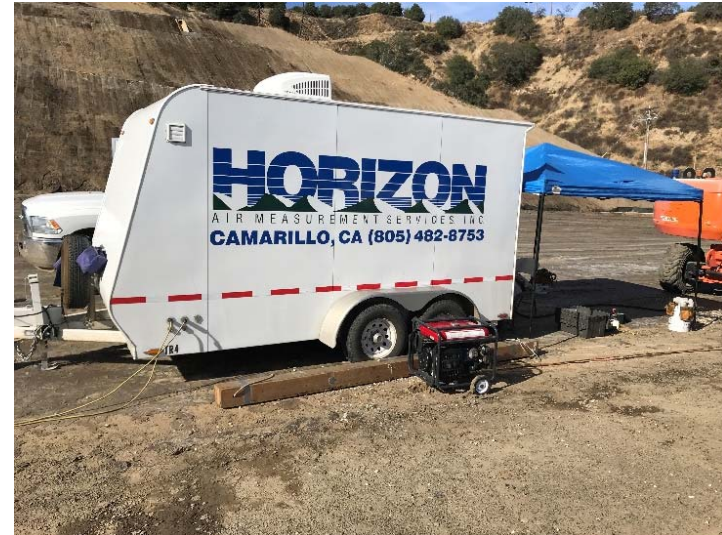
Photo 475: Flare 11 Emissions Test: January 10, 2018

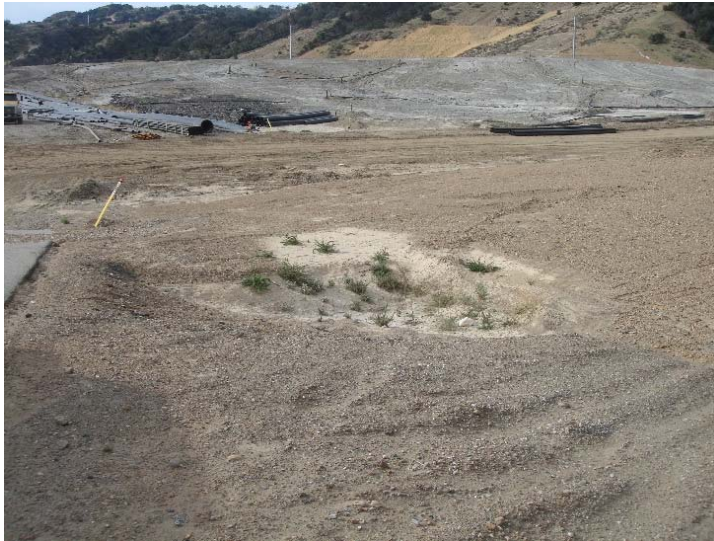
Photo 476: Plugged Drain at Flare 9-11 Access Road: January 30, 2018

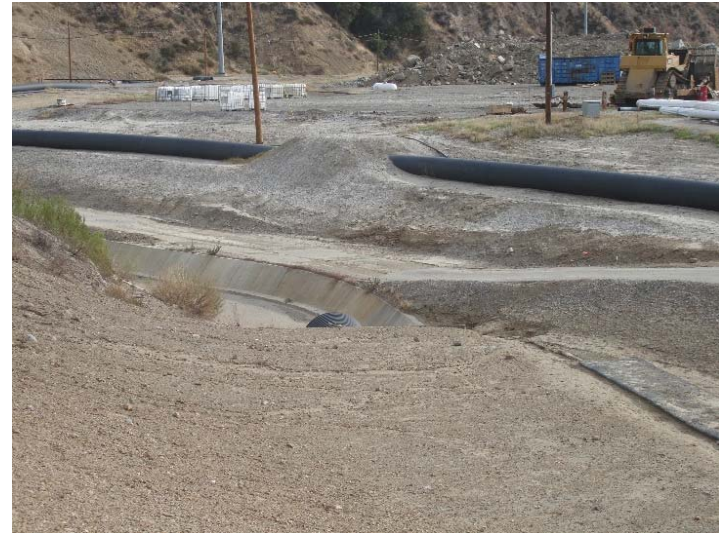
Photo 477: Plugged Drain at Flare 9-11 Access Road: January 30, 2018

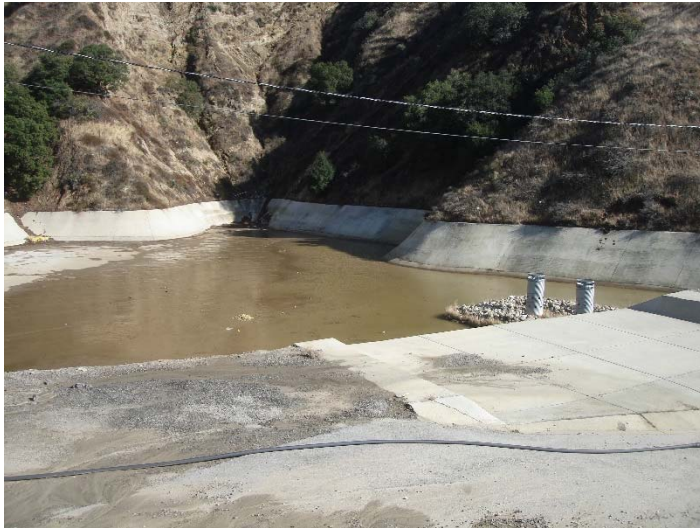
Photo 564: Basin B: January 10, 2018

Monitor: James Aidukas	Page: 1 of 2
Discipline: Project Manager	Date: 1/10/18
Site Conditions: Clear, 45-65°F, 0-10 MPH winds	
SITE LOG	
<p>Republic General Manager - Chris Coyle</p> <p>Drove the Granada Hills and adjacent Sylmar neighborhood areas from 6:30 to 7:30 a.m. and there were no landfill odors detected. Met with Mike Lindsay (UltraSystems) signed in, had a brief meeting with Joshua Mills, and proceeded to monitor the site and observed the following:</p> <ul style="list-style-type: none"> • Drove San Fernando Road north and Sierra Highway and did not observe any illegal dumping or windblown litter. • The terminal basin outlet channel had a significant amount of sediment that was discharged during yesterday's rain. The cause of the discharge was not evident. <p>Met with Gladys Gallardo (LACDPW) and she joined us during the monitoring.</p> <ul style="list-style-type: none"> • There was water ponding on the closure turf. The lower portion of the green grass cover of the turf slid down along the edge of the main access road, exposing the HDPE liner. The western area where it meets with the soil slope of CC-3A had washout areas and exposed trash. • Slope erosion and exposed waste was seen on the slopes of CC-4 Part 2. Standing water in the lined drainage channel was scheduled to be pumped into trucks and sewered. • Significant slope erosion was seen in some areas of CC-4A Parts 1 and 2, CC-3A and CC-3B. • A slope HDPE drainage channel was washed away on the eastern slope of CC-3B. • There was a strong odor coming from the top deck of CC-3A. This could be coming from the soil amendment for the revegetation activity. • Ponding of rainwater was seen on the Old City North top deck near the leachate and condensate tank farm. • Rainwater ponding was seen on the top deck of CC-3B. • CC-4A Part 1 was accepting waste with three tippers operating. CC-4A Part 2 was not active. • The eastern slopes of CC-3A and the County inactive decks and slopes being revegetated had deep erosion rills. The straw wattles were not effective in controlling the runoff. Ponding was seen in these areas. • The Posi-Shell appeared to hold up to the rain event. There were only minor areas that needed to be repaired. • The effectiveness of the erosion control measures being used on the whole site need to be evaluated. The areas that had erosion exposing trash need immediate remedial attention. • The eastside drainage channel had an area north of Basin B where the concrete channel wall was spalling. The channel had significant sediment behind the gabions. • Basin B had sediment and standing water.

1. Repair buckling concrete at sediment basin B drainage channel.
2. Eliminate ponding water at tank farm.
3. Eliminate ponding water at Cell CC-4 Part 2.
4. Repair erosion ruts at Cell CC-4 Part 1 and Part 2.
5. Repair erosion ruts above Flare 1.
6. Eliminate ponding water at sediment basin B.
7. Eliminate fine sediment at terminal basin outlet channel.

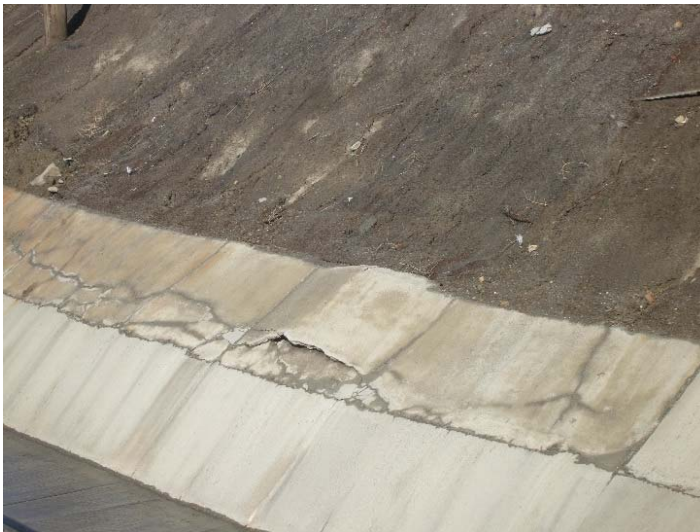
Photo 570: Eastside Drainage Channel: January 10, 2018

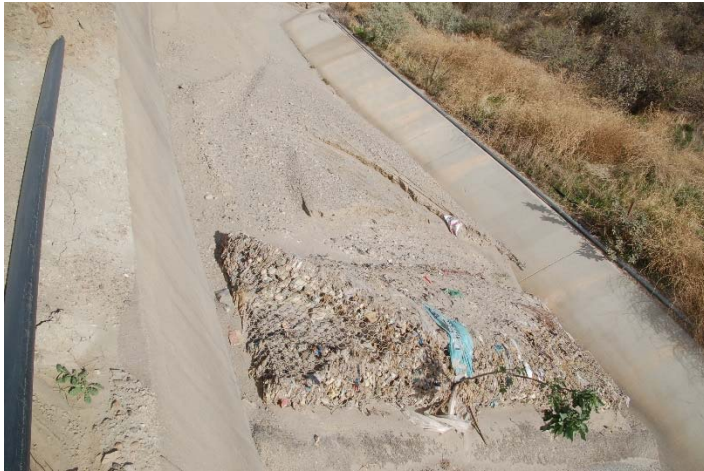
Photo 584: Eastside Drainage Channel: January 30, 2018

Monitor: James Aidukas	Page: 1 of 2
Discipline: Project Manager	Date: 1/30/18
Site Conditions: Clear, 45-65°F, 0-10 MPH winds	
SITE LOG	
<p>Republic General Manager - Chris Coyle</p> <p>Drove the Granada Hills neighborhood areas from 6:45 to 7:30 a.m. and there were no landfill odors detected. Met with Mike Lindsay (UltraSystems) and Tarik Hadj-Hamou (SLR), signed in, had a brief meeting with Ricky Dhupar, and proceeded to monitor the site and observed the following:</p> <ul style="list-style-type: none"> Erosion rills on slopes in Cells CC-3A, CC-3B southern side, CC-4A Parts 1 and 2, and the Old City south were in the process of being repaired. All areas where trash was previously exposed have been repaired. There were no liquids odors detected on the CC-3A access road adjacent to the closure turf where a previous landfill liquids spill occurred. There was an area of the slope closure turf that appears to have slid or sunk. The City South landfill soil stockpile area south of the office parking lot has one area that has further subsidence. This area needs to be monitored by Republic. The Old City north deck liquids handling tank farm was operating with liquids being trucked away. Connection to the sewer was not yet completed. The rest of this deck was graded and rain impacts repaired. The CC-3B top deck erosion and drainage gullies were repaired. There were significant erosion rills on the eastern vegetated slopes of CC-3B and CC-3A. The straw wattles were not buried when installed and water flowed under them, creating rills. Basin B was cleared of litter with minimal sediment and standing water. The native hillsides had windblown litter. Wet weather road base and landfill drainage rock was stockpiled on the County top deck along with drainage piping and gas collection piping and materials. The drainage channel along the paved access road to the Flares 9, 10, and 11 site had the outlet plugged. Basin D outlet channel liner leading edge was lifting and had tumbleweed and sediment under the liner. The deck above Basin D still had stockpiles of tree trunks and branches, wood waste and other debris. The portion of the County sage area that was covered with jute netting and hydroseeded held up to the rains with no erosion seen, and were greening up with vegetation. Basin A had sediment and standing water at the outlet risers. There was windblown litter in the back and side native vegetation areas. The gas collection piping to Flare 3 was sliding off its supports and becoming unstable due to the cut hillside sloughing soil. Cells CC-4A Part 1 and 2 were accepting waste. The eastside drainage channel had significant sediment and litter behind channel gabions.
