**Sunshine Canyon Landfill
Independent Monitor
Quarterly Site Monitoring Status Report
January 1, 2018 – March 31, 2018**

City of Los Angeles Department of City Planning

County of Los Angeles Department of Regional Planning

May 25, 2018

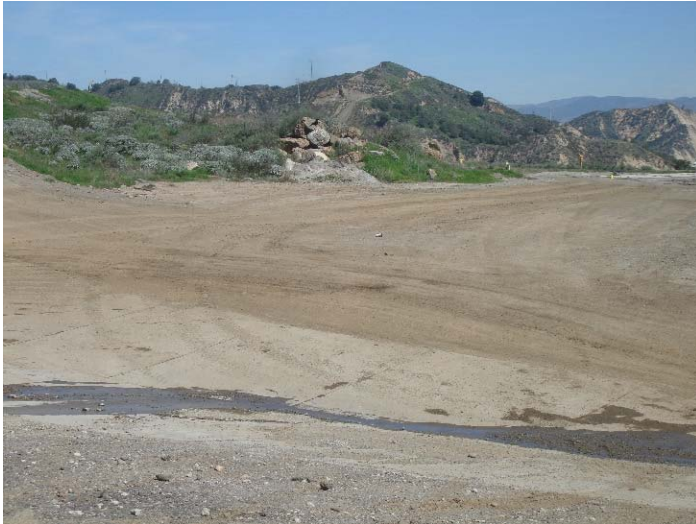
Photo 604: Basin B Back Hillside Litter: March 29, 2018

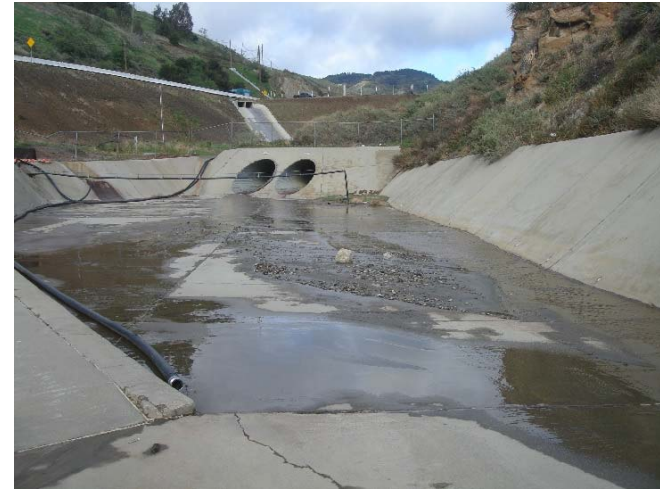
Photo 629: Terminal Basin Inlet: March 14, 2018

- CC-3B basin had standing water. The low-flow drain was plugged.
- The terminal basin has one skimmer riser support break and caused an uncontrolled release of sediment during yesterday's rain event. The risers were being repaired and reinforced.

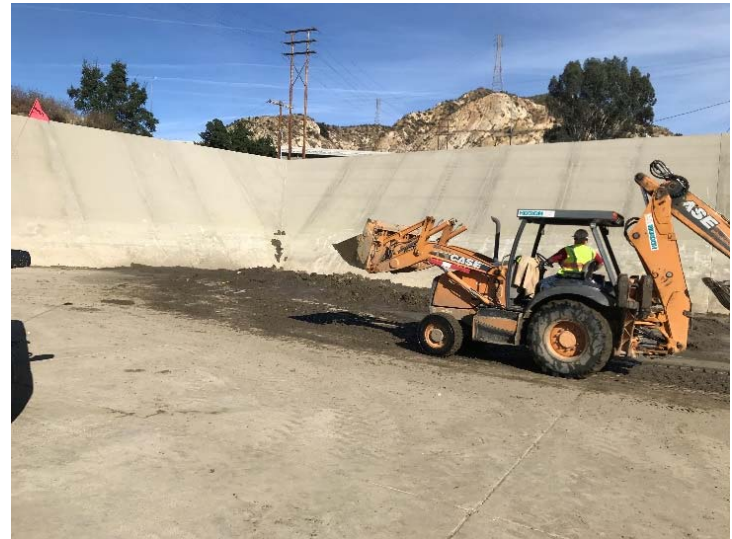
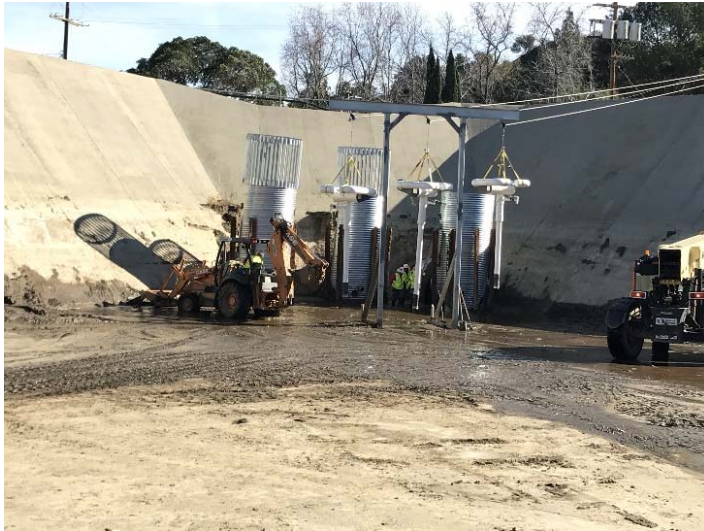
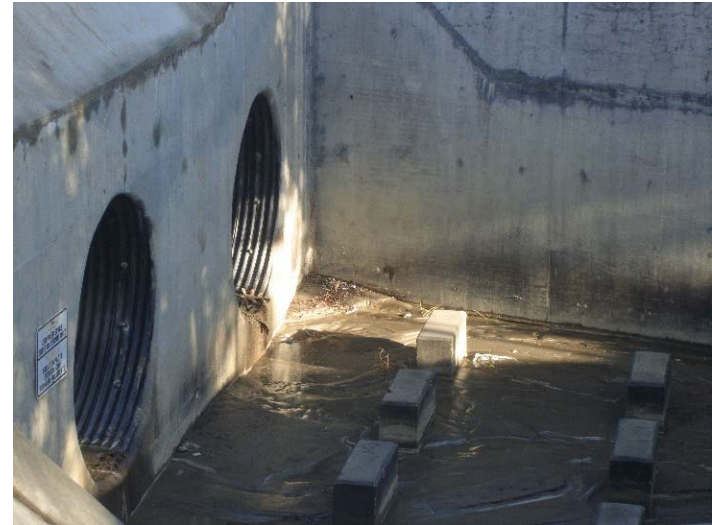
Photo 651: Terminal Basin: January 10, 2018

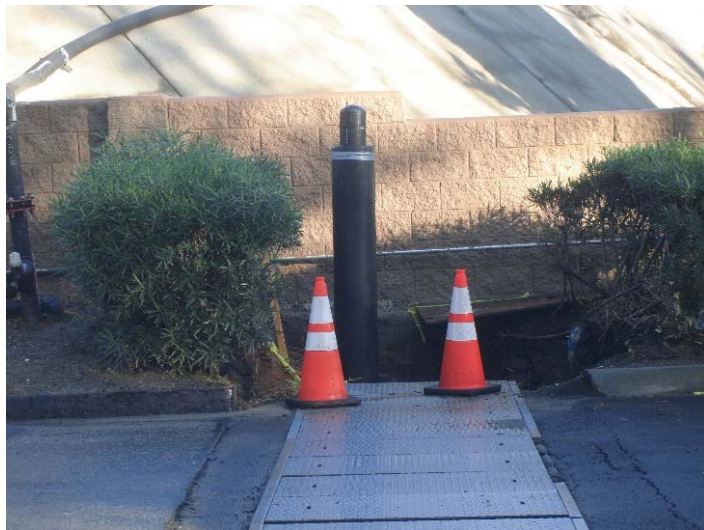
Photo 654: Terminal Basin Outlet: January 10, 2018

1. Repair buckling concrete at sediment basin B drainage channel.
2. Eliminate ponding water at tank farm.
3. Eliminate ponding water at Cell CC-4 Part 2.
4. Repair erosion ruts at Cell CC-4 Part 1 and Part 2.
5. Repair erosion ruts above Flare 1.
6. Eliminate ponding water at sediment basin B.
7. Eliminate fine sediment at terminal basin outlet channel.

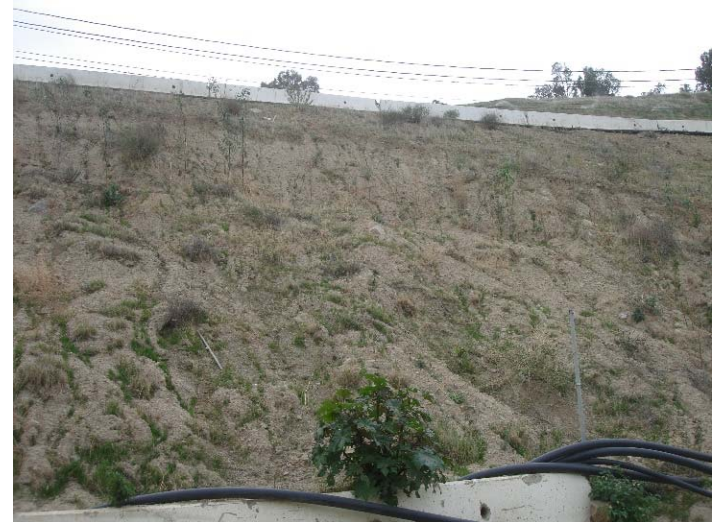
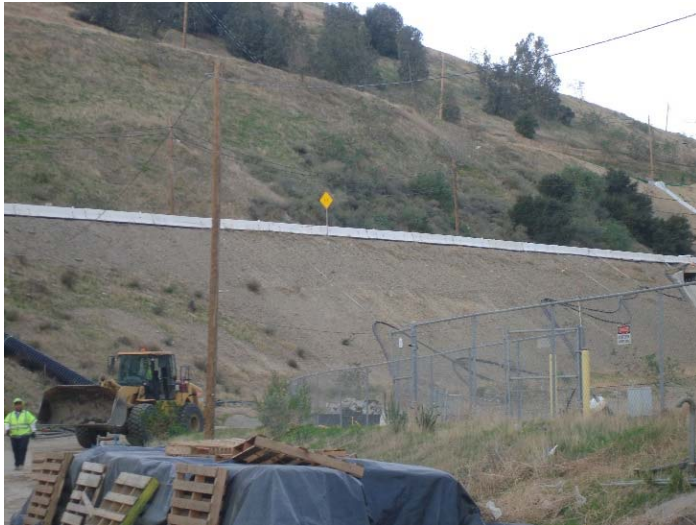
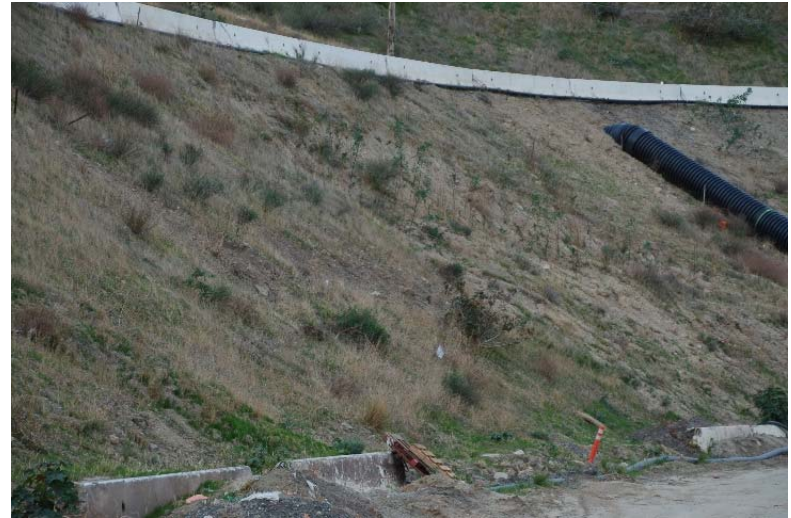
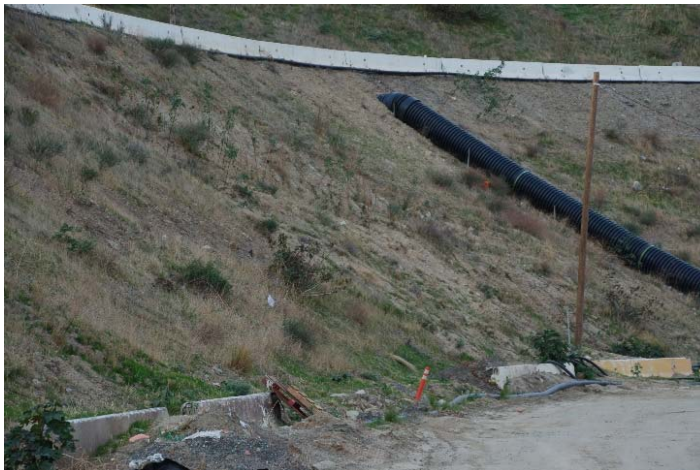
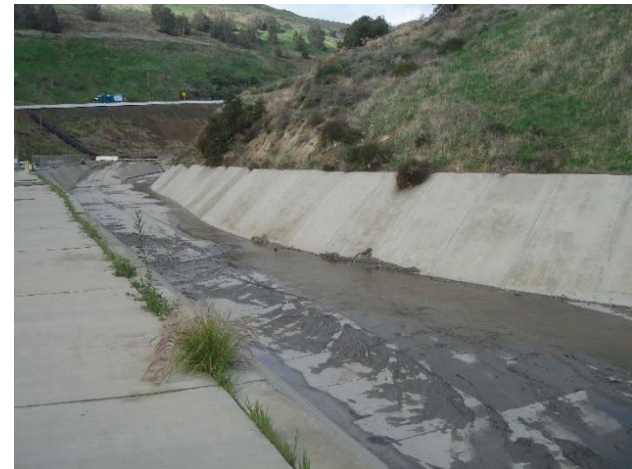
Photo 667: Access Road near Terminal Basin: January 30, 2018

Access roads.	<ul style="list-style-type: none"> • Main access road • the sloughing on the embankment of the access road observed during the previous visits is still there and may have worsened some based on inclining to utility pole (Photo 13)
Closure Turf on slopes of CC3:	<ul style="list-style-type: none"> • The leachate break-out that occurred at access road to the deck of cell CC3 in an area covered with Closure Turf has been repaired, we did not detect any smell
Retaining wall on San Fernando Road:	<ul style="list-style-type: none"> • No comments – are looks clean of sediments
Overall landfill inspection.	<ul style="list-style-type: none"> • no other geotechnical issues than that noted at access road were observed during the visit

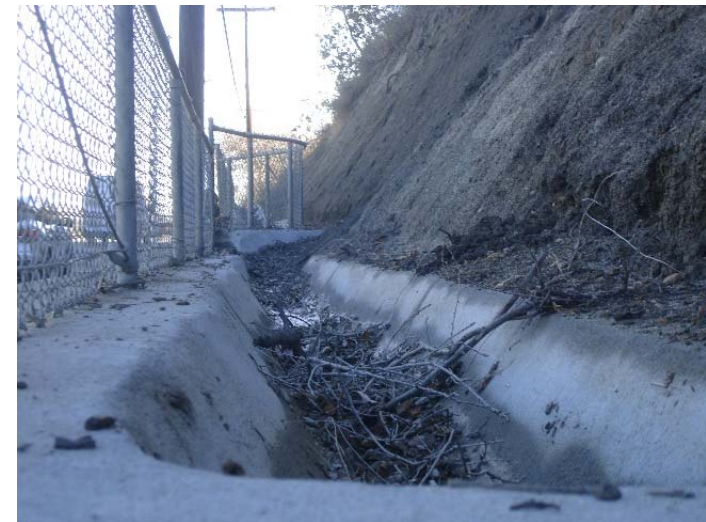
Photo 771: New Sewer Connection Facility: March 14, 2018

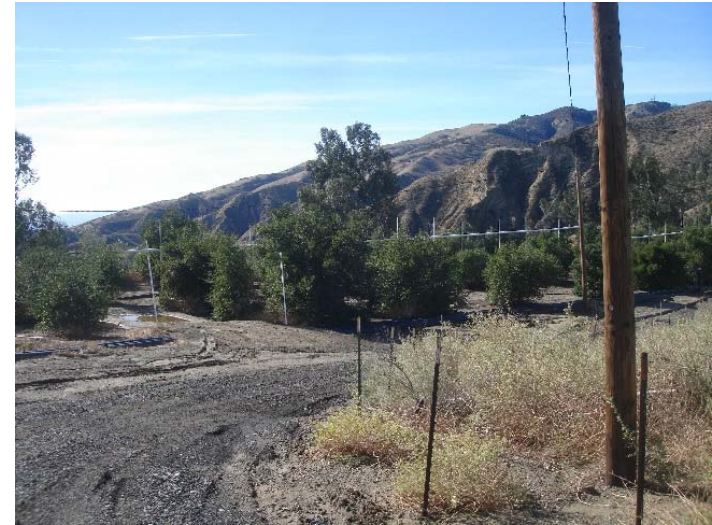
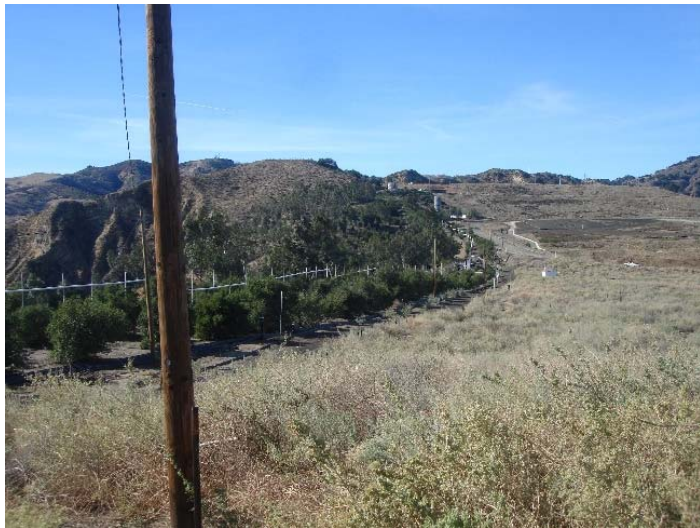
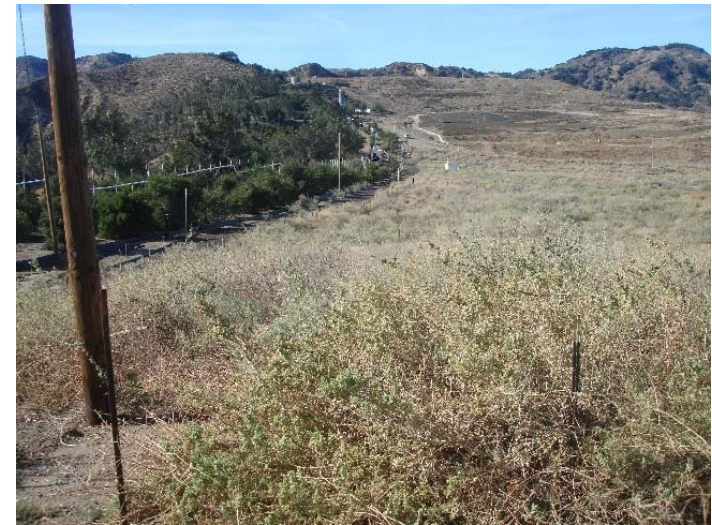
Photo 789: PM 10 Berm Area: January 10, 2018

Photo 790: PM 10 Berm Area: January 10, 2018

Photo 791: PM 10 Berm Area: January 10, 2018

- Deck C sage mitigation was greening up due to the cooler weather and moisture. No maintenance work appears to have been done.
- The PM-10 berm Oak Trees were doing well, greening up, and growing.

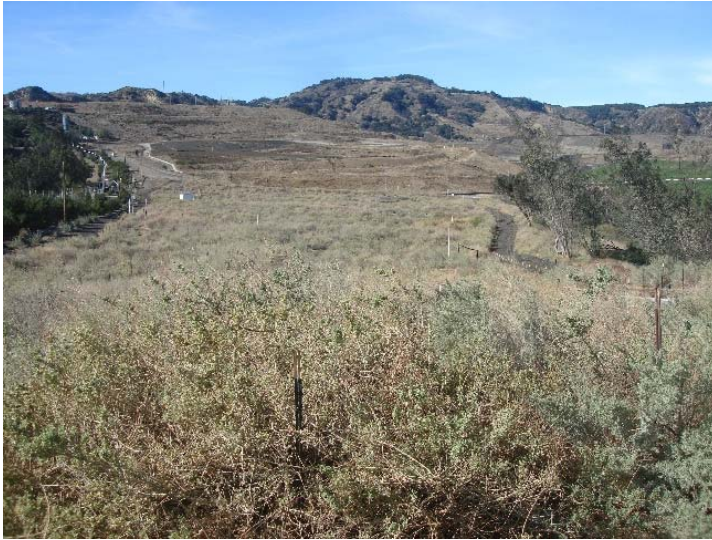
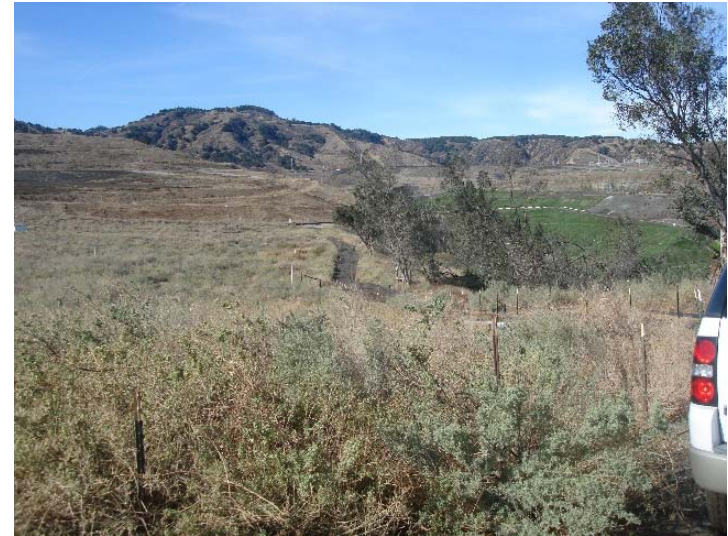
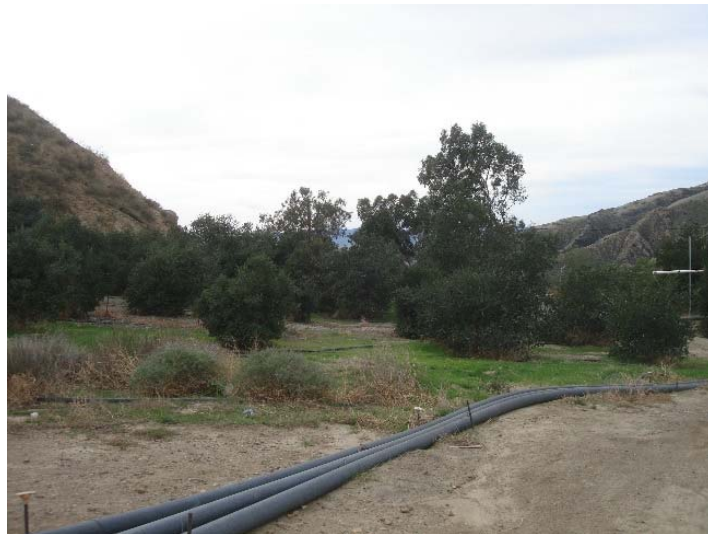
Photo 792: Deck C Sage Mitigation Area: January 10, 2018

Photo 793: Deck C Sage Mitigation Area: January 10, 2018

Photo 794: Deck C Sage Mitigation Area: January 10, 2018

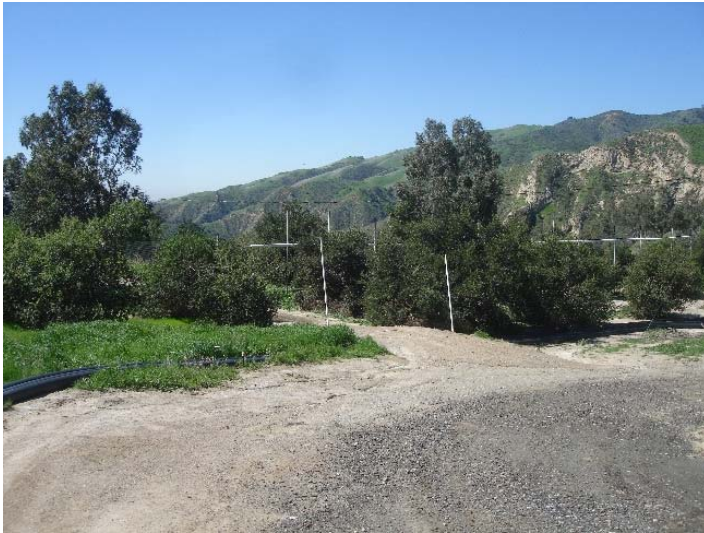
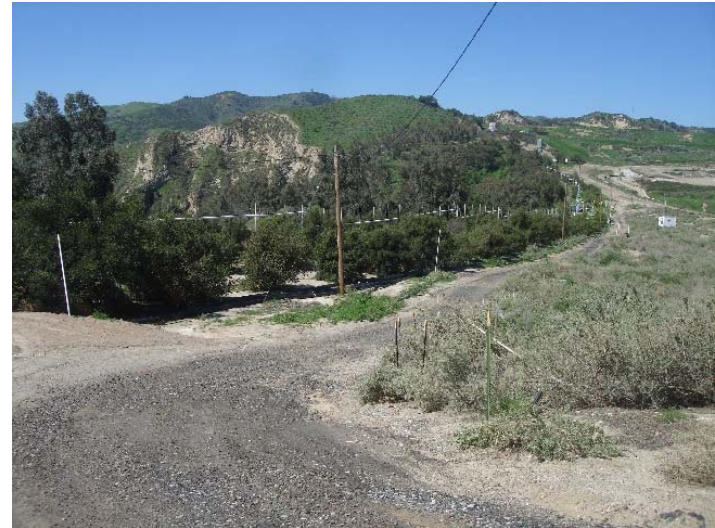
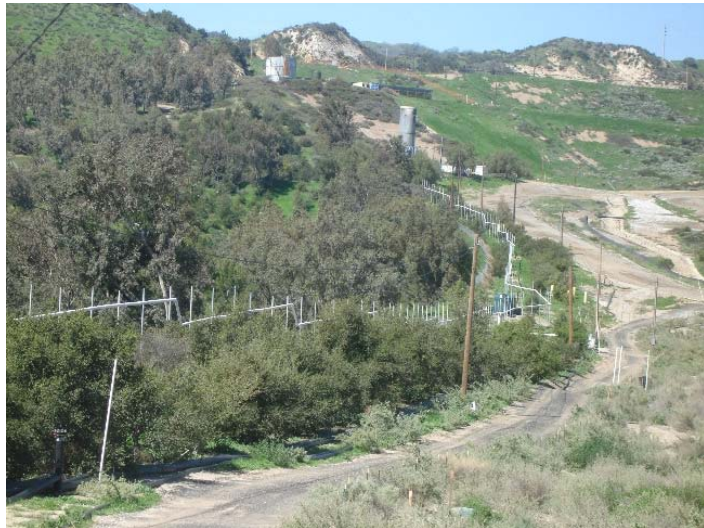
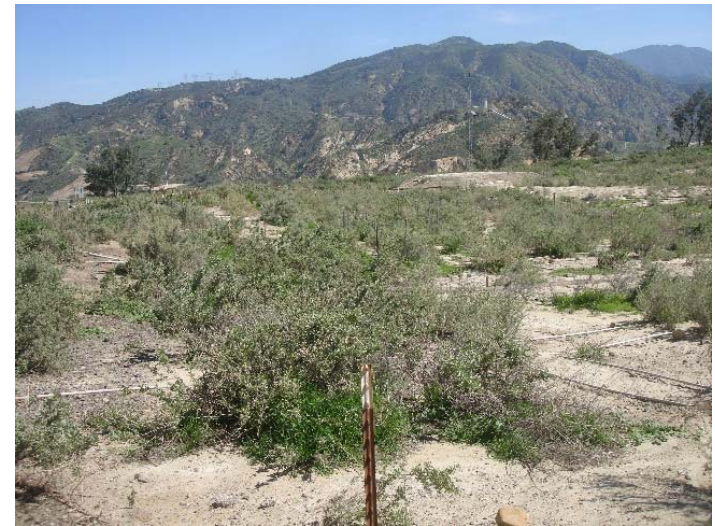
Photo 804: Deck C PM 10 Berm Area: March 29, 2018

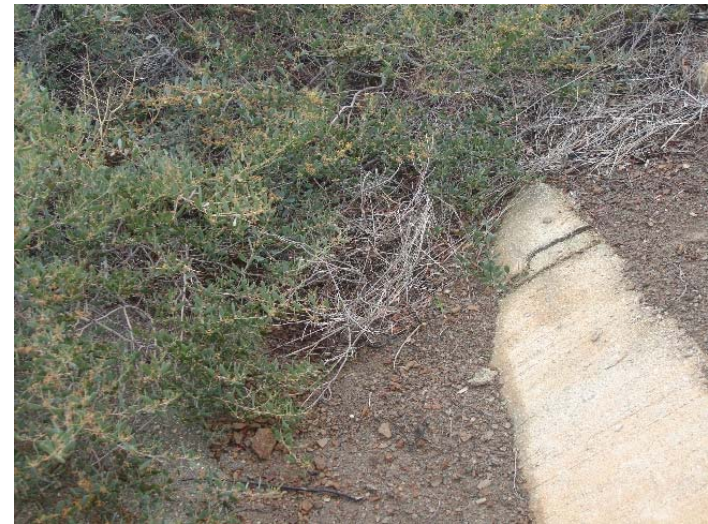
Photo 839: Flare 1 Hillside V-Ditch: March 14, 2018

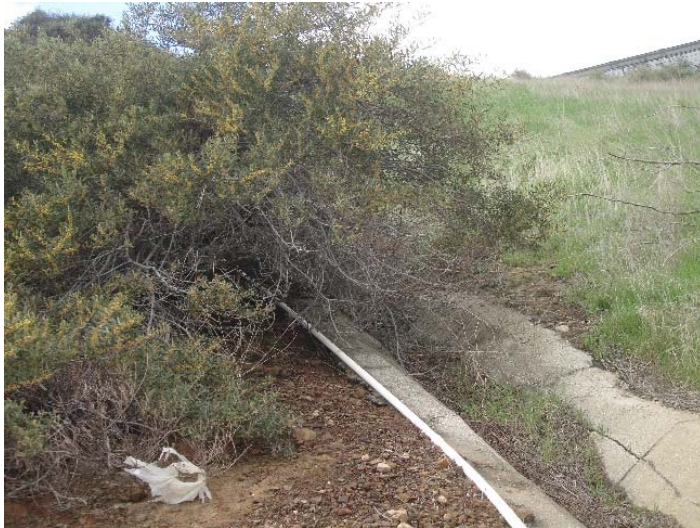
Photo 840: Flare 1 Hillside V-Ditch: March 14, 2018

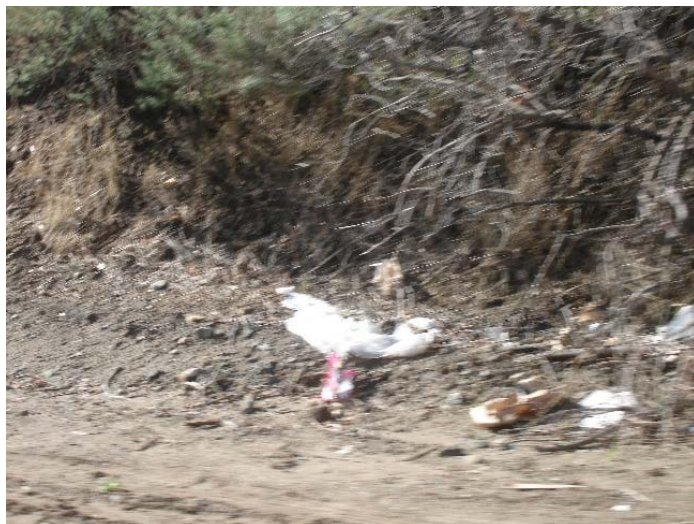
**Photo 842: Illegal Dumping at Sierra Highway near I-14 Overpass:
March 14, 2018**

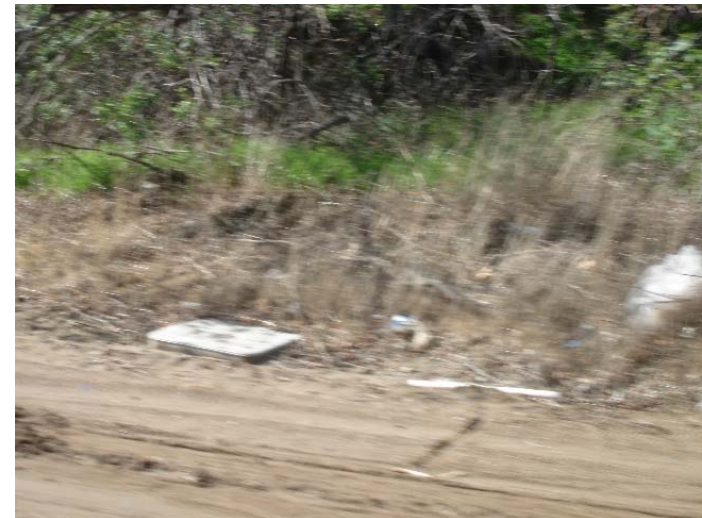
**Photo 843: Illegal Dumping at Sierra Highway near I-14 Overpass:
March 14, 2018**

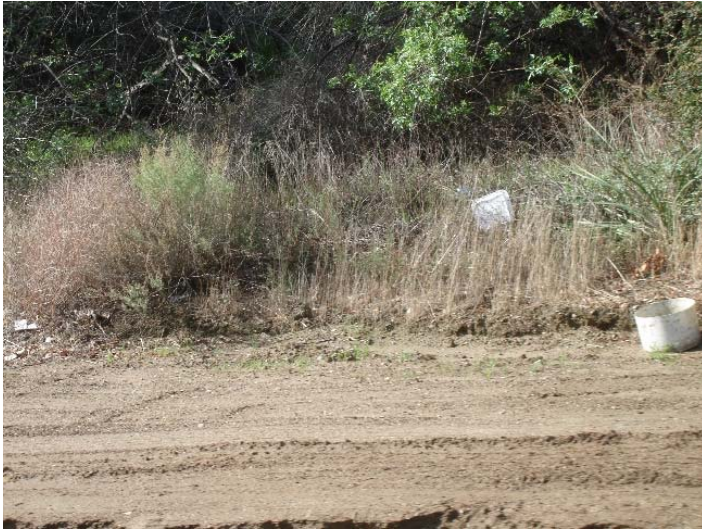
**Photo 844: Illegal Dumping at Sierra Highway near I-14 Overpass:
March 14, 2018**

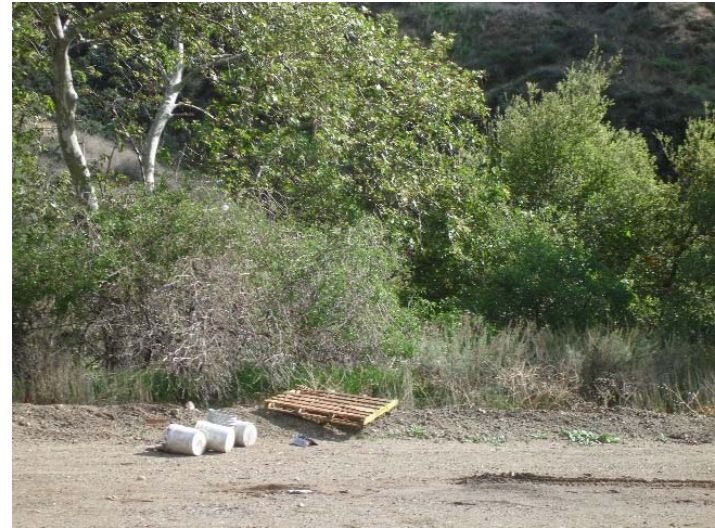
**Photo 845: Illegal Dumping at Sierra Highway near I-14 Overpass:
March 14, 2018**

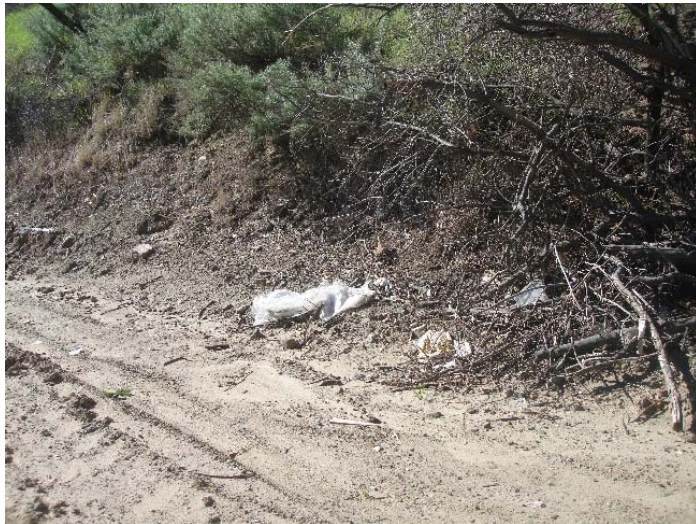
**Photo 846: Illegal Dumping at Sierra Highway near I-14 Overpass:
March 14, 2018**

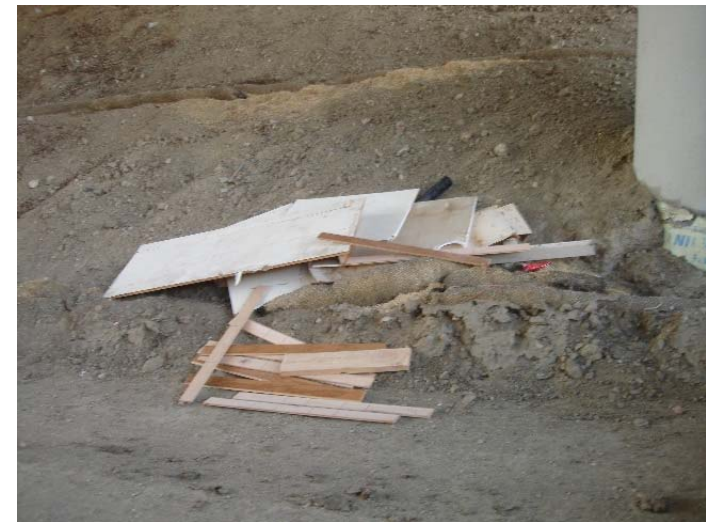
**Photo 847: Illegal Dumping at Sierra Highway near I-14 Overpass:
March 29, 2018**

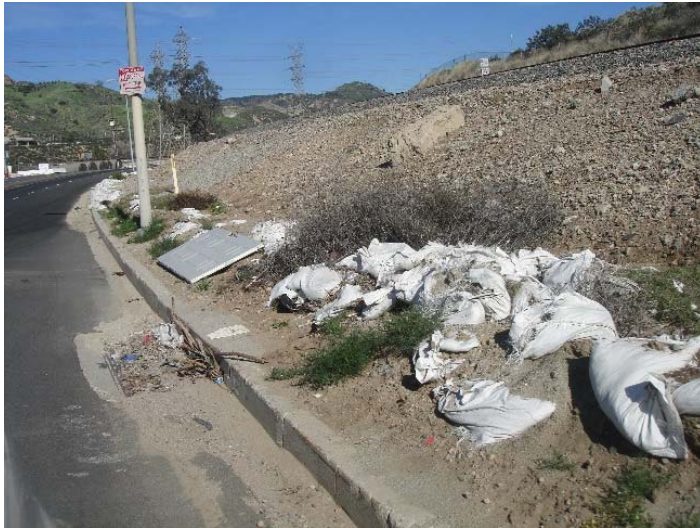
**Photo 848: Illegal Dumping at Sierra Highway near I-14 Overpass:
March 29, 2018**

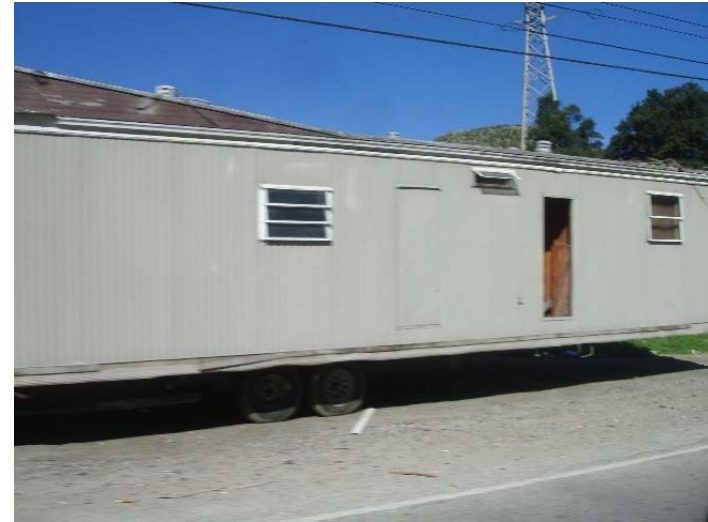
**Photo 849: Illegal Dumping at Sierra Highway near I-14 Overpass:
March 29, 2018**

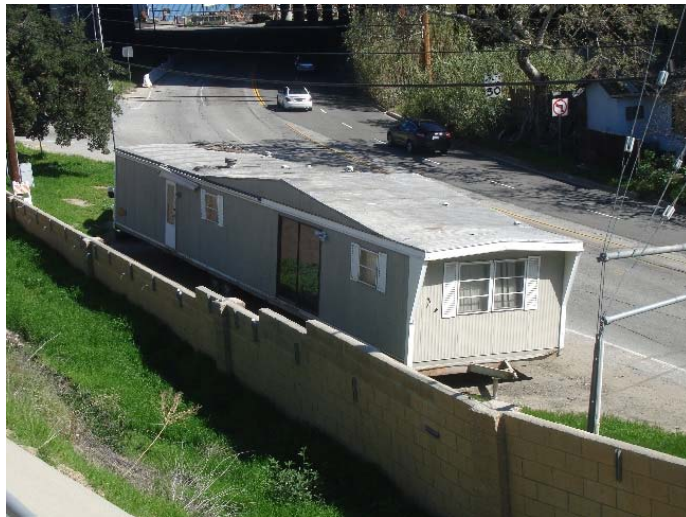
Photo 850: Abandoned Trailer North of Entrance: March 29, 2018

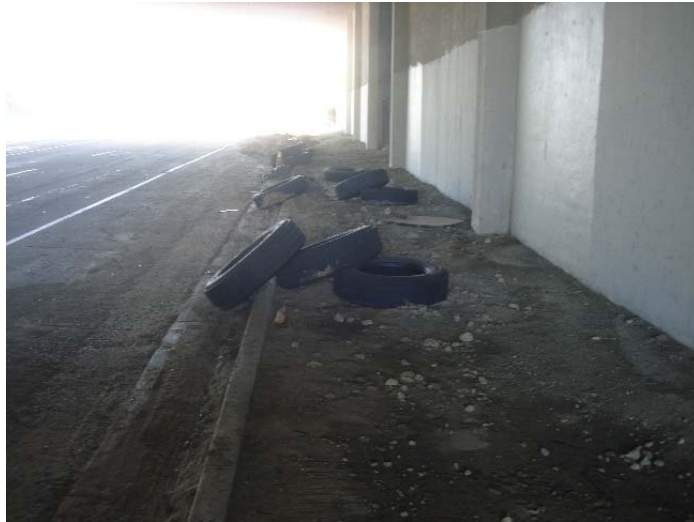
**Photo 852: Illegal Dumping San Fernando Road at I-5 Overpass:
March 29, 2018**

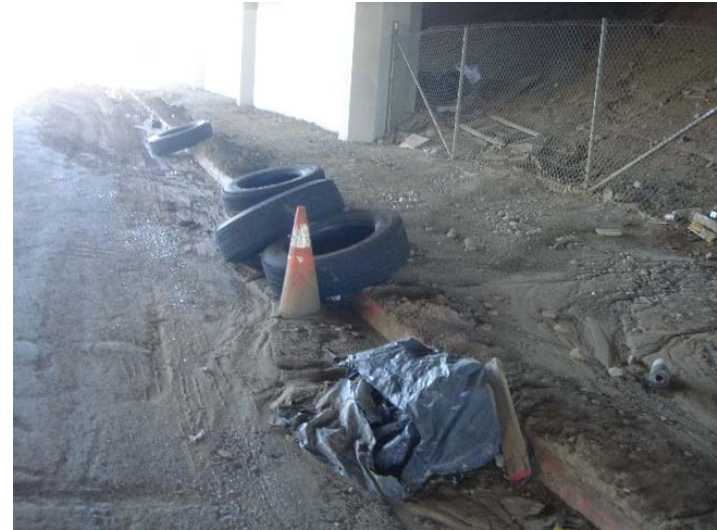
**Photo 853: Illegal Dumping San Fernando Road at I-5 Overpass:
March 29, 2018**

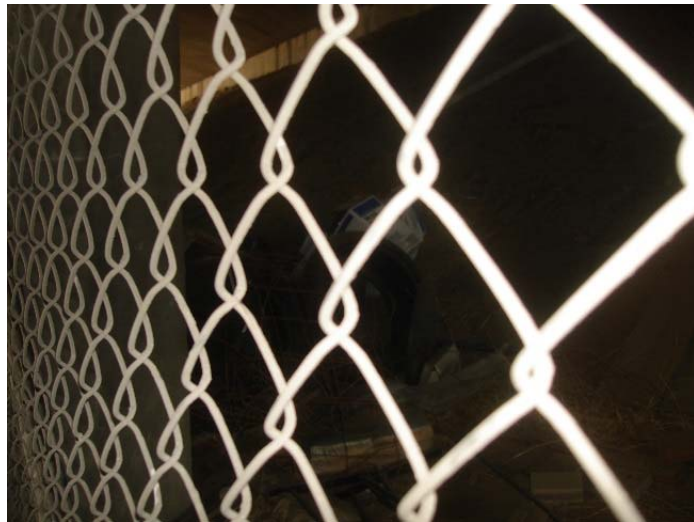
**Photo 854: Illegal Dumping San Fernando Road at I-5 Overpass:
March 29, 2018**

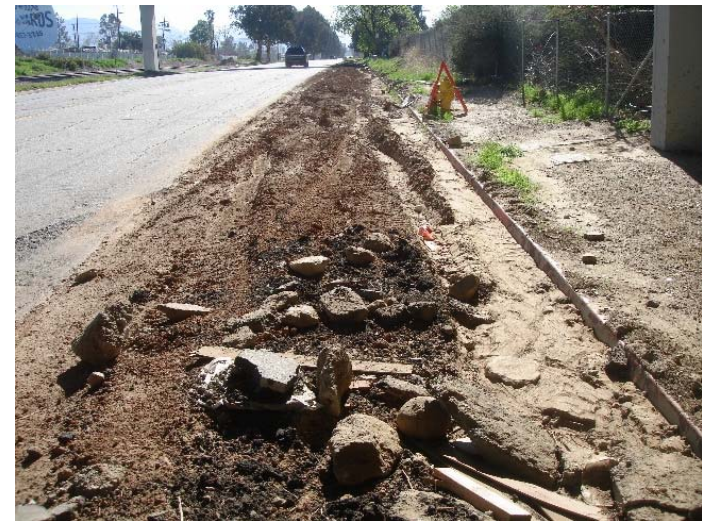
**Photo 855: Illegal Dumping San Fernando Road at I-5 Overpass:
March 29, 2018**

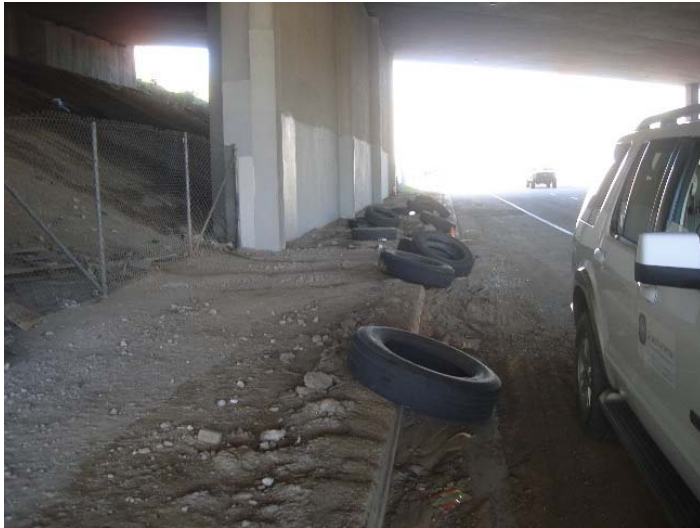
**Photo 856: Illegal Dumping San Fernando Road at I-5 Overpass:
March 29, 2018**

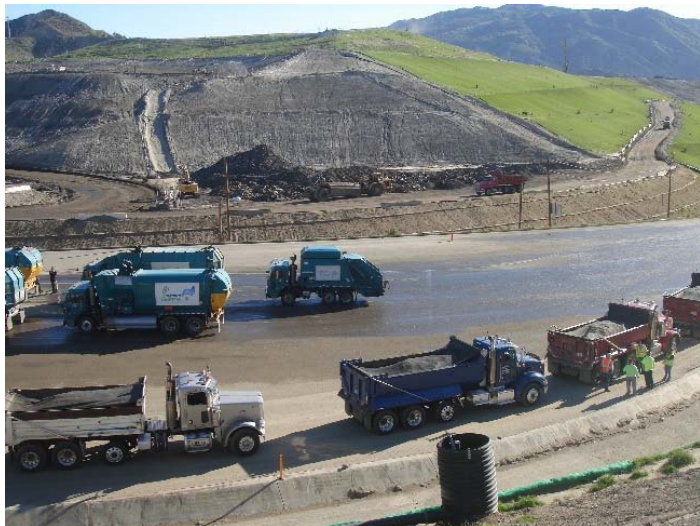
Photo 858: Trucks Staging at Scales: March 29, 2018

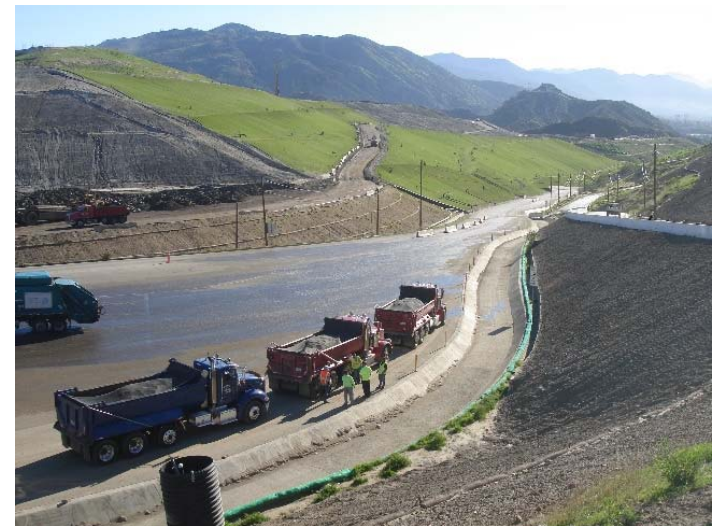
Photo 859: Trucks Staging at Scales: March 29, 2018

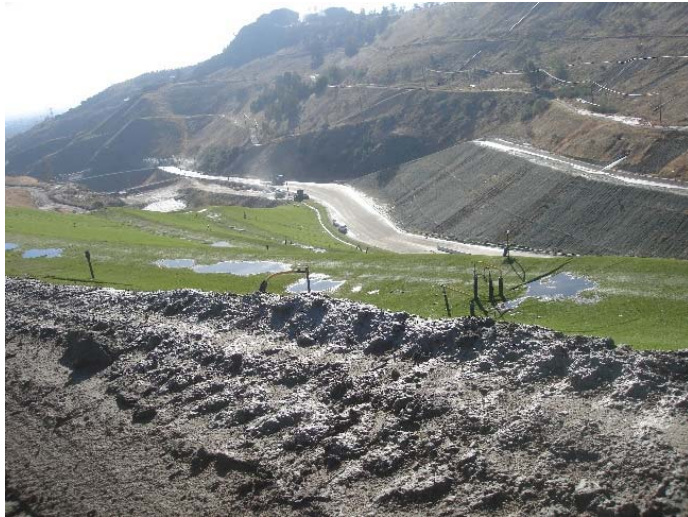
Photo 860: Trucks Staging at Scales: March 29, 2018

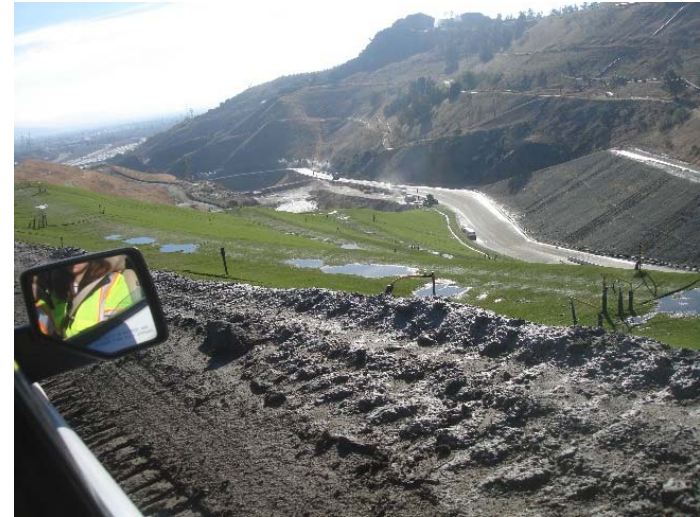
Photo 861: Site Water Pounding: January 10, 2018

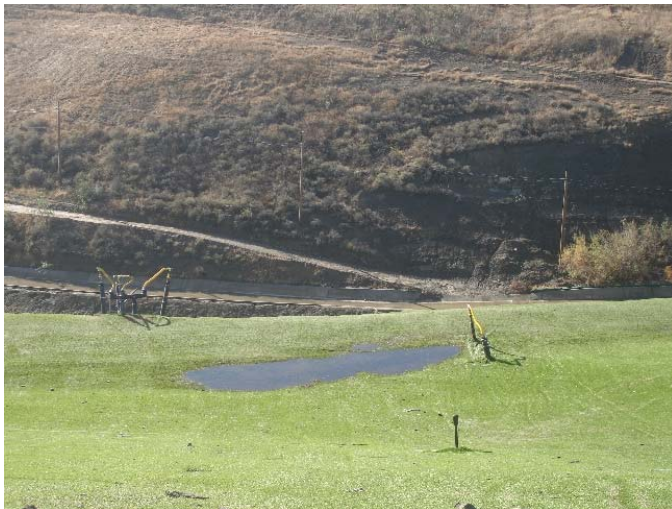
Photo 862: Site Water Pounding: January 10, 2018

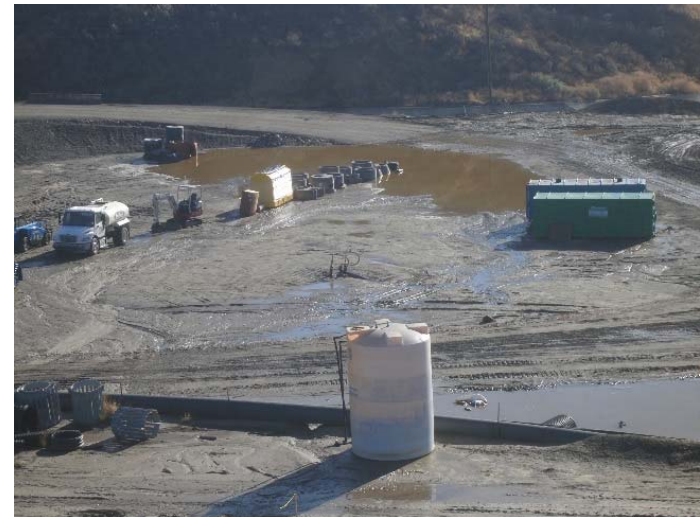
Photo 863: Site Water Pounding: January 10, 2018

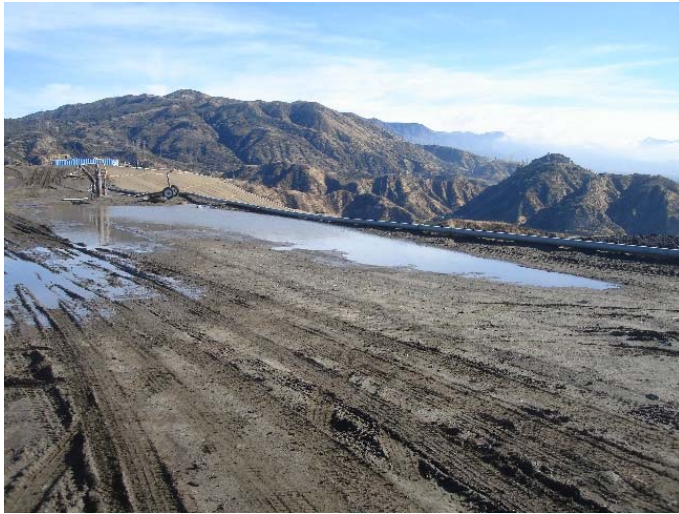
Photo 864: Site Water Pounding: January 10, 2018

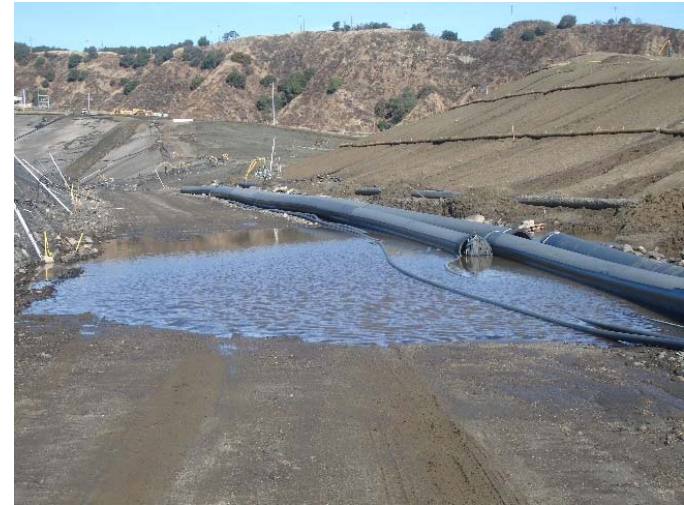
Photo 865: Site Water Pounding: January 10, 2018

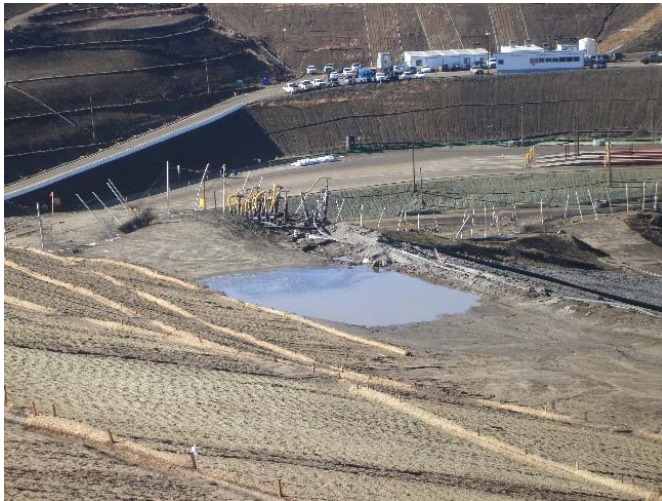
Photo 866: Site Water Pounding: January 10, 2018

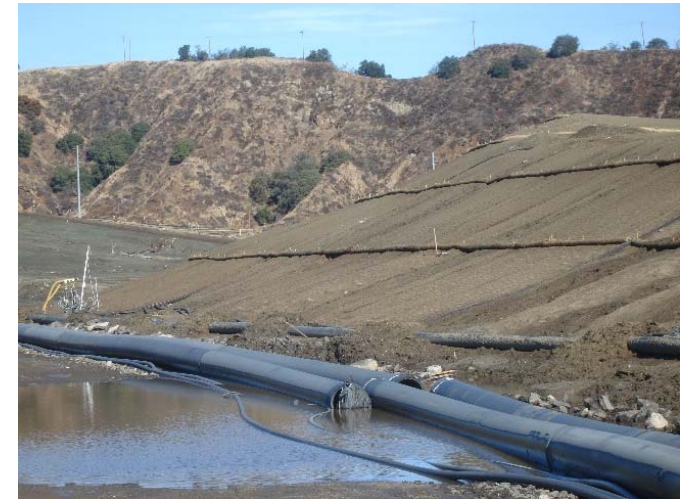
Photo 867: Site Water Pounding: January 10, 2018

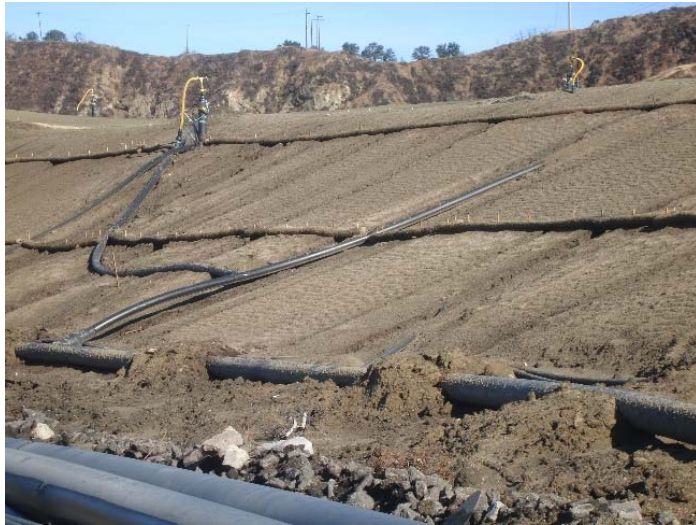
Photo 868: Site Water Pounding: January 10, 2018

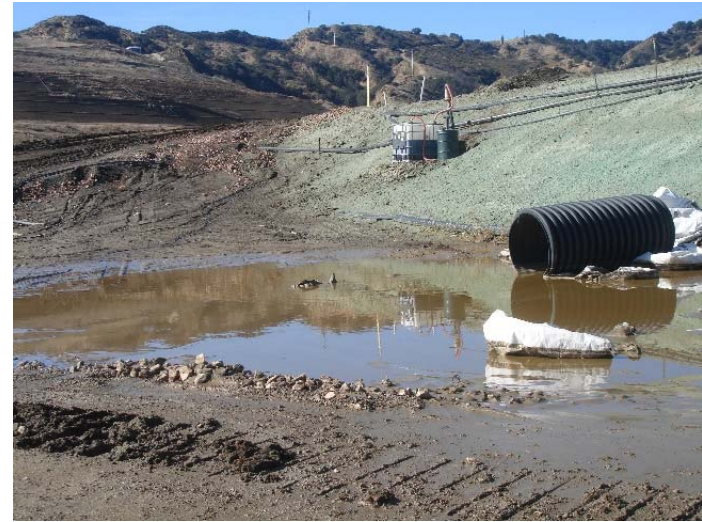
Photo 869: Site Water Pounding: January 10, 2018

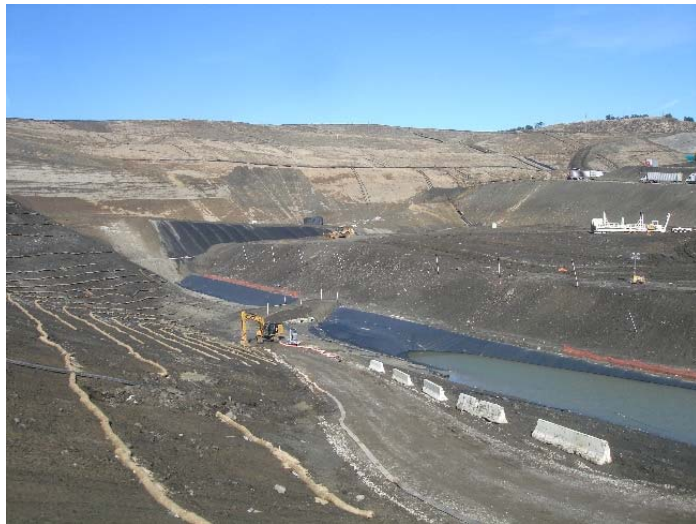
Photo 870: Site Water Pounding: January 10, 2018

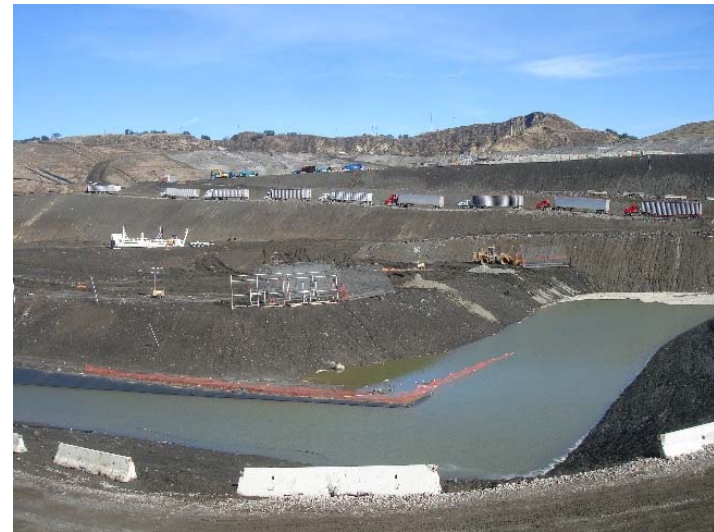
Photo 871: Site Water Pounding: January 10, 2018

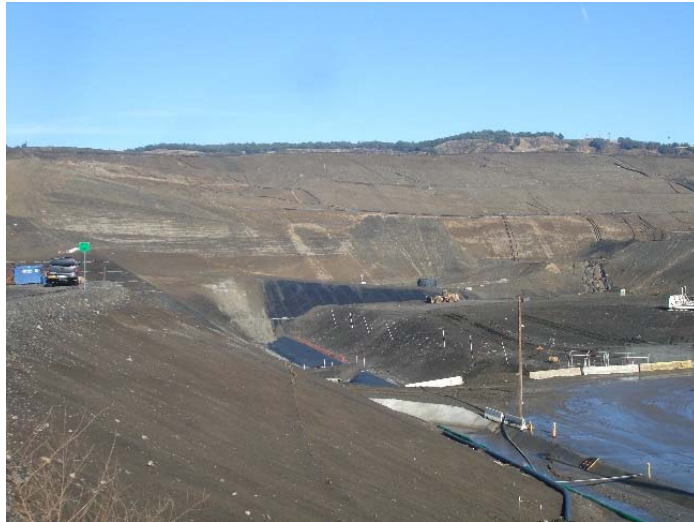
Photo 872: Site Water Pounding: January 10, 2018

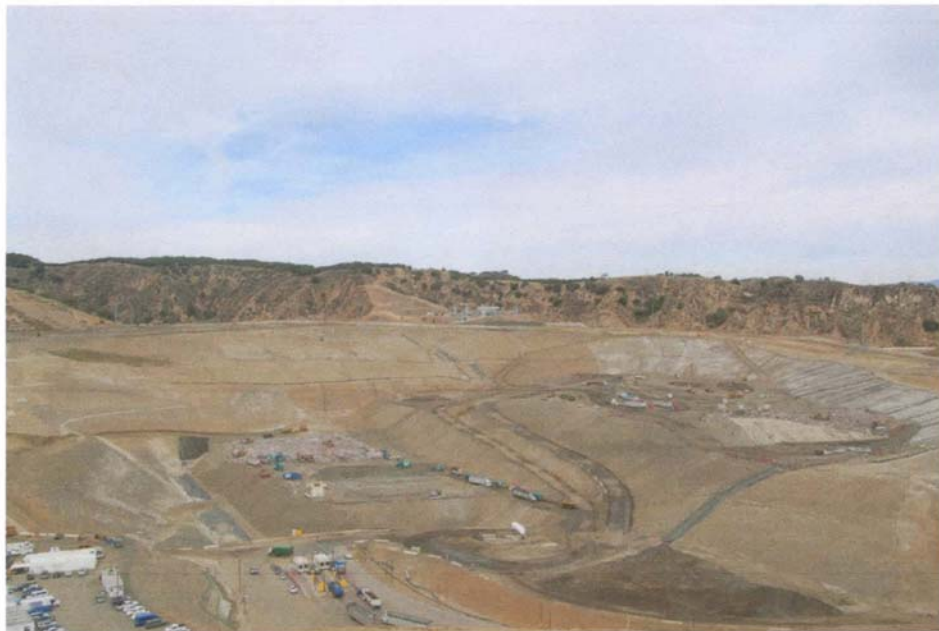
Photo 13: Sloughing Tilted Utility Pole on Embankment of Main Access Road near Entrance of Terminal Basin

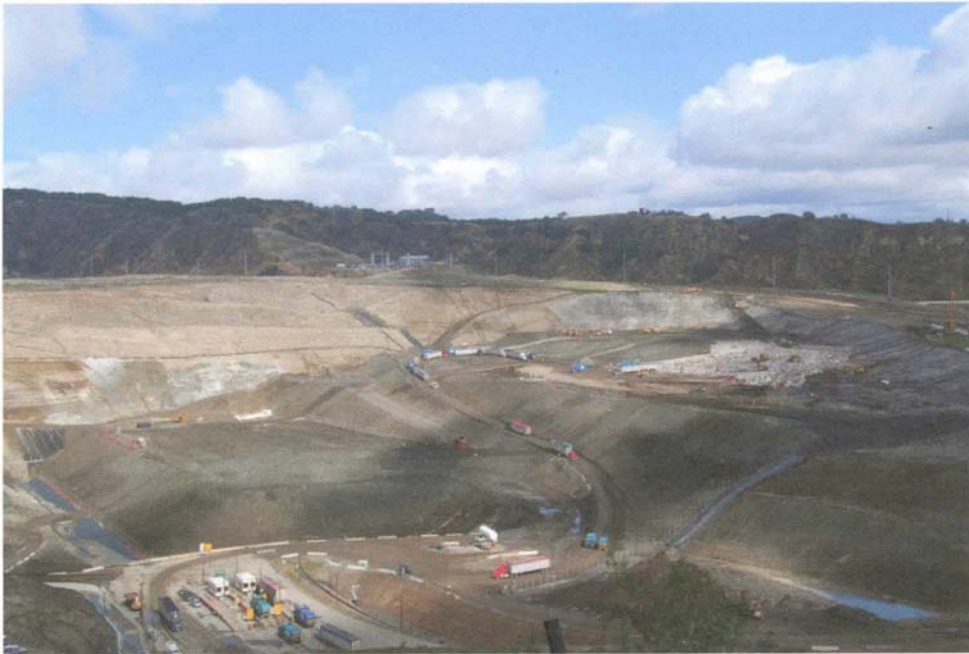
Photo 1 : Waste placement at Cell CC4
