**Sunshine Canyon Landfill  
Independent Monitor  
Quarterly Site Monitoring Status Report  
July 1, 2016 – September 30, 2016**

**City of Los Angeles Department of City Planning**

**County of Los Angeles Department of Regional Planning**

December 22, 2016

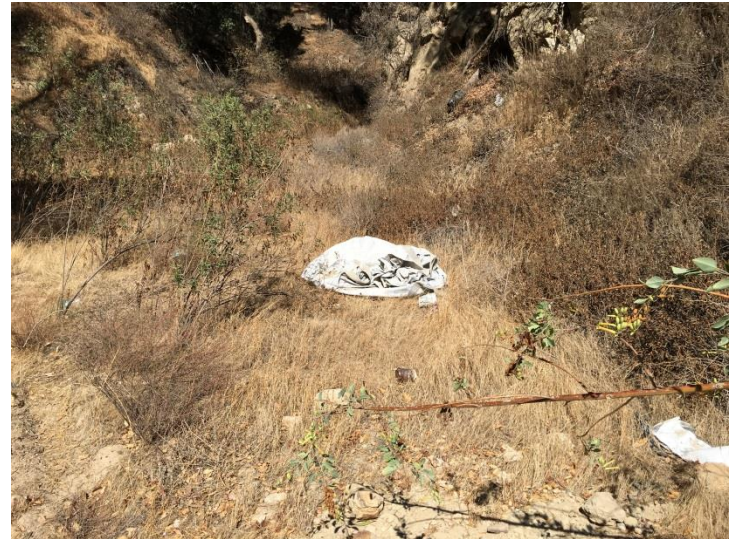
**Photo 30: Basin A Litter & Trash: September 14, 2016**

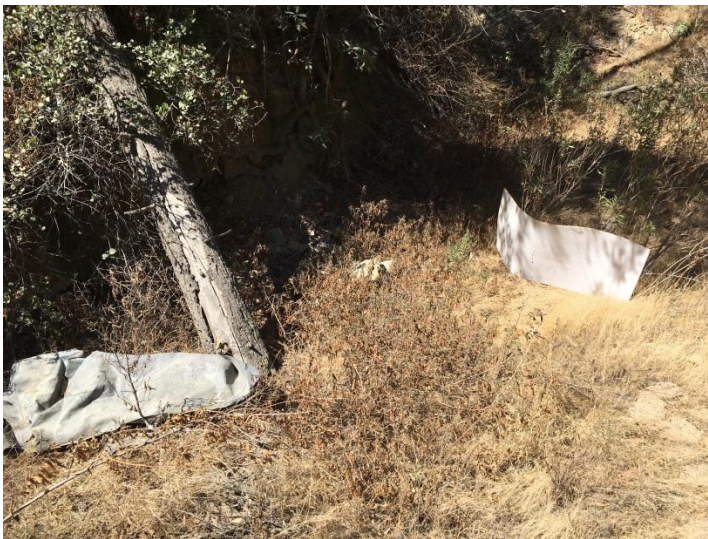
**Photo 31: Basin A Litter & Trash: September 14, 2016**

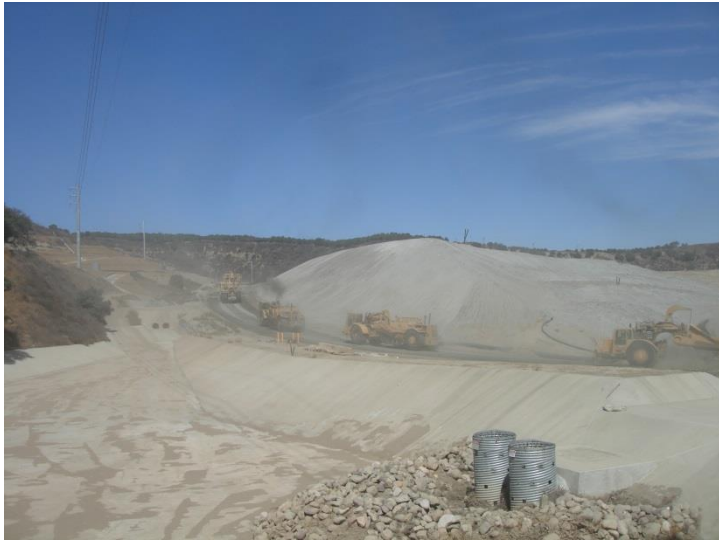
**Photo 37: Scraper Dust near Basin A: September 27, 2016**

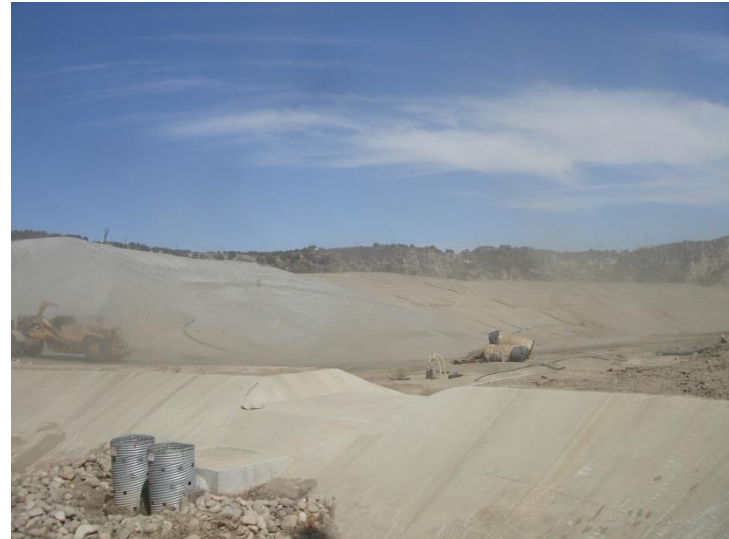
**Photo 38: Scraper Dust near Basin A: September 27, 2016**

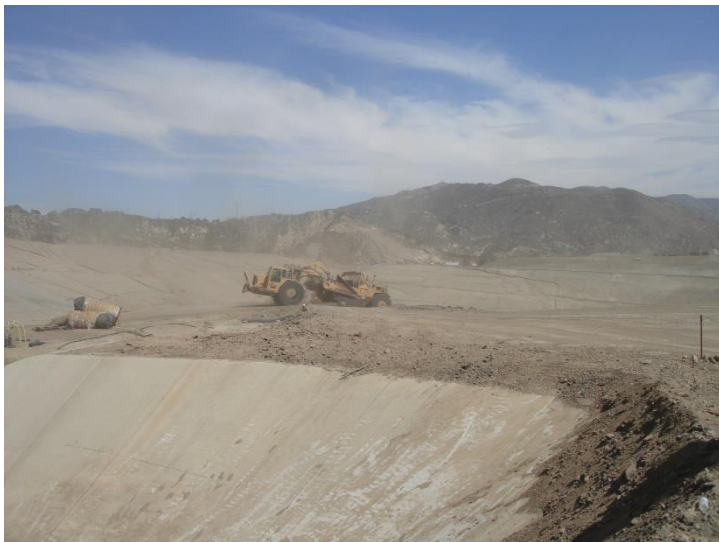
**Photo 39: Scraper Dust near Basin A: September 27, 2016**

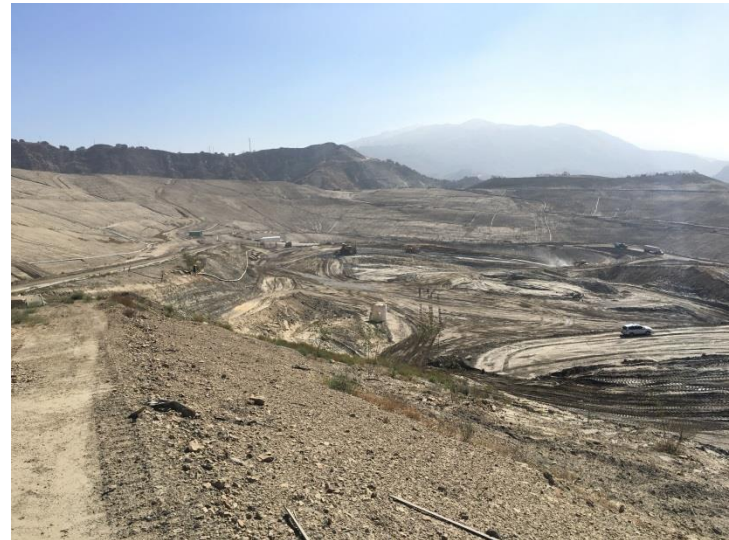
**Photo 40: Grading South of Basin A: July 12, 2016**

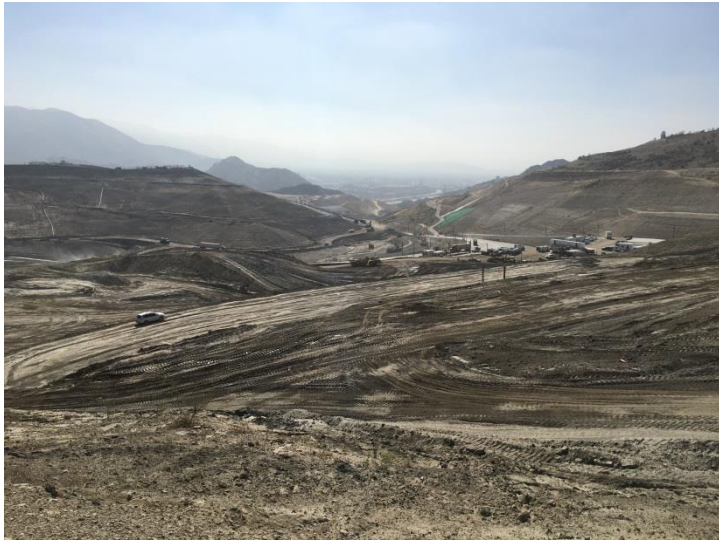
**Photo 41: Grading South of Basin A: July 12, 2016**

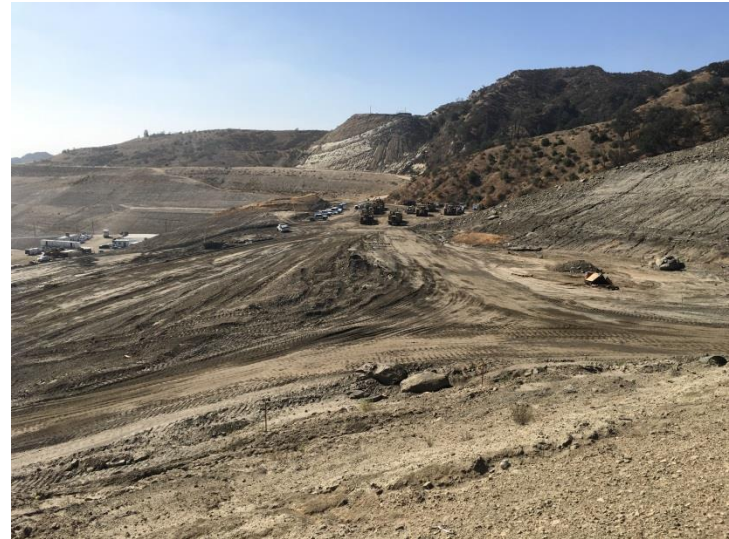
**Photo 42: Grading South of Basin A: July 12, 2016**

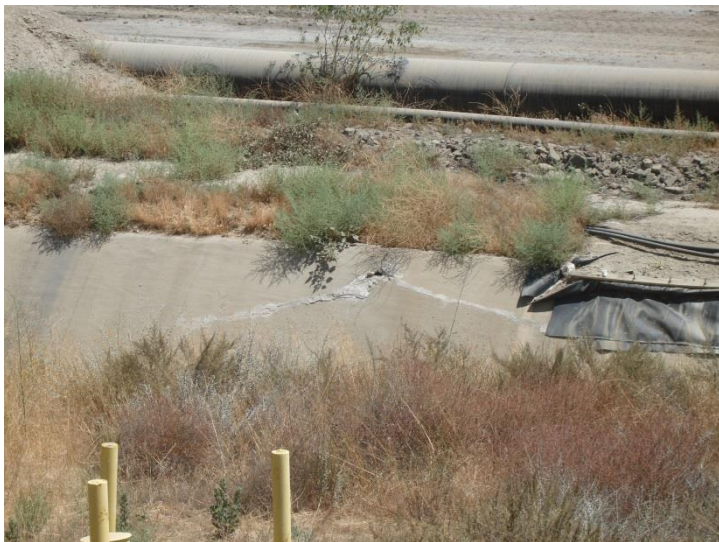
**Photo 43: Westside Drainage: July 27, 2016**

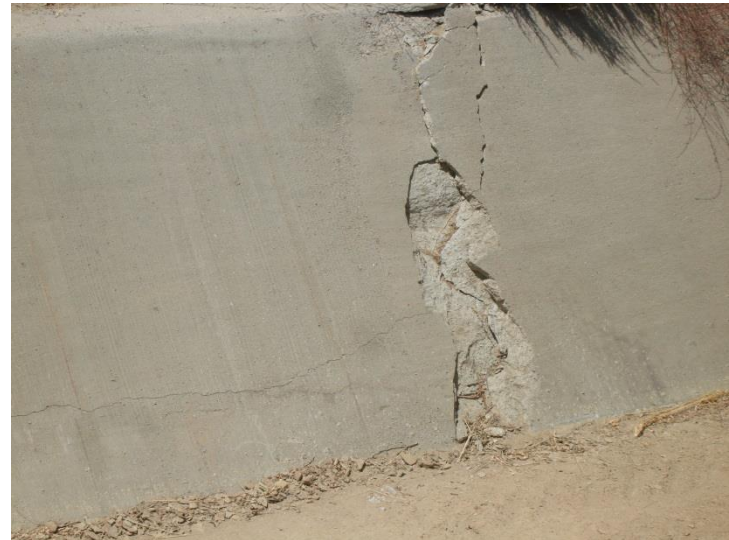
**Photo 44: Westside Drainage: July 27, 2016**

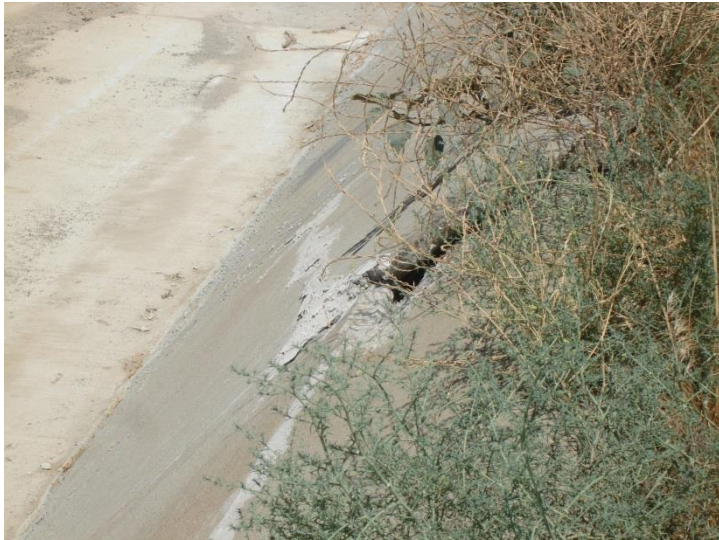
**Photo 45: Westside Drainage: July 27, 2016**

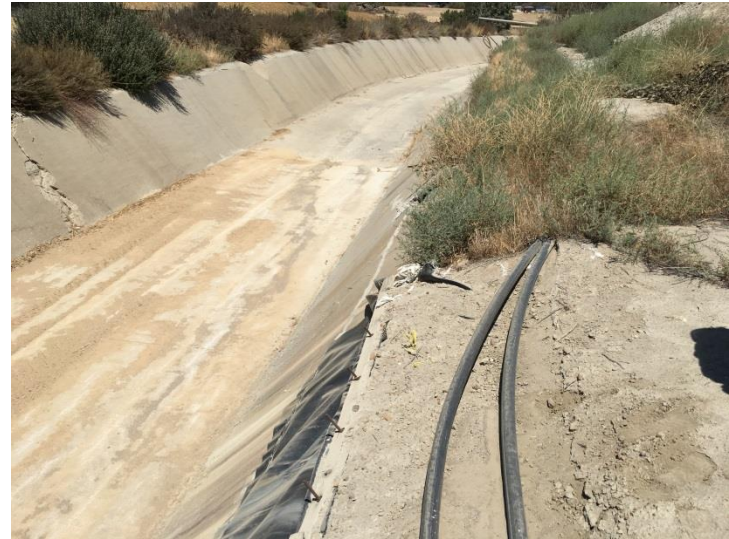
**Photo 46: Westside Drainage: July 27, 2016**

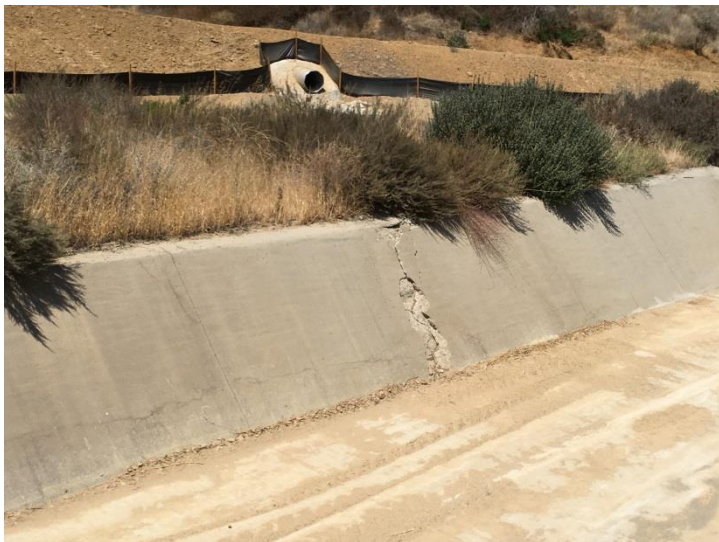
**Photo 47: Westside Drainage: July 27, 2016**

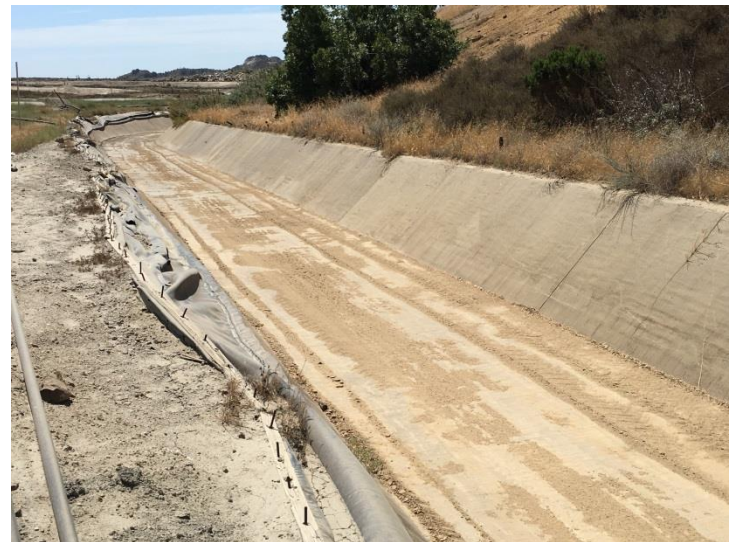
**Photo 48: Westside Drainage: July 27, 2016**

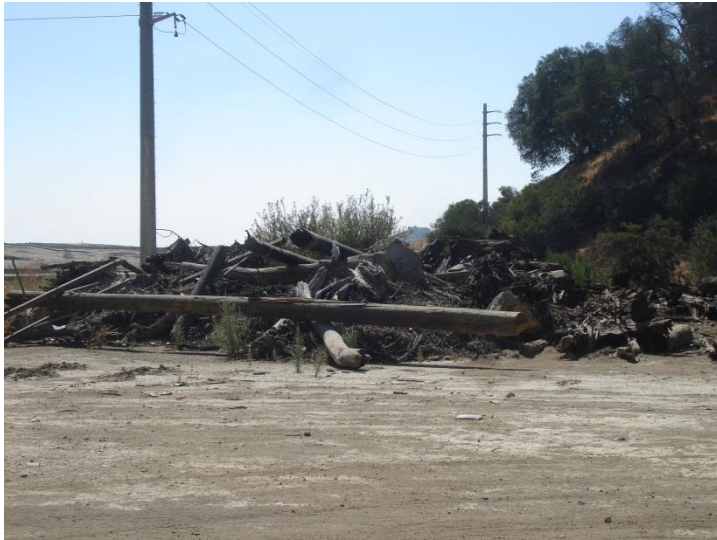
**Photo 53: Waste Adjacent to Basin D: September 14, 2016**

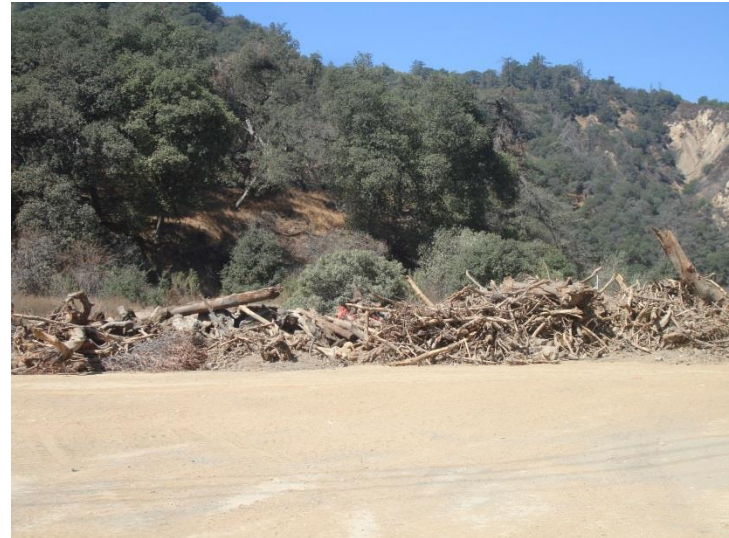
**Photo 54: Waste Adjacent to Basin D: September 14, 2016**

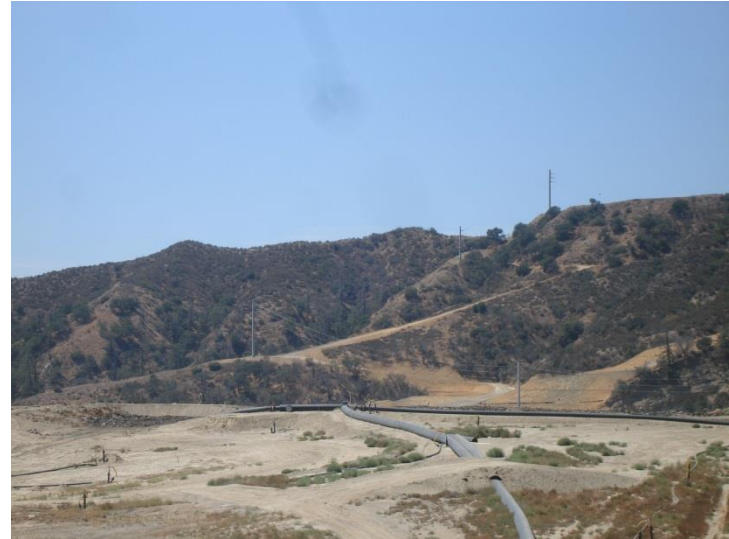
**Photo 58: Edison Pole Installation on County Slope: July 27, 2016**

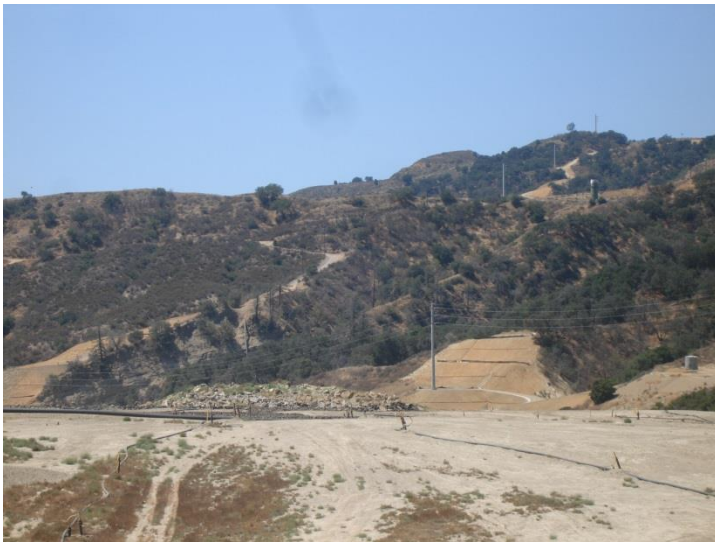
**Photo 59: Edison Pole Installation on County Slope: July 27, 2016**

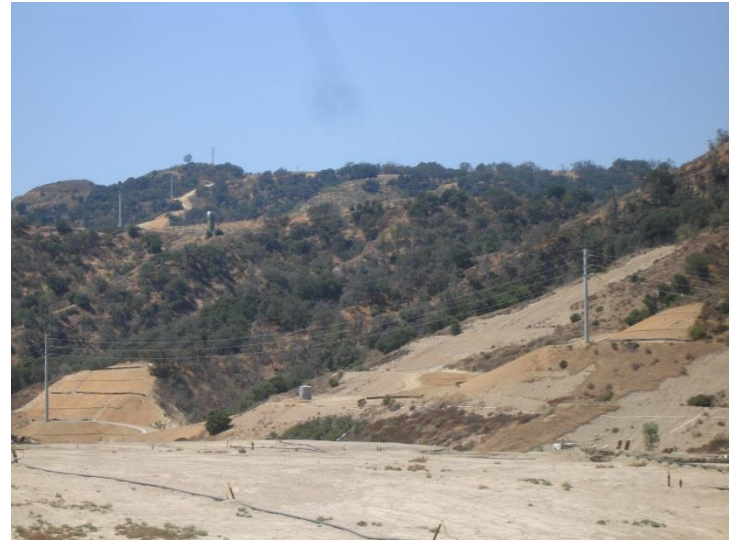
**Photo 60: Edison Pole Installation on County Slope: July 27, 2016**

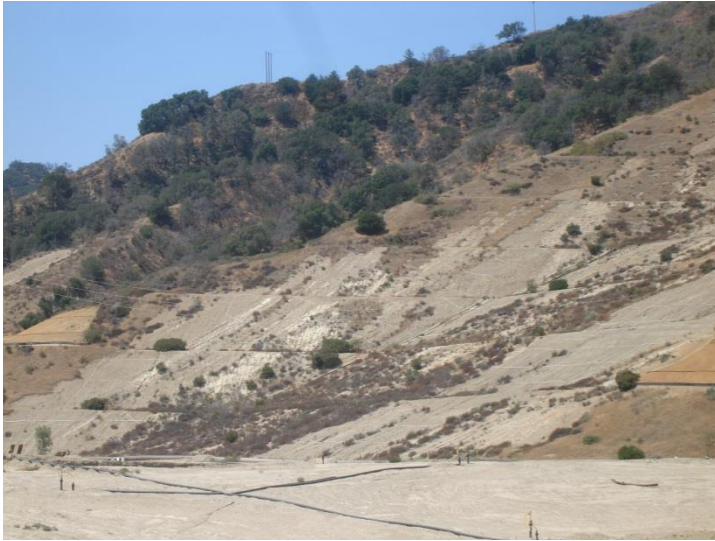
**Photo 61: Edison Pole Installation on County Slope: July 27, 2016**

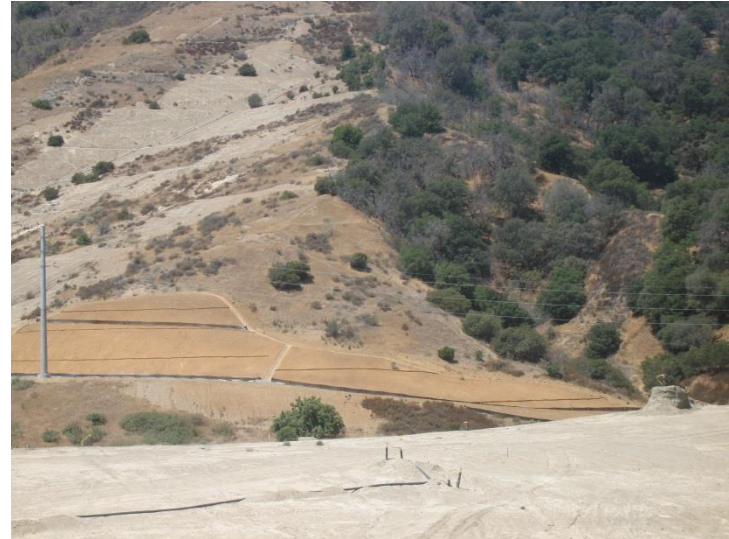
**Photo 62: Edison Pole Installation on County Slope: July 27, 2016**

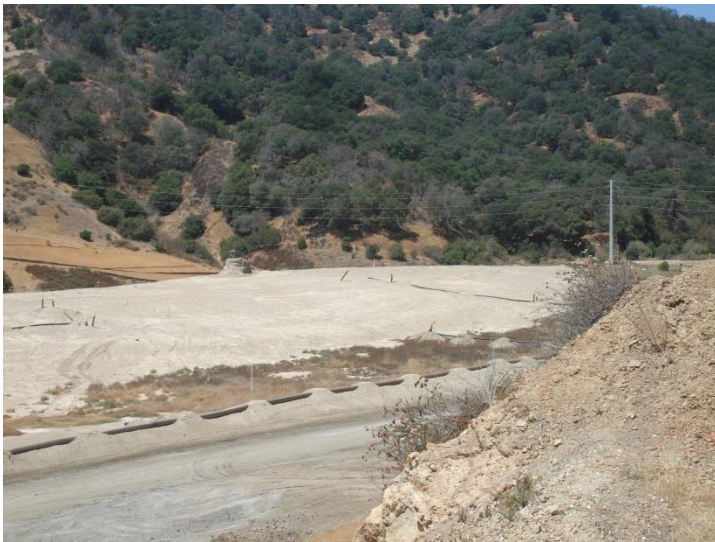
**Photo 63: Edison Pole Installation on County Slope: July 27, 2016**

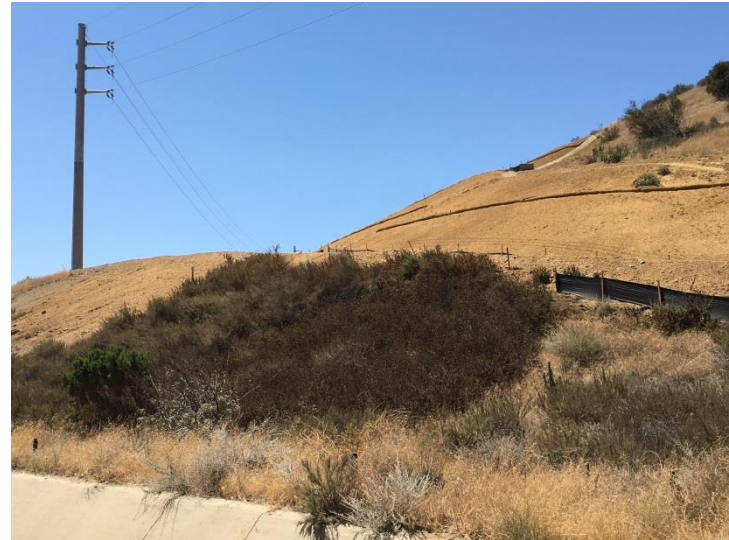
**Photo 64: Edison Pole Installation on County Slope: July 27, 2016**

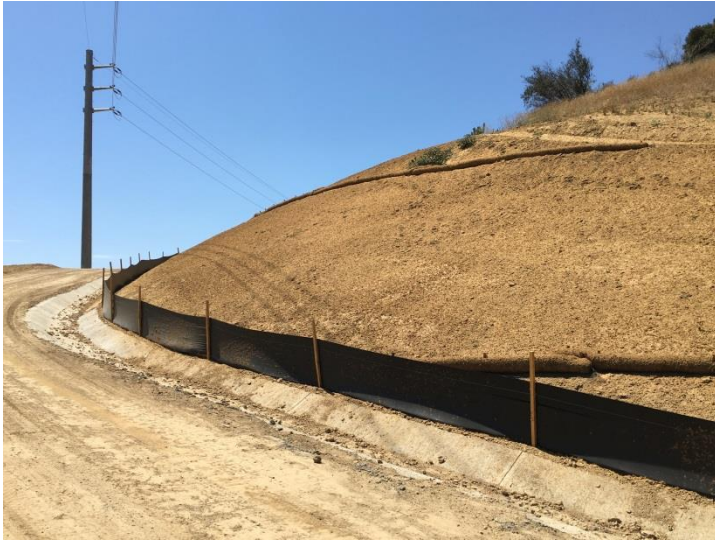
**Photo 65: Edison Pole Installation on County Slope: July 27, 2016**

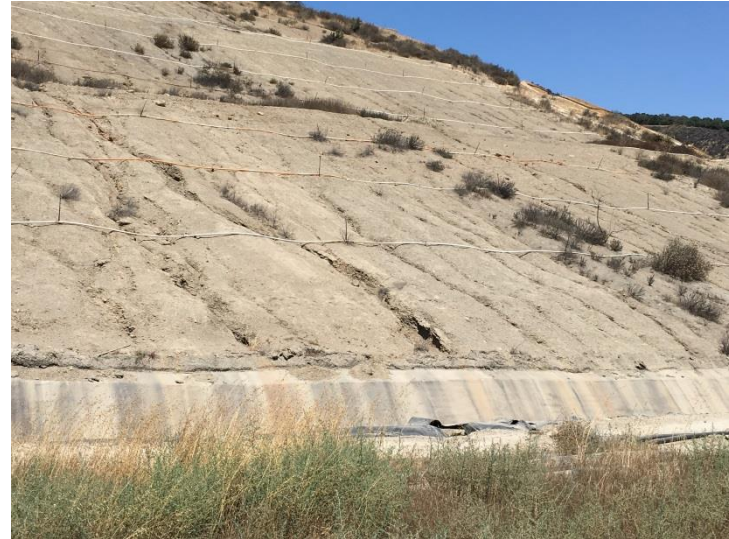
**Photo 66: Edison Pole Installation on County Slope: July 27, 2016**

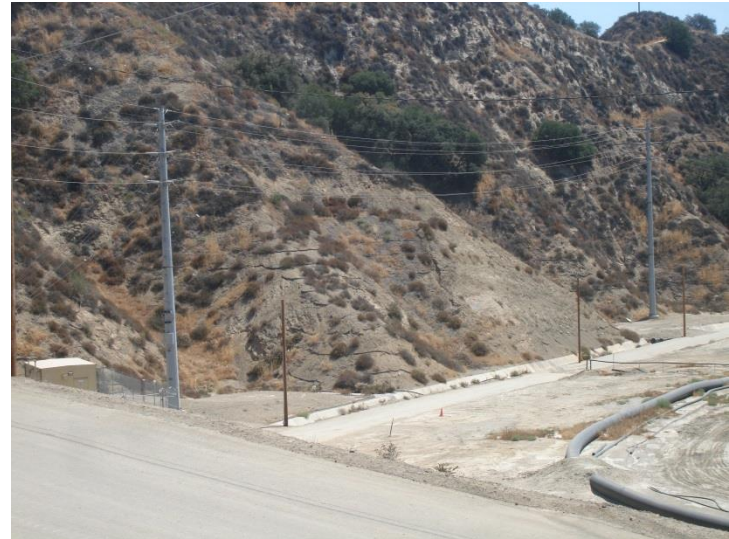
**Photo 69: Edison Unprotected Drainage Hazard at pole 38:  
September 14, 2016**

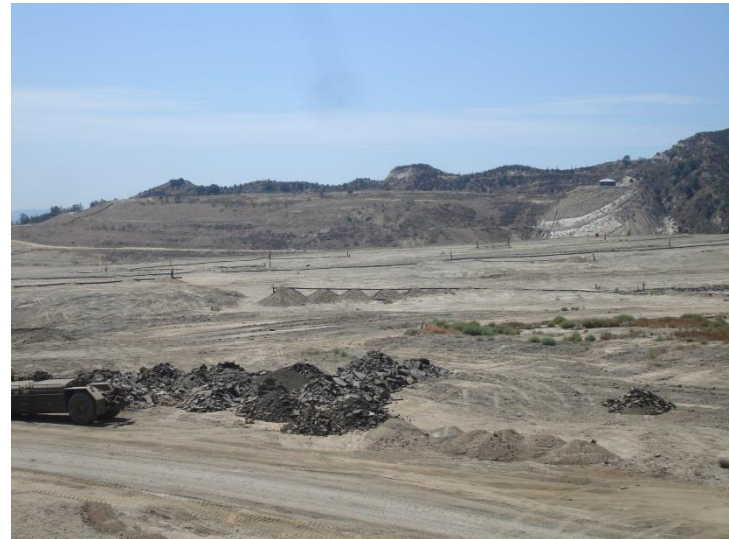
**Photo 80: County Top Deck Blowing Dust: July 27, 2016**

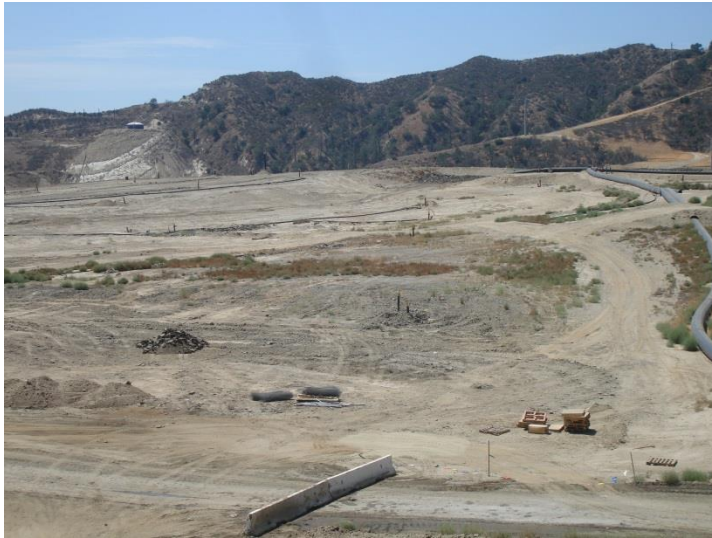
**Photo 81: County Top Deck Blowing Dust: July 27, 2016**

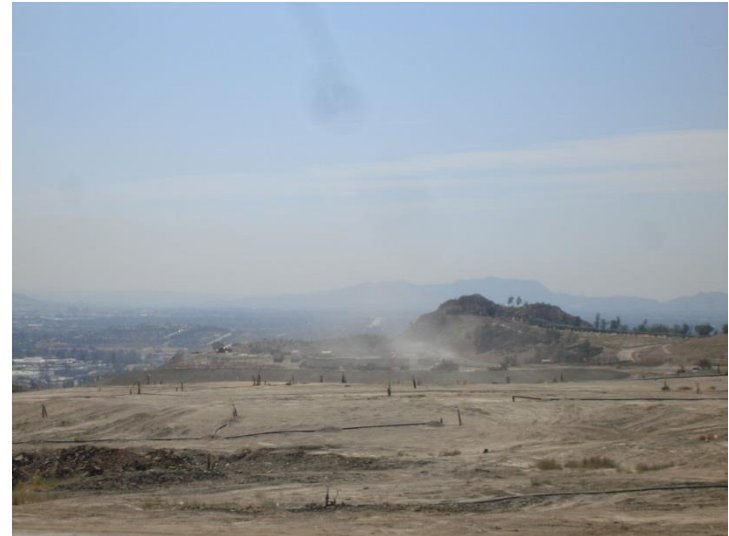
**Photo 82: County Top Deck Blowing Dust: July 27, 2016**

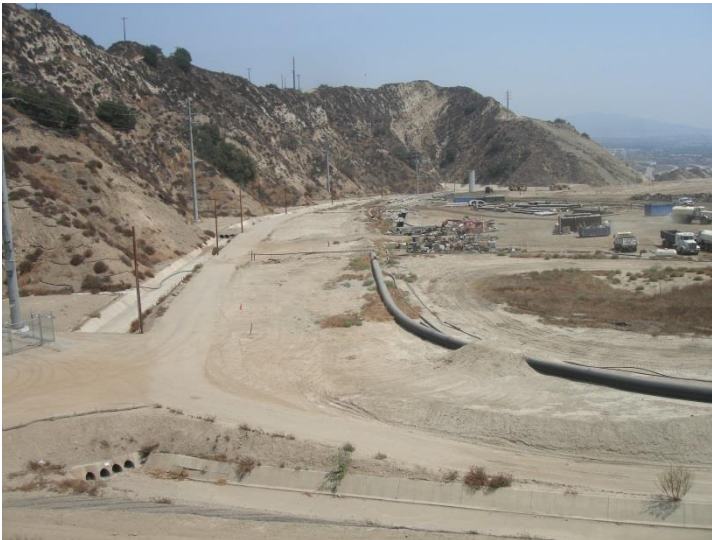
**Photo 83: County Top Deck: August 24, 2016**

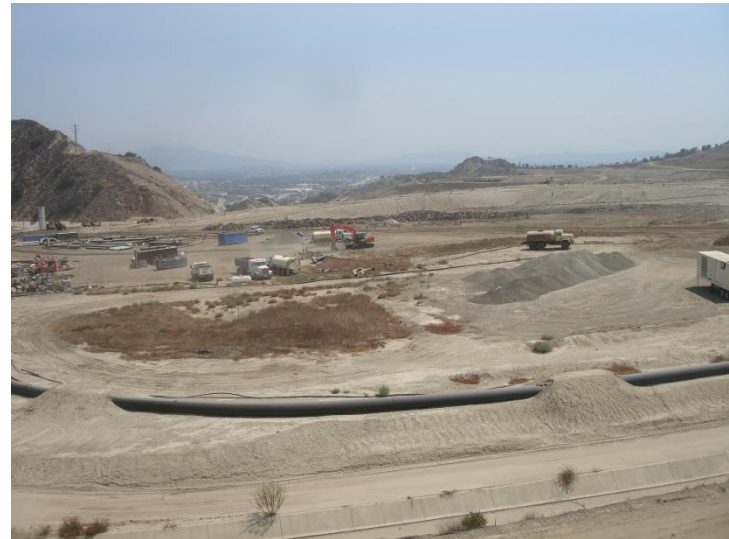
**Photo 84: County Top Deck: August 24, 2016**

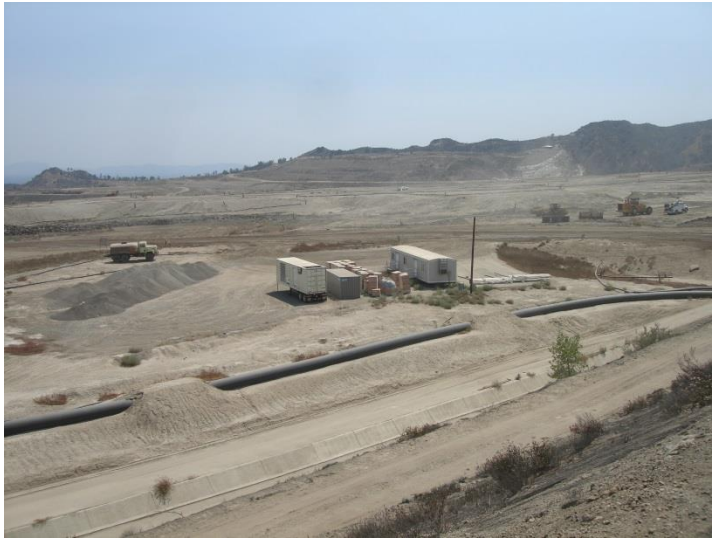
**Photo 85: County Top Deck: August 24, 2016**

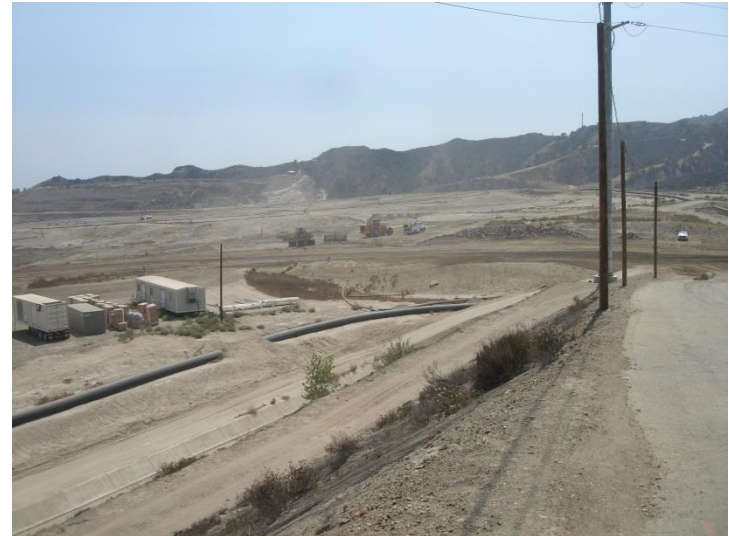
**Photo 86: County Top Deck: August 24, 2016**

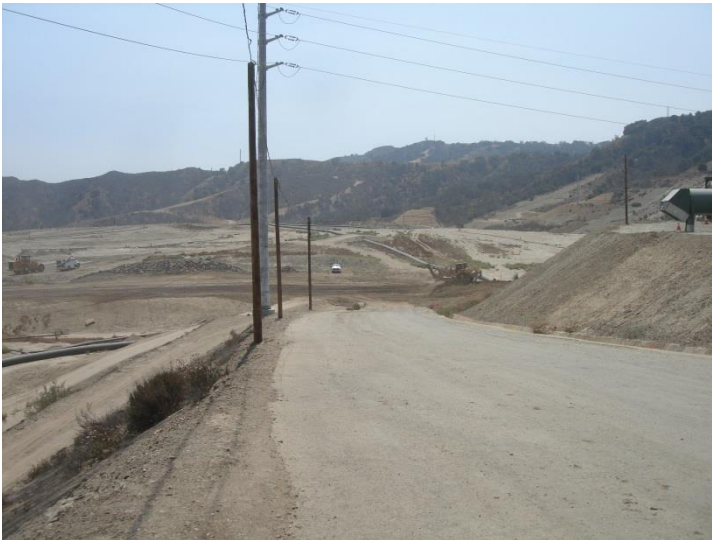
**Photo 87: County Top Deck: August 24, 2016**

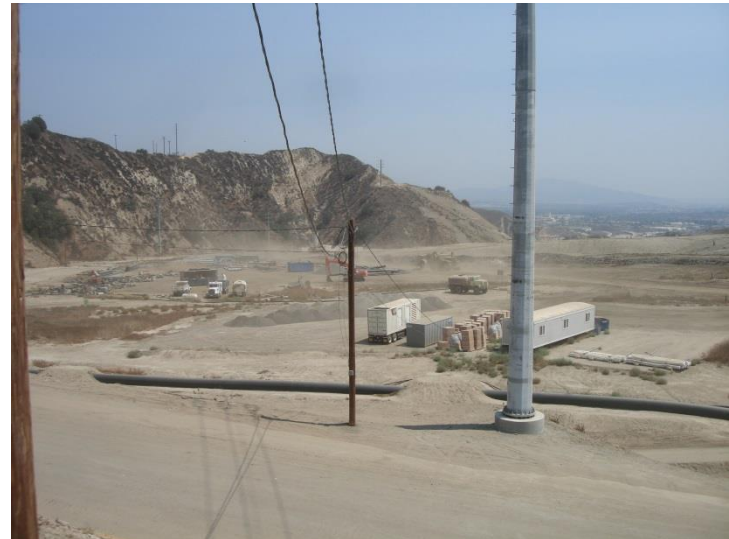
**Photo 88: County Top Deck Blowing Dust: August 24, 2016**

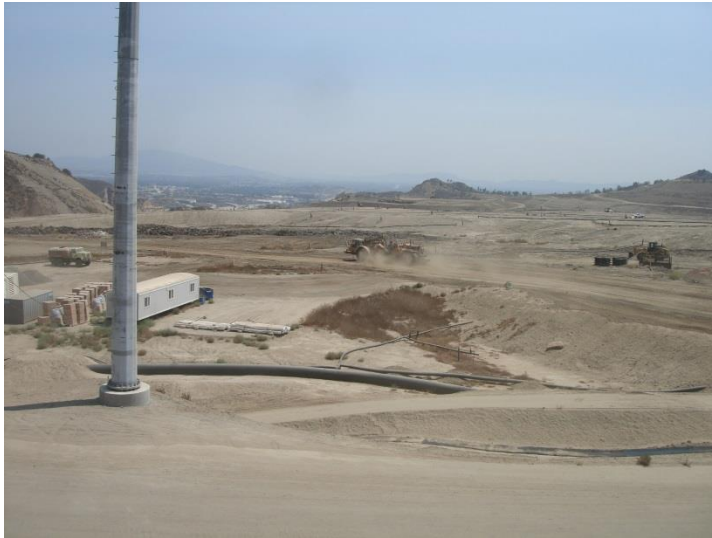
**Photo 89: County Top Deck Blowing Dust: August 24, 2016**

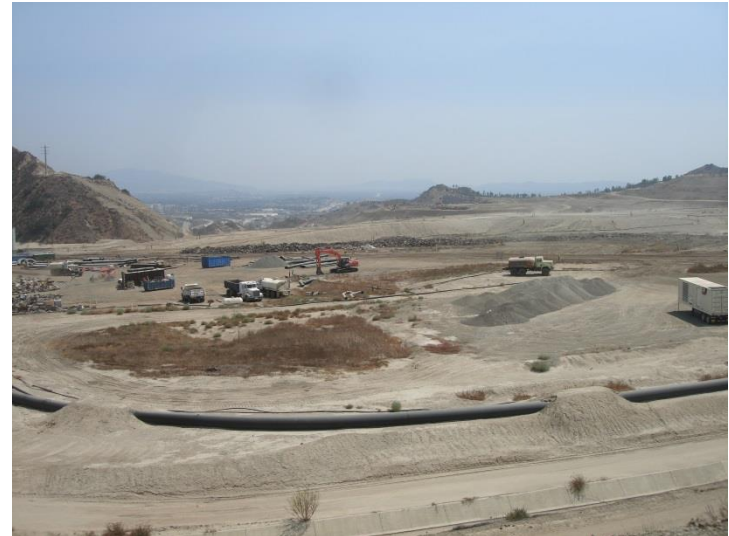
**Photo 90: County Top Deck Blowing Dust: August 24, 2016**

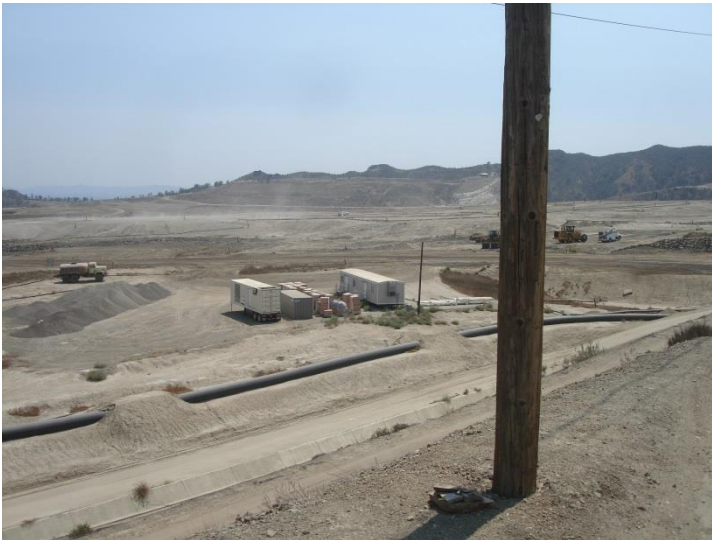
**Photo 91: County Top Deck Blowing Dust: August 24, 2016**

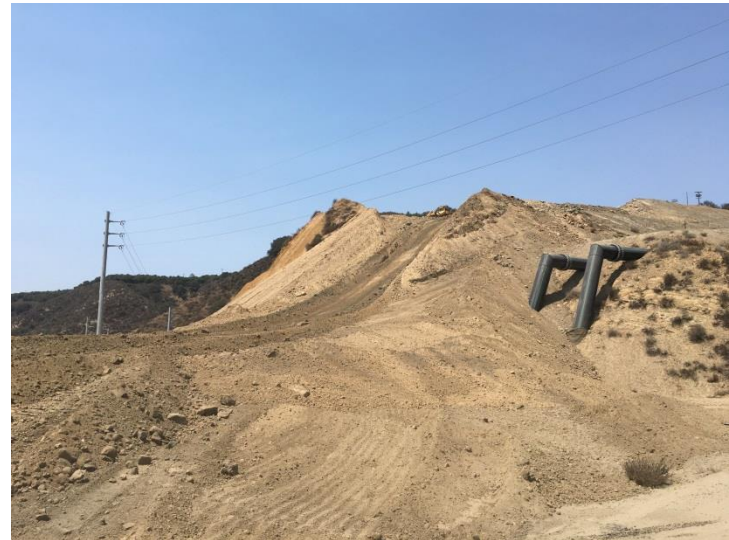
**Photo 108: Flare 11 Site Grading: August 24, 2016**

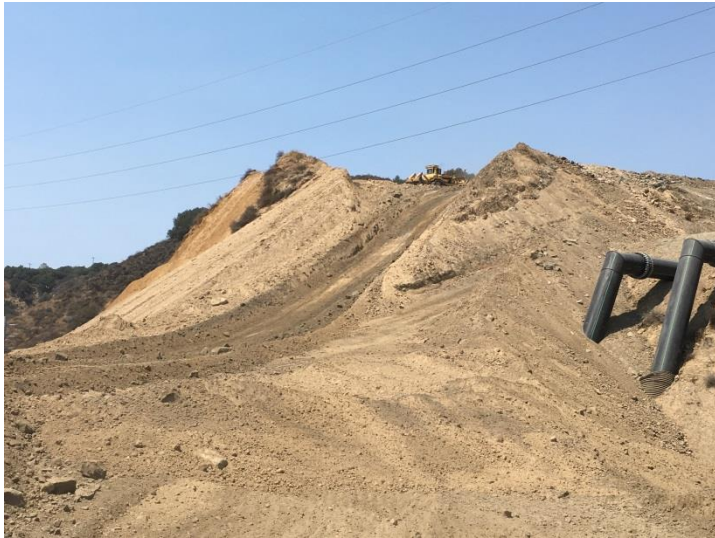
**Photo 109: Flare 11 Site Grading: August 24, 2016**

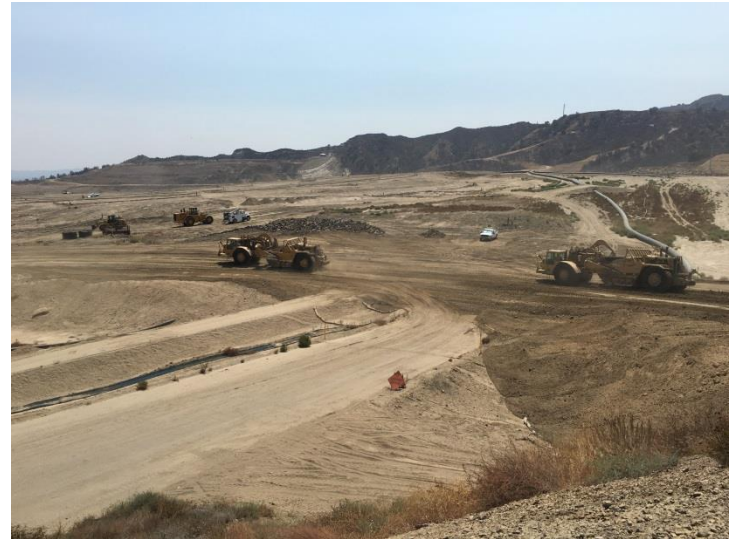
**Photo 110: Flare 11 Site Grading: August 24, 2016**

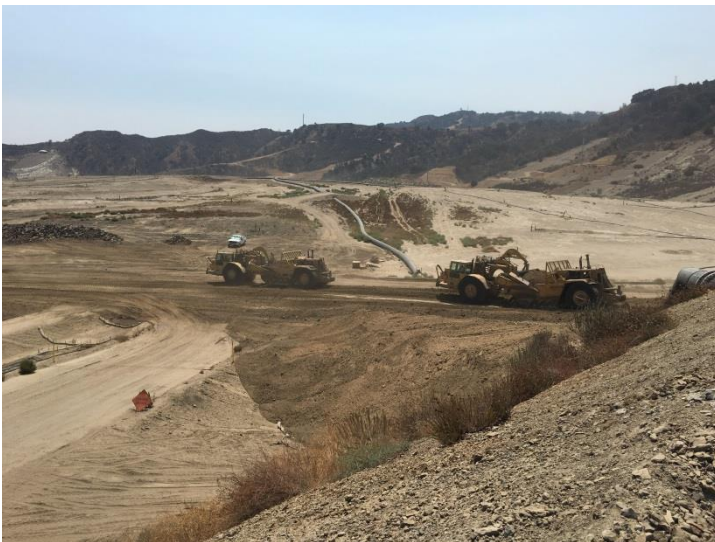
**Photo 111: Flare 11 Site Grading: August 24, 2016**

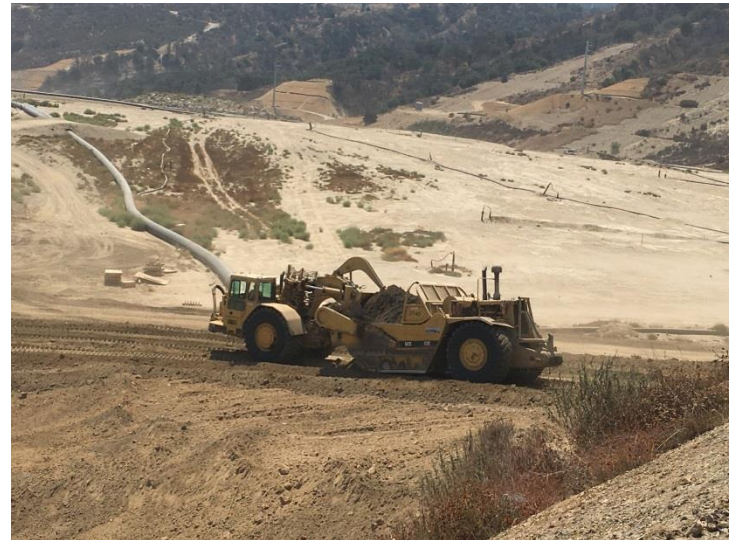
**Photo 112: Flare 11 Site Grading: August 24, 2016**

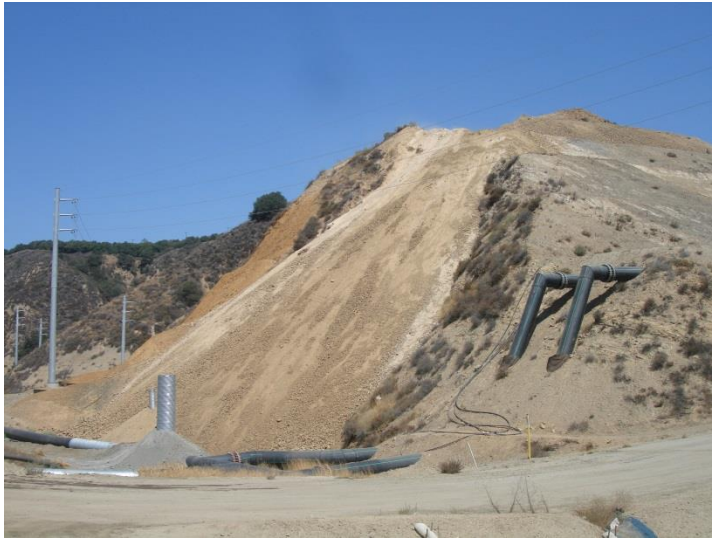
**Photo 113: Flare 9 & 10 Back Hill: July 27, 2016**

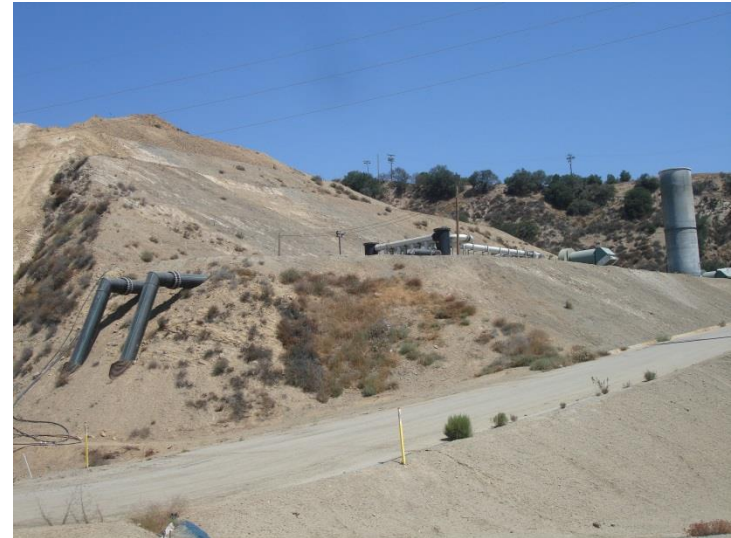
**Photo 114: Flare 9 & 10 Back Hill: July 27, 2016**

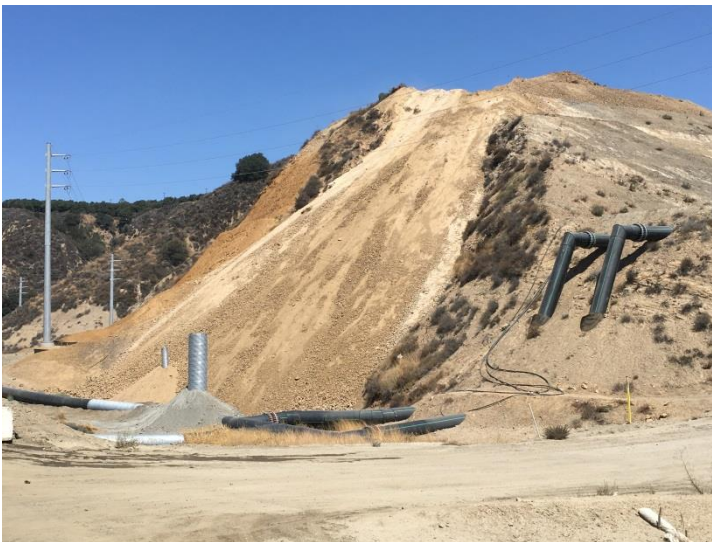
**Photo 115: Flare 9 & 10 Back Hill: July 27, 2016**

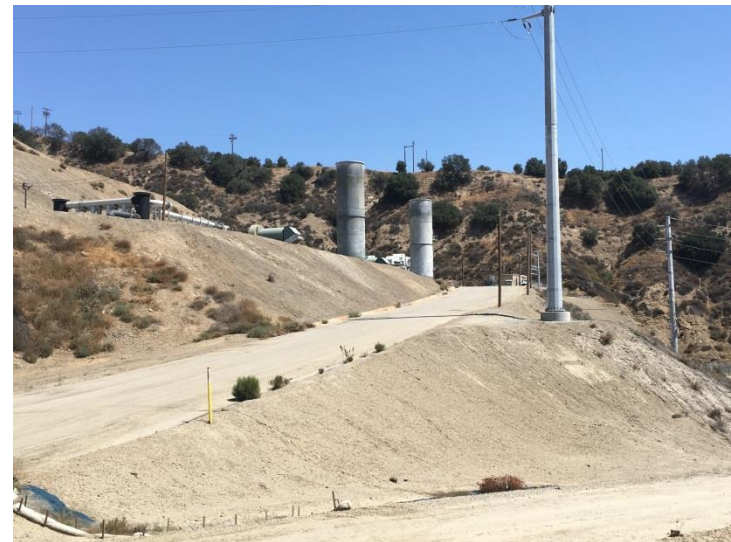
**Photo 116: Flare 9 & 10 Back Hill: July 27, 2016**

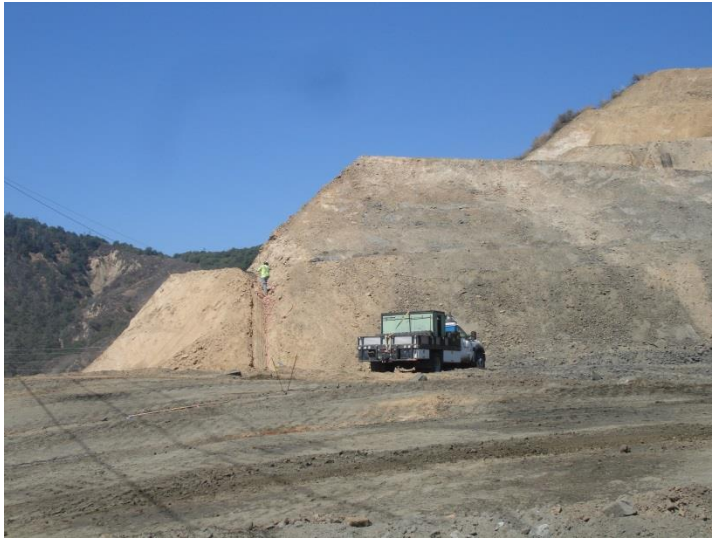
**Photo 117: Flare 11 Site Grading: September 14, 2016**

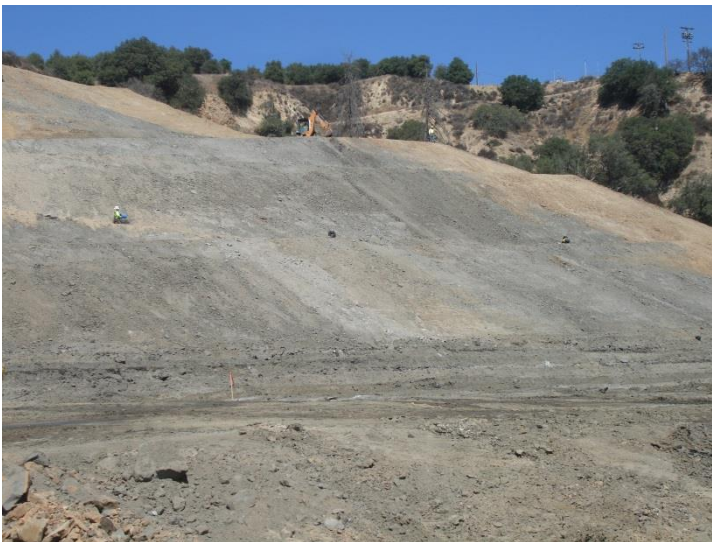
**Photo 119: Flare 11 Site Grading: September 14, 2016**

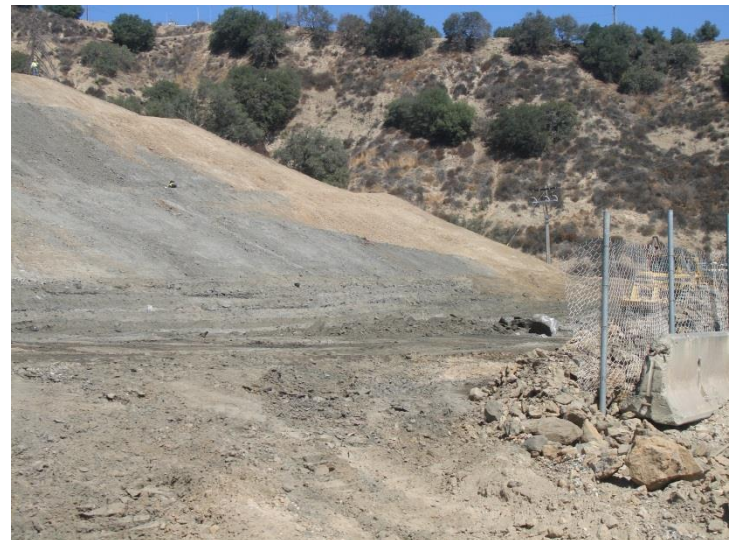
**Photo 120: Flare 11 Site Grading: September 14, 2016**

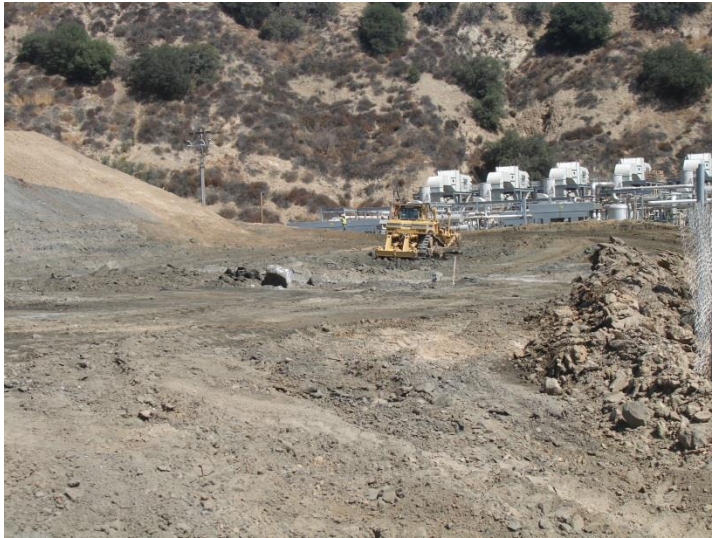
**Photo 121: Flare 11 Site Grading: September 14, 2016**

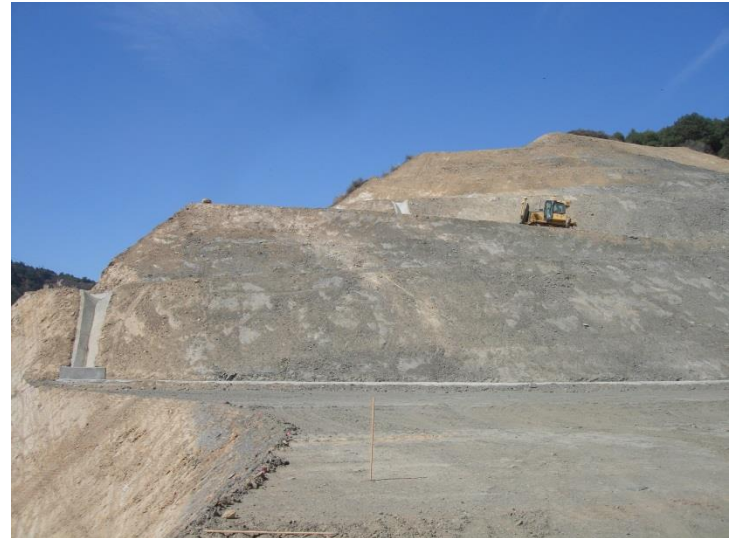
**Photo 122: Flare 11 Site Grading: September 27, 2016**

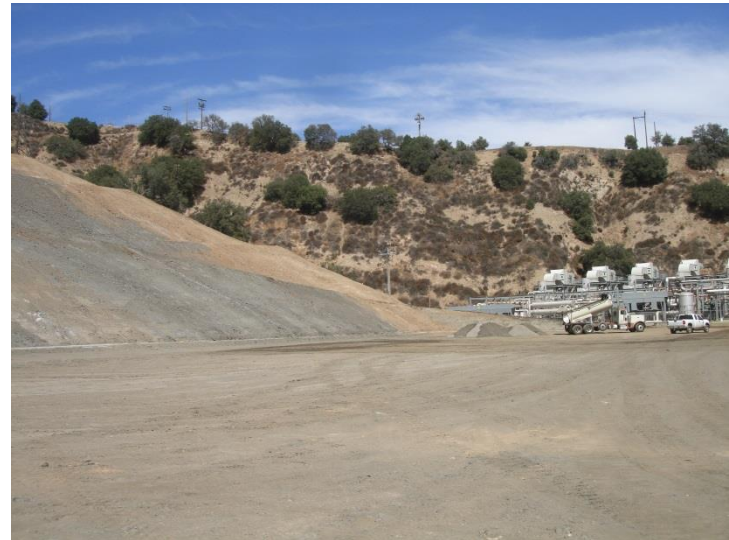
**Photo 123: Flare 11 Site Grading: September 27, 2016**

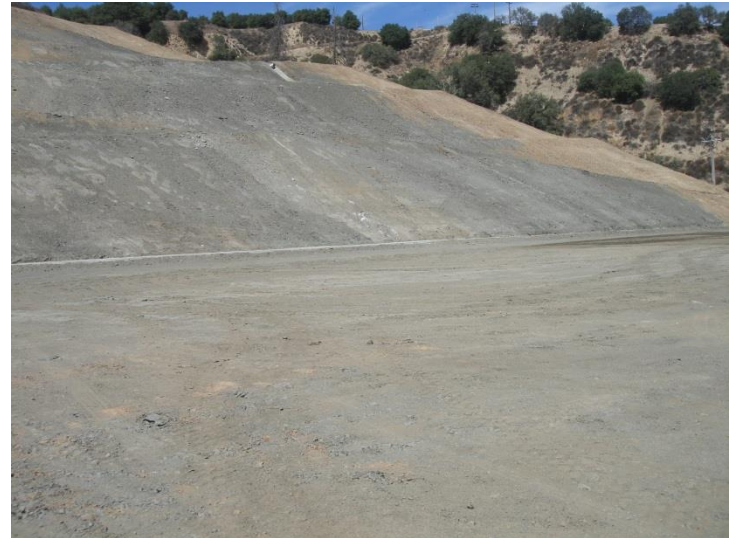
**Photo 125: Flare 11 Site Grading: September 27, 2016**

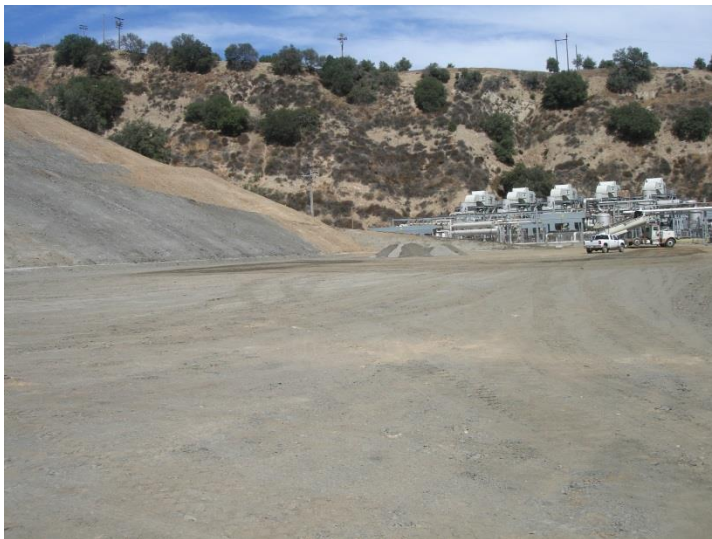
**Photo 126: Flare 11 Site Grading: September 27, 2016**

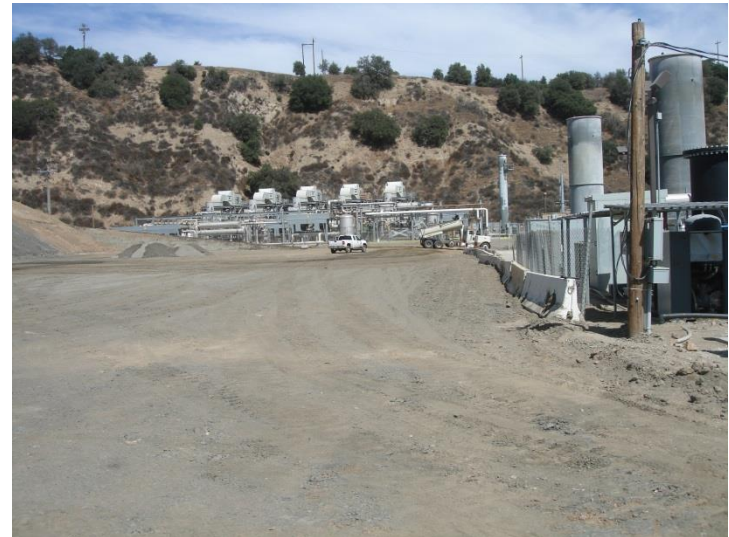
**Photo 127: Flare 11 Site Grading: September 27, 2016**

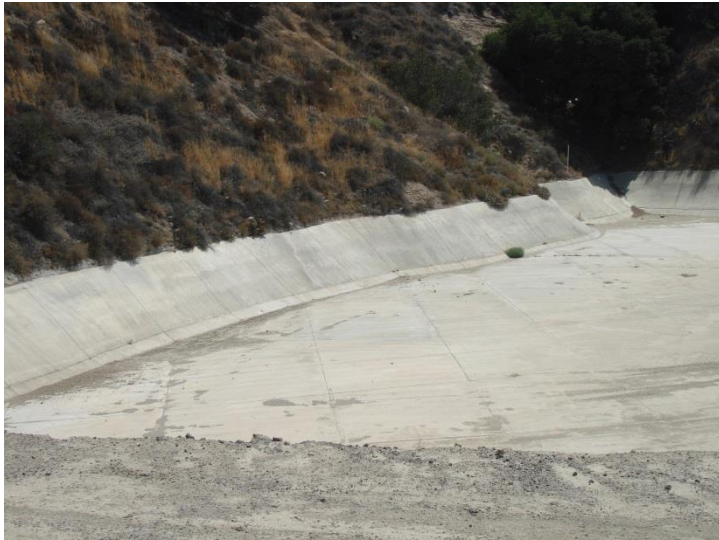
**Photo 128: Flare 11 Site Grading: September 27, 2016**
