**Sunshine Canyon Landfill  
Independent Monitor  
Quarterly Site Monitoring Status Report  
July 1, 2016 – September 30, 2016**

**City of Los Angeles Department of City Planning**

**County of Los Angeles Department of Regional Planning**

December 22, 2016

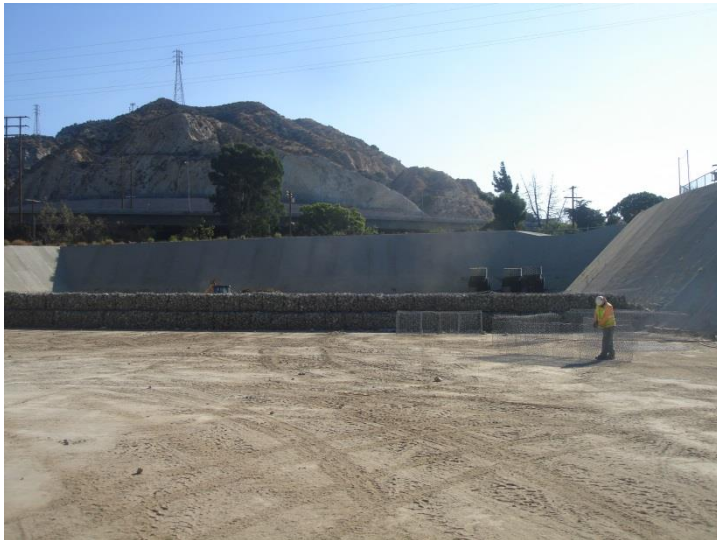
**Photo 178: Terminal Basin Inlet: September 14, 2016**

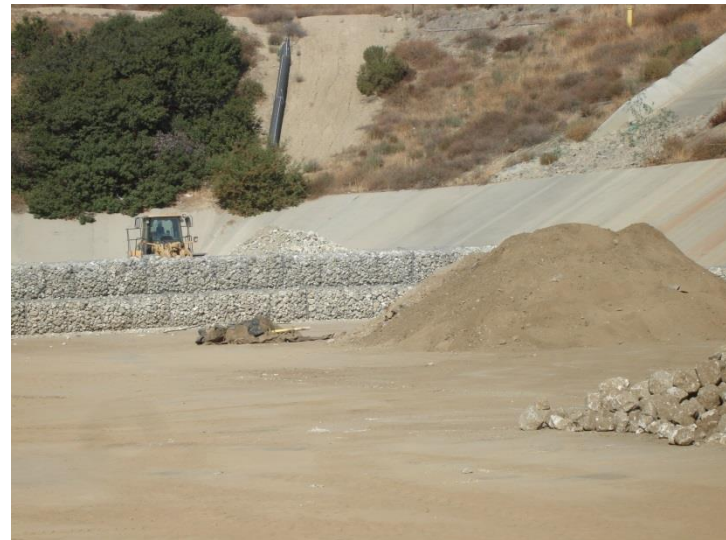
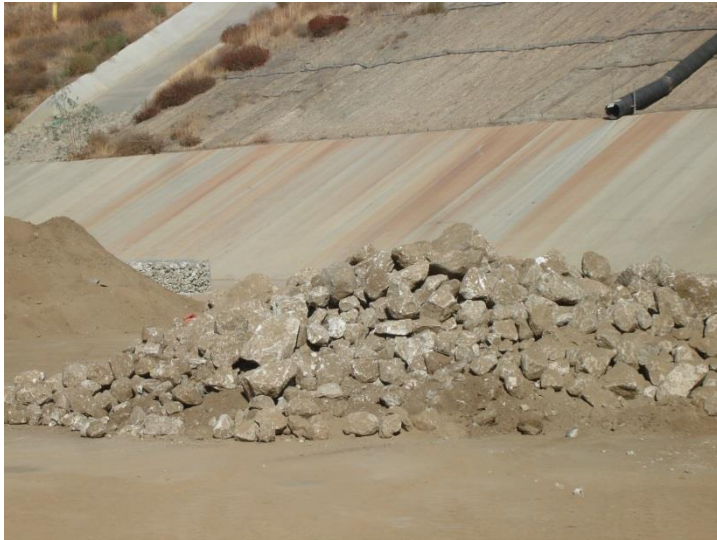
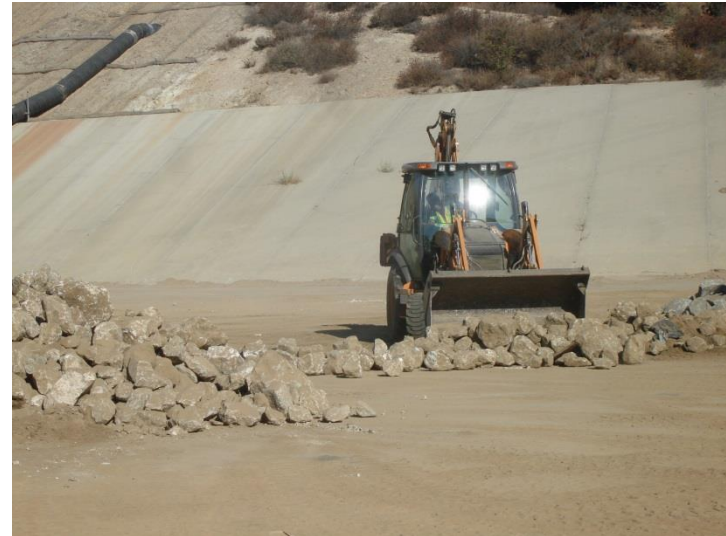
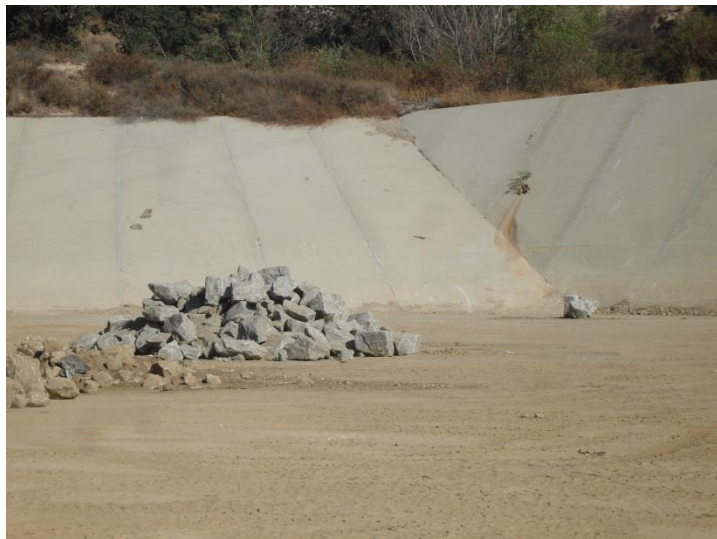
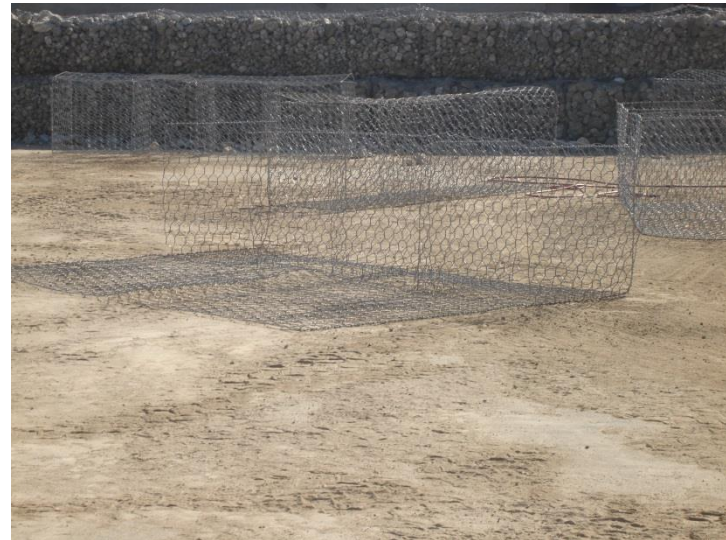
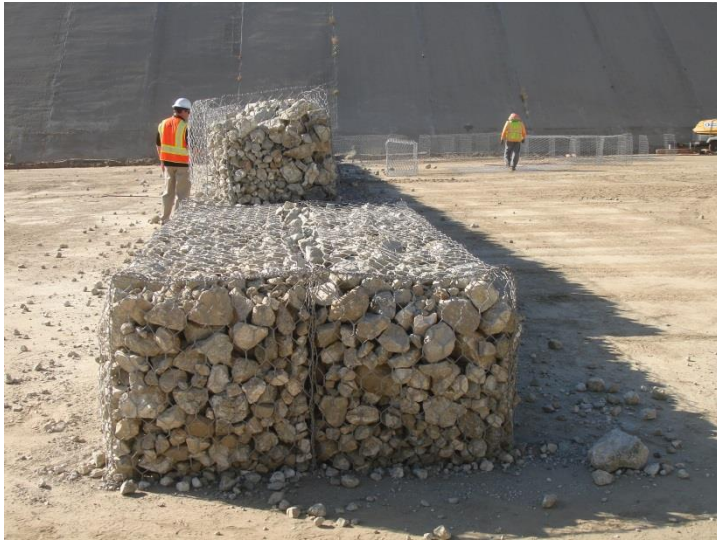
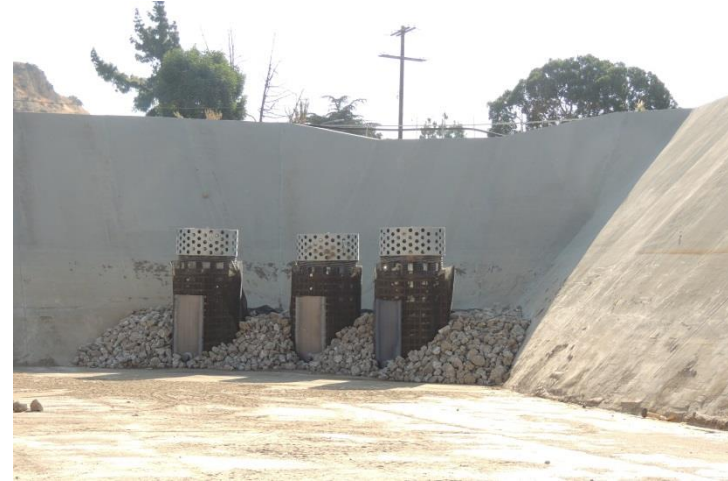
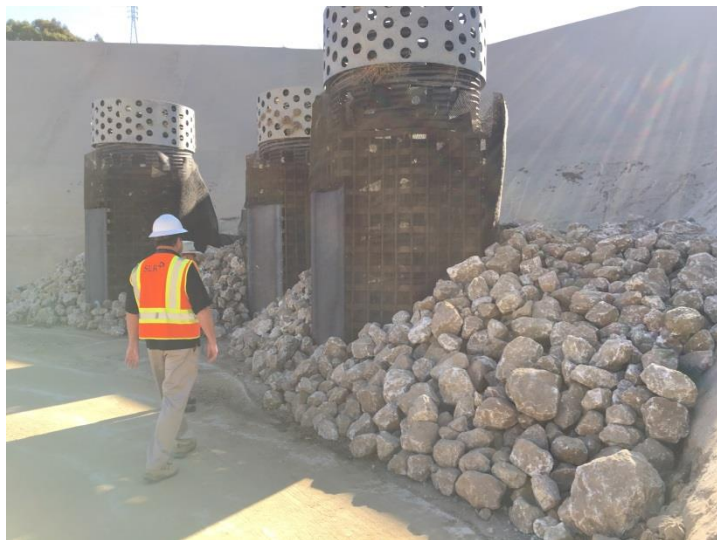
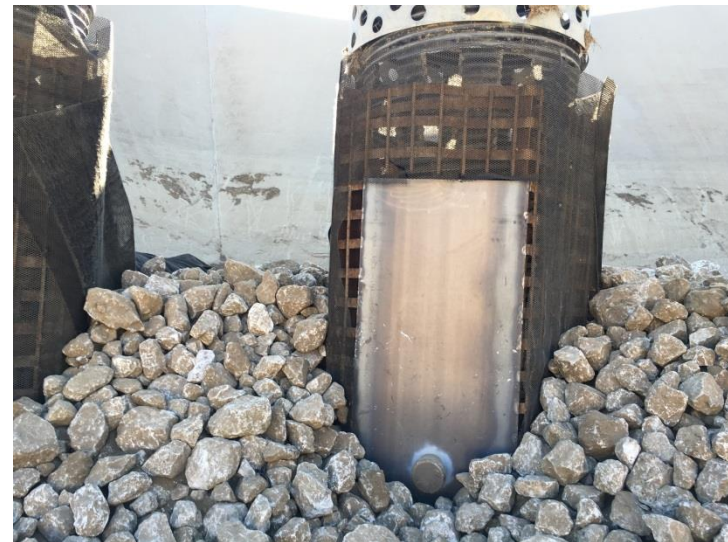
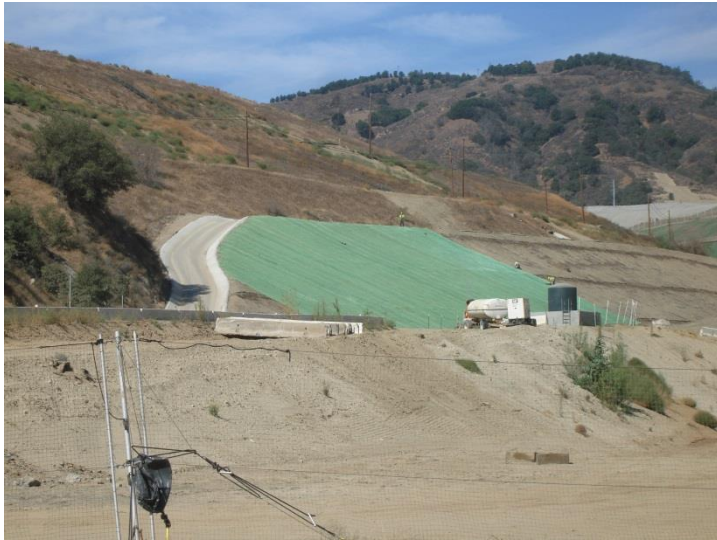
**Photo 179: Terminal Basin: September 14, 2016**

**Photo 180: Terminal Basin: September 14, 2016**

**Photo 181: Terminal Basin: September 14, 2016**

**Photo 182: Terminal Basin: September 14, 2016**

**Photo 183: Terminal Basin: September 14, 2016**

**Photo 184: Terminal Basin: September 14, 2016**

**Photo 185: Terminal Basin: September 14, 2016**

**Photo 186: Terminal Basin: September 14, 2016**

**Photo 187: Terminal Basin: September 14, 2016**

**Photo 188: Terminal Basin: September 14, 2016**

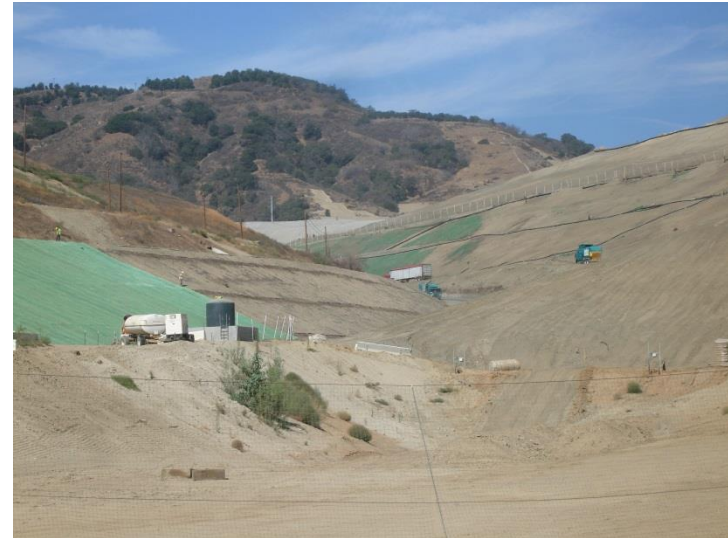
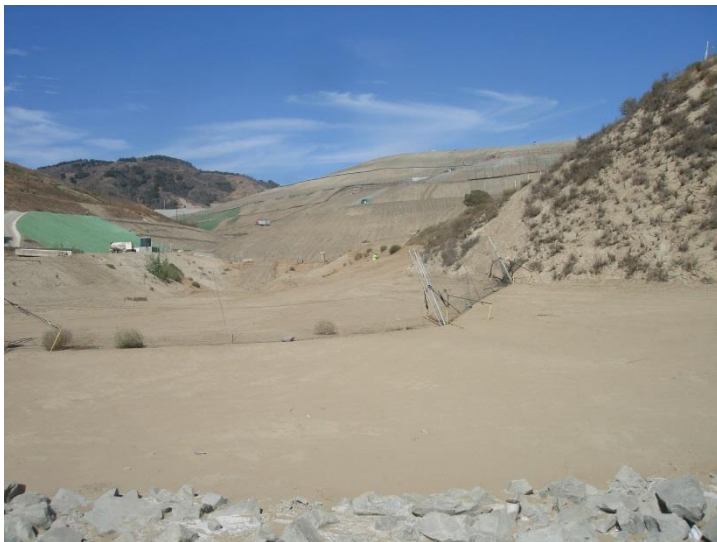
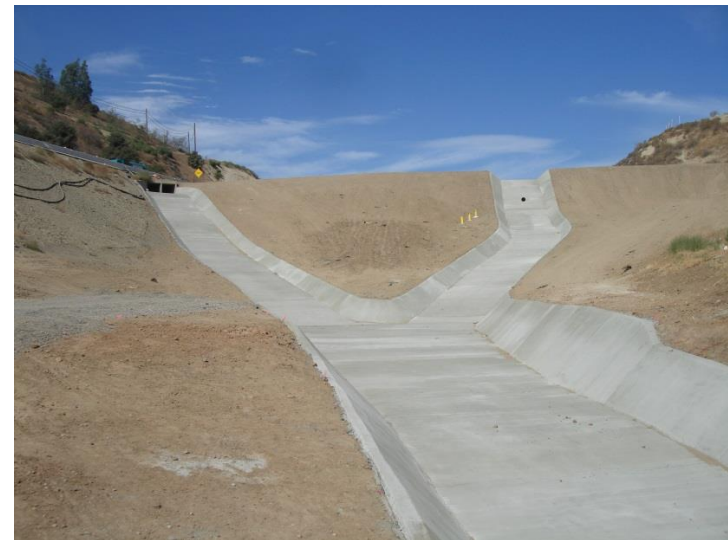
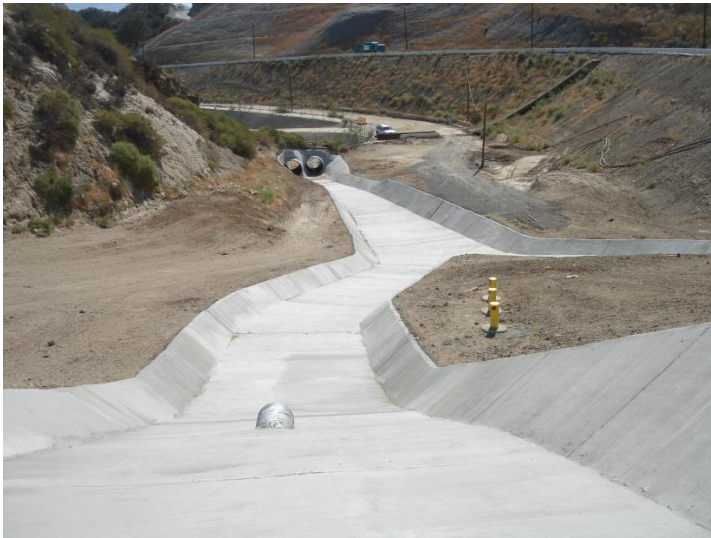
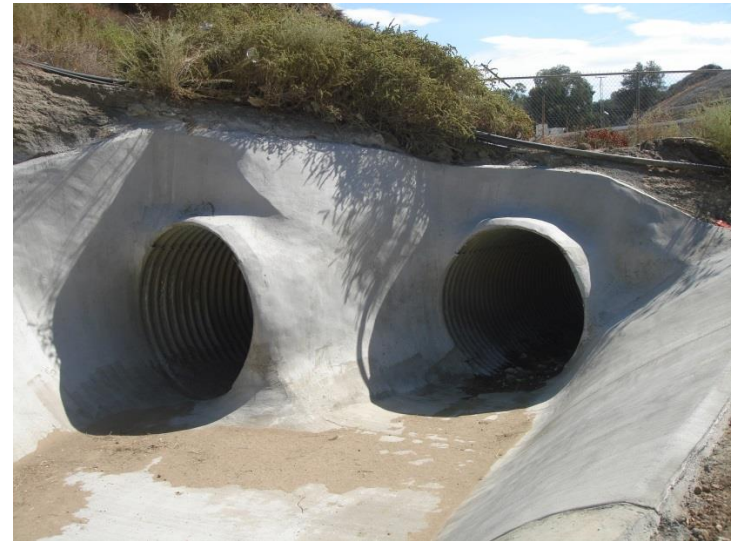
**Photo 189: Cell CC3B Drainage to Terminal Basin: September 27, 2016**

**Photo 190: Cell CC3B Drainage to Terminal Basin: September 27, 2016**

**Photo 191: Cell CC3B Drainage to Terminal Basin: September 27, 2016**

**Photo 192: Cell CC3B Drainage to Terminal Basin: September 27, 2016**

**Photo 193: Cell CC3B Drainage to Terminal Basin: September 27, 2016**

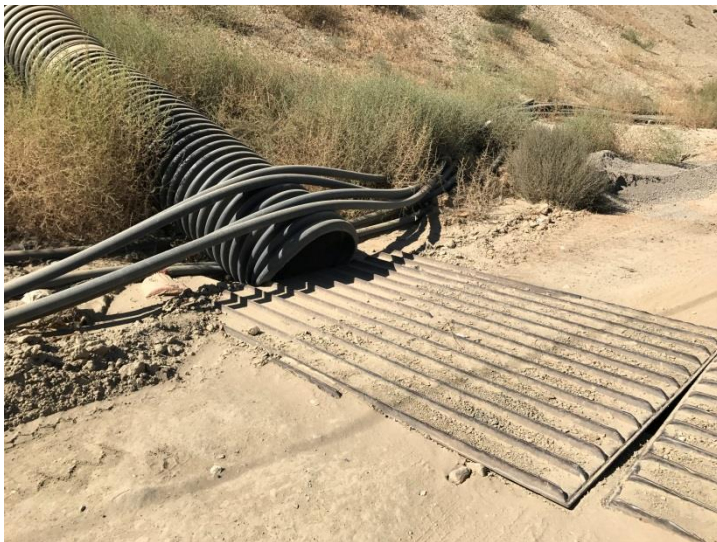
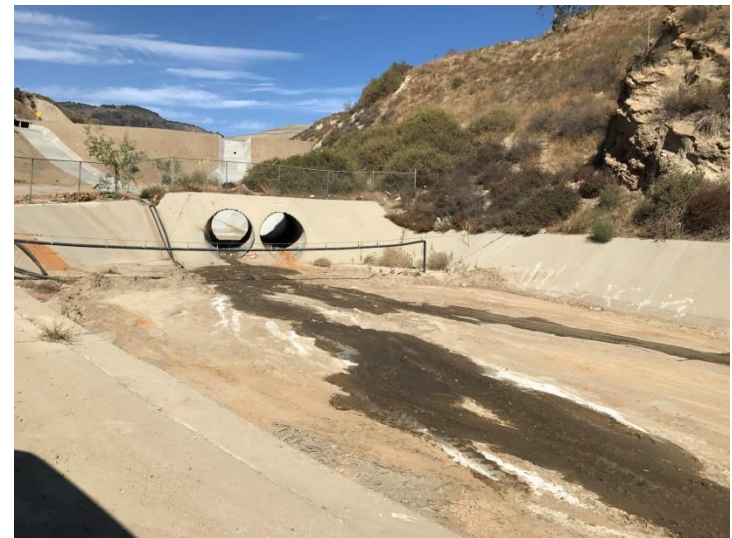
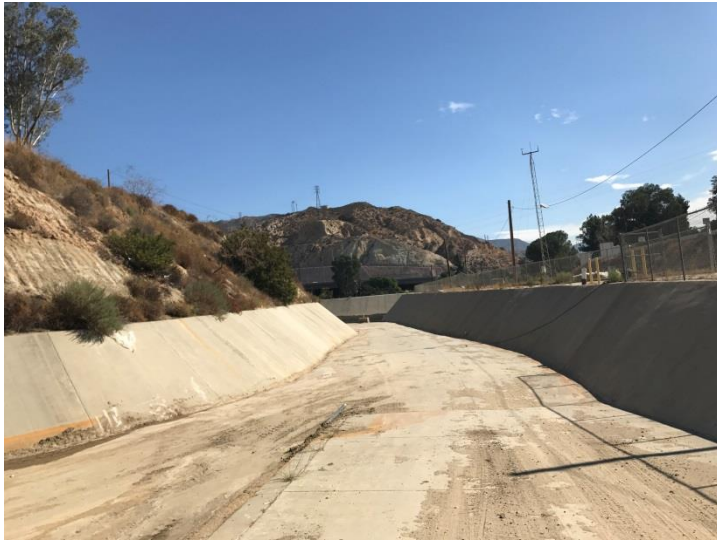
**Photo 194: Cell CC3B Drainage to Terminal Basin Inlet: September 27, 2016**

**Photo 195: Cell CC3B Drainage to Terminal Basin Inlet: September 27, 2016**

**Photo 196: Cell CC3B Drainage to Terminal Basin Inlet: September 27, 2016**

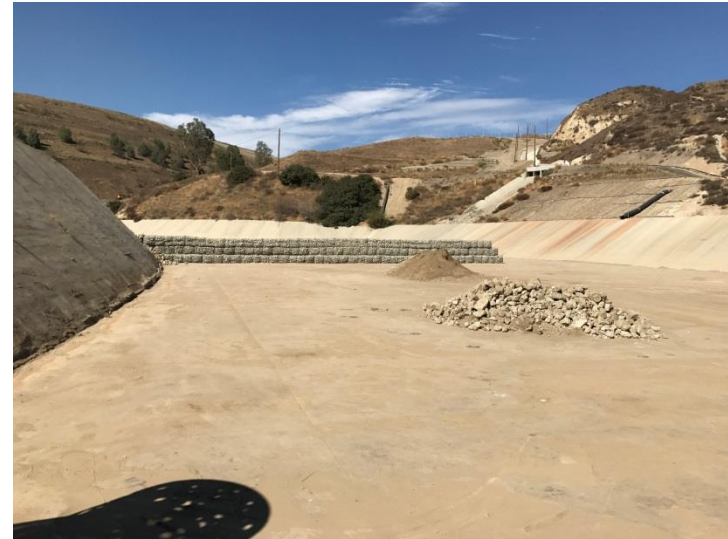
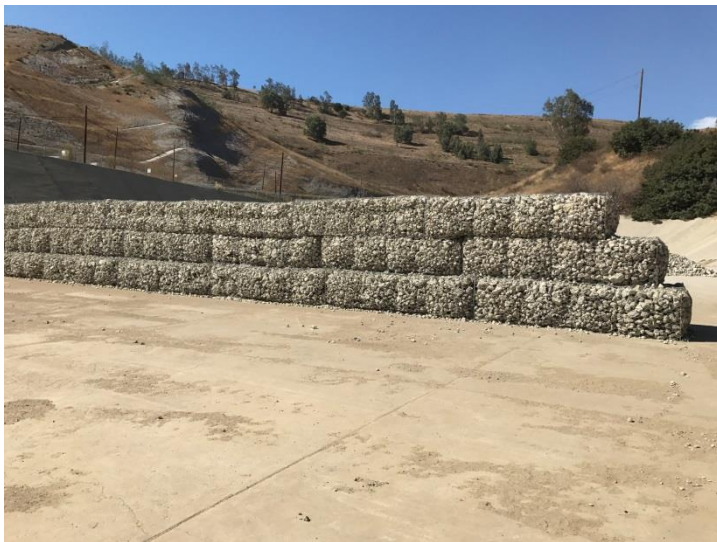
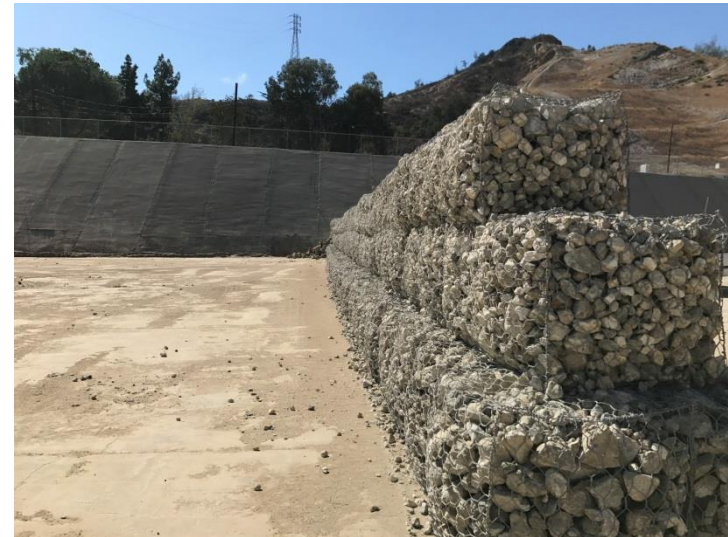
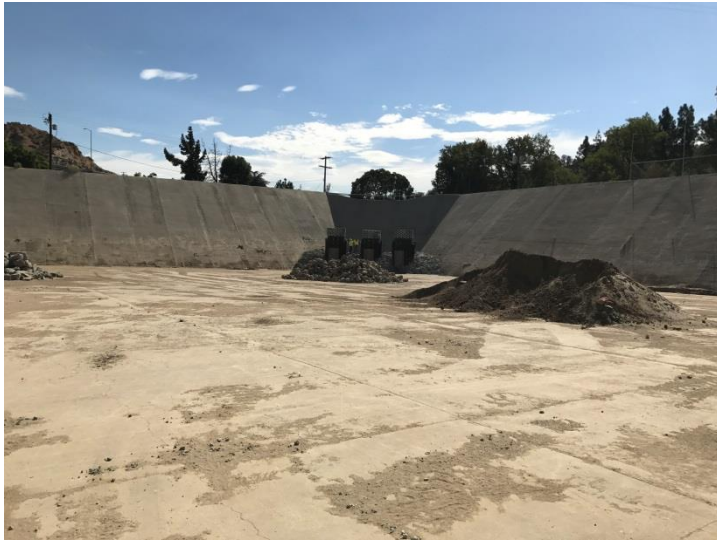
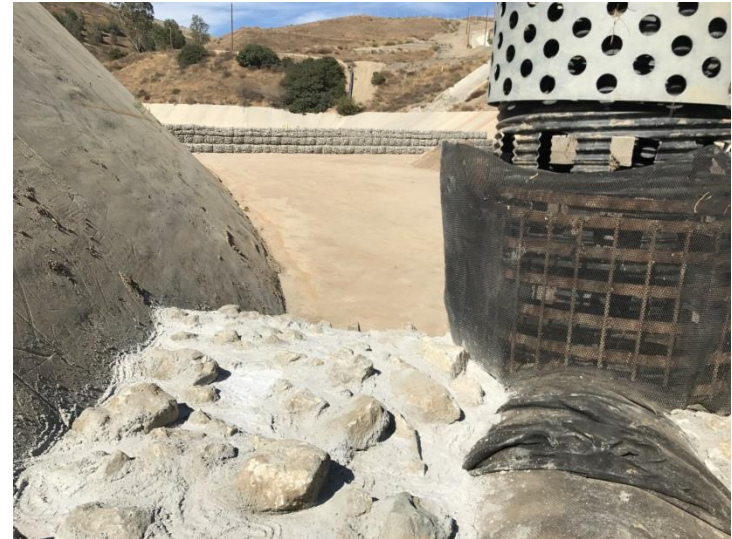
**Photo 197: Terminal Basin: September 27, 2016**

**Photo 198: Terminal Basin: September 27, 2016**

**Photo 199: Terminal Basin: September 27, 2016**

**Photo 200: Terminal Basin: September 27, 2016**

**Photo 201: Terminal Basin: September 27, 2016**

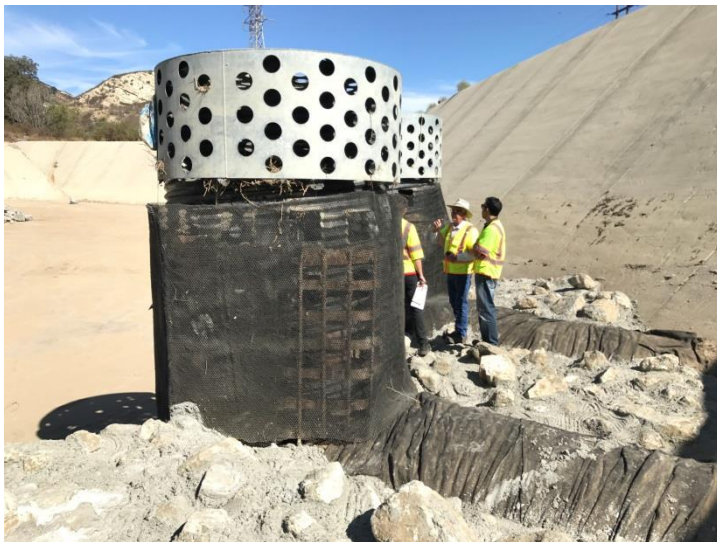
**Photo 202: Terminal Basin: September 27, 2016**

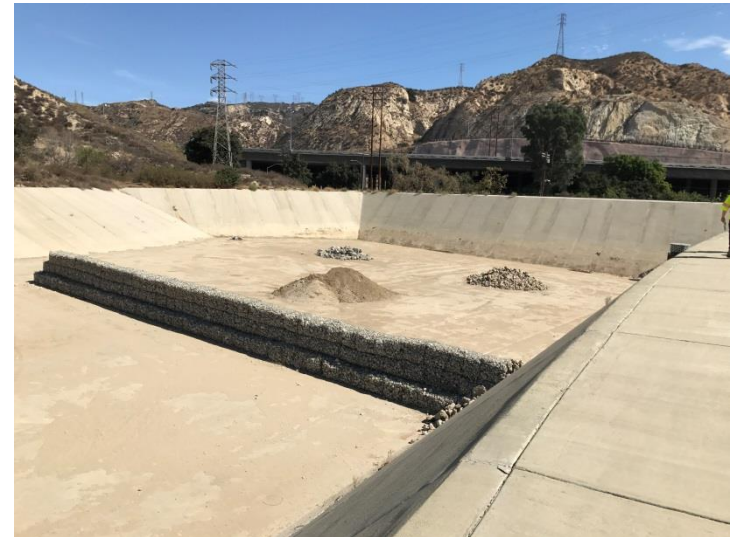
**Photo 203: Terminal Basin: September 27, 2016**

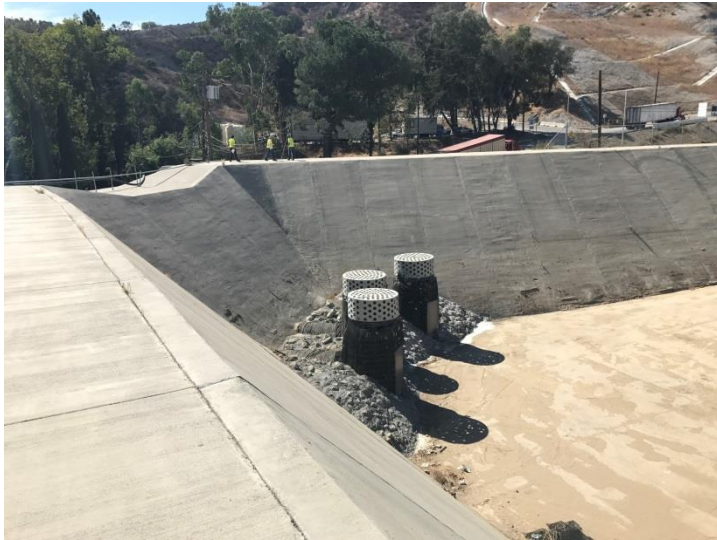
**Photo 204: Terminal Basin: September 27, 2016**

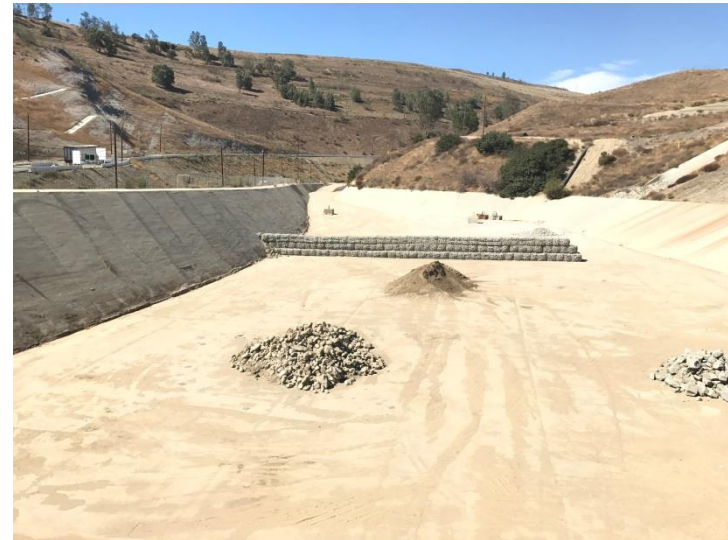
**Photo 205: Terminal Basin: September 27, 2016**

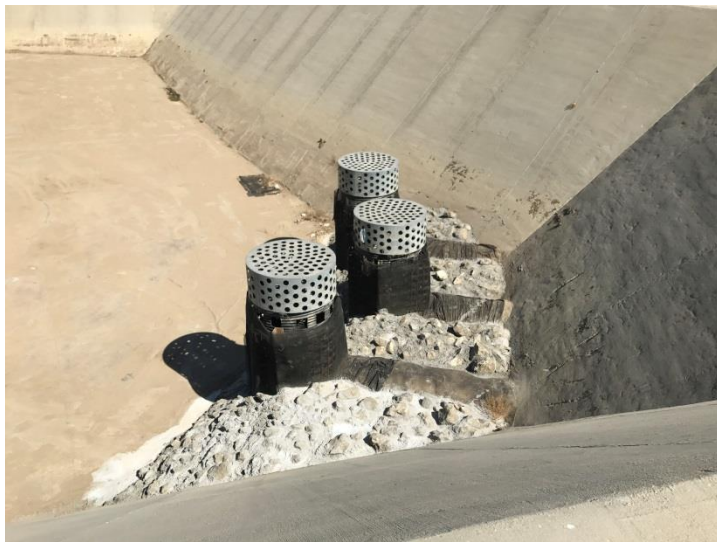
**Photo 206: Terminal Basin: September 27, 2016**

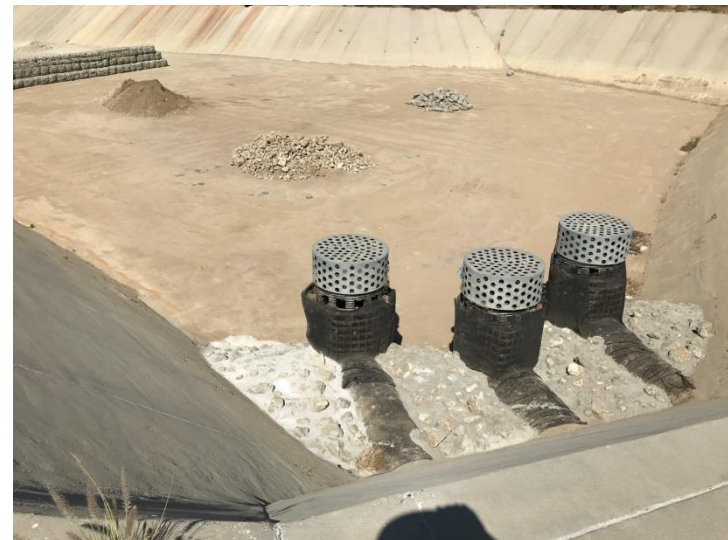
**Photo 207: Terminal Basin: September 27, 2016**

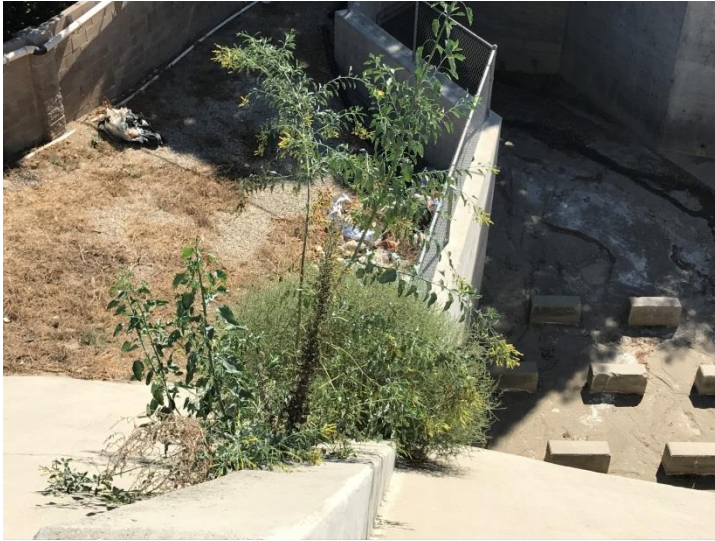
**Photo 208: Terminal Basin: September 27, 2016**

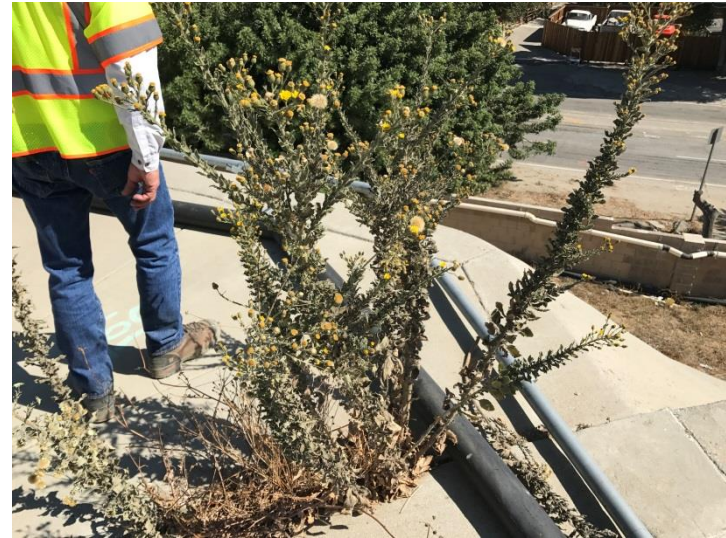
**Photo 209: Vegetation Growing Out of Terminal Basin Concrete:  
September 27, 2016**

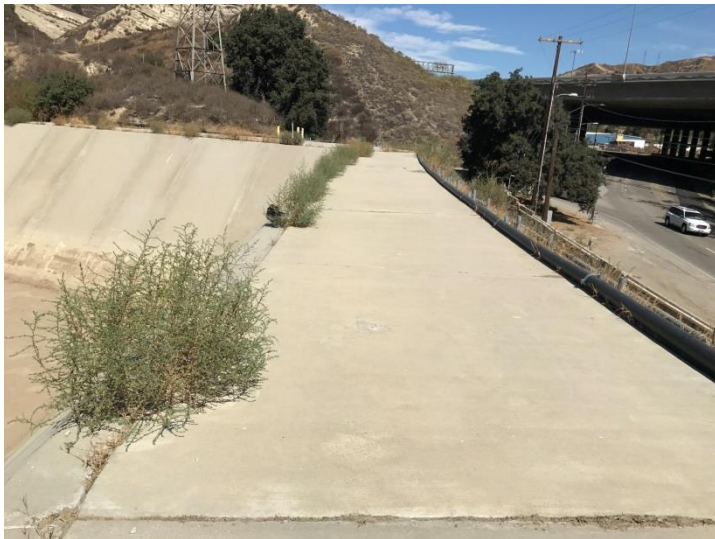
**Photo 210: Vegetation Growing Out of Terminal Basin Concrete:  
September 27, 2016**

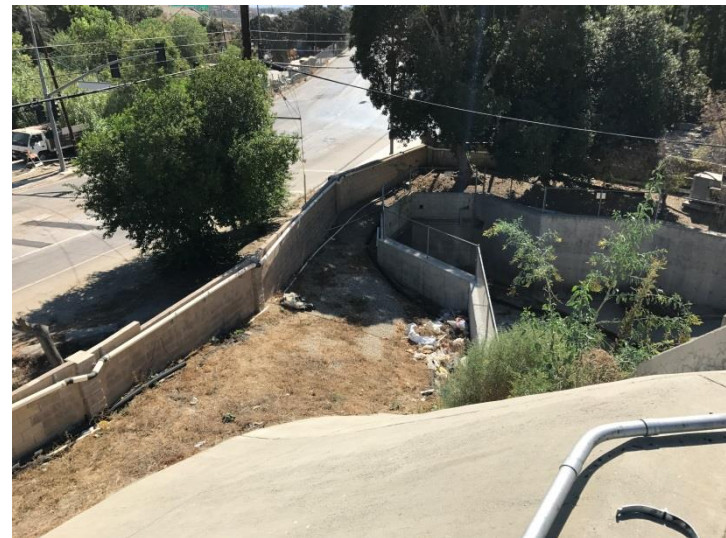
**Photo 211: Vegetation Growing Out of Terminal Basin Concrete:  
September 27, 2016**

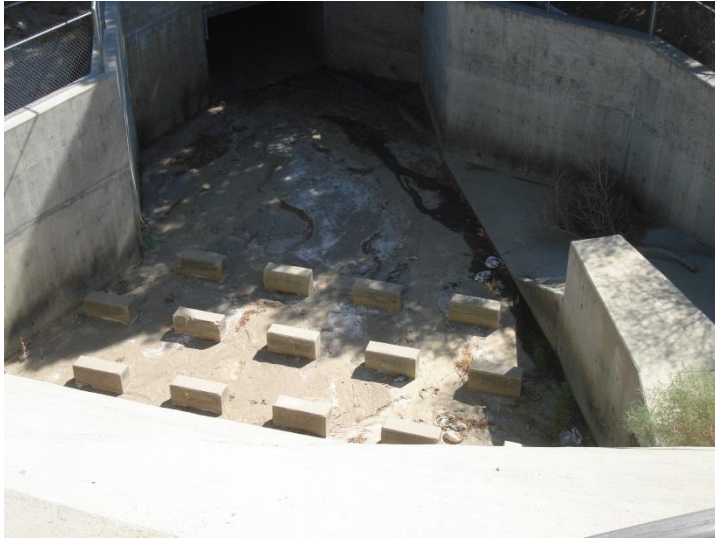
**Photo 212: Vegetation Growing Out of Terminal Basin Concrete:  
September 27, 2016**

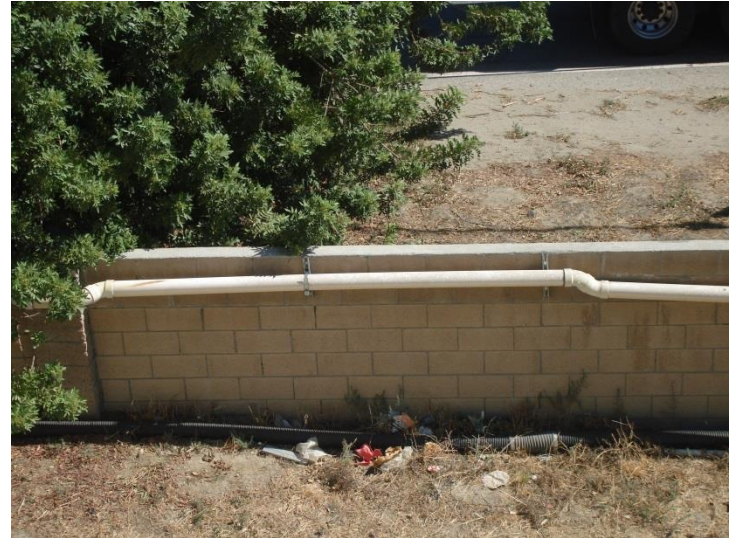
**Photo 213: Terminal Basin Outlet: September 27, 2016**

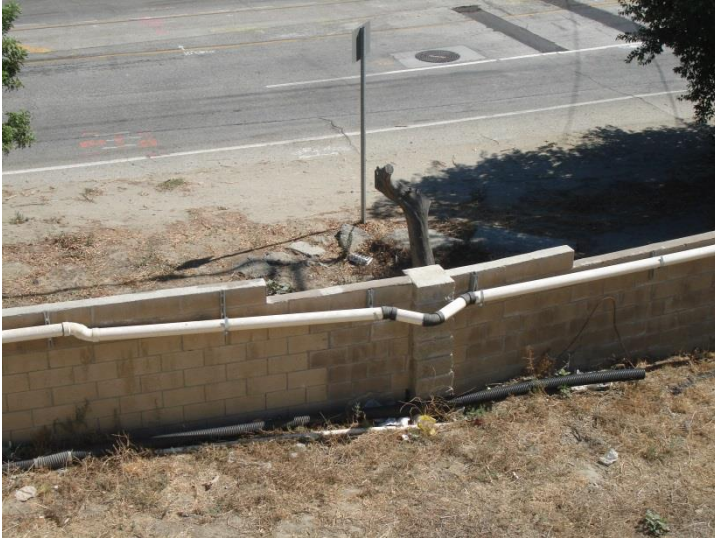
**Photo 214: Trash between San Fernando Road Block Wall and Terminal Basin: September 27, 2016**

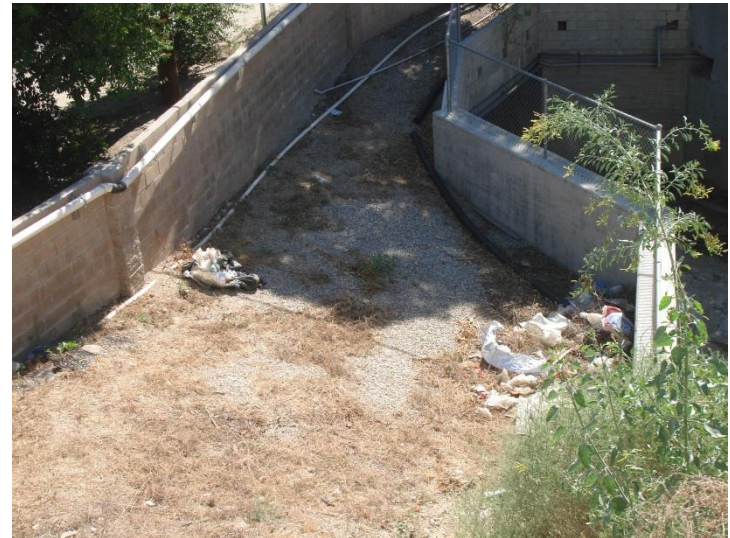
**Photo 215: Trash between San Fernando Road Block Wall and Terminal Basin: September 27, 2016**

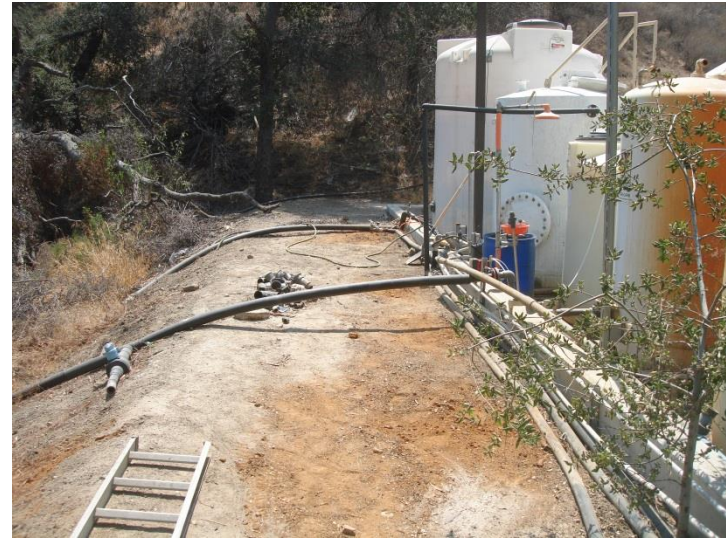
**Photo 221: Potable Water Supply Piping Leak: September 27, 2016**

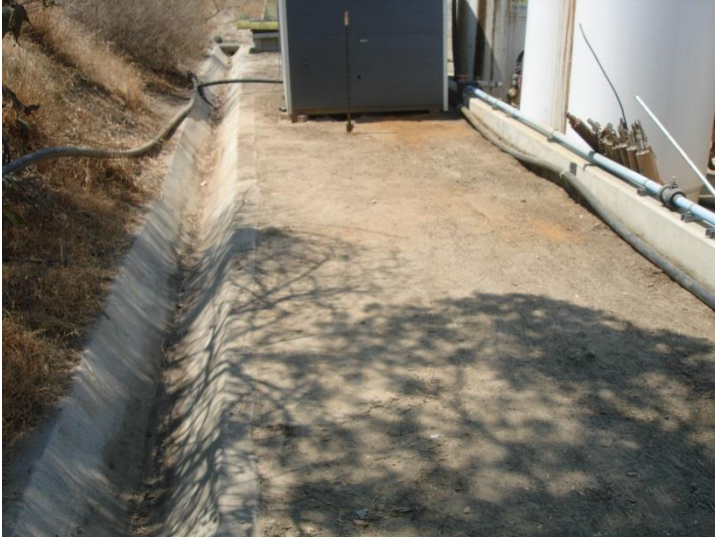
**Photo 222: Leachate Treatment Area Cleaned: August 24, 2016**

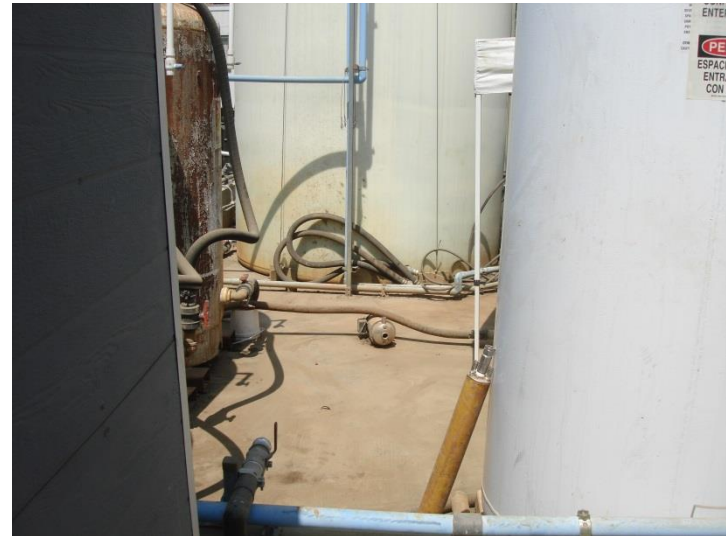
**Photo 223: Leachate Treatment Area Cleaned: August 24, 2016**

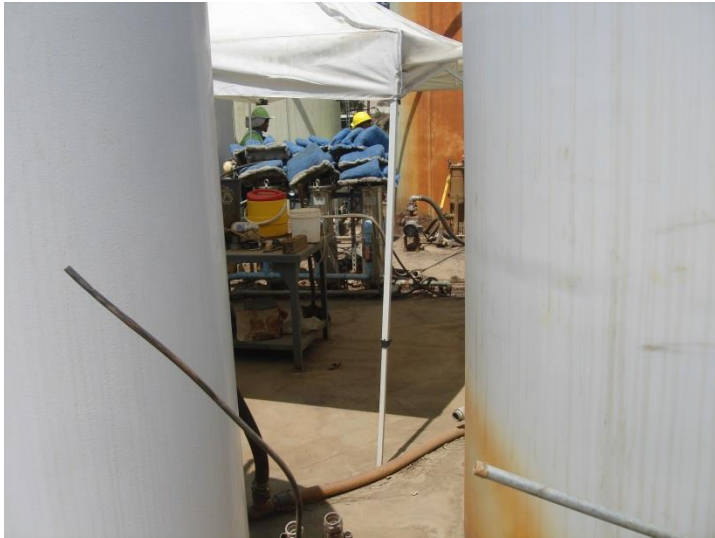
**Photo 224: Leachate Treatment Area Cleaned: August 24, 2016**

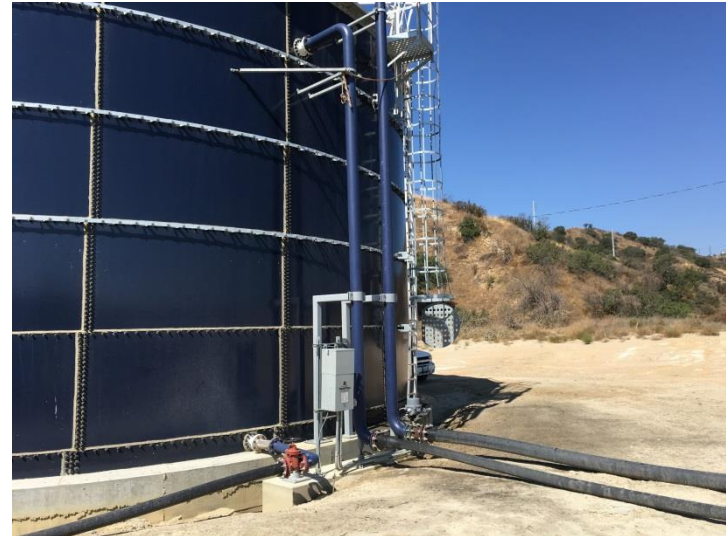
**Photo 225: Leachate Treatment Area Cleaned: August 24, 2016**

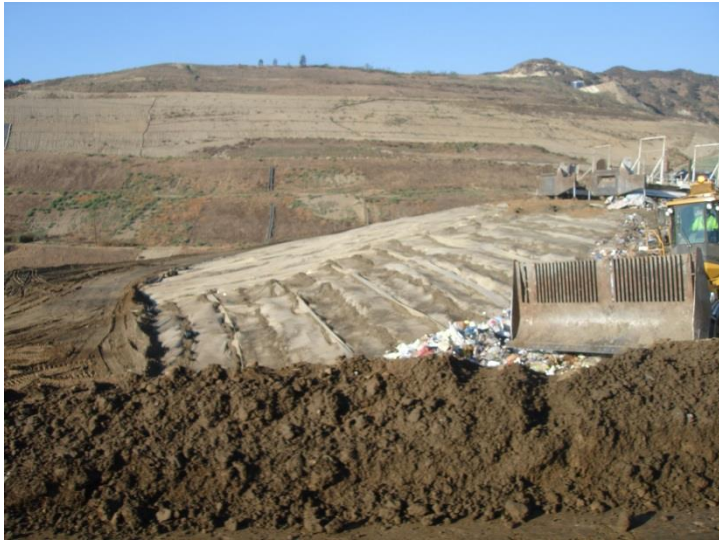
**Photo 228: Deck A Water Tank Foundation Not Backfilled:  
September 14, 2016**

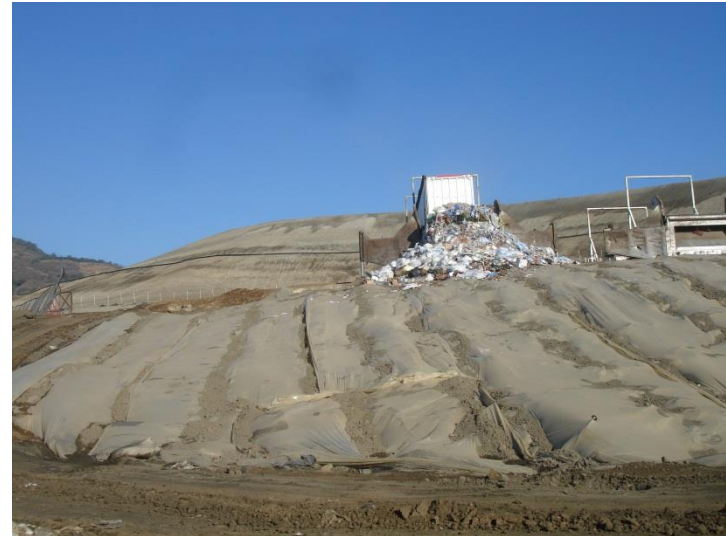
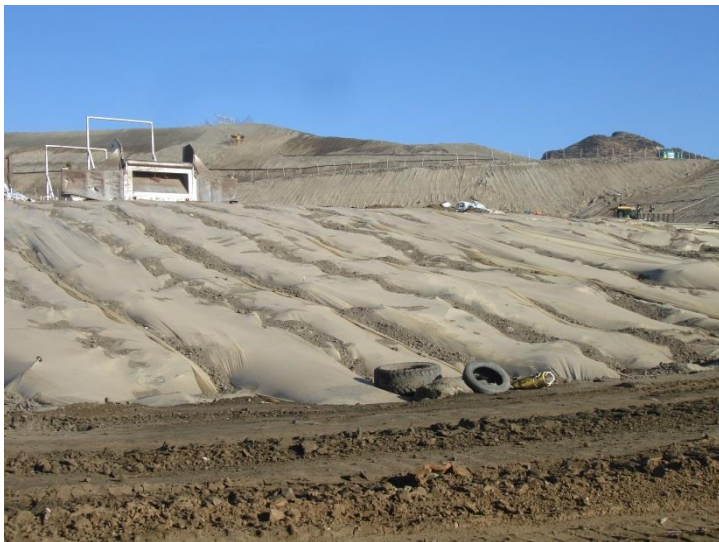
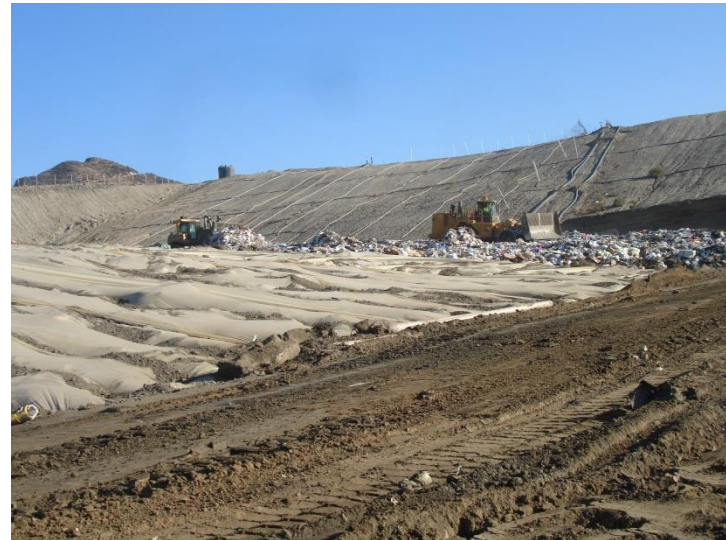
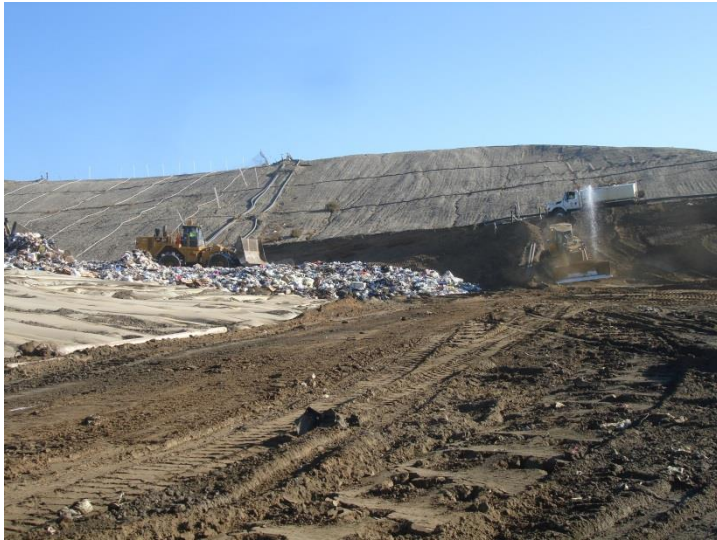
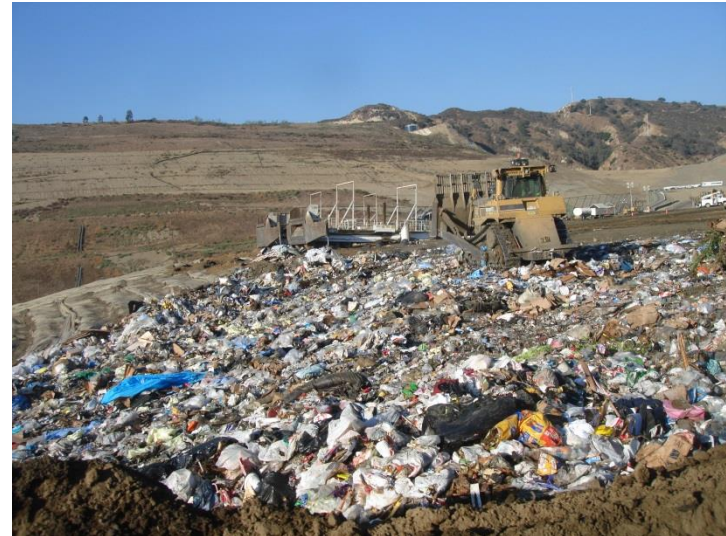
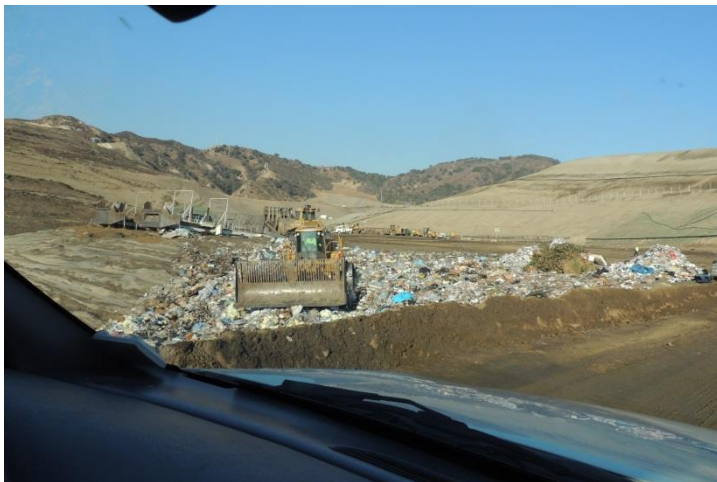
**Photo 229: Cell CC3B 800am: September 14, 2016**

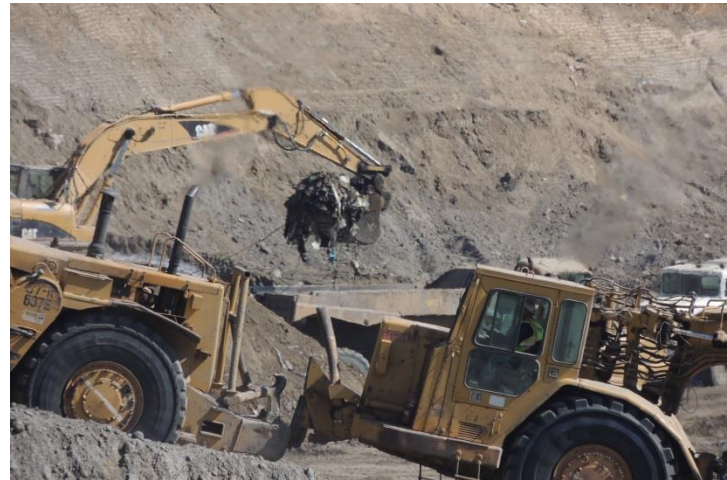
**Photo 263: Uncovering Edge of Liner for Cell CC4A: September 14, 2016**

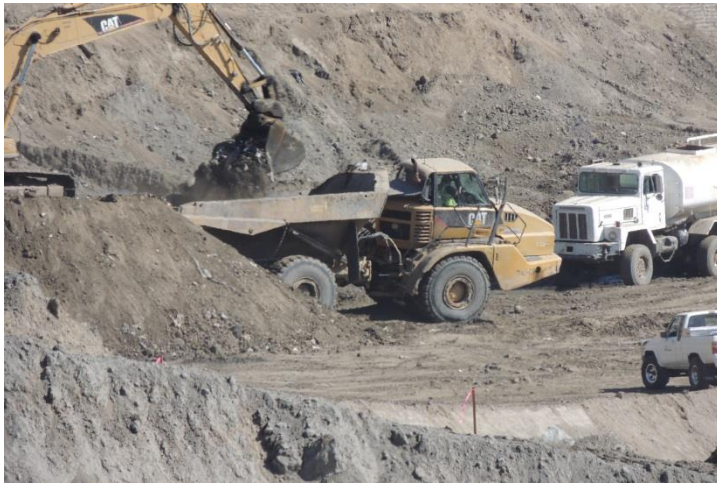
**Photo 264: Uncovering Edge of Liner for Cell CC4A: September 14, 2016**

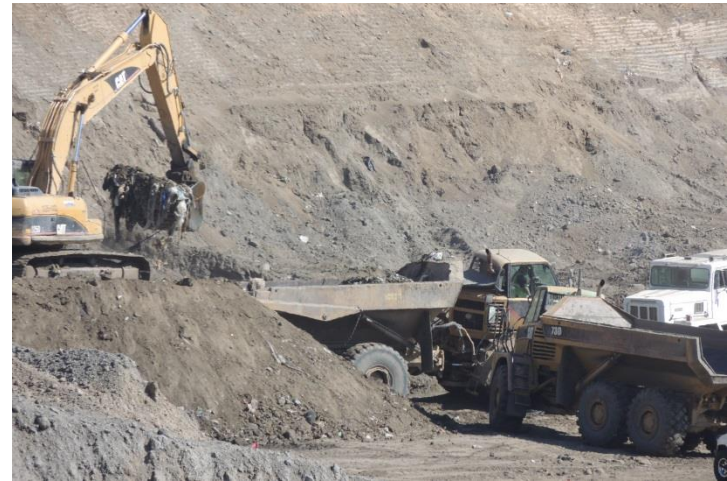
**Photo 265: Uncovering Edge of Liner for Cell CC4A: September 14, 2016**

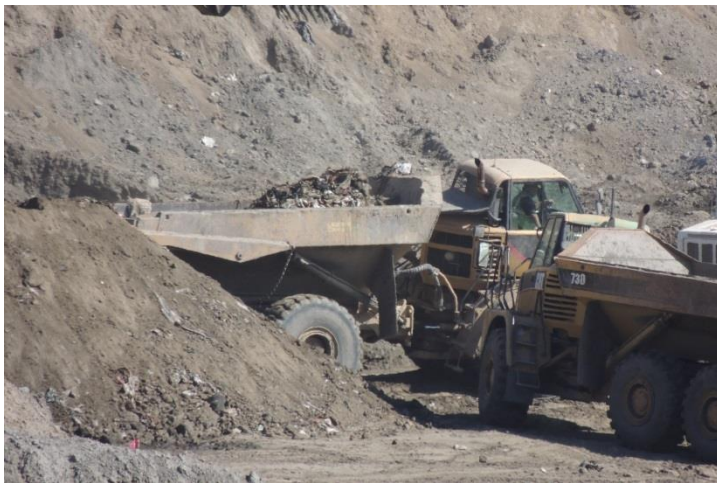
**Photo 266: Uncovering Edge of Liner for Cell CC4A: September 14, 2016**

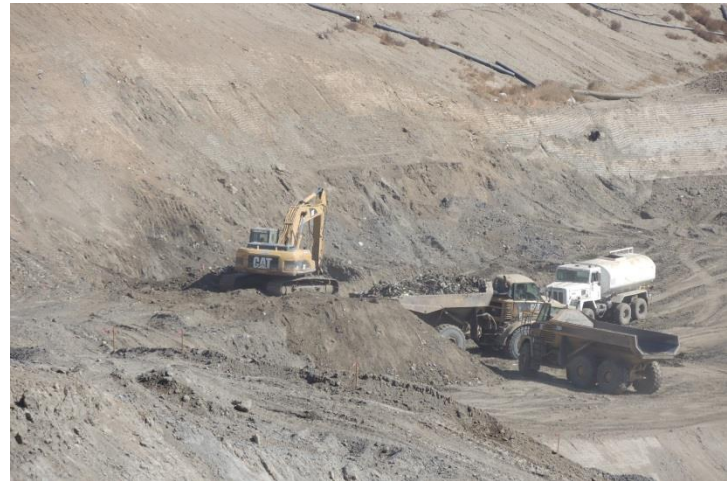
**Photo 267: Uncovering Edge of Liner for Cell CC4A: September 14, 2016**

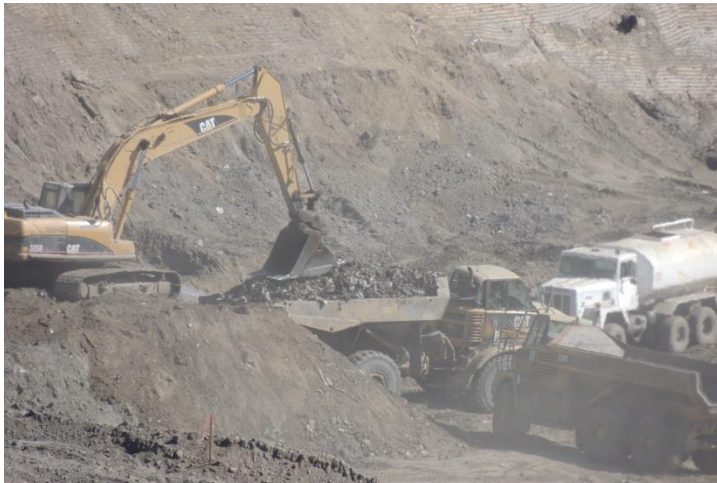
**Photo 268: Uncovering Edge of Liner for Cell CC4A: September 14, 2016**

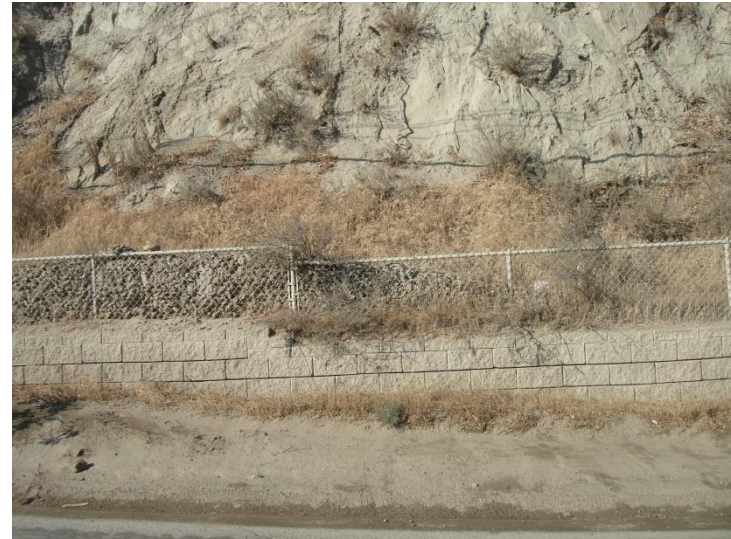
**Photo 365: Frontage Retaining Wall on San Fernando Road: July 27, 2016**

1. Remove soil that is impacting retaining wall near landfill entrance.
2. Repair the localized landfill gas leak at Flare 1, blower number 2.
3. Repair the V-ditch and slope drainage issues above Flare 1.
4. Remove wind-blown trash from Sediment Basin B.
5. Remove soil from Sediment Basin A.
